Streamside ^{at} Clarksburg

Located in Sub-Watershed LSTM 206

Response to

Ten Mile Creek Limited Master Plan Amendment Presentations

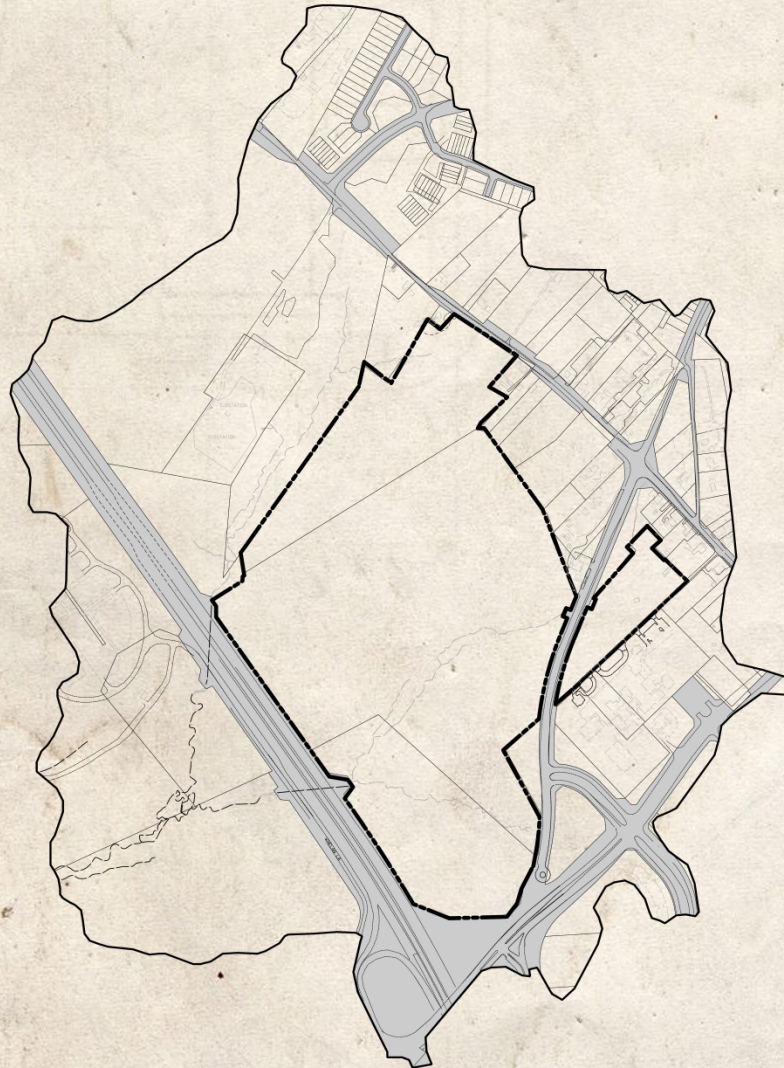
Roads

Major Roadways

60% Impervious

(Total Area 2,664,500 Sq. Ft.)

(Approximate Impervious Area
1,600,000 Sq. Ft.)

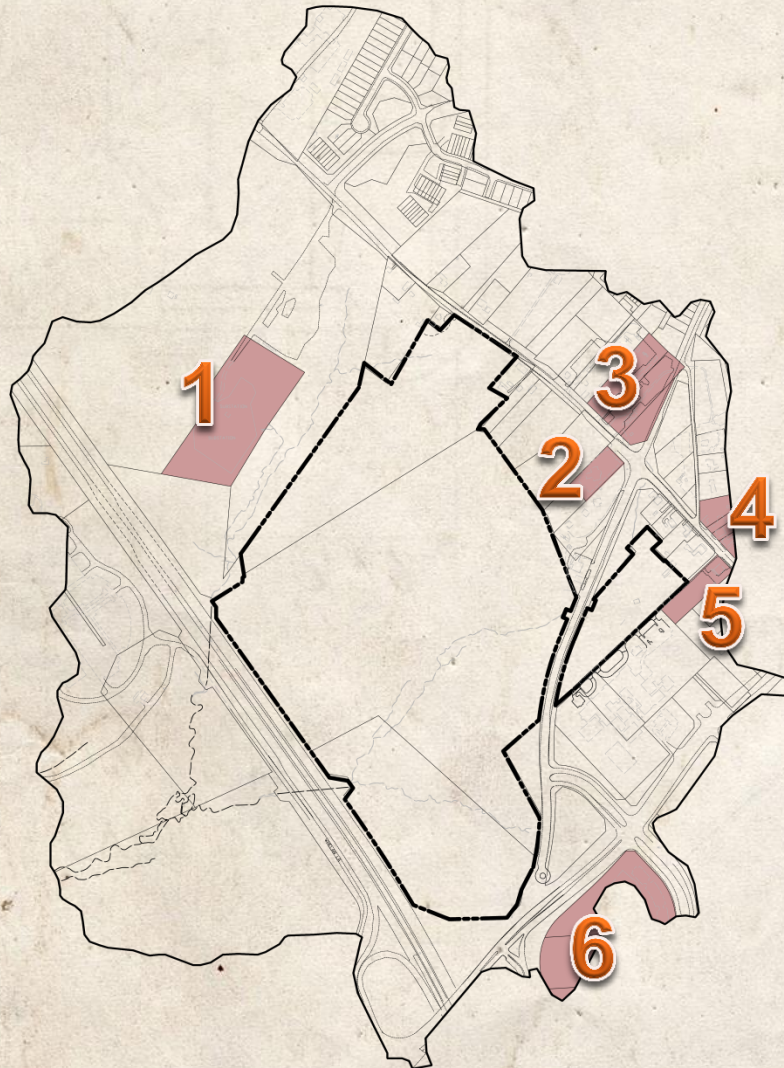
Commercial Zone

1
Substation
40 % Impervious
(Total Area 314,020 Sq. Ft.)
(Impervious Area 124,622 Sq. Ft.)

2
Bank
70 % Impervious
(Total Area 39,980 Sq. Ft.)
(Impervious Area 27,850 Sq. Ft.)

3
355 East Commercial
52 % Impervious
(Total Area 174,569 Sq. Ft.)
(Impervious Area 90,179 Sq. Ft.)

4
East 121 Commercial
32 % Impervious
(Total Area 43,095 Sq. Ft.)
(Impervious Area 13,742 Sq. Ft.)

5
Gateway Commons
12 % Impervious
(Total Area 208,862 Sq. Ft.)
(Impervious Area 25,342 Sq. Ft.)

6
Gateway Center
24 % Impervious
(Total Area 55,007 Sq. Ft.)
(Impervious Area 13,127 Sq. Ft.)

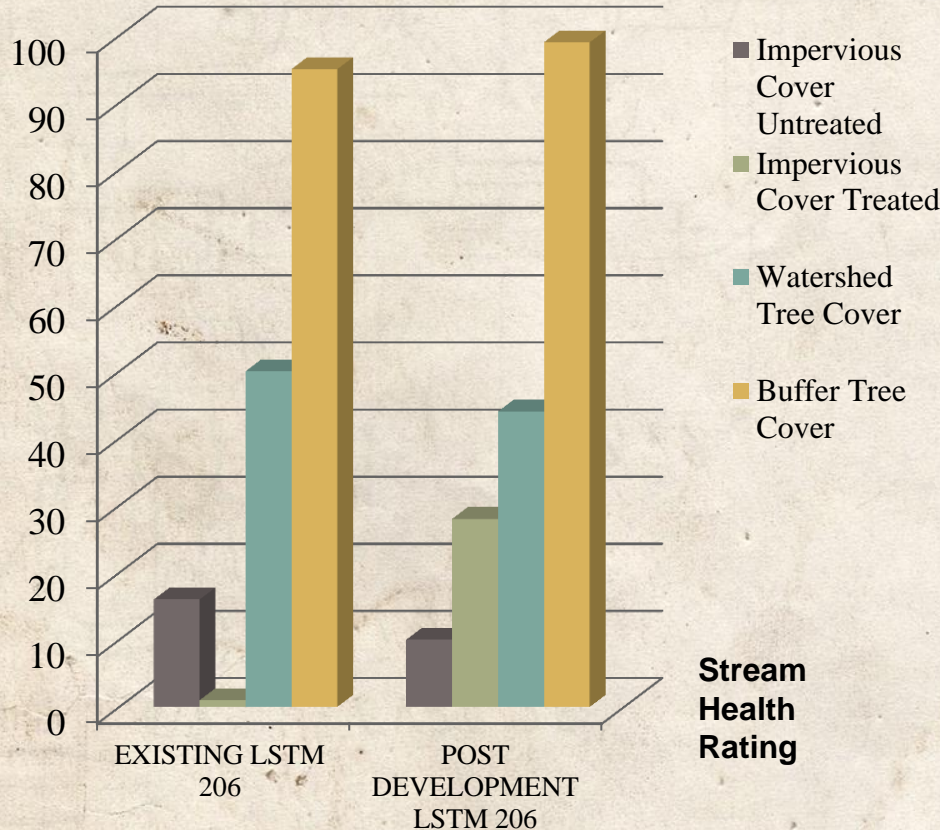
Impact of Montgomery County Land Cover on Stream Quality

What does this tell us?

POST CONSTRUCTION, STREAMSIDE STREAM HEALTH CAN IMPROVE TO **GOOD**

- Untreated and unregulated Stormwater from existing development is degrading the Streamside stream quality.
- Forested buffers are working to raise the stream quality rating.
- Retrofits and responsible development will further improve existing conditions.

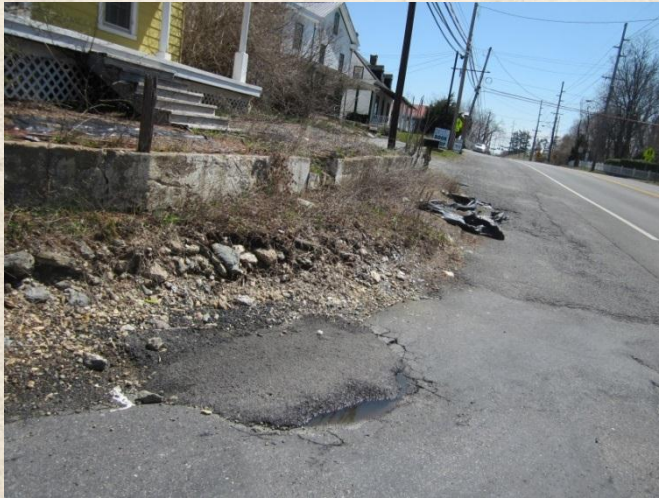
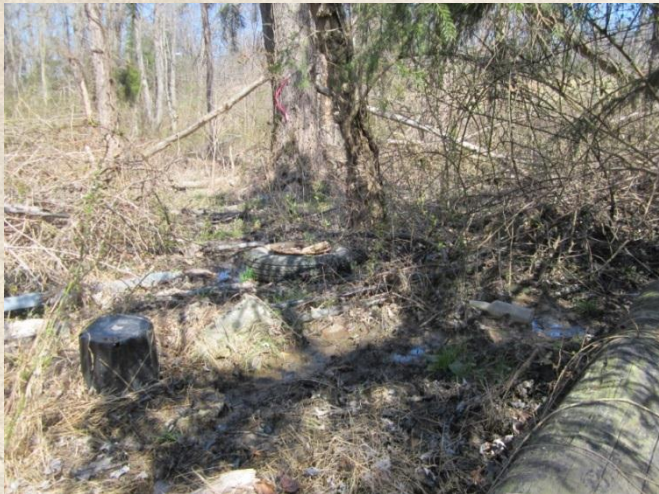
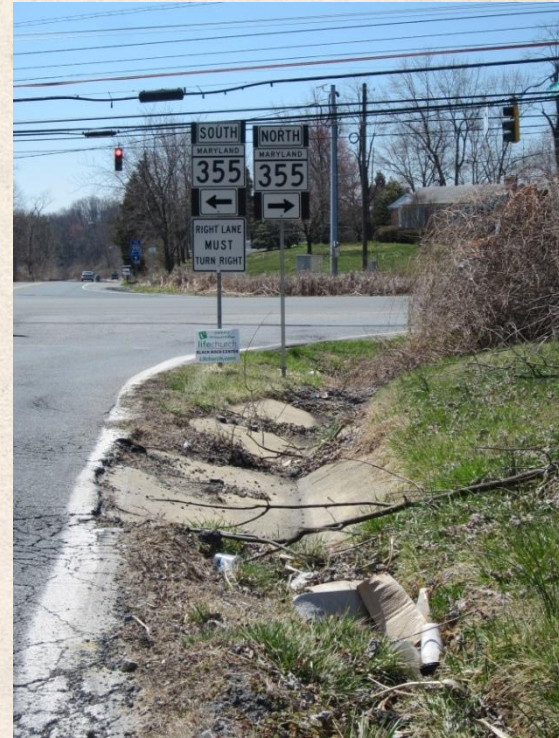
Untreated stormwater runoff is picking up pollutants and debris from the urban environment. Outdated SWM techniques are channeling this untreated flow directly into streams channels and adjacent wetlands.

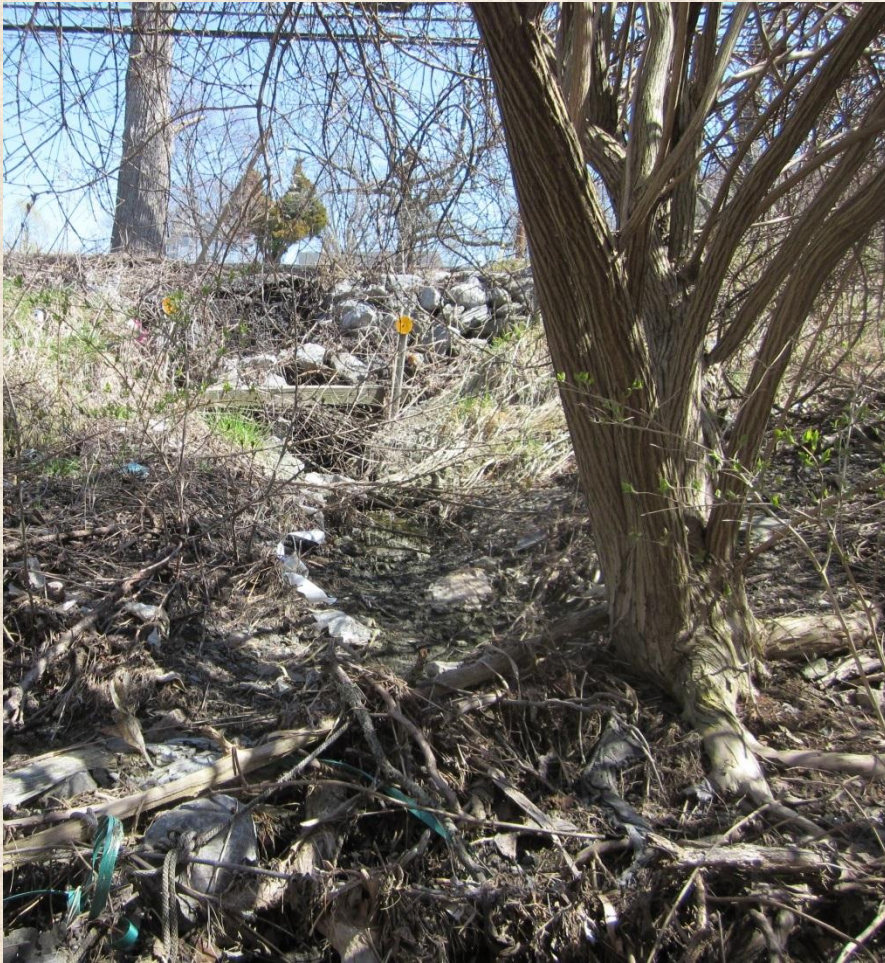
Direct untreated runoff from Route 355 to stream

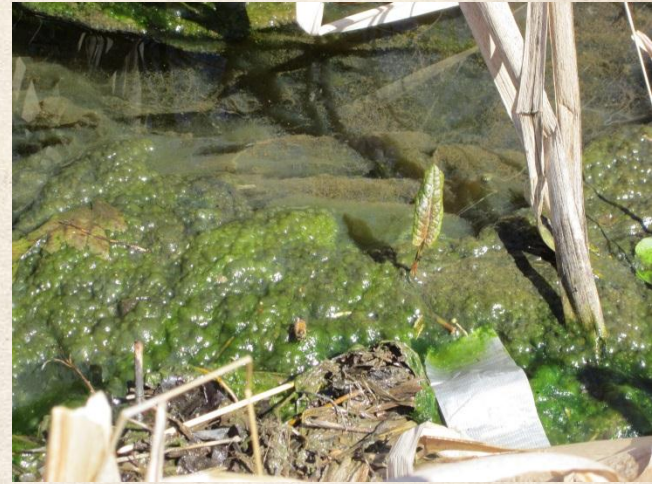
Excessive nutrients cause algae to choke habitat

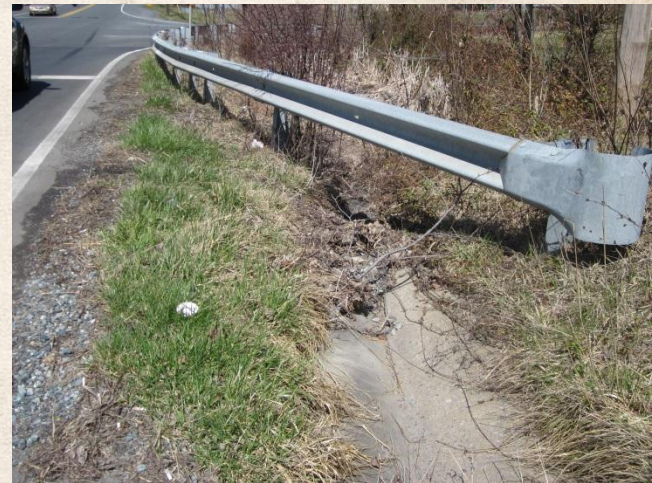
Channelized flow intensifies velocities

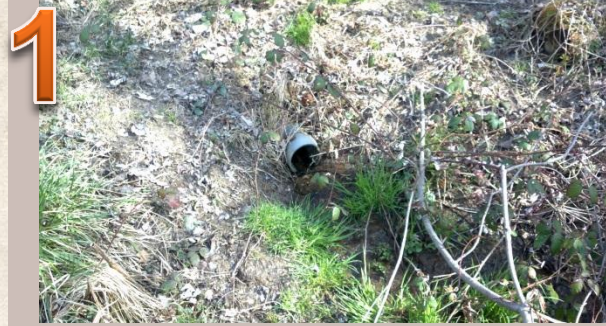
1 Offsite illegal drainage from well discharge pipe feeding wetland system.

- Visible sources are well and sump pump discharge pipes, and untreated overflows from outdated SWM practices.
- Probable additional sources are improperly abandoned septic and well systems, and failing outdated SWM practices.

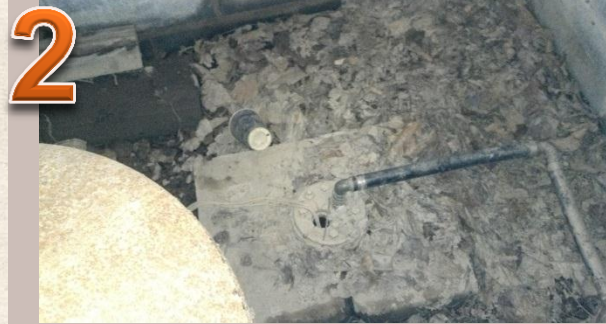
2 Illegal discharge from existing well house, sump pumps, And abandoned septic/well systems.

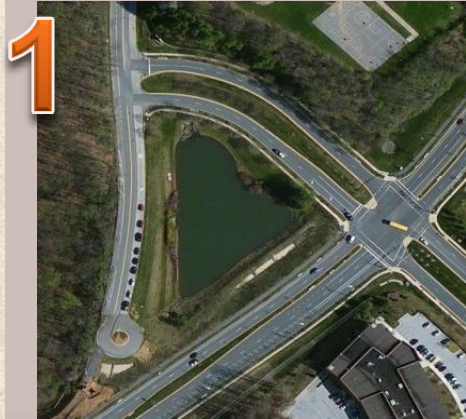
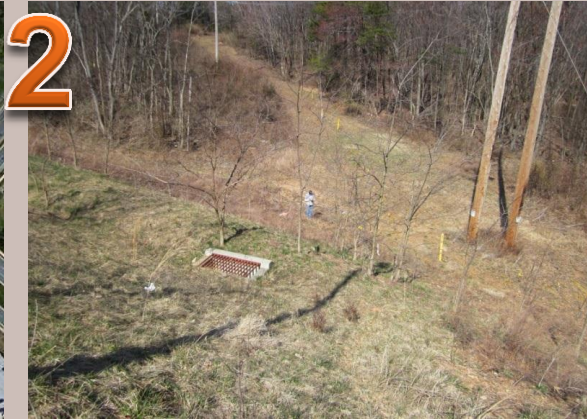
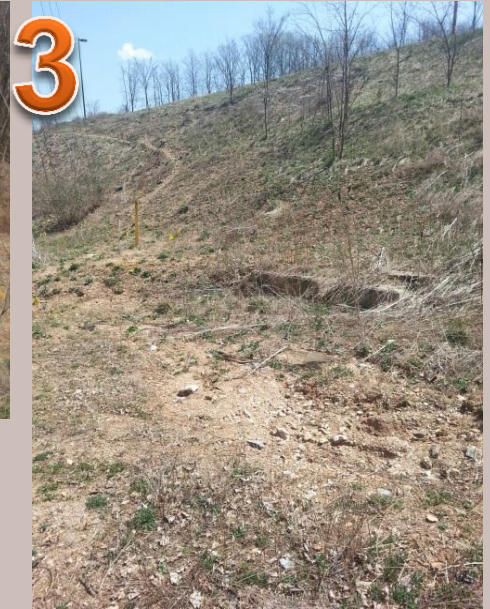
Degradation from Artificial Hydrology

- Creates artificial channels that currently pull agricultural and urban pollutants into the stream system.
- Pulls groundwater out of its natural underground channels to subsurface flows.
- Artificial extended surface flow contributes to heightens stream temperatures.

- 1 Outdated SWM Pond
- 2 MD- 121 Failing Outfall
- 3 I-270 Runoff Rills

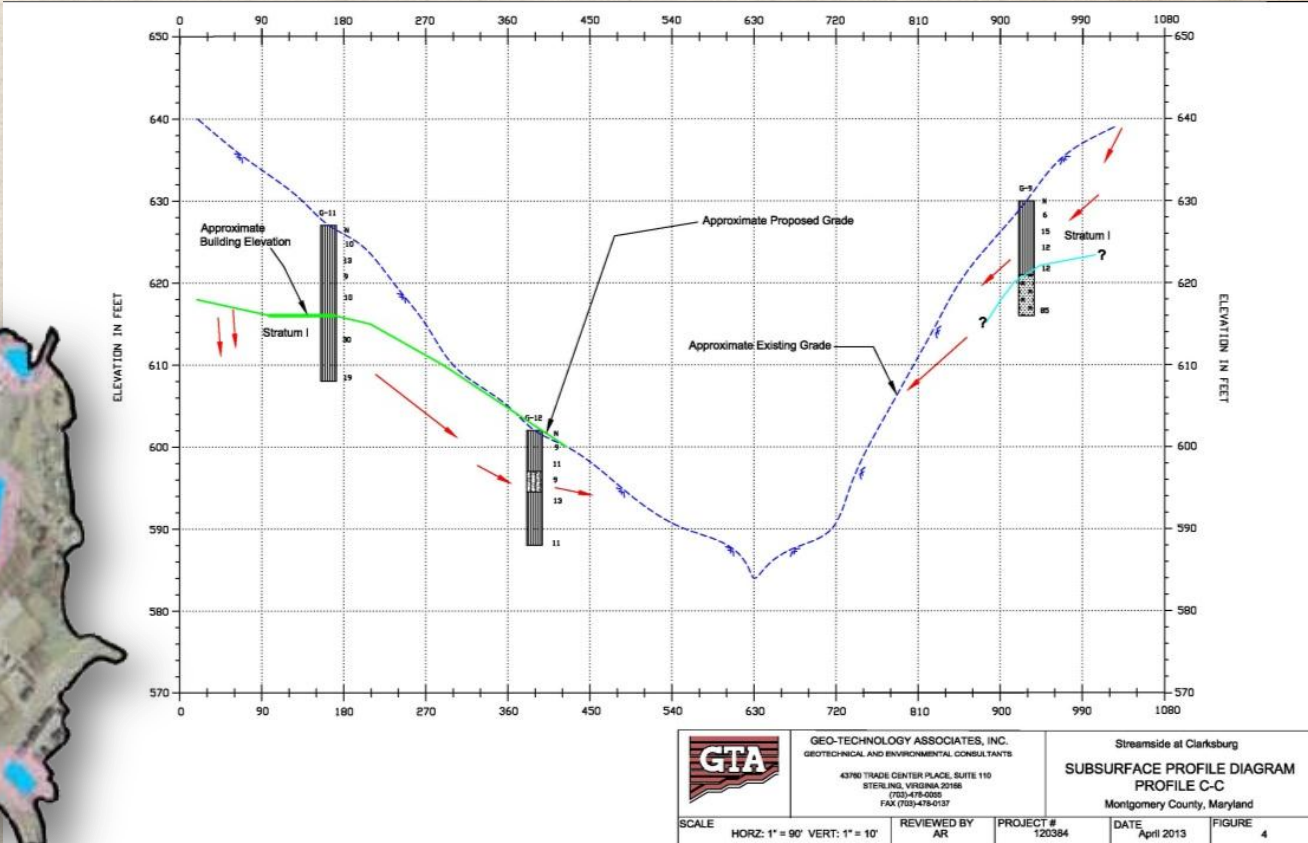
Soil borings support the idea that natural seeps are infrequent in the 206 sub-watershed

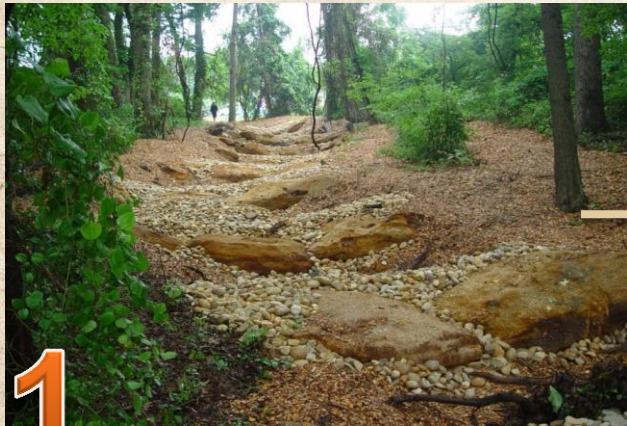
1 Initial installation

- Regenerative SPSCs are open-channel conveyance structures that convey surface storm flow to ground water flow via surface pools and a bio-retentive and infiltrating soil media.

- Reduces flow velocity
- Removes suspended nutrient and pollutant particles
- Increased infiltration rates

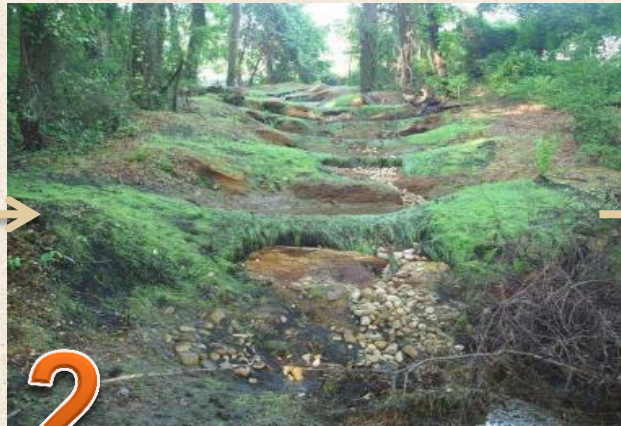
2 One Year Later

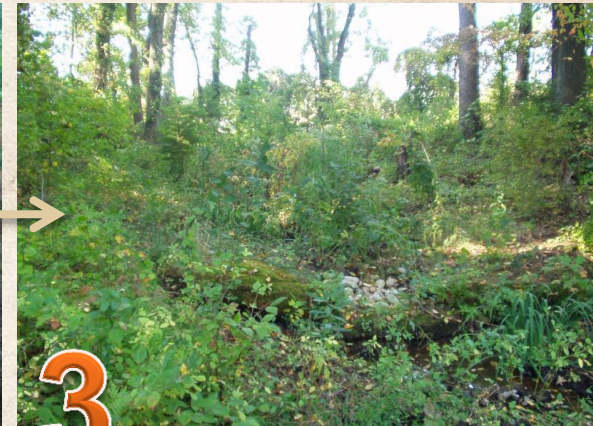
3 Six Years Later

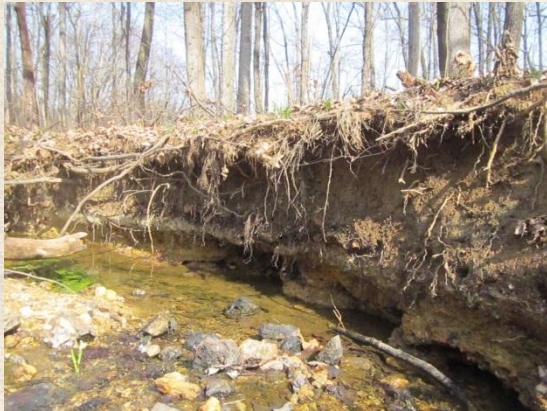
Western-most Channel

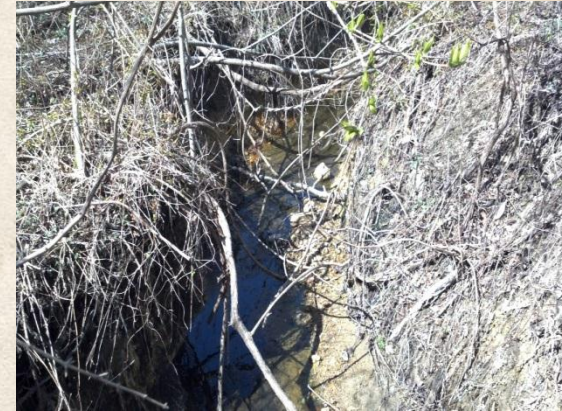
Central Channel

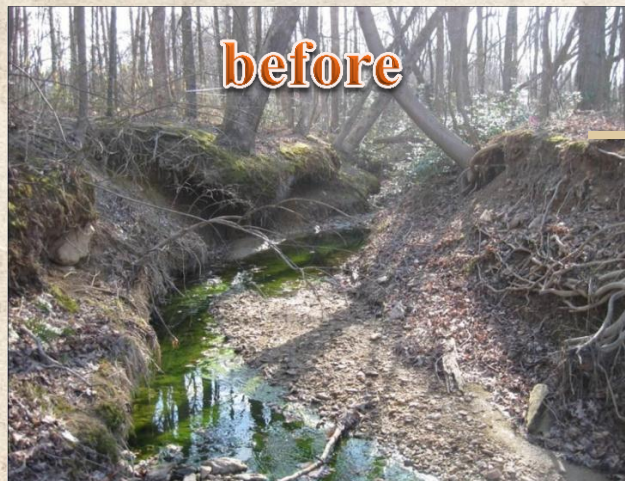
before

Degraded channel reconnected to floodplain

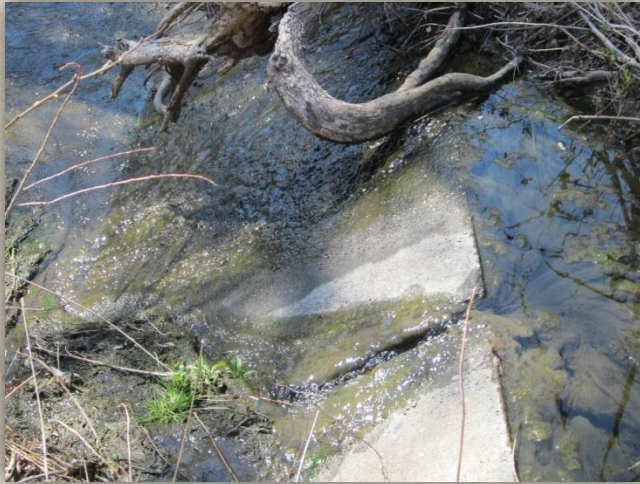
Remnants of Concrete Channels

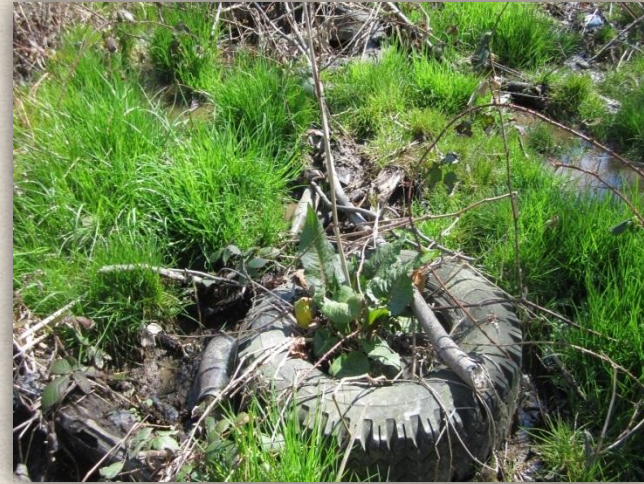
Debris

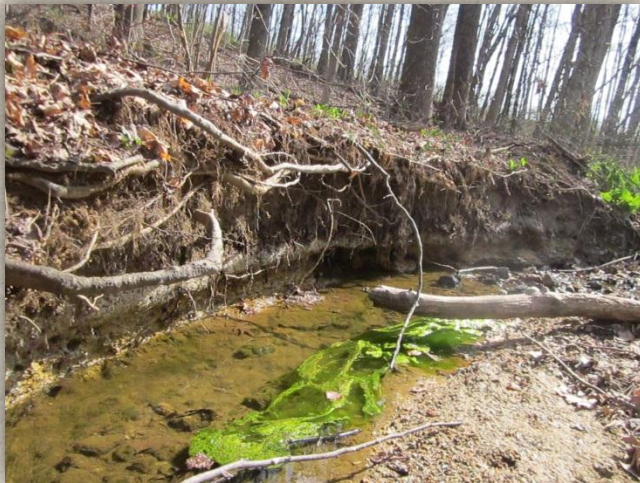
Excessive Algae and Sediment

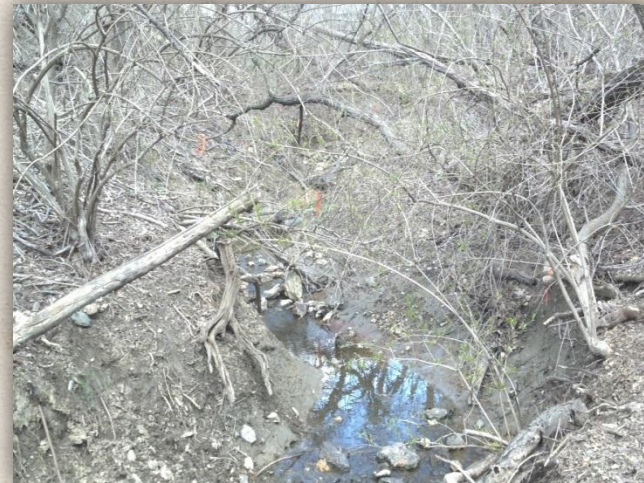
Scoured Stream Channels

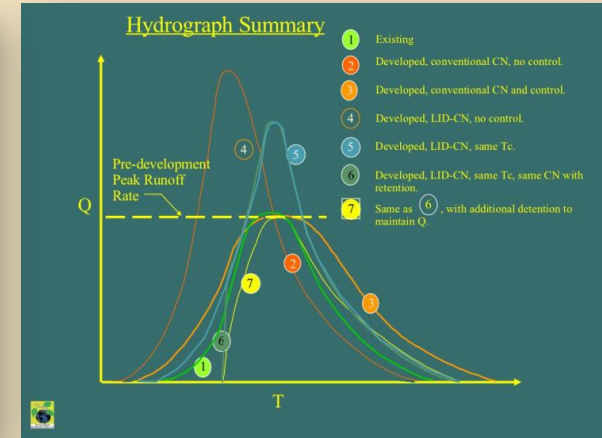
Pre development conditions at Streamside TODAY flow similarly the POST DEVELOPMENT hydrograph above because SWM controls are lacking and/or outdated.

- Direct discharge into creeks
- Failing outfalls
- Illegal discharge into creeks and wetlands

Post development conditions at Streamside will closely align with #7 on the model developed by Low Impact Design Center.

- ESD stormwater management throughout new development.
- Supplemental detention provided as a result of treatment train approach
- Strategic enhancements and retrofits to existing impervious areas
