Chapter Three

OUTBUILDINGS

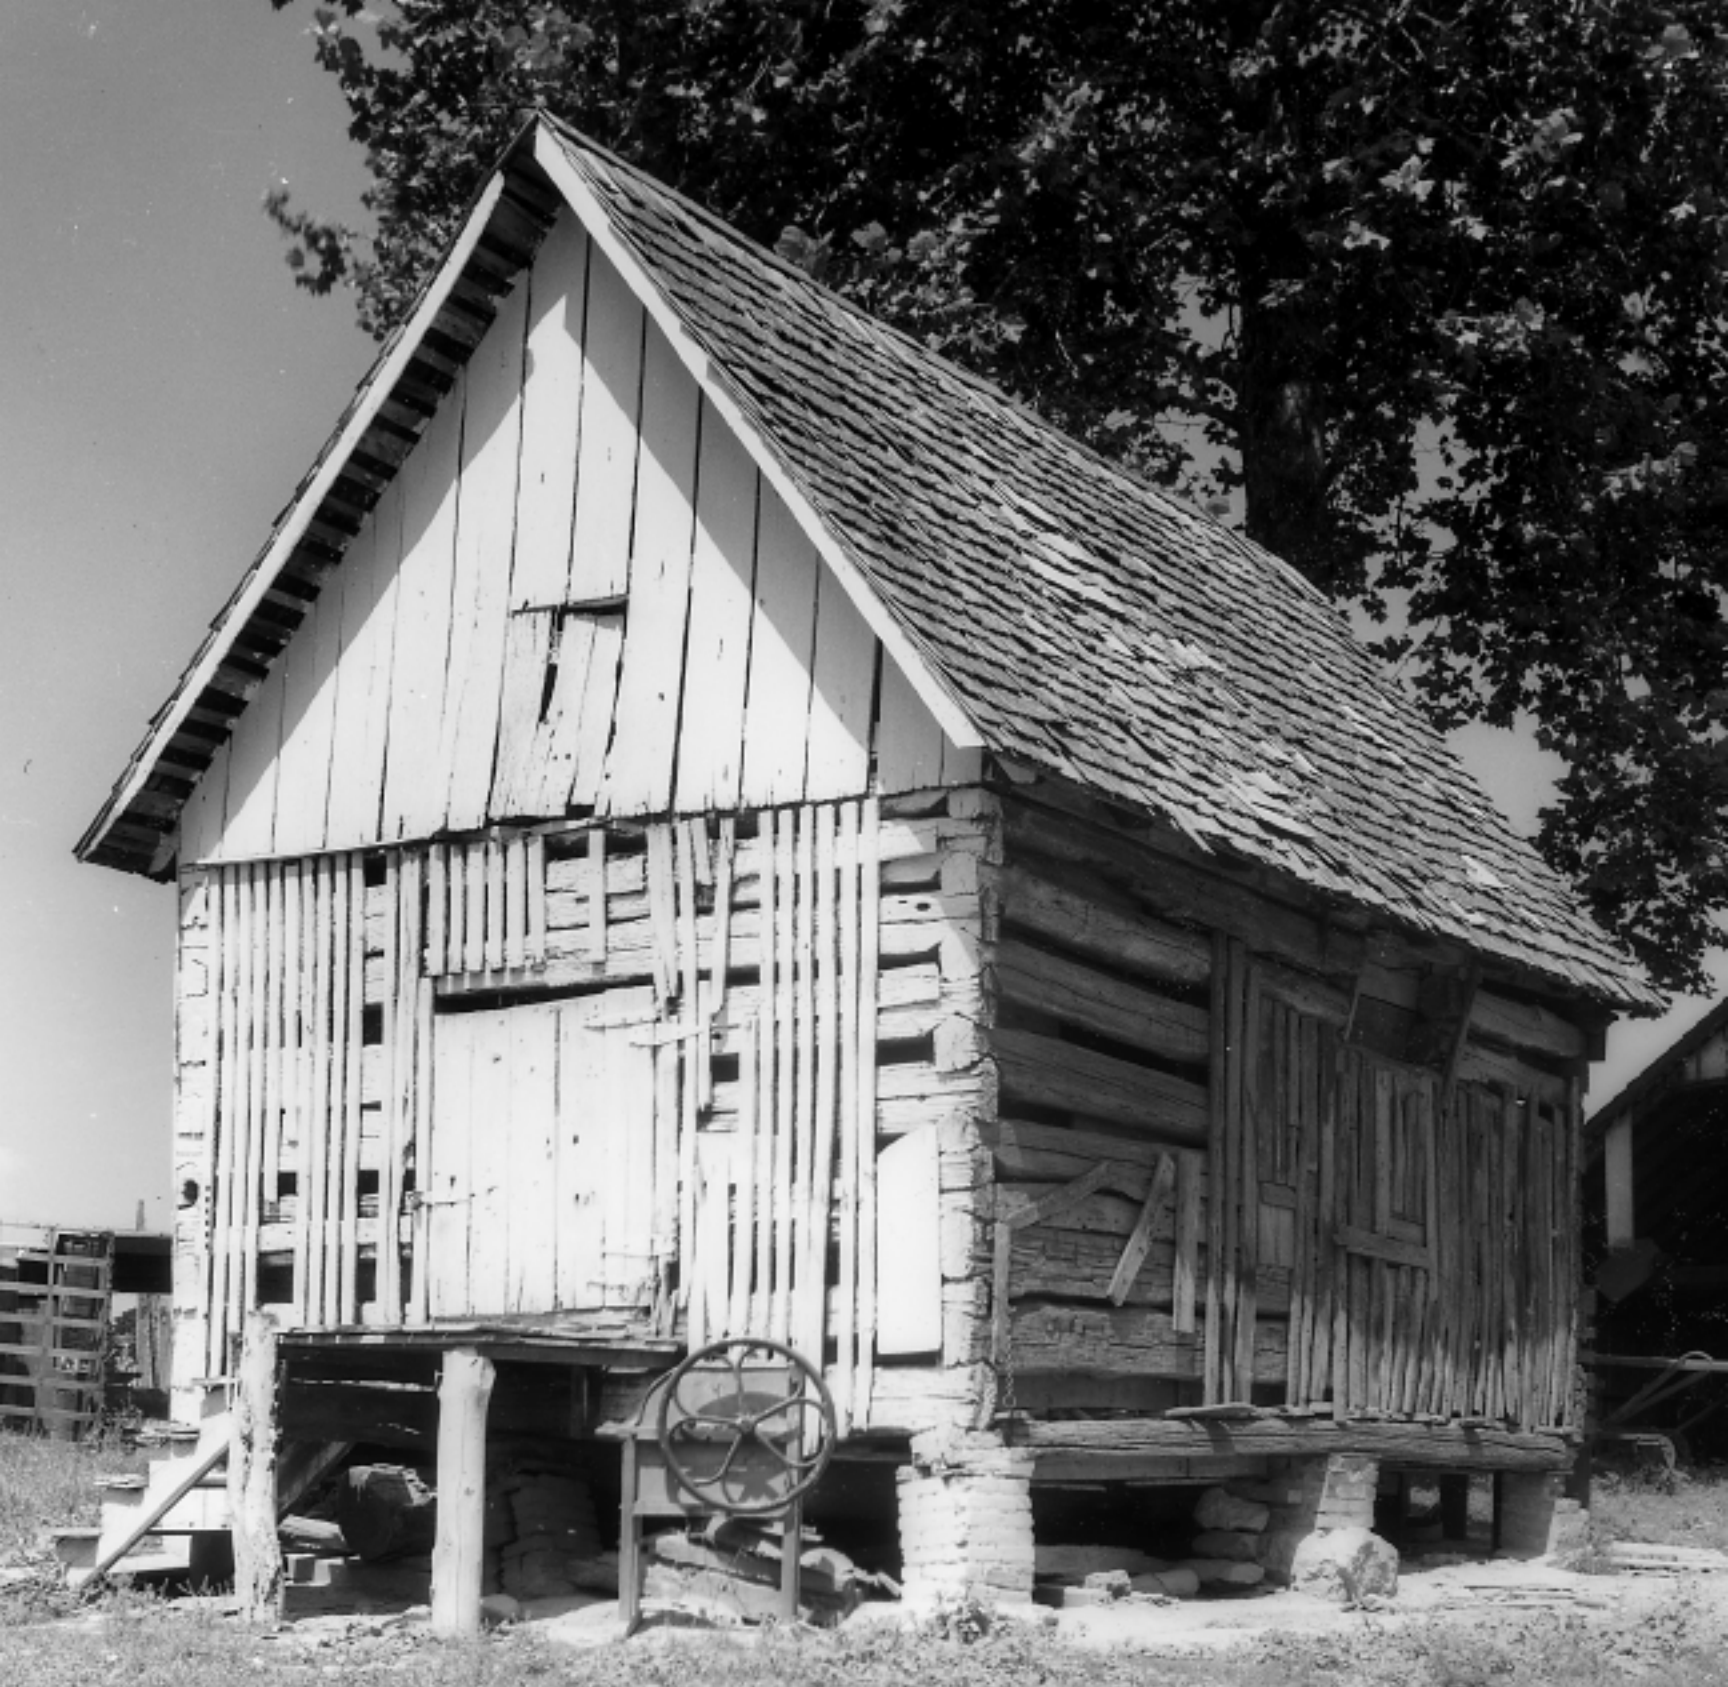
*This log outbuilding at **Falling Green**, possibly a corn house, was photographed in 1936. When the property was surveyed for a historic sites inventory in 1979, the structure was no longer standing.*

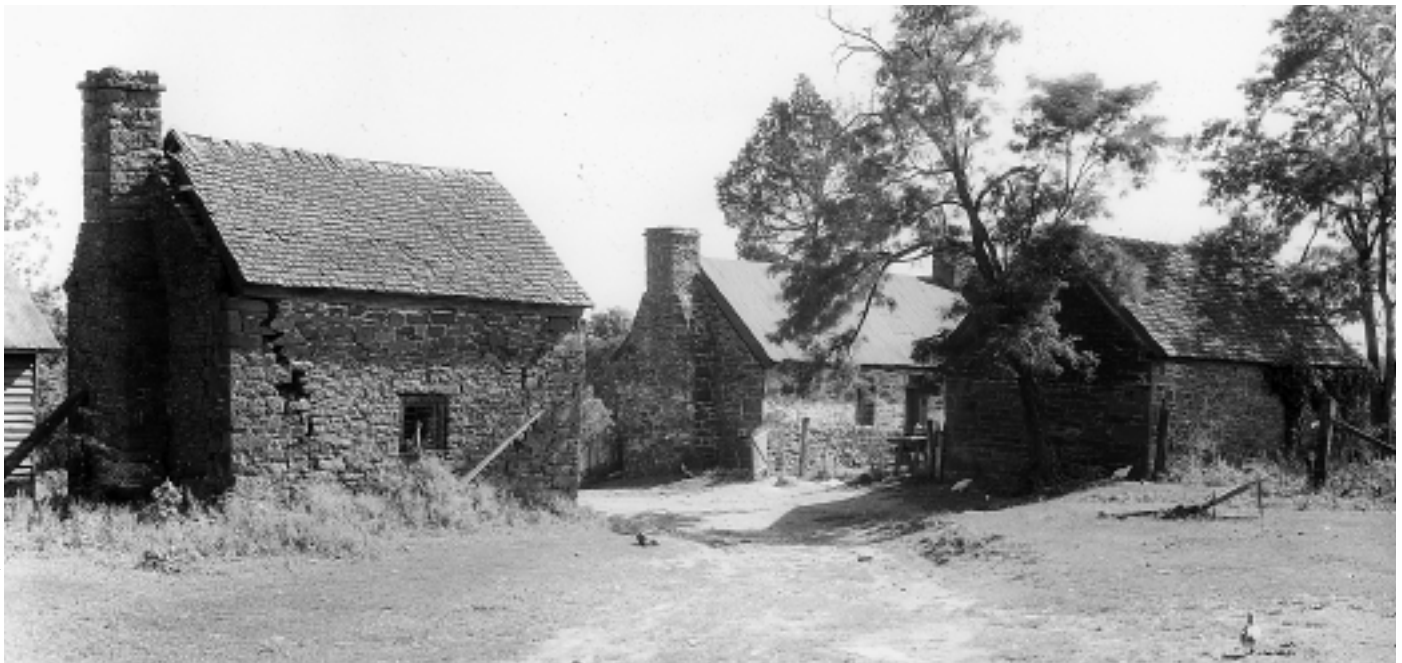
*The **Darnall Place**, on Whites Ferry Road, has one of the finest collections of early farm buildings in the county. Simple, yet substantial, the buildings are constructed of uncoursed Seneca sandstone and probably date from the late 1700s. The complex of stone structures includes a slave quarter, kitchen, combination smokehouse and dairy, and a small barn.*

Several houses grew to incorporate kitchens that were originally detached. A stone kitchen at the **Darnall Place** (late 1700s) is attached to the main house by a frame addition, as is a log kitchen at **Valhalla** (1835). A log outbuilding covered with siding at the **A. J. Cashell Farm** may be a summer kitchen or a wash house. The structure has a large rear brick chimney, and a projecting wood shingle roof with brackets.

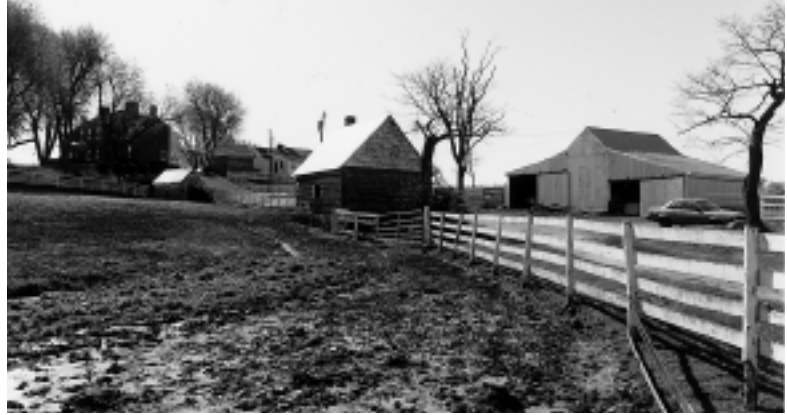
M-NCPPC, 1986

Above: **Inverness** is a visual reminder of the nearly self-sufficient lifestyle of farmers in the early 1800s, with its large grouping of outbuildings clustered around the substantial farmhouse. The farmstead includes a log blacksmith shop, log smokehouse, stone springhouse, log and stone slave quarter, a frame corncrib, and a stone-end bank barn.

Many farmsteads retain only one or two of their original cluster of outbuildings. Few properties maintain an intact collection of buildings. A farmstead with one of the finest collection of outbuildings is **Inverness**, in the Monocacy watershed. The main house, built in 1818, is a three-part brick residence with a kitchen wing. The complex includes a log and stone slave quarter, stone end wall bank barn, log smokehouse, stone spring house, log blacksmith shop and timber frame corn crib. Nearby **East Oaks** has an impressive collection of substantial outbuildings supplementing its three-part brick house (1829). The complex includes a brick smokehouse, sandstone slave quarter, stone bank barn, stone milk house, and tenant house. A topic for further research is the arrangement of outbuildings in the farmstead. Anglo-American plantations tended to have a formal geometric arrangement of buildings, while Germanic farmsteads in the Mid-Atlantic tended to be arranged in a row along the top of a low ridge.¹

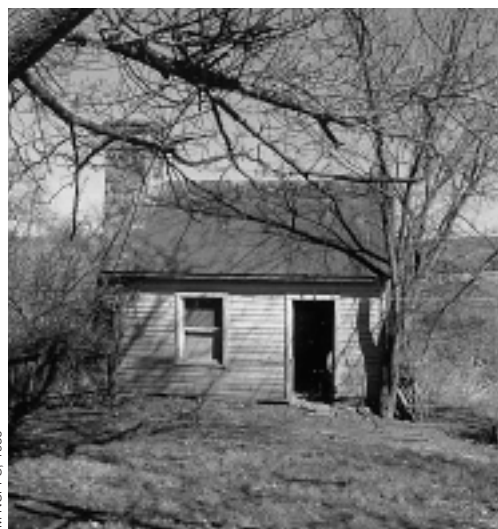
MANCPFC, 1966

Top: The log kitchen at **Valhalla** stands at the southeast corner of the main stone dwelling, built in 1835 and expanded c1855-65. The outbuilding was connected to the residence by a small frame addition two years after this photograph was made.

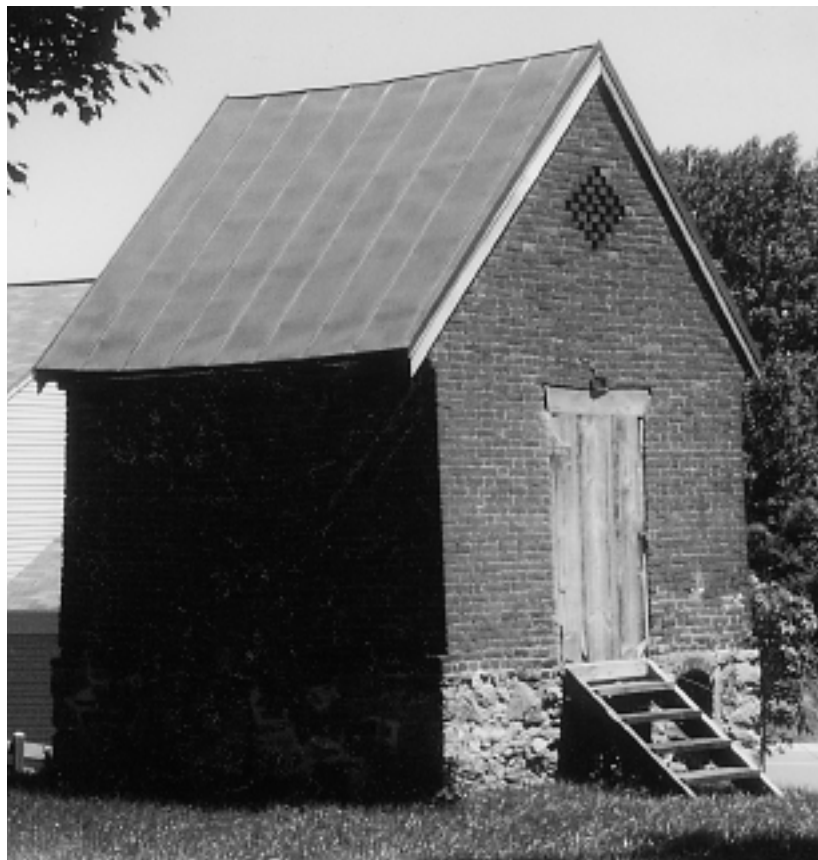
Kay Whitney, Traces, May 1990

A fine example of a brick smokehouse stands at the **O'Hare House** in Eastern Montgomery County.

Nearly all the brick smokehouses are gable front buildings. Typical is the 12' x 15' structure at **Dowden's Luck**, near Poolesville, built by 1842. The gable end is pierced with holes to vent smoke. In the eastern region, the **O'Hare House** (c1825) has an especially fine brick smokehouse with a high stone foundation and a diamond pattern of vents in the gable.

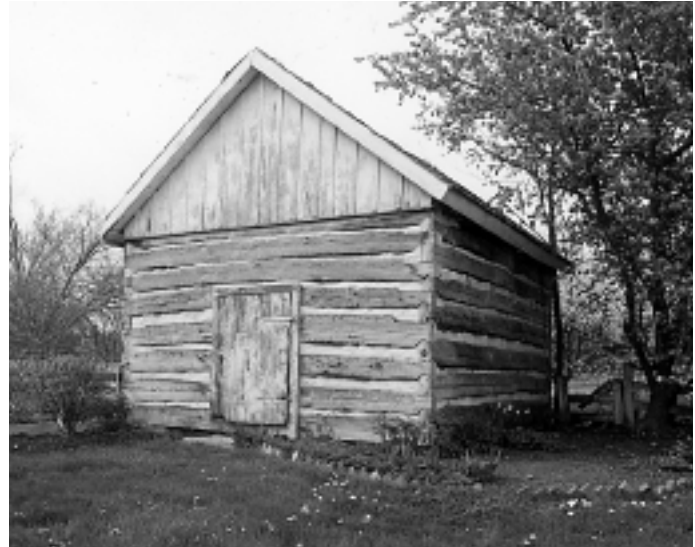
M-NCPPC, 1986

*This log smokehouse stands at the Allnut's **Rocklands** farm on Montevideo Road. The logs are joined with V-notches and filled with stone chinking.*

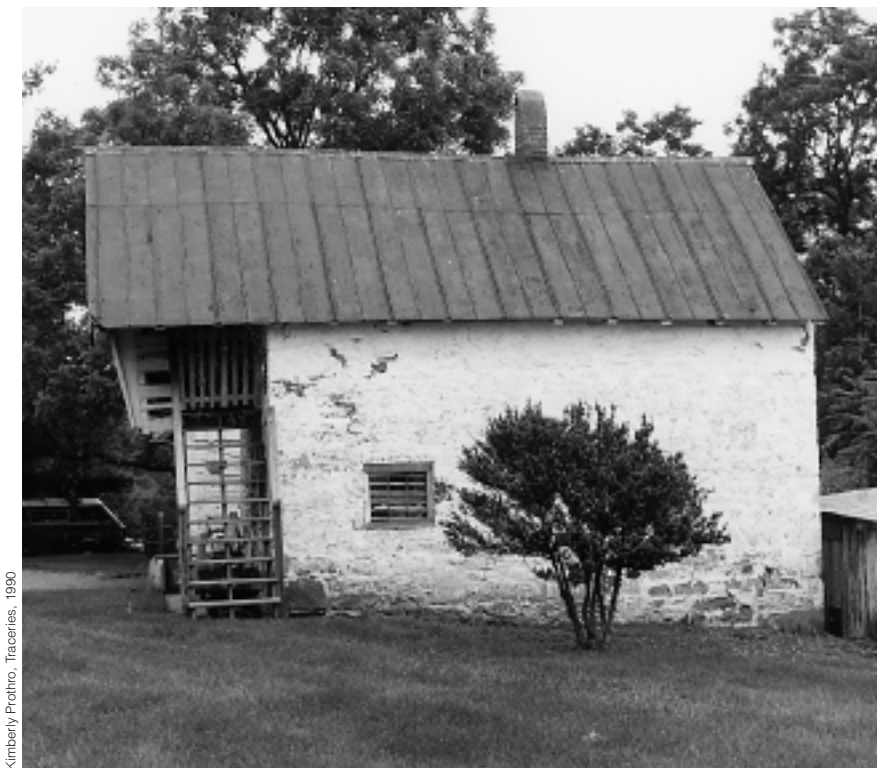
*Below left: This two level outbuilding stands next to the **Needwood** mansion. The projecting roof gable protects an exterior staircase. The lower level was probably either a dairy or icehouse. The original use of the upper room, measuring 18' x 12', is unknown. The brick chimney, which is not original to the structure, was connected to a stove that heated the space for farm workers in the early 20th century. William George Robertson built the main dwelling in 1856 on land he inherited from his father in 1842.*

Another group of two-story, dual-use outbuildings have gable-end roof projections that shelter second-level doorways. At **Needwood**, established 1856, a two-story outbuilding is said to have had a dairy or icehouse on the first level. The second level housed workers in later years, but its original use is unknown. A similar structure is found at **Oatland**, established 1875. Both buildings have louvered windows on the eaves side of the first story. The **Waters Farm** of 1790 had a similar dual use outbuilding with second story landing and balustrade. At the **Hilary Pyles Farm** (mid-1800s), a two-story frame springhouse, covered with board and batten siding, has a loft room accessed from the gable end.

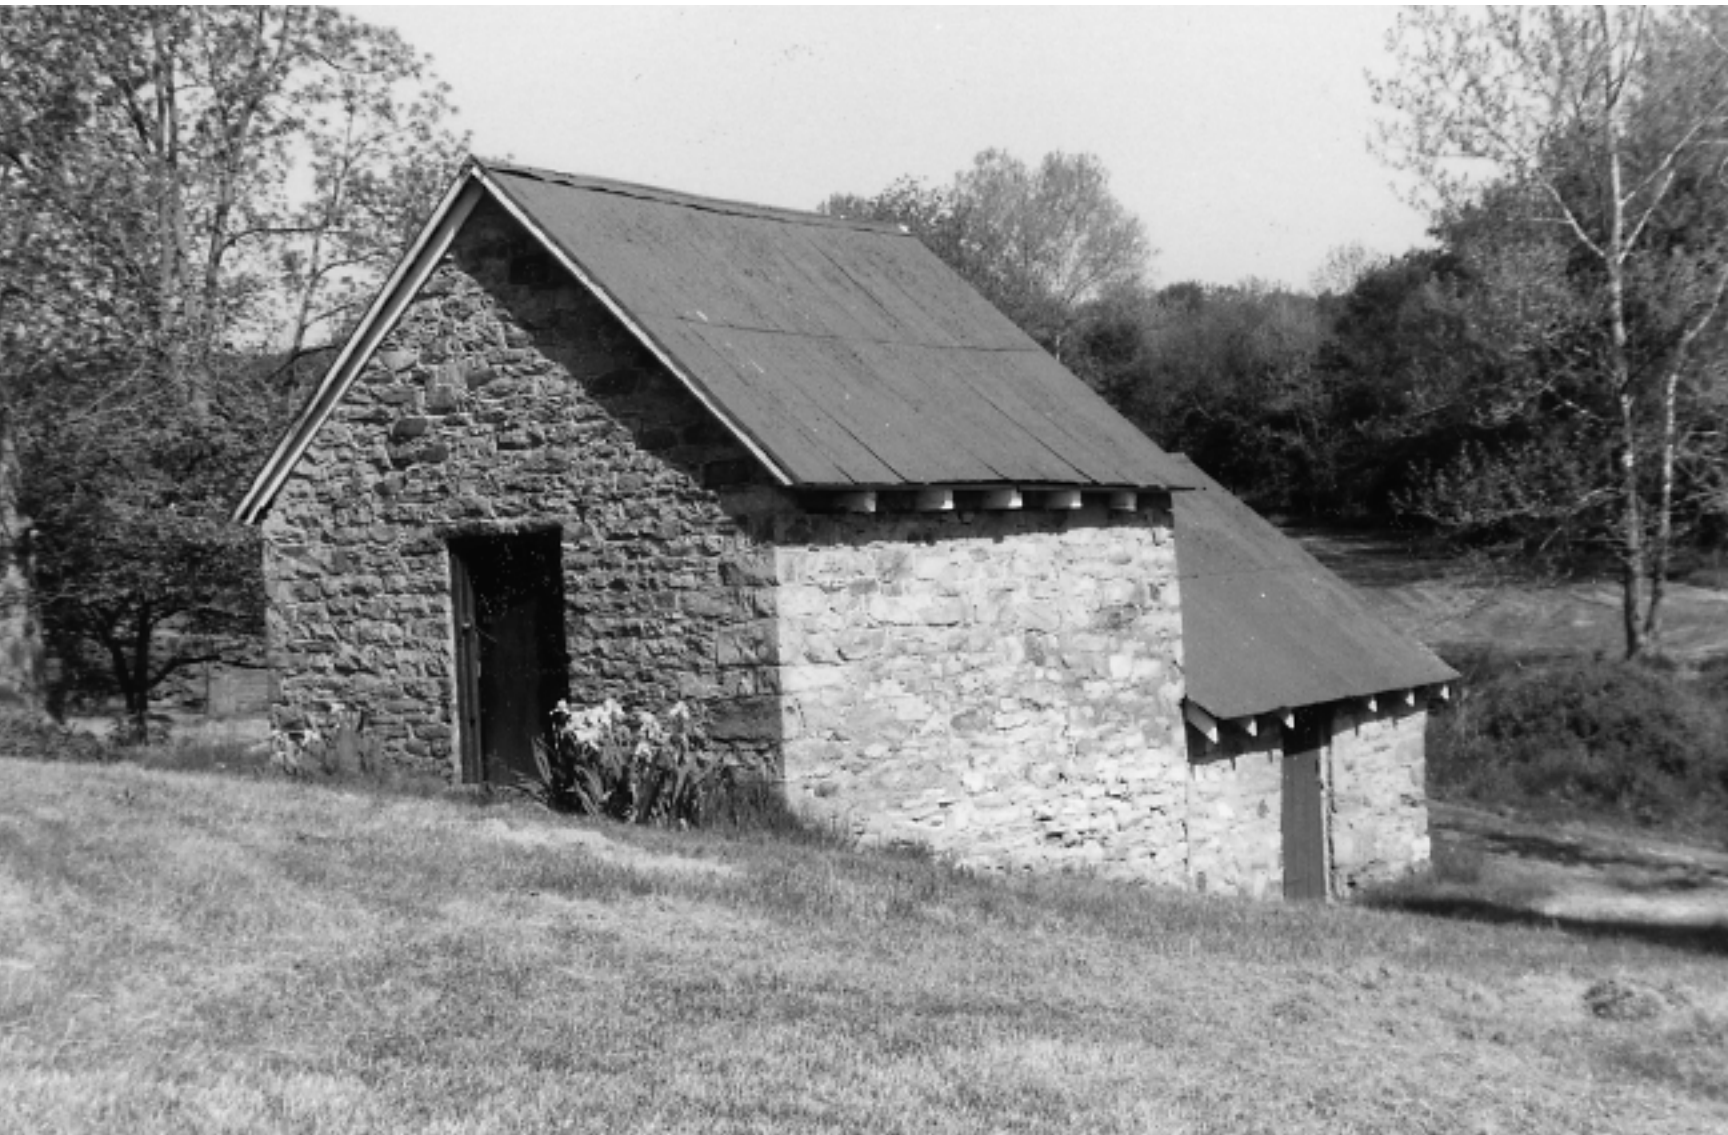
*Opposite: Banked into a hillside, this stone outbuilding at **Elton** consists of an upper level smokehouse and a lower level springhouse. Elton was owned in the late 1700s by Henry Griffith, and then by George Gaither from 1822.*

Other dual use outbuildings were one-story structures, used as a combination springhouse and smokehouse. At **Elton**, near Brookeville, the c1783 farmstead includes such a stone dual-use outbuilding built into a hillside. Attached to the downhill side of the gable-front smokehouse is a springhouse. At the **Darnall Place**, of c1808, and **Harewood**, of the late 1700s, one-story, side-gable structures serve as springhouse and smokehouse.

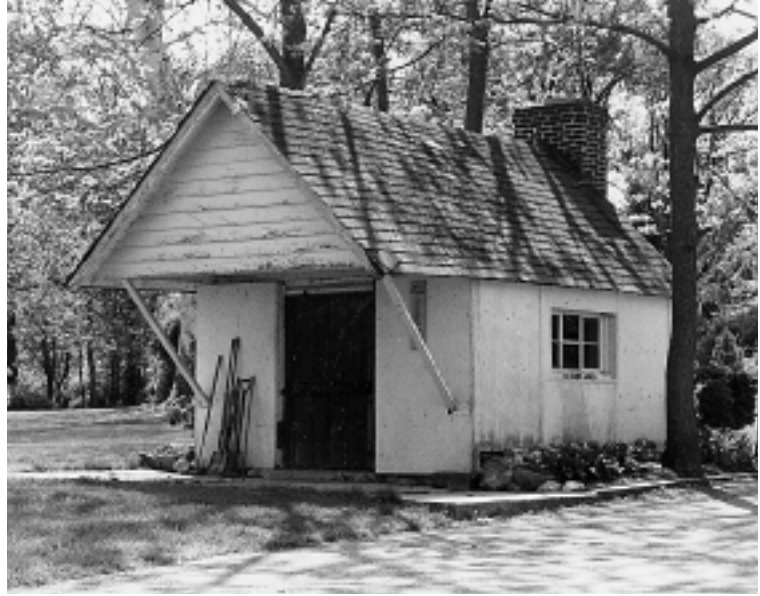
Lois Snyderman, 1991

The wash house at the **Cashell Farm** is constructed of log covered with siding. A projecting gable roof supported by front braces shelters the board and batten door. The large rear chimney is constructed of brick.

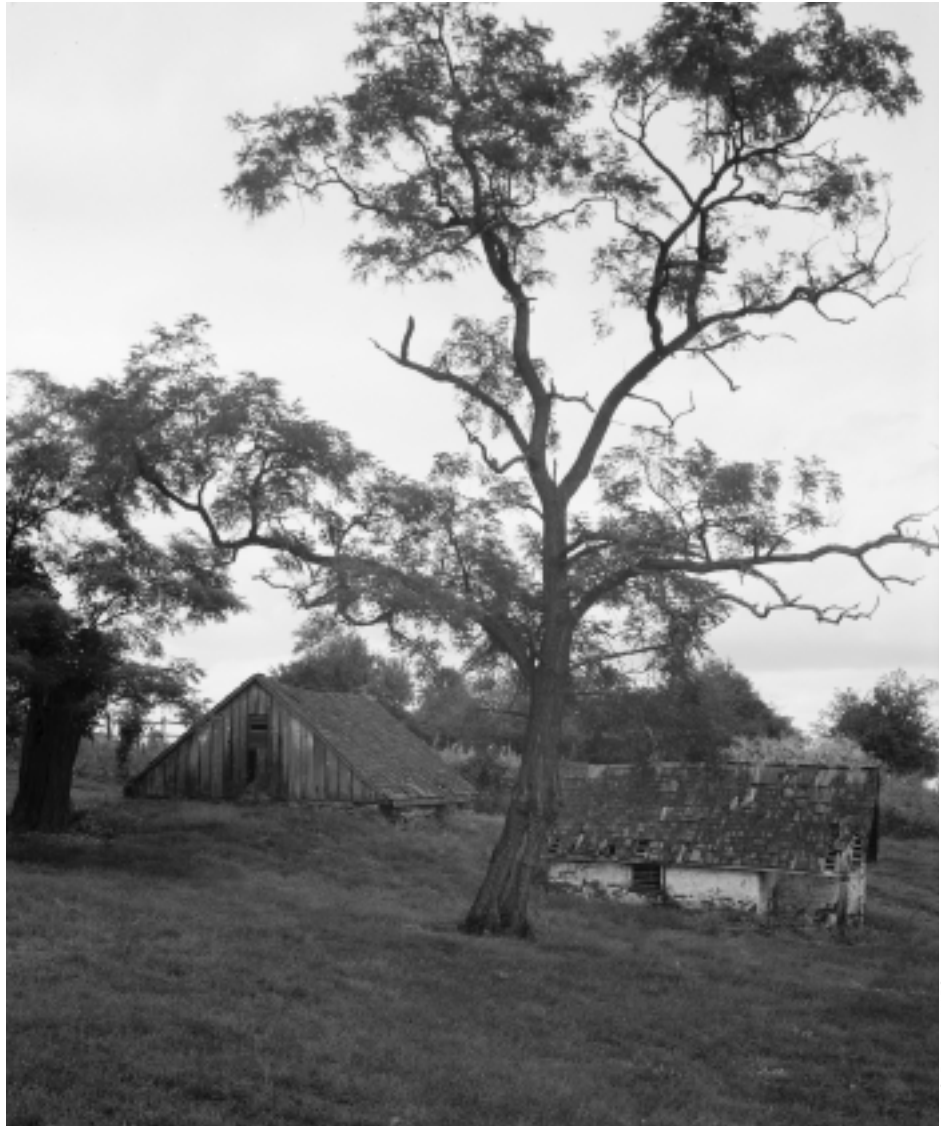
John O. Brostrup, HABS, 1936

When it was photographed in 1936, the property at the Overseer’s House of Montevideo, also known as River View, included a sunken gable roof ice house (left) similar to that built at the main **Montevideo** residence. Also standing at the time was a stone spring house (at right).

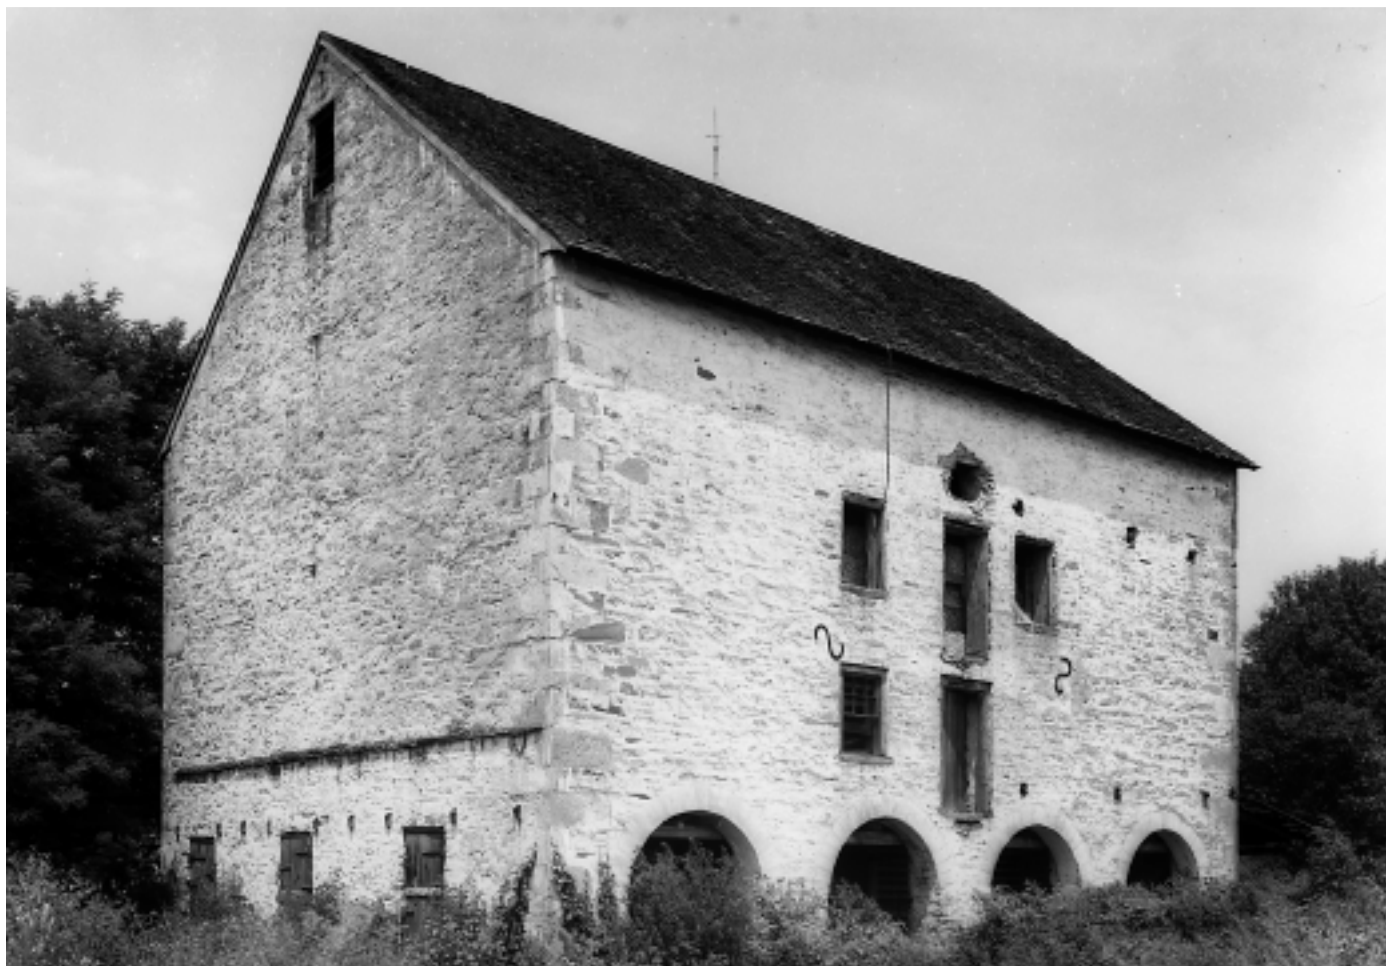
The **Woodlawn** bank barn (1832) is a double decker barn with a two-level loft and stone-arched forebay. Dr. William Palmer, a medical doctor, moved to Montgomery County from Pennsylvania in 1815 and later purchased the Woodlawn estate near Sandy Spring. Palmer engaged master stonemason Isaac Holland to build a magnificent stone bank barn in 1832. The exceptional three-story structure has large round-arched openings on the basement level.

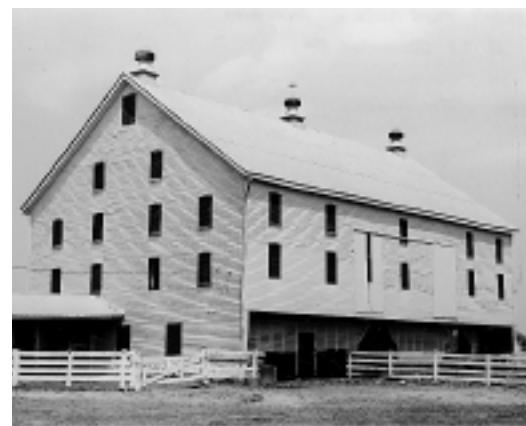
Michael Dwyer, M-NCPPC, 1974

Several Montgomery County bank barns were constructed of stone. A magnificent stone bank barn at the **Trundle Farm** has stone outsheds flanking the wagon ramp. Examples of this type of barn have been identified

from Lancaster County to northern Maryland.¹⁶ The extensions hold granary rooms, making more room on the main interior for hay and straw storage. Sandstone quoins, sills and lintels highlight the stonework. Walls are vented with louvered windows. On the downhill side, the cantilevered forebay is of wood construction. Stone bank barns at **East Oaks** and **Inverness**, probably built about 1818-1830, have slotted openings in the stonework to provide ventilation.

Below left: The stone bank barn at the Trundle Farm, Martinsburg Road, was built between 1816 and 1835. Stone outsheds on either side of the upper level entrance typically held granary rooms.

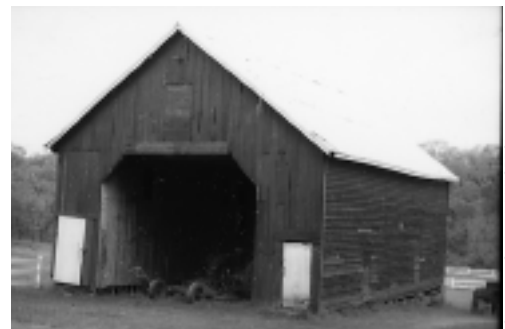
The double corn crib at **Rocklands**, near Seneca, is typical of most Montgomery County corn houses built after 1850. Gable end doors to access storage areas are found on both lower and upper levels.

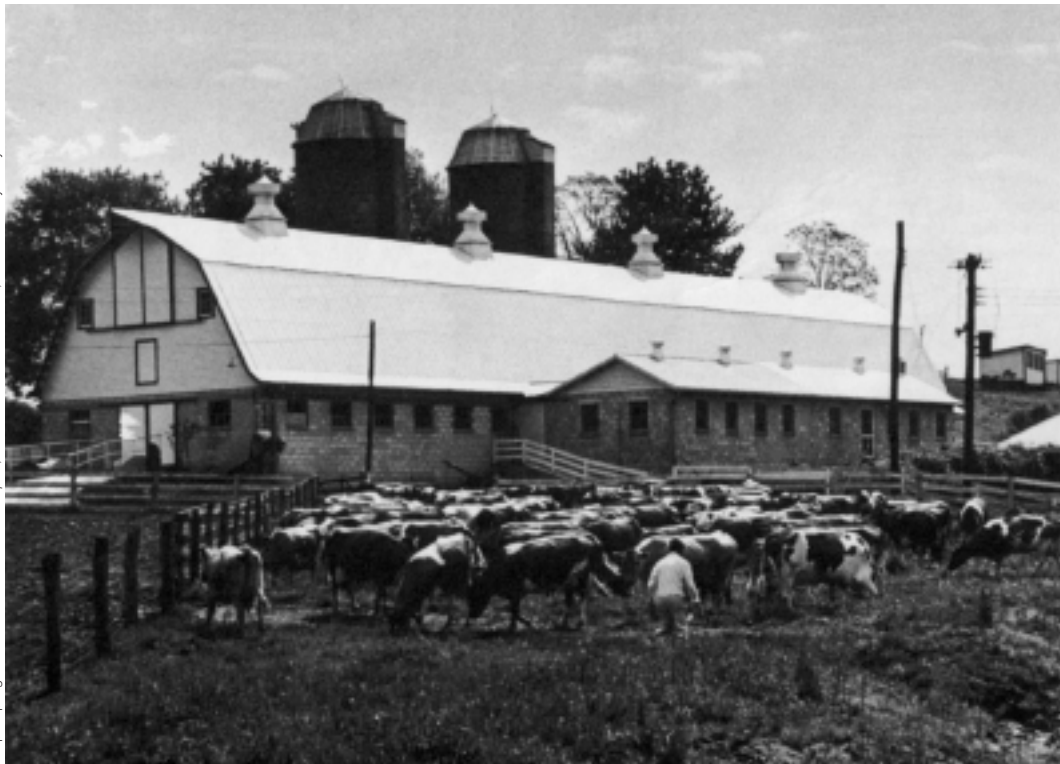
*A prime example of an early 20th century, state of the art agricultural facility, **Maple Spring Farm** was one of the leading dairy operations in the State of Maryland. The 19-bay long dairy barn (1942) has a gambrel roof punctuated by four metal ventilators. Thomas Moore Garrett, a leader in the dairy industry, owned and operated the 355-acre farm with a herd of 110 cows.*

windows and steel cupolas ventilated both levels. The arched roof with its self-supporting truss, or braced rafter frame, sheltered an unobstructed hayloft for increased storage capacity. The dairy barns were equipped with first level cow stanchions, airy second story hayloft, silo, and attached milk house. Maple Spring Farm had the first milking parlor in the county, established about 1943. The first bulk milk tank in the Virginia-Maryland Coop region was installed in the early 1950s at Kingstead Farm.
