***EXPEDITED***  
**MONTGOMERY COUNTY HISTORIC PRESERVATION COMMISSION STAFF**  
**REPORT**

<b>Address:</b>	24 Montgomery Ave., Takoma Park	<b>Meeting Date:</b>	5/10/17
<b>Resource:</b>	Contributing Resource Takoma Park Historic District	<b>Report Date:</b>	5/3/17
<b>Review:</b>	HAWP	<b>Public Notice:</b>	4/26/17
<b>Case Number:</b>	37/03-17M	<b>Tax Credit:</b>	Partial
<b>Applicant:</b>	David Christy	<b>Staff:</b>	Dan Bruechert
<b>Proposal:</b>	Foundation replacement and basement stair construction

Re: Foundation Condition – 24 Montgomery Ave – Takoma Park, MD.

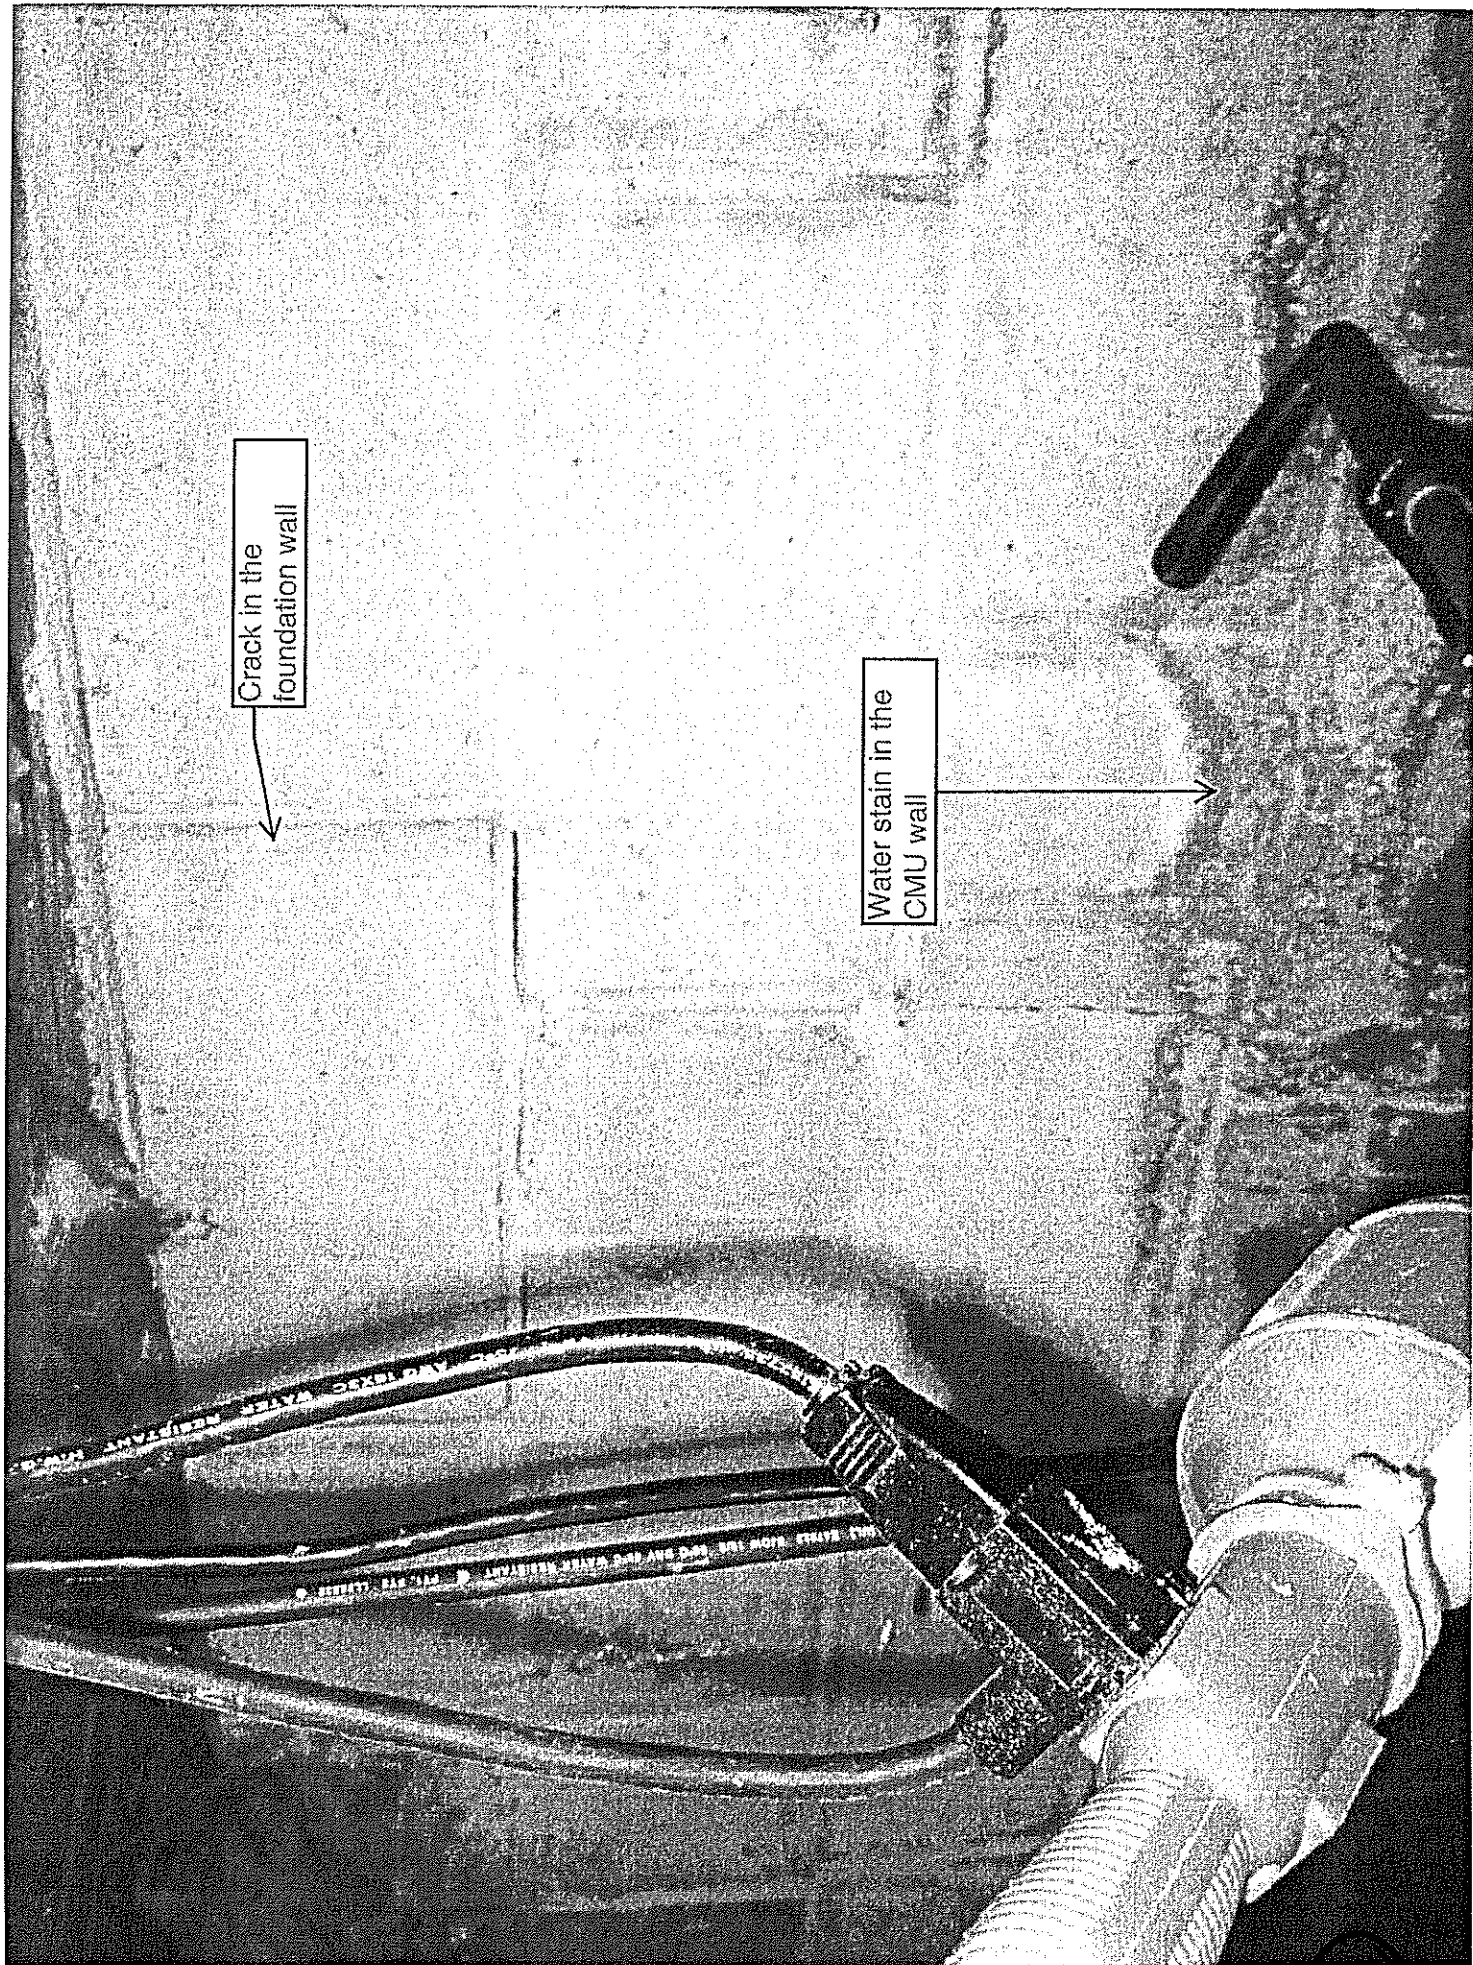
1. The foundation wall on the West side of the home has been replaced at some point in the past with a CMU wall. There is noticeable vertical and diagonal step cracking in the South and West walls around the SW corner of the home.

Crack in the  
foundation wall

1. To remediate the foundations against vertical settlement and horizontal pressure we recommend that the foundation wall and footing be removed and replaced with a properly reinforced wall on a properly sized footing. The reason for this is twofold. First on the East side of the home the foundation of the perimeter walls needs to be lowered so it is below the influence line of the current cellar floor. Secondly removing and replacing the entire wall will provide more access to reinforce the wall with steel rebar and grout to address the horizontal forces described above. The work needs to be done in incremental sections similar to traditional underpinning.

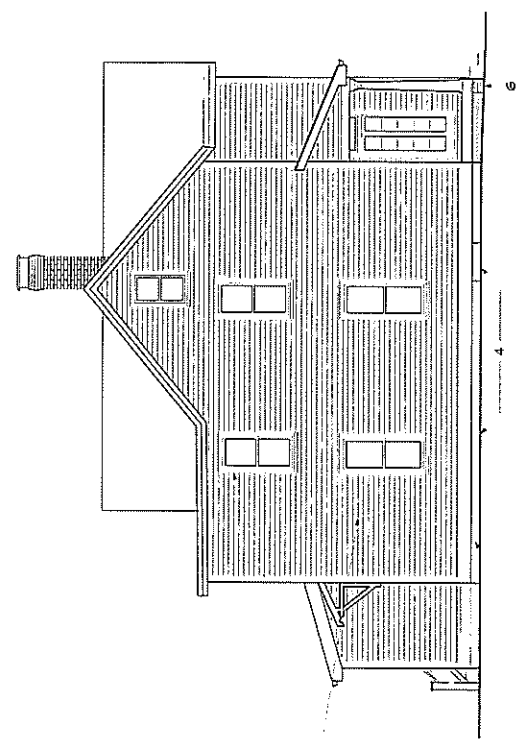
4 SIDE DEMOLITION ELEVATION  
Scale: 1/4" = 1'-0"

- DEMOLITION / SALVAGE NOTES:**
1. REMOVE EXISTING FOUNDATION WALL. CELLAR REMAINS WALLS AND FLOOR CONCRETE BUTTRESSES & SLABS
  2. REMOVE EXISTING MASONRY CHIMNEY. EXISTING STRUCTURE AT CELLAR LEVEL ONLY. SALVAGE BRICK FOR POTENTIAL DECORATIVE REUSE. PROVIDE TEMPORARY SUPPORT OF CHIMNEY ABOVE UNTIL CHIMNEY IS SUPPORTED BY NEW PERMANENT BEAMS
  3. REMOVE CELLAR STEPS TO FIRST FLOOR
  4. REMOVE WINDOW SASHES AND FRAME TYP. AT CELLAR ONLY
  5. REMOVE EXISTING DOOR AND REINFORCE FOR CABINET
  6. EX. MASONRY PORCH SUPPORTS TO REPAIR
  7. REMOVE CABINETRY AND FLOOR WALLS NEEDED TO CREATE WALKWAY / GREENING TO FLOOR RETAIN DROPPED CEILING
  8. REMOVE GAS EXISTING BOILER & HOT WATER HEATER

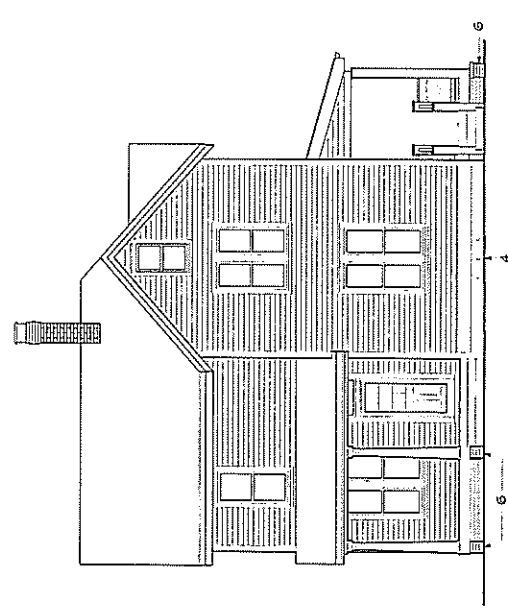
1 FRONT DEMOLITION ELEVATION  
Scale: 1/4" = 1'-0"

REMOVE EXISTING ESC. FOUNDATION (TYP.)
