Appendix F: Archaeology

Appendix - Archaeology Summary

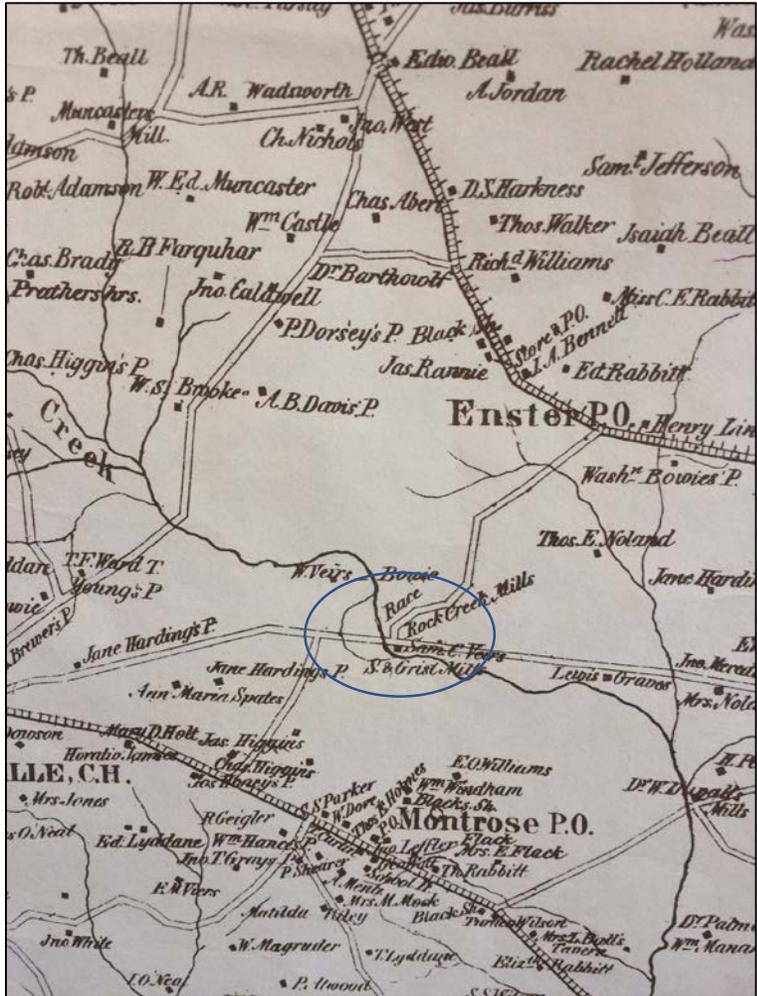
1865 Martenet and Bond Map of Montgomery County

Review of background research did not provide a clear indication of the original location of the Veirs Mill or nearby structures. Historic files referenced include: 1865 Martenet and Bond; 1878 Hopkins; 1908, 1923 and 1944 United States Geological Survey quadrangles; and aerials from 1951, 1970, 1979, 1993, 1994, 2008, and 2012; as well as Maryland State Highway Administration (SHA) as-built plans from 1953 and 1970.

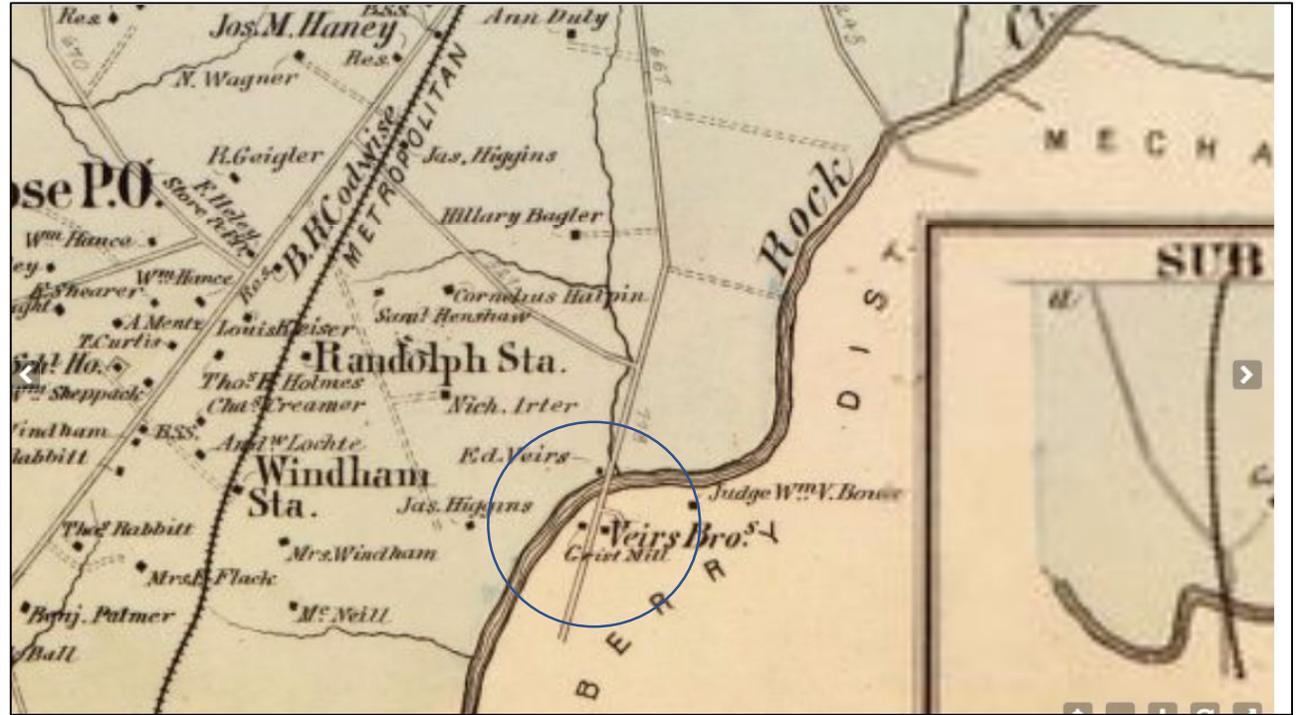
1878 GM Hopkins Atlas of Fifteen Miles Around Washington, including the County of Montgomery, Maryland.

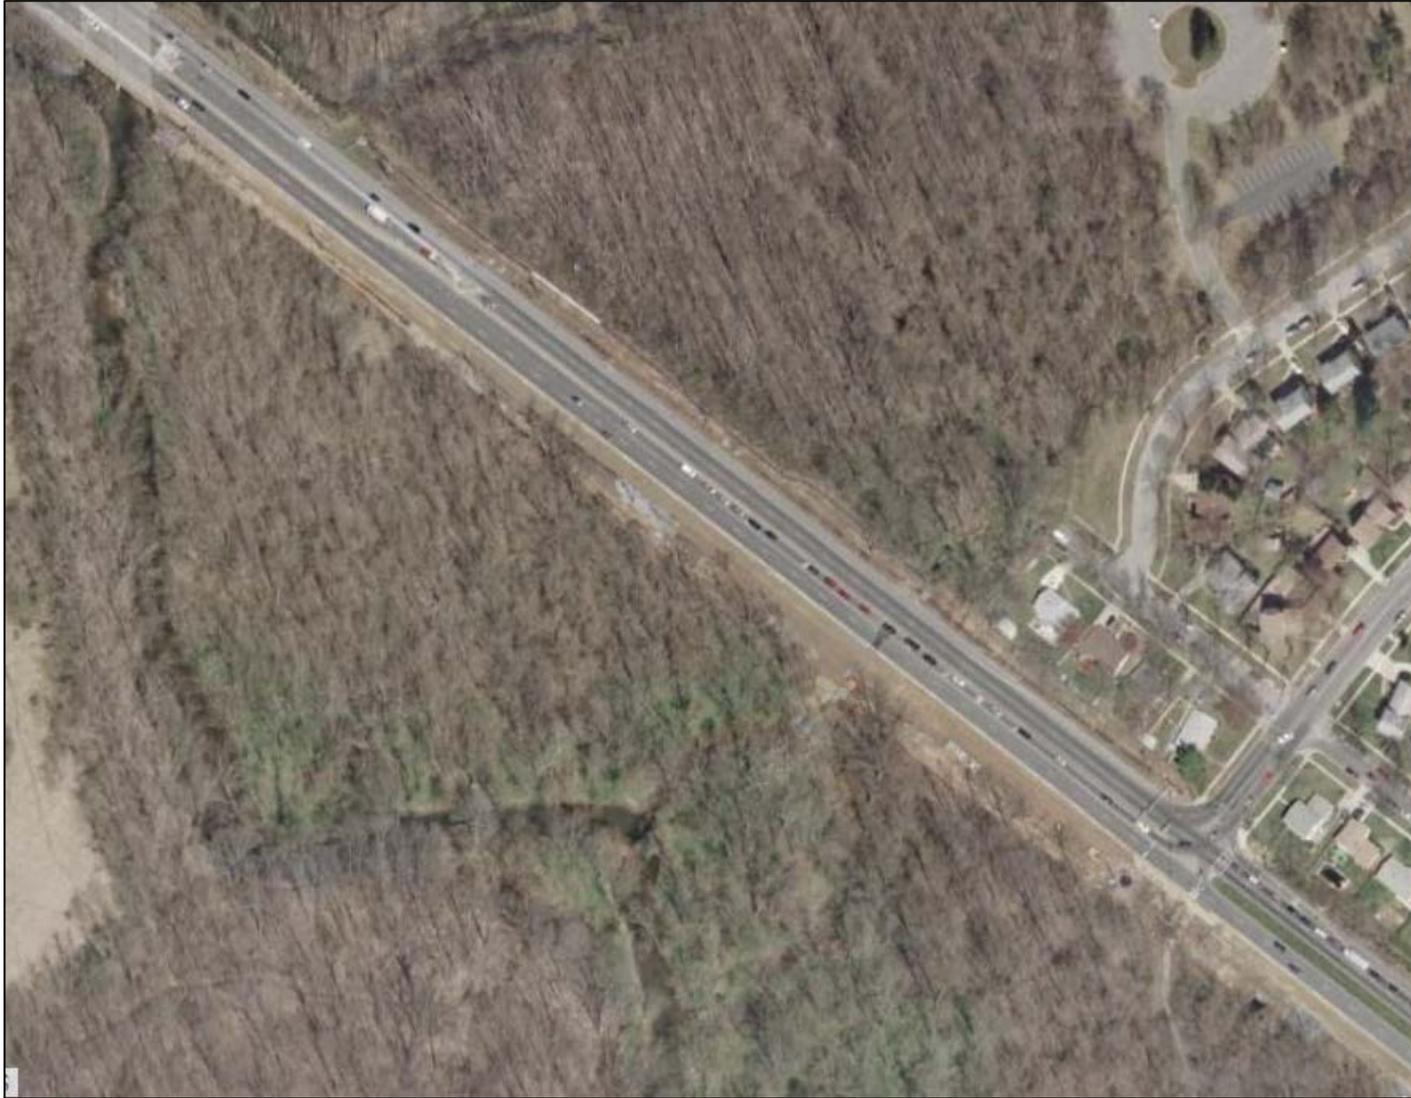
*2004 aerial showing construction activity along south side of Veirs Mill Road (MD 586)
http://gis3.montgomerycountymd.gov/historical_images/*

Review of aerials shows the parkland south of Veirs Mill Road remained largely forested, except for a clearing shown in 1951 just southeast of where Rock Creek passes under Veirs Mill Road and is a potential location for the mill. The 1994 aerial shows construction activity immediately adjacent to Veirs Mill Road along the south side. By 2012, a hiker-biker bridge over Veirs Mill Road was constructed in almost the same area

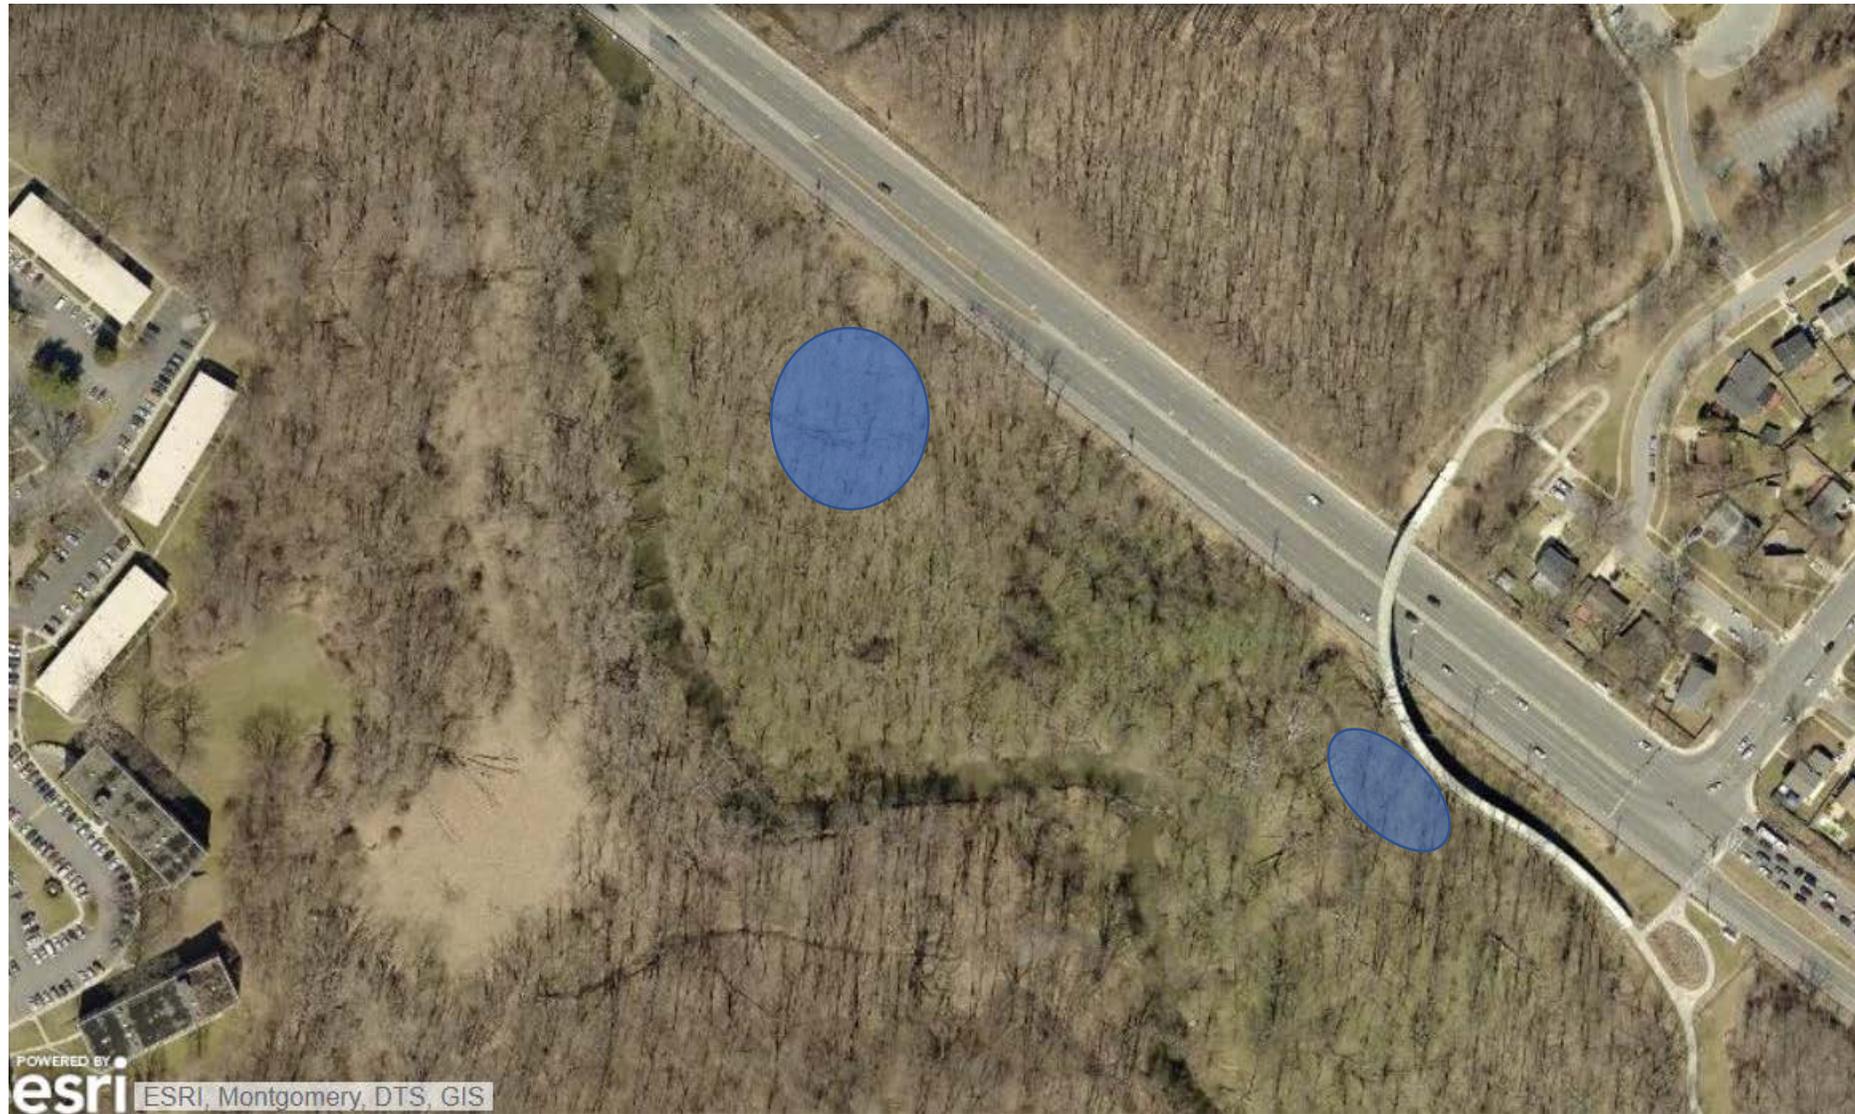
*Areas tested by soil test pits and potential locations for mill structure
2015 aerial, http://gis3.montgomerycountymd.gov/historical_images/*

Montgomery Parks staff conducted a field visit on May 9, 2017 to determine the potential for archaeological resources to be present on Park land outside of the road and bridge construction corridors. Six judgmentally placed Soil Test Pits (STP) were excavated – four were placed south of the bridge, between it and the U-shaped watercourse off Rock Creek, potentially a mill race.

STPs 1-4 showed the soils to be free of modern disturbances related to road or bridge construction and in areas that are currently wooded. Artifacts recovered from these STPs include: a brick fragment, two unidentified metal fragments, and a nail, possibly machine-cut. Significant charcoal fragments were encountered at 1.4 feet below the surface in STP1. Given the intact condition of soils in this area, there is potential for archaeological resources to be present south of the pedestrian bridge, outside the limits of disturbance for bridge construction.

Two additional STPs (5 and 6) were excavated further northwest, on a rise of land closer to the Rock Creek crossing at Veirs Mill Road. The landscape in this area appears to have been modified and could be remnants of a mill race and building locations, as well as 20th century access road construction further west. Concrete rubble, asphalt, and recent trash – bottles, beer cans, plastic tarps – were present on the surface. Both STPs encountered destruction debris and neither were excavated to sterile subsoil due to the amount of rubble. The few artifacts recovered from these two STPs included brick, mortar, corroded nails, and miscellaneous metal fragments that appear to date from the 20th century.

As sterile soil was not encountered, it is possible that deposits from earlier time periods are located below this destruction layer, and one of these could be the location of the 19th century structure shown on historic maps. The mill location mentioned in the Facility Plan is near STPs 5 and 6, and there is potential for archaeological resources to be present in those areas.
