MONTGOMERY COUNTY HISTORIC PRESERVATION COMMISSION
STAFF REPORT

| Proposal: | Solar array and associated fencing | | |

2420 Spencerville Road, Spencerville, MD

Property Restoration Report

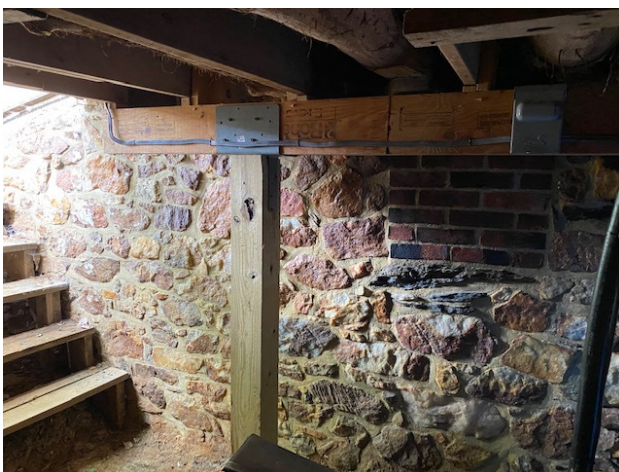
Crawl Space Access

The existing basement crawl space access hatch is badly deteriorated and allows water intrusion. It should be replaced with a commercially available access hatch cover.

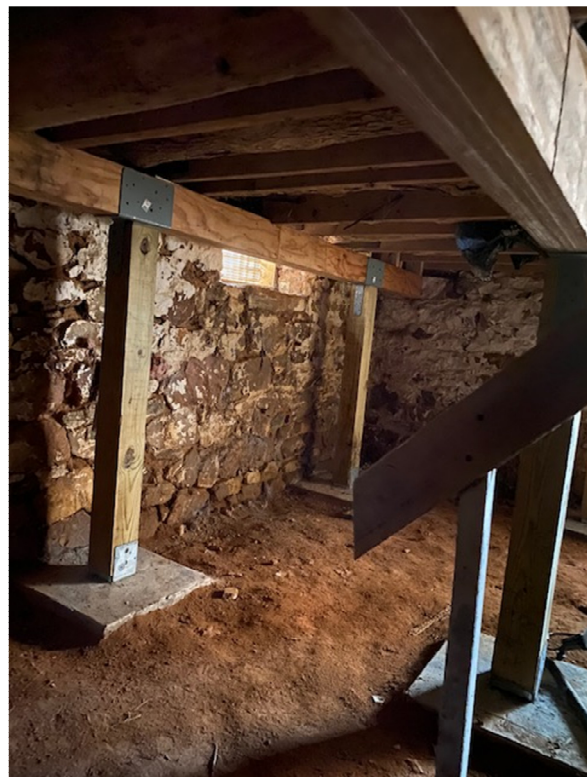
Crawl Space

The stone foundation is in generally good condition, and the dirt floor crawl space was dry on the day of inspection. Care should be taken to keep the gutters and downspouts operational to minimize water infiltration into the crawl space. Additional repointing should be undertaken in the south-east corner of the crawl space.

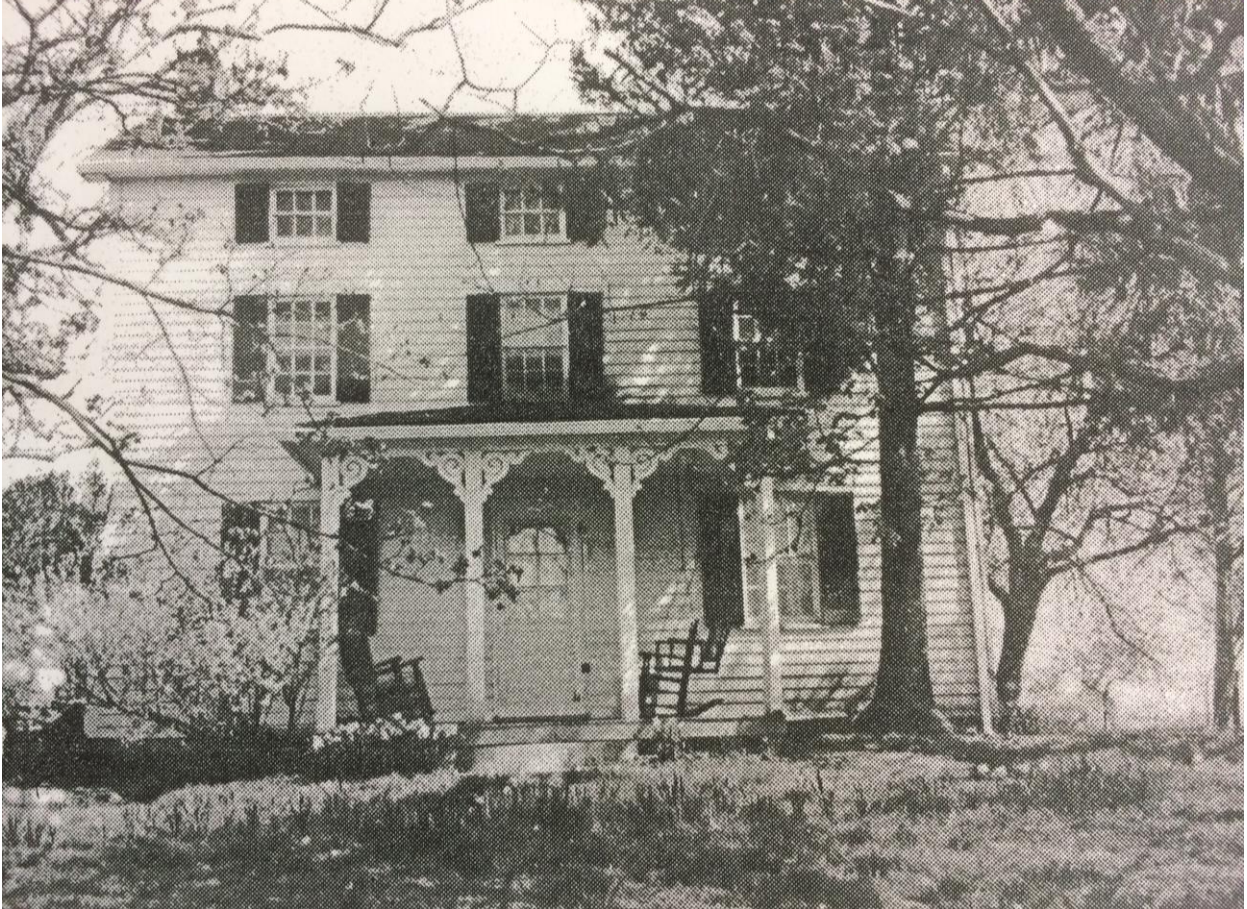
The farmhouse in 1973

The main block of this three-story house has six-over-six sash windows on the first and second floors, and shorter three-over-three windows on the third floor. The hip-roofed front porch is shorter than most front porches found in Burtonsville; it being only half as long as the house. It has chamfered posts and elaborate corner brackets. The gable ends are plain, with a pair of small two-over-four windows in the gable. A chimney rises from within each gable end. This main block contains a central stair flanked by one room on either side. There is a full depth basement under this portion of the house, which was rare for the time. There is no stair hall, and access to the slightly later rear addition is through the room to the left.
