# SCOTLAND A.M.E ZION CHURCH

10902 Seven Locks Road Potomac, Maryland, 20854

November 2020

EHT || TRACERIES

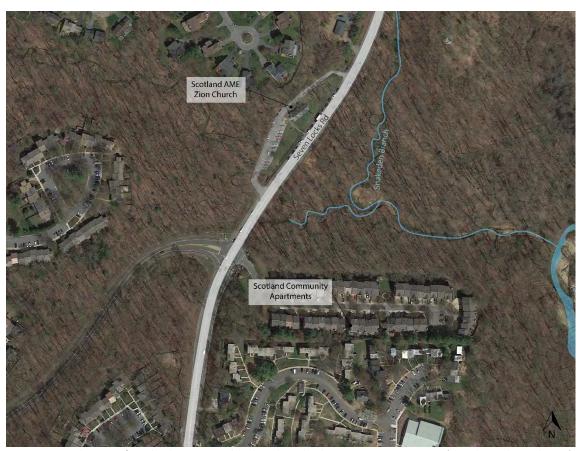
Figure 1. Aerial image of Scotland AME Zion Church and Scotland Community Apartments (Google Earth, April 2015).

The narrow, irregularly shaped property at 10902 Seven Locks Road extends along a southwest-northeast axis, immediately west of the present Seven Locks Road (east of the former Seven Locks Road right of way). The one-story rectangular-plan Scotland A.M.E. Zion Church building is centrally located within the lot and faces southwest onto the former Seven Locks Road right of way (Figure 3 and Figure 4). The property is accessed from Seven Locks Road via a thru-drive that follows a shallow elliptical route along the west and north property boundaries, which formerly existed as the Seven Locks Road right of way, relocated between 1957 and 1963.1 Vehicular traffic enters the drive from the southwest tip of the property, passes a parking area with approximately a dozen angled parking spots, continues on behind the rear of the church building and exits to Seven Locks Road at the property's northeast corner (Figure 5). A wood pedestrian footbridge crosses from Seven Locks Road over a low-lying channel, meeting a narrow stone footpath that leads to the church's primary entrance on the southwest façade (Figure 6). In contrast to the heavily forested surrounding area (except for the nearby cul-de-sac on Lakenheath Way), the property itself is only moderately wooded. A stand of mature trees is located northeast of the church; the trees are not so densely planted as to significantly obscure visibility of the church from Seven Locks Road (Figure 7). The site features three large specimen trees (the majority of which are Tulip Poplars), some smaller-sized trees, a large swath of lawn, and shrub plantings at the building foundation. Unmarked graves northeast of the building have been located but those interred have not been identified (Figure 8).2

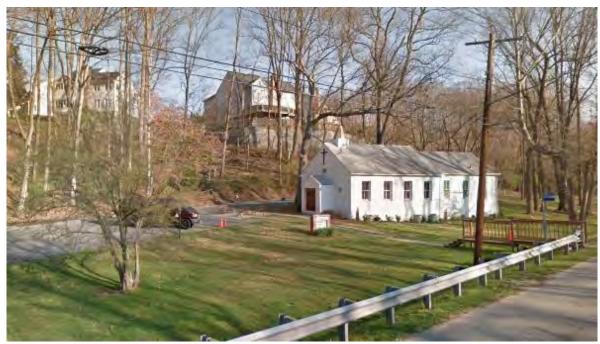
Topographically, there is a substantial uphill grade change northwest of the church, where residential development has encroached upon the property (**Figure 10**). A cul-de-sac with a number of single-family residences is located atop the small hill, northwest of the Scotland A.M.E. Zion Church. A culvert at the far southern tip of the property diverts water under Seven Locks Road to the Snakeden Branch Creek. Unless otherwise noted, current site photographs to follow were taken by EHT Traceries, Inc. on July 9, 2020.

Figure 10: Scotland A.M.E. Zion Church, looking northwest from Seven Locks Road. Source: Google Street View (March 2012).

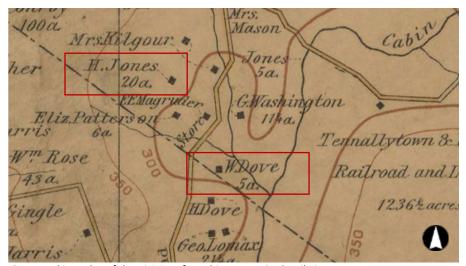
Figure 33: 1894 G.M. Hopkins Atlas of the Vicinity of Washington, D.C., detail view. Note H .Jones property, underlined in red (later, subdivided and developed as Scotland A.M.E. Zion Church) and Dove property (later, site of core Scotland community).

acres, and in 1884, Noah Mason and his brother Augusta secured nine acres and six acres respectively. The Doves and the Masons became two of the most prominent founding families of Scotland, passing property down through the generations (**Figure 33** and **Figure 34**). William Dove, the original land buyer, is said to have had 15 children.<sup>23</sup>

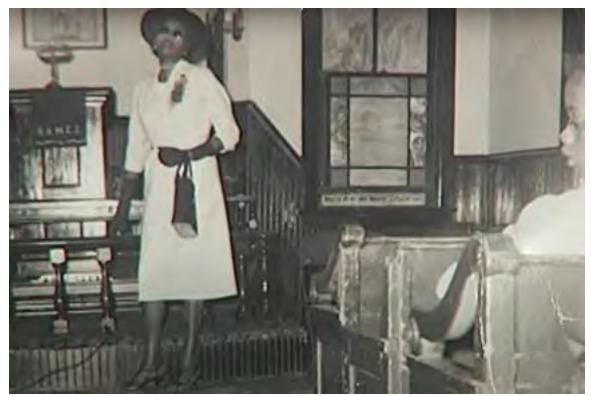
Figure 38: Undated photograph (pre-1963), when services were moved into the front addition). View looking northeast to altar, which currently accommodates the church office/minister's study. Source: "Scotland A.M.E. Zion Church," Paths to the Present, Montgomery County Stories Video Series (December 2005). https://www.youtube.com/watch?v=9XRZo0fQRP0

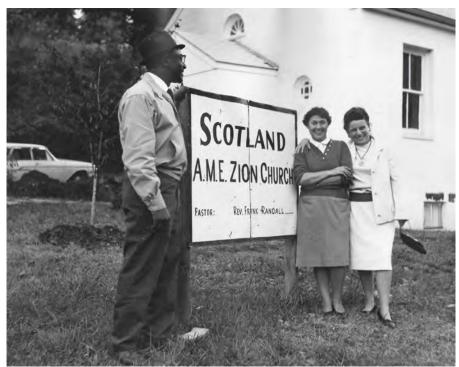
Figure 39: October 1966 photograph of Scotland A.M.E. Zion Church. Note that multiple records state the front addition (pictured) was not completed until 1967. Pictured are Reverend Frank Randall, Ginetta Sagan (center), and Trudy Morse (right).

The modest, wood-frame, gabled church supported the congregation for the next several decades, until it became necessary to construct an addition in the 1960s (**Figure 39**). In November 1962, the Board of Trustees of the Scotland A.M.E. Zion Church secured a \$7,000 mortgage from the Bank of Bethesda for the construction of the addition.<sup>39</sup> According to a cornerstone incorporated into an exterior wall of the front addition, the church was "rebuilt in 1963." However, historic documentation reveals the original chapel remained generally intact and the addition was not completed until 1966-67.<sup>40</sup> The addition did, however, require the removal of the original chapel façade. Site observations indicate that a new foundation for the original chapel was likely installed at this time. The first church service held in the new addition took place in November 1967, and the cornerstone was laid in February 1968.<sup>41</sup>

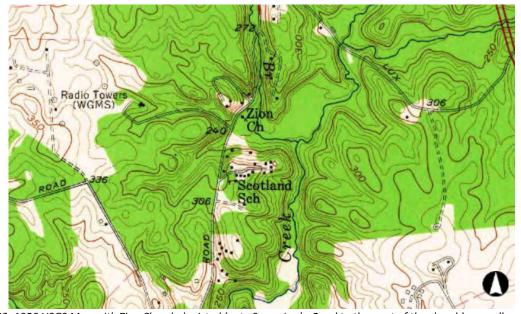
Figure 43: 1956 USGS Map with Zion Church depicted (note Seven Locks Road to the west of the church), as well as Scotland School. Source: United States Geological Survey map of Rockville (1956).

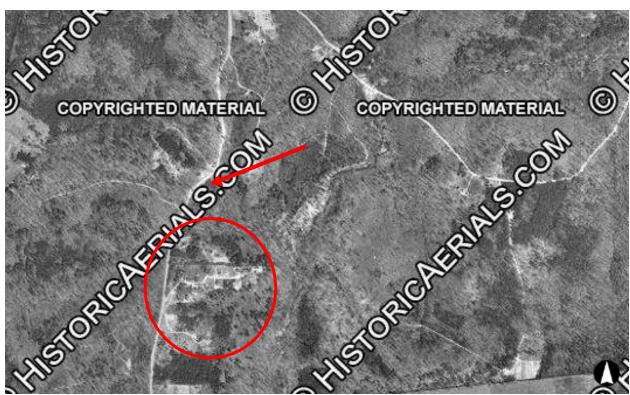
Figure 44: 1957 aerial image showing the approximate location of Scotland A.M.E. Zion Church (obscured but indicated with red arrow) and the nearby Scotland community (circled in red). Source: Historicaerials. Edited by EHT Traceries, Inc.

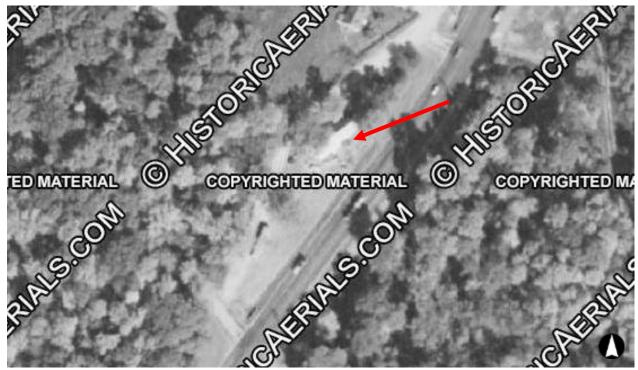
Figure 47: 1963 aerial image, detail view showing Seven Locks Road and the Scotland A.M.E. Zion Church (indicated with red arrow). Note Seven Locks Road has been re-routed around the church. Source: Historicaerials.com. Edited by EHT Traceries, Inc.

<sup>&</sup>lt;sup>1</sup> Historic aerial photographs indicate the road was re-routed between 1957 and 1963. The original route of Seven Locks Road west of the church (now the thru-drive for the church) was officially abandoned by the County in 1982.

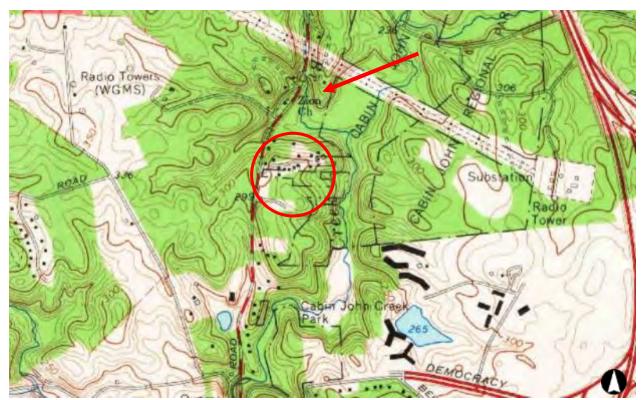
Figure 48: 1965 USGS Map with Zion Church depicted (note relocation of Seven Locks Road to the east of the church). Scotland community circled in red. Source: United States Geological Survey map of Rockville (1965).

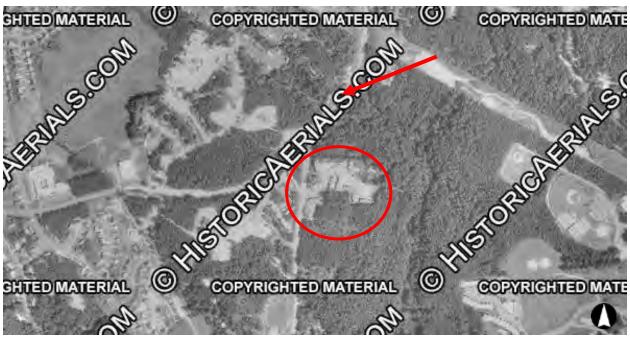
Figure 55: 1970 aerial image, showing Seven Locks Road and the Scotland A.M.E. Zion Church (indicated with red arrow). Note the partially completed new Scotland community, and increased development in the surrounding areas. Source:

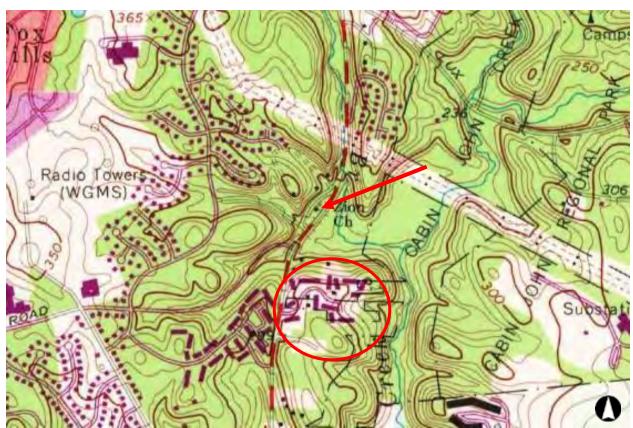
Figure 57. 1972 USGS Map with Zion Church depicted. Scotland community circled in red. Source: United States Geological Survey map of Rockville (1972).

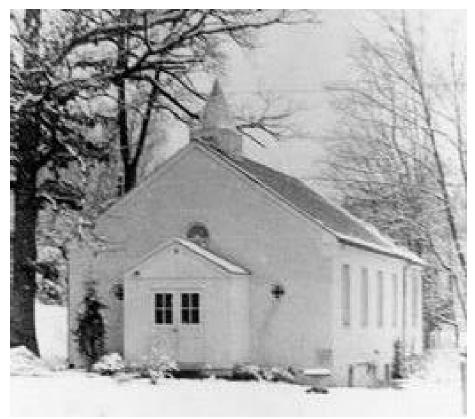
Figure 58: March 22, 1969 photograph of the southwest elevation of Scotland A.M.E. Zion Church, looking north. Source: "Community Cornerstones: A Selection of Historic African American Churches in Montgomery County, Maryland," Heritage Montgomery (2012).

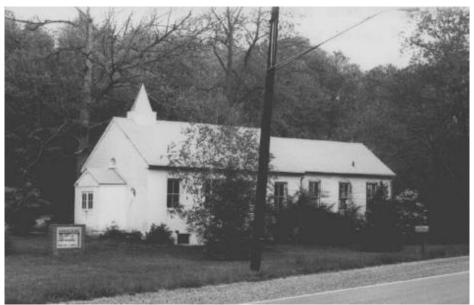
Figure 59: 1975 photograph of the primary southwest elevation and southeast side elevation of Scotland A.M.E. Zion Church, looking northeast. Photo taken by Michael F. Dwyer on May 12, 1975. Source: M-NCPPC, "Maryland Historical Trust Worksheet Nomination Form for the National Register of Historic Places, National Parks Service: Zion Church/Scotland," (May 12, 1975).
