MONTGOMERY COUNTY HISTORIC PRESERVATION COMMISSION STAFF REPORT

Address: 11650 Snowden Pkwy., Germantown Meeting Date: 6/22/2022

Howes Farm (13/19)

PROPOSAL: Demolition of three (3) accessory structures

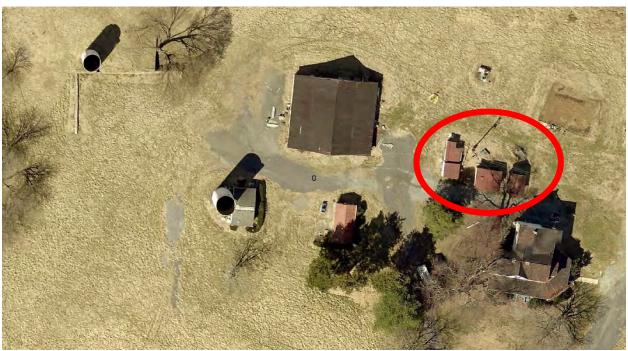
Between the historic farmhouse and the principal barn, there are three buildings, identified in the historic documentation as "dairy equipment/hen house, handyman room, and pump house." All three buildings have wood siding (German shiplap for the hen house, clapboards for the pump house, and vertical siding for the pump room) and were constructed on poured concrete foundations. These buildings have suffered from deferred maintenance to varying degrees. The applicant proposes to demolish these buildings.

Figure 2: Detail showing the house and farm structures. Outbuildings proposed for demolition circled.

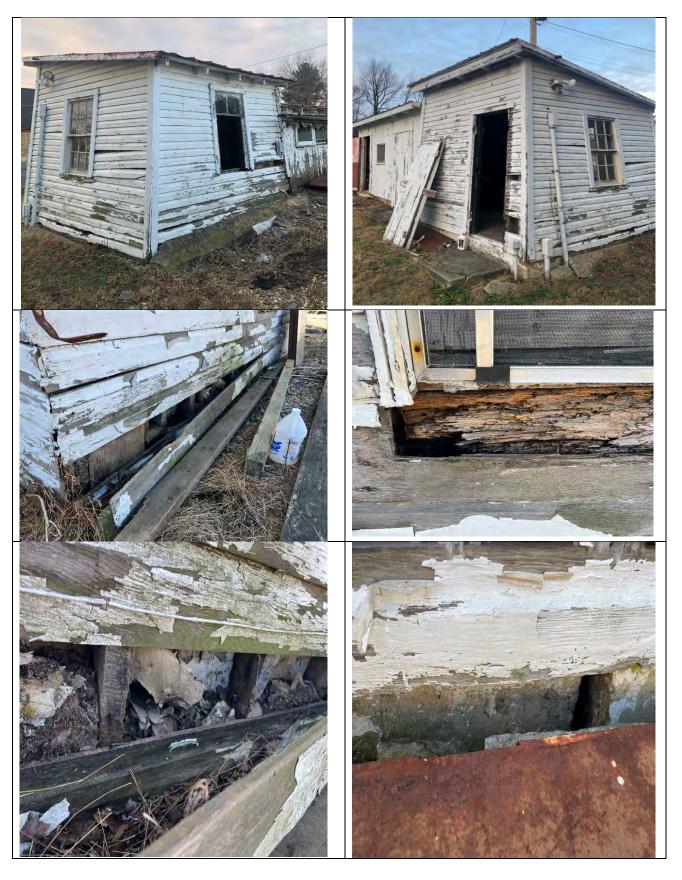
Current photographs of the Hen House:

Hen House

- The external wall of hen house is falling apart, horizontal siding and vertical studs are rotting.
- The building is leaning more than 5 degrees to north side.
- The mudsill is rotten and cracks on the foundation wall are visible.
- Door and Window frames are rotting, panels are missing.
- The means of egress are not compliant to IBC 1008.1.1

NECC is requesting demolition permit for these three small outbuildings. NECC is planning to widen the existing road between the main historical building and three outbuildings to provide fire access to existing barn, new lord Buddha statue and proposed temple. The existing access road should be widened to meet fire access standard; the widening of this access road is not possible without these removing these outbuildings.

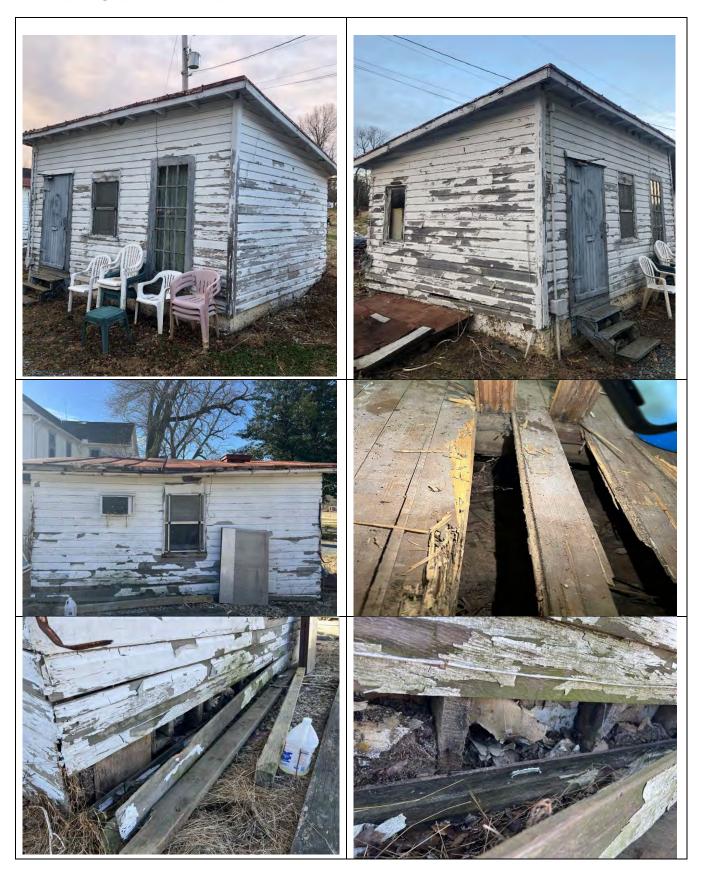
Current photographs of the Pump House:

Pump House:

- Outbuilding sits on perimeter foundation wall and floor beam.
- The roof is sagging, mudsill, studs and sidings are rotting.
- The hardwood floor is rotten beyond repair.
- The perimeter foundation wall has cracks.

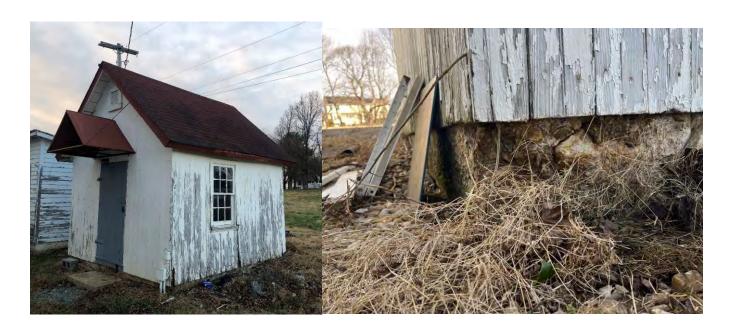
Current photographs of Handyman Room:

Handyman Room:

- Perimeter foundation wall has spalls and cracks.
- Vertical sidings are rotten.
- Concrete flooring may have placed recently.
