Preliminary Consultation
MONTGOMERY COUNTY HISTORIC PRESERVATION COMMISSION
STAFF REPORT

Address:	4000 Jones Bridge Rd., Chevy Chase	Meeting Date:	8/17/2022
Resource:	Individually Listed Master Plan Site (Hayes Manor #35/10)	Report Date:	8/10/2022
Applicant:	Howard Hughes Medical Institute Susan Pommerer, Architect	Public Notice:	8/3/2022
Review:	Preliminary Consultation	Staff:	Dan Bruechert
Proposal:	Site Work, House Rehabilitation, and Landscape Master Plan

HOWARD HUGHES MEDICAL INSTITUTE
HAYES MANOR REHABILITATION

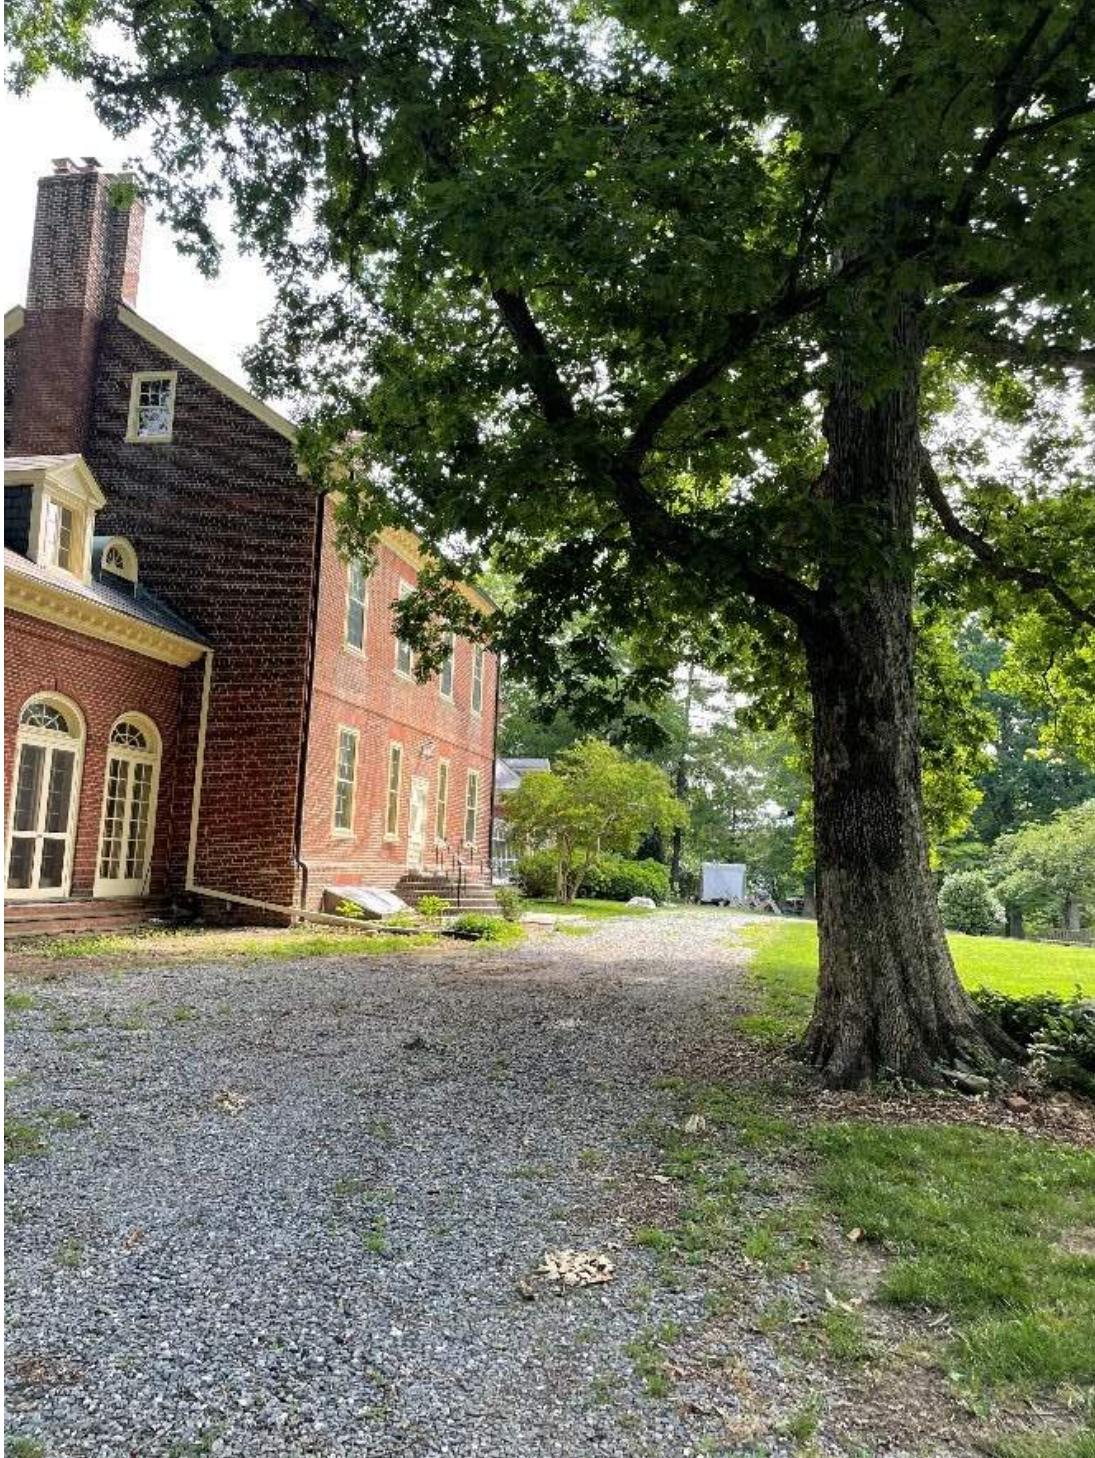
Description of Current Condition:

The existing gravel drive will be replaced by a seeded aggregate concrete drive near the existing south entry door to the Manor House.

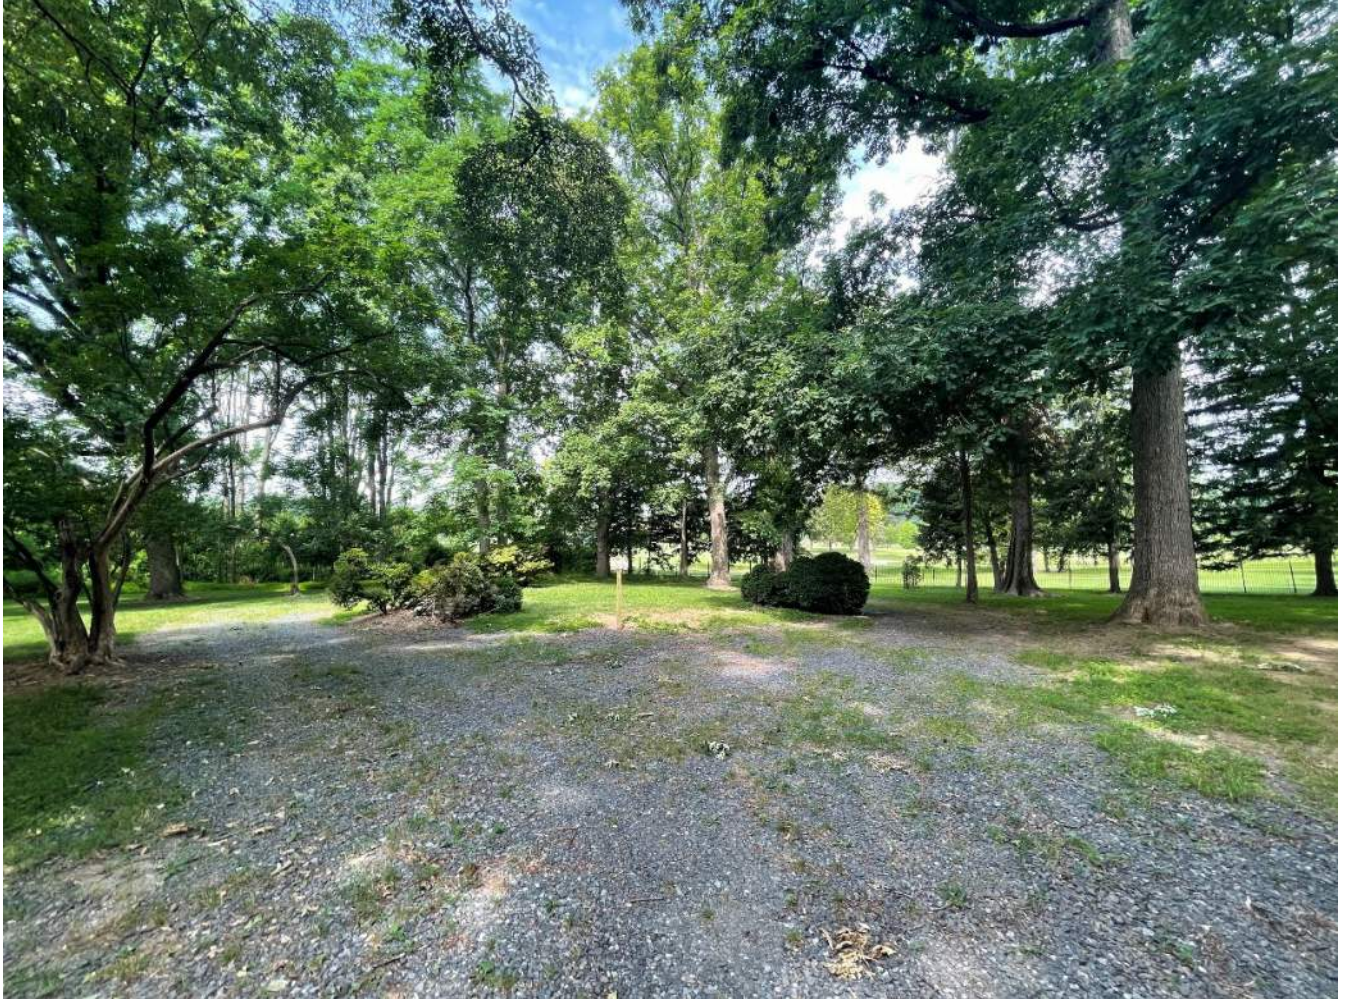
Work Item #2: Drive Turnaround**Description of Current Condition:**

An existing gravel turnaround is located southwest of the Sunroom.

The existing gravel turnaround will be replaced by a seeded aggregate concrete drive with mortar set cobble edge.

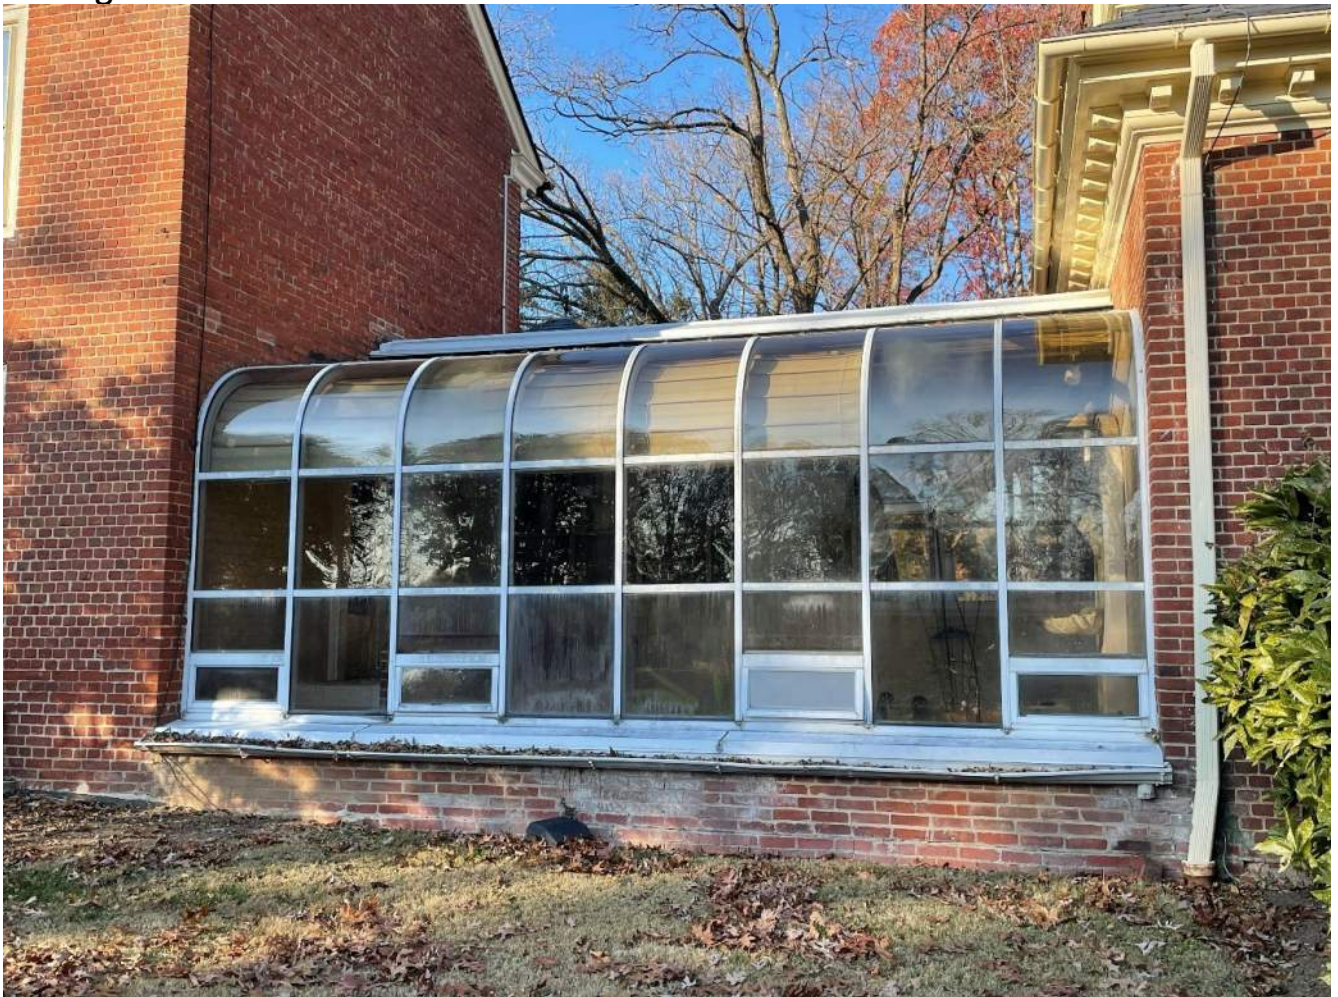
Work Item #7: Accessible East Patio

The existing greenhouse (constructed in the 1980s) located between the Manor House and the Garage is in poor condition.

The east plaza between the Manor House and the garage features a damaged trellis which is not structurally stable.

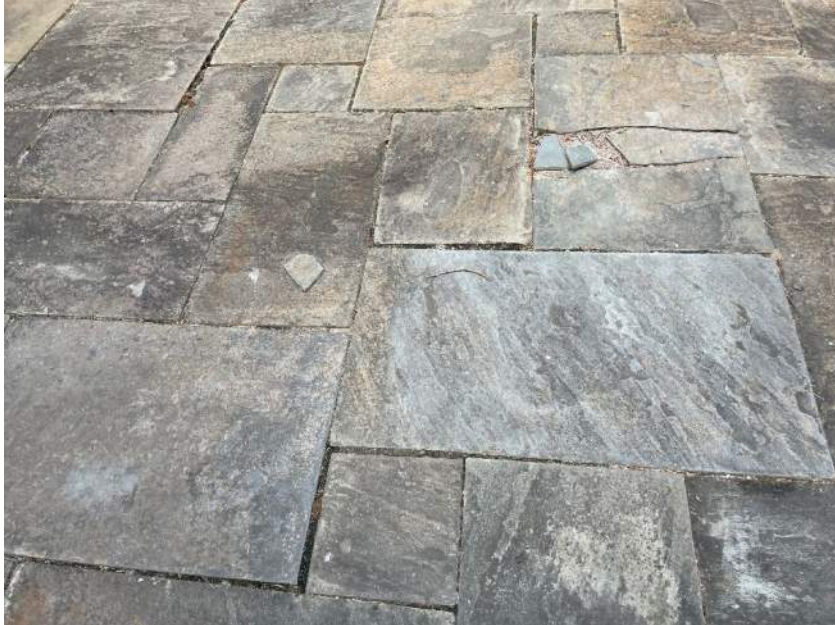
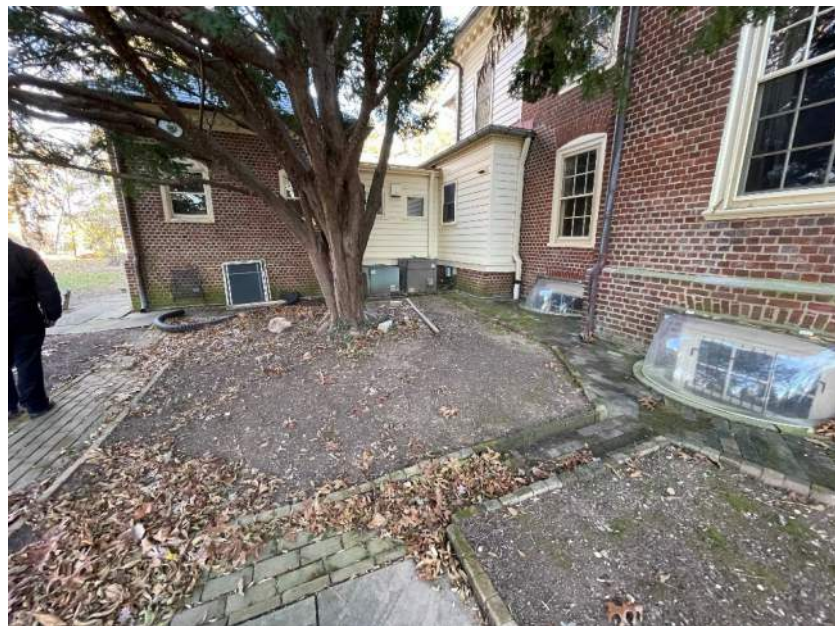
Work Item #8: North Patio: Uneven and Damaged Pavers

The existing walkways and patios do not provide adequate access and slopes for an accessible route, and the existing dry set bluestone pavers are damaged and uneven.

#8 – The north patio is constructed out of randomly sized stone dry set pavers and bricks. Over the years, the surface has settled and the pavers are uneven and damaged. Staff concurs that the pavers are unsafe and need to be removed and replaced (or at the very least, relaid on an even substrate). The applicant proposes to re-grade some sections of paving around the house and install new paving. Details for the replacement paving material was not included in the application materials. Staff request feedback from the HPC for the preferred material for the north patio.

Pavers and other areas of concrete paving will be replaced in the north plaza and the east plaza. Clearances and slopes will provide new accessible access and entry into the Manor House.

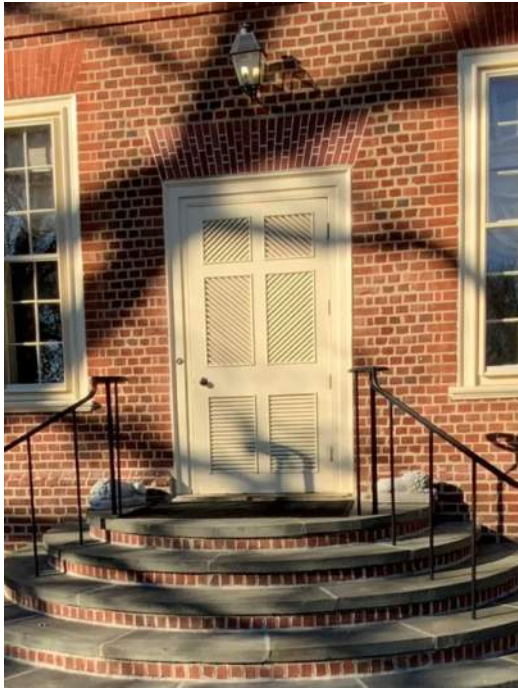
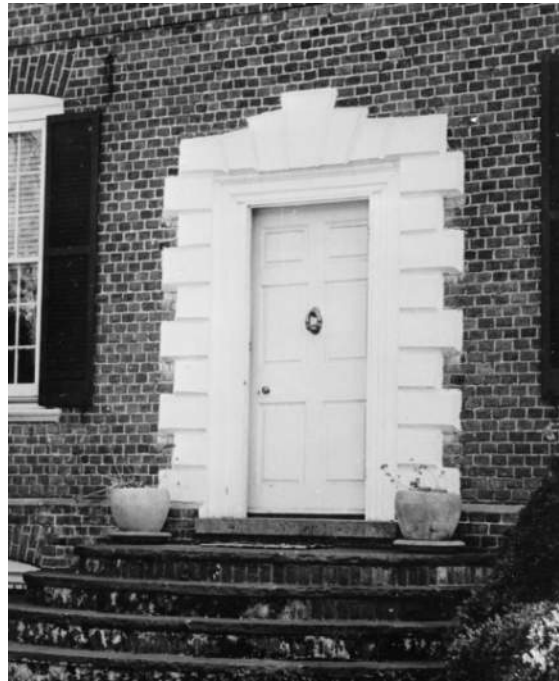
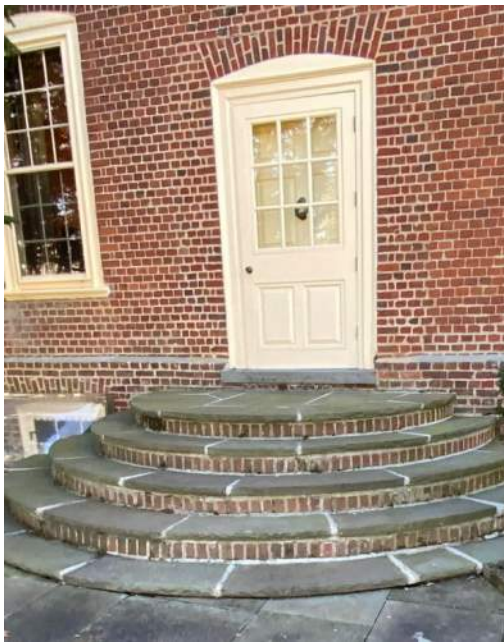
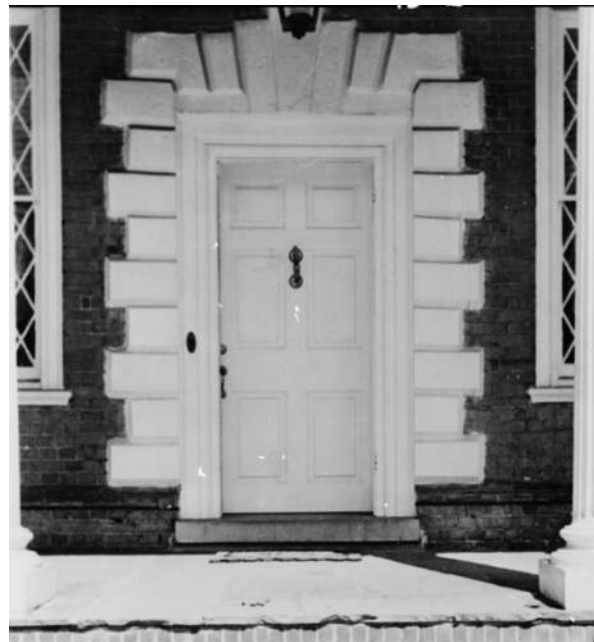
Work Item #10: Recreate Historic Rusticated Surround at North and South Door

The historic rusticated surrounds at the north and south entry to the Manor House have been removed from the façade.

The applicant proposes recreating the rusticated door surround on the north elevation. This door treatment was also documented by HABS in 1962. Staff supports this work and the level of documentation will allow this decorative feature to be accurately re-created. Staff will support the approval of a HAWP for this work.

Recreate the historic rusticated door surrounds per the HABS documentation.

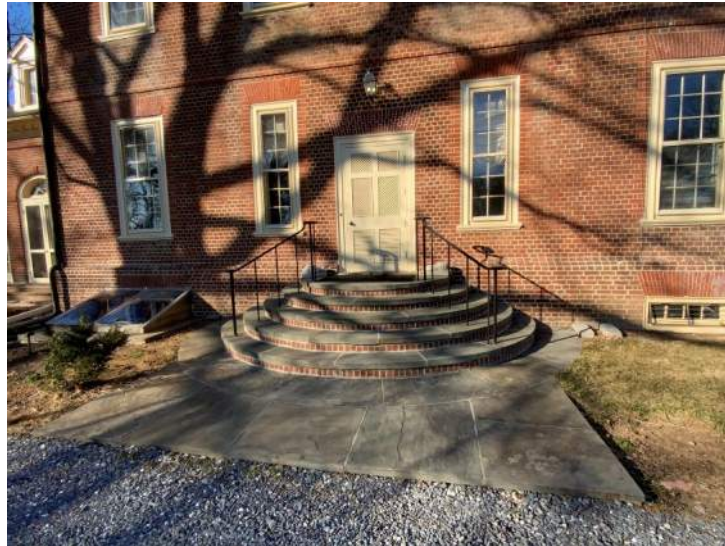
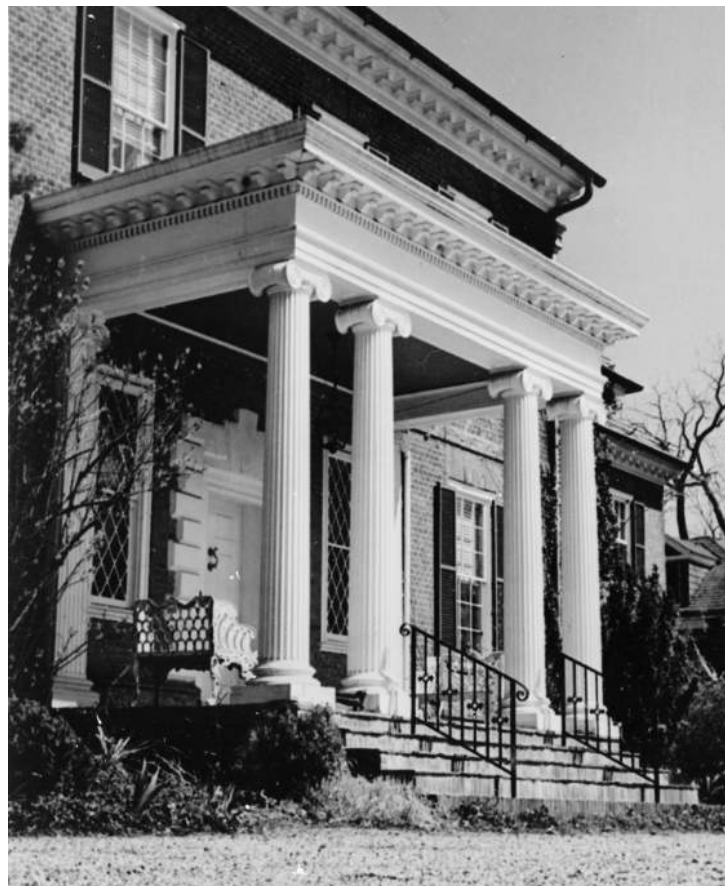
Work Item #11: Recreate South Porch**Description of Current Condition:**

The historic south porch that was documented in the 1960s HABS photography has been removed from the building.

On the south elevation, the applicant proposes to recreate the rusticated door surrounding and south porch. Both of these features were recorded in the 1962 HABS documentation. The design of the door surround may date to the house's construction. The south porch most likely dates from sometime between 1792 and 1849 (see 'Manor House Period 2A' in the submitted documentation). Staff finds a historical basis for both of these changes and will recommend approval for these changes when the HAWP is submitted.

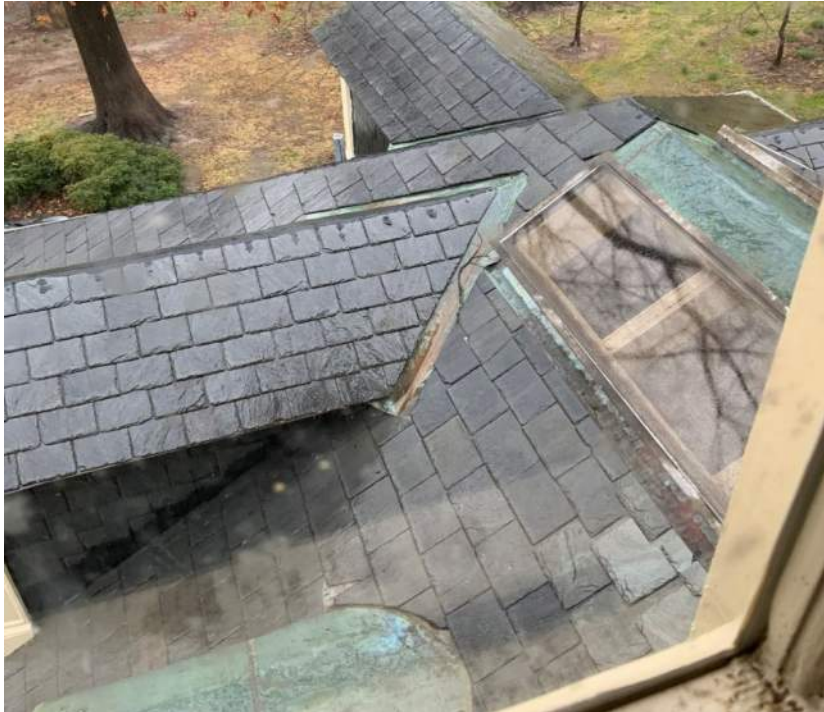
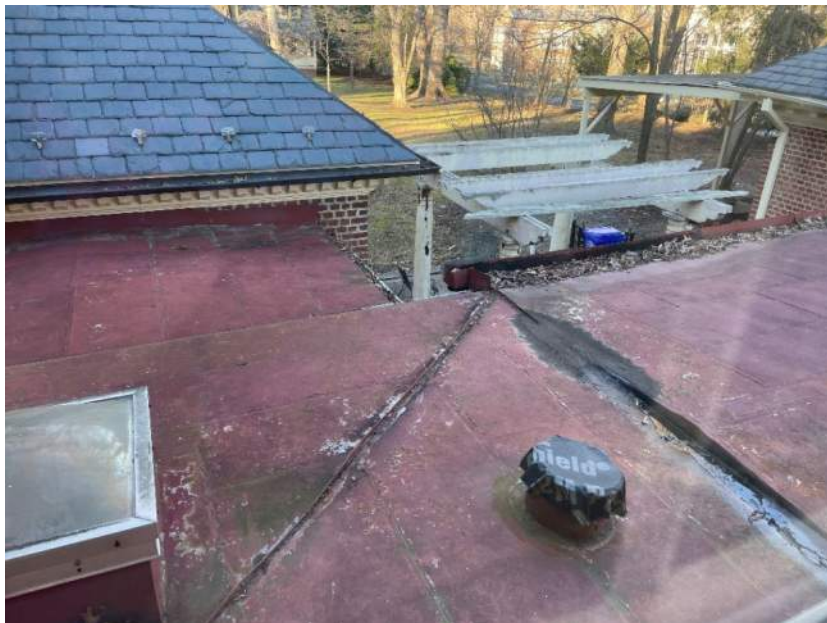
Work Item #12: Replace Roofing

Existing roofing is showing sign of wear with exposed flashing and missing roof tiles. Also, select modifications to the roof to remove skylights and other vent penetrations will require patching of the existing roof.

Staff finds the proposal to replace the slate and standing seam metal roofs along with new chimney caps is in-kind work that will not require a HAWP; however, specifications for those materials should be submitted to Staff before beginning the work. Additionally, cleaning and repairing the historic brickwork will not require a HAWP. No method or specification for the brickwork was included in the description for the work. Staff encourages the applicant to use the gentlest means possible following the guidance provided in Preservation Briefs #1 *Cleaning and Water-Repellent Treatments for Historic Masonry Buildings* and #2 *Repointing Mortar Joints in Historic Masonry Buildings*.

Replace the existing slate tile and metal roofing in-kind. Roof replacement will include new copper gutters and drain boxes to match HABS drawings.

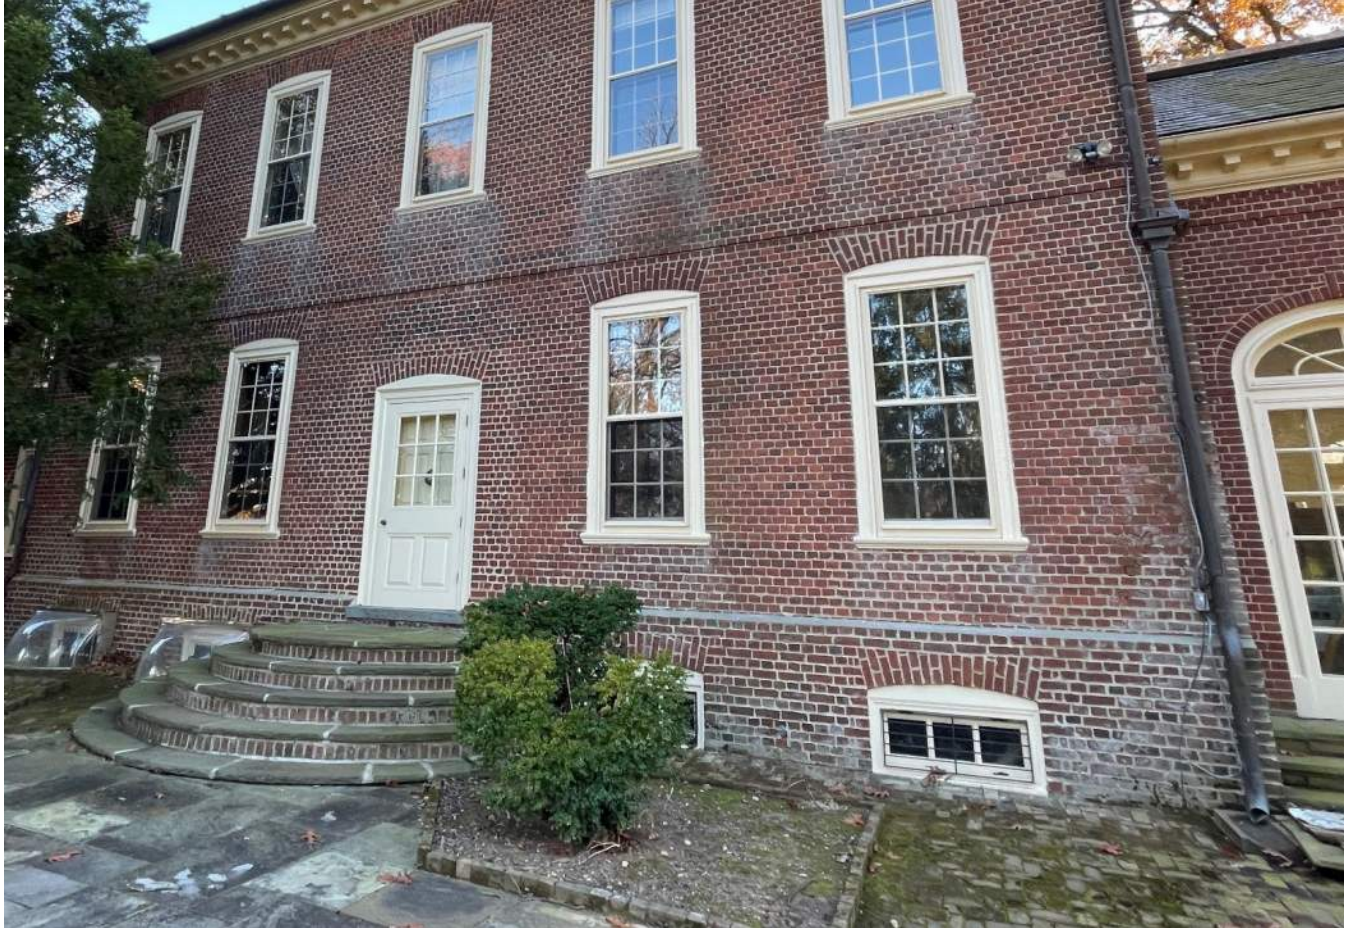
Work Item #13: Repair Brick Masonry Façade

The existing historic masonry has areas of staining, biological growth, incompatible mortar repairs, cracks in mortar joints, mortar loss.

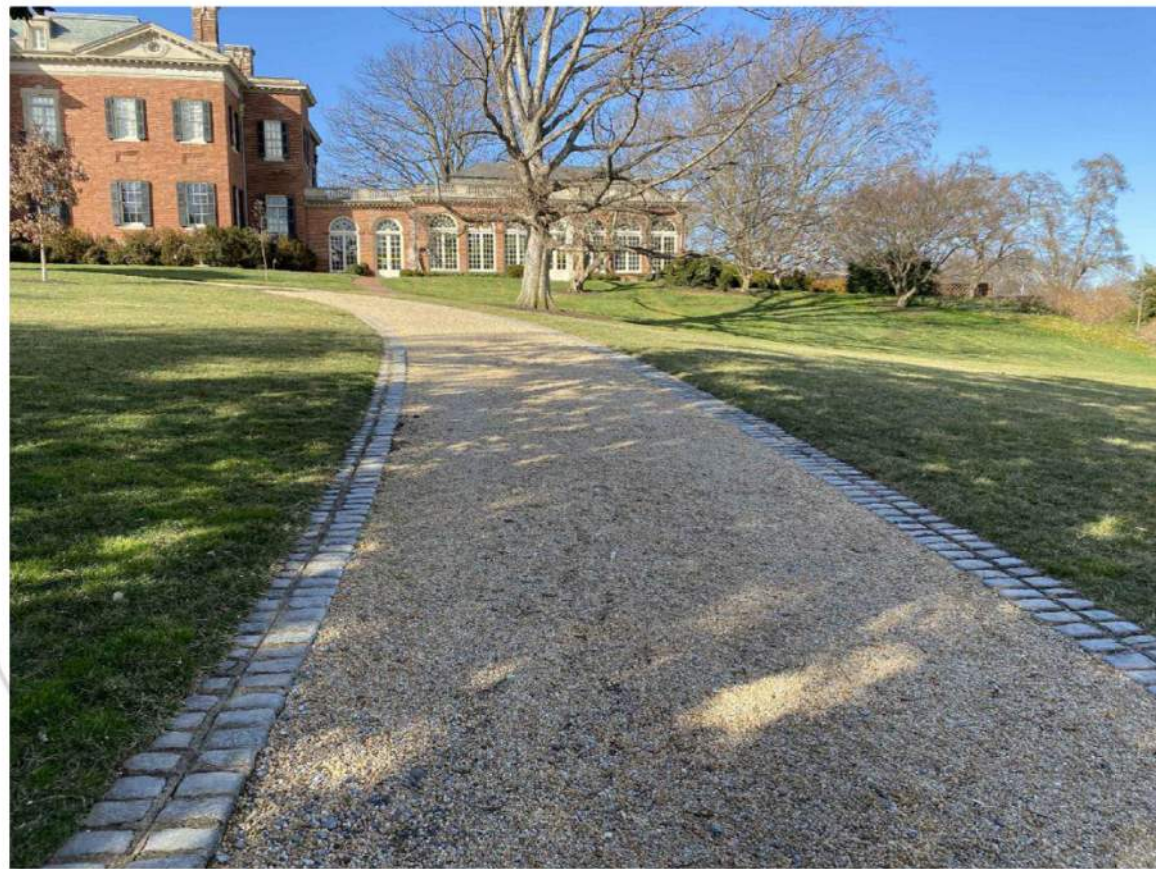
WORK ITEM #1 DRIVE ALONG SOUTH FAÇADE & WORK ITEM #2 DRIVE TURNAROUND
PROPOSED SEEDED AGGREGATE CONCRETE DRIVEWAY WITH MORTAR SET COBBLE EDGE

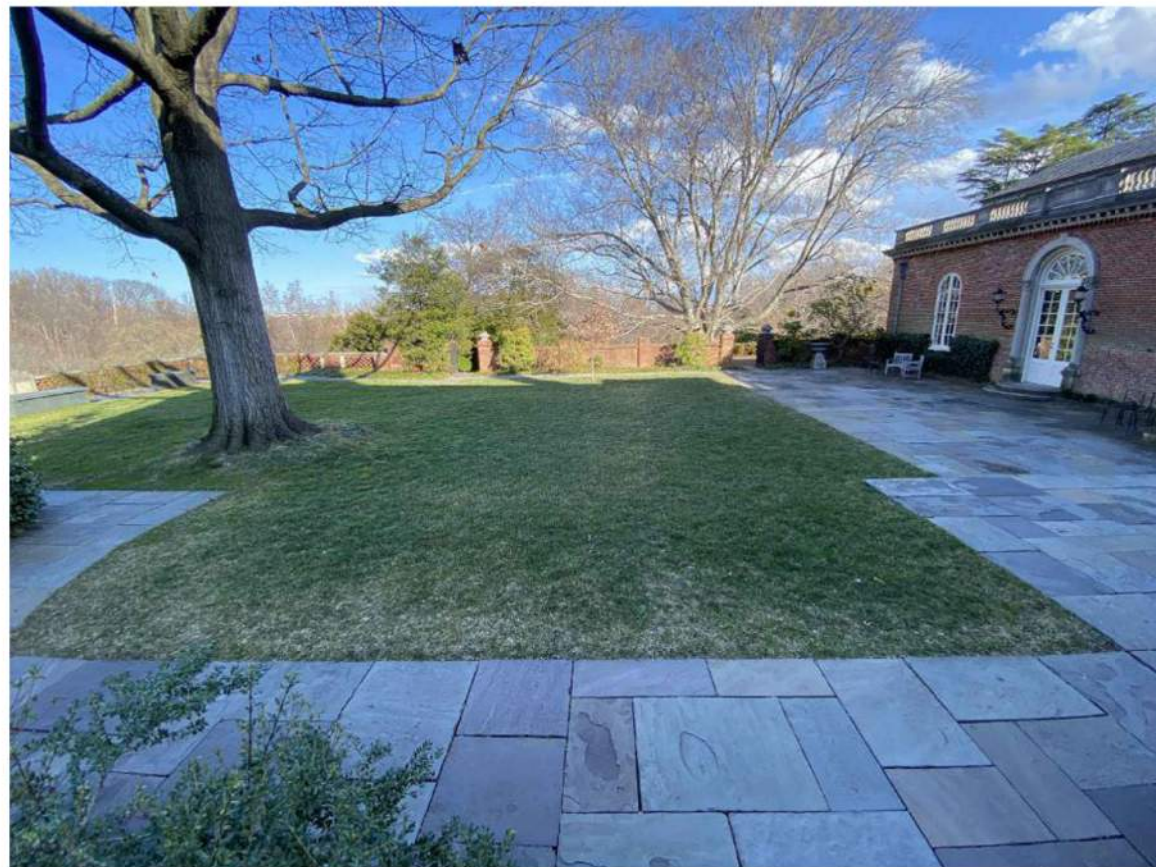
WORK ITEM #7 ACCESSIBLE EAST PATIO & WORK ITEM #8 ACCESSIBLE NORTH PLAZA: UNEVEN AND DAMAGED PAVERS
PROPOSED EAST PATIO AND EXISTING NORTH PATIO RENEWAL WITH MORTAR SET BLUESTONE PAVERS

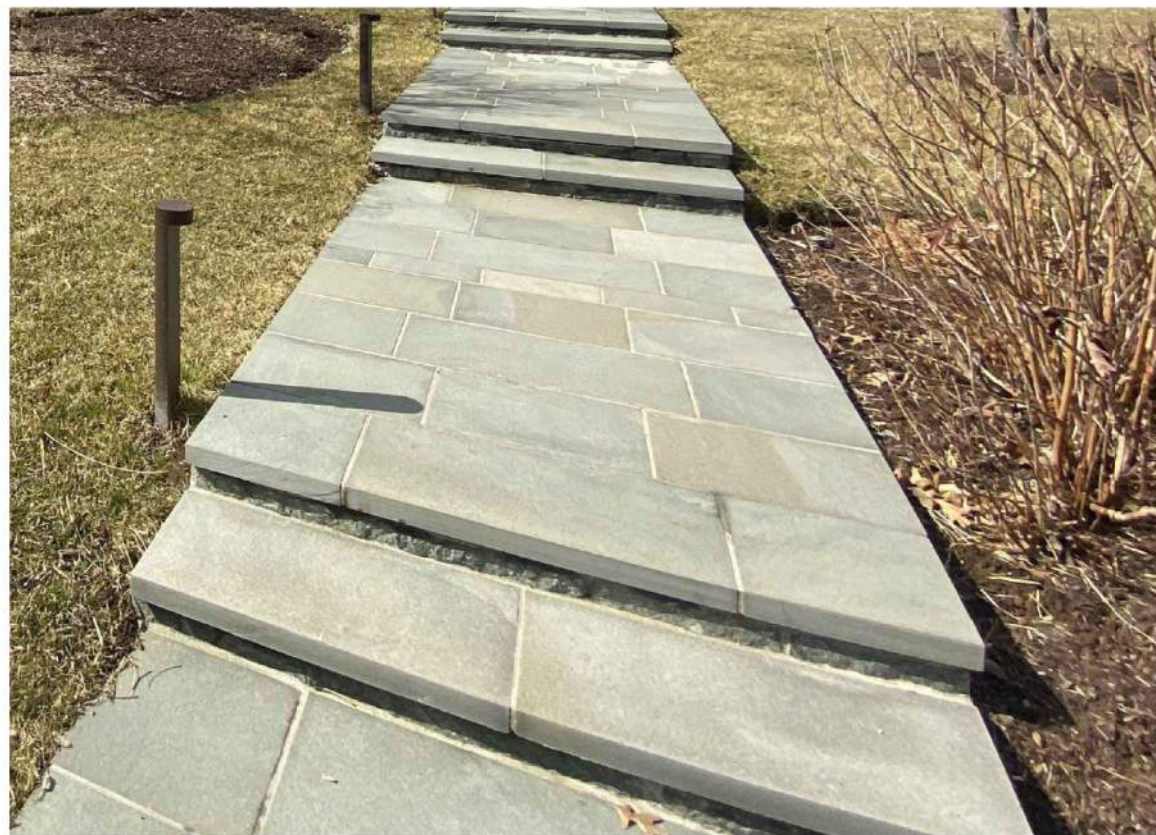
WORK ITEM #9 SUNROOM WEST PATIO AND STEPS TO GRADE
PROPOSED STEPS AND NEW WEST PATIO WITH MORTAR SET BLUESTONE PAVERS

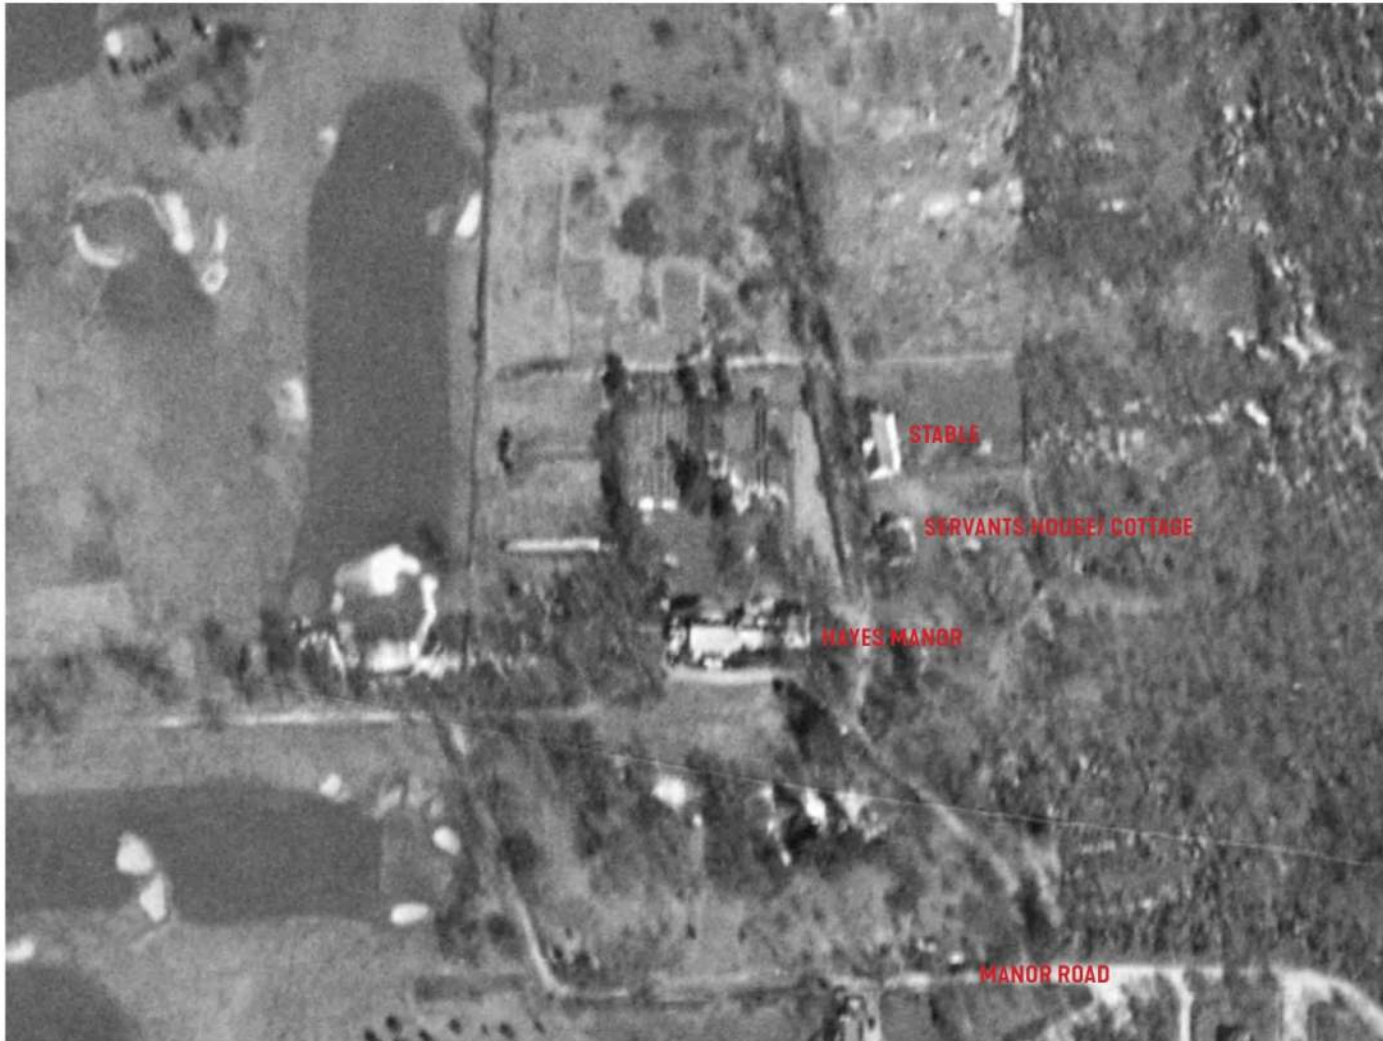
Landscape Period 6: 1949 Historic Aerial

The aerial image below represents the site in 1949. The rose garden and kitchen garden are seen located north of Hayes Manor. The stable and servants house are located east of the historic access road connecting Hayes Manor to Jones Bridge Road to the north.

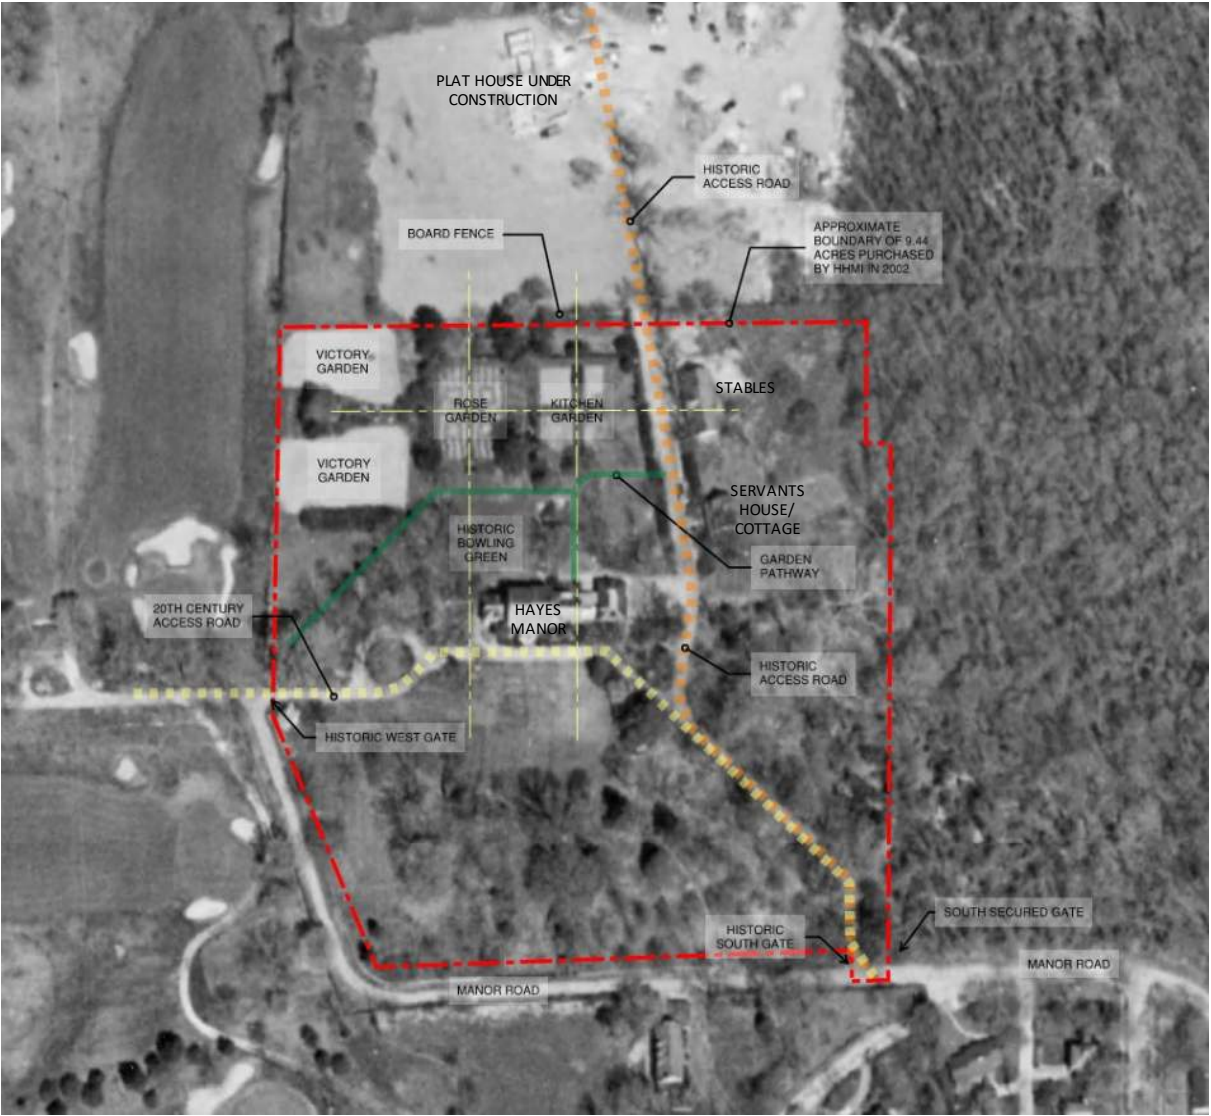
Landscape Period 6: 1957 Historic Aerial

The aerial image below represents the site in 1957.

- Clear axial relationship established between Manor House and north gardens
- Original access road from Jones Bridge Road seen northeast of Manor House
- Outbuildings seen along east side of road
- Access from Manor Road from the south and west (20th century)
- Pedestrian pathways between house, gardens, and original access road from north
- Victory gardens located on axis west of Rose Garden

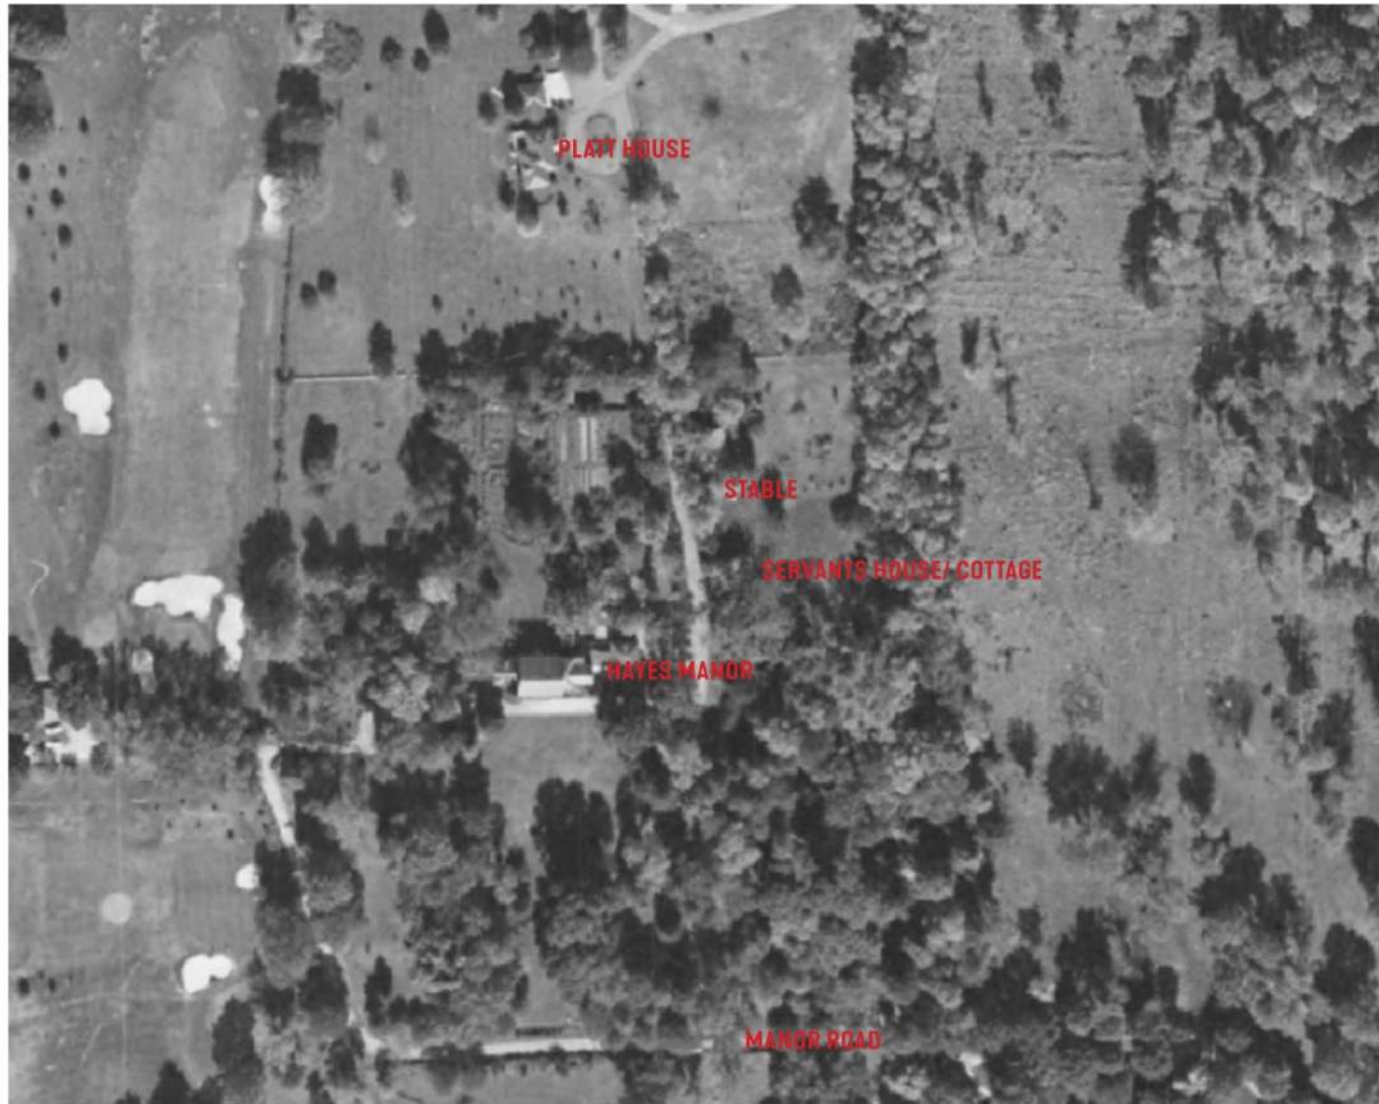
Landscape Period 6: 1963 Historic Aerial

The aerial image below represents the site in 1963. The Platt House, constructed in 1957, is located to the north of Hayes Manor.

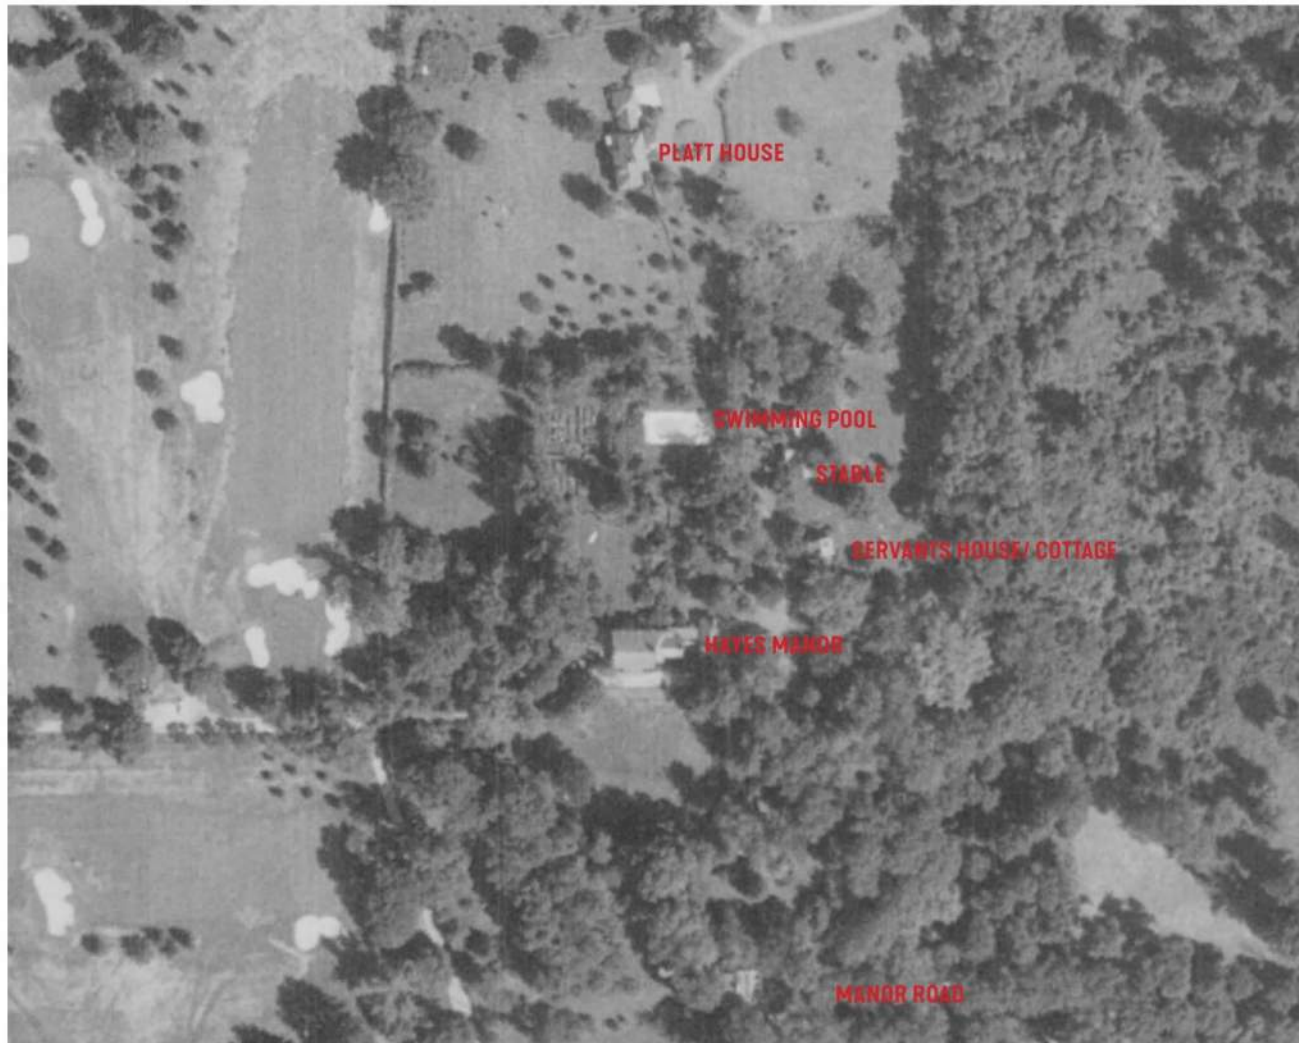
Landscape Period 7: 1970 Historic Aerial

The aerial image below represents the site in 1970. A notable change is the swimming pool which was constructed in place of the historic kitchen garden.

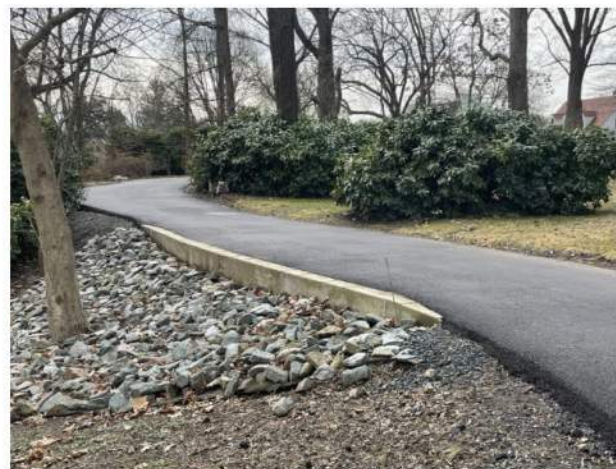
Existing cart path connecting Loop Road to the Manor House access road.

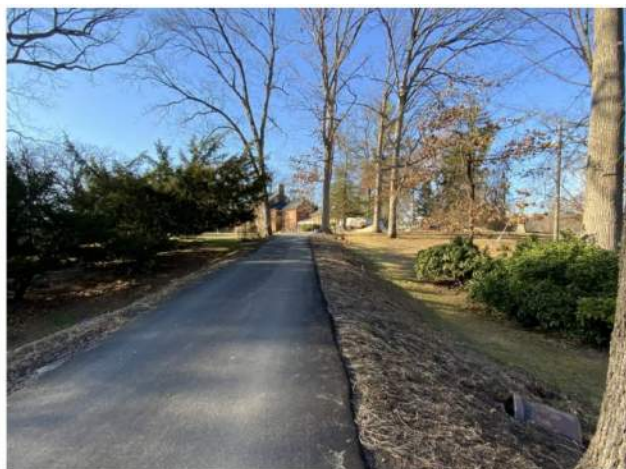
Existing access road from Manor Road to the south. Hayes Manor seen in the distance.

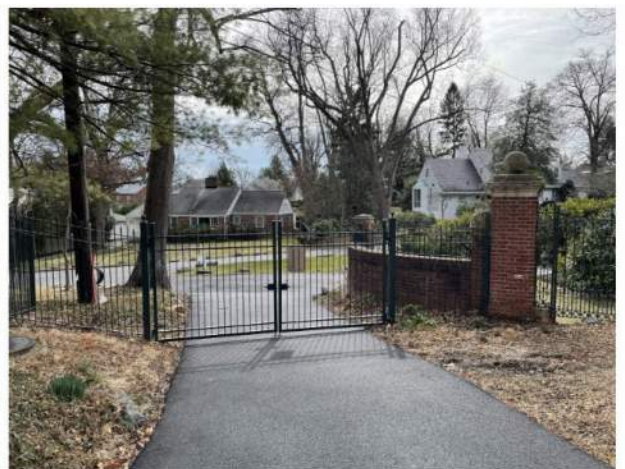
Existing security gate at Manor Road. Historic brick gate posts seen to the right.

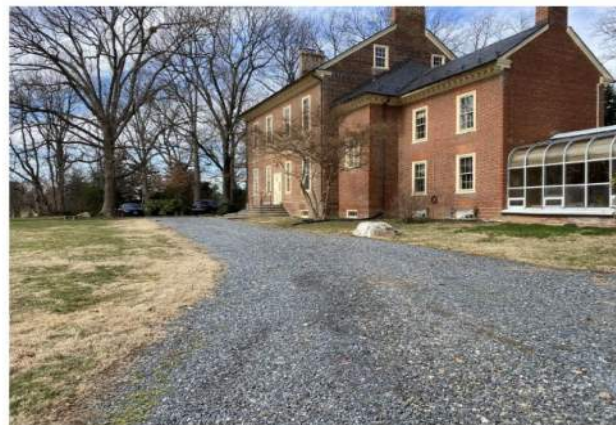
Existing gravel drive along the south side of Hayes Manor.

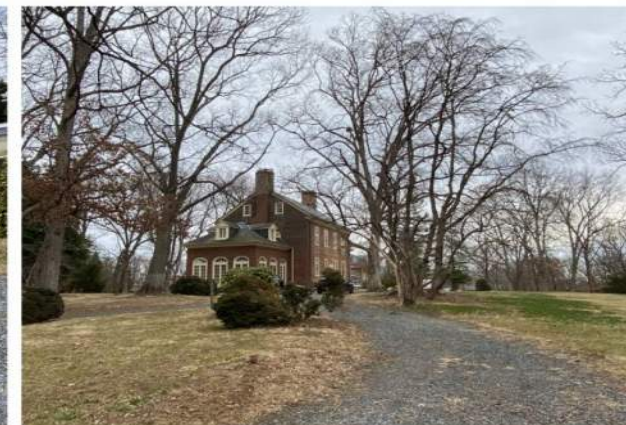
Existing gravel driveway turnaround located southwest of Hayes Manor.

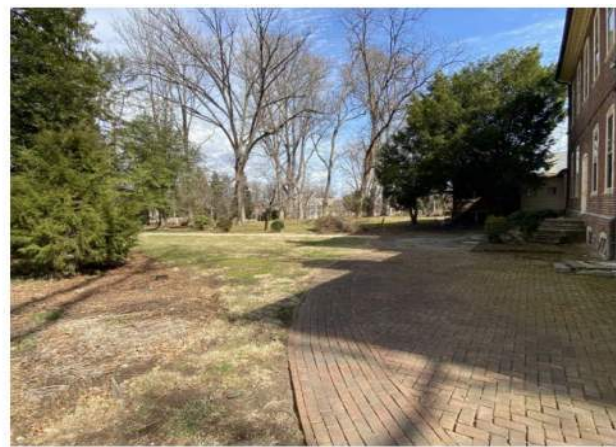
View of existing North Patio looking towards the headquarters building.

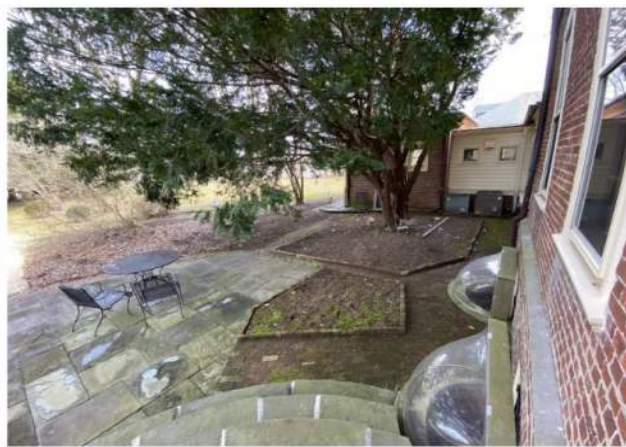
View of existing North Patio from north entrance to Hayes Manor.

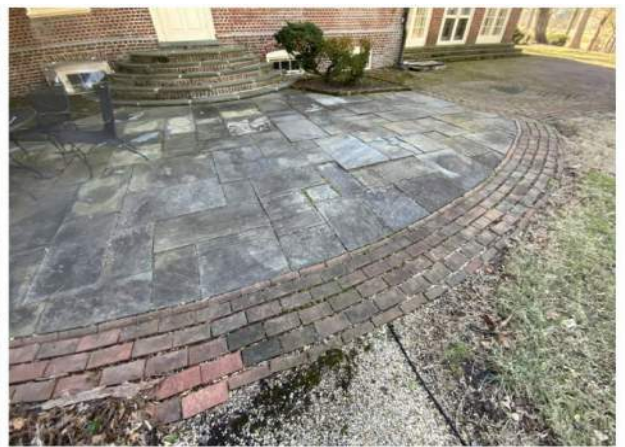
View of existing North Patio, featuring flagstone paving with brick border.
