Preliminary Consultation
MONTGOMERY COUNTY HISTORIC PRESERVATION COMMISSION
STAFF REPORT

Address:	4000 Jones Bridge Rd., Chevy Chase	Meeting Date:	8/17/2022
Resource:	Individually Listed Master Plan Site (Hayes Manor #35/10)	Report Date:	8/10/2022
Applicant:	Howard Hughes Medical Institute Susan Pommerer, Architect	Public Notice:	8/3/2022
Review:	Preliminary Consultation	Staff:	Dan Bruechert
Proposal:	Site Work, House Rehabilitation, and Landscape Master Plan

HOWARD HUGHES MEDICAL INSTITUTE
HAYES MANOR REHABILITATION

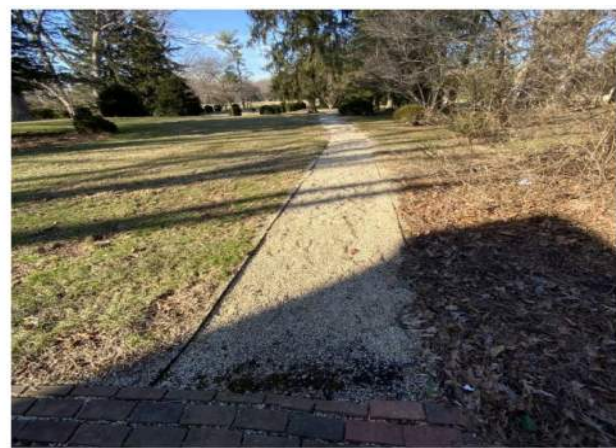
Existing pea gravel pathway leading from the North Patio to the Platt House.

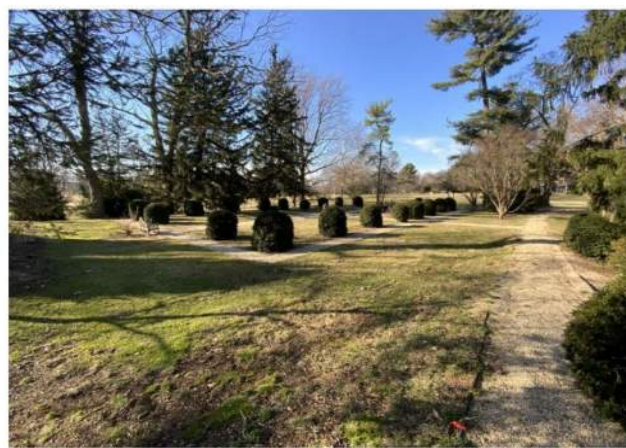
Existing pea gravel pathway leading from the North Patio to the Platt House. Rose Garden seen to the left.

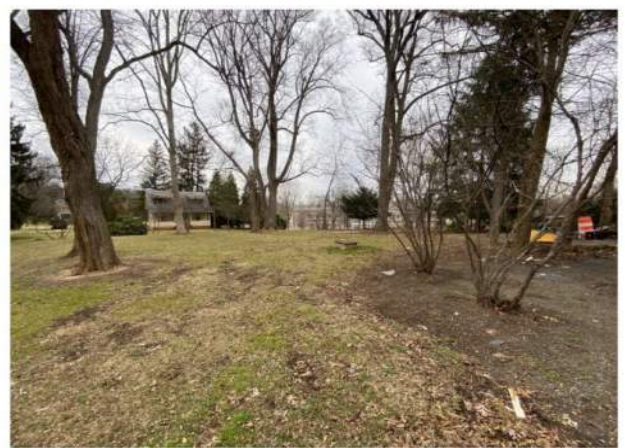
View of the Cottage from the North Patio.

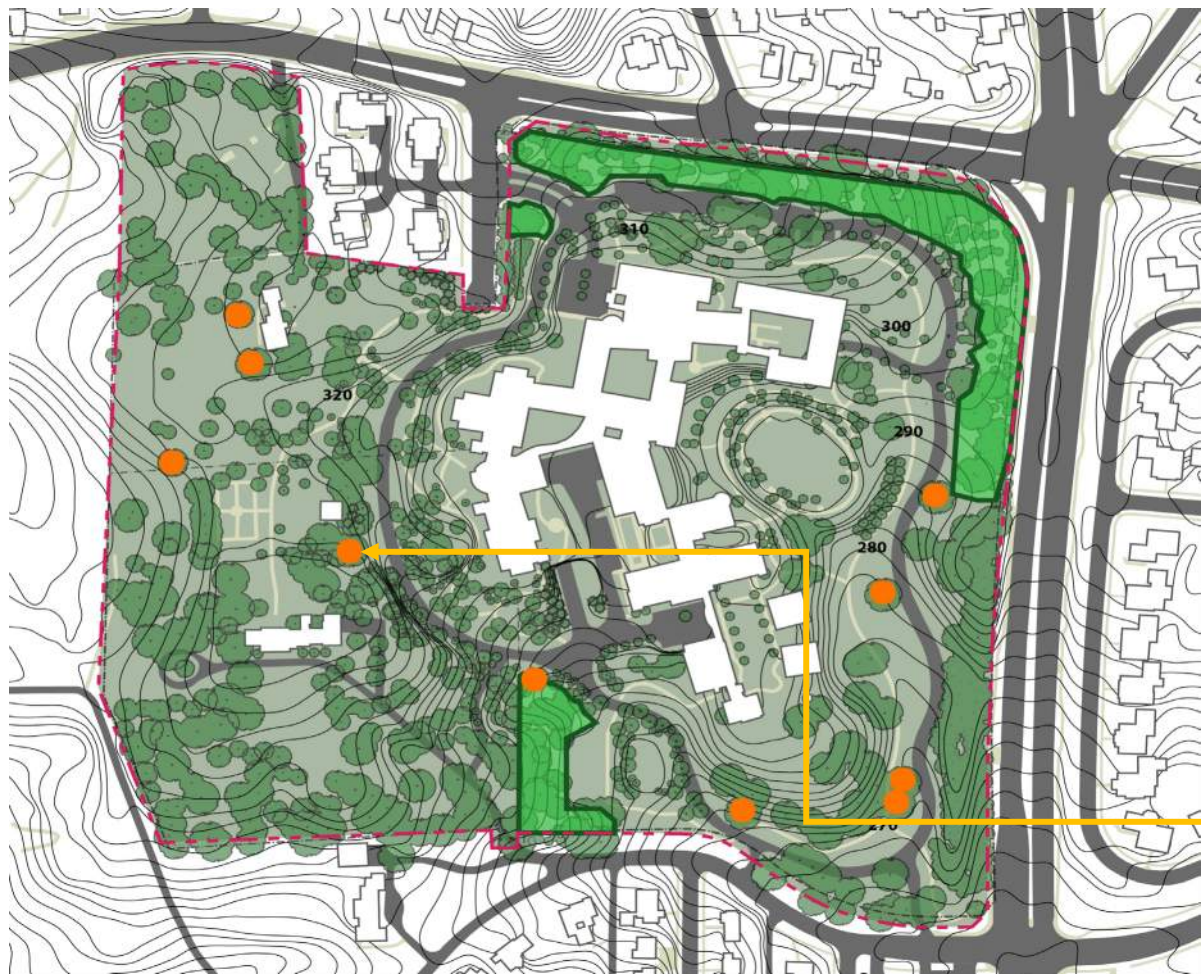
HHMI routinely contracts with Bartlett Tree Experts to maintain an inventory and assessment of existing trees on the campus. A high value tree, #826, is located within the proposed limit of disturbance for this project. All efforts will be made to protect and preserve this valuable landscape feature.

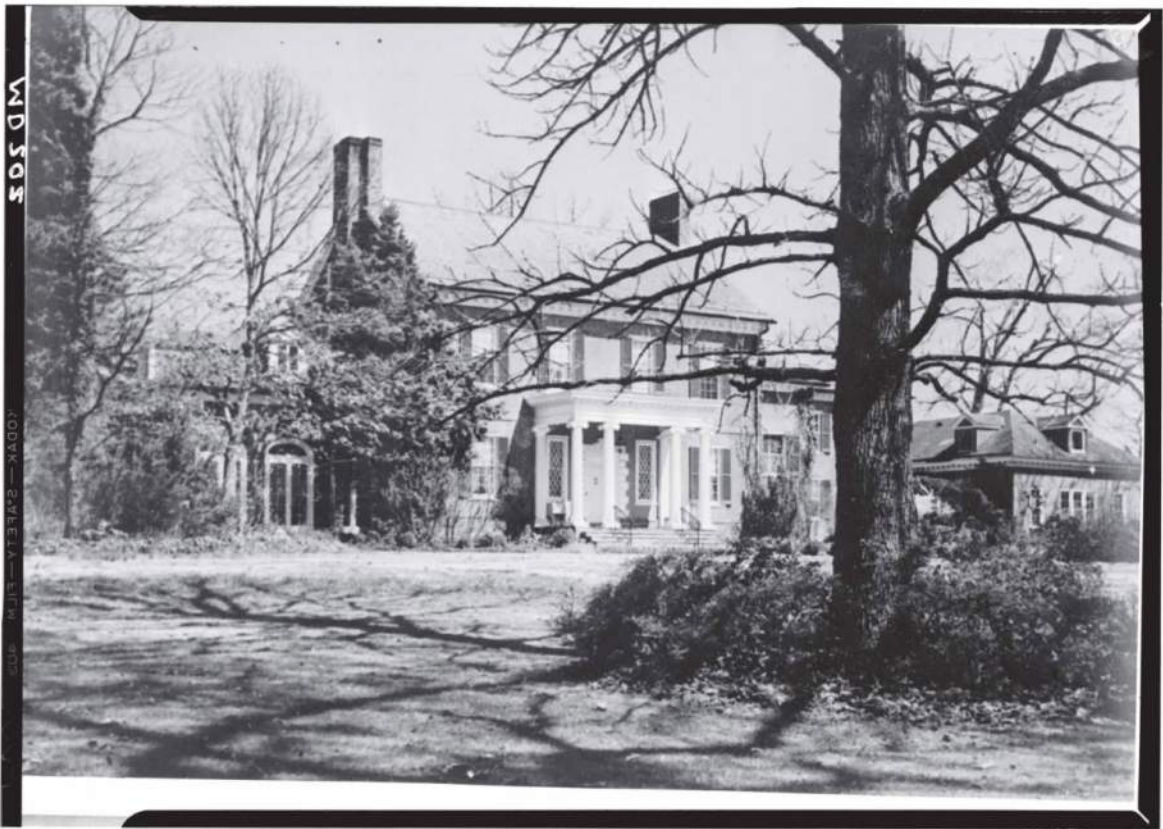
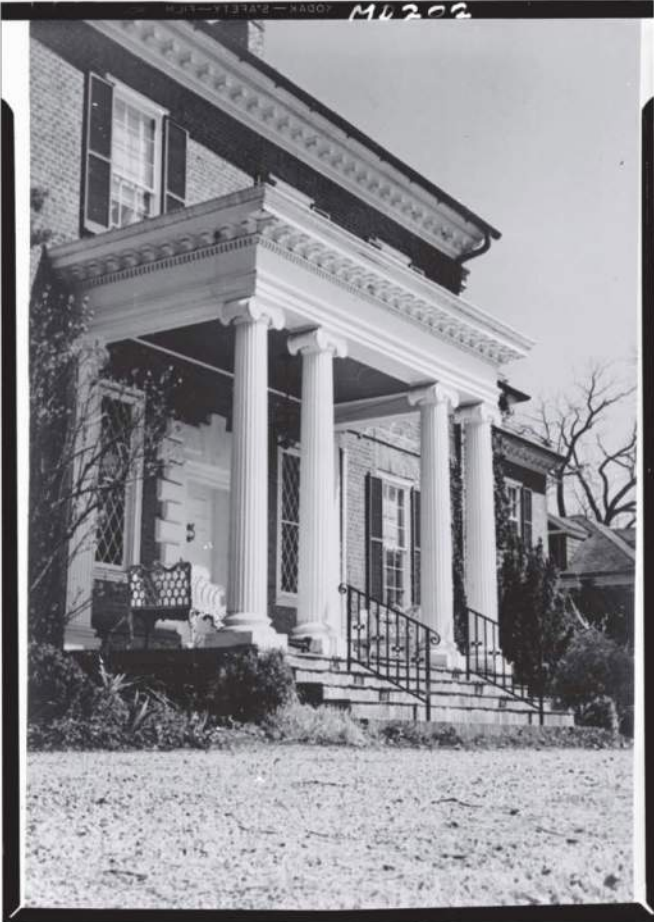
Historic American Building Survey (1961) - South Facade

The Historic American Building Survey (HABS) documented the Manor House and surround landscape in the 1960s. Select photos featured in this document were taken in 1961. The Manor House was measured and drawn by the National Park Service in 1962. The photographs shown below feature the south façade of the Manor House and provide an invaluable documentation of the South Porch which has since been demolished.

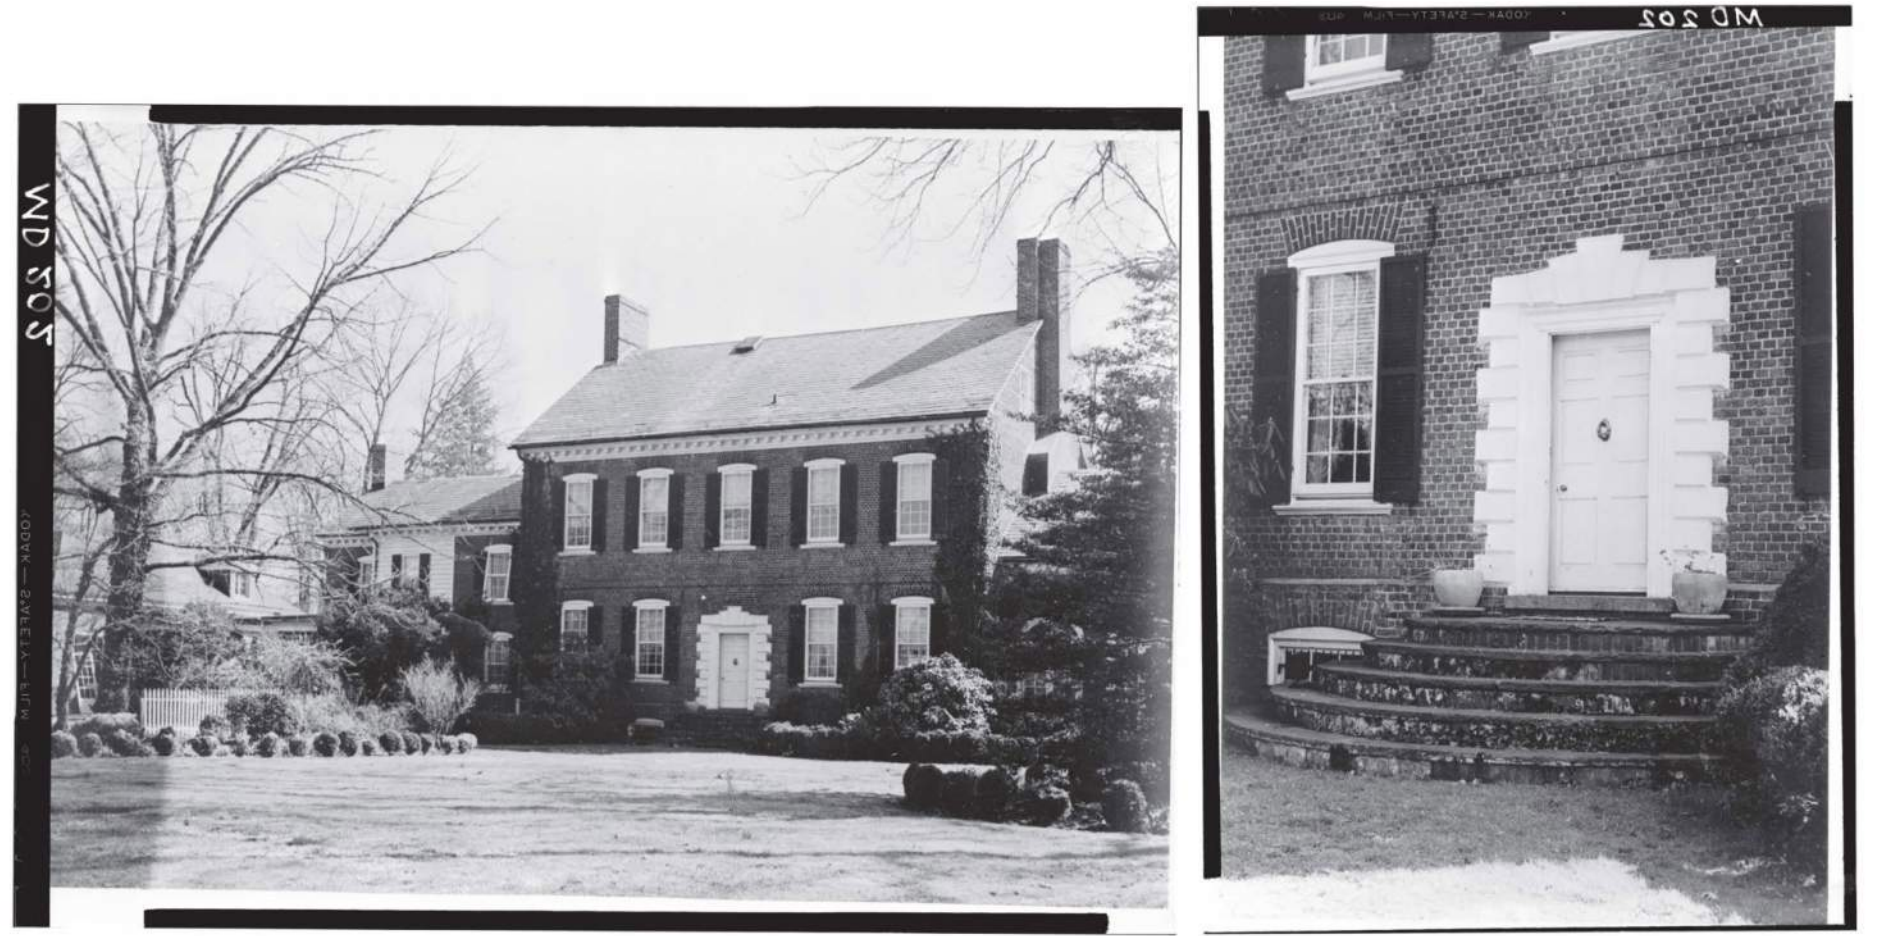
Historic American Building Survey (1961) – North Facade

The photographs shown below feature the north façade of the Manor House. It is notable that the rusticated plaster surround at the north door is no longer extant. This feature is also missing from the south façade.

The historic rusticated surrounds at the north and south entry to the Manor House have been removed from the façade.

Recreate the historic rusticated door surrounds per the HABS documentation.

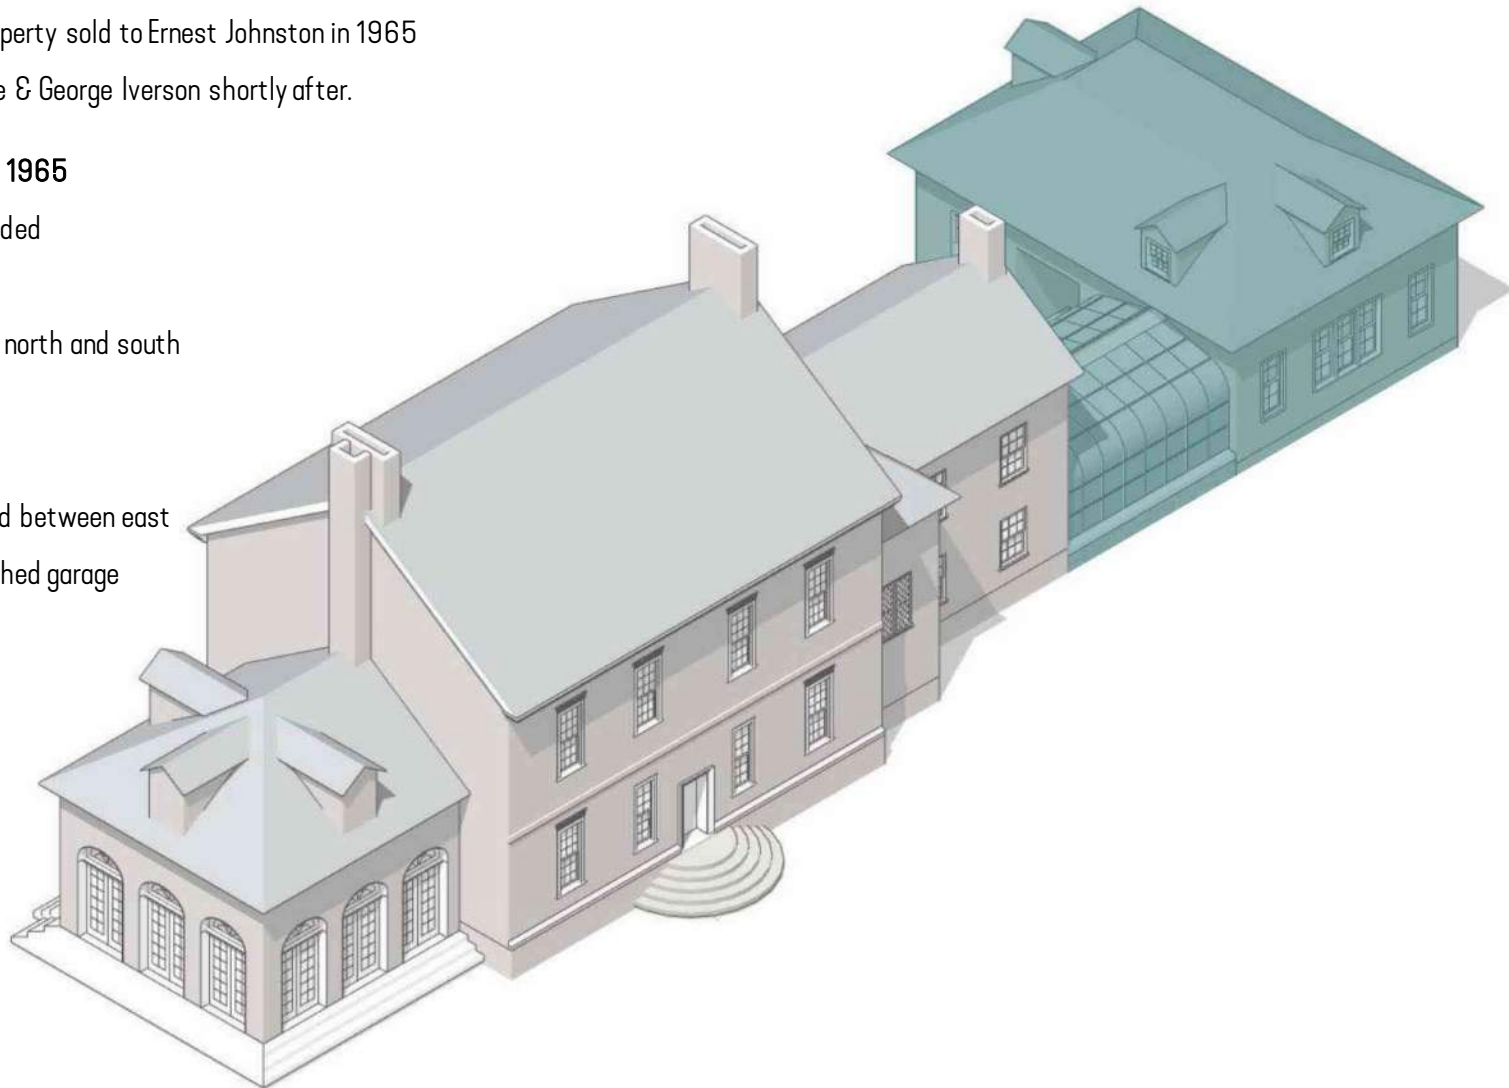
Changes implemented in 1965

- Detached garage expanded
- Shutters removed
- Rusticated surround at north and south doors removed
- South portico removed
- Greenhouse constructed between east kitchen wing and detached garage

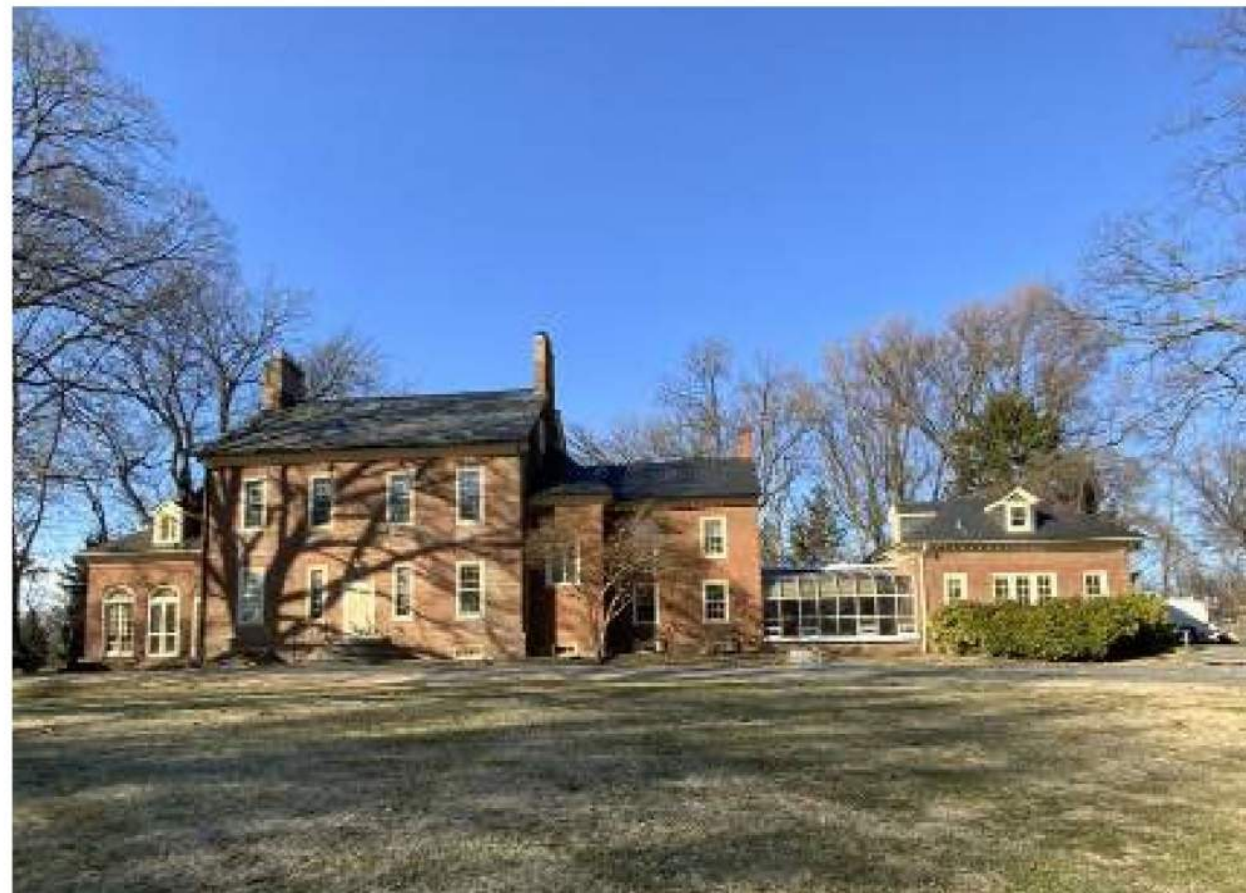
The following images represent the existing south and west façades of Hayes Manor. The central foursquare of the house was constructed from 1762-1767. The west Sunroom addition and the detached Garage to the east were added in 1908. The greenhouse connecting the house to the Garage was added in 1965.

View of south façade of Hayes Manor.

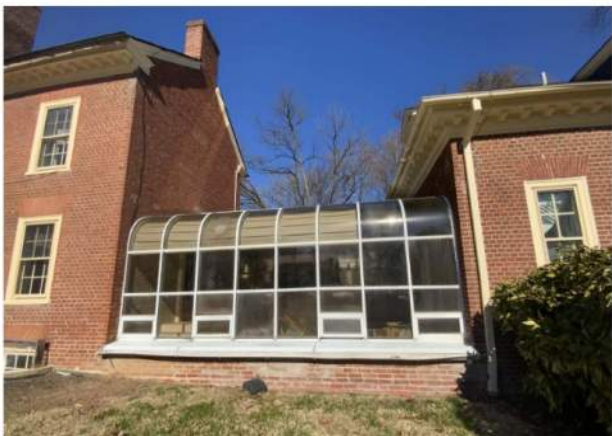
View of greenhouse located between the Manor House and Garage to the east.

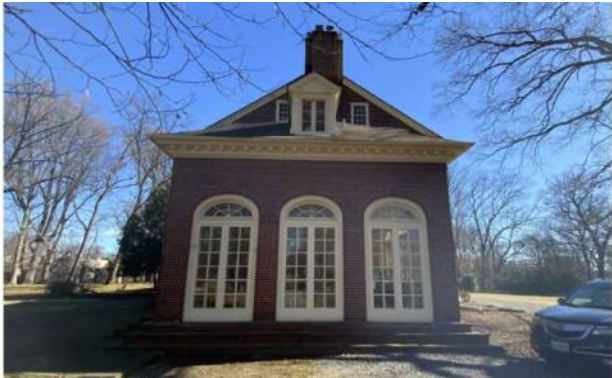
View of west façade of Sunroom.

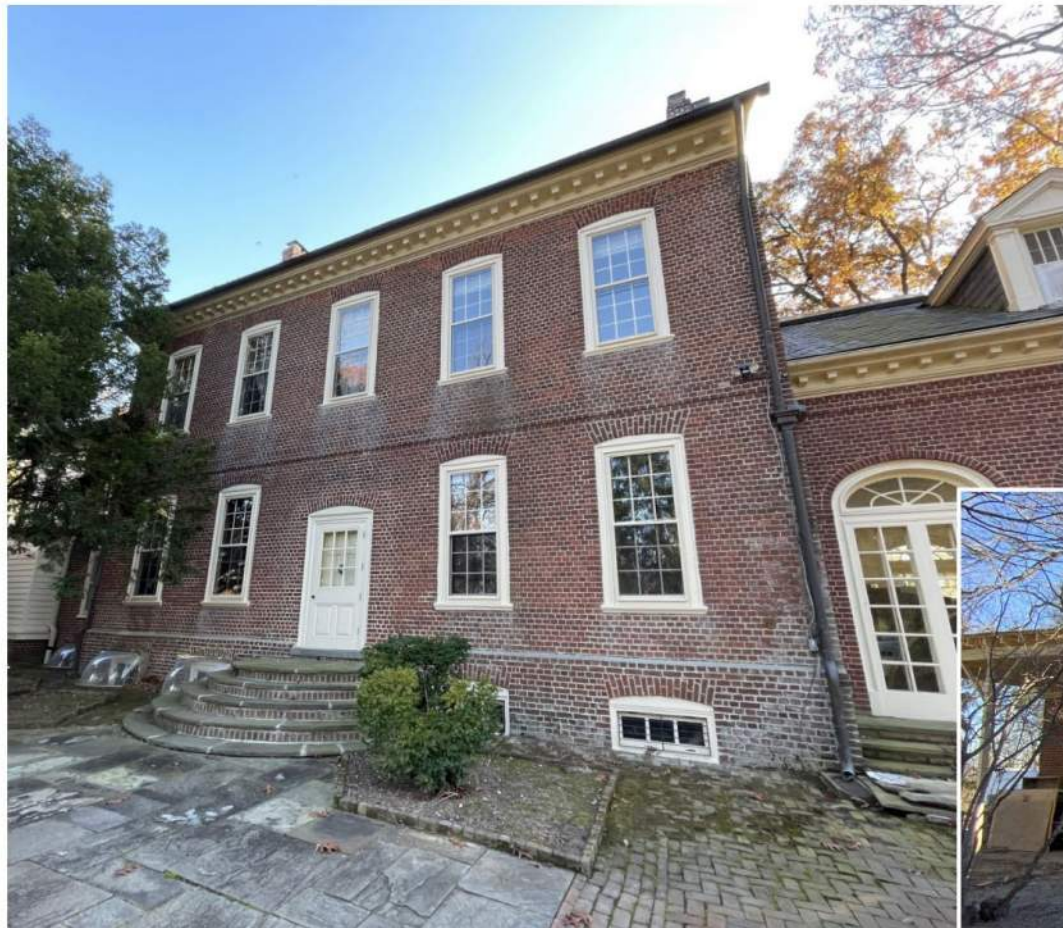
The following images represent the existing north façade of Hayes Manor. The central foursquare of the house was constructed from 1762-1767. The west Sunroom addition and the detached Garage to the east were added in 1908. The kitchen addition east of the foursquare was added in 1899 and subsequently renovated in the late 20th century.

View of north façade of Hayes Manor with steps leading to the North Patio.

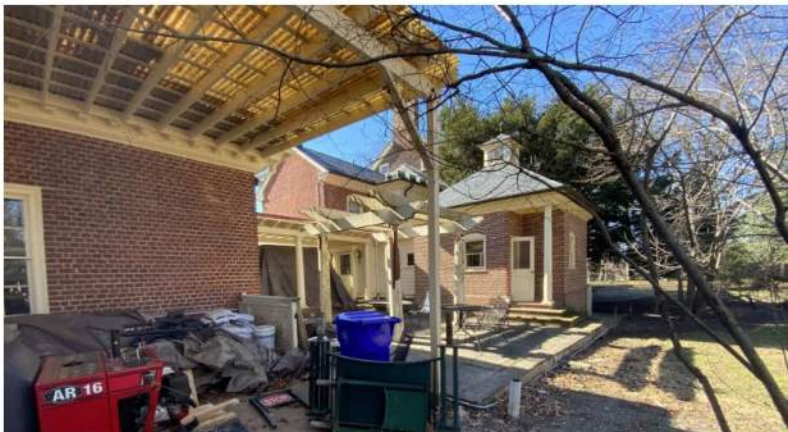
View of existing maintenance north of the Garage and the East Patio.

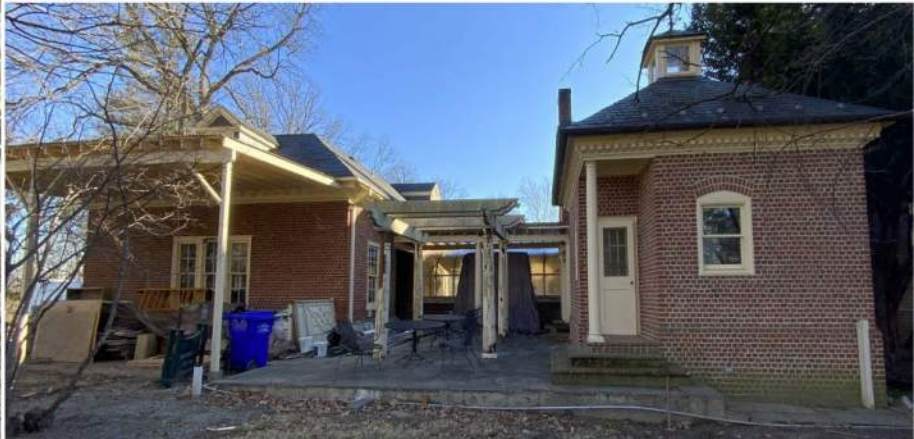
View of existing maintenance north of the Garage and the East Patio.
