MEMORANDUM

RE: Reduction of the Environmental Setting for Flint Hill II (M: 22/17), 17800 Bowie Mill Road,
Derwood

Re: Request for Determination on Environmental Setting -- Fraley Farm, 17800 Fraley Farm Road (the "Property")

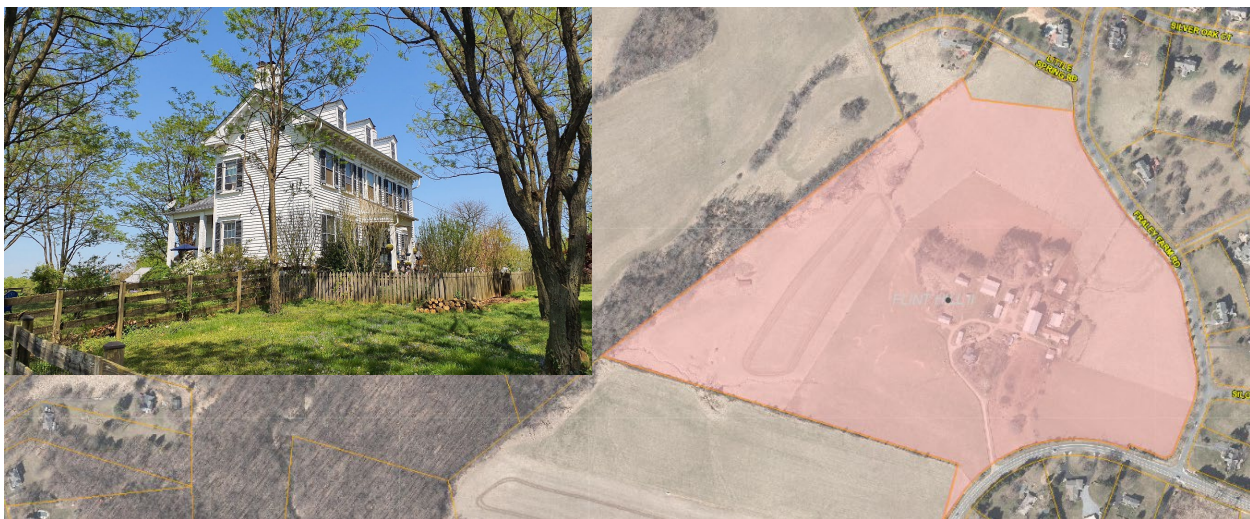
Figure 1: View of the house at Flint II and the current environmental setting shaded red. Source: Montgomery Planning and Dutton + Associates.

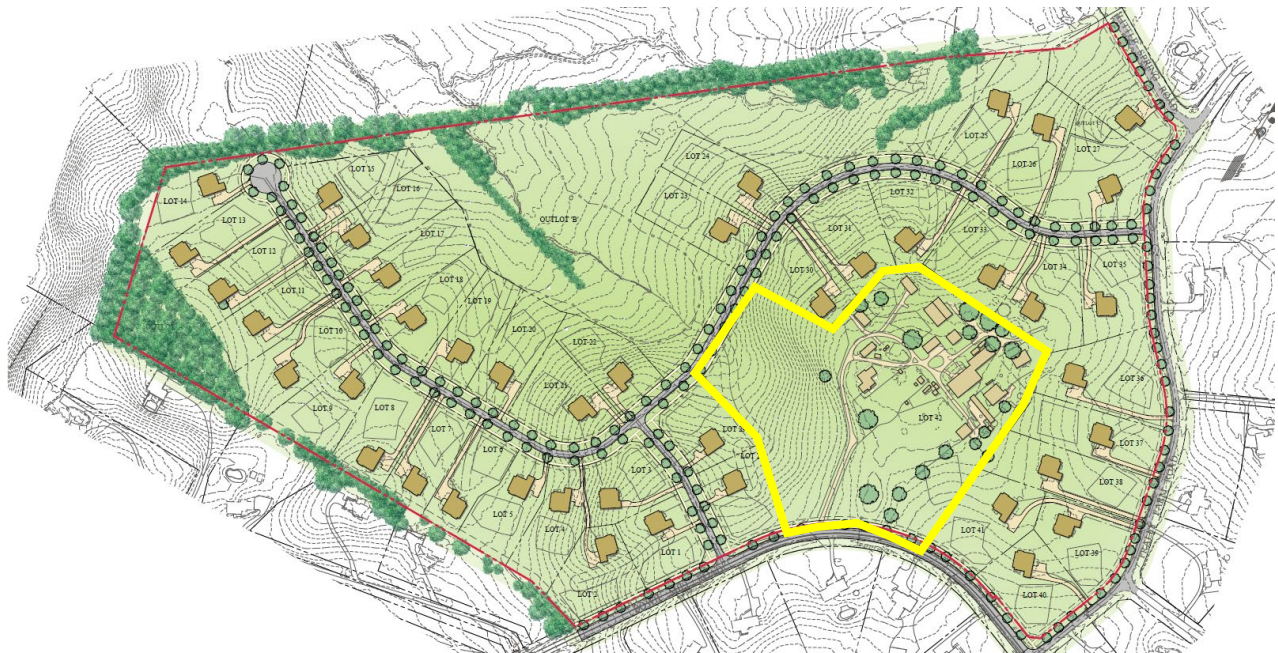
Figure 2: Concept Plan for Fraley Farm West. The yellow outline is the proposed (reduced) environmental setting. Source: Applicant.

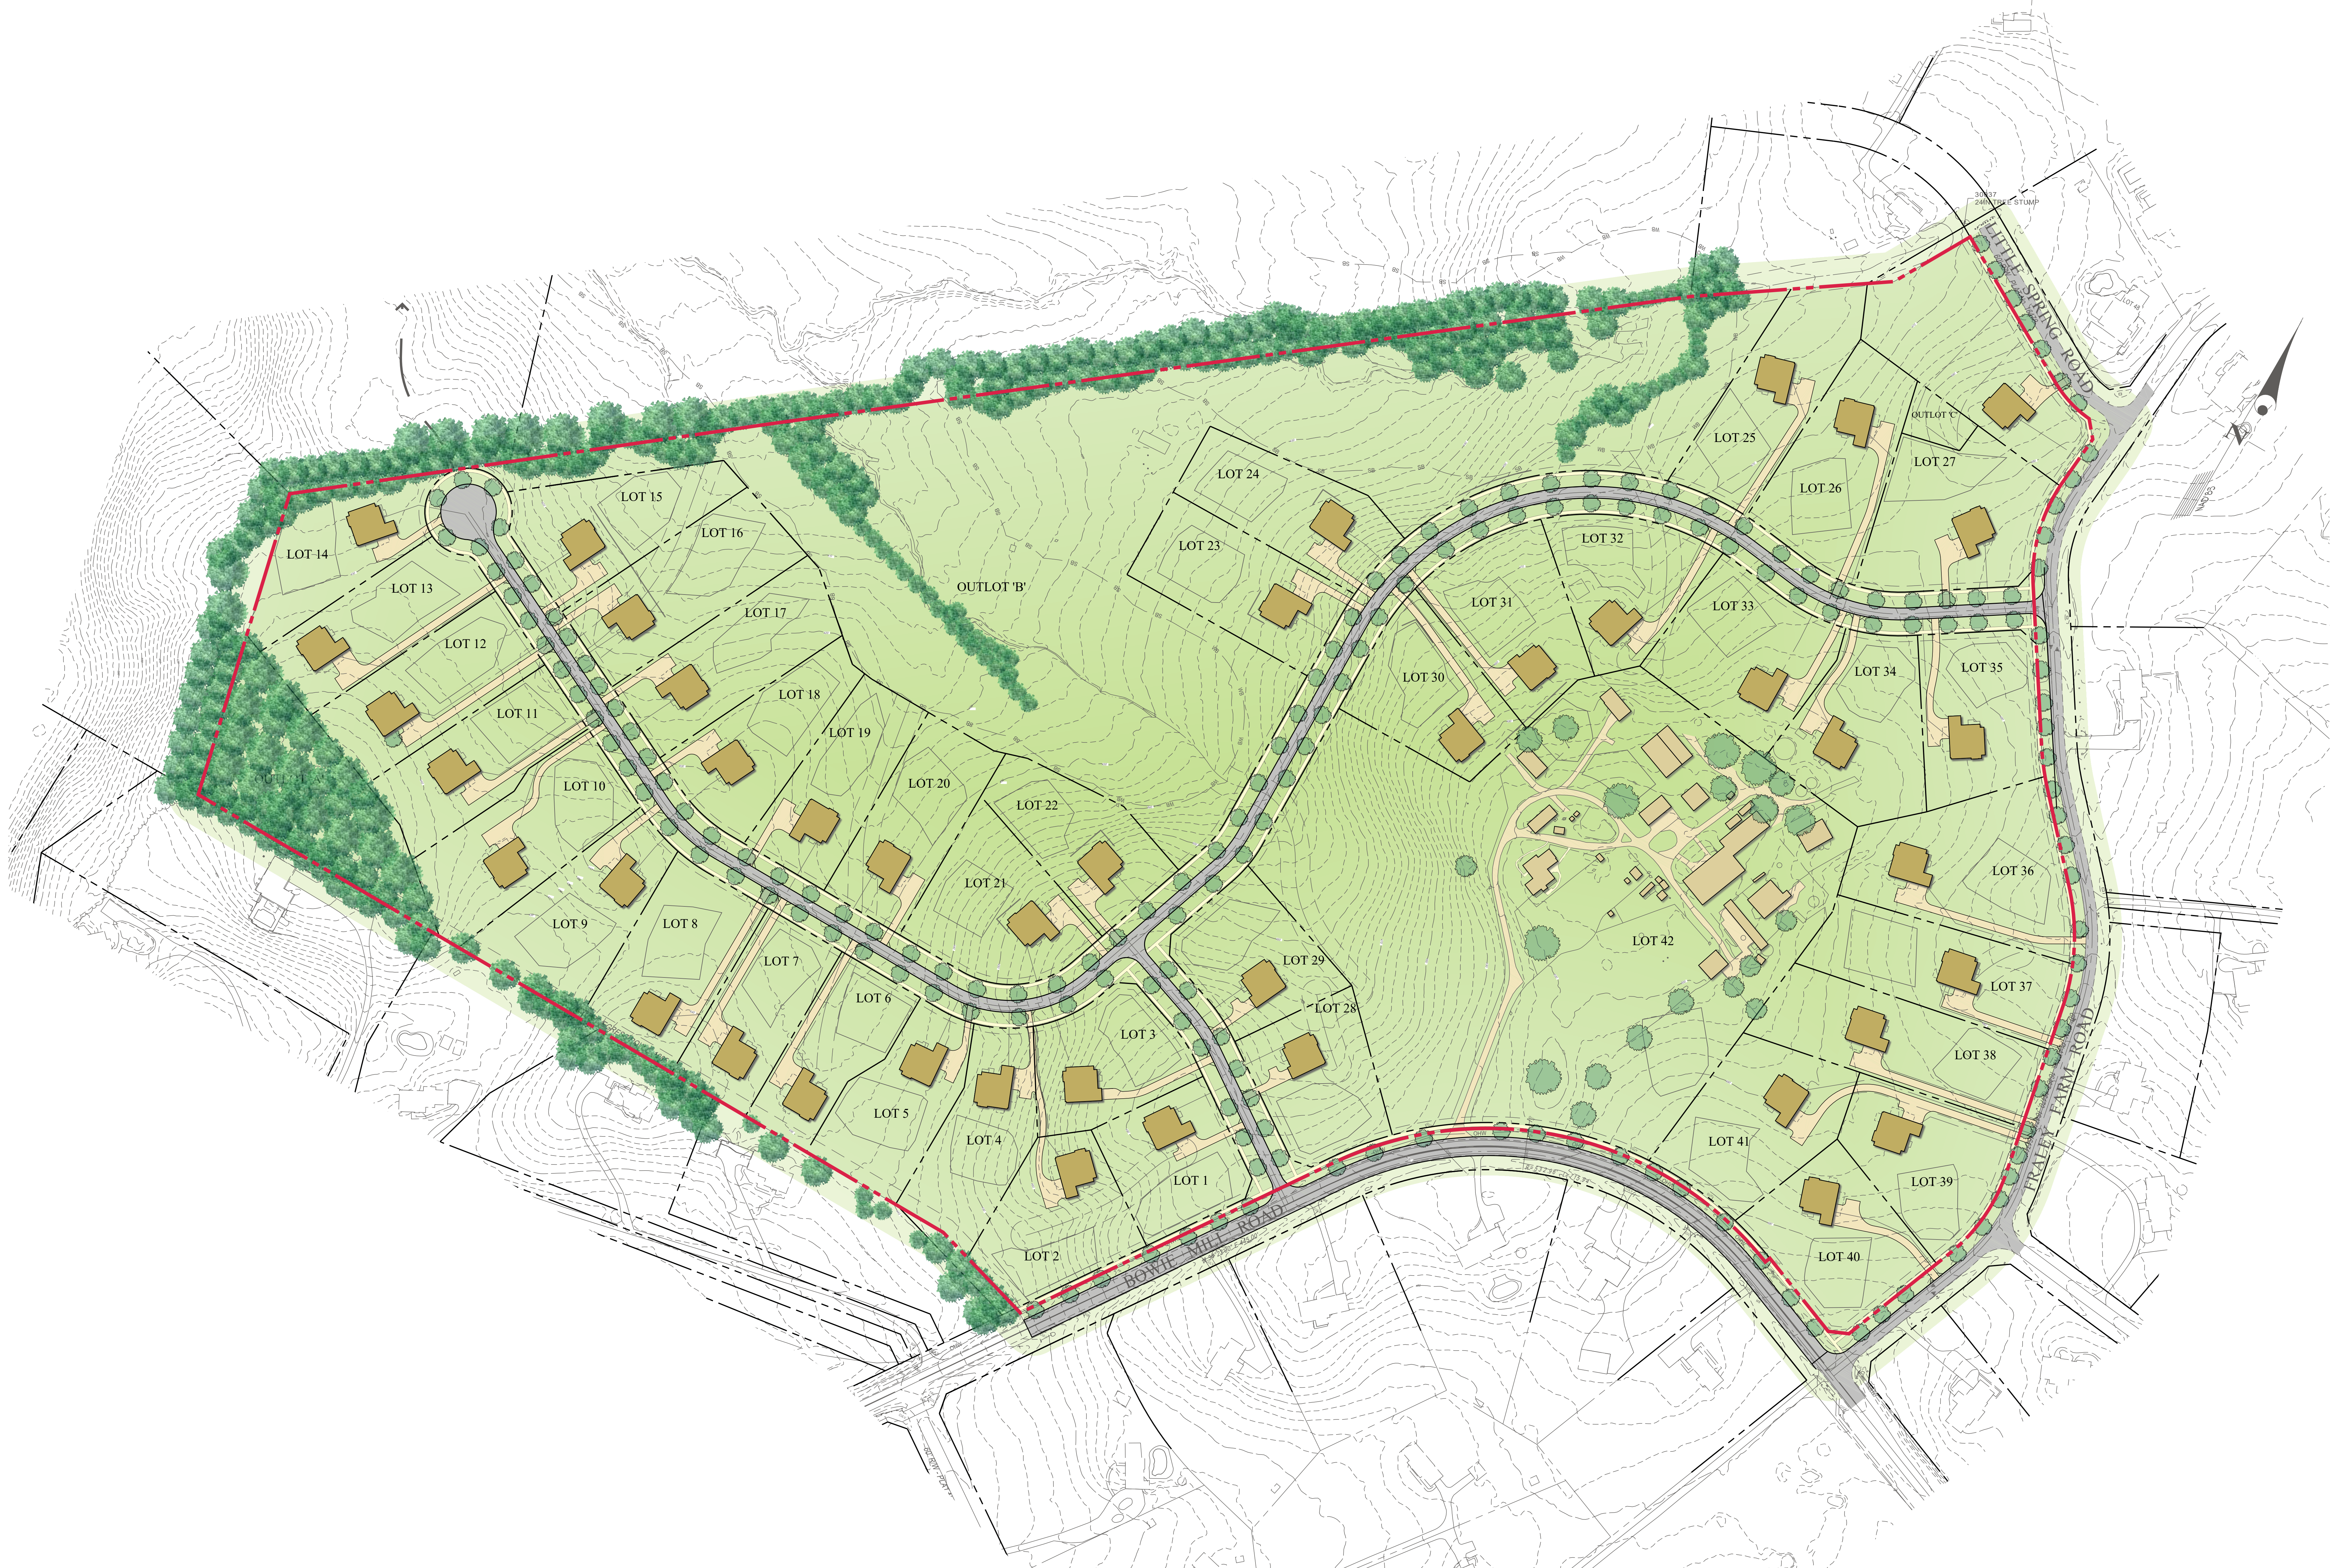
Attachment A

**CONCEPT PLAN
 FRALEY FARM - WEST
 MONTGOMERY COUNTY, MARYLAND**

Pulte Homes, the contract purchaser of the 91-acre Fraley Farm—which includes an adjacent parcel outside of the designated Master Plan Historic Site Environmental Setting—proposes to develop the property with 43 lots (*Figures 1 and 2*). This includes an existing single-family lot, a new 12.44-acre lot for Flint Hill II (the subject historic resource), and 41 new single-family lots. The entire 12.44-acre lot comprises the new environmental setting for the Master Plan Historic Site.

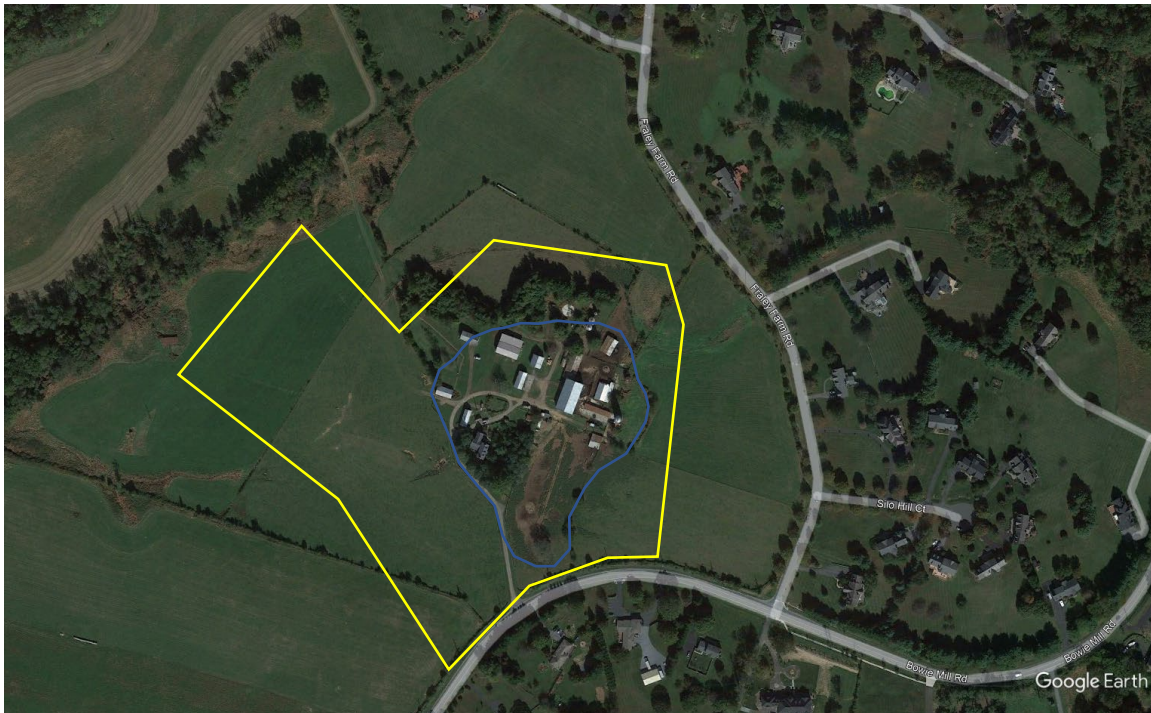
Figure 3: Approximate 495’ contour (blue) in relation to proposed project exclusion/preservation area (yellow).

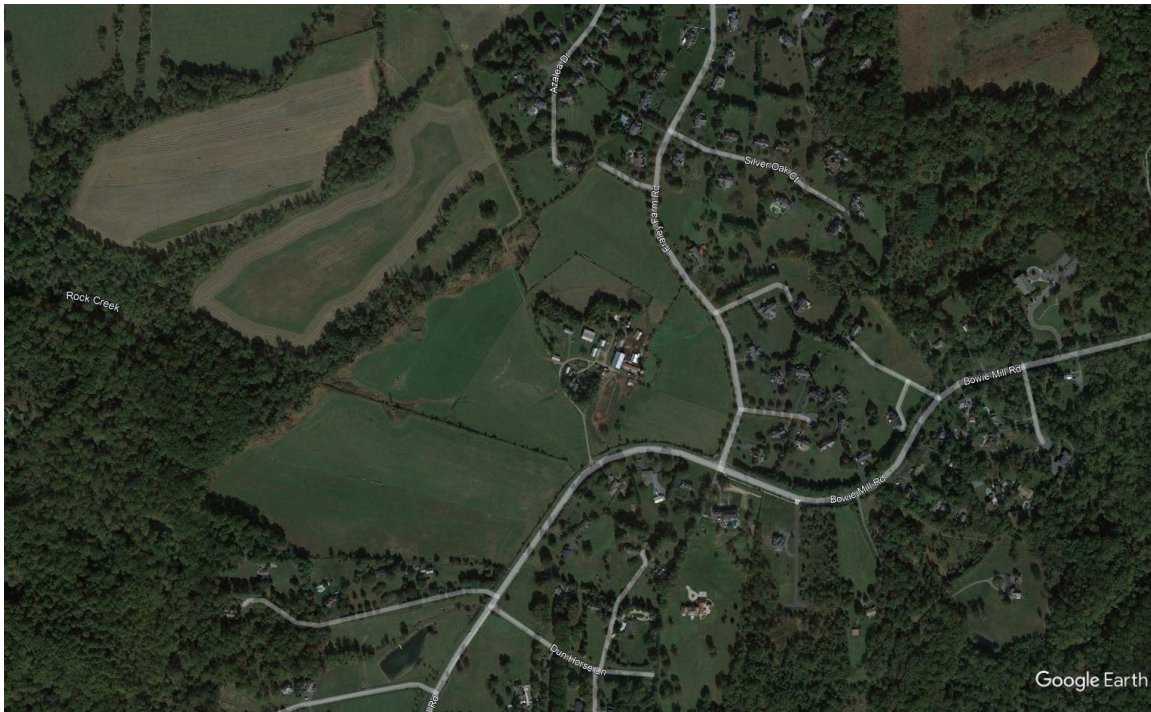
Figure 4: Aerial photograph illustrating vegetation within and bordering property, as well as suburban development to the south, east, and north.

At this time, the Flint Hill house is situated on a 49.28-acre property parcel, although it is flanked by separate 36.28-acre and 1.78-acre parcels also associated with the property. The property is bordered by suburban residential development to both sides and across the road while a large undeveloped rural tract borders it to the rear. The home is setback from the road by roughly 450-feet atop a slight knoll. It is approached by a gravel driveway that loops around the rear of the house to the associated agricultural building complex. Most of the property around the building complex is open pasture with clusters of trees immediately around the home and to the rear of the barn complex. Additional treelines border the perimeter of the property along the road, and along field edges (Figure 4). The terrain of the property is rolling, with the home resting on the highest point and sloping down in all directions, gently to the north and east and more steeply to the southwest.

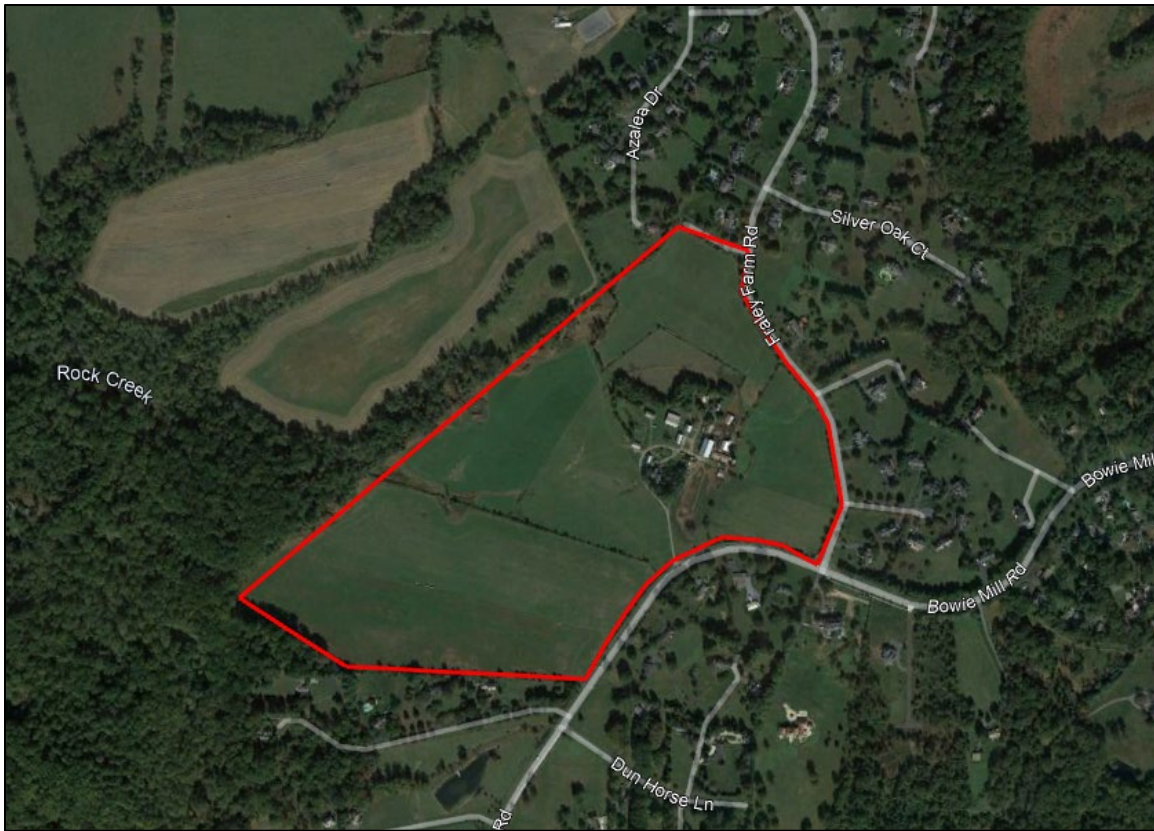
Figure 5: Aerial image of the current limits of the Flint Hill Farm property (outlined in red). Source: Google Earth 2023

Site inspection confirmed the house site sits on a prominent ridge top, with steep slopes to the west down to lower lying pastures, and more moderate slopes to the south down to Bowie Mill Road. A copse of mature hardwoods surrounds the main dwelling and agricultural building complex with ornamental plantings located throughout the yardscape. Larger bushes and evergreen vegetation border fences lining Bowie Mill Road and fields throughout the property. A network of gravel and unpaved roads circulate throughout the complex with a two-track farm road leading northwest to the property's northern boundary (Figure 5).

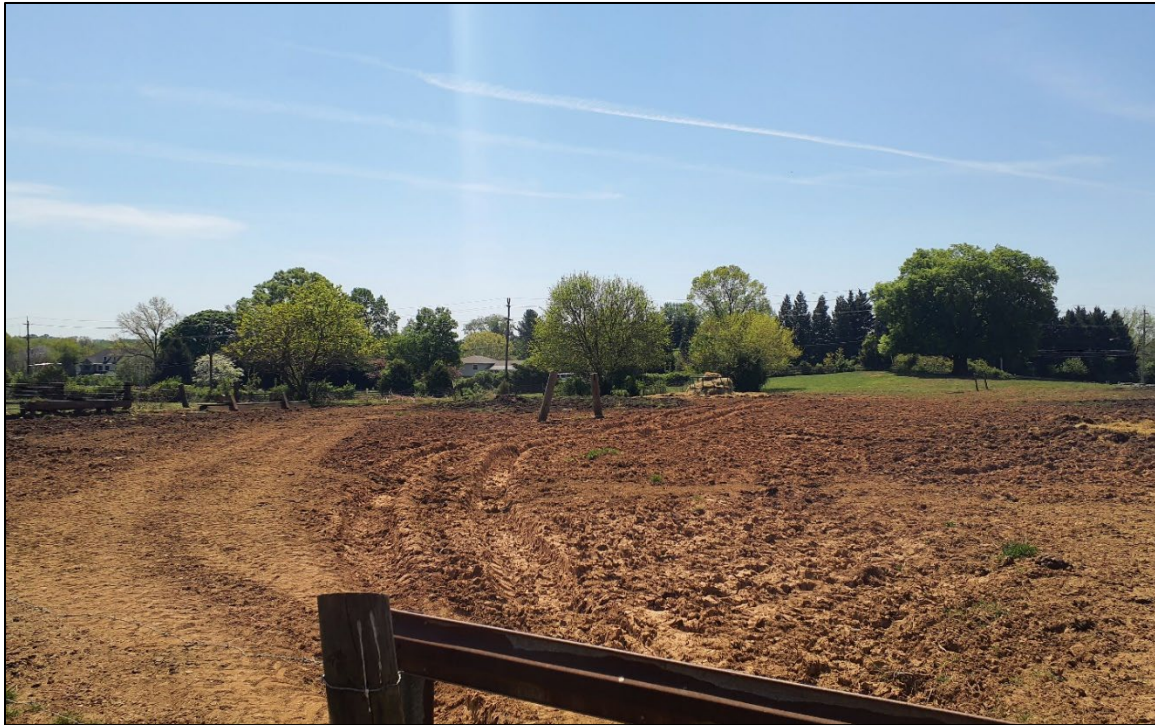
At the time of the pedestrian reconnaissance, the fields were in pasture. Exposed soils were widespread in agricultural spaces immediately adjacent to the barn structures located southeast and northeast of the main residential dwelling. These areas showed disturbed and rutted soils because of animal and equipment activity (Figure 8).

Figure 8: View of exposed soils in active farmyard north of main barn facing north.

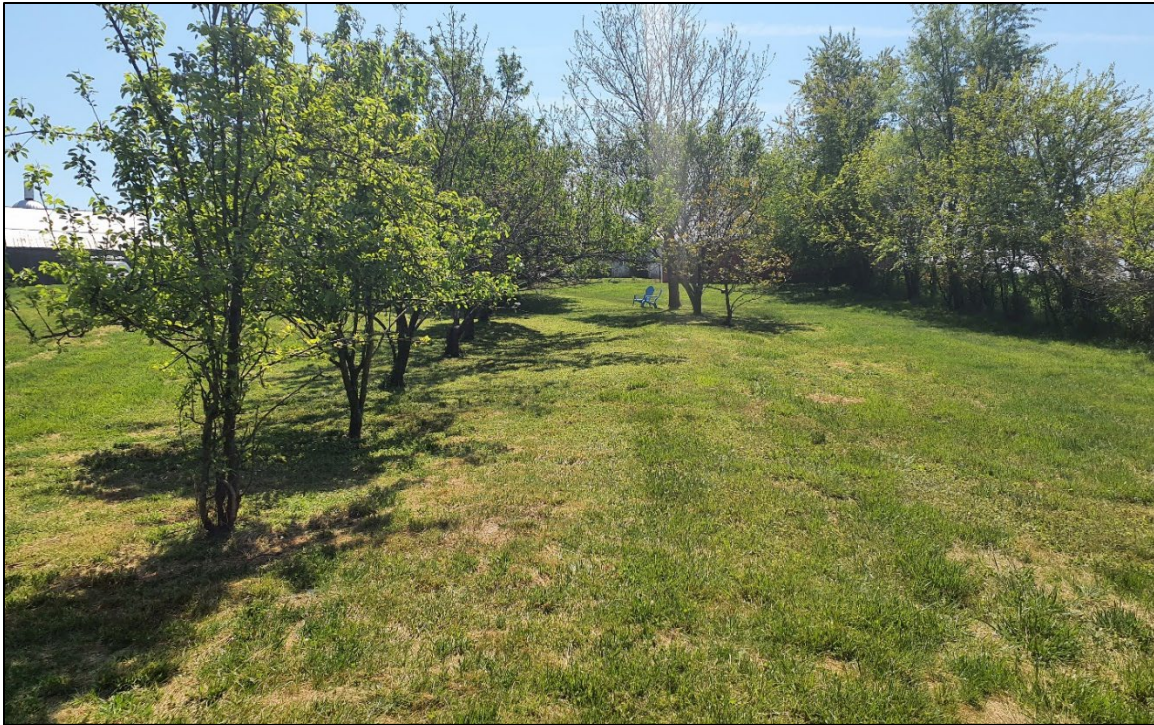
A possible raised earthen road trace was observed running roughly northwest from the main agricultural building complex toward the northern property boundary (Figure 9). Located on the eastern side of the road in a forested area was an abandoned and ruinous twentieth century frame dwelling, which was used as a tenant house according to Mr. Fraley (Figures 10 and 11). The structure is located in the same location as a mapped building on the 1945 USGS topographic map of the area. Inspection suggests the form and construction of the building is consistent with a mid-twentieth century date of construction (Figures 12 and 13). Modern debris and farm equipment was observed on the ground surface in the vicinity of the structure.

Figure 9: View of possible road trace facing southeast.

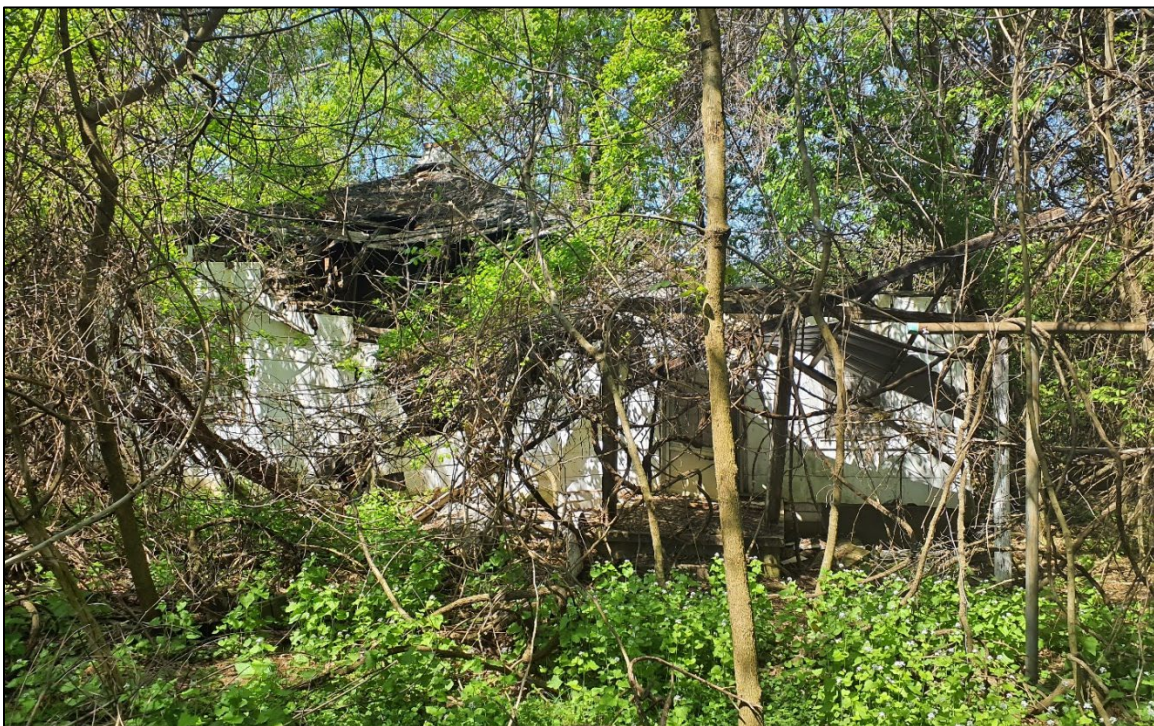
Figure 10: View of ruinous tenant building facing south.

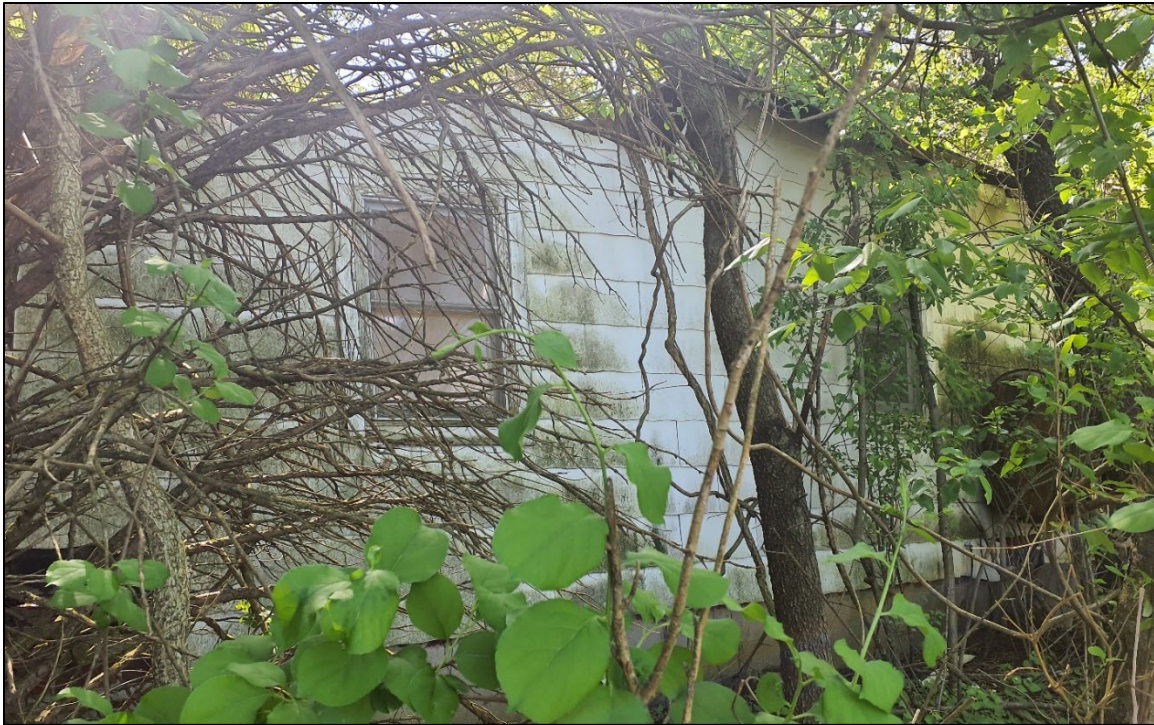
Figure 11: View of ruinous tenant building facing southwest.

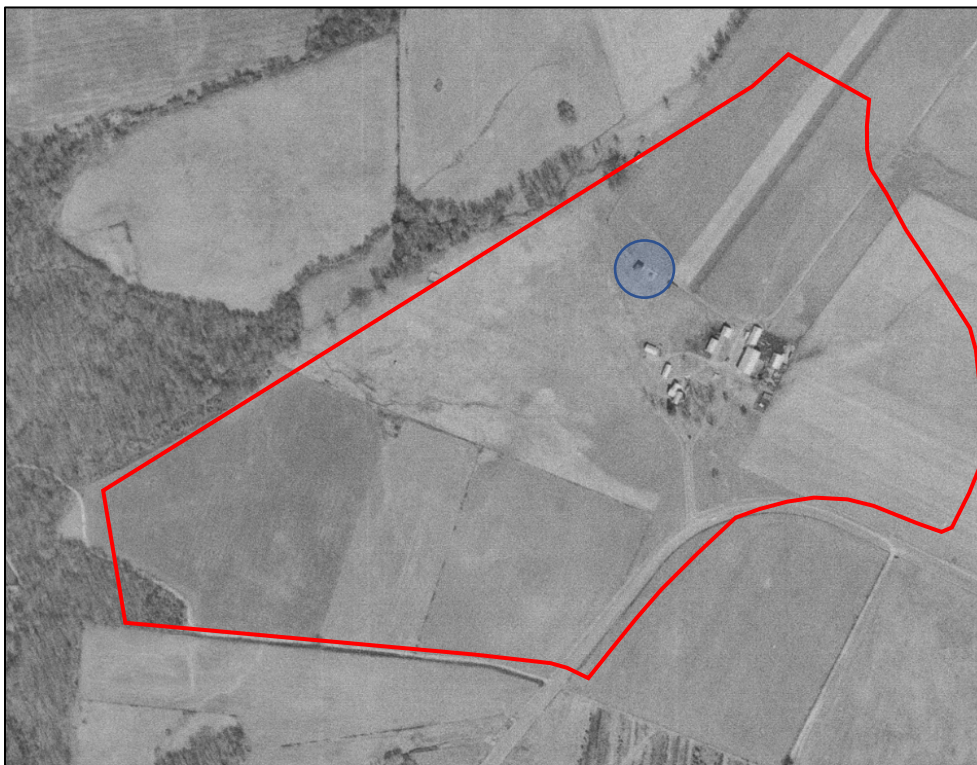
Figure 12: Location of ruinous tenant building circled in blue. Note airplane landing strip running northeast from the building. Source: United States Geological Survey (USGS) 1963 Aerial, 28 March 1969. Retrieved from Earth Explorer

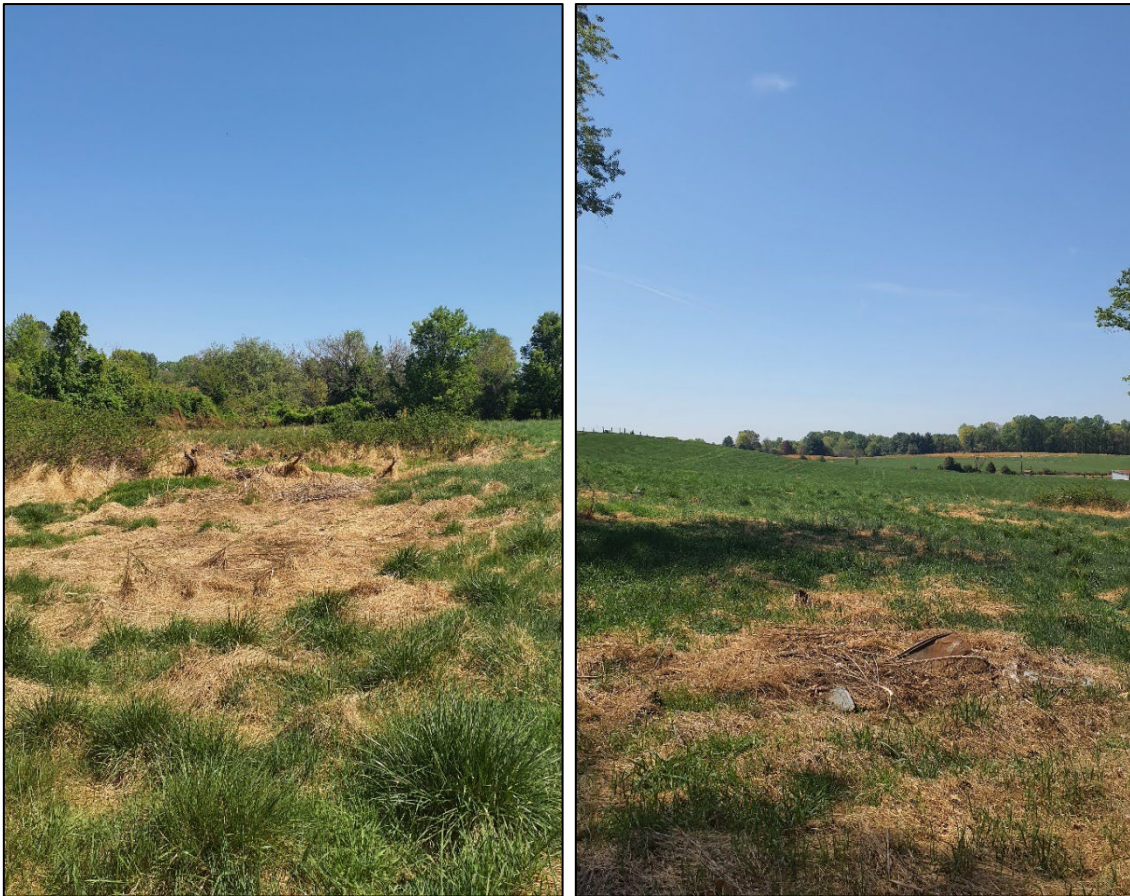
Further north along the same road alignment is the location of a former structure, which was demolished and burned sometime within the last decade according to Mr. Fraley. The area is currently covered in heavy field grasses and some roofing metal and smaller push piles visible (Figure 14). No additional evidence of a domestic structure or material was observed in the area.

Figure 14: View of area of demolished structure facing northeast (left) and southwest (right).

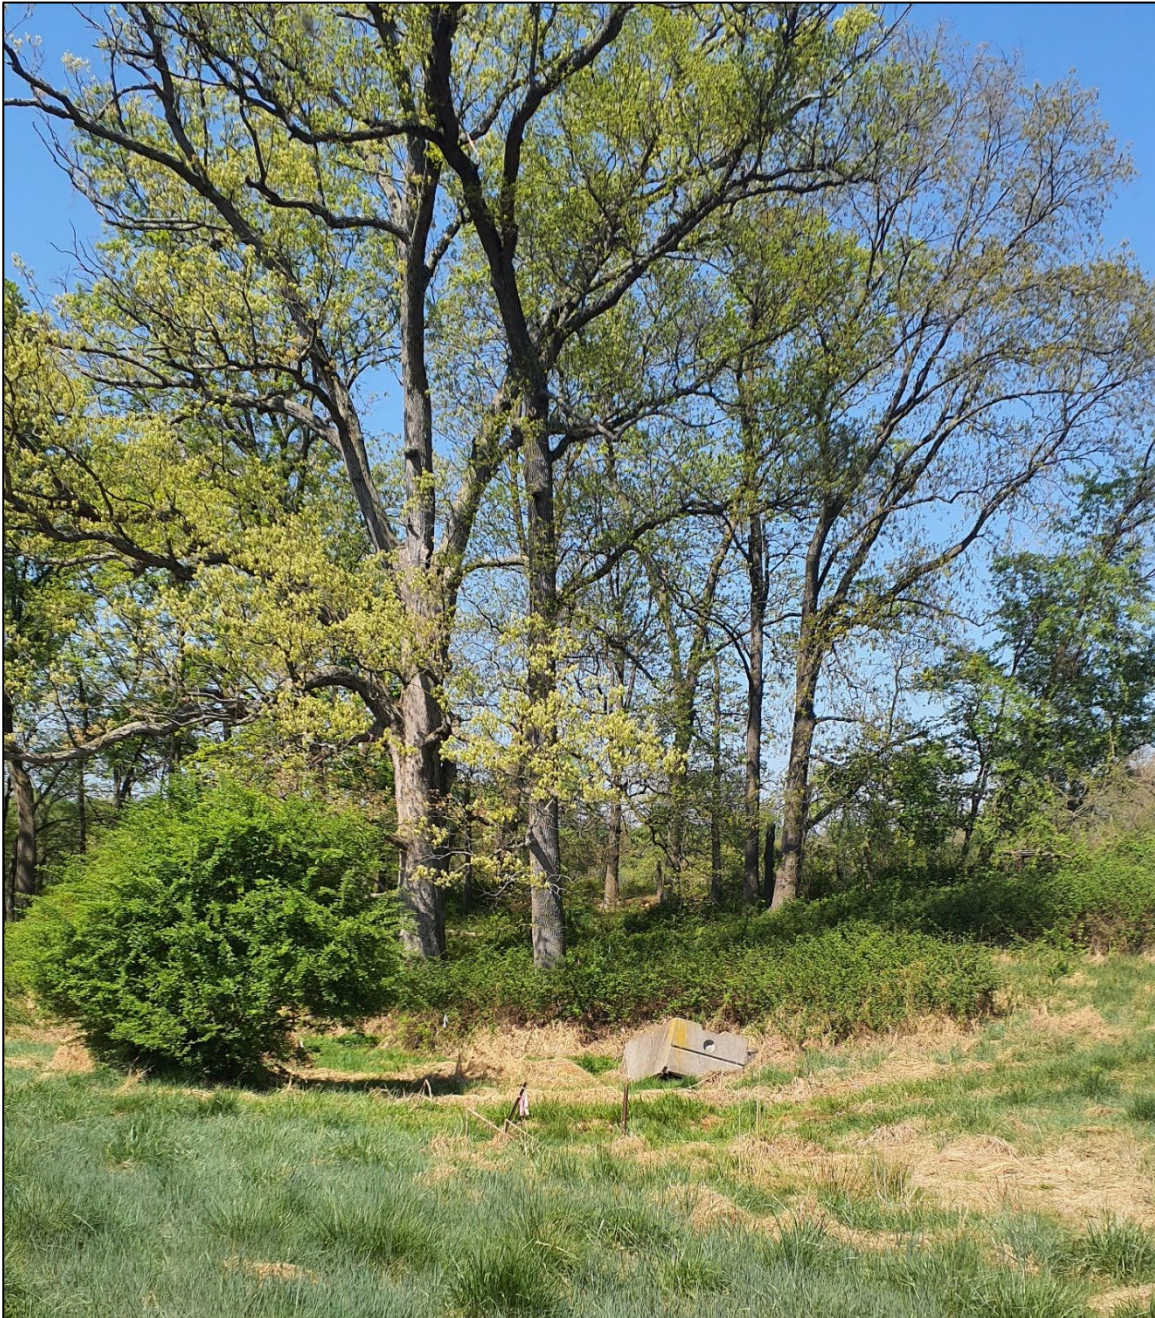
An intermittent stream, which ultimately flows into Rock Creek to the west, runs along the northern property boundary in this location and mature hardwoods, brambles and briars border the stream channel. A concrete septic tank box was observed in the area of the creek and Mr. Fraley informed archaeologists that the box had been used to create a spring box for cattle (Figure 15). Areas of exposed soil near the demolished structure and intermittent stream revealed eroded subsoil and no evidence of cultural material or features was observed.

Figure 15: View of intermittent stream at northern property boundary and location of demolished building facing north.

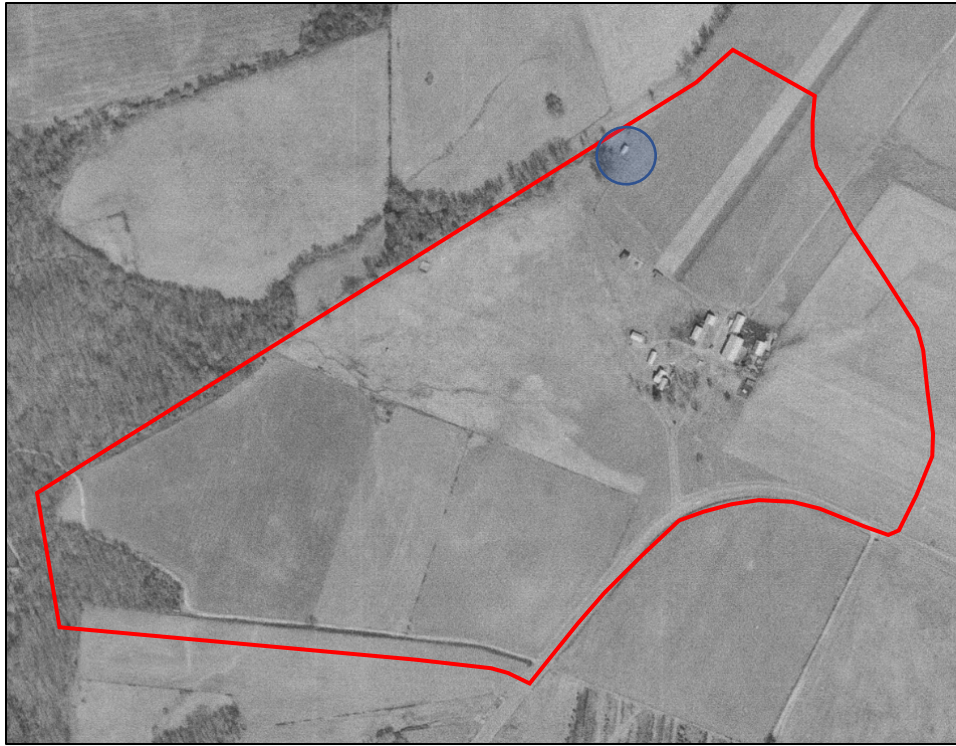
Figure 16: Location of ruinous tenant building circled in blue. Note airplane landing strip running northeast from the building. Source: United States Geological Survey (USGS) 1963 Aerial, 28 March 1969. Retrieved from Earth Explorer

Review of topographic maps and aerial imagery show a structure in the location of the demolished building as early as 1908, indicating it pre-dated the extant but deteriorated mid-twentieth century tenant house up the road to the south (Figures 16 through 18).

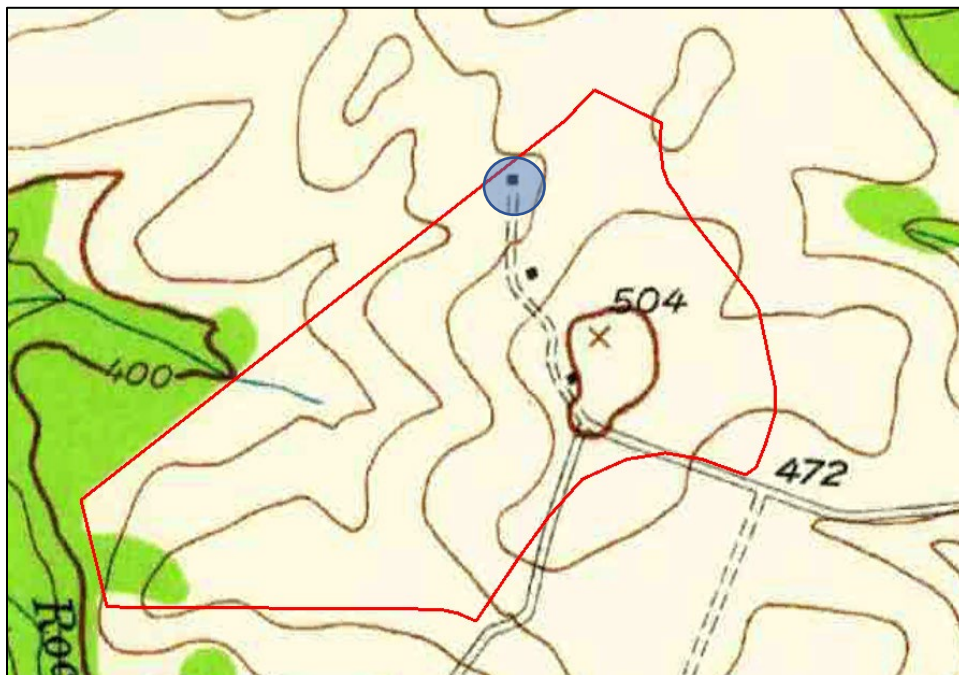
Figure 17: Location of ruinous tenant building northwest of residential and agricultural complex circled in blue. Source: United States Geological Survey (USGS) 1945 *Sandy Spring, MD Quadrangle*. 7.5 Minute Series Topographical Map, Scale 1:24000

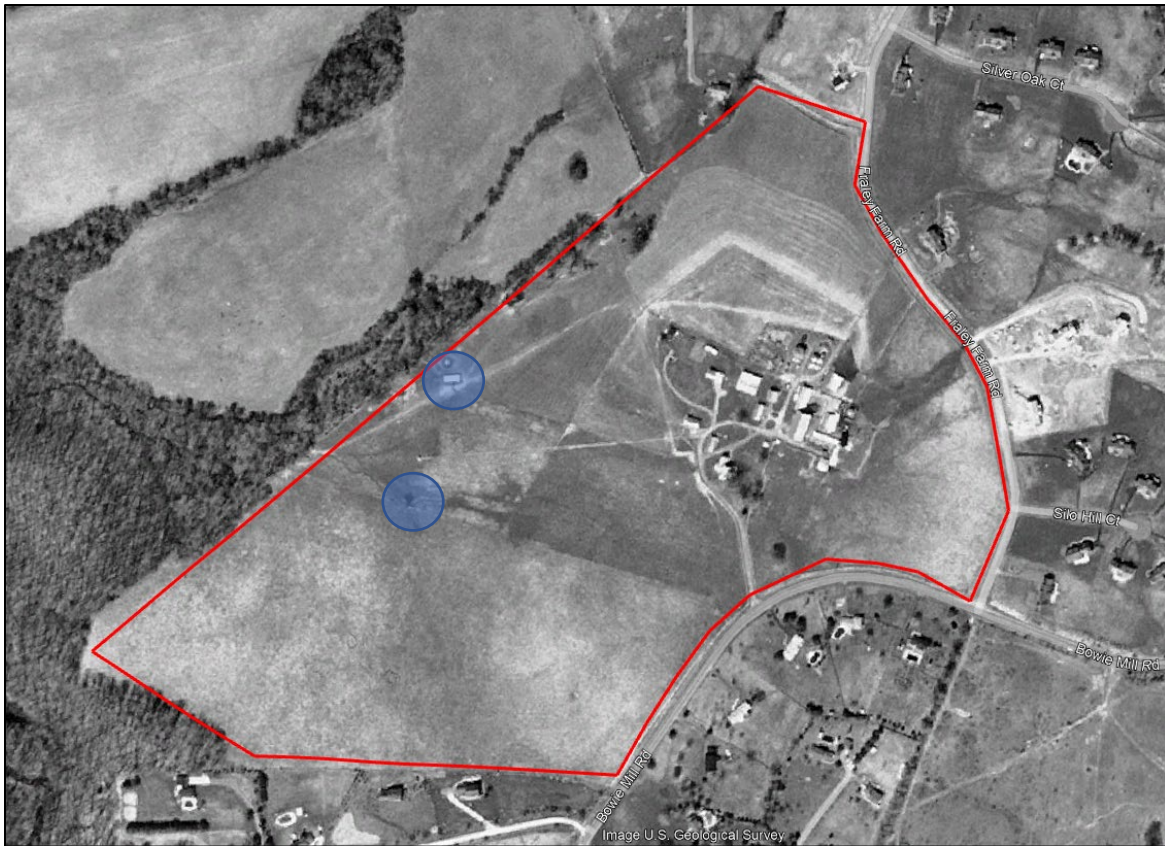
Figure 19: Aerial image of property with two modern structures located west of the main dwelling and agricultural complex circled in blue. Source: Google Earth 1993.

The remaining evidence of buildings or structures on the property outside of the residential and primary agricultural complex included the location of a former small structure associated with animal husbandry practices and a modern barn/shed both west of the main dwelling in the lower lying pasture. Both structures are visible on aerial imagery of the property from the last quarter of the twentieth century but are not included on earlier maps of the property and area (Figures 19 and 20).

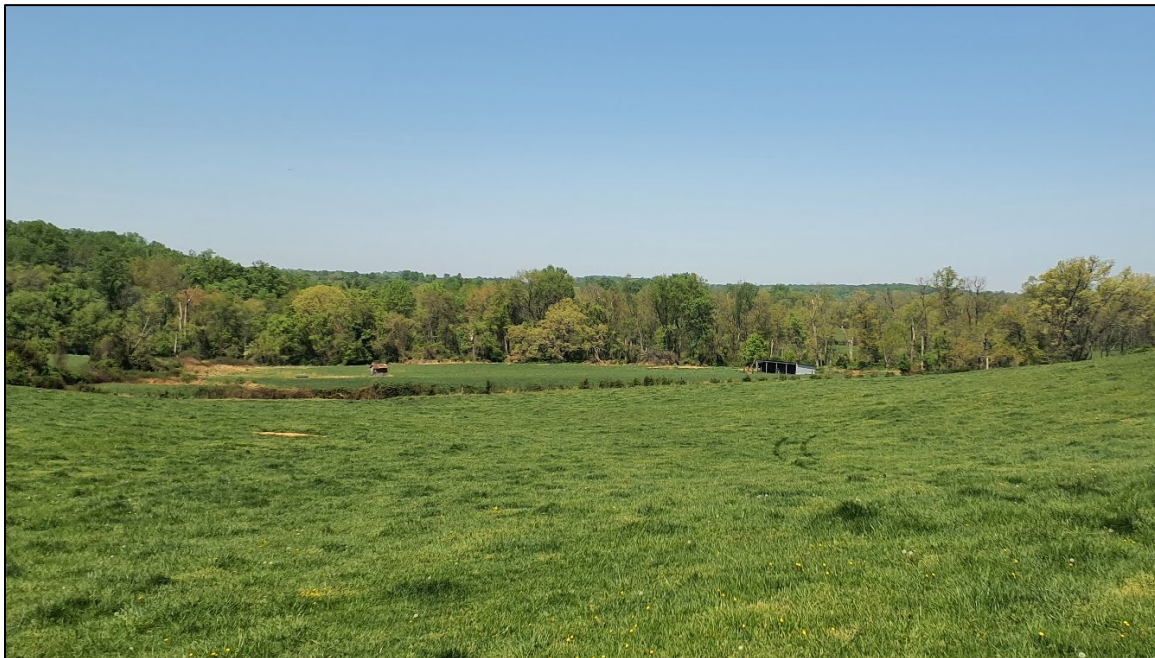
Figure 20: View modern farm structures in low lying pasture west of the main dwelling facing west.

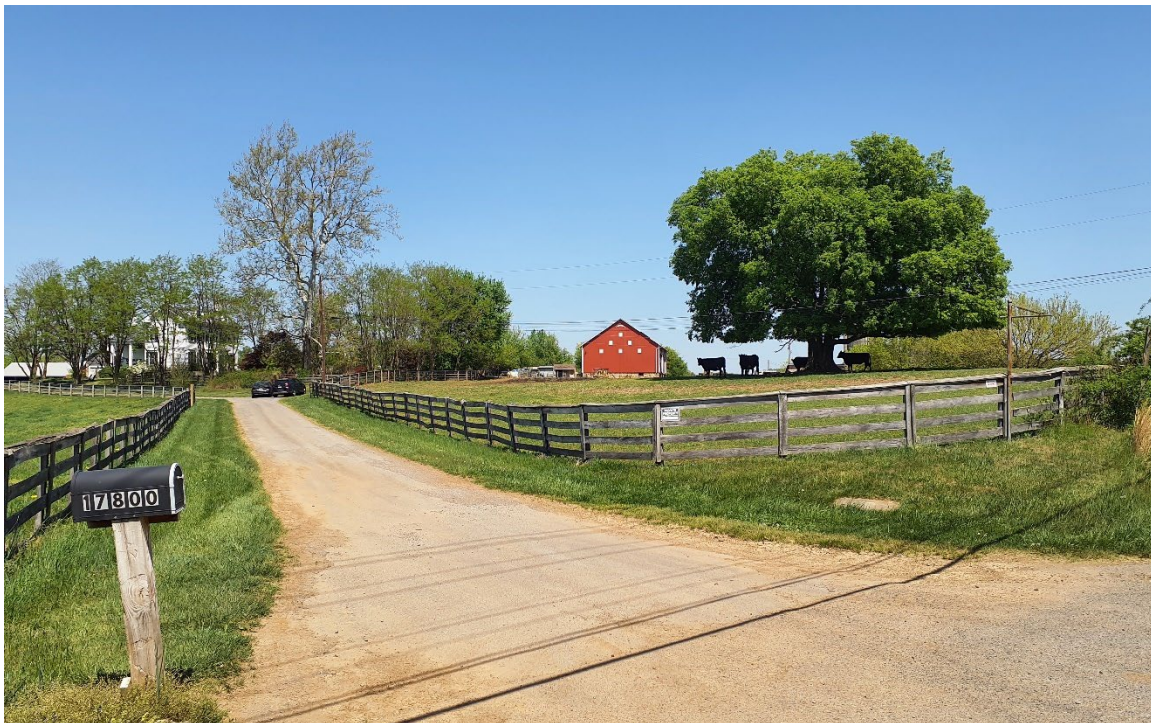
Figure 21: General view of Flint Hill house setting with agricultural complex to the rear, facing northwest.

This effort found that the interior or direct setting of the home in relation to the property remains moderately intact from the historic period although not from the period of significance. The home remains situated centrally within an agricultural complex surrounded by agricultural fields and pasture in keeping with its rural character (Figures 21 and 22). However, while the majority of the barns and outbuildings are at least 50 years old, none are contemporary to the house or the period of ownership by the Bowie family which has previously been noted as primary significance to the property. The oldest extant outbuilding on the property is a large bank barn believed to date from the turn of the twentieth century, likely contemporary to the transfer of ownership to the Fraley family (Figures 23 through 27). The 1984 Montgomery County staff report that designated the property a local landmark indicated that the barn does not need to be considered as part of the environmental setting, thereby indicating that it was not considered contributing to the property's significance and further implying that all other outbuildings that post-date the barn would likewise not be considered contributing.

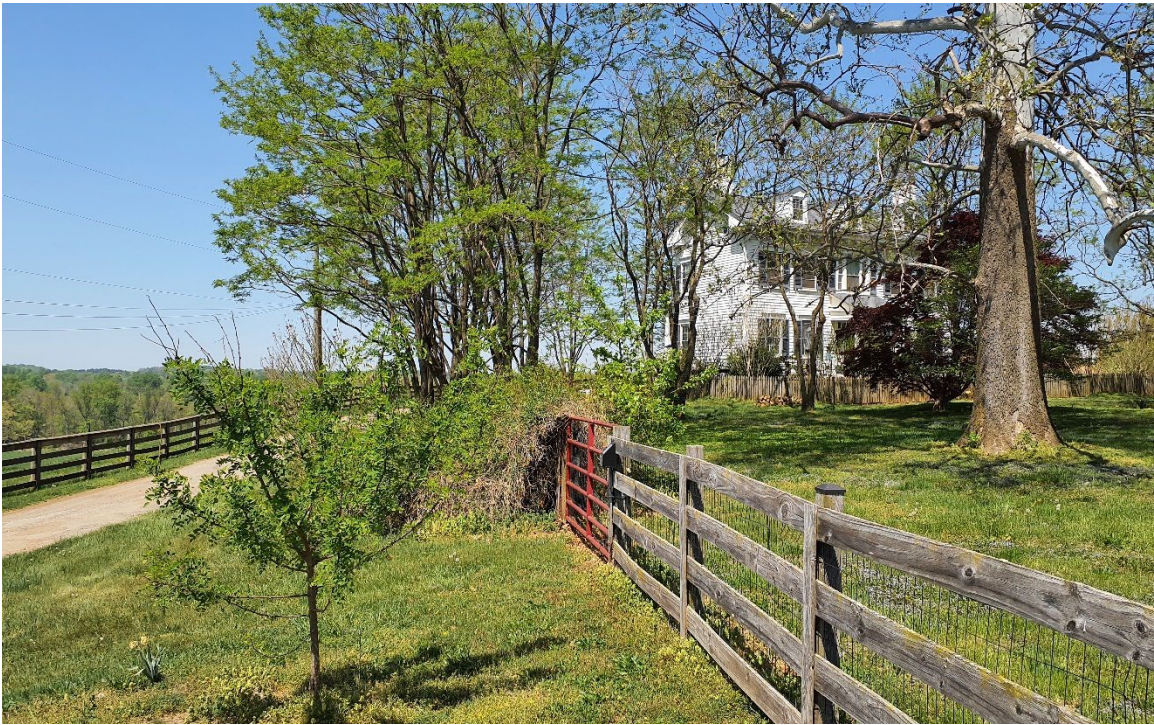
Figure 22: Flint Hill house and domestic yard to the east, facing northwest.

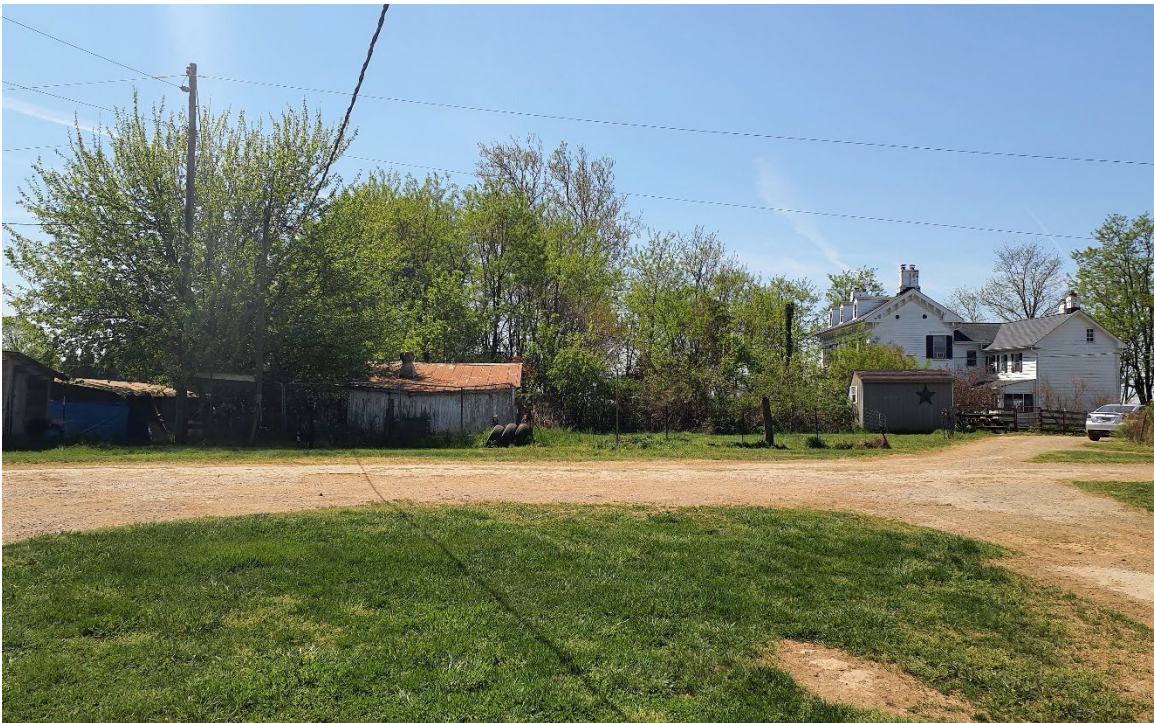
Figure 23: General view of agricultural work yard depicting twentieth century outbuildings, facing south.
