MEMORANDUM

RE: Reduction of the Environmental Setting for Flint Hill II (M: 22/17), 17800 Bowie Mill Road,
Derwood

Re: Request for Determination on Environmental Setting -- Fraley Farm, 17800 Fraley Farm Road (the "Property")

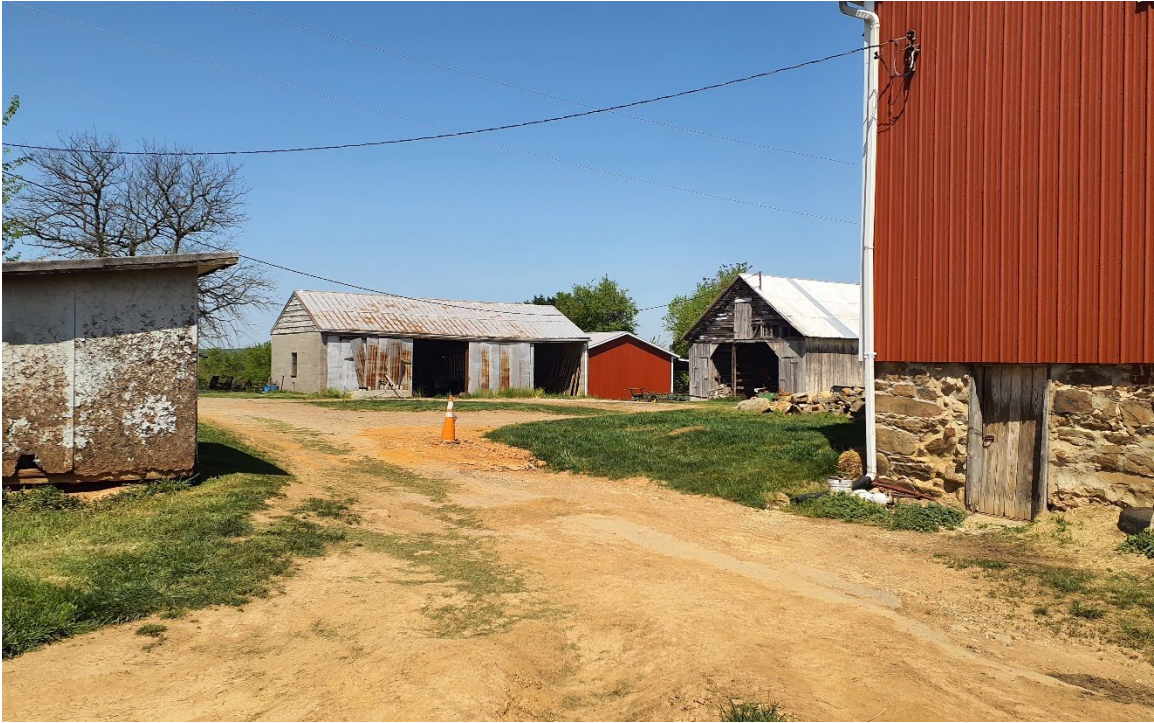
Figure 24: General view of twentieth century agricultural buildings and nineteenth century bank barn, facing northwest.

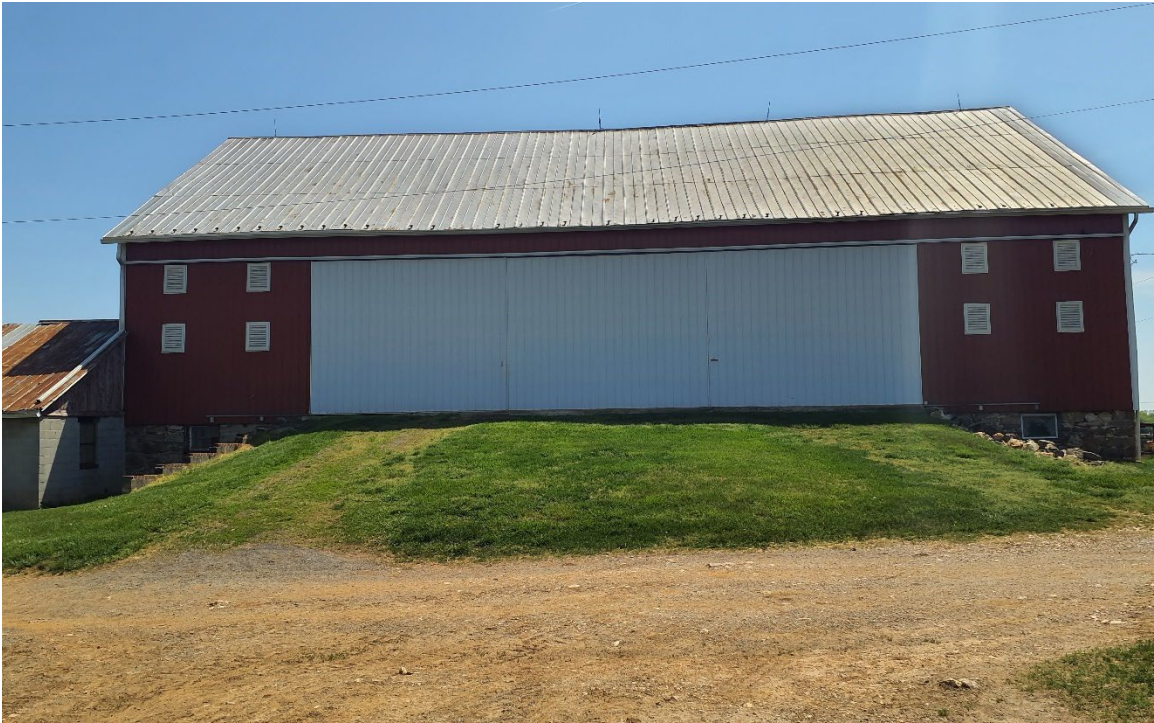
Figure 25: General view of nineteenth century bank barn, facing east.

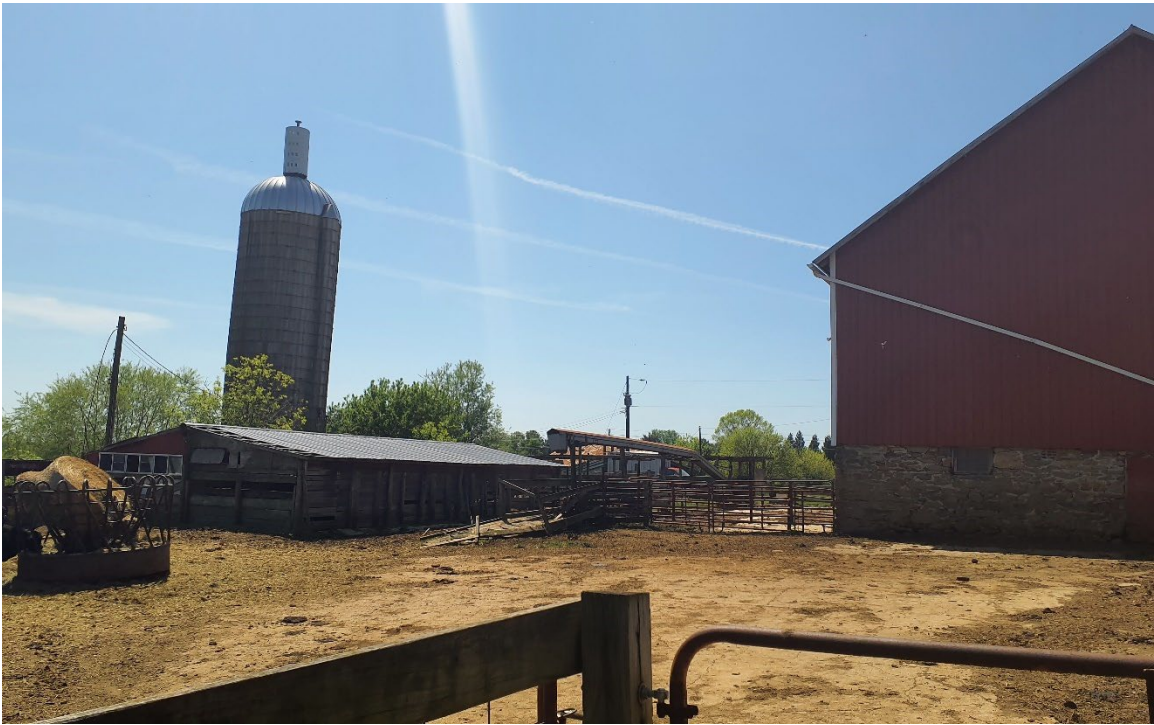
Figure 26: General view of twentieth century loading sheds and silo with cellular antenna affixed to top, facing southeast.

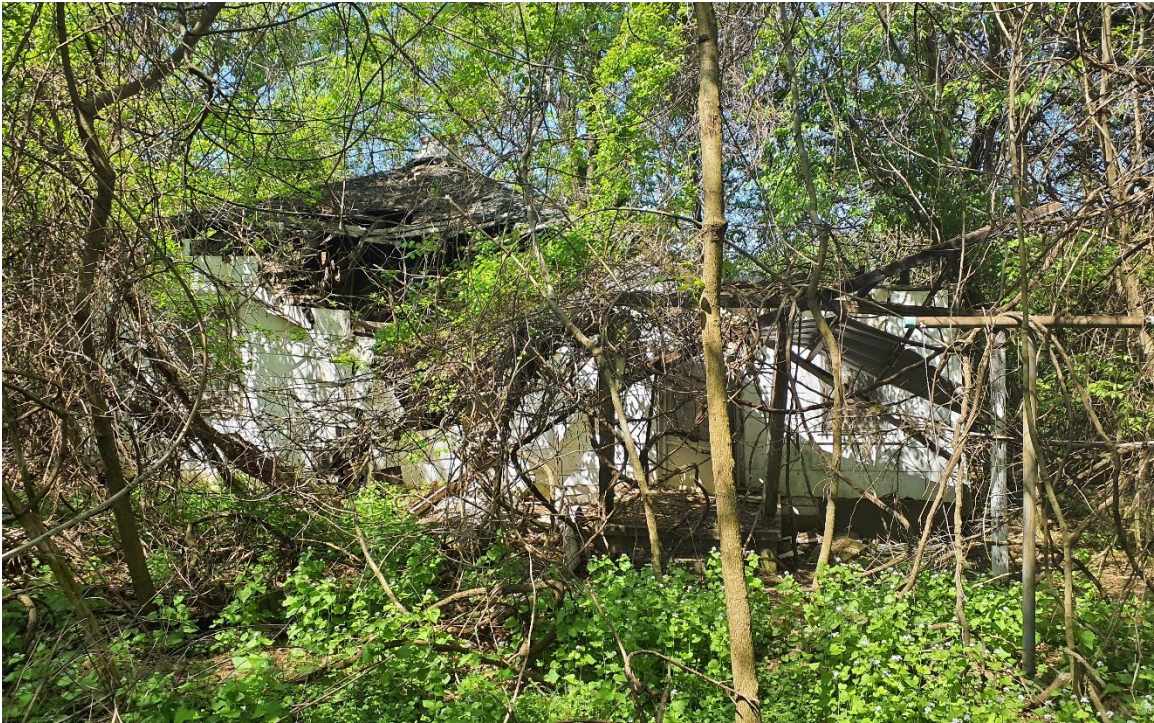
Figure 27: View of ruinous mid-twentieth century secondary dwelling downhill to rear of house, facing west.

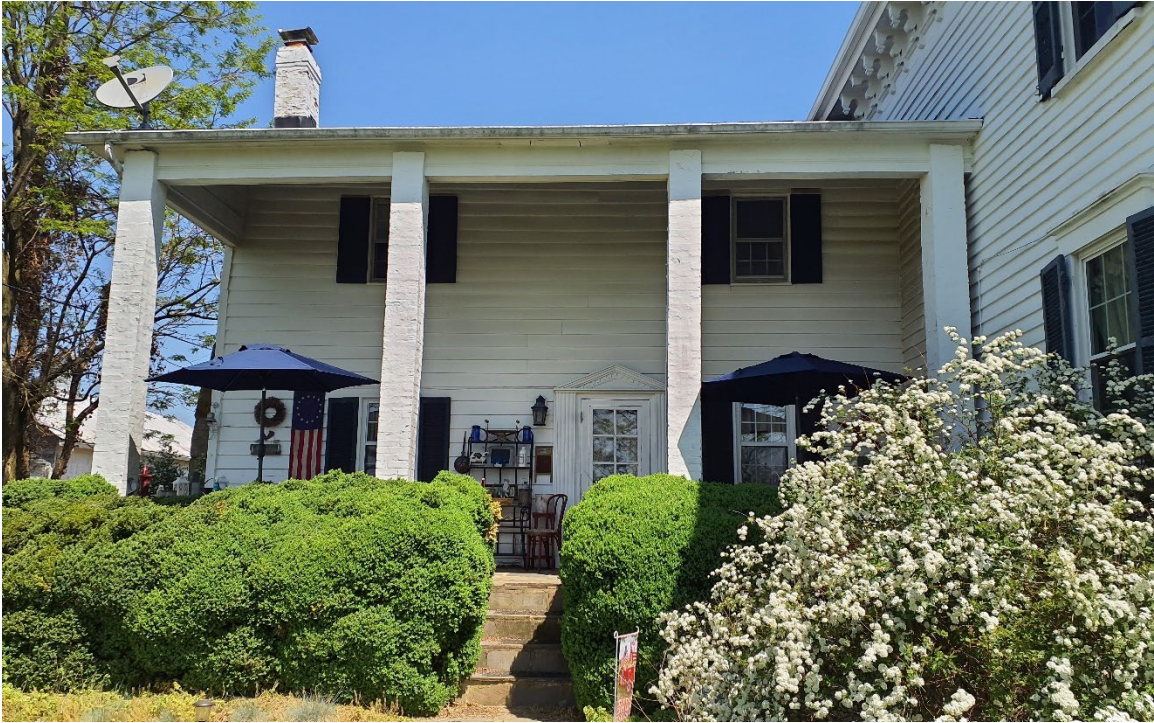
Figure 28: Original c.1820 front facade, facing north.

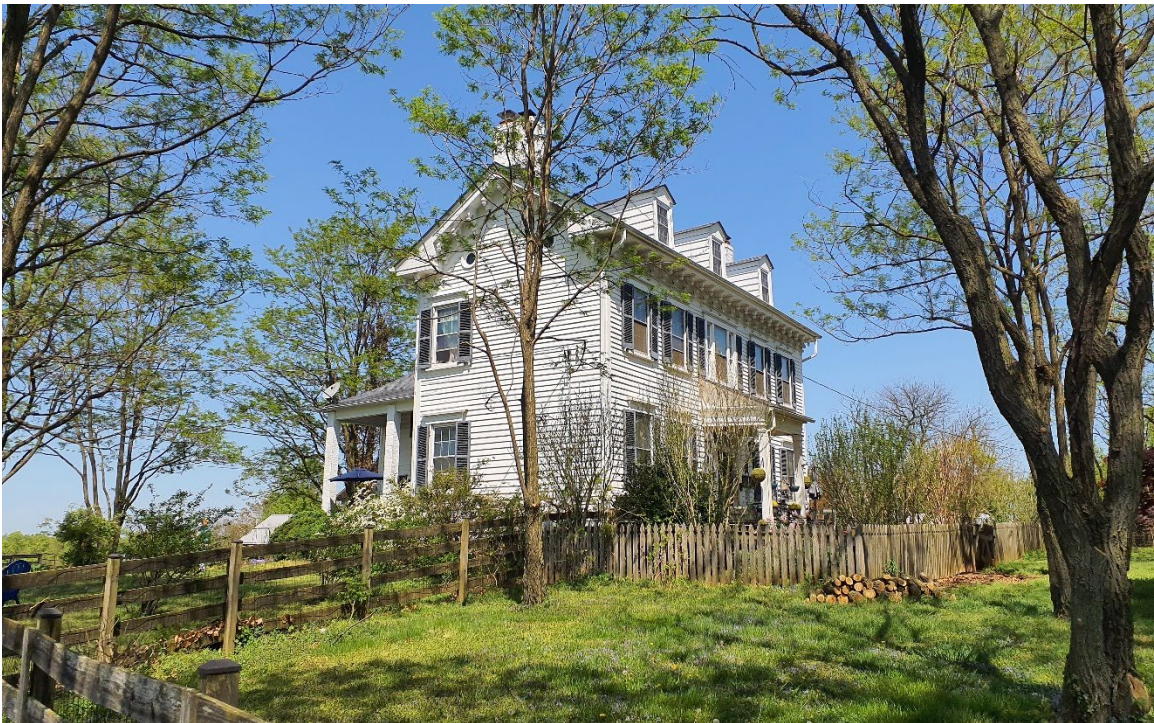
Figure 29: Circa 1850 front facade, facing northwest.

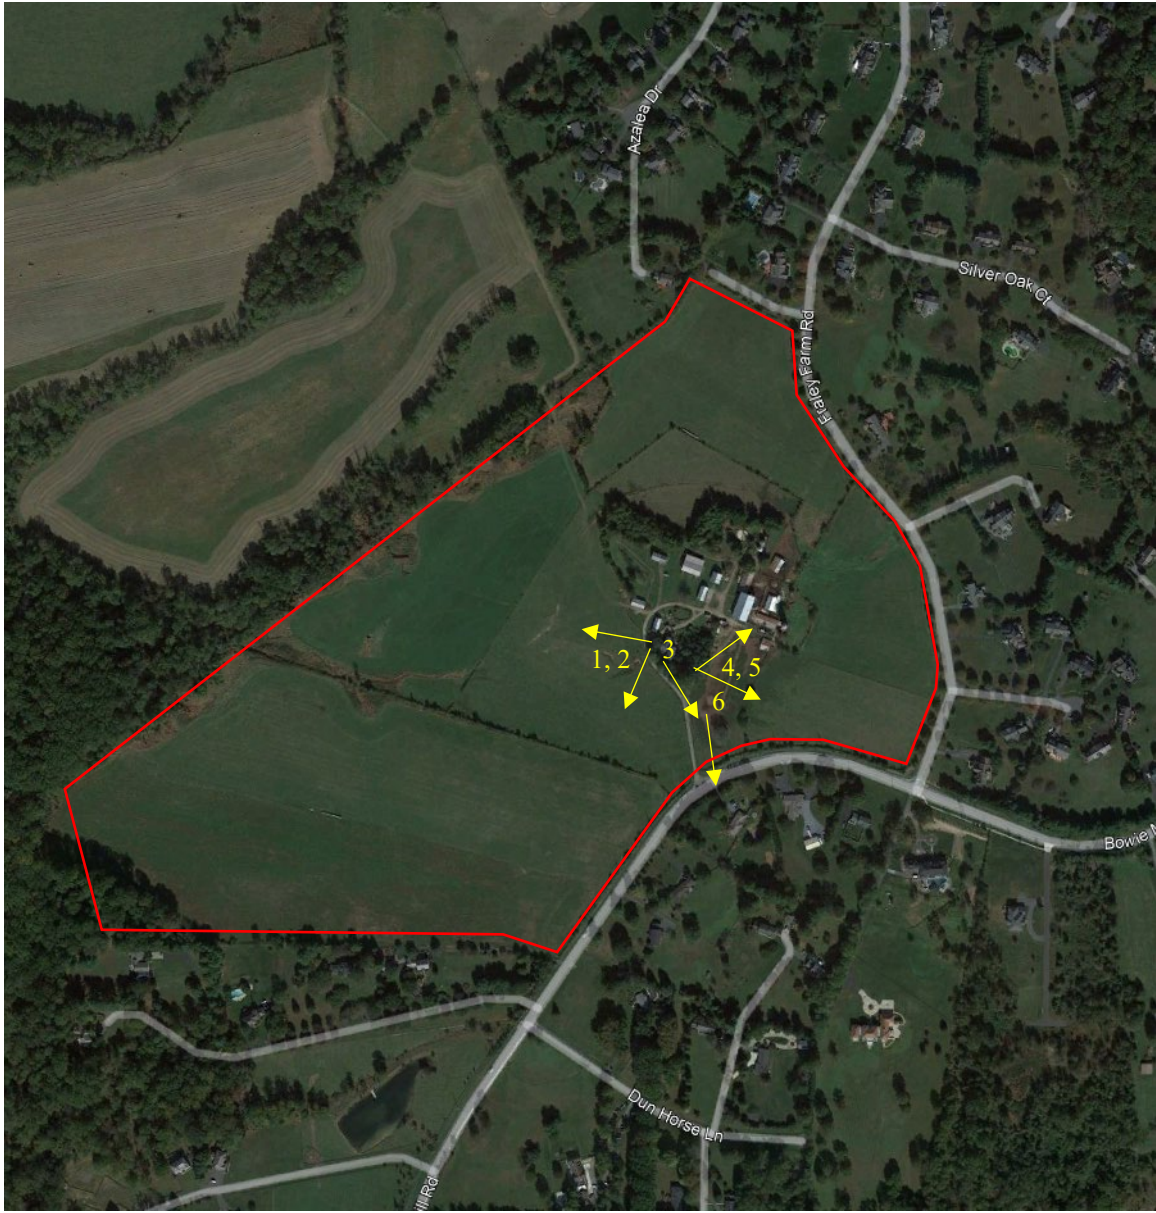
Figure 31: Location and direction of representative viewshed photographs from the homesite outward from the property. Photo numbers coincide with images on following pages.

Inspection from the homesite was conducted from throughout the building complex (Figure 31). This effort revealed that views from the front of the original block to the south are generally across a large open field. The downward slope in this direction allows wide and distant views outward, including views of existing modern homes along both sides of Bowie Mill Road to the south but generally more undeveloped views westward towards Rock Creek (Figures 33 through 34). Views from the front of the second phase of the home are generally to the east across pasture. The terrain in this direction slopes more gently down, however, the open landscape still permits views of multiple modern homes bordering Bowie Mill Road and Fraley Farm Road (Figures 35 through 37). In contrast, the viewshed to the north or rear of the house are short and interrupted by the barn and outbuilding complex within the working agricultural yard.

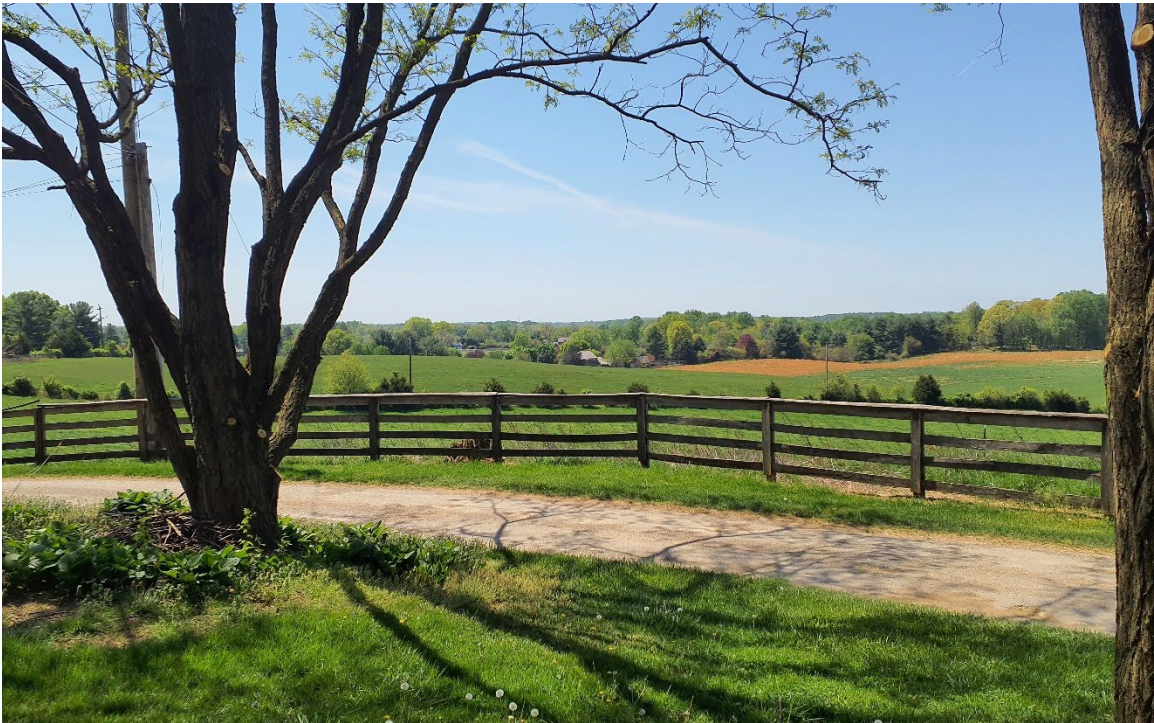
Figure 32: Photo 1 - View directly outward from front of the original block depicting existing development in background, facing south.

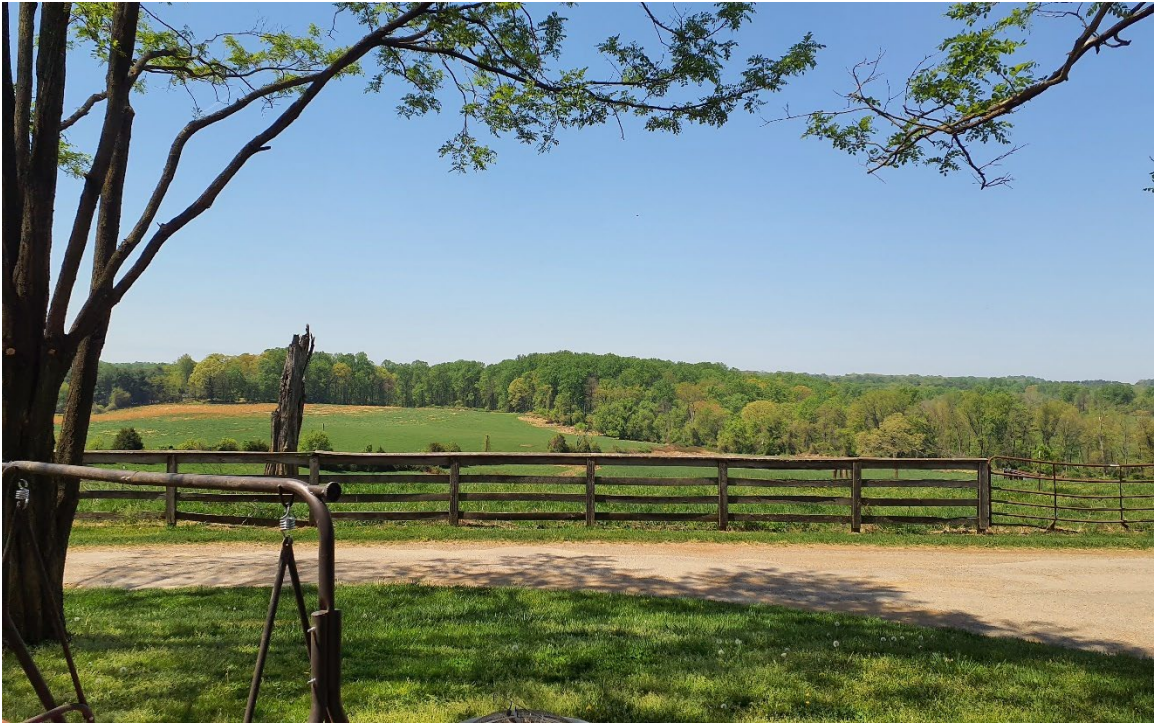
Figure 33: Photo 2 - Oblique view from front of the original block depicting undeveloped woodland to the west, facing southwest.

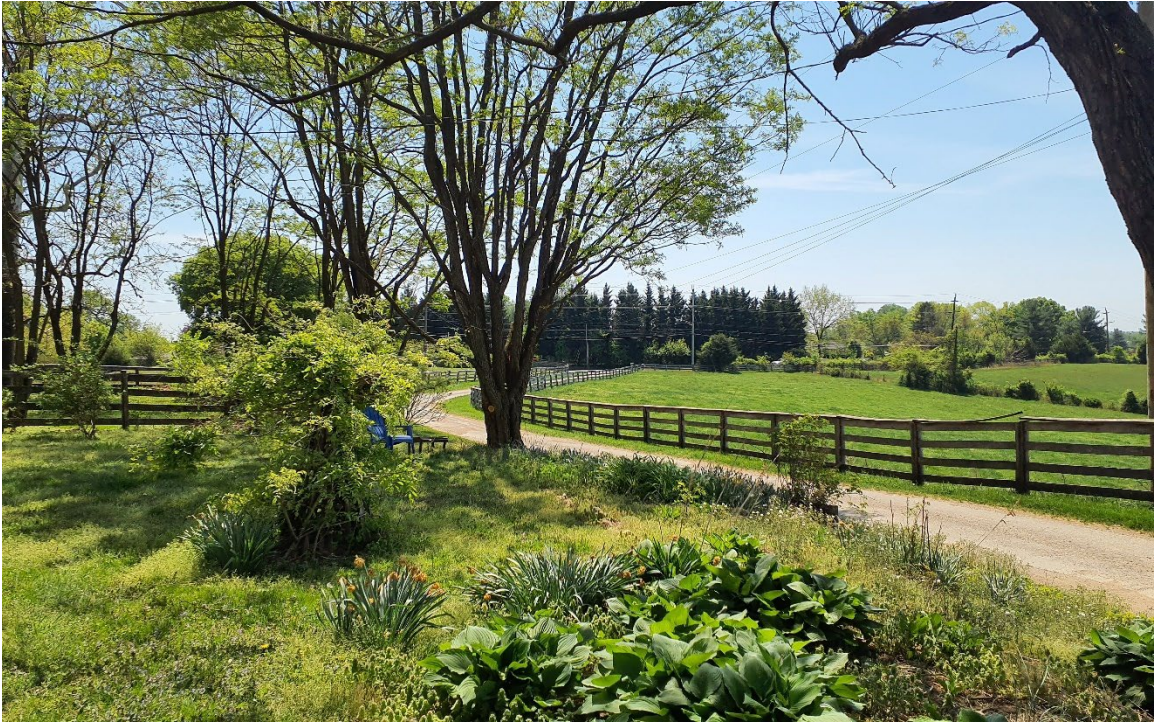
Figure 34: Photo 3 - Oblique view from front of the original block depicting development along Bowie Mill Road, facing southeast.

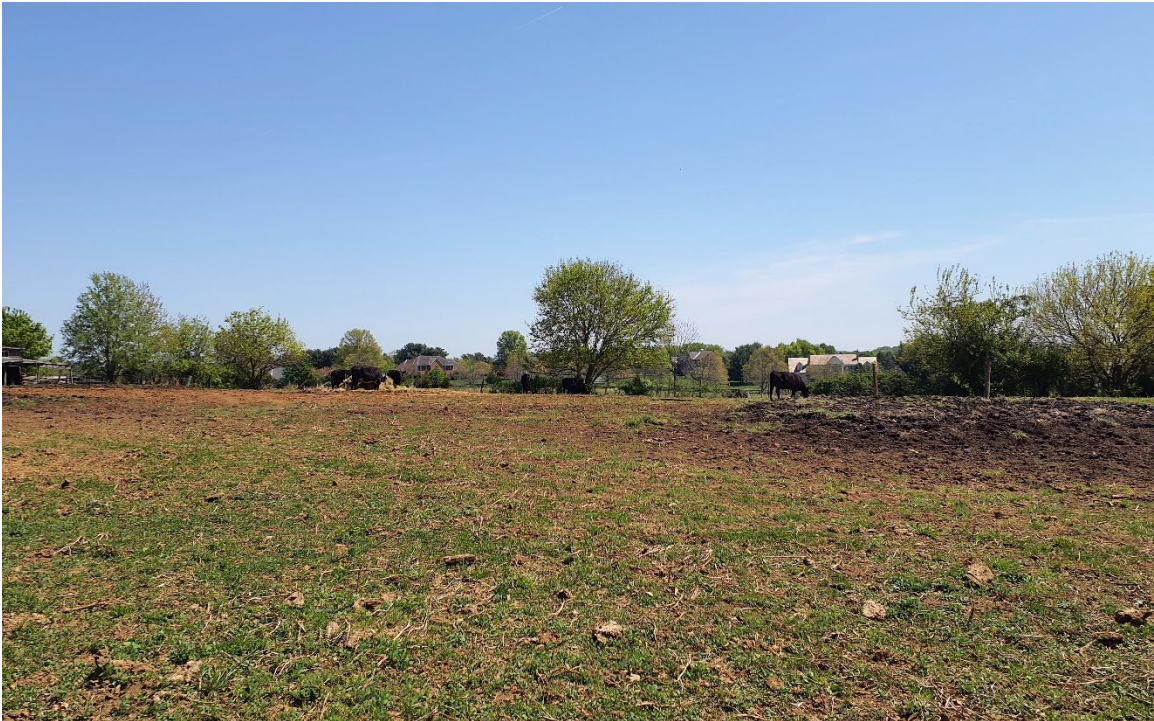
Figure 35: Photo 4 - View directly outward from front of the mid-nineteenth century block depicting existing development along Fraley Farm Road, facing east.

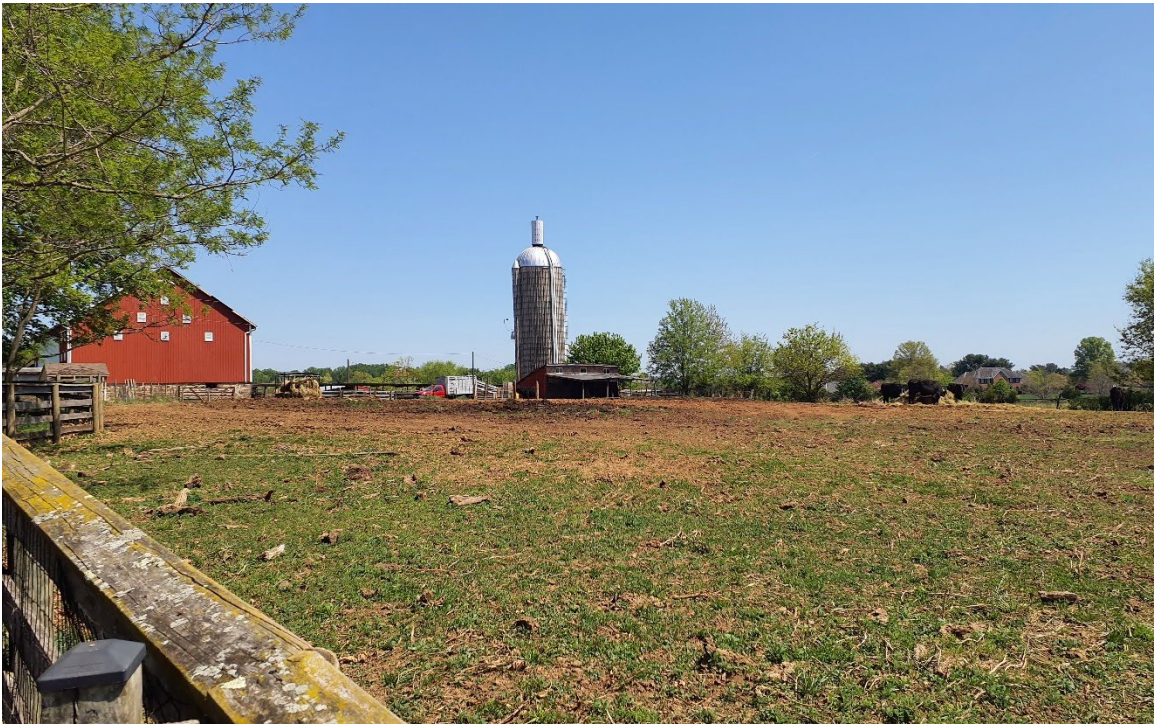
Figure 36: Photo 5 - Oblique view from front of the mid-nineteenth century block depicting existing development along Fraley Farm Road, facing northeast.

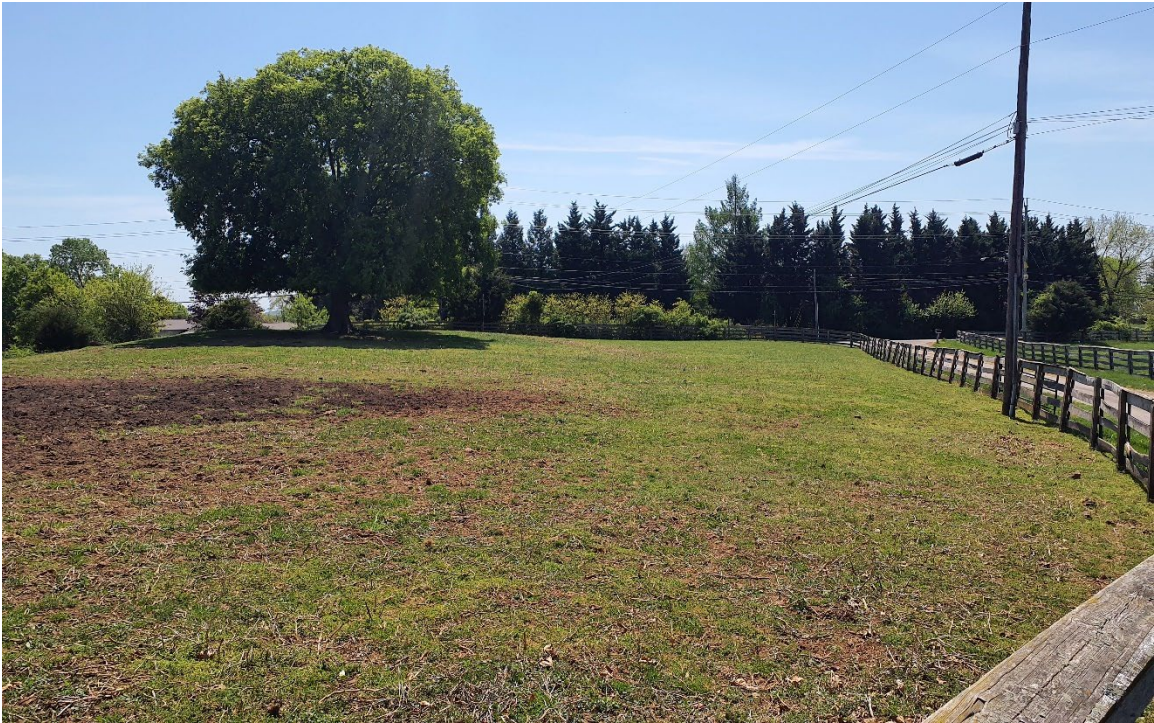
Figure 37: Photo 6 - Oblique view from front of the mid-nineteenth century block depicting existing development along Bowie Mill Road, facing southeast.

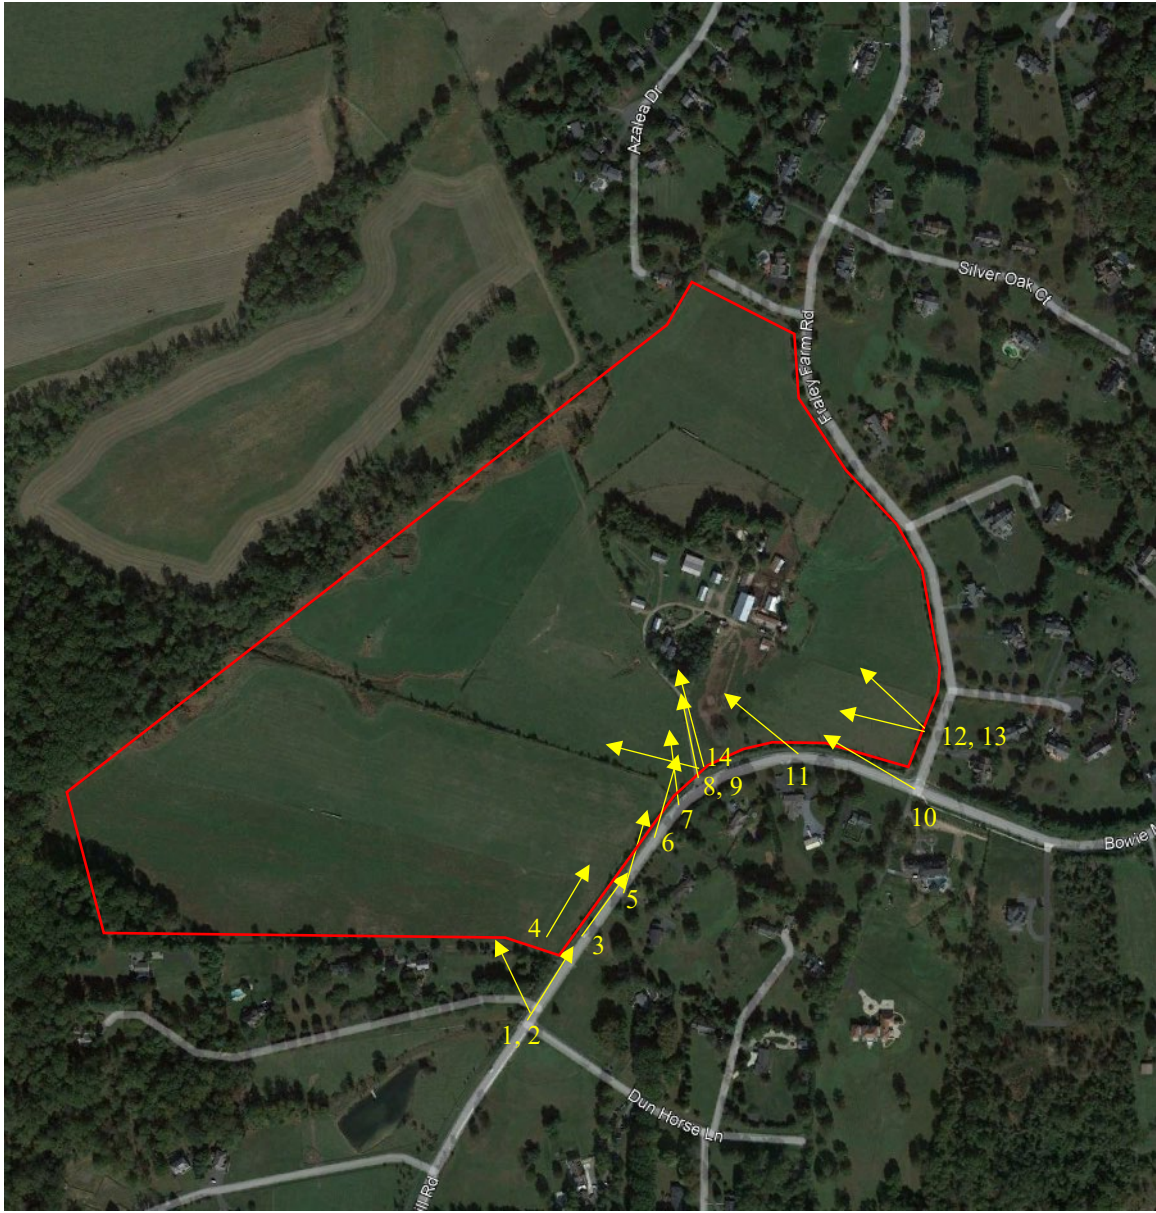
Figure 38: Location and direction of representative viewshed photographs from the homesite outward from the property. Photo numbers coincide with images on following pages.

Inspection from public vantage in the vicinity of the property was conducted from along Bowie Mill Road in both directions as well as from Fraley Farm Road (Figure 38). This revealed that the home, building complex, and much of the property are generally screened from public view by topography and existing vegetation patterns in many locations, however, this effort was conducted during the spring and therefore some seasonal change in vegetation may be expected. When approaching the property from the south along Bowie Mill Road, the upward slope of the terrain places the home and building complex beneath the line of sight. Bowie Mill Road is also bordered by a raised berm and treeline that provide further screening of the Flint Hill property and building complex beyond. As a result, the home is not currently visible from Bowie Mill Road further than 250-feet south of the driveway (Figures 39 through 47). When approaching the property from the east, views of the home are likewise screened by vegetation along the road further than 50 feet east of the driveway. However, the easternmost portion of the property is visible from beyond the end of the roadside vegetation at Fraley Farm Road and the barn and silo are visible above the vegetation (Figures 48 through 51). As such, the only vantage where views of the home are unobstructed are from the bend in Bowie Mill Road in close proximity to the end of the driveway. From there, the open landscape up the driveway in conjunction with the more elevated vantage permit views of the home and building complex, however, views of the home are still partially interrupted by trees and landscaping within the domestic yard. Due to the topography of the property, the fields downhill from and to the rear of the building complex are largely below the line of site from this vantage (Figure 52).

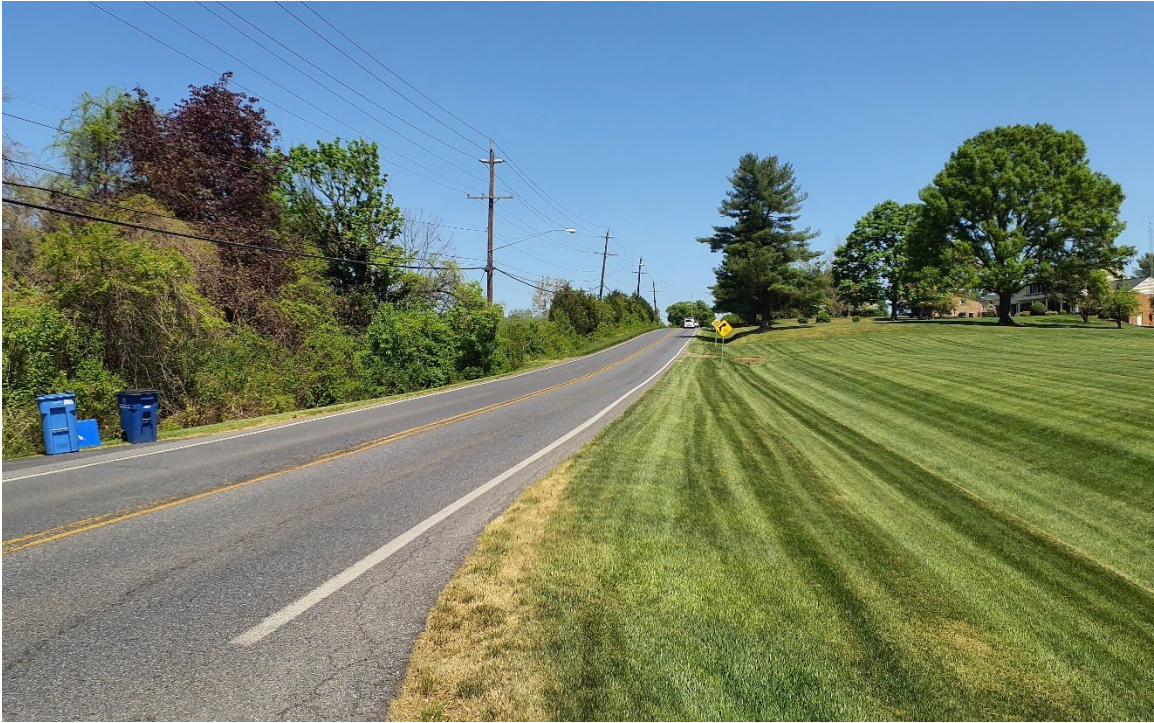
Figure 39: Photo 1 - View from Bowie Mill Road at Dun Horse Lane, facing north. -House and property not visible

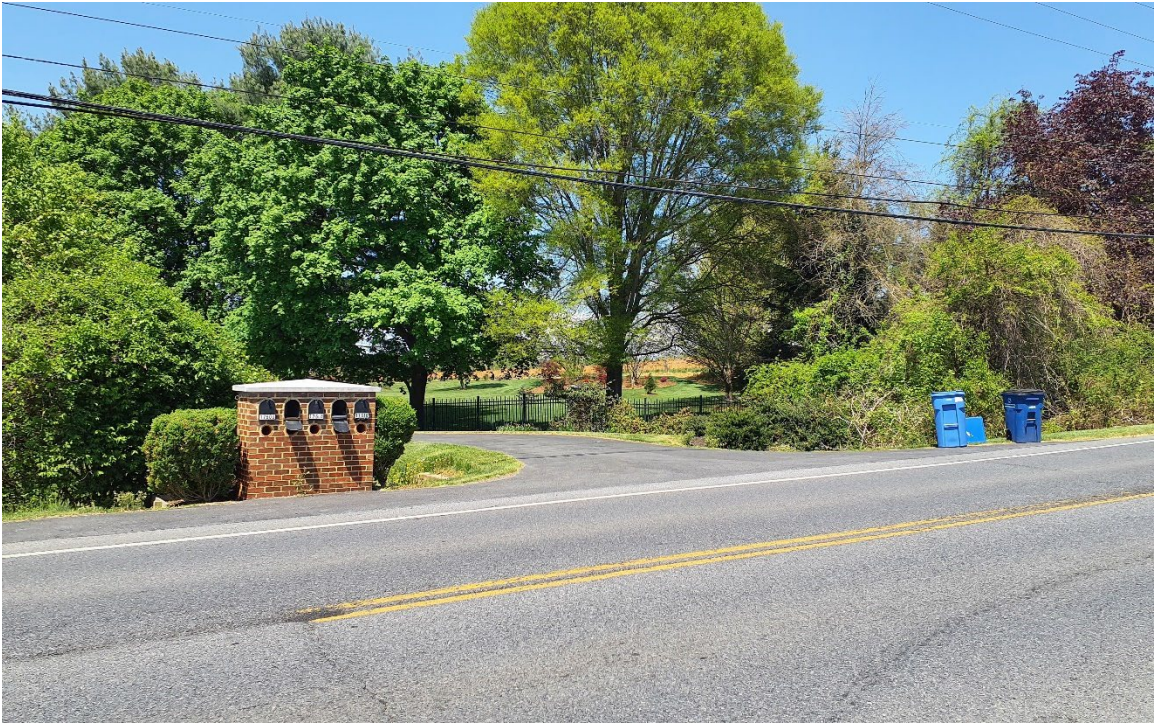
Figure 40: Photo 2 - View from Bowie Mill Road at Dun Horse Lane, facing northwest. -House and property not visible

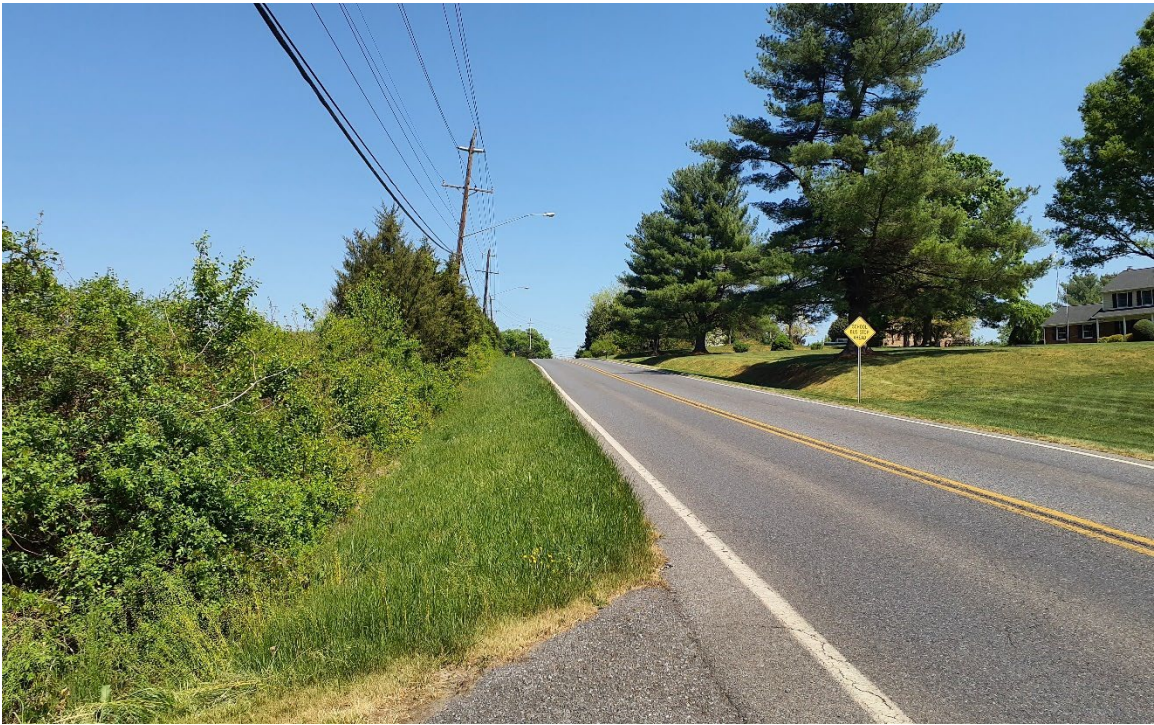
Figure 41: Photo 3 - View from Bowie Mill Road at southern edge of property, facing north. -House and property not visible

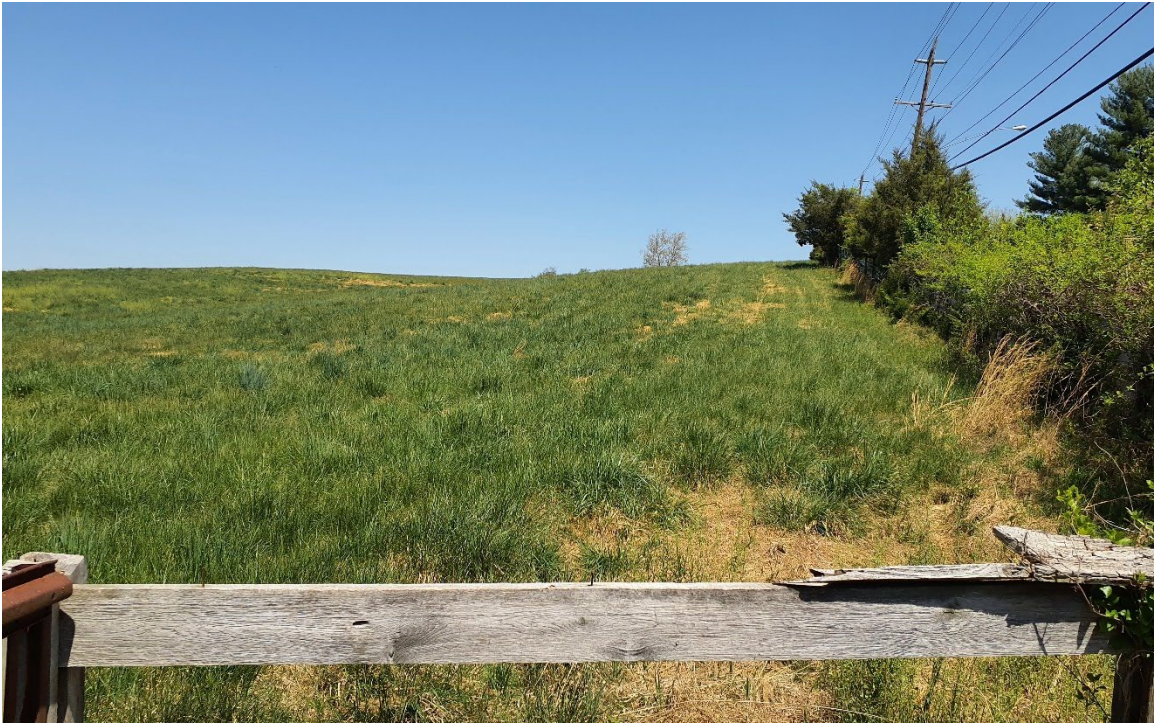
Figure 42: Photo 4 - View from farm lane at southern edge of property, facing north. -House not visible

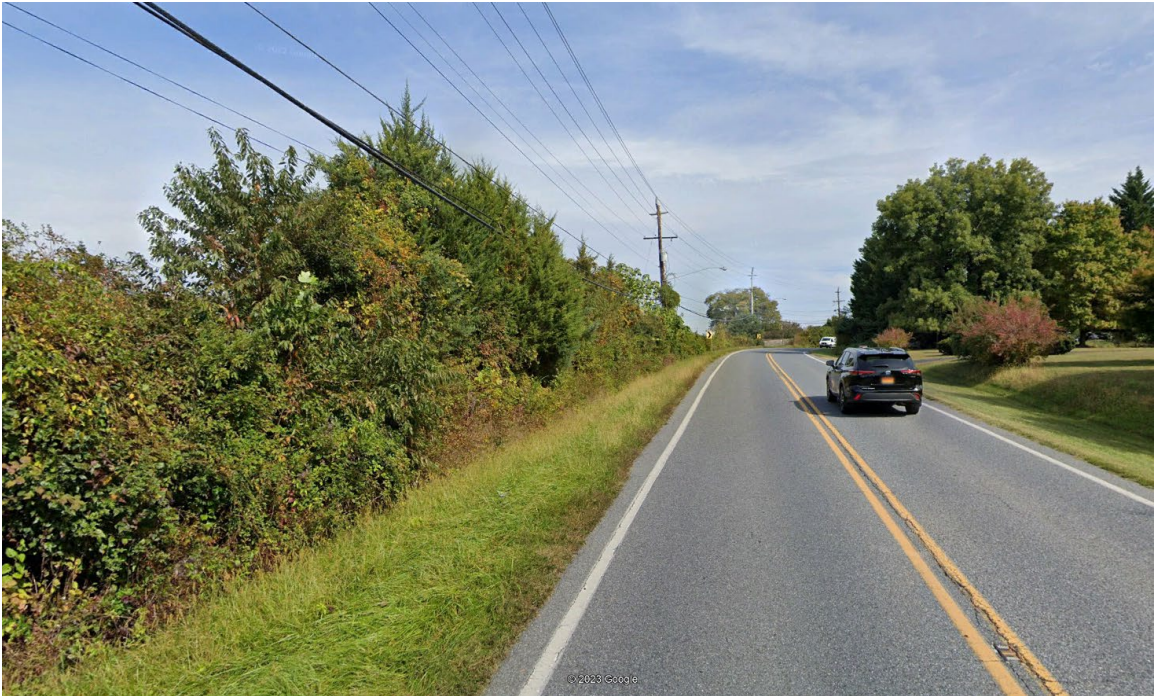
Figure 43: Photo 5 - View from Bowie Mill Road roughly 400 feet south of driveway, facing north. - House and property not visible

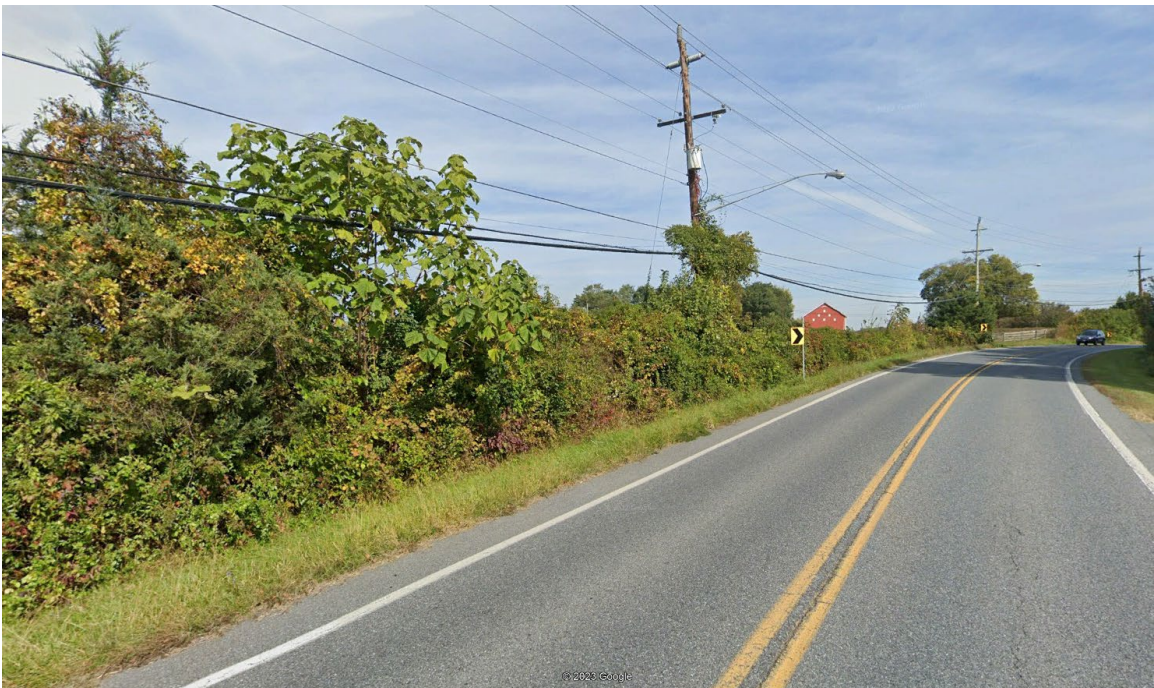
Figure 44: Photo 6 - View from Bowie Mill Road roughly 300 feet south of driveway, facing north. - Barn is visible but house is not

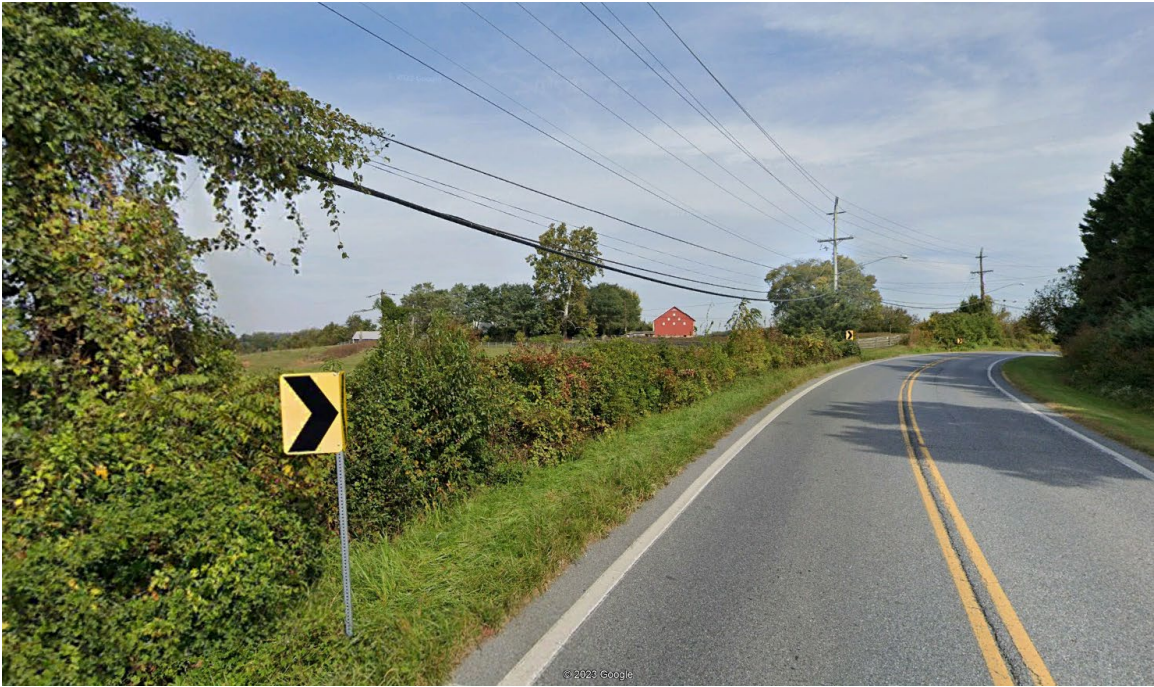
Figure 45: Photo 7 - View from Bowie Mill Road roughly 250 feet south of driveway, facing north. - House and building complex is visible, most of property is not

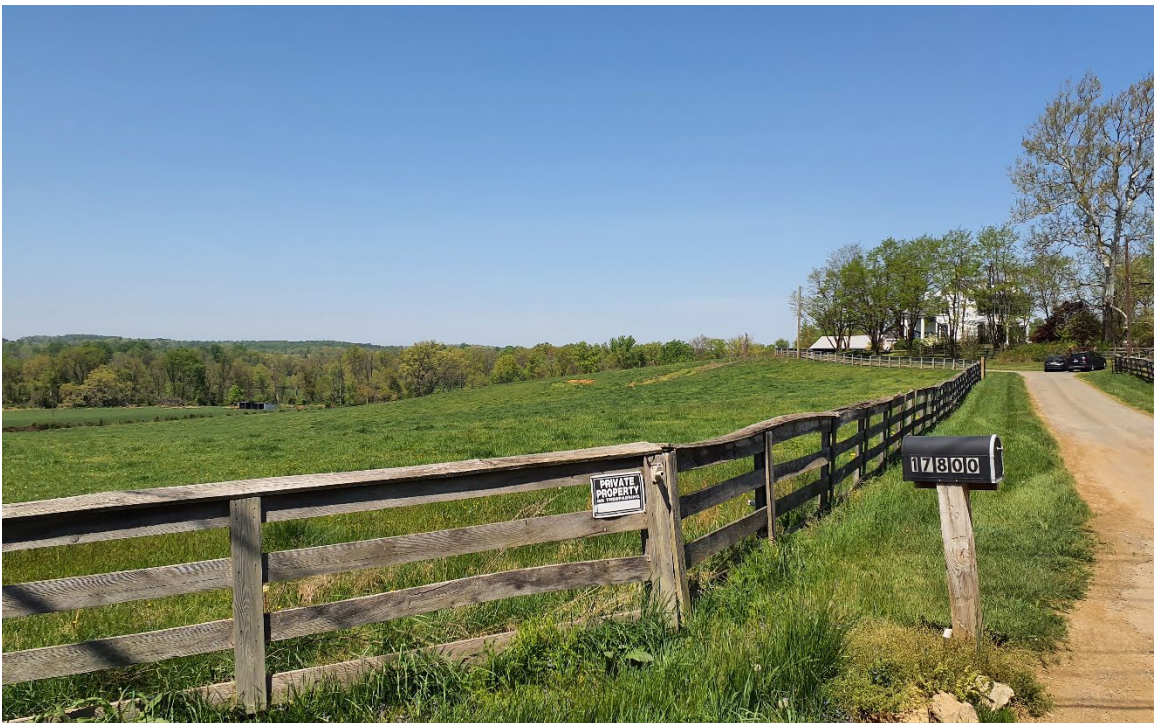
Figure 46: Photo 8 - View from driveway, facing northwest. -Building complex and southern fields are visible

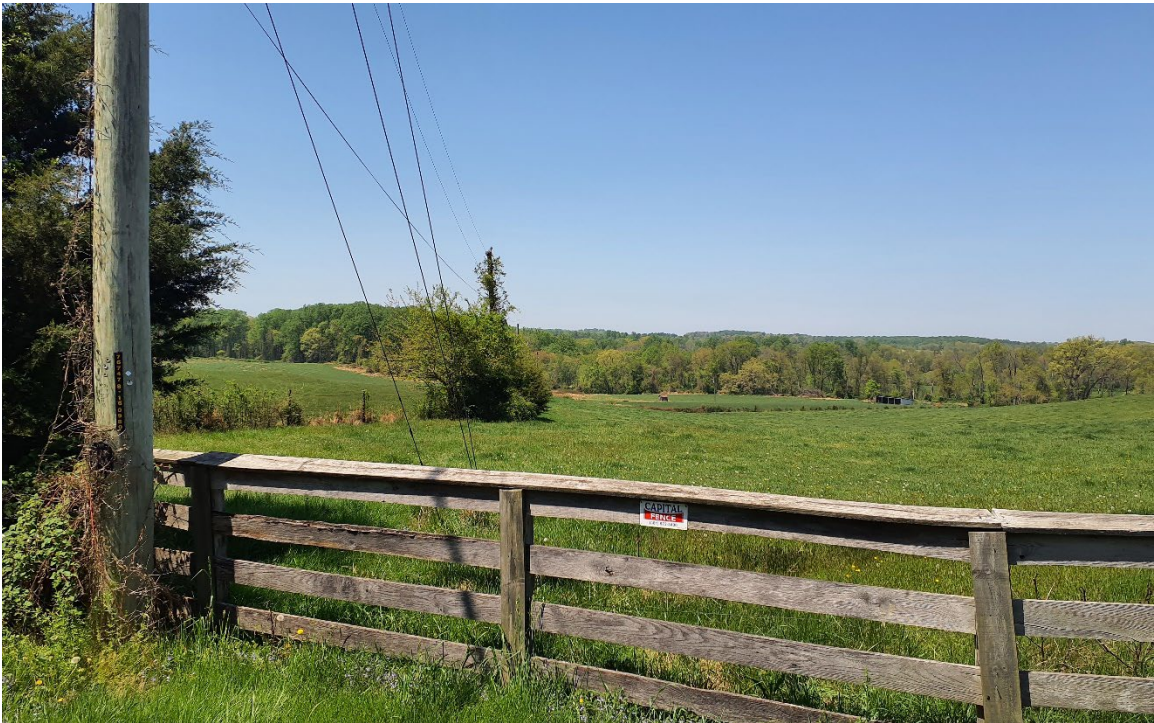
Figure 47: Photo 9 - View from driveway, facing southwest. - southern fields are visible

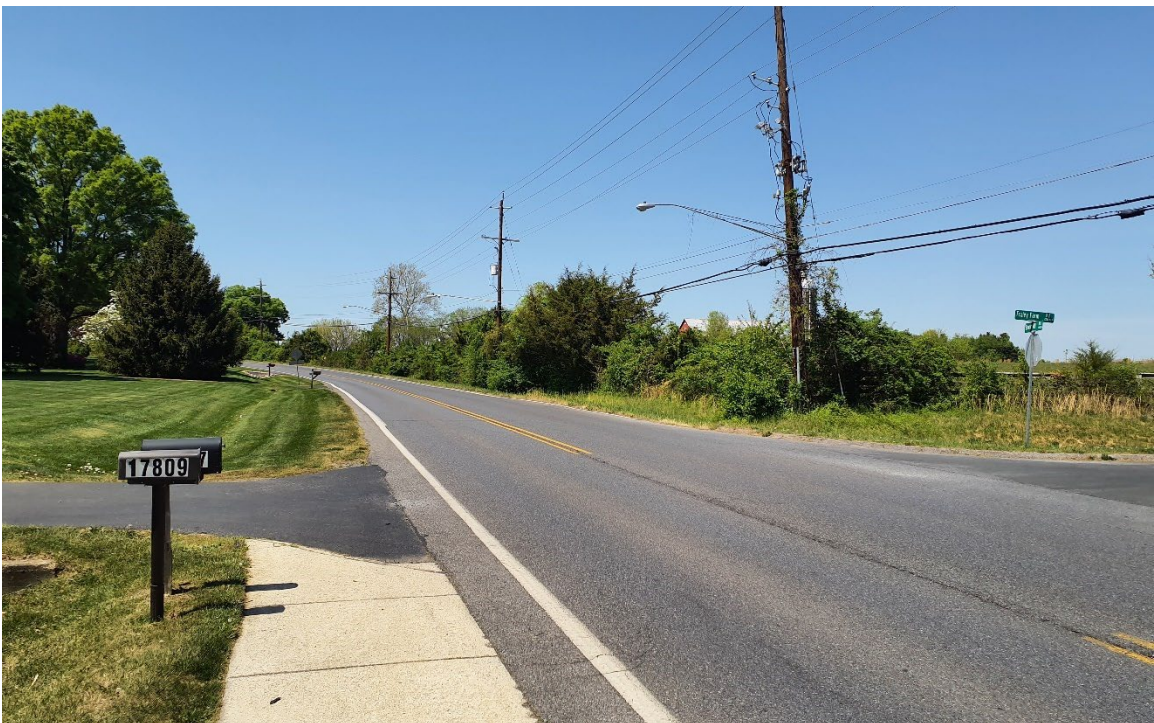
Figure 48: Photo 10 - View Bowie Mill Road at Fraley Farm Road, facing west. -House is not visible, eastern edge of property is visible
