MEMORANDUM

RE: Reduction of the Environmental Setting for Flint Hill II (M: 22/17), 17800 Bowie Mill Road,
Derwood

Re: Request for Determination on Environmental Setting -- Fraley Farm, 17800 Fraley Farm Road (the "Property")

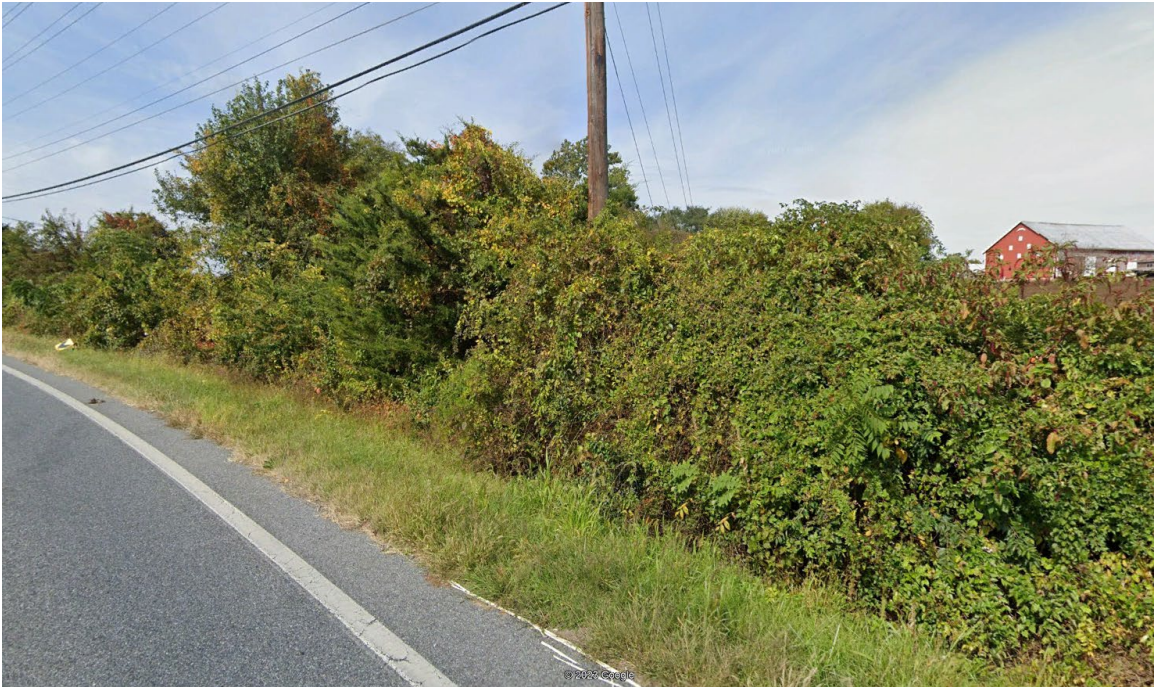
Figure 49: Photo 11 - View from Bowie Mill Road roughly 300 feet east of driveway, facing northwest. -House is not visible but barn and eastern portion of property are visible

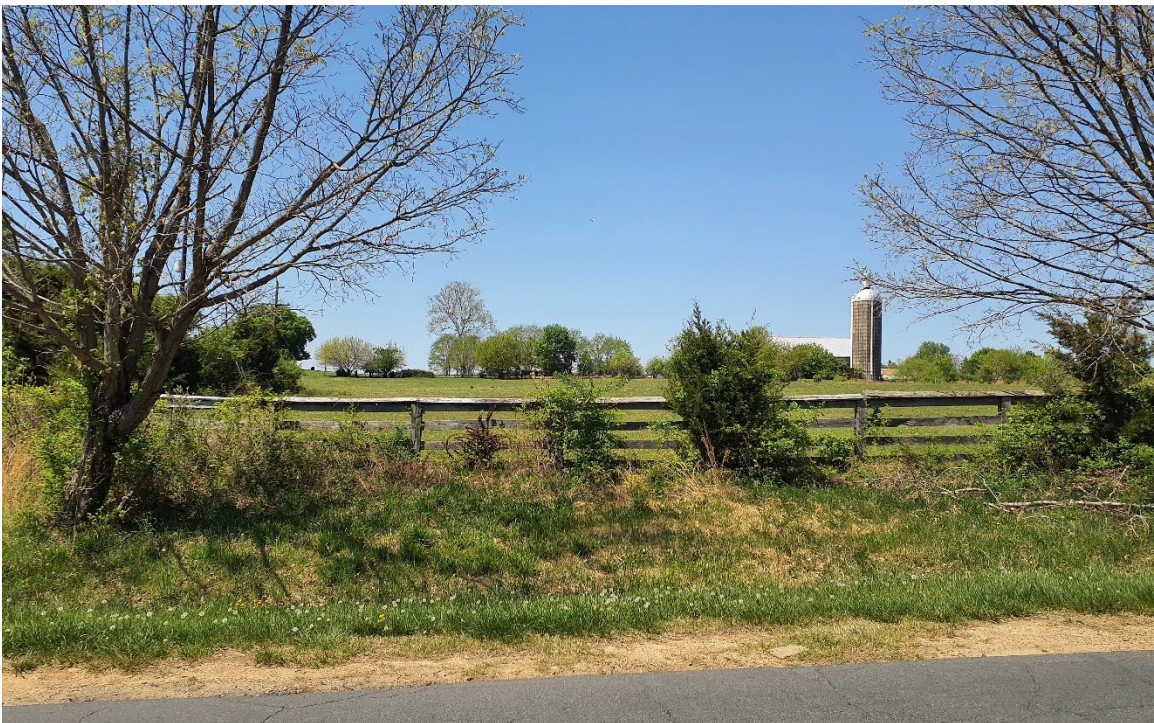
Figure 50: Photo 12 - View from Fraley Farm Road, facing west. -Building complex and eastern fields are visible

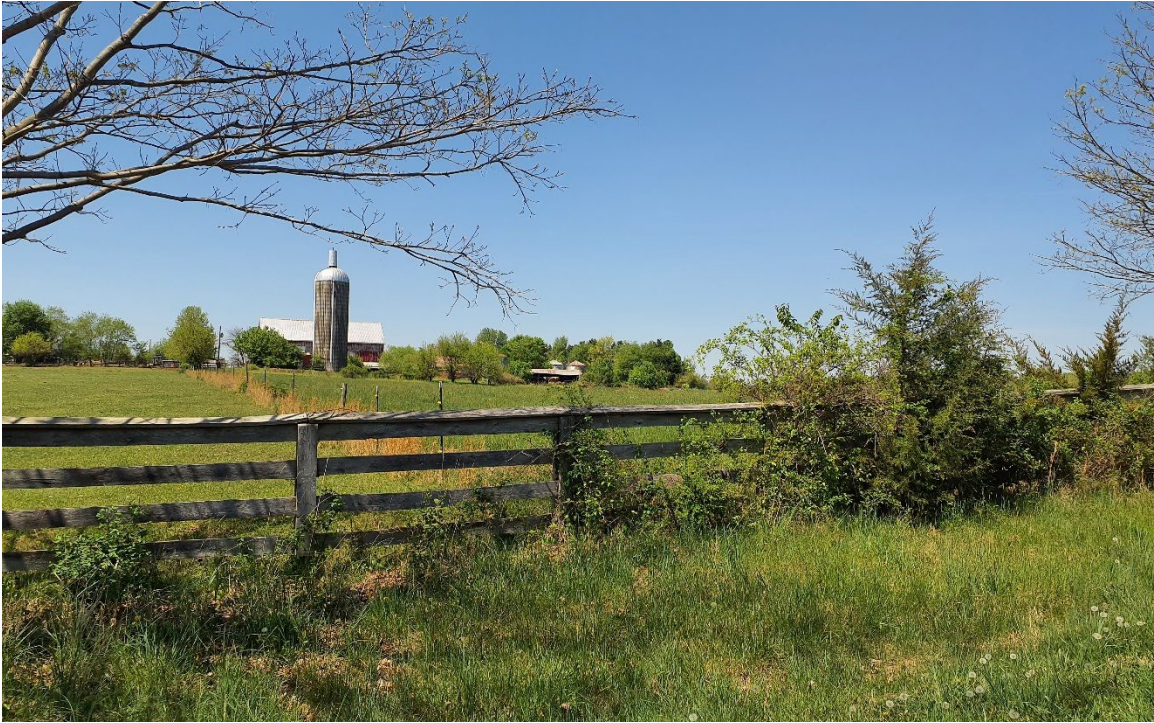
Figure 51: Photo 13 - View from Fraley Farm Road, facing northwest. -Building complex and eastern fields are visible

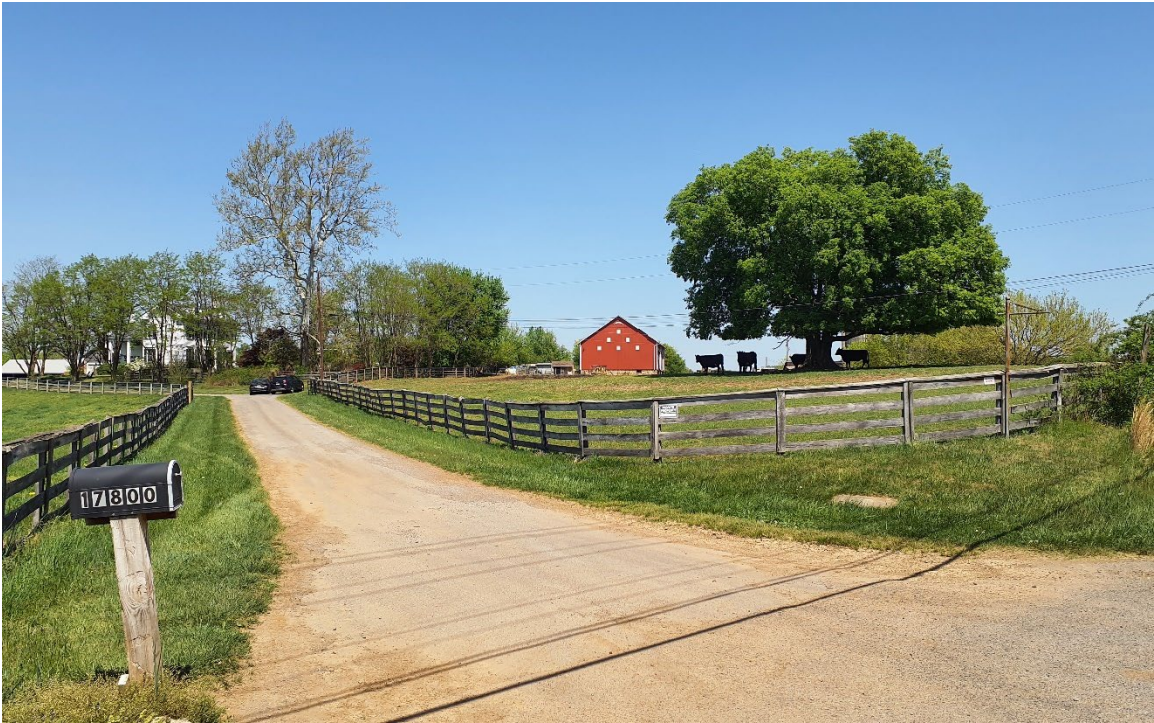
Figure 52: Photo 14 - Primary viewshed of Flint Hill from Bowie Mill Road at entrance to driveway, facing northwest. House and building complex are visible. Most of the property is below the line of sight with the exception of the field to the south.
