**MONTGOMERY COUNTY HISTORIC PRESERVATION COMMISSION**  
**STAFF REPORT**

| <b>Address:</b> | 3923 Prospect St., Kensington | <b>Meeting Date:</b> | 11/12/2025 |
| <b>PROPOSAL:</b> | Tree Removal | | |

**Tree Removal Project Description**  
**3923 Prospect St. and 3924 Baltimore St., Kensington**

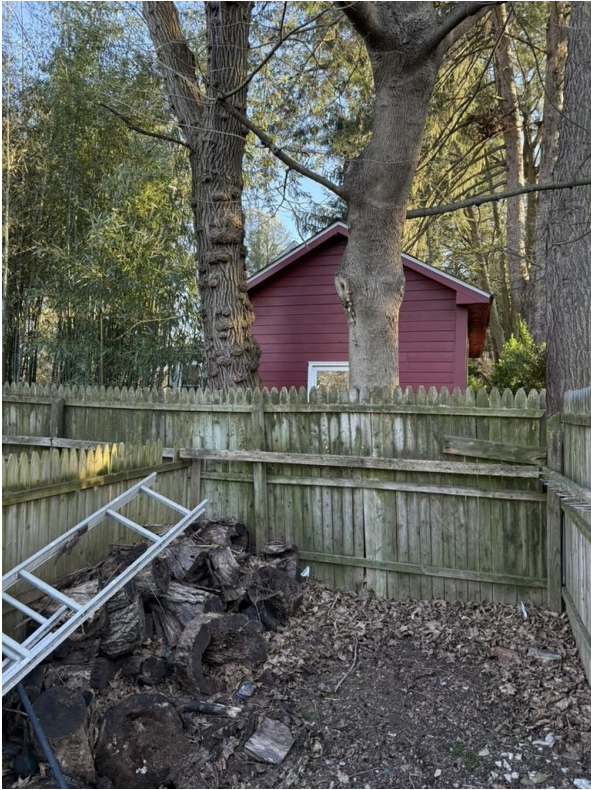
**Left to right: Trees #2 and #1 as viewed from 3924 Baltimore St. side of fence**

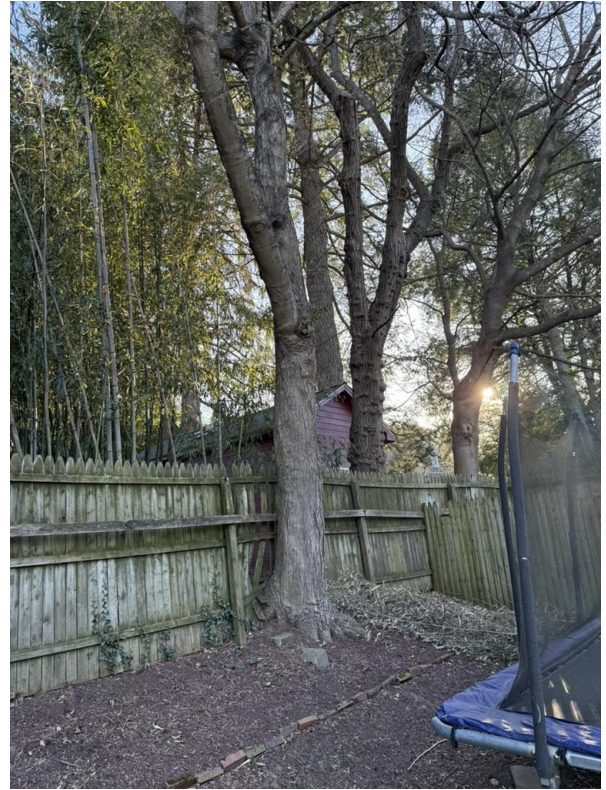
**Tree #3 (Maple):** Located at rear of 3924 Baltimore St. property, it is growing into and damaging the stockade fence located between the two properties. The tree's roots abut both properties. Its canopy overlaps significantly with Trees #1 and #2. Its root system will definitely be impacted significantly by the anticipated construction of a garage on the Willimans' property.

**View of tree #3 (foreground) with #2 & #1 (located on 3923 Prospect St. side) as viewed from 3924 Baltimore St.**

Trees #1 and #3 – Both of these trees are impacting the existing privacy fence at the rear of the property, but the larger rationale to remove these trees is that they are likely to be impacted by the construction of a garage that is anticipated at a future date. The health of both of these trees is good. Staff understands the desire to retain the existing fence and to remove all of the trees at the same time as a cost saving measure; however, Staff cannot base its recommendation on a potential future action (the construction of a garage).

Staff acknowledges that these two trees are at the rear of the property where they will have less impact on the district's overall tree canopy and recognizes the applicant's commitment to preserving the character of the Kensington Historic District; however, Staff does not find sufficient justification to recommend approval of these two trees without some measure of mitigation. The application states that the applicants would like to plant additional trees in the future, but Staff finds this speculative action is insufficient to make up for the loss of these trees.

Based on the trees modest size and their location at the rear of the property, Staff finds that removing trees #1 and #3 will not have a substantial impact on the overall character of the surrounding historic district. However, to support and promote the tree canopy that is a characteristic of the Kensington Historic District, Staff recommends the HPC add a condition to the approval of removing trees #1 and #3 that requires planting one hardwood canopy-species tree within twelve months each tree removed. With the recommended condition, Staff supports the removal of trees #1 and #3 under 24A-8(b)(2), the *Vision of Kensington*, and *Standard #2*.

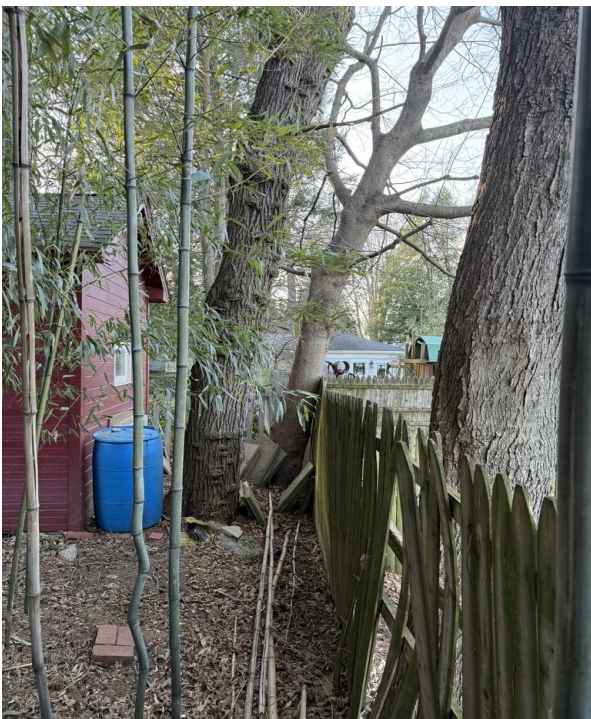
**Left to right: Tree #2 & #1, along left side of fence; Tree #3, on right side of fence**

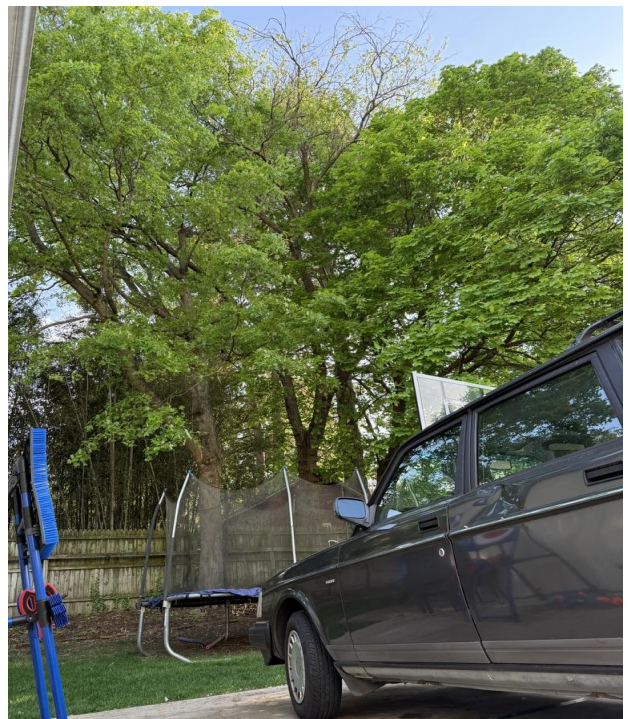
**Tree #2 (Mulberry):** Located at rear of 3923 Prospect side of stockade fence, next to Tree #1. It is the center tree of the three which are clustered together, to the detriment of each. There is significant dead wood in the crown; its roots are impinging on the foundation of the outbuilding (studio) located at that corner; and the trunk and crown lean heavily toward the Baltimore Street property as well as into the canopies of the two flanking maples (Trees #1 and #3).

**Tree #2 (Mulberry) has extensive dead wood in its canopy, as seen protruding at center of three-tree canopy**

Tree #2 – As noted in the application, the tree has significant deadwood in its crown and its roots are impacting an existing outbuilding. Staff additionally notes that Mulberries are an invasive species. Staff finds its removal will protect the foundation of the existing accessory structure and due to its location at the rear of the property, its removal will not substantially impact the mature tree canopy that is characteristic of the Kensington Historic District. Staff recommends approval under 24A-8(b)(2) and (4) and *Standard #2*.

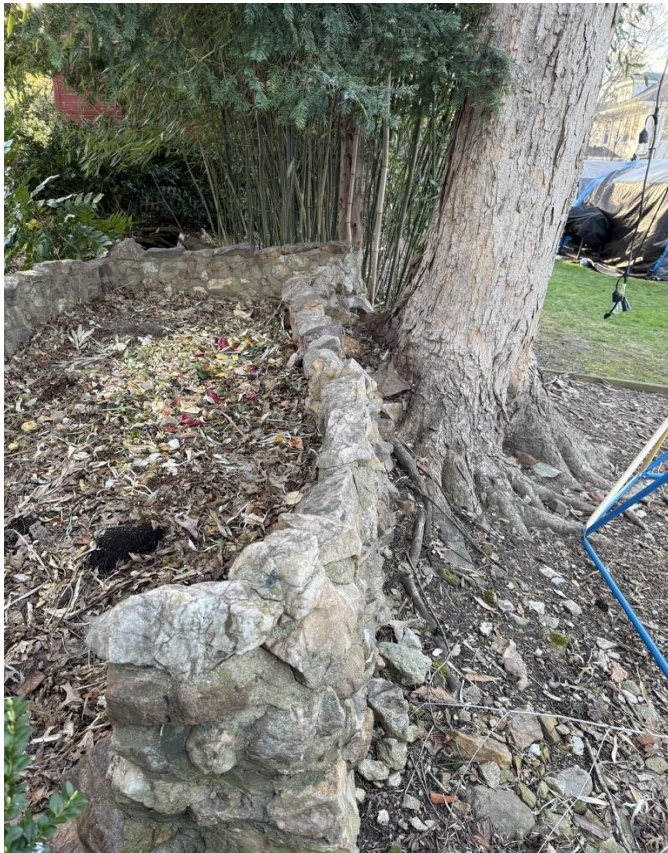
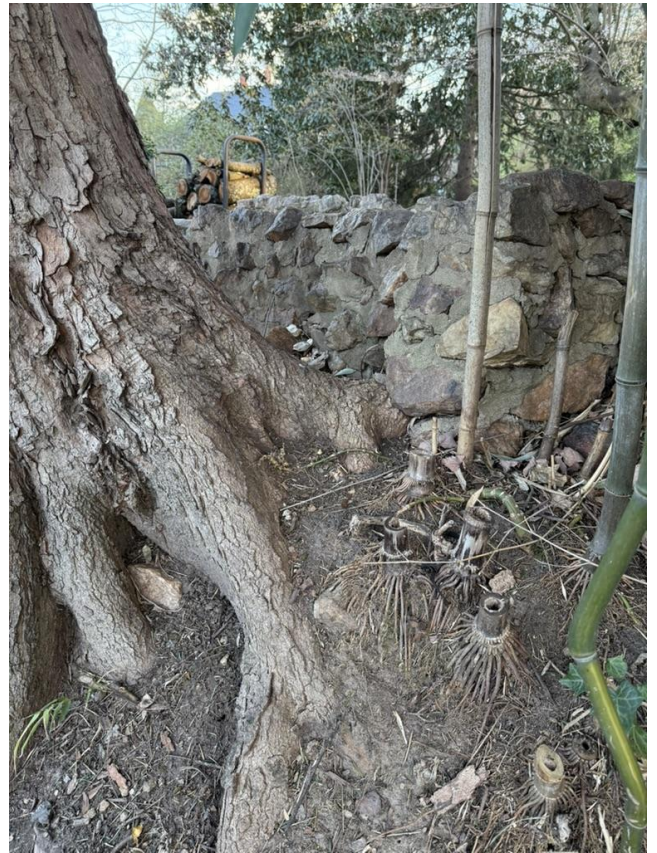
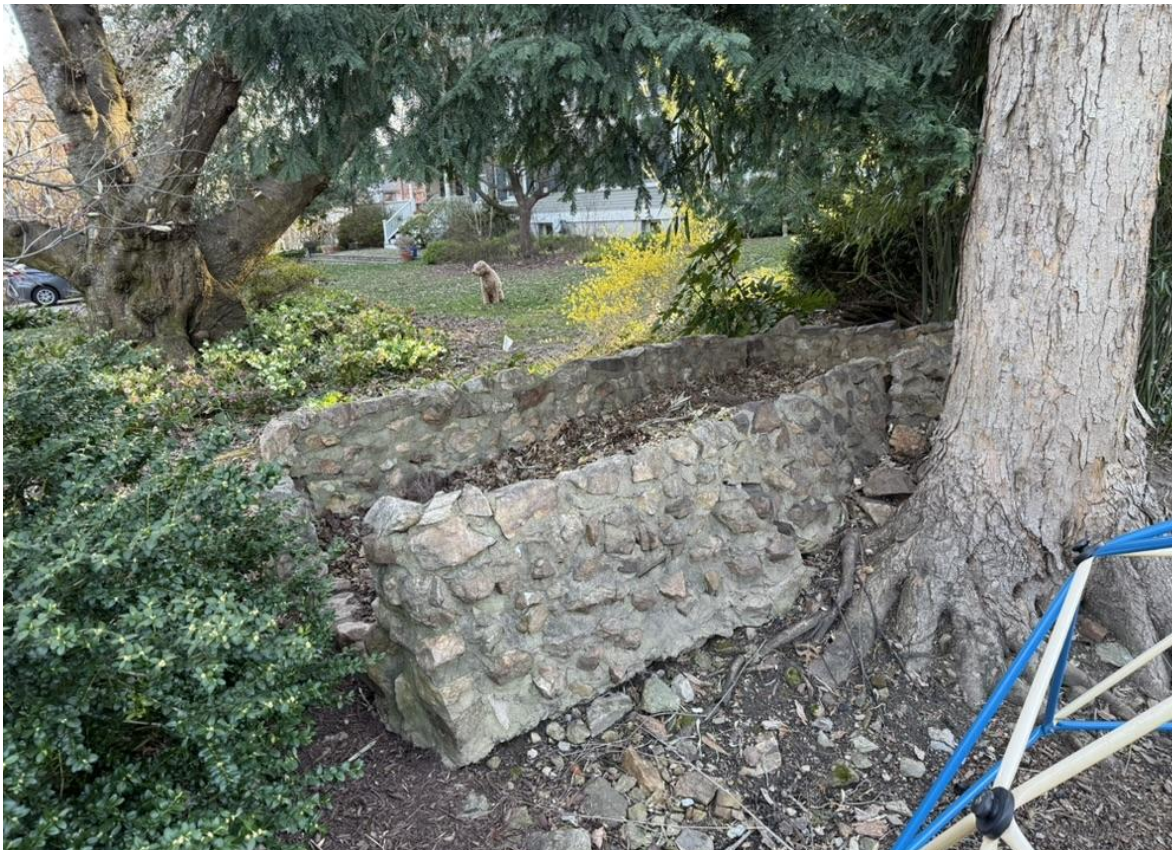
**Tree #4 (Maple):** Located at the property line between 3924 Baltimore and 3923 Prospect, this tree is slowly destroying the north wall of a three-sided, open stone wall structure located at the rear of 3923 Prospect, which contains a compost pile. It is a historic landscape feature of the property. The tree's trunk, which tilts heavily toward the Willimans' rear yard, and its root system are caving the wall in toward the compost pile. Its root system has expanded increasingly over the last few years to invade the compost contained within the stone structure, such that it is difficult to dig. The tree has dropped at least one large branch onto the rear yard of 3924 Baltimore in recent years as well as dead-wood debris, regularly. The tree's growth has further been affected in reaction to the huge canopy of the Yoshino cherry tree to its south, located on 3923 Prospect, which tilts heavily into this maple's canopy.

**Tree #4, situated at rear of 3924 Baltimore, is intruding into, and collapsing, the old stone wall of the compost pile at the rear of 3923 Prospect St.**

Tree #4 – The application indicates that this tree is damaging a garden compost structure the application refers to as "historic" in the rear of the property. While Staff was unable to find any documentation of this structure prior to a 1998 HAWP application, based on the fieldstone and concrete construction method and overall material condition, Staff finds this landscape feature is generally consistent with late

19<sup>th</sup> or early 20<sup>th</sup> century construction; however, the feature should not be considered character-defining for the site nor should the disposition of the garden structure dictate whether or not the tree should be removed. The proposal is to remove this tree and repair the structure. Staff supports the removal of this maple tree in the rear yard. Staff recommends approval under 24A-8(b)(2) and (4) and *Standard #2*.

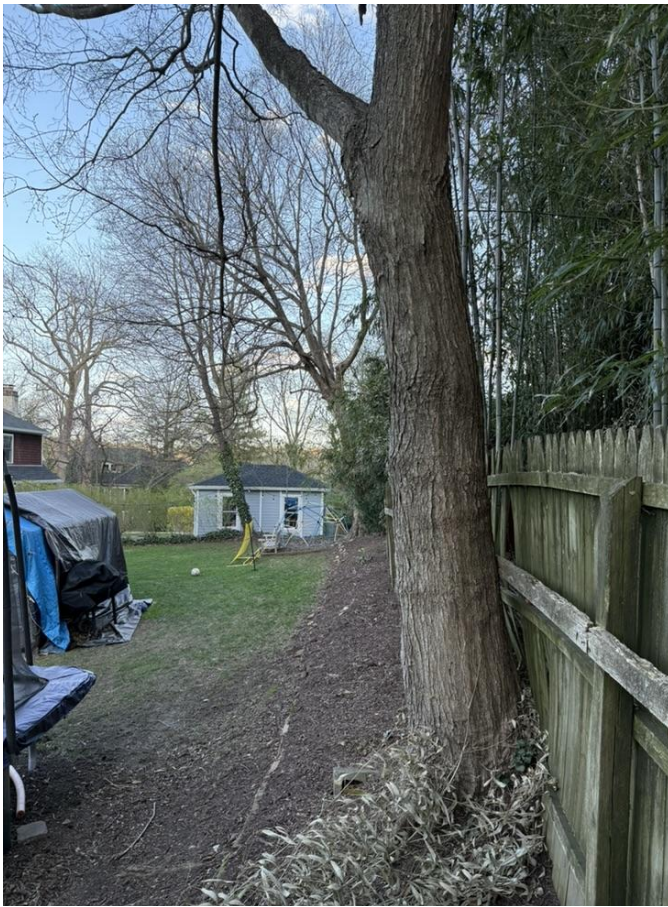
**Tree #3, in foreground; Tree #4, seen from a distance and tilting heavily into rear yard of 3924 Baltimore St; and Tree #5, in distance, as seen against garage at 3922 Baltimore St.**

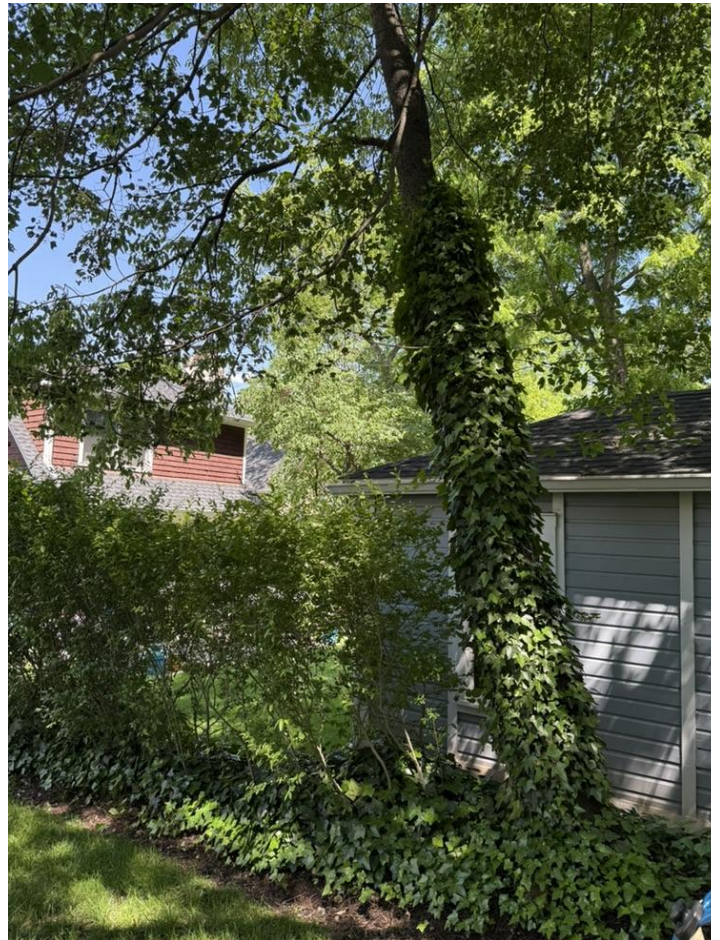
**Tree #5 (Cherry):** Located at the property line between 3924 and 3922 Baltimore (next door), it leans away from Tree #4 and toward the corner garage at the rear of 3922 Baltimore in search of more light. It's situated on a slightly humped ridge between the two properties which has a longer slope on the garage side due to the lower ground level adjacent to the garage. This contributes to the tilting of the tree toward the garage as its roots grow into the hump where it is rooted. The owners of 3922 would like to see that tree removed, for reasons of safety. Its trunk is also covered with ivy, which has, over time, further compromised the health of the tree.

**Tree #5, close-up**

Tree #5 – This tree is constructed immediately adjacent to an outbuilding and is leaning next to the existing accessory structure. This accessory structure was originally associated with 3920 Baltimore St. but was relocated from its historic location when the HPC approved the construction of the 3922 Baltimore St. in 2000.<sup>1</sup> Staff is unsure of the exact date of construction of this accessory structure, but notes it is shown on the 1924 Sanborn Fire Insurance Map of Kensington. Staff finds that the root system of this tree will likely damage the foundation of the historic outbuilding and its removal is necessary to protect the resource. Staff recommends approval under 24A-8(b)(2) and (4) and *Standard #2*.
