Chapter 3

**PHYSICAL DESCRIPTION AND ASSESSMENT
OF EXISTING CONDITIONS**

Farm Women's Market Investigation Conditions Assessment

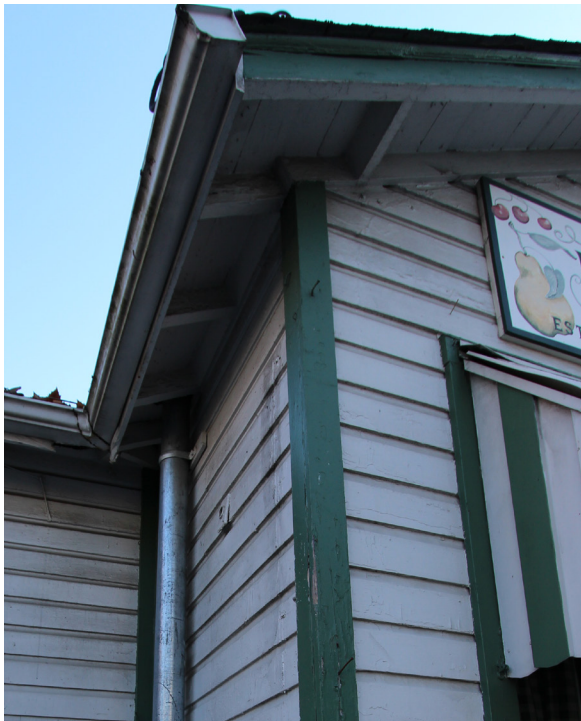
FIGURE 20 Detail of wood trim, overhanging eave with exposed rafter tails, and addition of gutter and downspout.

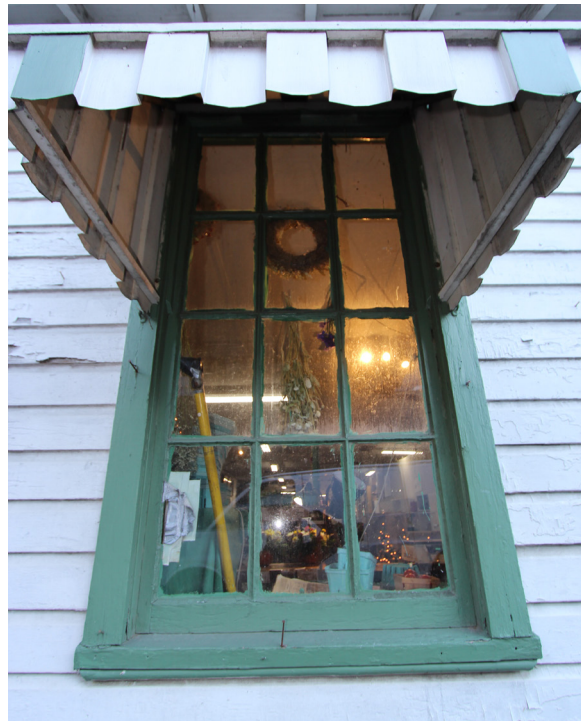
FIGURE 21 Original twelve-light, wood-sash pivot window.

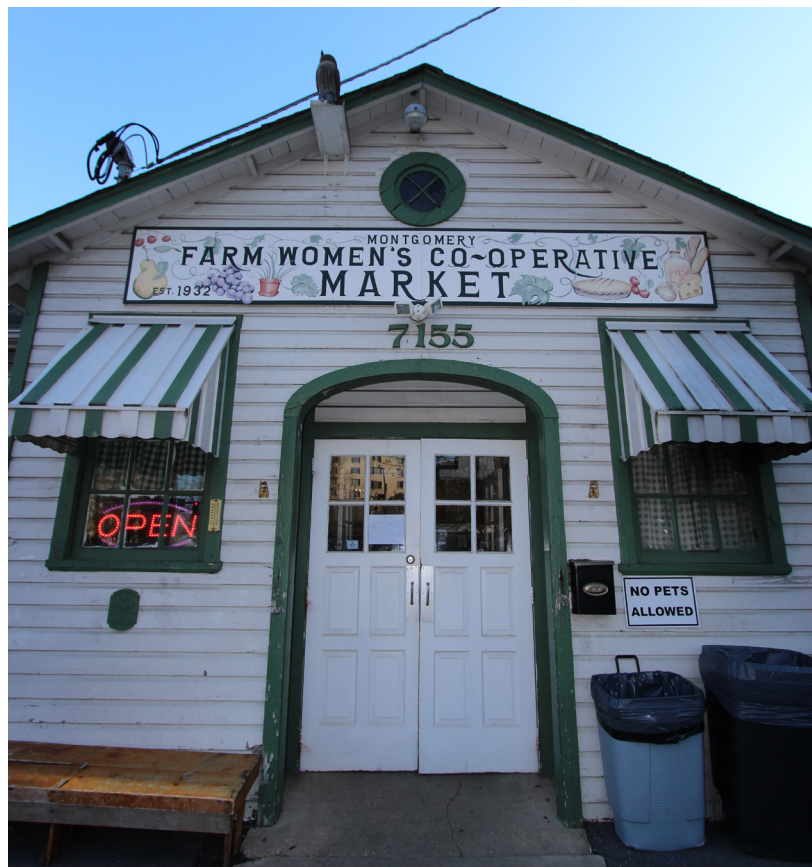
FIGURE 24 Replacement doors at front entrance.

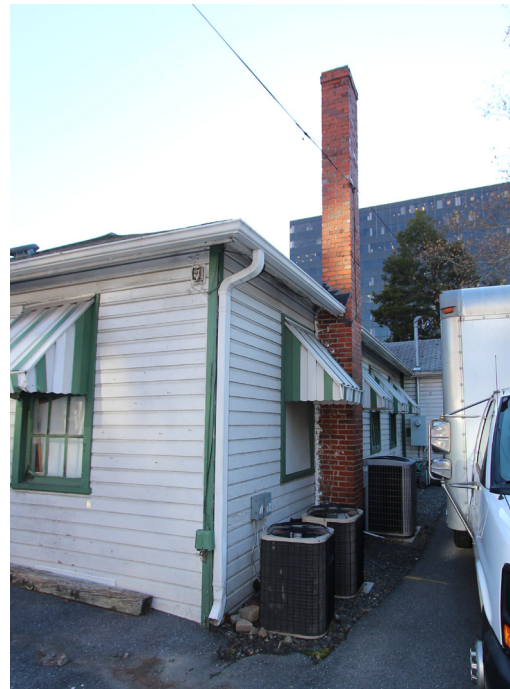
FIGURE 28 North side of west elevation including brick chimney and condenser units.

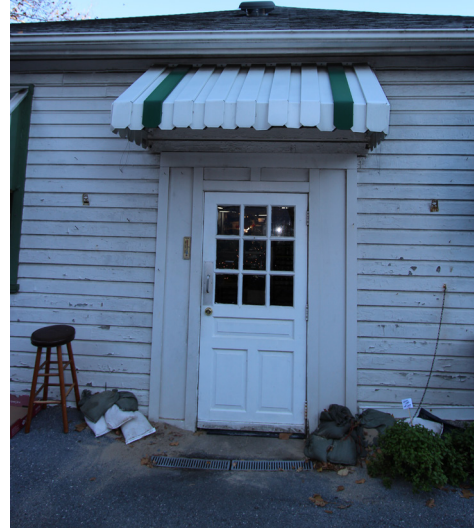
The side elevations, like the other elevations, are in fair condition. As a result of the surrounding pavement and the topography of the site, the side elevation door openings are at a lower level than the surrounding area, requiring ramps down to each doorway. The lack of positive site drainage has allowed water to pool against the building, resulting in water damage and flooding. French drains have been installed in front of each doorway. Sandbags stored nearby each opening are evidence of the drainage issues the building encounters on a regular basis (Figure 39).

FIGURE 39 South elevation doorway and sandbags.

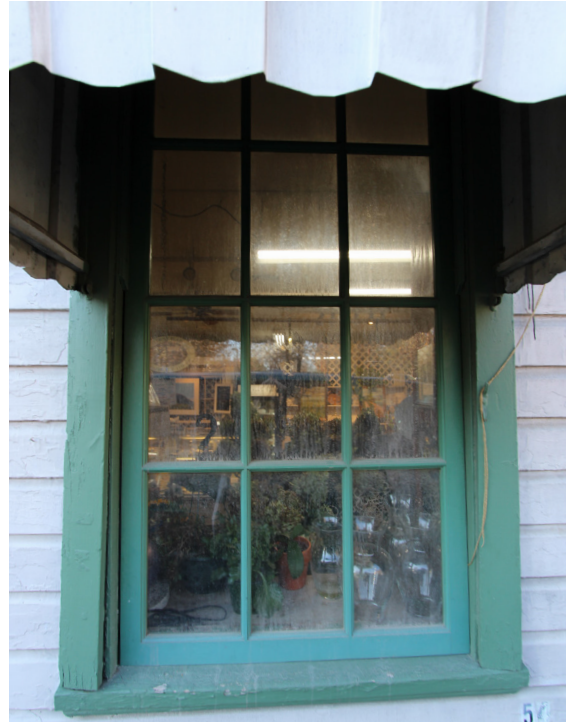
FIGURE 45 Replacement window on the east elevation.

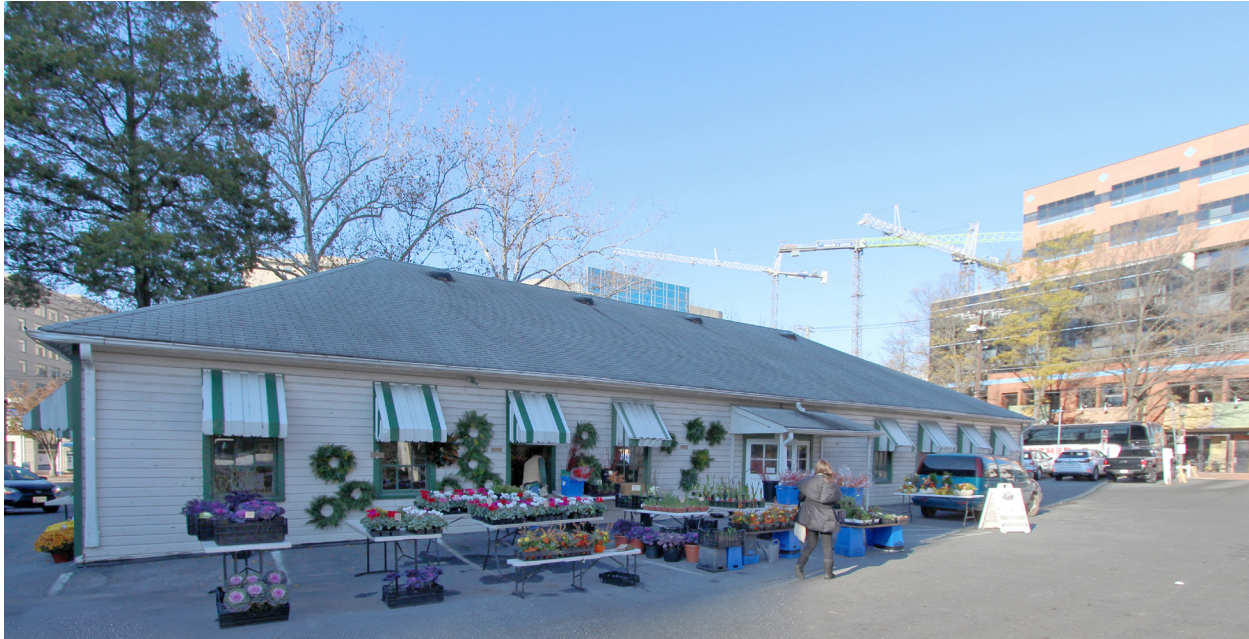
FIGURE 48 View of east elevation, roof and contemporary roof venting, looking west.

The roof appears to be in fair condition. Staining is visible where gutters are damaged or downspouts are missing. No leaks were apparent during survey.

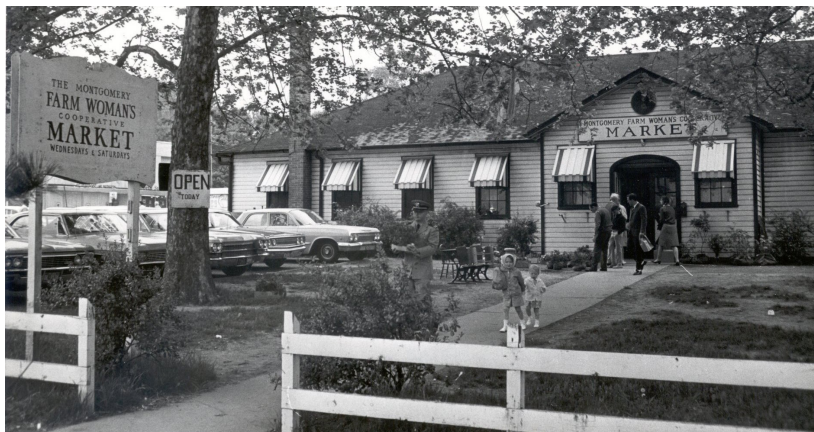
FIGURE 53 Deteriorated lawn, mature trees, and foundation plantings, 1968. Montgomery County Historical Society.

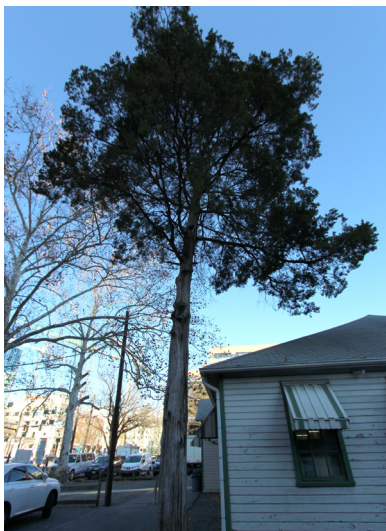
The site and landscape is in generally poor condition. The site, once landscaped with turf lawn, plantings, and unpaved parking, is now generally devoid of landscaping and mostly paved, causing significant damage to the historic building. A strip of gravel located along the foundation on the west side of the building allows for proper drainage; however, asphalt elsewhere abuts the building, inhibiting drainage. The once landscaped “front lawn” between the entry and Wisconsin Avenue is now covered in asphalt and gravel. Additional evaluation of the mature trees is necessary. The tall tree at the southwest corner of the building poses a threat to the building due to its proximity and height (Figure 56 - Figure 57).

FIGURE 56 Mature tree adjacent to the southwest corner of building.

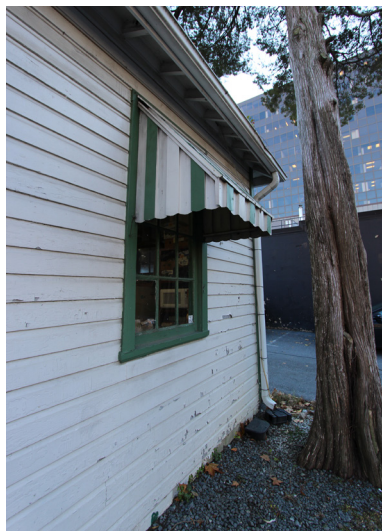
FIGURE 57 Detail of the distance of tree from southwest corner.

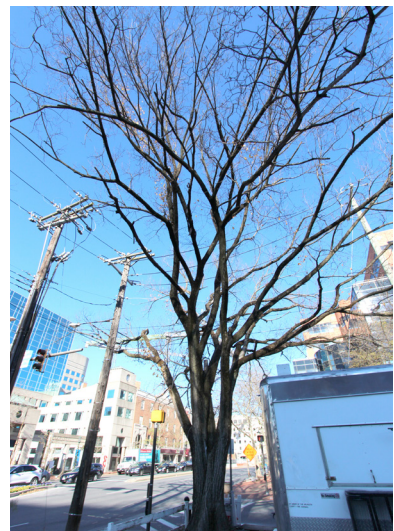
FIGURE 59 Mature tree at northwest corner of property.

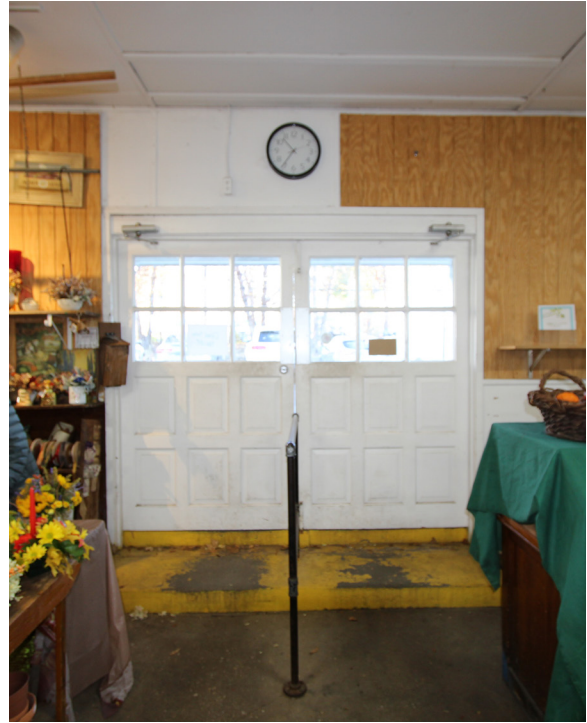
FIGURE 72 Interior view of north elevation door and concrete ramp.

The site slopes down from the northeast corner of the site. As a result, the north elevation and east elevation doorways are reached on the interior by a concrete ramp and concrete step, respectively (Figure 72-Figure 73). The concrete ramp does not extend the full width of the doorway and is thus not likely original.

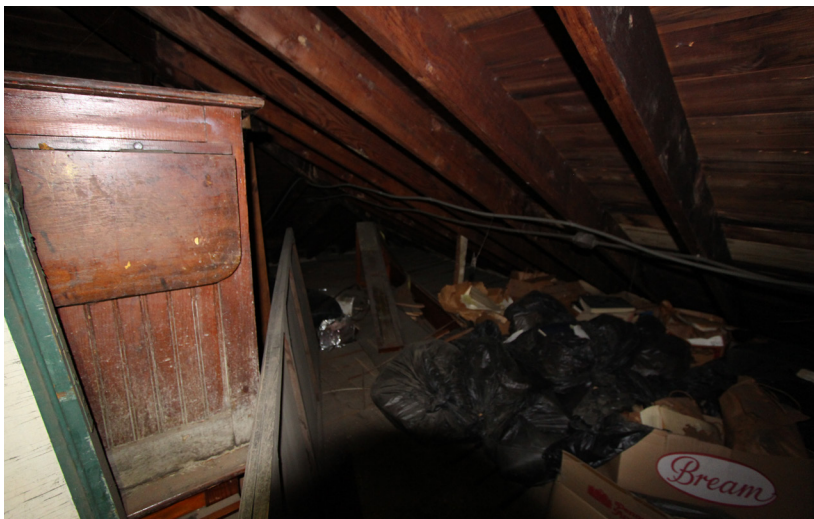
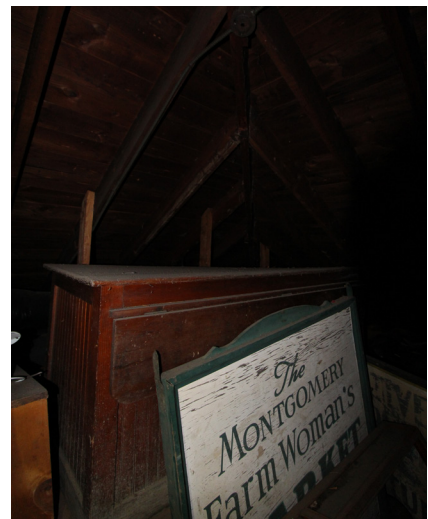
FIGURE 74 Original display tables and cases.

Originally sellers were provided with golden-oak display cabinets and two-tiered stepped tables made by a local cabinetmaker in Rockville. Many of these cabinets remain in use today, though contemporary display cases are also utilized. Some of the original display cases are extant within the attic (Figure 74 - Figure 75).

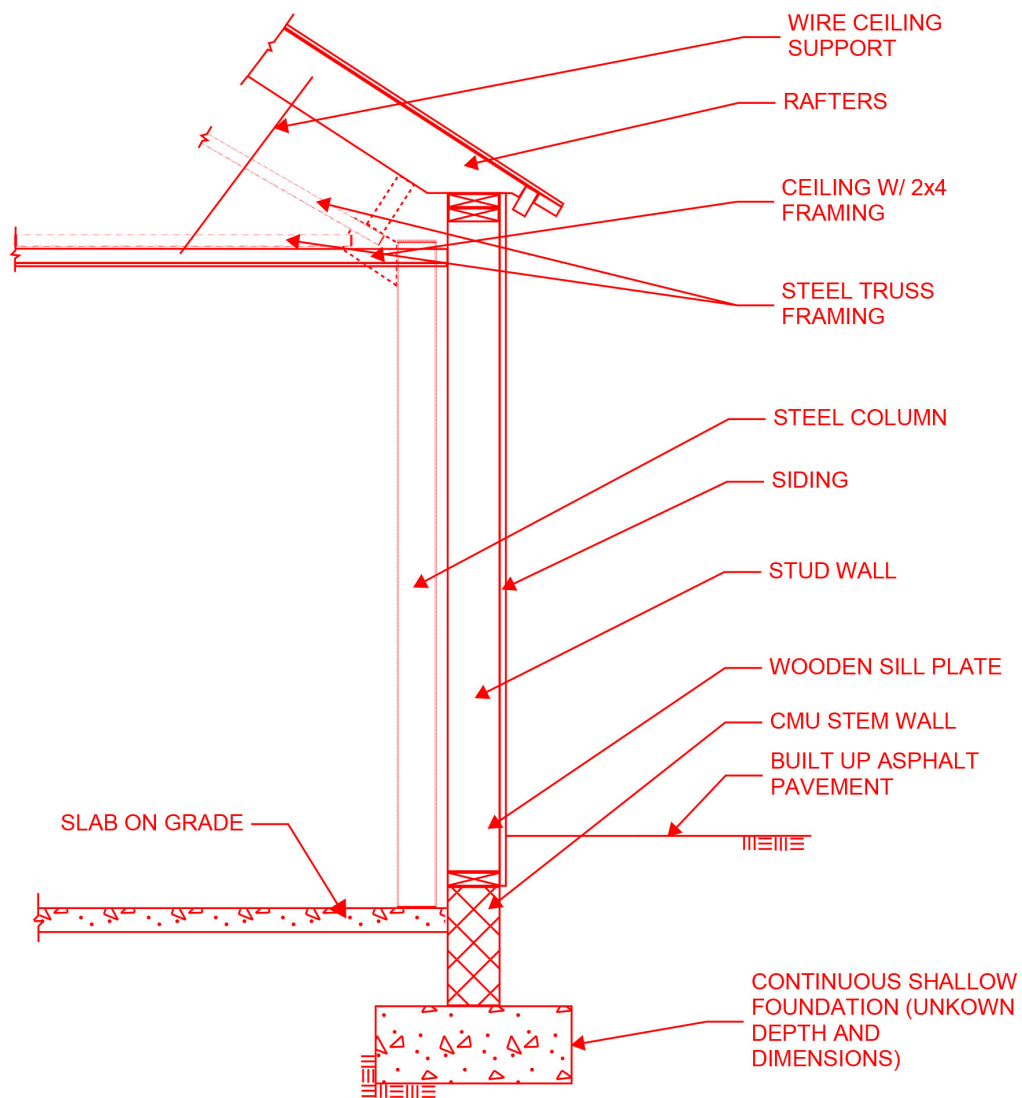
FIGURE 79 Typical End Bay Bearing Section, NTS. Silman, December 2018.

Foundation: The north and south ends of the building display obvious signs of settlement that can be attributed to one or more factors: settlement of bearing wall foundations at the end bays of the building, settlement caused by poor drainage, or the degradation of the sill plate between the stud wall and stem wall. Since there is a known grading issue on site, the causes that might lead to moisture damage of the structure are more likely.

Wall framing: The walls do not support the roof in the middle 3/5th of the building. As noted above, the end bays exhibit vertical settlement likely due to soils and moisture damage to sills. When viewed from the exterior of the building, the east and north walls appear to undulate along their length with a maximum inward displacement of 4". The deformation of the wall is due to the buildup of asphalt against the wall, which has applied a lateral pressure over an extended period of time.

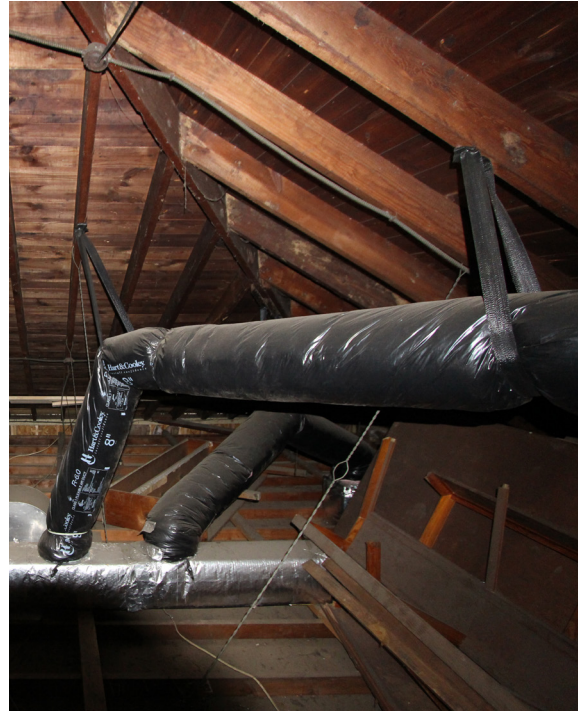
FIGURE 81 Wires supporting non-original ceiling joists.

Items were being stored in the southern storage area at the time of the investigation. The footprint of the stored items extended beyond the finished storage area and were resting directly on the unreinforced ceiling framing, as shown in Figure 14. The ceiling framing is only supported by wire hangers and should not be used for storage.

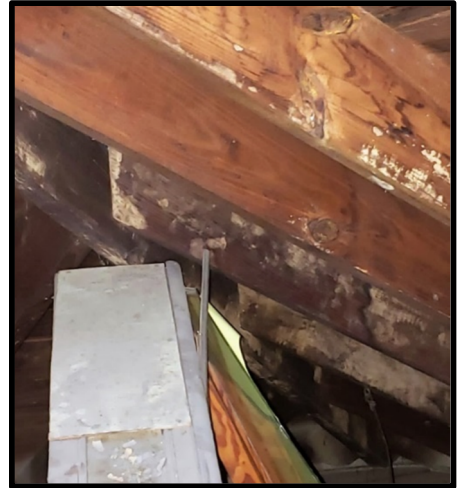
Figure 13 – Southeast Roof Framing

The observations of the roof framing were limited to the southern end of the building in the modified storage area. The steel trusses, beams, and rafters between the trusses showed no signs of distress. The wood framing at the southern end of the building showed isolated signs of damage due to a previous termite infestation (Figure 13).

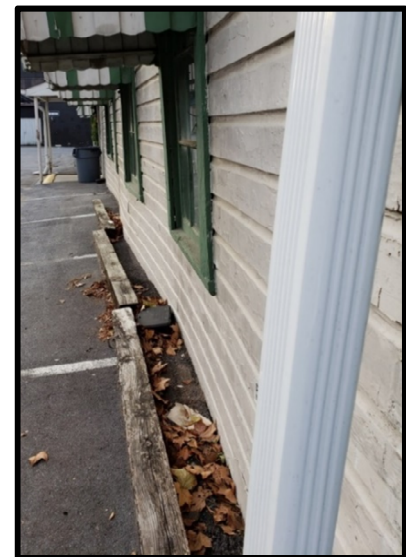
Figure 15 – Eastern Wall

There are ongoing drainage issues due to poor grading of the site. Water has flowed towards the structure and required additional efforts to redirect surface water runoff along the southern perimeter of the structure. The grading of the parking lot appears to have been unsuccessful in directing water away from the building. Trench drains have been added at the north and south entrances. Asphalt has been placed directly against the structure along the north and east walls, as shown in Figure 15. The asphalt buildup has caused the north and east walls to deflect inward, undulating between columns, with a maximum inward displacement of 4".
