FARM WOMEN’S COOPERATIVE MARKET
7155 WISCONSIN AVENUE | BETHESDA, MD

Second Draft Submission
July 2019

Farm Women's Market Investigation Conditions Assessment

December 18th, 2018

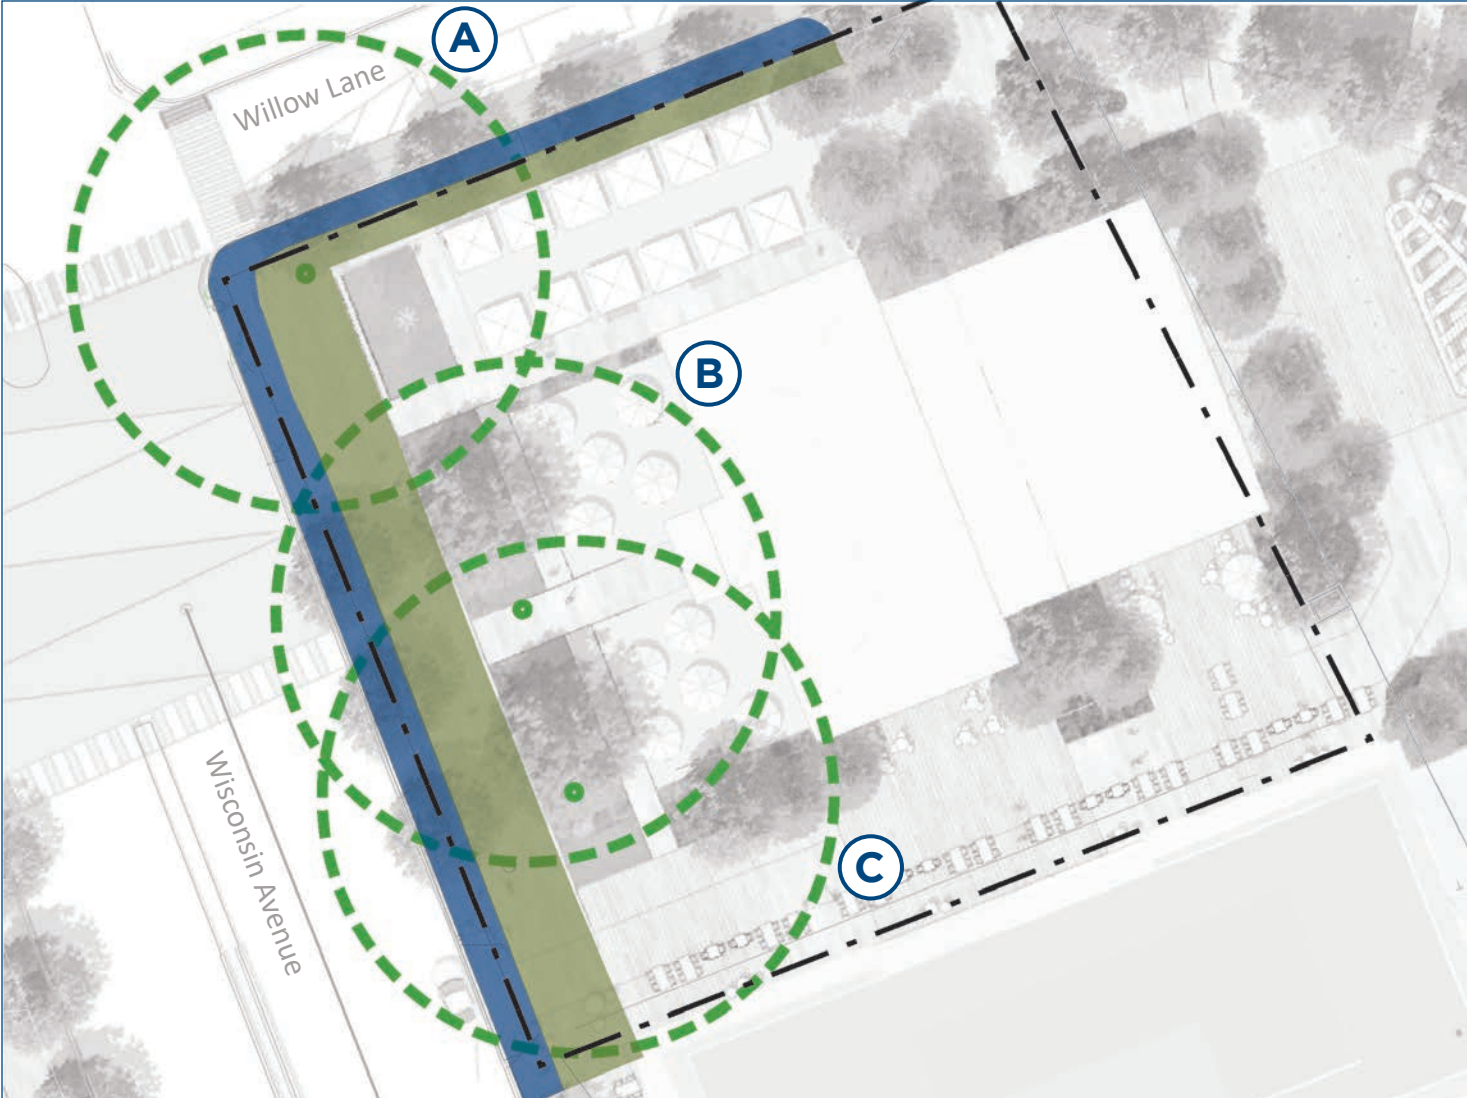
Trench Impact - Existing utilities in this area to be relocated in underground trench
-

Bethesda Streetscape - Frontage Improvements/pavers for pedestrian circulation
-

Tree	Impact #1	% CRZ Impact
A	PROPOSED UTILITY TRENCHING & STREETSCAPING	30%
B	PROPOSED UTILITY TRENCHING & STREETSCAPING	30%
C	PROPOSED UTILITY TRENCHING & STREETSCAPING	30%

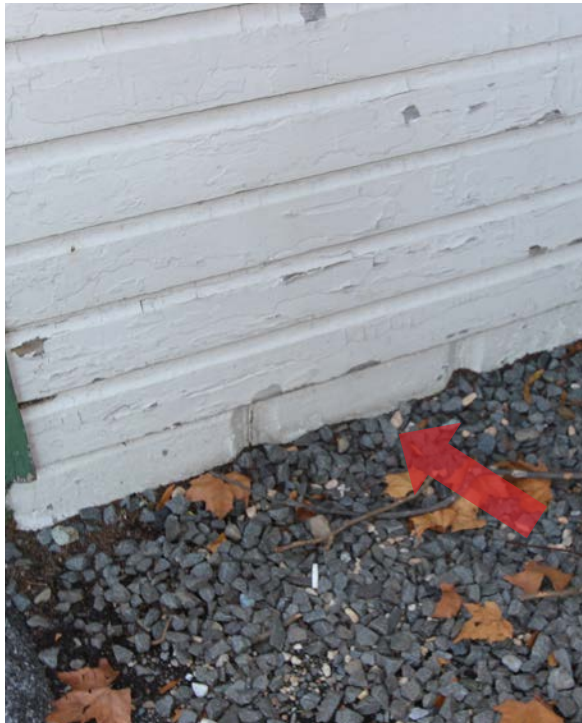
FIGURE 18 Siding and exposed concrete block foundation stem wall (identified with arrow) along the west elevation.

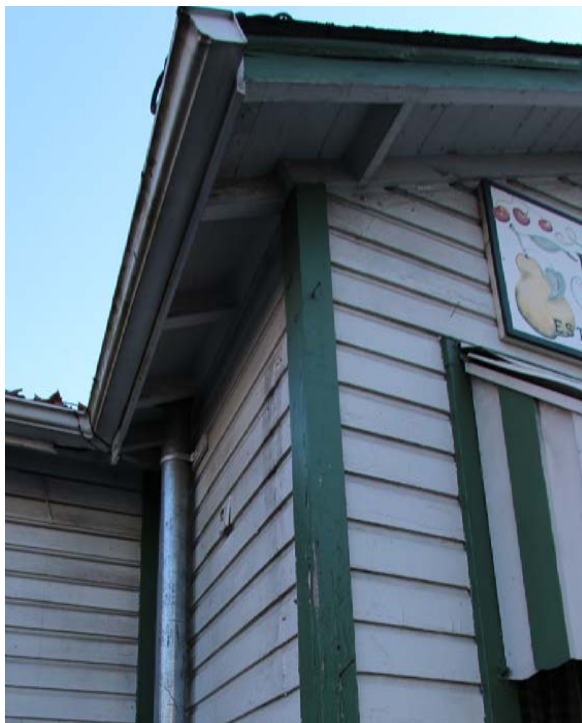
FIGURE 20 Detail of wood trim, overhanging eave with exposed rafter tails, and addition of gutter and downspout.

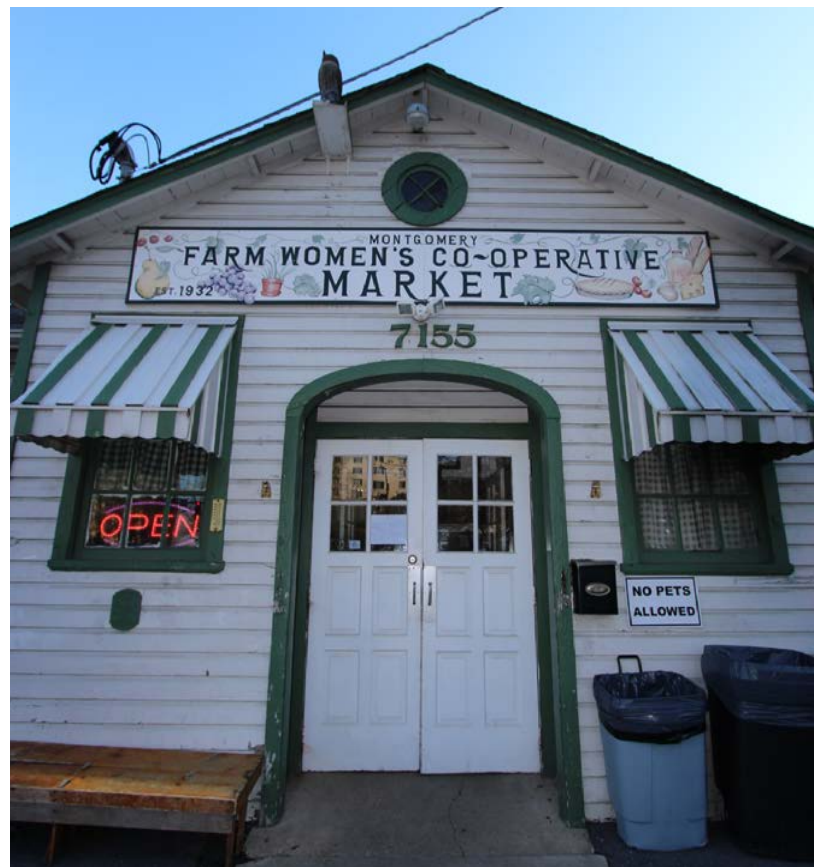
FIGURE 24 Replacement doors at front entrance.

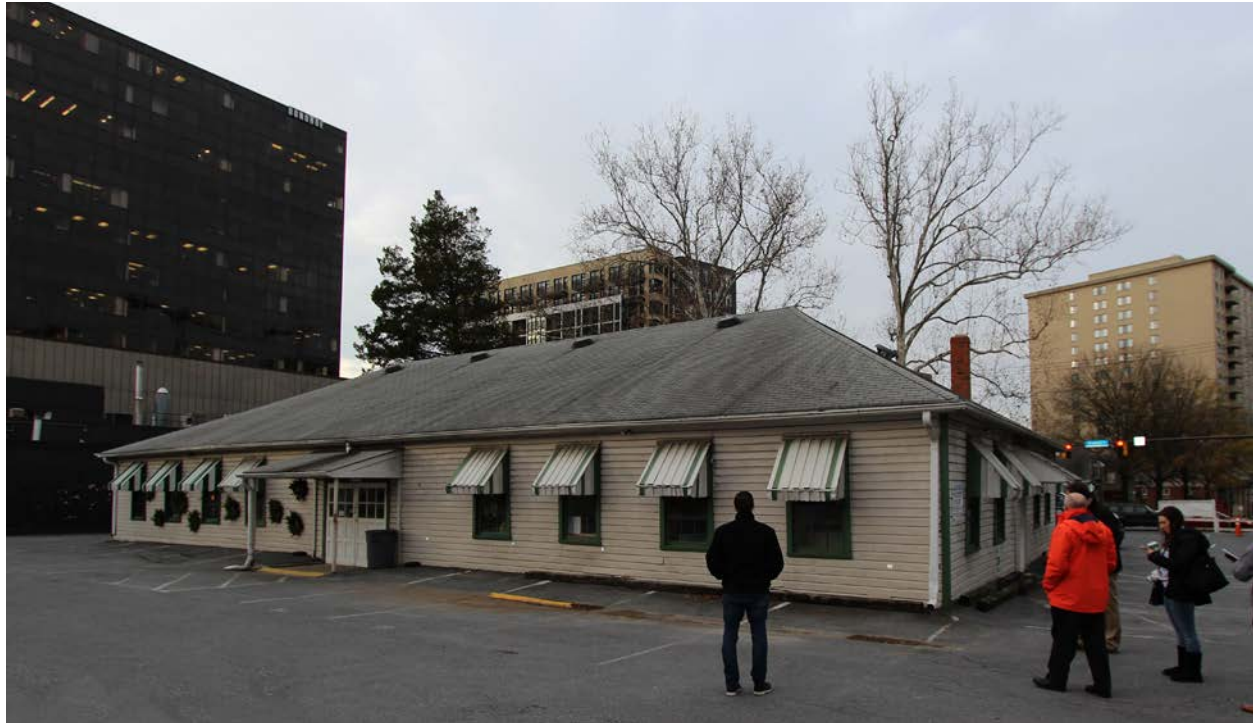
FIGURE 29 Rear elevation, looking southwest. Traceries.

The north side of the elevation, undulates. This undulation is a result of the asphalt paving being poured against the wood frame walls (Figure 32). The areas of wood framing indent into the building, while the locations of the steel frame on the interior have pushed out against the pressure.

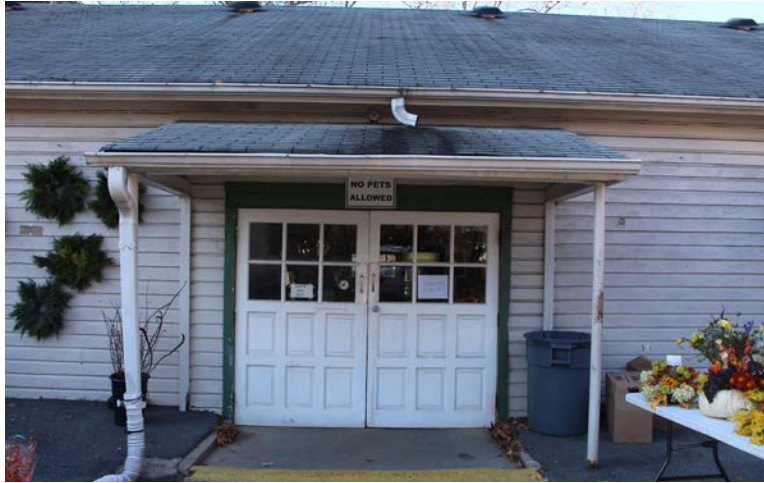
FIGURE 30 Non original rear doorway

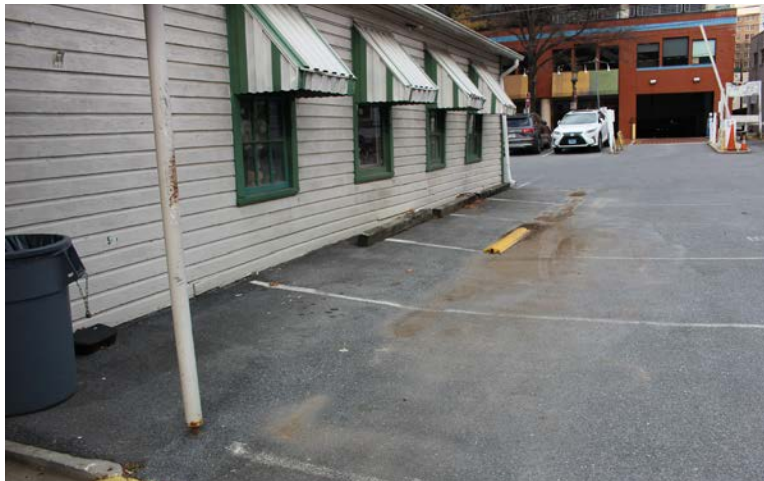
The continuous repair/re-pouring of asphalt paving surrounding the building appears to have damaged the building structure and has also generated drainage issues at the building foundation. As layers of paving have accumulated over the years, in combination with the topography of the site, which slopes down from the northeast to the southwest corner, water is able to collect and pool at the foundation. In addition, the exterior walls appear to undulate, particularly on the east elevation. This undulation is a result of the lateral pressure of the asphalt paving against the wood frame walls. The areas of wood framing indent in towards the building, while the locations of the steel beams on the interior have remained in their original position.

FIGURE 31 Slope of site/ building in hole

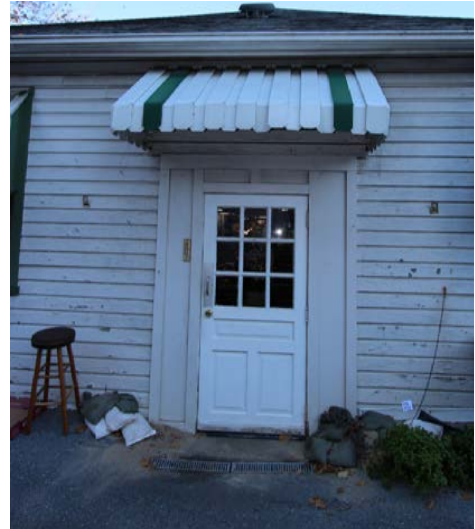
The side elevations, like the other elevations, are in fair condition. As a result of the surrounding pavement and the topography of the site, the side elevation door openings are at a lower level than the surrounding area, requiring ramps down to each doorway. The lack of positive site drainage has allowed water to pool against the building, resulting in water damage and flooding. French drains have been installed in front of each doorway. Sandbags stored nearby each opening are evidence of the drainage issues the building encounters on a regular basis (Figure 39).

FIGURE 39 South elevation doorway and sandbags.

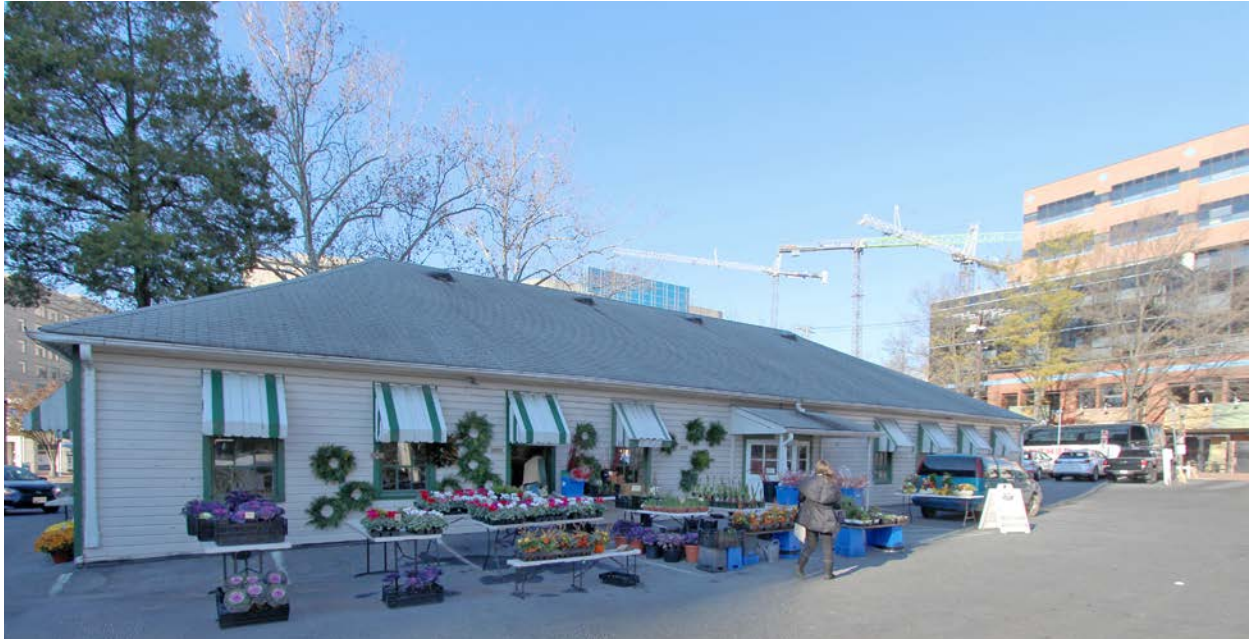
FIGURE 48 View of east elevation, roof and contemporary roof venting, looking west.

The roof appears to be in fair condition. Staining is visible where gutters are damaged or downspouts are missing. No leaks were apparent during survey.

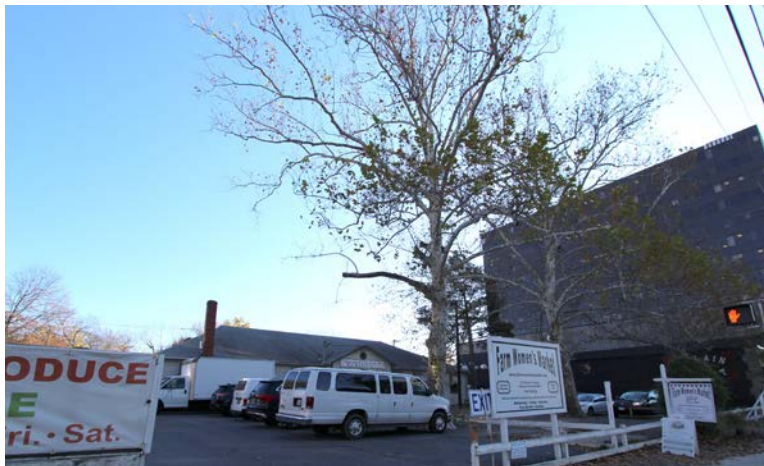
The site and landscape is in generally poor condition. The site, once landscaped with turf lawn, plantings, and unpaved parking, is now generally devoid of landscaping and mostly paved, causing significant damage to the historic building. A strip of gravel located along the foundation on the west side of the building allows for proper drainage; however, asphalt elsewhere abuts the building, inhibiting drainage. The once landscaped “front lawn” between the entry and Wisconsin Avenue is now covered in asphalt and gravel. Additional evaluation of the mature trees is necessary. The tall tree at the southwest corner of the building poses a threat to the building due to its proximity and height (Figure 56 - Figure 57).

FIGURE 57 Market and site looking southeast, 2018.

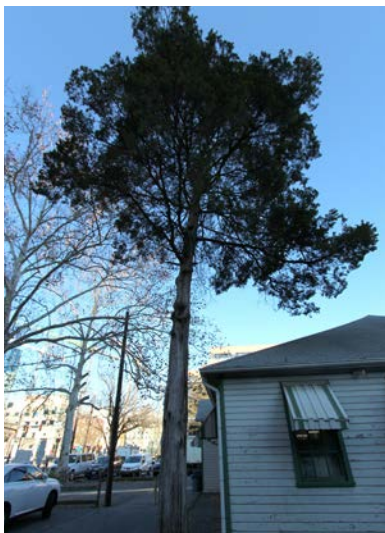
FIGURE 55 Mature tree adjacent to the southwest corner of building.

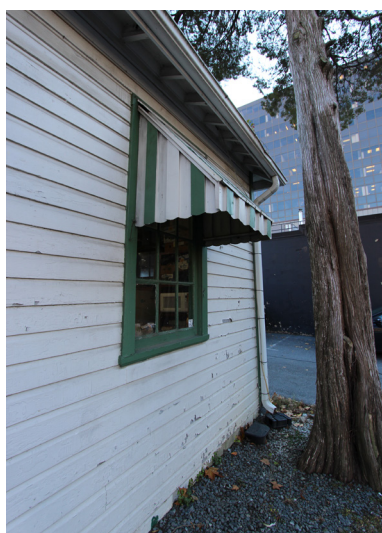
FIGURE 56 Detail of the distance of tree from southwest corner.

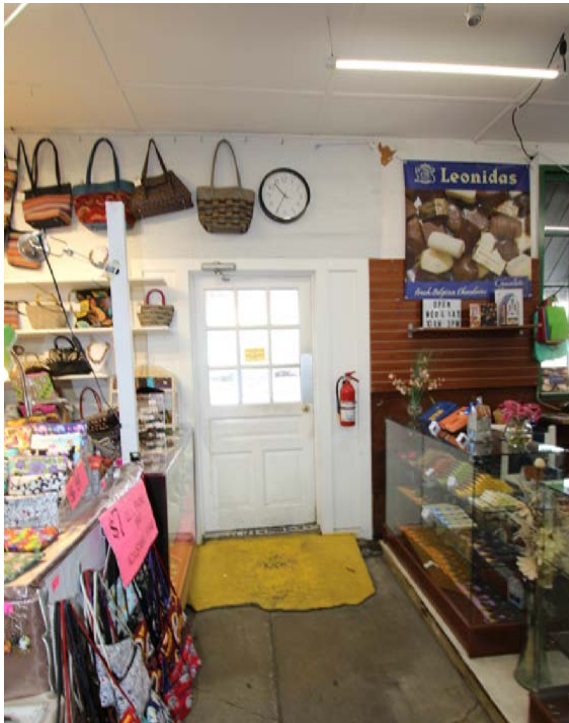
The site slopes down from the northeast corner of the site. As a result, the north elevation and east elevation doorways are reached on the interior by a concrete ramp and concrete step, respectively (Figure 72-Figure 73). The concrete ramp does not extend the full width of the doorway and is thus not likely original.

FIGURE 72 Interior view of north elevation door and concrete ramp.

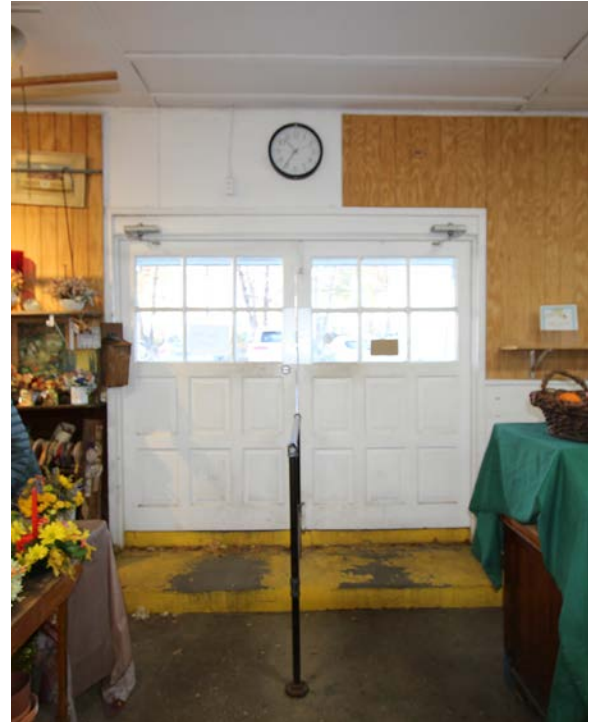
FIGURE 73 Interior view of east elevation door and concrete step.

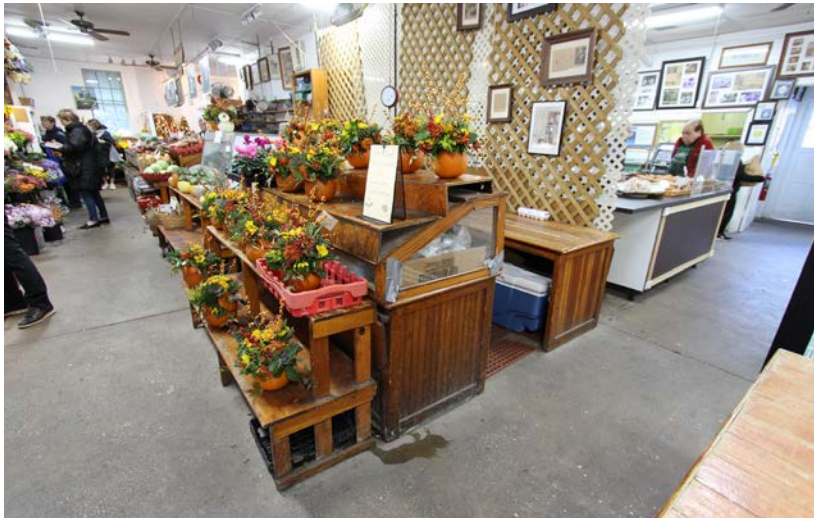
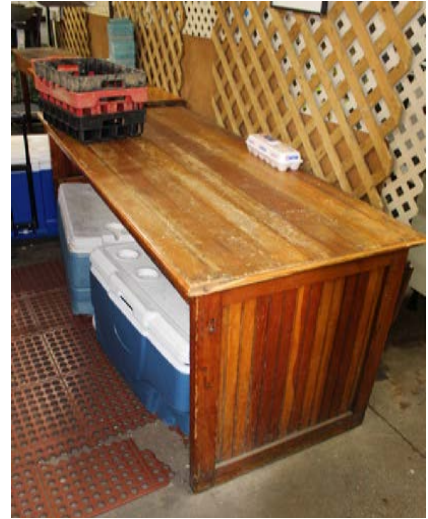
Originally sellers were provided with golden-oak display cabinets and two-tiered stepped tables made by a local cabinetmaker in Rockville. Many of these cabinets remain in use today, though contemporary display cases are also utilized. Some of the original display cases are extant within the attic (Figure 74 - Figure 75).

FIGURE 74 Original display tables and cases.

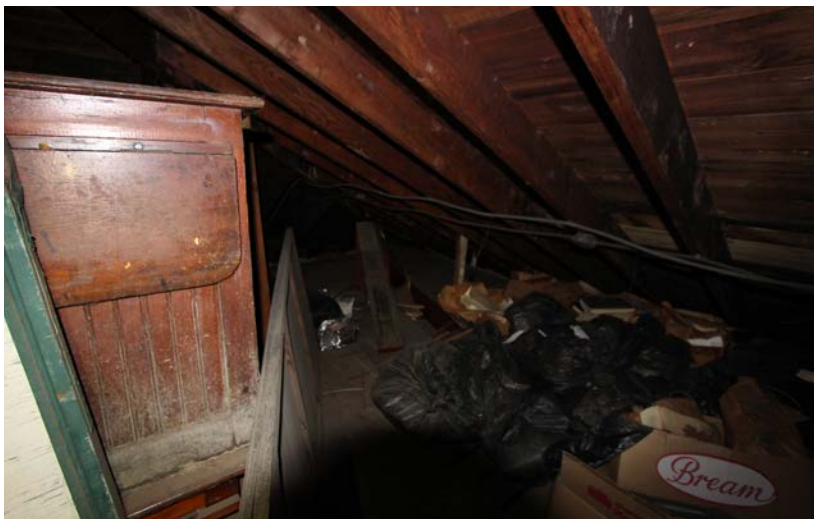
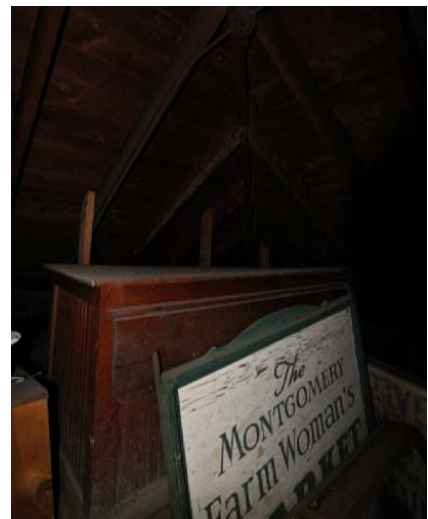
FIGURE 75 Original furnishings stored in the attic.

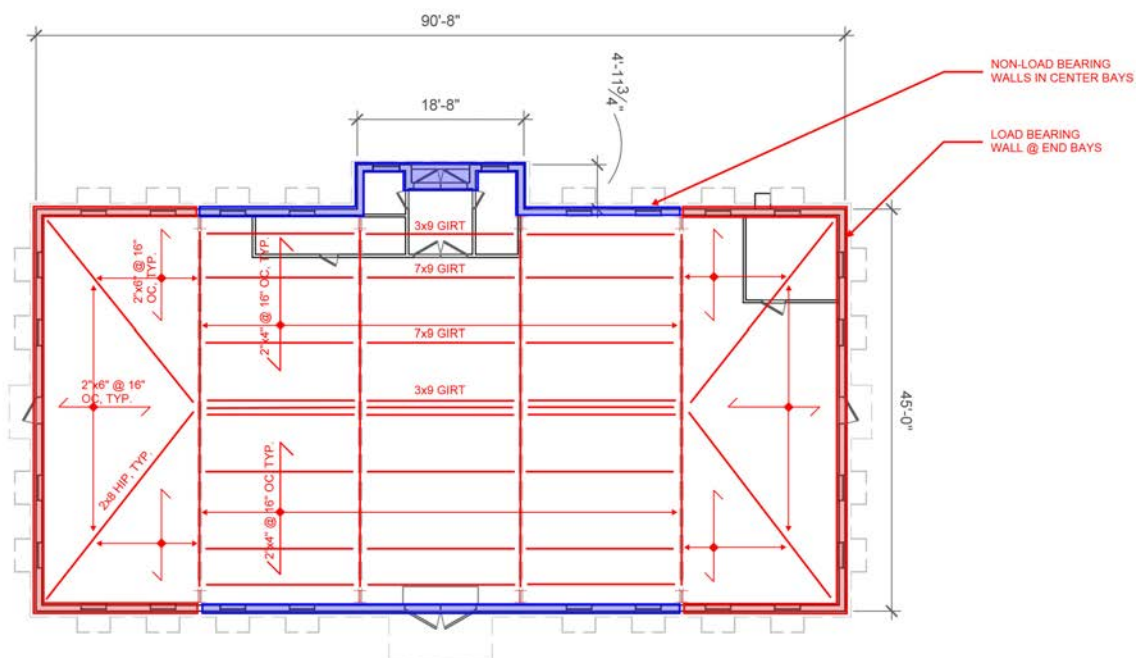
FIGURE 76 Existing Framing Plan. Silman, December 2018.

Structural issues are evident. Settlement and displacement is observed on the north and south ends of the building due to the construction, namely a lack of steel supports on the north or south ends of the building.

Wall framing: The walls do not support the roof in the middle 3/5th of the building. As noted above, the end bays exhibit vertical settlement likely due to soils and moisture damage to sills. When viewed from the exterior of the building, the east and north walls appear to undulate along their length with a maximum inward displacement of 4". The deformation of the wall is due to the buildup of asphalt against the wall, which has applied a lateral pressure over an extended period of time.

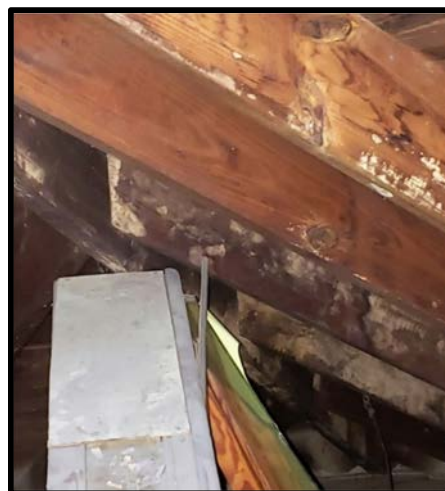
Figure 13 – Southeast Roof Framing

The observations of the roof framing were limited to the southern end of the building in the modified storage area. The steel trusses, beams, and rafters between the trusses showed no signs of distress. The wood framing at the southern end of the building showed isolated signs of damage due to a previous termite infestation (Figure 13).

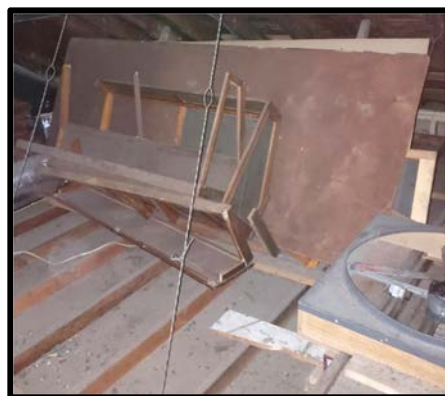
Figure 14 – Stored Items on Ceiling Framing

Items were being stored in the southern storage area at the time of the investigation. The footprint of the stored items extended beyond the finished storage area and were resting directly on the unreinforced ceiling framing, as shown in Figure 14. The ceiling framing is only supported by wire hangers and should not be used for storage.

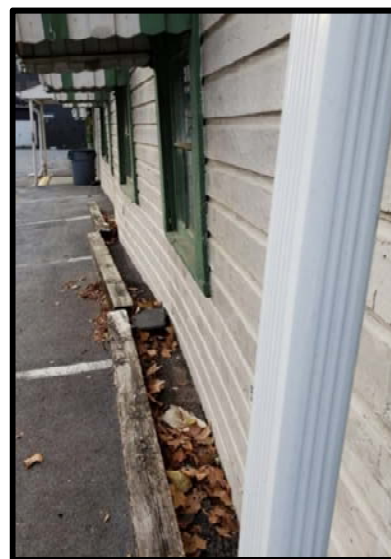
Figure 15 – Eastern Wall

There are ongoing drainage issues due to poor grading of the site. Water has flowed towards the structure and required additional efforts to redirect surface water runoff along the southern perimeter of the structure. The grading of the parking lot appears to have been unsuccessful in directing water away from the building. Trench drains have been added at the north and south entrances. Asphalt has been placed directly against the structure along the north and east walls, as shown in Figure 15. The asphalt buildup has caused the north and east walls to deflect inward, undulating between columns, with a maximum inward displacement of 4".

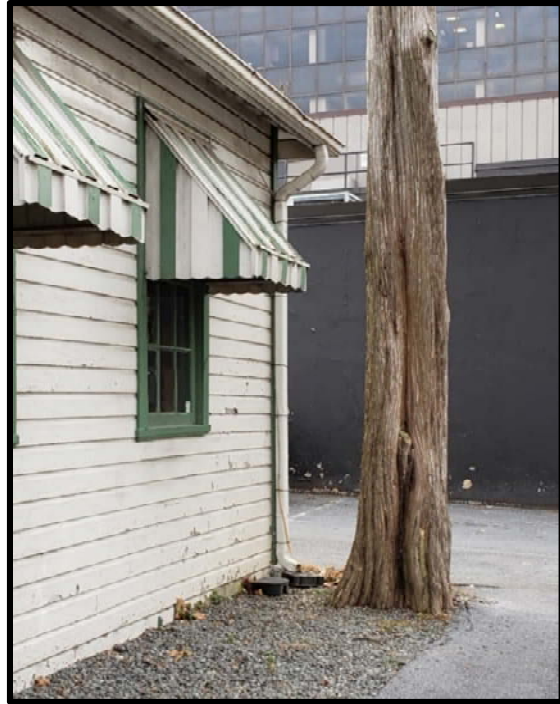
Figure 17 – Southeast Corner of Building

A tree has grown in close proximity to the southeast corner of the building (Figure 17). This is the same corner where termite damage was observed in the attic.
