Preliminary Consultation
MONTGOMERY COUNTY HISTORIC PRESERVATION COMMISSION
STAFF REPORT

Address:	7700 Seven Locks Rd., Bethesda	Meeting Date:	2/26/2020
Resource:	Master Plan Site #29/39 Gibson Grove AME Zion Church	Report Date:	2/19/2019
Applicant:	First Agape AME Zion Church (Thomas Taltavull, Architect)	Public Notice:	2/12/2019
Review:	Preliminary Consultation	Tax Credit:	N/A
Case Number:	N/A	Staff:	Michael Kyne
PROPOSAL:	Demolition and stabilization

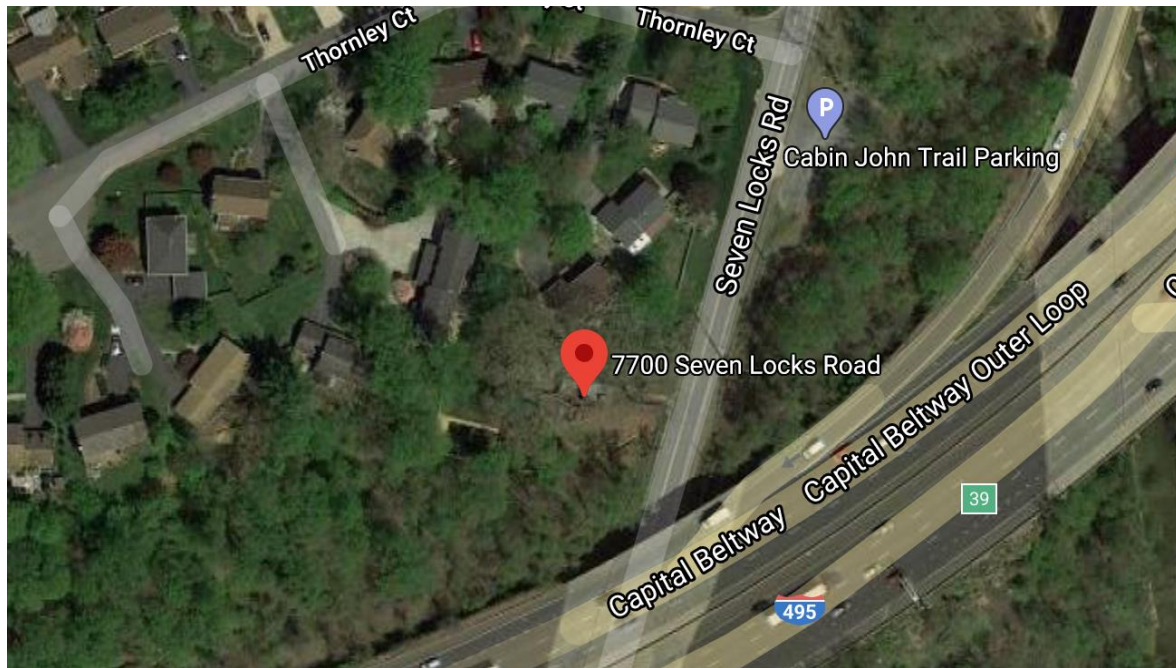
Fig. 1: Subject property.

The church was damaged by fire in 2004 and by a fallen tree in July 2015.

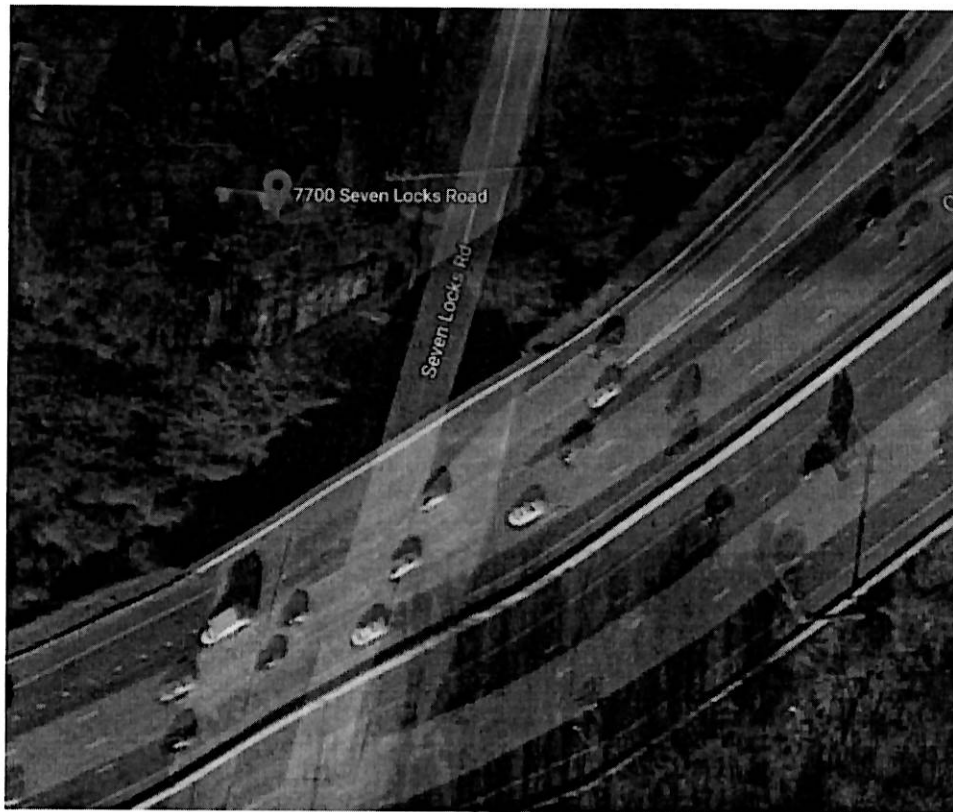
Photo No. 1: Aerial view of 7700 Seven Locks Road, Bethesda, Maryland. Note that the church structure is located in the northwest quadrant of where Seven Locks Road runs beneath Interstate 495.

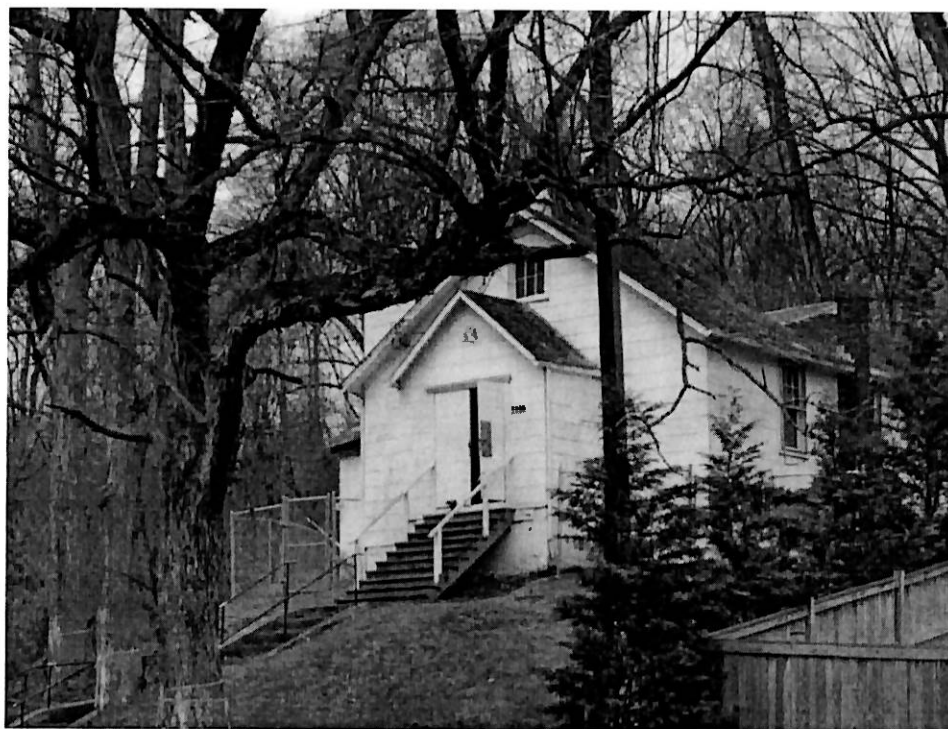
Photo No. 3: Similar (closer) view as previous photo.

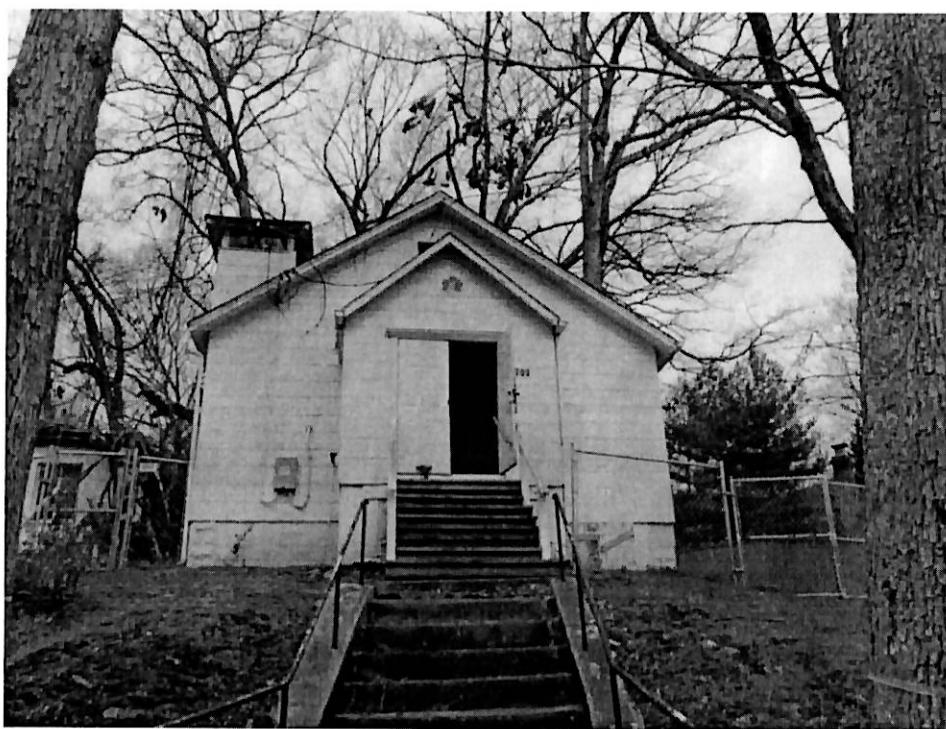
Photo No. 4: Front (east) elevation view of structure as seen from the steps leading up to the entrance from Seven Locks Road.
