MONTGOMERY COUNTY HISTORIC PRESERVATION COMMISSION
STAFF REPORT

Address:	7700 Seven Locks Rd., Bethesda	Meeting Date:	3/25/2020
Resource:	Master Plan Site #29/39 Gibson Grove AME Zion Church	Report Date:	3/18/2019
Applicant:	First Agape AME Zion Church (Thomas Taltavull, Architect)	Public Notice:	3/11/2019
Review:	HAWP	Tax Credit:	N/A
Case Number:	29/39-20A	Staff:	Michael Kyne
PROPOSAL:	Demolition and stabilization

29/39 Gibson Grove African Methodist Episcopal Zion Church (1923)

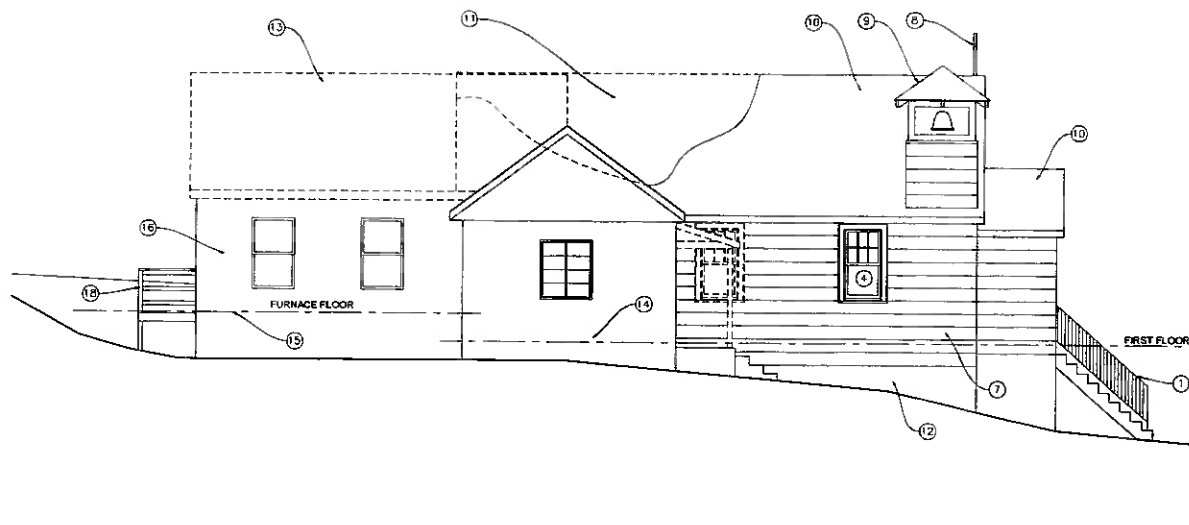
EXISTING SOUTH ELEVATION

- 8 EXISTING CROSS TO REMAIN.
- 9 EXISTING BELFRY TO REMAIN.
- 10 ASPHALT SHINGLE ROOFING, WOOD FASCIA AND SLOPED WOOD SOFFIT
- 11 ESTIMATED THAT 80% OF ROOF IN CHURCH IS DAMAGED BY FALLEN TREE AND WATER INTRUSION.

- 12 CONCRETE MASONRY UNIT EXTERIOR WALLS INFILL ORIGINAL 1923 ASHLAR MASONRY PIERS
- 13 WOOD ROOF FRAMING AT 1979 ADDITIONS COMPLETELY DAMAGED BY FALLEN TREE AND WATER INFILTRATION

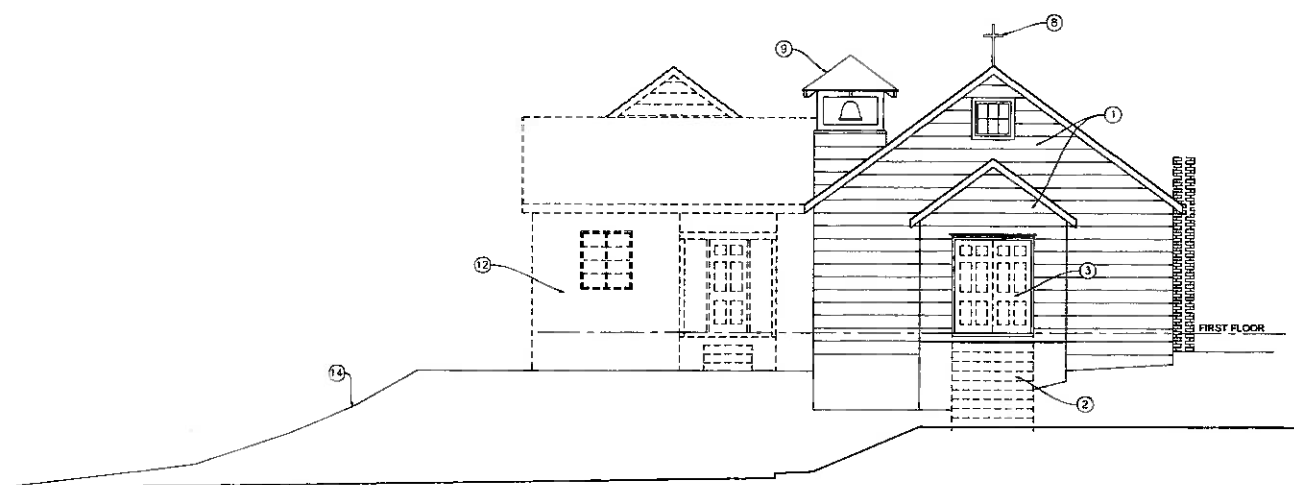
DEMOLITION NORTH ELEVATION

- 1 EXISTING PORTION OF CHURCH TO BE RETAINED IN PLACE. THE REMAINING CHURCH IS TO BE DEMOLISHED. DUE TO DAMAGED BY FALLEN TREE AND WATER INTRUSION. CONTRACTOR SHALL PROVIDE TEMPORARY BRACING AND WEATHER PROOF EXISTING FRONT SECTION OF CHURCH, BELFRY AND CROSS

- 8 EXISTING CROSS TO REMAIN
- 9 EXISTING BELFRY TO REMAIN
- 10 REMOVE ASPHALT SHINGLE ROOFING, WOOD FASCIA AND SLOPED WOOD SOFFIT
- 11 REMOVE ROOF, WALL, FLOOR FRAMING, MASONRY FOUNDATION AND FOOTINGS IN CHURCH DAMAGED BY FALLEN TREE AND WATER INTRUSION.

- 12 REMOVE ROOF, WALLS, FRAMED FLOORS AND FOUNDATION AT 1970'S ADDITIONS.
- 13 EXISTING CONCRETE SLAB AREA AND FOUNDATION TO REMAIN.
- 14 LINE OF EXISTING GRADE.

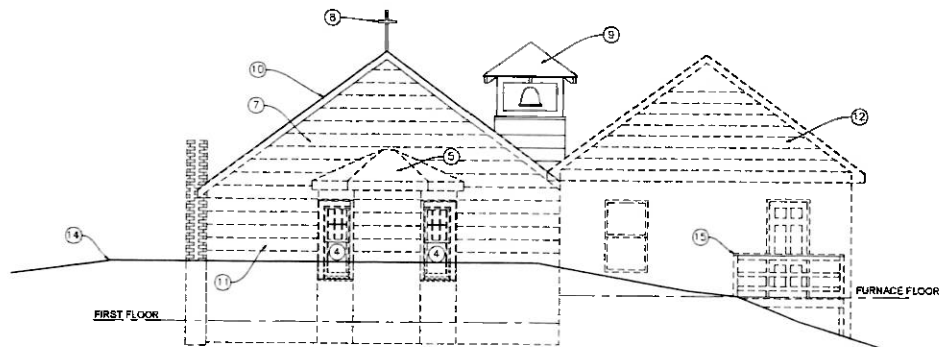
DEMOLITION SOUTH ELEVATION

- 1 EXISTING PORTION OF CHURCH TO BE RETAINED IN PLACE. THE REMAINING CHURCH IS TO BE DEMOLISHED. DUE TO DAMAGE BY FALLEN TREE AND WATER INTRUSION. CONTRACTOR SHALL PROVIDE TEMPORARY BRACING AND WEATHERPROOF EXISTING FRONT SECTION OF CHURCH, BELFRY AND CROSS.

- 8 EXISTING CROSS TO REMAIN.
- 9 EXISTING BELFRY TO REMAIN.
- 10 REMOVE ASPHALT SHINGLE ROOFING, WOOD FASCIA AND SLOPED WOOD SOFFIT.
- 11 REMOVE ROOF, WALL, FLOOR FRAMING, MASONRY FOUNDATION AND FOOTINGS IN CHURCH DAMAGED BY FALLEN TREE AND WATER INTRUSION.

- 12 REMOVE ROOF, WALLS, FRAMED FLOORS AND FOUNDATION AT 1970S ADDITIONS.
- 13 EXISTING CONCRETE SLAB AREA AND FOUNDATION TO REMAIN.
- 14 LINE OF EXISTING GRADE.
