*Preliminary Consultation*  
**MONTGOMERY COUNTY HISTORIC PRESERVATION COMMISSION**  
**STAFF REPORT**

<b>Address:</b>	22200 Clarksburg Road, Clarksburg	<b>Meeting Date:</b>	5/27/2020
<b>Resource:</b>	Master Plan Site #13/25 <i>Cephas Summers House</i>	<b>Report Date:</b>	5/20/2020
<b>Applicant:</b>	Pulte Homes (Bob Harris, Agent)	<b>Public Notice:</b>	5/13/2020
<b>Review:</b>	Preliminary Consultation	<b>Tax Credit:</b>	N/A
<b>Case Number:</b>	N/A	<b>Staff:</b>	Michael Kyne
<b>PROPOSAL:</b>	Discussion of rehabilitation

# CONDITIONS ASSESSMENT REPORT

**Conditions Assessment and Preservation Plan for the “Cephas Summers House”, located immediately south of 22210 Clarksburg Road, Boyds, Montgomery County, MD.**

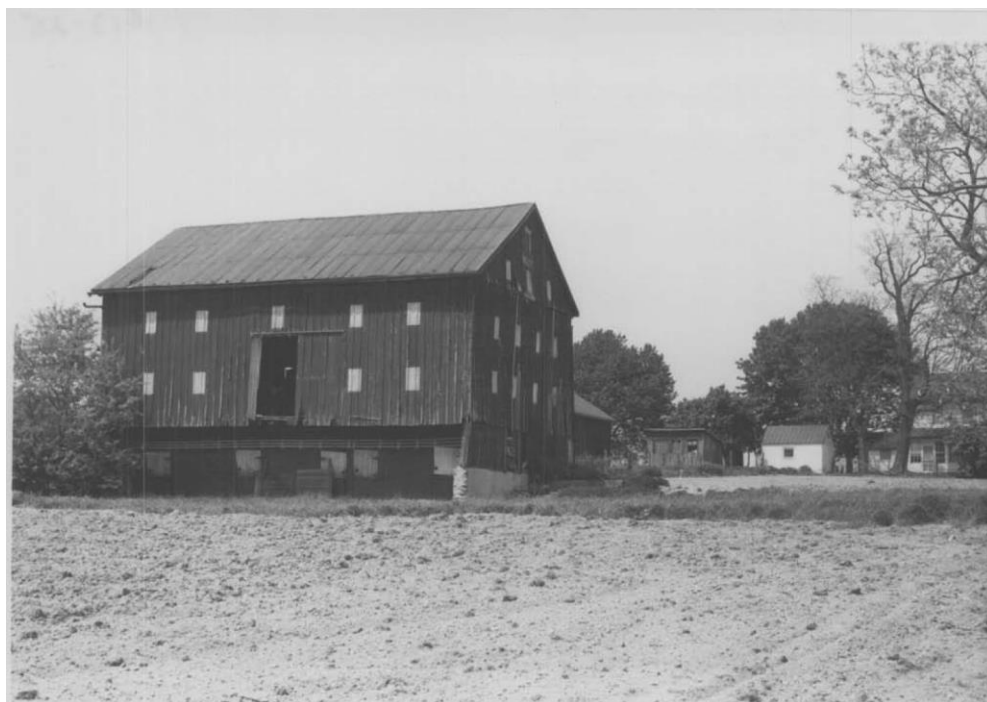
The subject property is a c. 1850-60 Greek Revival influenced house known as the Cephas Summers House. The property was designated an individually listed Master Plan Site as part of the *Clarksburg Master Plan and Hyattstown Special Study Area* amendment in 1994. Currently, the environmental setting is comprised of 66.42 acres, which was historically farmland. From available information, the house appears to have been abandoned in the mid- to late-1970s, and it has not been maintained since. Additionally, all of the outbuildings, including a large bank barn (Fig. 3), have collapsed.

***Fig. 3: Bank barn (since collapsed) on the Cephas Summers House property as it appeared in 1974.***

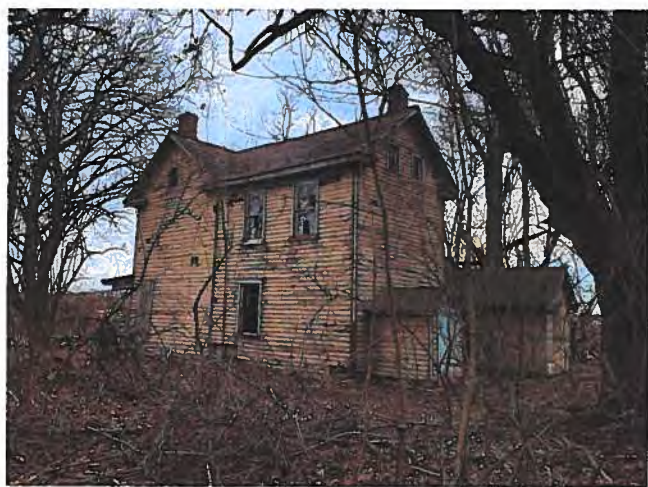
Fig. 3: West and North (rear) sides. 2020-01-02

On the west facade of the Rear "L" there is a gable-roofed enclosure over the cellar steps at the southeast corner, 5'-7 1/2" east to west and 5'-9" north to south (*figs. 3,4*). This enclosure is clad in beveled wood siding, with a shallow, standing seam metal roof. It has a raking eave. Patches on the Rear "L" siding inside the cellar enclosure indicate that this is a replacement for an earlier bulkhead cellar door. The current cellar enclosure most likely dates to the early 20th Century. Attached to the west wall of the enclosed Rear "L" porch is an outbuilding, 10'-3" east to west and 8'-3" north to south (*figs. 4,5*). It has a gable roof clad with corrugated metal which also forms the cladding for the west shed wall of the enclosed porch. It is sided with vertical, shiplap boards attached with wire nails, similar to the adjacent porch enclosure and indicating a similar origin date. It is accessed by a door in the west wall of the enclosed porch and in the north wall of the outbuilding where it adjoins the Rear "L". The gable roof has a raking eave on the west wall, and had one 9-light window slight off center to the north in the gable side, and one 9-light window approximately centered in the south wall. Due to deterioration and debris, the exact use of this outbuilding could not be determined.

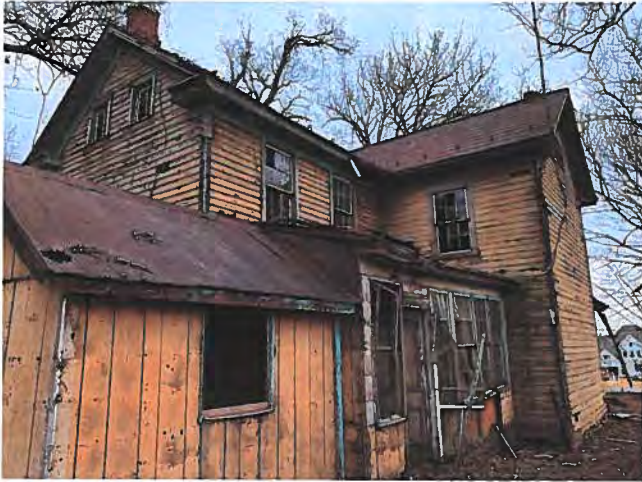
Fig. 5: North (rear) and South sides. 2020-01-02

The porch extending across the south facade of the Rear "L" was enclosed into 6-bays as follows, from east to west: one 6/6 window, one door, and four 6/6 windows (*figs. 5, 6*). The porch has a shed roof clad in shallow, standing seam metal. Wood siding for the porch enclosure consists of vertical, shiplap boards attached with wire nails, indicating an early 20th Century origin to the enclosure. Its roof was supported by a plain wood post on the east and at the center and the east wall of the main house on the west. The ceiling is beaded board.

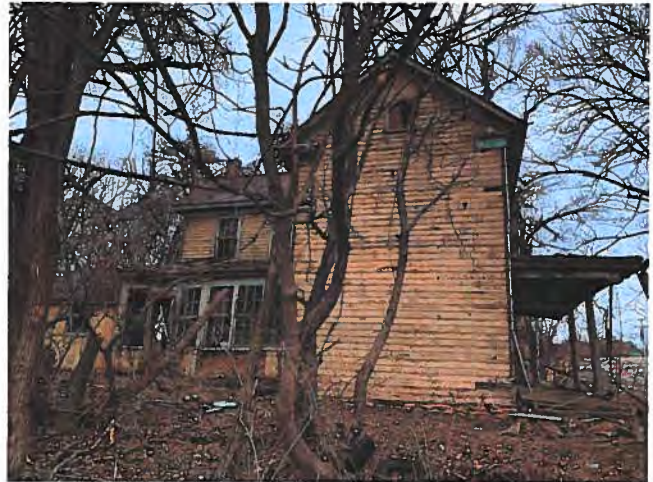
Fig. 6: South Side. 2020-01-02

The Front House has one, roman-arched side window in each gable, slightly off-centered to the front. This is most likely because the central chimney passes partially in front of these windows (*fig. 6*). Historic photos from around 1992 show that these windows had 4-light sash. The existing west jamb of the north, roman-arched attic window and the historic photos show evidence that the attic jamb casings had cavetto-shaped capitals forming a column effect supporting the arched top casing. The Rear L attic has two, 4-light windows, one on each side of the central chimney, with pane sizes that appear to be approximately 9" x 12".

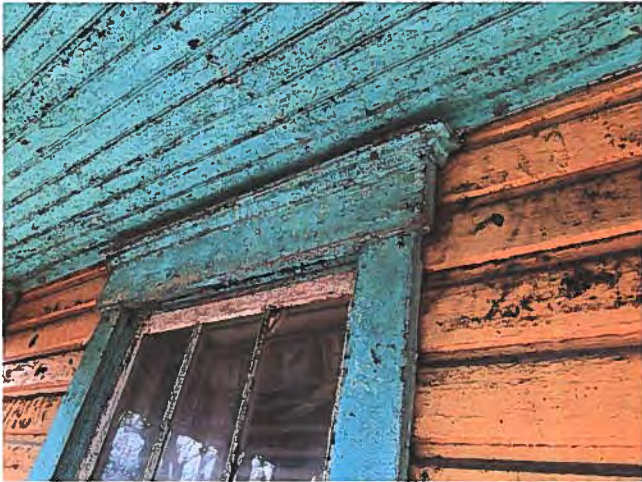
Fig. 9: West side (front) window head. 2020-01-02

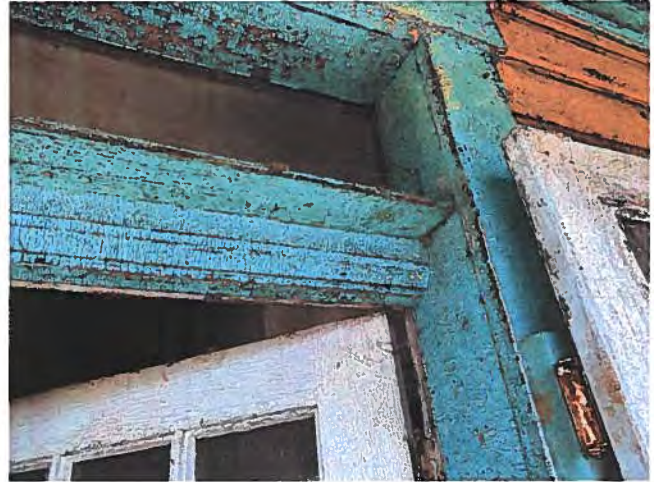
Fig. 10: Front door transom bar (Door head matches adjacent windows.) 2020-01-02

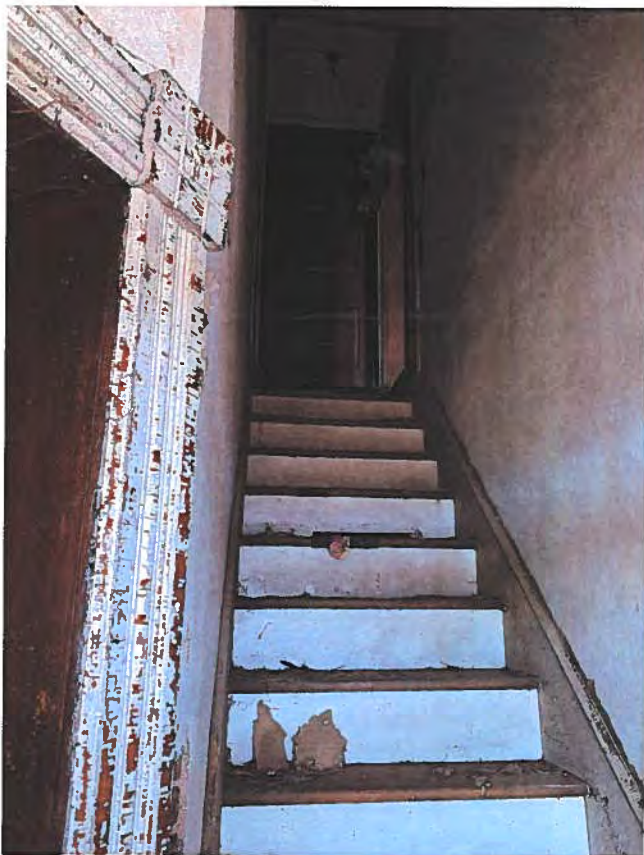
The first floor plan (*plan 1/A1*) of the Front House is divided into two rooms ("North Room" and "South Room") on either side of a center stair enclosed by walls (*fig. 15*). The front door of the Front House opens into a small, asymmetrical "Foyer" vestibule. On either side is a door into each first floor room; directly in front of the front door is the center stair. Both rooms had decorative mantel surrounds (since removed) and were heated with stoves; there is no evidence of fireplaces: the mantel backs are the depth of the end chimneys, wood-framed, and too shallow to have ever supported fireplaces. The South Room (*fig. 13*) has one east (front) window and one west (rear) window. The North Room (*fig. 12*) has one east (front) window, and one side (north) window near the east corner, which exterior evidence suggests was once a door (see above). The North Room has a door at the rear of the south wall, most likely to access a closet under the stair, and a door approximately centered in the west (rear) wall which accesses the Rear "L". Interior doors in the first floor, Front House and on the second floor landing are 4-panel (flat panels), grained, with butt hinges and mortise locks. (The doors to the Foyer appear have shallow raises in the flat panels, brass butt hinges, brass knobs and had rim locks.) Windows and doors are trimmed with symmetrical casings with decorative corner blocks decoratively grooved into a 9-square grid (*fig. 14*). The baseboard appears to have a simple cyma reversa or beveled cap. Most interior casings and wood is painted, except for the grained doors in the Front House and evidence that trim surrounding the grained doors may have also originally been grained.

Fig. 15: Looking up main stair from front door. 2020-01-02

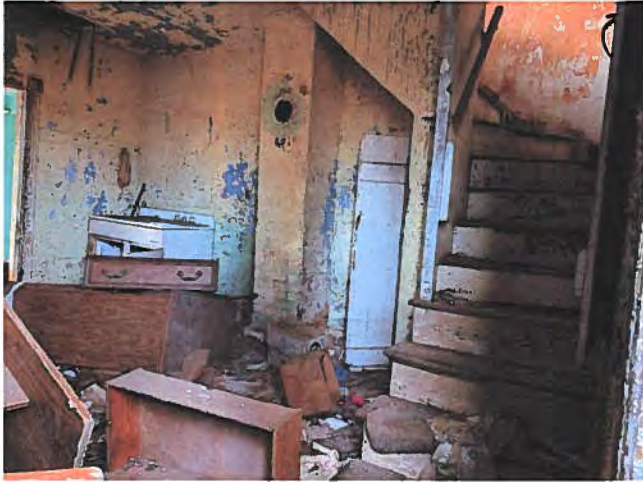
The first floor of the Rear "L" is raised one step above the floor of the Front House. (The floor boards of the Rear "L" form the riser nosing capping the baseboard which forms the face of the tread.) The first floor Rear "L" (*figs. 16,17*) consists of one room ("East Room") with one side window on the north wall, and on the south wall one side window directly opposite the north window and one exterior door. The door is 9-light over one horizontal panel with no transom. The door opens from the south (enclosed) porch. There is a mid-20th Century kitchen sink unit in the southwest corner, which is the only evidence of indoor plumbing anywhere in the house. The central chimney is centered on the west wall, with evidence of a stovepipe connection. Between the chimney and the north wall, in the northwest corner, is an "L" shaped, winder stair to the second floor above (*fig. 17*), consisting of approximately five straight-run risers/board & batten door/winders/straight-run risers. There is a closet under this stair. The siding of the Front House interestingly forms the east wall of this room; all other walls are plastered (*fig. 16*).

Fig 17: East Room in Rear L, looking southeast, showing rear stair in northeast corner. 2020-01-02
