**MONTGOMERY COUNTY HISTORIC PRESERVATION COMMISSION**  
**STAFF REPORT**

<b>Address:</b>	7102 Maple Ave., Takoma Park	<b>Meeting Date:</b>	7/10/2024
<b>Resource:</b>	Outstanding Resource <b>Takoma Park Historic District</b>	<b>Report Date:</b>	7/3/2024
<b>Applicant:</b>	Roxanne Fulcher & Keith Chamberlin Rosalind Grigsby, Agent	<b>Public Notice:</b>	6/26/2024
<b>Review:</b>	HAWP	<b>Tax Credit:</b>	Yes
<b>Case Number:</b>	1074837	<b>Staff:</b>	Dan Bruechert
<b>Proposal:</b>	Porch Demolition and Reconstruction

The applicant proposes to demolish the existing front porch and construct a new front porch.

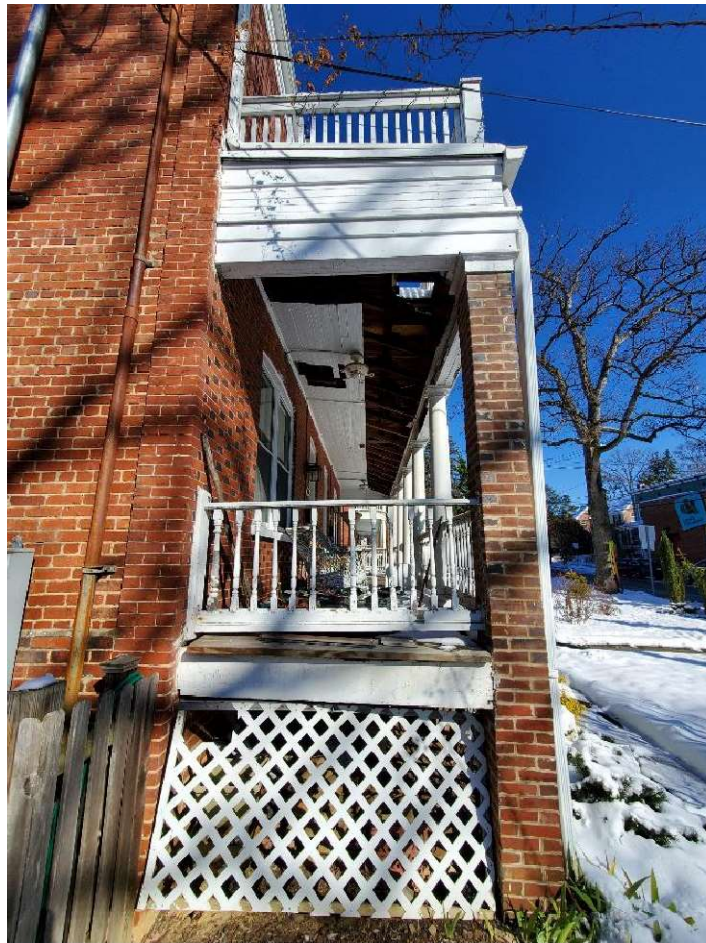
**Photo 1 - 7102 Maple Ave – cut joists too short**

The entire upper-level has been altered, most likely due to a fire that began there and traveled below to damage columns and balustrades but did not reach the tongue and groove (T&G) on the lower floor. (Photos 1,2)

Alterations/repairs were cobbled together with charred, water-damaged, irregularly cut, and painted pieces; planed and un-planed wood; OSB plywood; roofing materials (tar-paper, asphalt, flashing), decking; and off-the-shelf products. Structural changes were likely made to install shorter, wider, and less-expensive columns. (Photo 1).
