**MONTGOMERY COUNTY HISTORIC PRESERVATION COMMISSION**  
**STAFF REPORT**

<b>Address:</b>	309 Market Street, Brookeville	<b>Meeting Date:</b>	10/09/2024
<b>Resource:</b>	Primary Resource (19 <sup>th</sup> Century) <b>Brookeville Historic District</b>	<b>Report Date:</b>	10/02/2024
<b>Applicant:</b>	Matthew Keller, Building Solutions LLC	<b>Public Notice:</b>	9/25/2024
<b>Review:</b>	Historic Area Work Permit	<b>Tax Credit:</b>	No
<b>Permit Number:</b>	1075954	<b>Staff:</b>	Rebecca Ballo
<b>PROPOSAL:</b>	Demolition of shed, stone wall, and tree removal

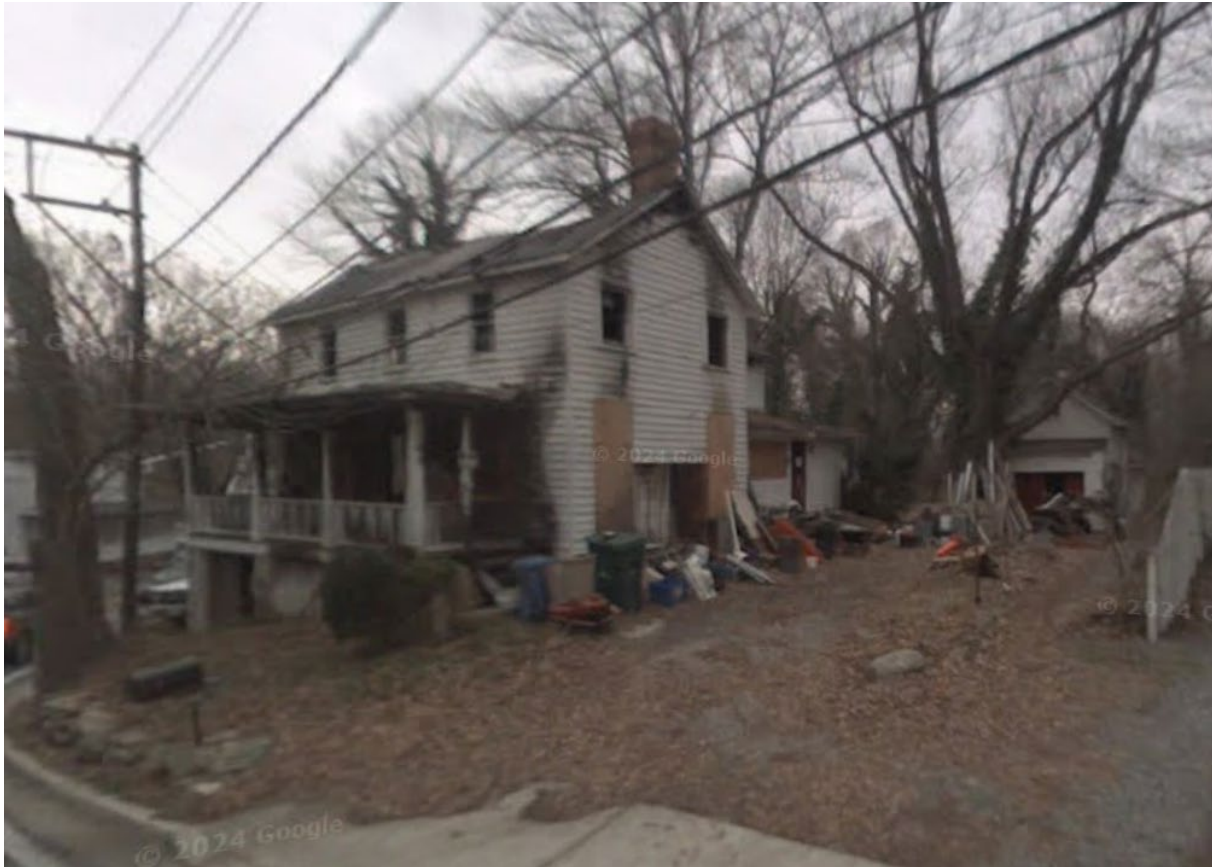
***Figure 2: Streetview image of the main historic house prior to its demolition from Market Street. The outbuilding is visible to the far right behind the tree. (Google streetview from 2007)***
