**MONTGOMERY COUNTY HISTORIC PRESERVATION COMMISSION**  
**STAFF REPORT**

<b>Address:</b>	2420 Spencerville Rd., Spencerville	<b>Meeting Date:</b>	3/26/2025
<b>Resource:</b>	Master Plan Site #15/55 <b>Spencer-Carr House</b>	<b>Report Date:</b>	3/19/2025
<b>Applicant:</b>	Cedar Ridge Community Church (Ginger Donohue, Agent)	<b>Public Notice:</b>	3/12/2025
<b>Review:</b>	HAWP	<b>Staff:</b>	Dan Bruechert
<b>Permit Number:</b>	1107038	<b>Tax Credit:</b>	n/a
<b>Proposal:</b>	Silo Demolition

Project Name: 2410 Spencerville Road – Masonry/Brick Silo Initial Investigation  
Structural Engineering Services  
Our Project No.: 225C026 – Masonry/Brick Silo

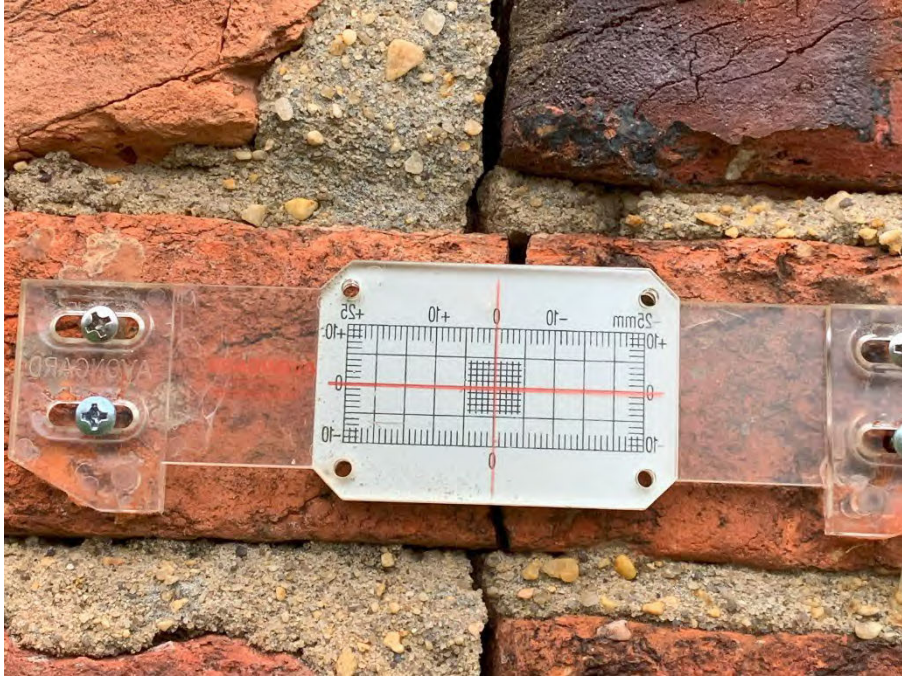
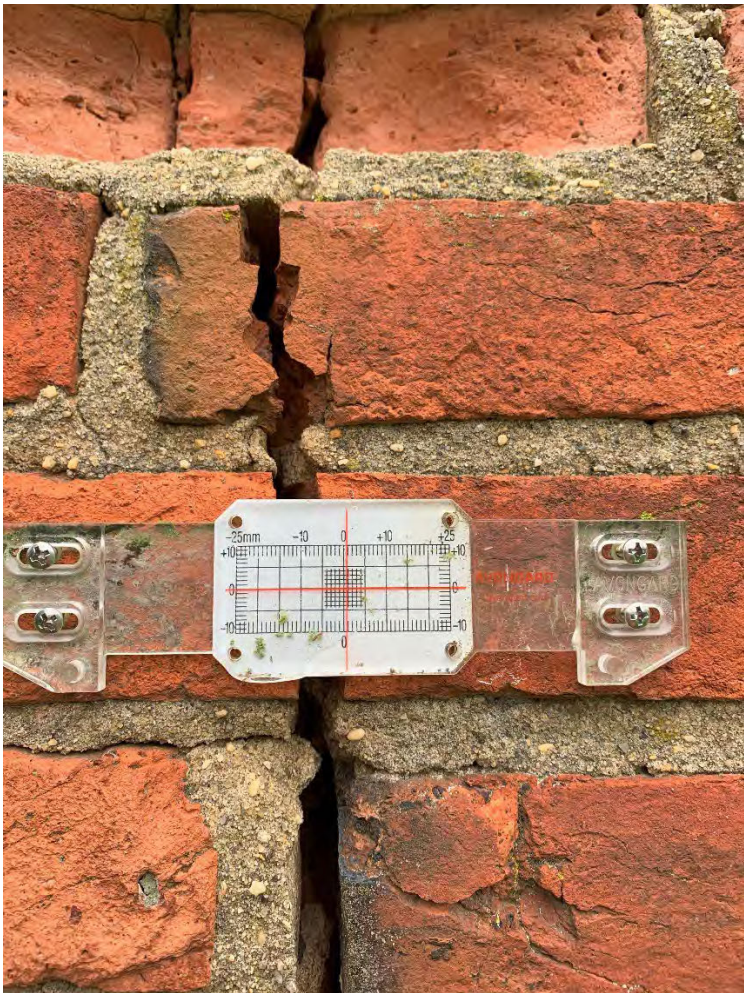
During this time, investigation efforts to locate feasible ways to rehabilitate the silo were unsuccessful. Until recently, there was no change in the devices. The device installed on the area closest to the problematic broken ceramic tiles, recently registered movement prompting us to seek another assessment of the silo. We contracted with Residential Engineering Solutions to evaluate the silo condition and were provided with the report dated 2/19/25 that states the silo is now deteriorated to the point of instability and collapse danger.
