MONTGOMERY COUNTY HISTORIC PRESERVATION COMMISSION
STAFF REPORT

Address:	9 Chevy Chase Circle, Chevy Chase	Meeting Date:	9/17/2025
Resource:	Master Plan Site #35/13-001A Newlands-Corby Mansion	Report Date:	9/10/2025
Applicant:	Adrienne Arsht Revocable Trust (CAS Engineering, Agent)	Public Notice:	9/3/2025
Review:	HAWP	Tax Credit:	No
Case Number:	1130413	Staff:	Laura DiPasquale
Proposal:	Tree removal and expansion of driveway apron

Tree Risk Assessment Report

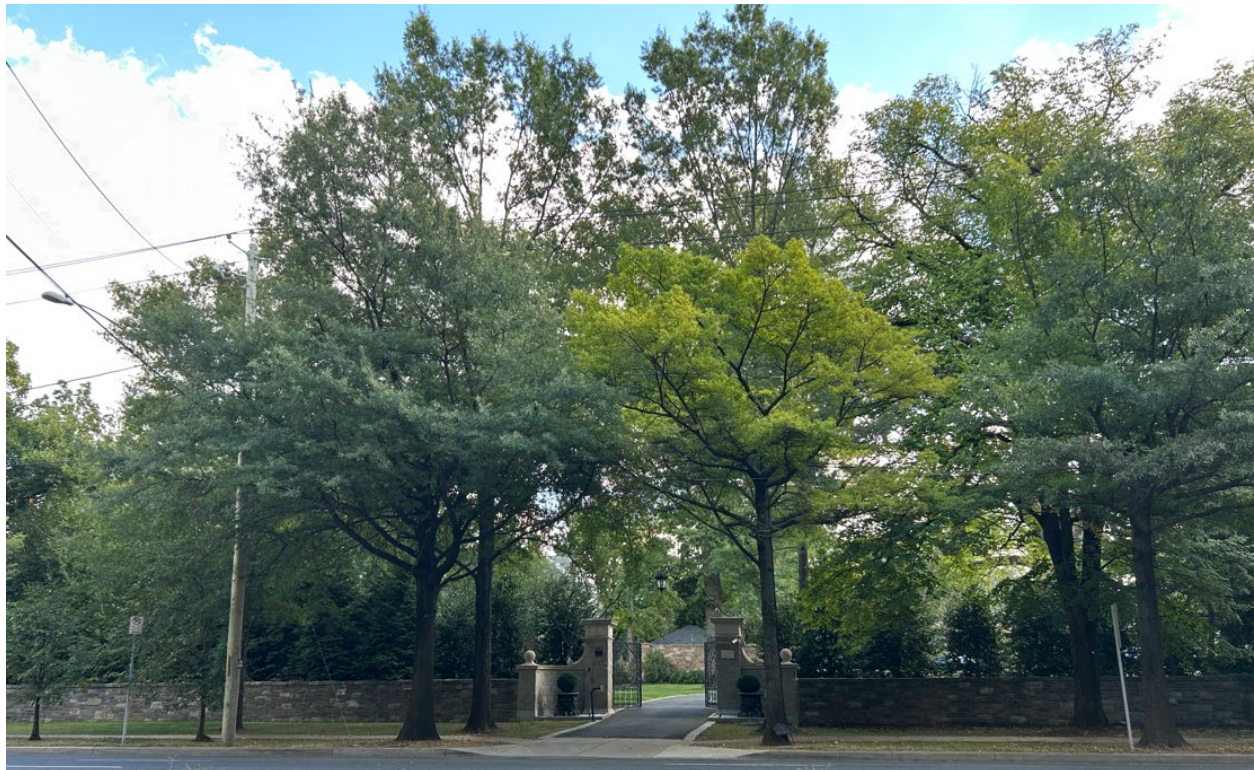
The applicants also call for removal of the two trees closest to the street flanking the driveway. The application includes a detailed tree assessment from a licensed arborist which describes the condition of the two trees proposed for removal (Willow Oak #1 and #3) as follows: “Willow oaks #1 and #3 were positioned under power lines and in small planting beds situated between the sidewalk, the driveway, and Connecticut Avenue. These restrictions on the trees growth on all sides including vertical growth give these two trees a location value of poor because the location is ill suited for this species of tree. The trees have been topped to maintain clearance from the power lines and have lost the good structure of a strong central stem. These trees are ill suited for preservation and investment.”

Figure 9: View looking east towards the trees flanking the Connecticut Avenue driveway entrance.

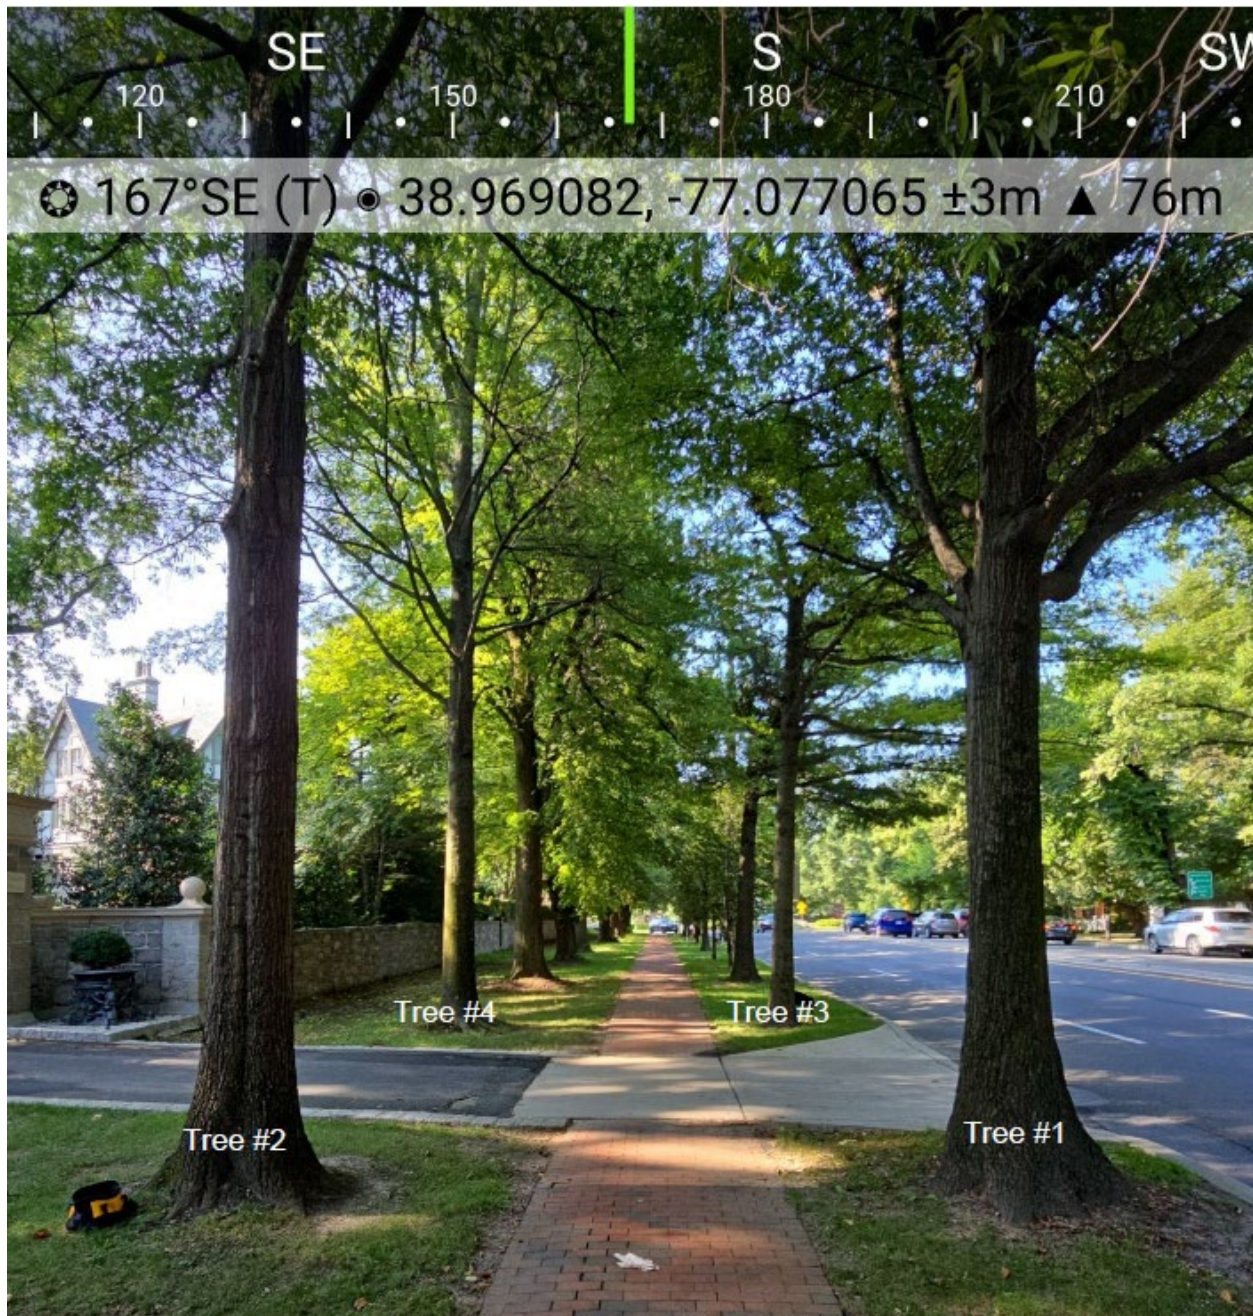
Figure 11: View south from the sidewalk parallel to Connecticut Avenue (July 2025, Bartlett Tree Experts).
