### MONTGOMERY COUNTY HISTORIC PRESERVATION COMMISSION STAFF REPORT

Address: 113 Elm Ave., Takoma Park Meeting Date: 7/23/2025

Case Number: 1116058 Staff: Dan Bruechert

**Proposal:** Door and Window Replacement

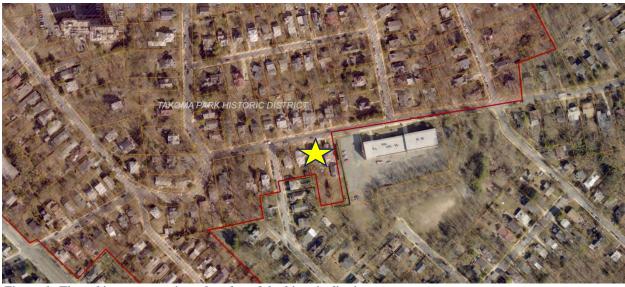
Figure 1: The subject property is at the edge of the historic district.

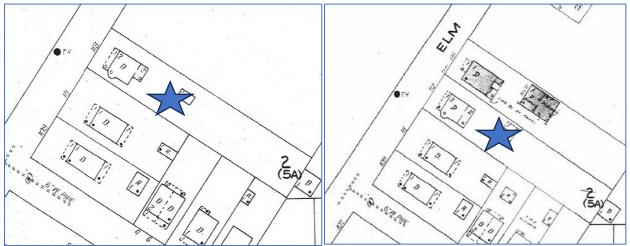
The subject property is a two-story Colonial Revival house, with a stucco sided front porch with aluminum siding on the second. At the front, there is a floor full-width front porch with second-story access. Based on Sanborn Fire Insurance Maps, the rear of the house has been modified so that it now has a full-width addition across the rear (see *Figure 2*, below). As identified in the 2020 HAWP Staff Report, linked above, the subject house was constructed by John Raines, a local carpenter responsible for constructing many of the neighborhood houses. It appears that Mr. Raines made several alterations to the house after its construction including widening the rear, altering the roofline, and other material changes.

Figure 2: 1927 Sanborn (left) showing the original, partial-width rear porch. 1953 Sanborn (right) shows full-width rear.

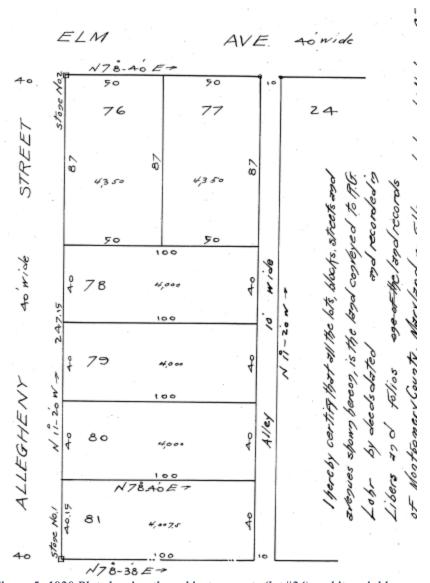
Second, Staff finds that seven of the eight windows are visible from the public right-of-way along the right side. *Figure 4*, below shows the highly visible right elevation. A 10' (ten foot) wide dedicated alley between the houses at 113 Elm Ave. and 111 Elm Ave. will preserve the open space between the properties and maintain the open appearance of the left elevation.

Figure 5: 1920 Plat showing the subject property (lot #24) and its neighbor separated by an alley.
