Preliminary Consultation
MONTGOMERY COUNTY HISTORIC PRESERVATION COMMISSION
STAFF REPORT

Address:	25321 Frederick Road, Clarksburg	Meeting Date:	2/25/2026
Resource:	Master Plan Site #10/57 David Zeigler House	Report Date:	2/18/2026
Applicant:	Montgomery Parks (Catherine Stratton Treadway, Agent)	Public Notice:	2/11/2026
Review:	Preliminary Consultation	Staff:	Laura DiPasquale
Proposal:	Stabilization of frame main block, and demolition and reconstruction of log building section with fenestration modifications and dormer construction

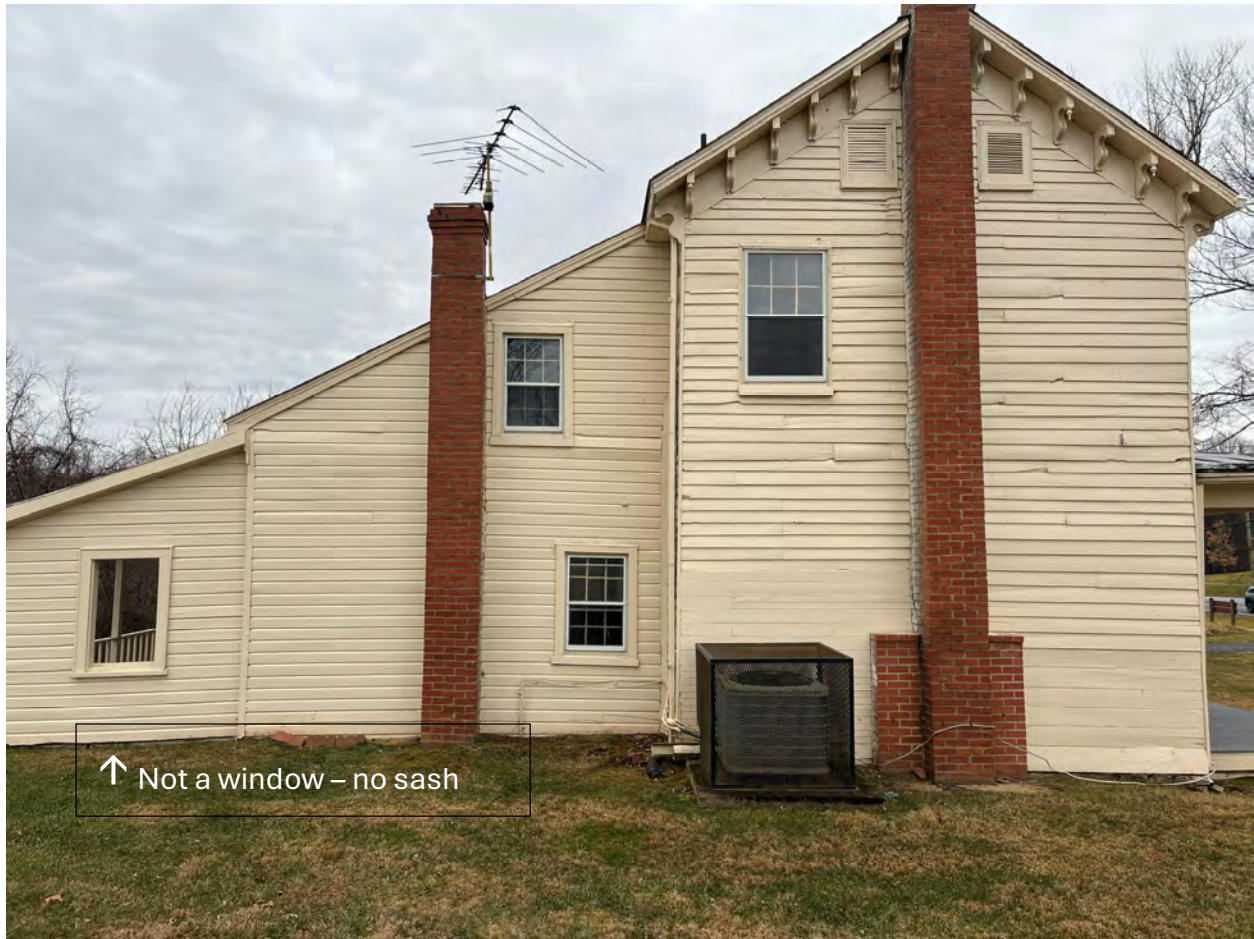
North Elevation Window Key:

↑ Not a window - no sash

N2-2 (bottom sash is missing)

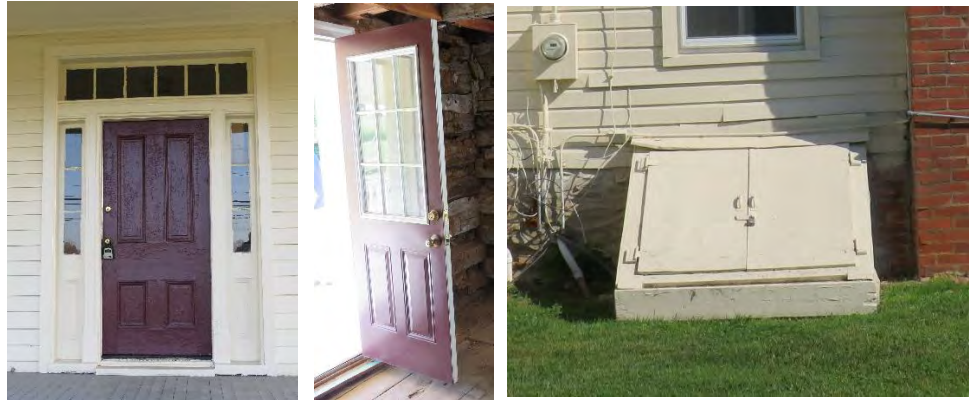
Front, back, and bulkhead doors

The back door is certainly a modern replacement, with a foursquare inset window and a paneled base.

The basement door is a typical bulkhead door at the south of the cabin section, bipartite metal with padlocked handles, and a wood frame inset on a brick structure.

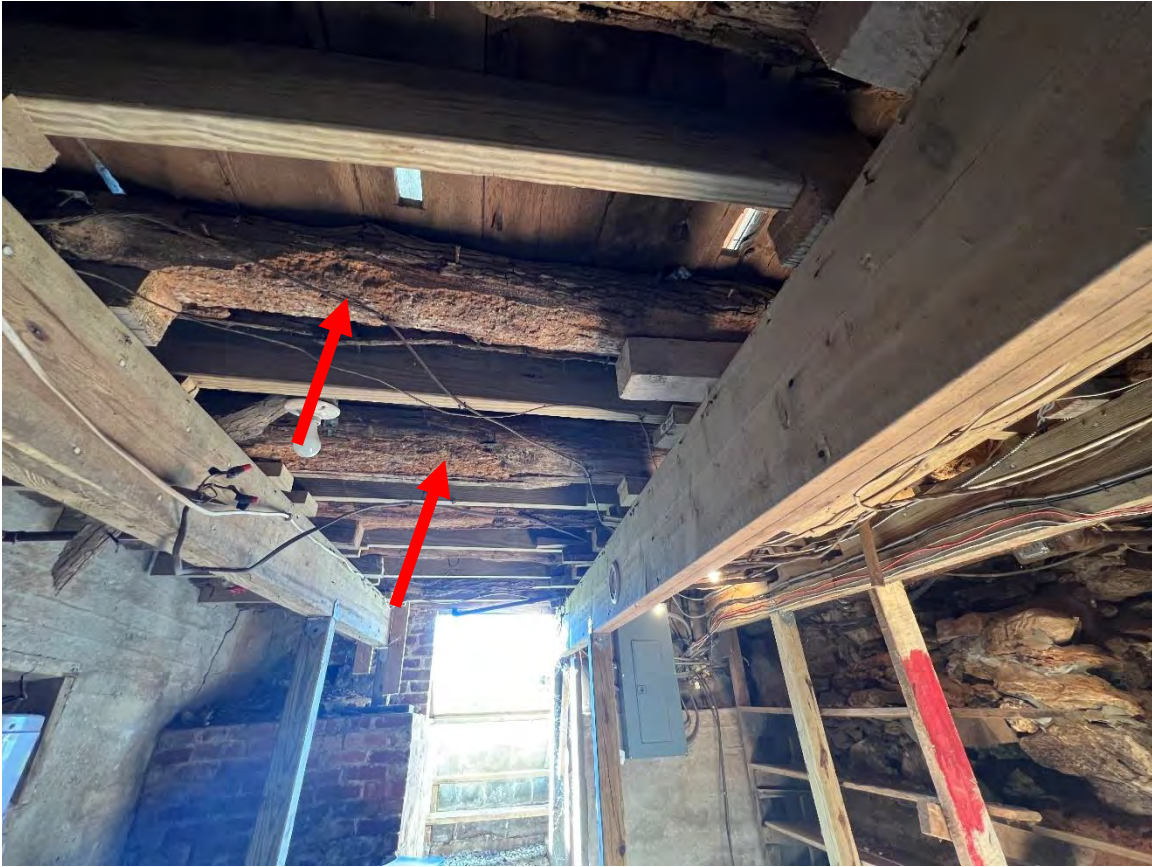
Photograph 3 – Typical original log house first floor framing (logs).

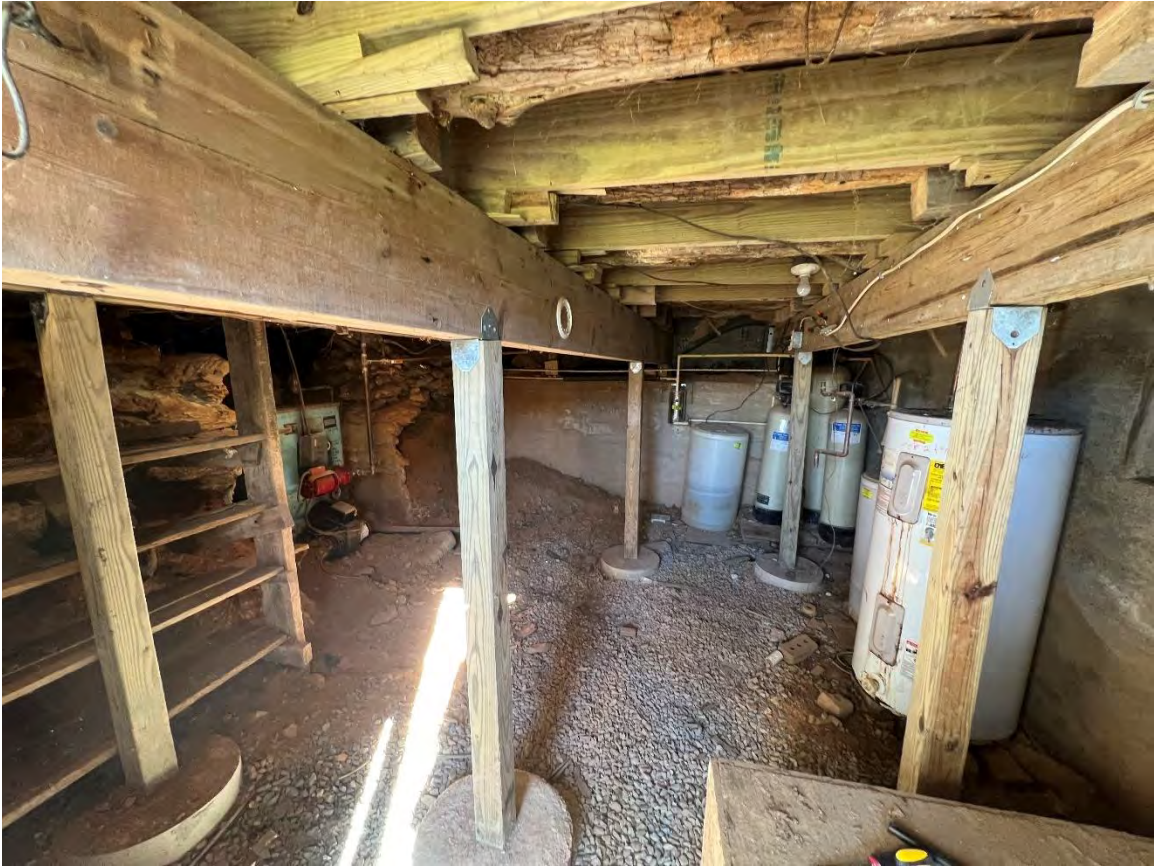
Apparent supplemental framing was recently added to support the original logs. Wood 4x4s were installed horizontally beneath (and parallel to) each log and bear on a network of double-2x12 beams, 4x4 posts, and 18-inch diameter footings (see Photograph 5). Additionally, wood 2x8s were installed between (and parallel to) the logs which also bear on the aforementioned double-2x12 beams (also see Photograph 5). The supplemental framing appears to be in good condition.

Photograph 5 – Typical supplemental framing beneath original log house.

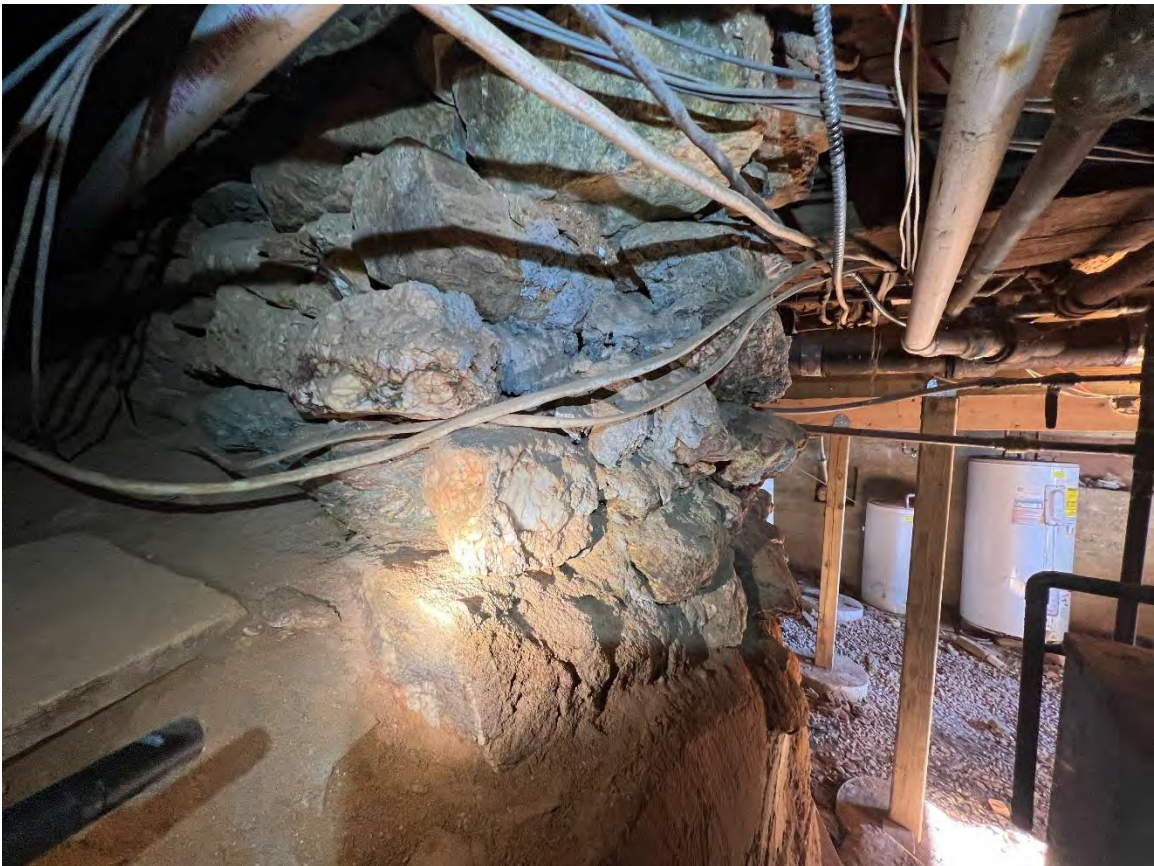
2. The foundation beneath the footprint of the original log house consisted of a stacked stone wall along the west end (see Photograph 6), and what appeared to be newer concrete walls (or parged masonry/stone walls) along the north, east, and south ends. The foundation walls generally appeared to be in good condition.
3. The first floor framing supporting Room 1C of the addition consists of logs similar to the logs supporting the log house (see Photograph 7) which span from front-to-back. The logs were in fair condition exhibiting many checks, but were harder than the logs beneath the log house when probed.

Photograph 6 – Typical stacked stone foundation wall.

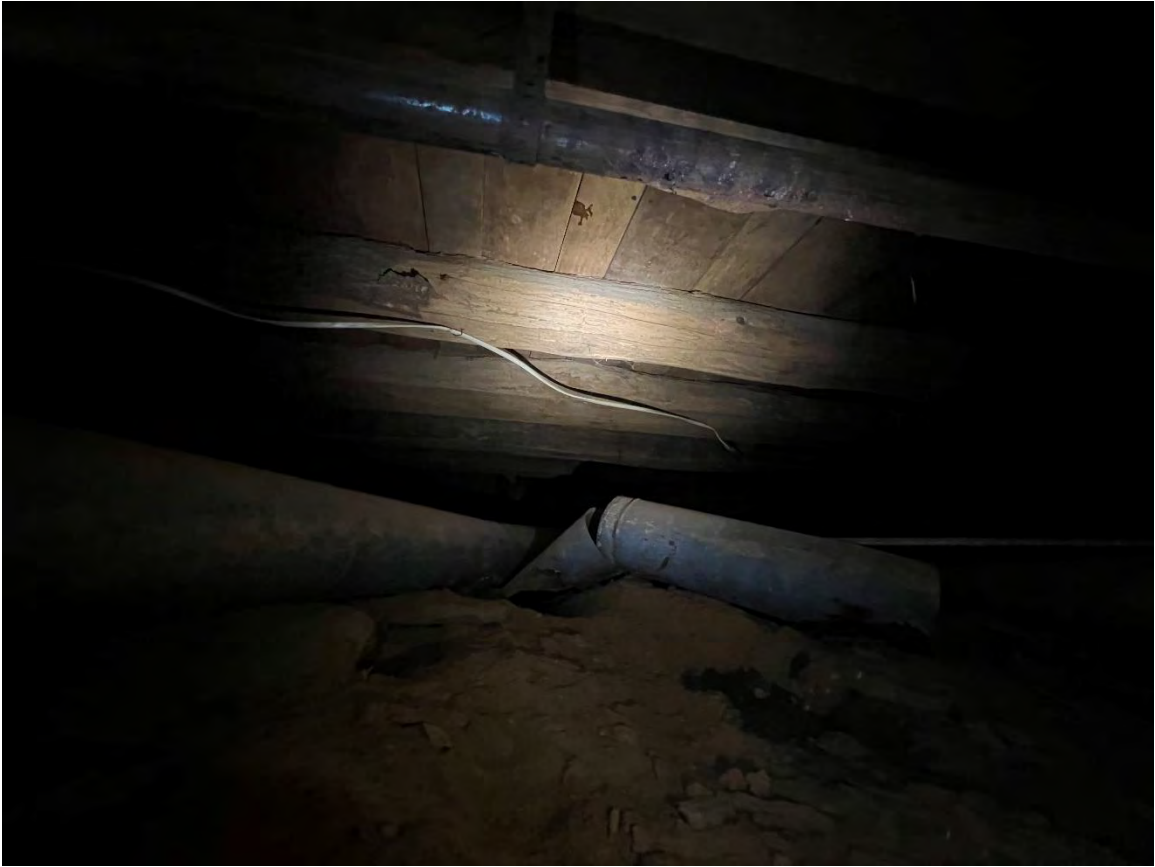
Photograph 7 – Typical log supporting first floor of Room 1C of addition.

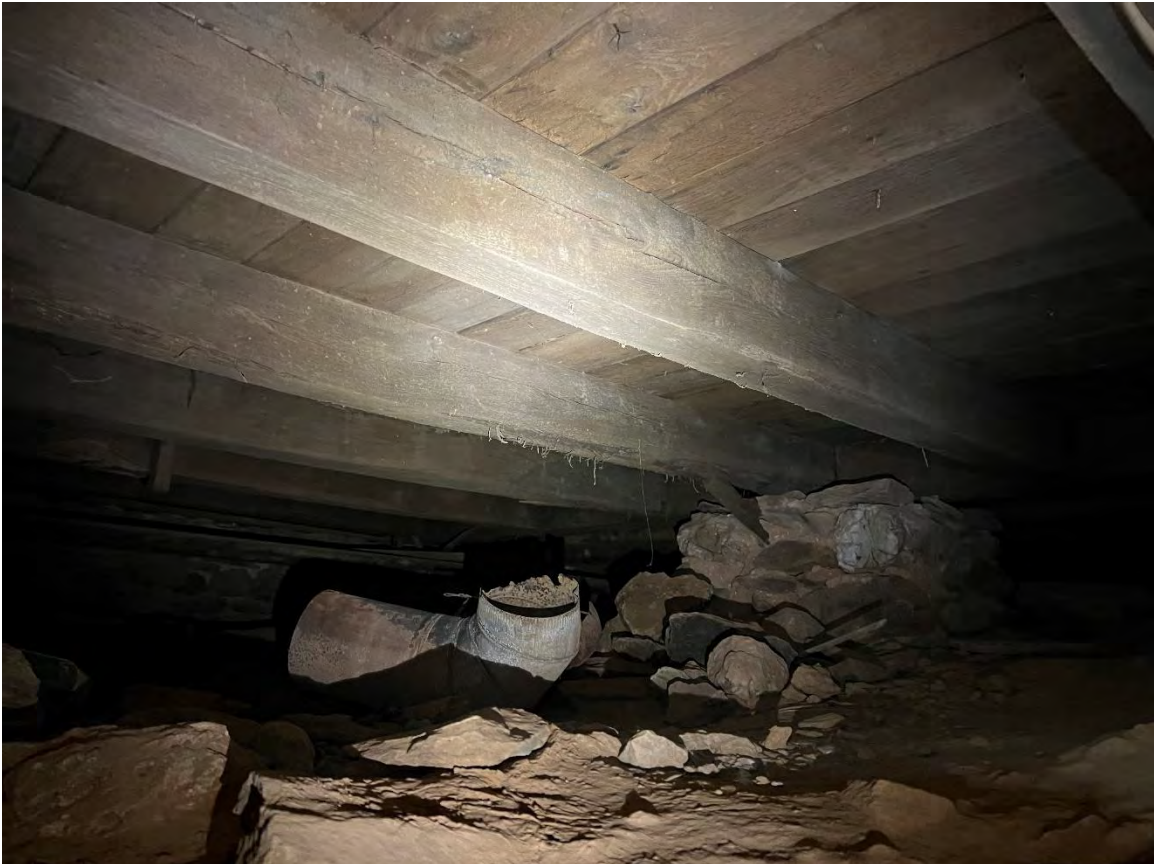
The first floor framing supporting Rooms 1A and 1B consisted of 4x6 timbers (see Photograph 8) spanning from side-to-side (north-to-south). The timbers were in fair condition also exhibiting many checks and splits.

Photograph 8 – Typical timbers supporting first floor of Rooms 1A and 1B of addition.

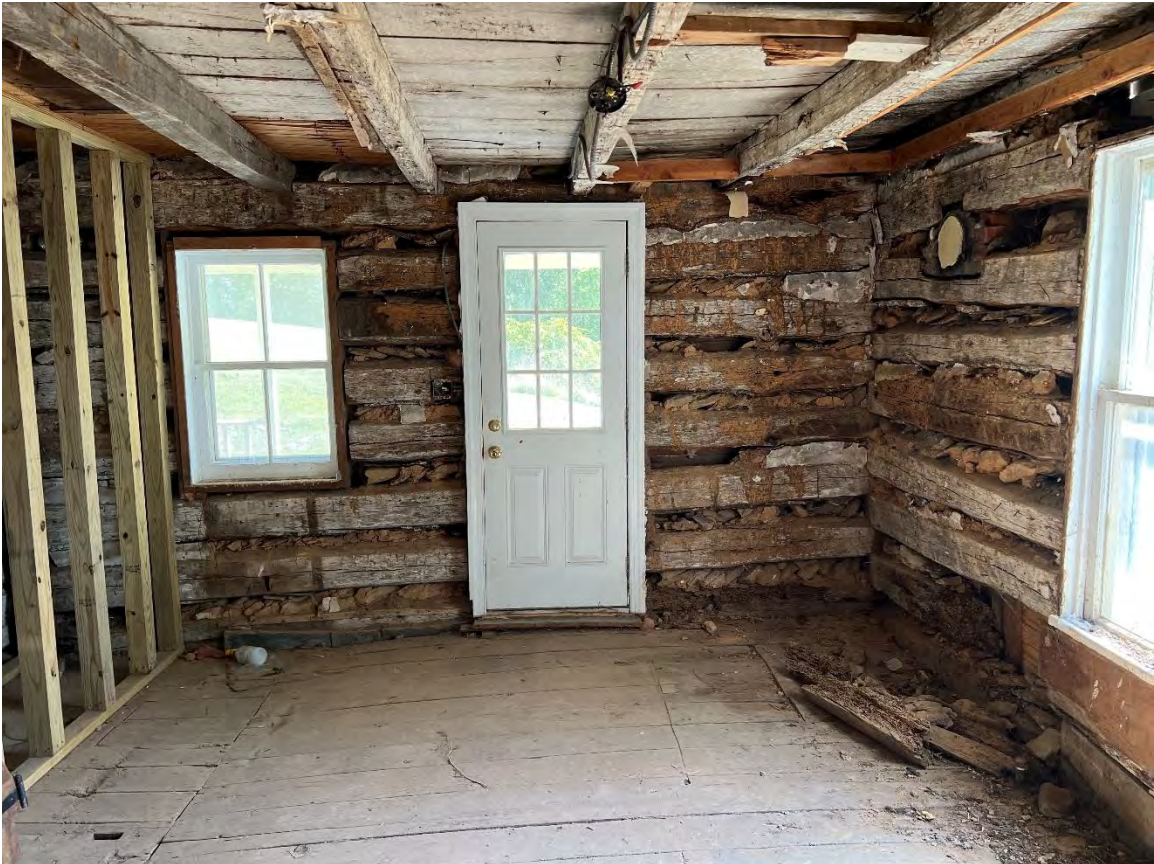
1. The log house walls consist of logs oriented horizontally and stacked vertically, with stone infill (see Photograph 10). The logs along the exterior walls were in poor condition and the logs along the interior walls were in fair condition. The logs along the base of all of the walls exhibited the most severe signs of termite damage and in many instances had dislodged from the walls (see Photographs 10 and 11).

Photograph 10 – Typical view of log walls within log house interior.

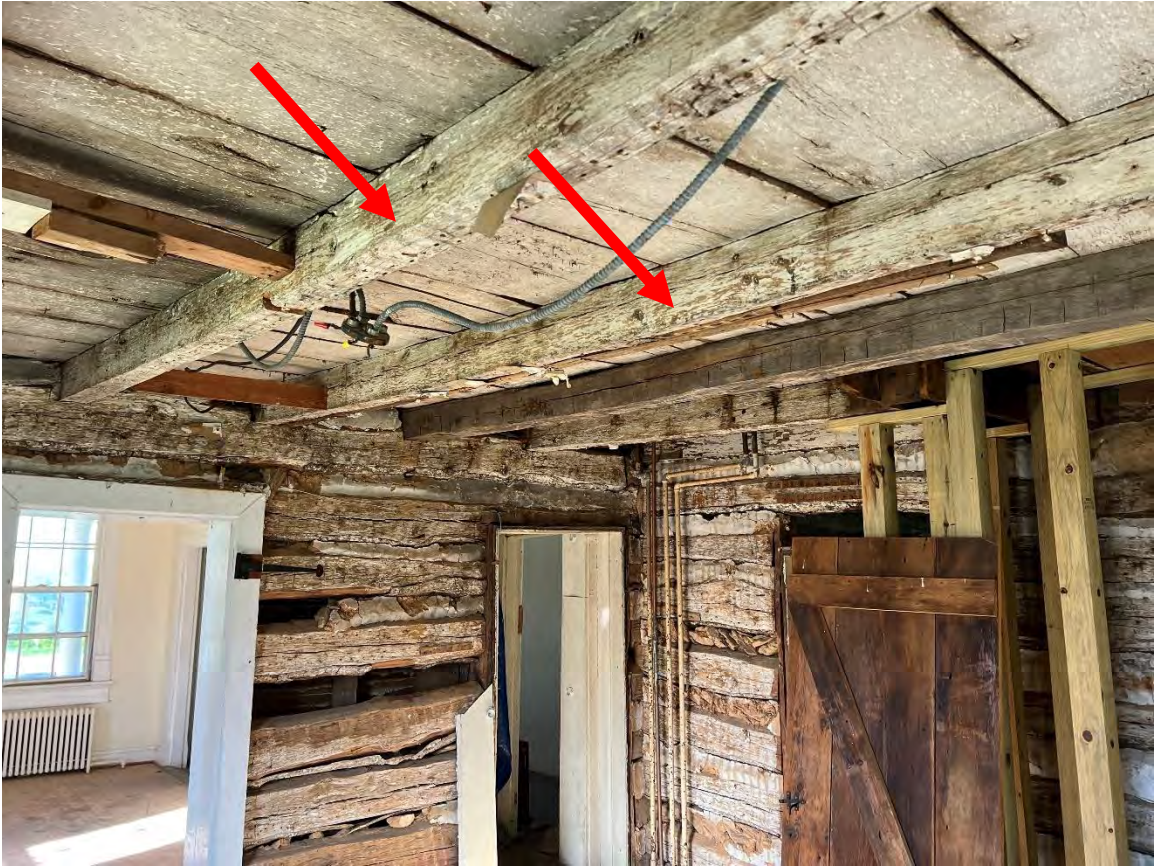
5. The joists supporting the 2nd floor above consisted of 4x6 timbers spanning front-to-back and bearing on the log walls (see Photograph 15). The joists had generally deflected at midspan indicating the members could be overloaded. Additionally, the joists appear to slope towards the rear exterior wall which could be related to observed deterioration of the wall (i.e., the wall supporting the joists has deteriorated causing the joists to drop).

Photograph 15 – Typical timbers supporting 2nd floor above log house.

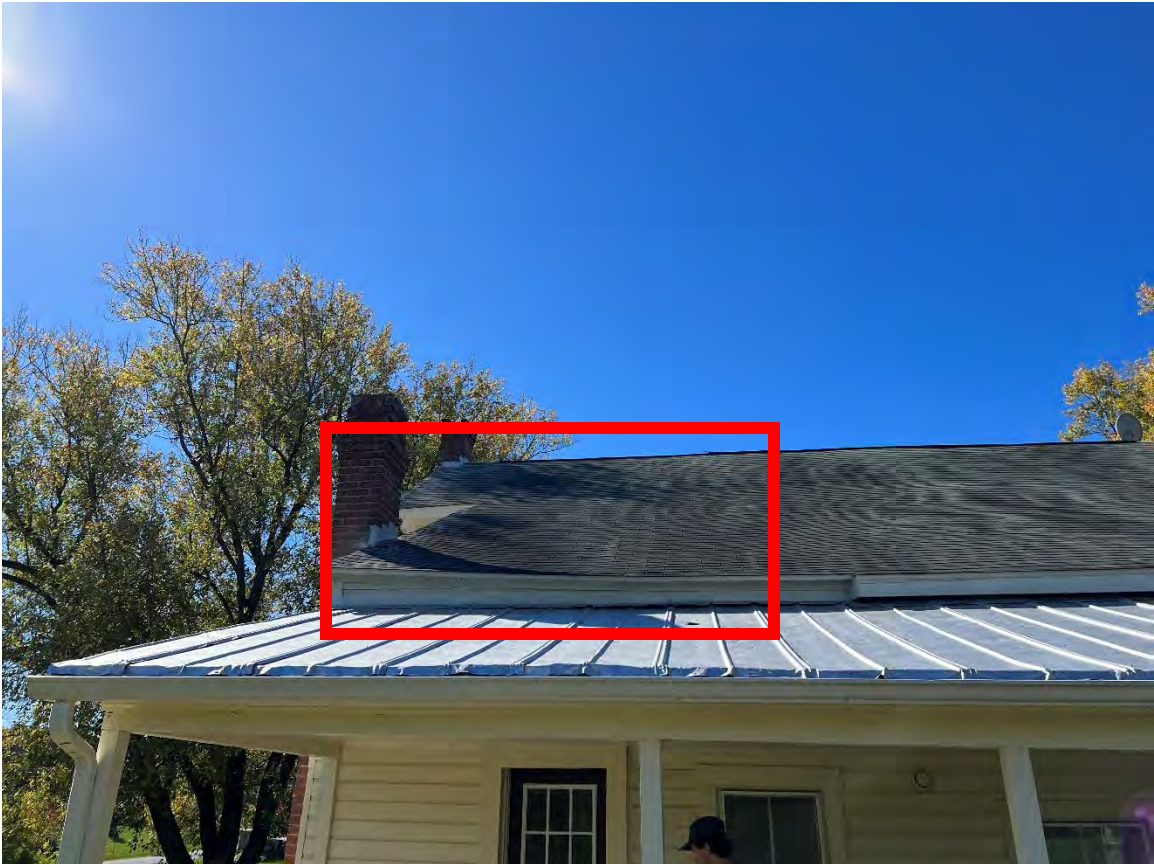
1. From ground level of the building exterior, we noted several large depressions in the main roof (see Photograph 20) over Rooms 2A and 2B.
2. Portions of the ceiling were removed in Room 2B to allow for inspection of the concealed conditions (see Photograph 21). The roof structure appears to consist of plywood sheathing (likely not original) supported primarily by four (4) inch deep rafters which span front-to-back between load-bearing walls.

Photograph 20 – Typical sag in roof.

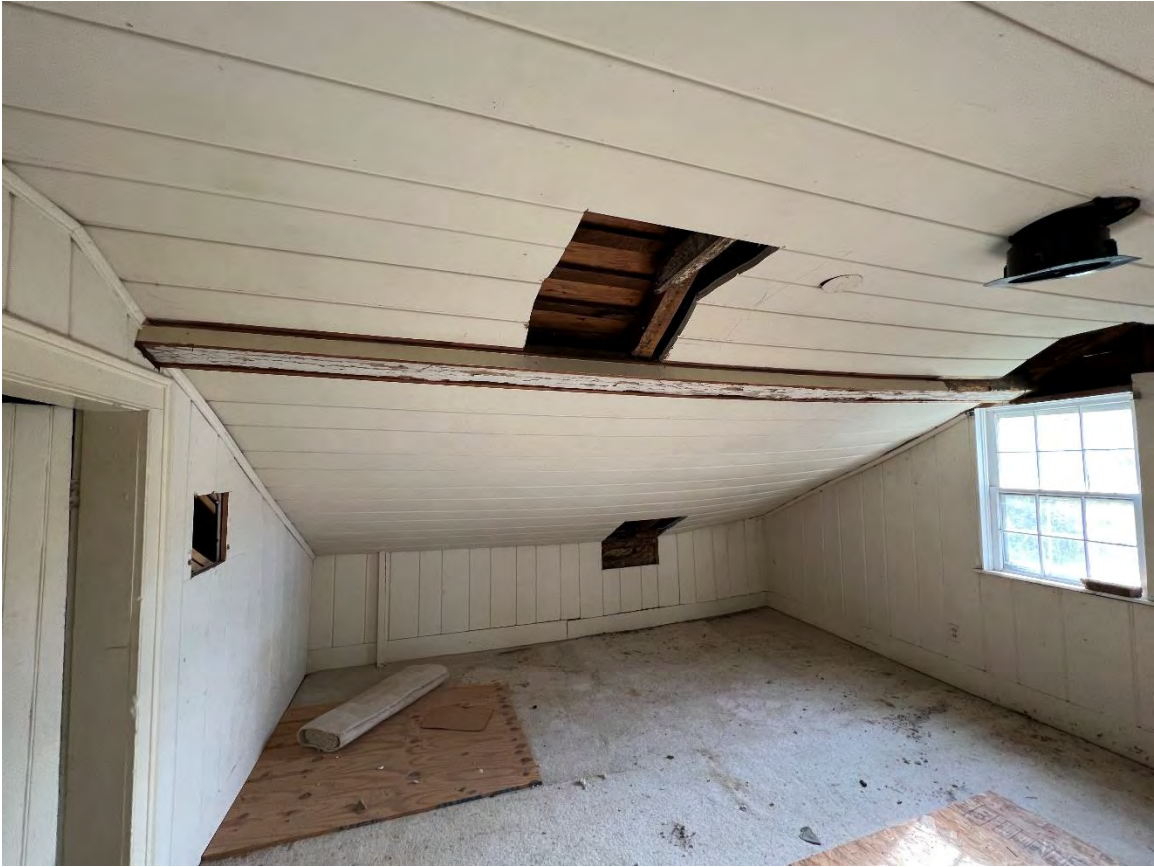
Photograph 21 – Intrusive sample locations in Room 2A.
