MONTGOMERY COUNTY HISTORIC PRESERVATION COMMISSION
STAFF REPORT

Address:	50 Elm Ave., Takoma Park	Meeting Date:	4/8/2026
Resource:	Contributing Resource Takoma Park Historic District	Report Date:	4/1/2026
Applicant:	Tamir Ezzat	Public Notice:	3/25/2026
Review:	HAWP	Tax Credit:	Partial
Case Number:	1148441	Staff:	Dan Bruechert
Proposal:	Retroactive Roof Replacement and Chimney Removal

FIELD REPORT

Inspected Site: 50 Elm Ave. Takoma Park, MD 20912	Purpose of Investigation: Structural review of tree impact TEC #: 25-191FH
Date of Site Visit: 16 July, 2025	Date Report Issued: 25 July, 2025
Report Prepared For: Tamir Ezzat, DDB Workshop	Persons Contacted: Christian Alvez, Insured Connor Sparks, Jenkins Restoration Ali Tolson, Jenkins Restoration

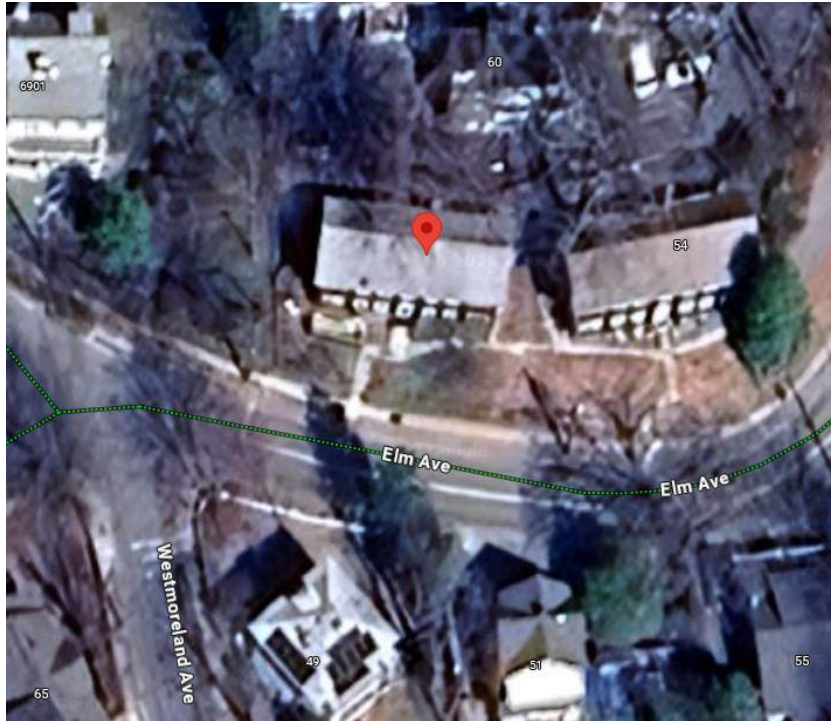
PHOTO 1: SITE PLAN

For purposes of this report, the front of the home is considered to face South towards Elm Avenue (*Appendix A: Photo 1*)¹. The site consists of a two-story, multi-unit apartment building comprised of four units, two each level, with walkout basement. The building features wood framing with CMU foundation wall below grade and a brick chimney on the north exterior wall. A CMU retaining wall makes up the walkout basement egress path on the north side and transitions to a timber site retaining wall at the northeast corner (*Appendix A: Photos 1-5*).
