MONTGOMERY COUNTY HISTORIC PRESERVATION COMMISSION
STAFF REPORT

Address:	5904 Cedar Parkway, Chevy Chase	Meeting Date:	10/24/2018
Resource:	Outstanding Resource Chevy Chase Village Historic District	Report Date:	10/17/2018
Applicant:	David O'Neil & Laura Billings (David Jones, Architect)	Public Notice:	10/10/2018
Review:	HAWP	Tax Credit:	Partial
Case Number:	35/13-18Z	Staff:	Dan Bruechert
Proposal:	Garage demolition, non-historic addition removal, new construction, hardscape, and landscape alterations.

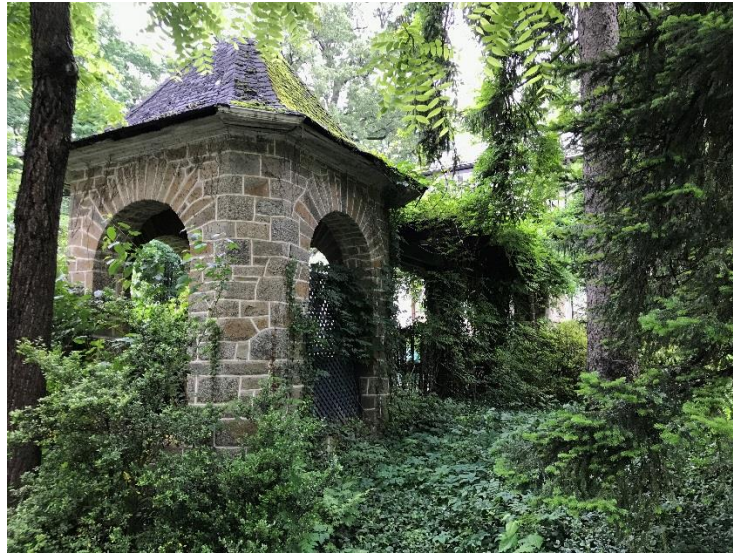
Figure 1: Stone tower with arbor/pergola.

In the south end of the property there is a folly/gazebo that is connected to the house by a pergola. These elements are constructed from masonry that matches the construction of the house foundation. The pergola is largely overgrown with vines and ivy, with the remnants of deteriorated wood fencing between the columns (see the image below). The applicant proposes to add a second row of columns to the pergola, behind the existing historic columns and construct a new pergola structure. Aligned with these new columns the applicant proposes to install a 5’ (five foot) iron fence enclosure with a gate (discussed below). Based on the input from the HPC at the two preliminary consultations, Staff finds the proposal to add a new row of stone columns is appropriate. The applicant proposes to match the column design and materials. Staff finds that alterations to this feature is most analogous to gazebos, which should be subject to moderate scrutiny. Staff further finds that expanding this feature in a matting design is an appropriate treatment within the Chevy Chase Village Historic District, per the *Guidelines*.

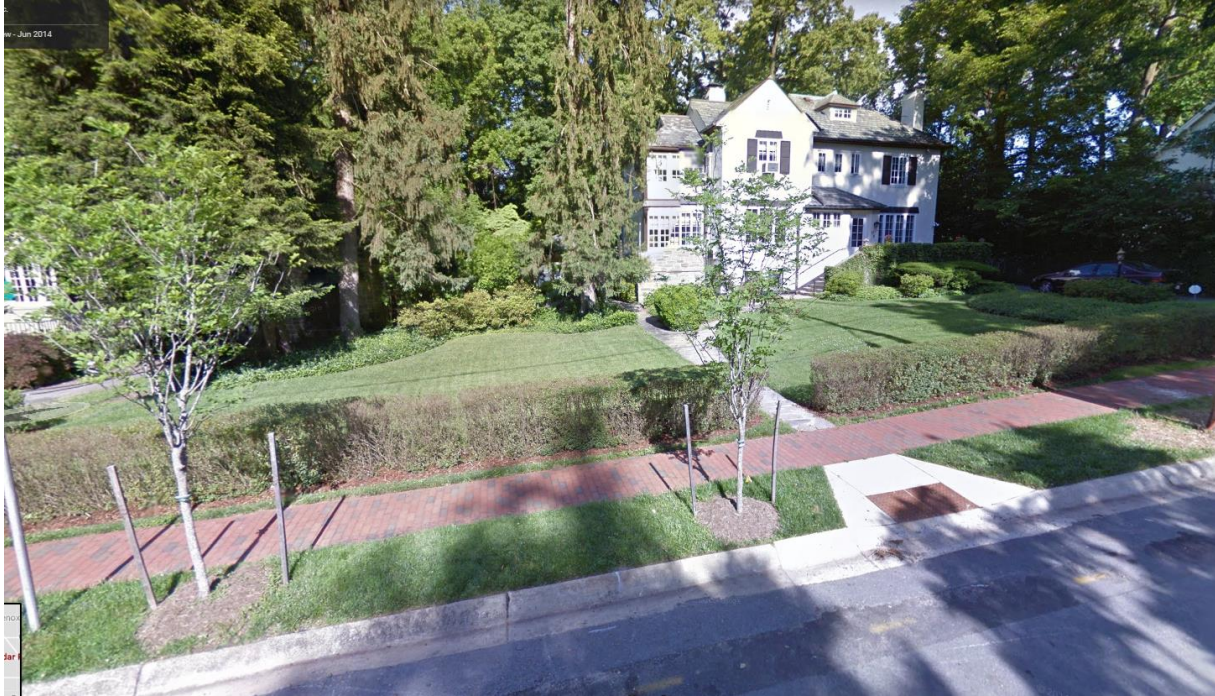
Figure 3: Perspective from the southeast of the house in the location of the proposed drive and parking pad.

The applicant proposes to construct a new drive and formal lawn approximately 10' (ten feet) wide to the left of the historic house. The lawn is roughly elliptical-shaped and is located between the new driveway and the steps to the front door. The applicant has included the proposed drive on its site plan and in a rendering comparing an existing view of the house with the new feature. Staff finds that this alteration will alter the historic character, but will do so in a manner that the house will still contribute to the historic character of the surrounding district, per the *Guidelines*. Several materials were discussed at the Preliminary Consultation; however, the HPC's comments could generally be summed up as a new drive should have a varied texture and color. The applicant proposes to use an exposed aggregate for this feature, which satisfies both the varied color and texture requirements. While Staff was unable to locate any other front parking pads in the Chevy Chase Village Historic District, Staff remains supportive of this feature. It is offset from the front of the house, so parked cars will not have a significant visual impact on the historic house from the right-of-way. Staff finds that the applicants' proposal to construct a new drive and lay-by will have not have an adverse effect on the house and is appropriate under the guidelines. Staff supports approval of this element.

Staff was initially concerned that the new drive would create a large section of impervious surface and significantly increase lot coverage. The landscape architect for the project included calculations of existing and proposed lot coverage with the application materials. The existing lot coverage (which consists of paved, built-on, and impervious surfaces in the right of way) is 8,025 ft². This is 49.1% of the 16,317 ft² lot. If all of the proposed new construction is built, including the accessory structure not under consideration under this HAWP, the lot coverage will be 7,533 ft². This is a lot coverage of 46.1% of the total lot. Because the proposal calls for the removal of a large amount of asphalt paving to the rear, there will be more space available for planting and reinforcing the park-like setting promoted by the historic district.

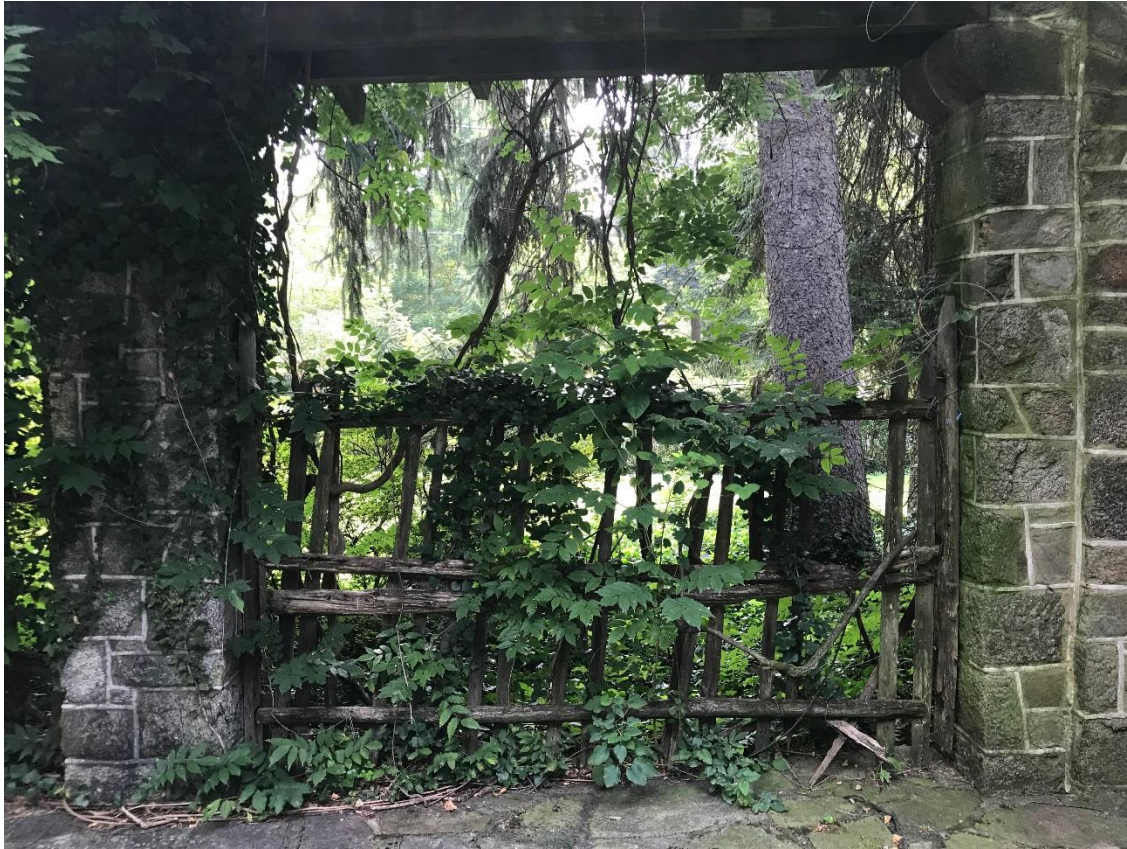
Figure 4: Columns supporting the pergola with fencing and vines between the columns.

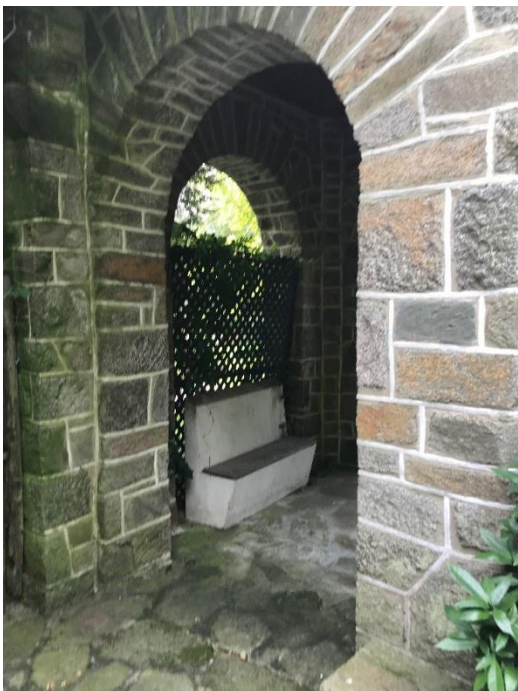
Figure 5: View of the gazebo looking through the north and east openings.

Staff finds that overall the proposed fencing will not significantly impact the historic character of the house and grounds. The new fence in the pergola will align with the proposed new columns and their distance from the public right-of-way will make them less visible. The proposed fixed panel at the front opening of the gazebo will replace a piece of wood lattice that has been proposed to provide a small measure of privacy. The proposed panel will create a more open appearance for the gazebo than the existing appearance. Staff finds that the slender proportions of the fencing will not detract from the heavy masonry used to construct the gazebo and pergola columns. Due to the orientation of the gazebo, the gate proposed for the north opening will not be visible from the public right-of-way and should be approved as a matter of course.

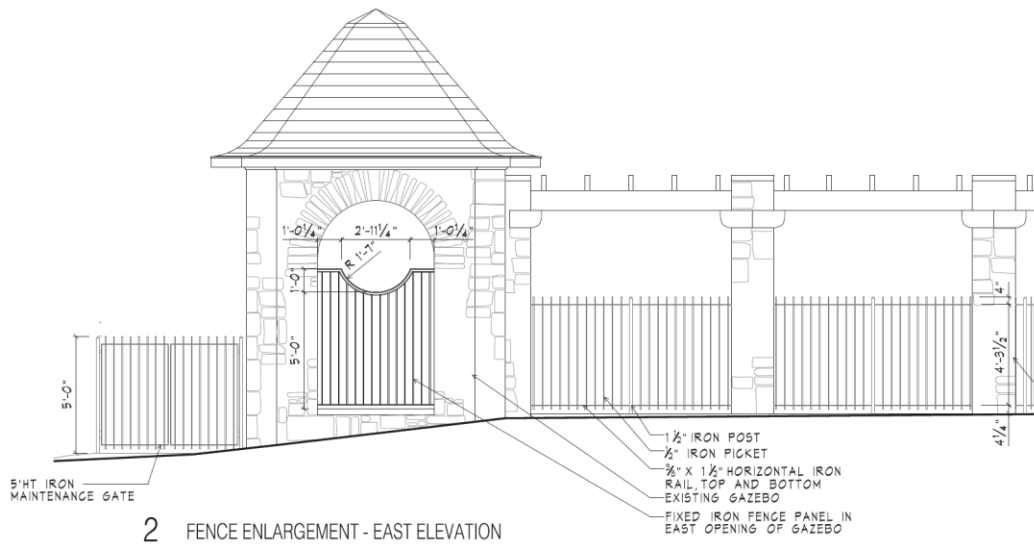
Figure 6: Detail image showing proposed fencing and change in grade.

The gate proposed to the left of the gazebo matches the details of the proposed fencing throughout the project. The fence height, 5’ (five feet), exceeds typical HPC guidance; however, Staff supports its approval for a number of reasons. First, the lot slopes down to the south, as seen in the figure below. The top of the gate is several feet below the fencing in the pergola. Second, because this portion of the fence is so far away from the house, it will have less of a visual impact than fencing that is closer to the house. Staff finds that this gate is not a substantial

alteration to the historic house (Chapter 24A-8(b)(1) and will not detract from the historic character of the site (per Standard 2). Staff supports approval of the proposed fencing.

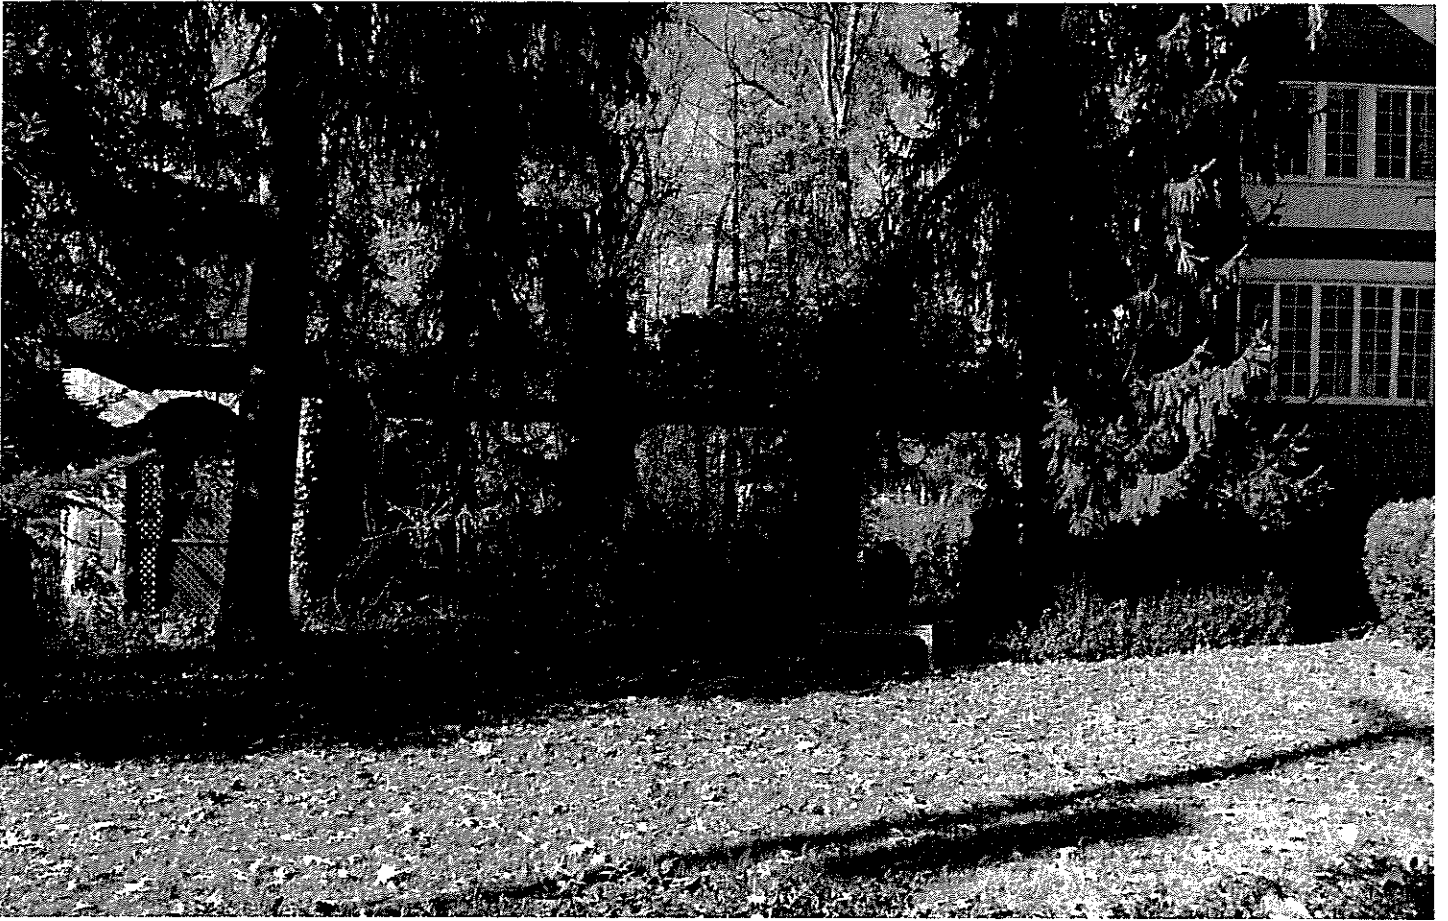
Existing pavilion & trellis from Cedar Parkway

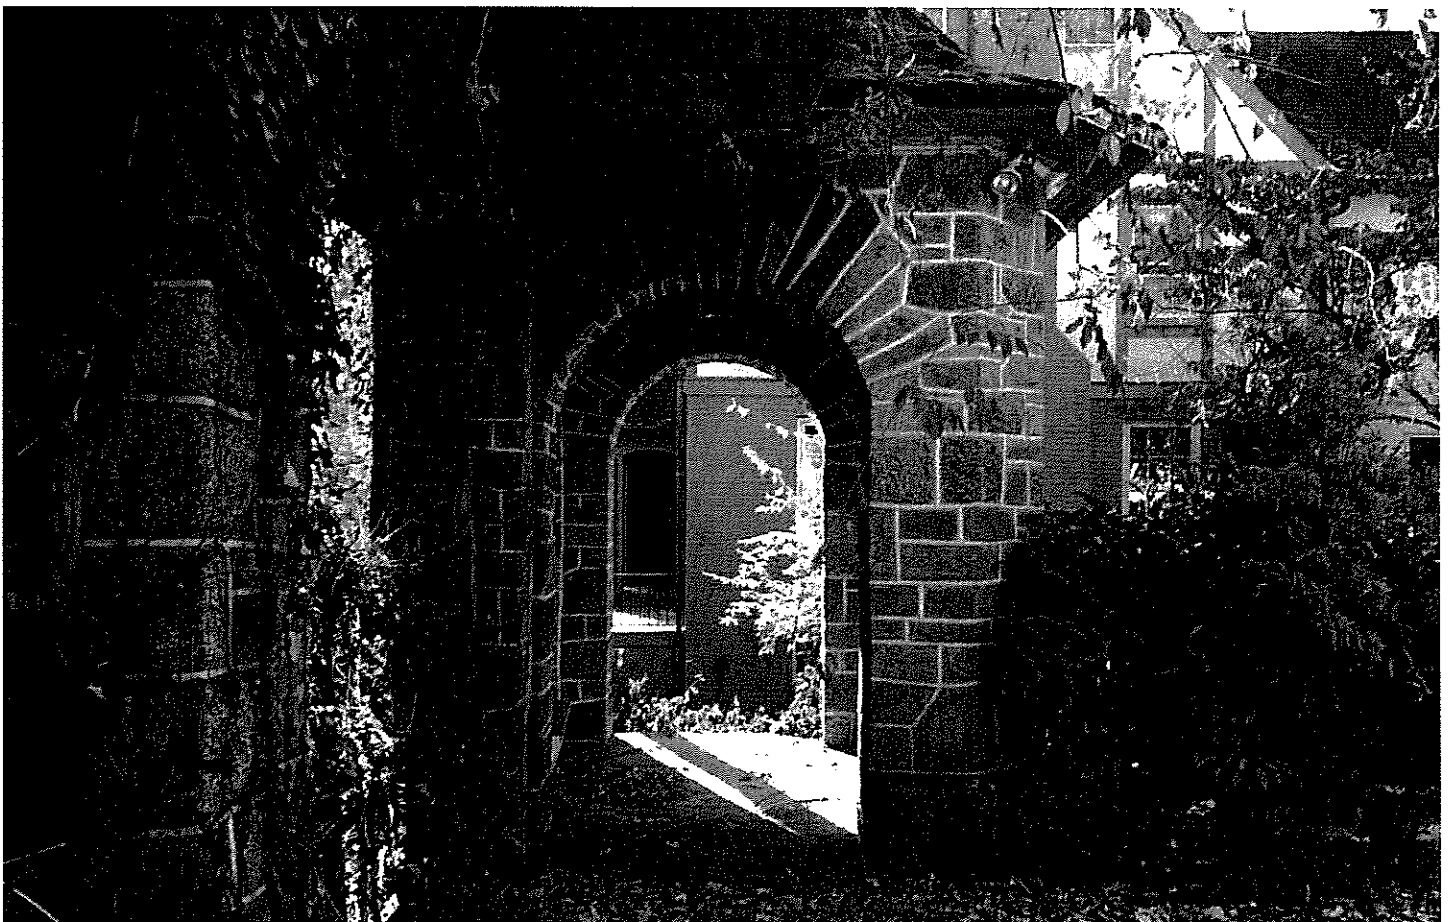
Existing pavilion

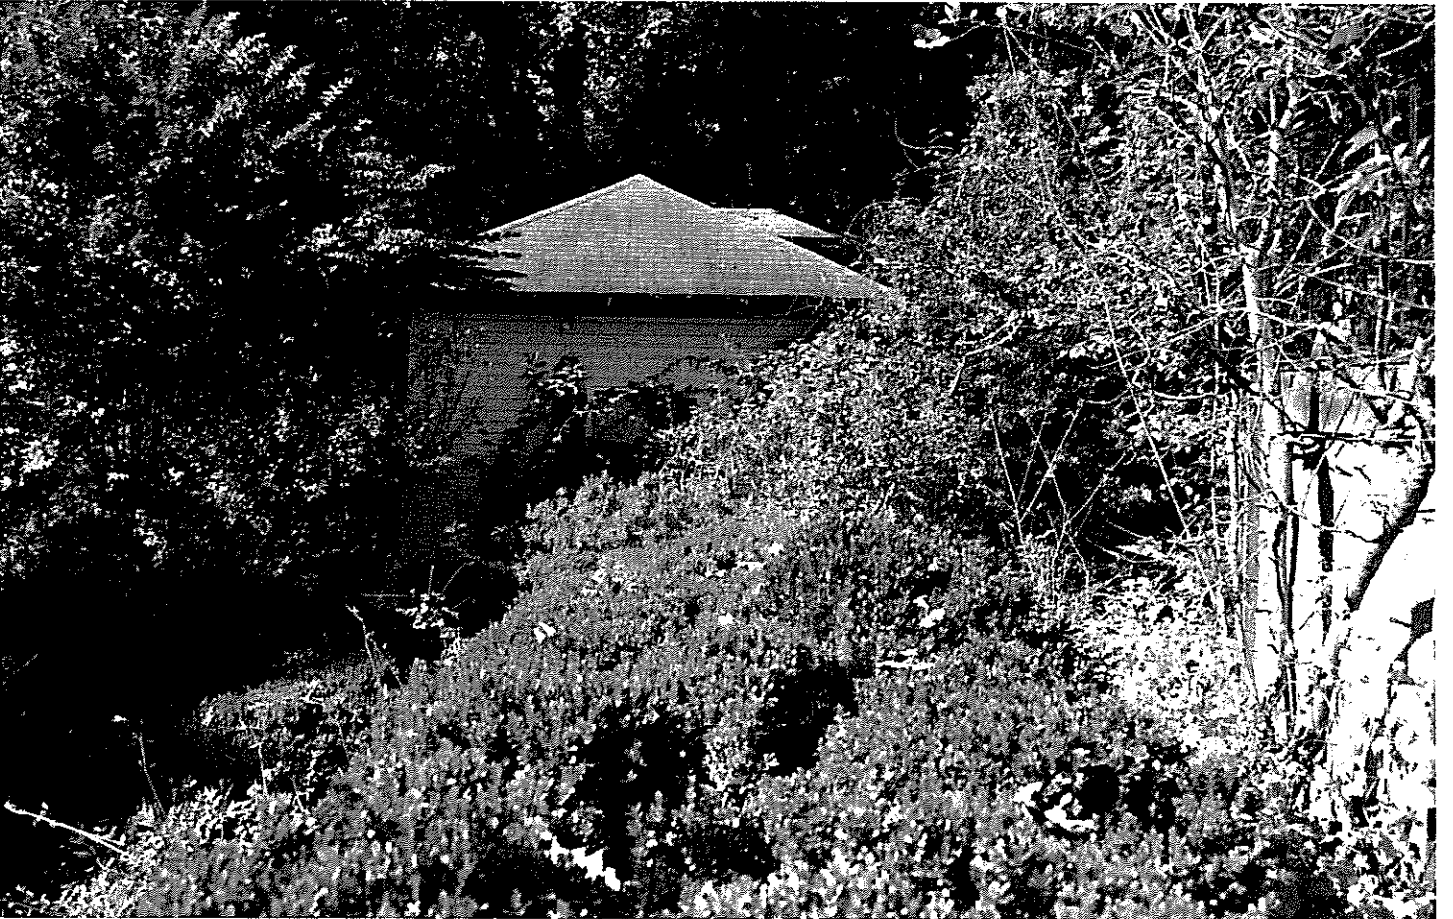
Existing garage East elevation

The existing garage is a wood framed building on a brick foundation with an asphalt-shingled hipped roof with a hipped dormer. The doors are all wood carriage style doors with lites in the upper section. The construction date of the garage has not been conclusively shown, however, Staff's research into Sanborn Maps and County Atlas, demonstrate that the garage was constructed sometime after 1948. Due to the placement of the garage at the rear of the yard and the slope of the lot and the terracing of the side yard the garage is only minimally visible from the public right-of-way. The applicant proposes to demolish this building.

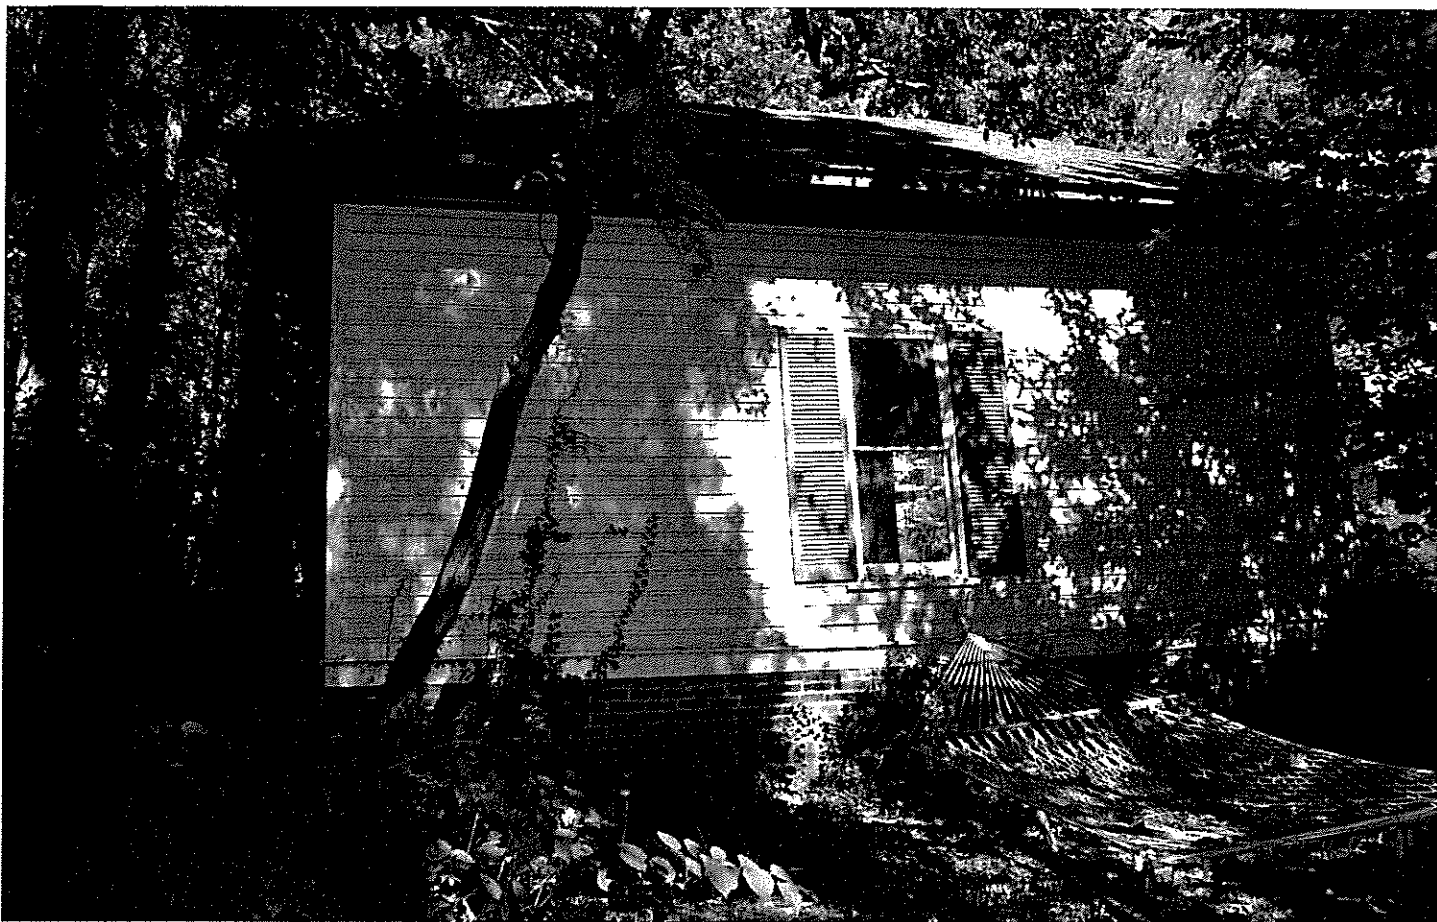
Existing garage South elevation

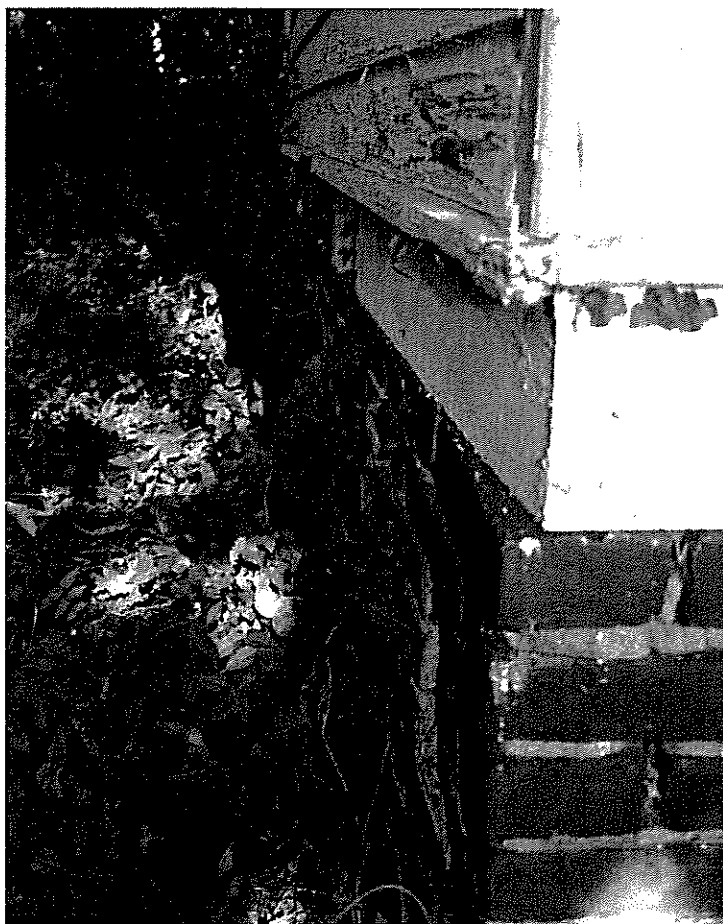
Existing garage foundation

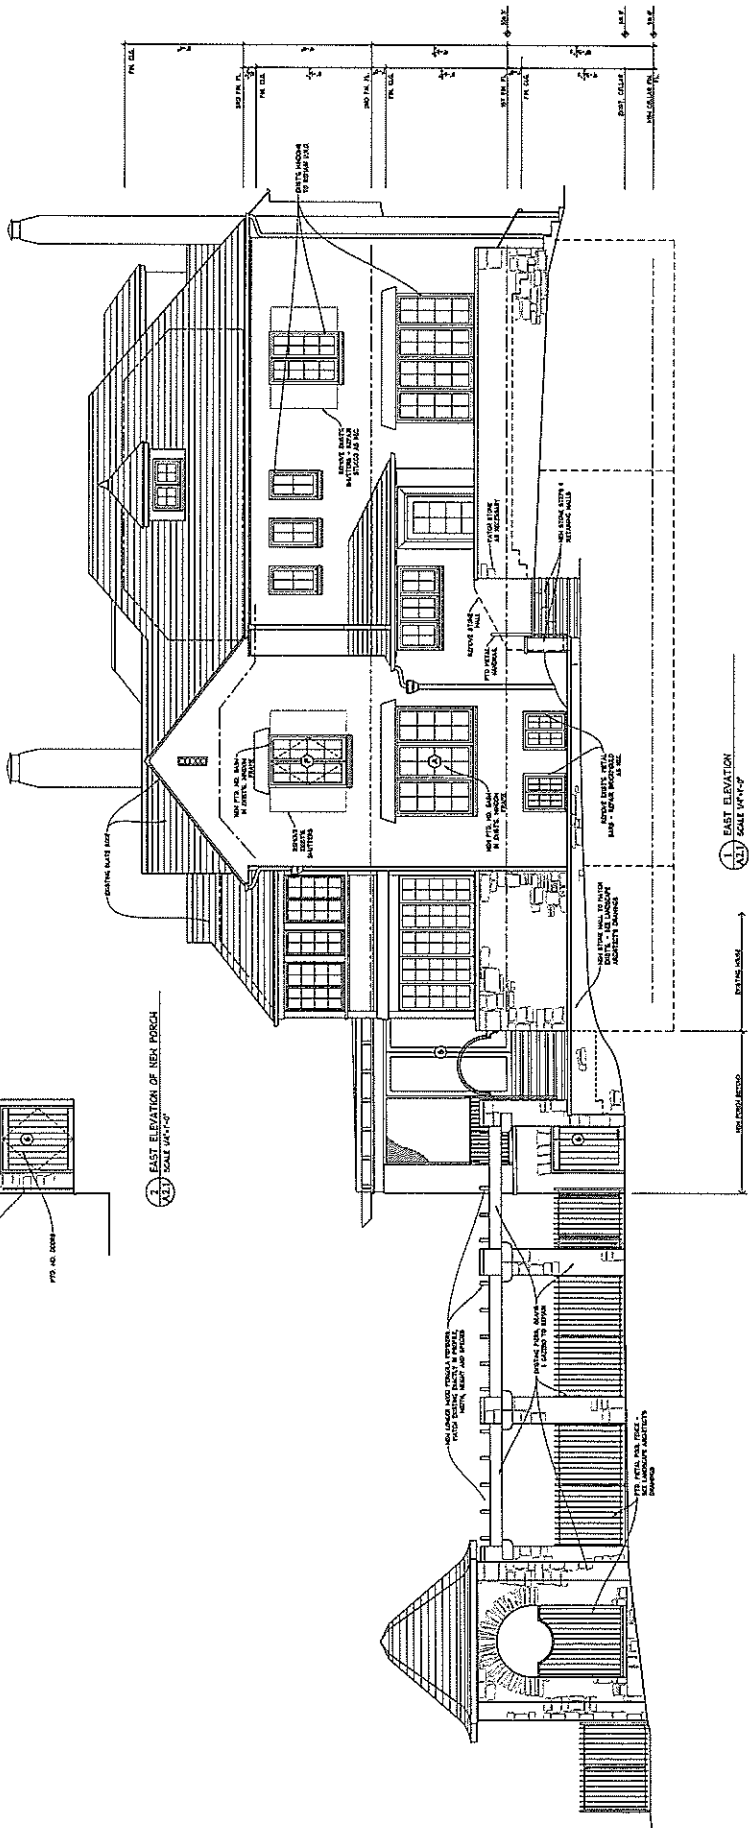
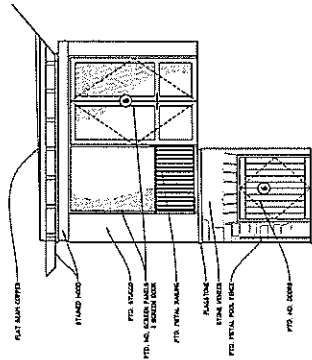
EAST ELEVATION OF NEW PORCH
SCALE 1/4"=1'-0"

EAST ELEVATION
SCALE 1/4"=1'-0"

In the southwest corner the applicant proposes to construct a new porch on a stone foundation that matches the historic. The porch will be screened in with a pergola covered by a flat seam copper roof and will project to the left beyond the wall plane of the historic house. The pergola and columns will sit several feet above the historic arbor/pergola to the left of the house and will be visible from the public right-of-way.

The foundation for the new porch and rear addition will be stone to match the historic foundation and will have stuccoed siding to match. The windows will be painted wood, multi-lite casement windows, and the roofing will be slate to match the historic. The new pergola on the side porch will be stained wood.

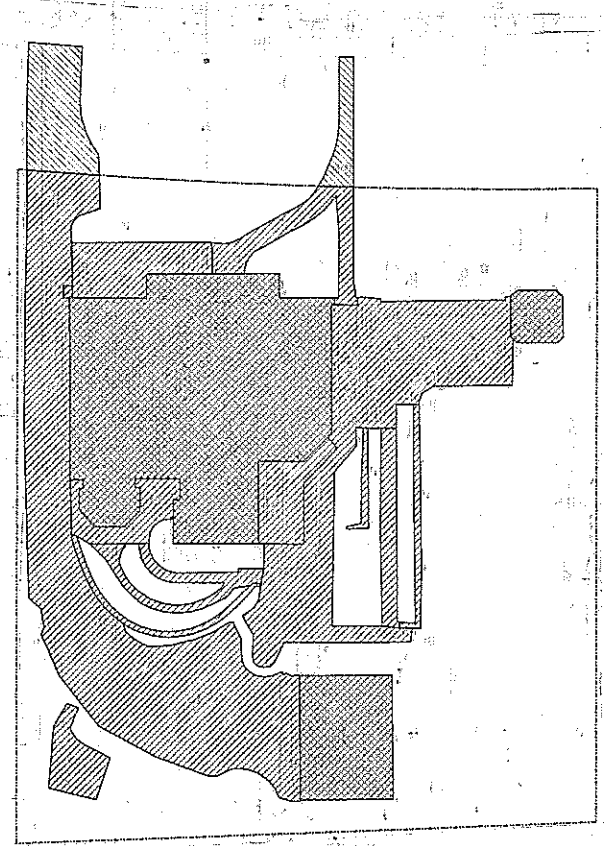
EXISTING LOT COVERAGE

KEY	IDEAL
IMPERVIOUS AREA	130 SQ FT
RAISED STRUCTURES, PAVED WALKS, TERRACES, POOL, DRIVEWAY	455 SQ FT
IMPERVIOUS AREA, P.R.G.P.	450 SQ FT

Lot Area	Existing Lot Coverage	Proposed Lot Coverage	Existing Right of Way Coverage (to sidewalk)	Proposed Right of Way Coverage (to sidewalk)
16,317 SF	House, Gazebo, Outbuilding	3,308 SF	125 SF	117 SF
	Paved Walks, Terraces, Raised Structures	4,024 SF	325 SF	276 SF
	Driveway	201 SF		
	Total:	8,025 SF		
	House, Gazebo, Outbuilding	7,533 SF		
	Paved Walks, Terraces, Pool, Raised Structures			
	Driveway			
	Total:	7,533 SF		
			450 SF	
				393 SF

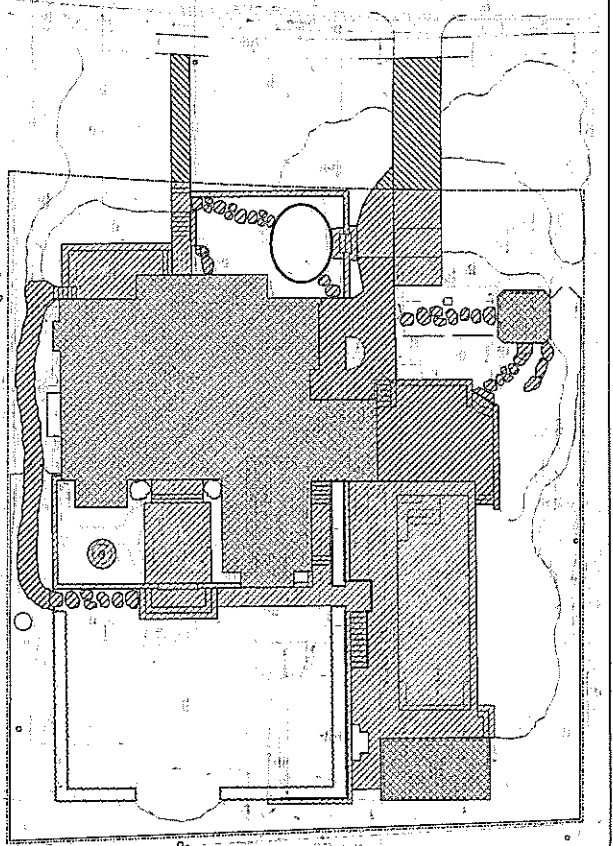
PROPOSED LOT COVERAGE

KEY	IDEAL
IMPERVIOUS AREA	230 SQ FT
RAISED STRUCTURES, PAVED WALKS, TERRACES, POOL, DRIVEWAY	428 SQ FT
IMPERVIOUS AREA, P.R.G.P.	315 SQ FT
