MONTGOMERY COUNTY HISTORIC PRESERVATION COMMISSION STAFF REPORT

Address: 1000 Kensington Parkway Meeting Date: 04/19/17

Resource: Kensington Cabin Report Date: 04/12/17

Proposal: Building Rehabilitation and ADA Access

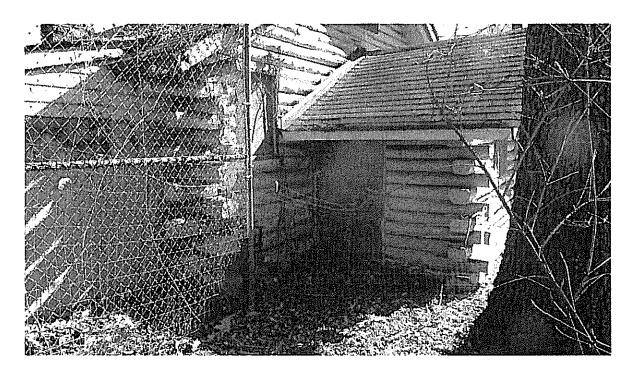
Rear (west) elevation of south wing (with boarded up entry) and south elevation of main block and rear addition.

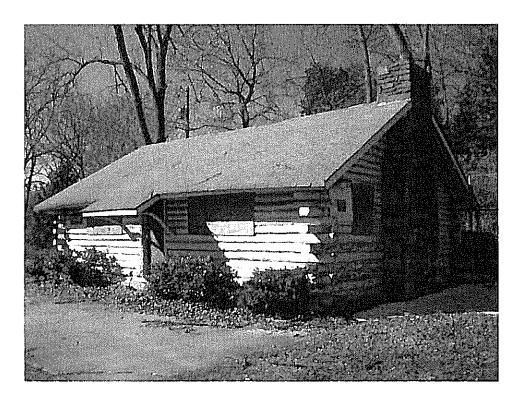
East (main) and North elevations

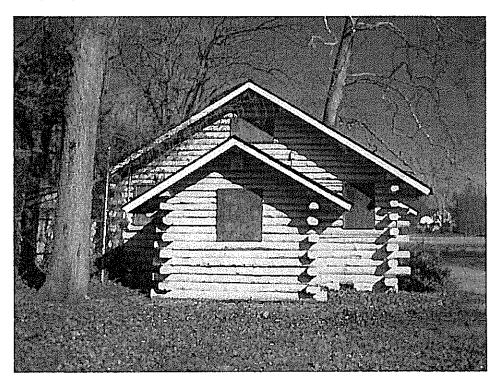
South Elevation

- a. Raise roof height approx. 14-inches to accommodate new, ADA-compliant entrance on south elevation. As with the rear addition, the south wing is several steps below the main cabin level and will need to be raised to create an accessible entrance to the building. The existing front entrance could not be made accessible without extensive alteration to the front of the cabin. This alterative design is proposed to help maintain the historic façade.
- b. Cut new entrance into south elevation where window is now and install ADA-compliant, historically sensitive, wood door.
- 6. Replace old, non-historic asphalt shingle roof with new asphalt shingle.

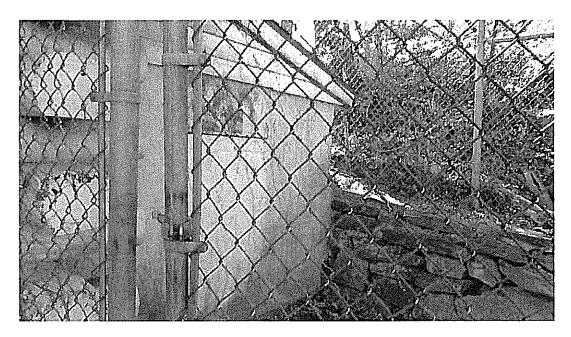
Rear Enclosed Restroom Addition

- 1. Replace the non-historic front door with one that more closely matches the historic design (see attached historic plans).
- 2. Install missing windows and repairing damaged historic windows with ones that match the historic plans.
- 3. Repair damaged logs with epoxy or dutchmen and paint/stain.
- 4. Raise roof approx. 18-inches on rear addition to accommodate new raised interior floor level. The extant addition is several steps lower than the main portion of the cabin, as described above. Its floor level and ceiling height need to be raised to create an accessible interior restroom.

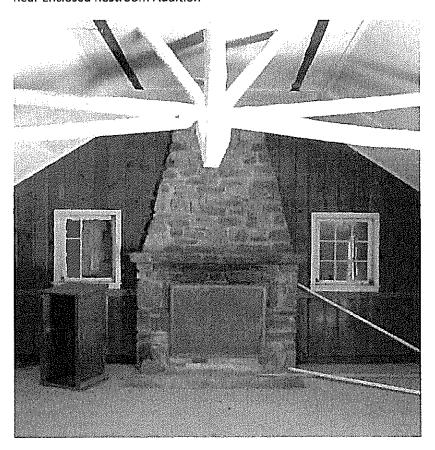
Example of window (L) to be repaired in-kind to match window (R)
