HISTORIC PRESERVATION COMMISSION STAFF REPORT

Address:	107 Elm Ave., Takoma Park	Meeting Date:	12/06/17
Resource:	Outstanding Resource Takoma Park Historic District	Report Date:	11/29/17
Review:	HAWP	Public Notice:	11/22/17
Case Number:	37/03-17BBBB	Tax Credit:	Partial
Applicant:	Thomas & Clara Bossuroy	Staff:	Dan Bruechert
Proposal:	Rehabilitation and Rear Addition

The applicant proposes work in two areas. First, the applicant will conduct repairs related to the fire damage including window replacement, roof replacement, repair/replacement of front porch elements, and the replacement of damaged trim with matching trim. Additionally, the applicant proposes to install a 1 ½ story addition at the rear that will face Allegheny Ave. The addition will have a gable-L roof, clad in a mix of stucco and Hardi siding, with two-over-two windows, and a small pediment covering a new entrance.

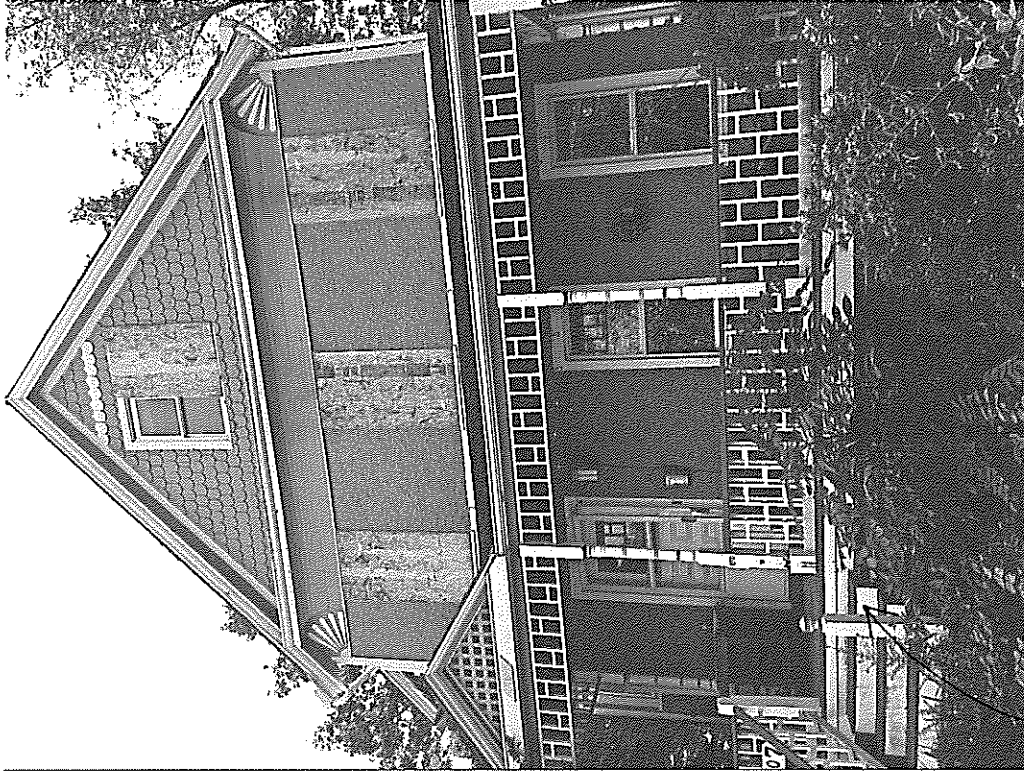
ELM AVE./FRONT (NORTH)

MISSING
RAILING

1. All 2nd and 3rd floor windows. They will be replaced by painted wood SDL double-hung and awning windows, as noted on elevations.
2. Siding and trim damaged by fire.
3. Front porch posts and stair railing will be re-built to match existing, as necessary.
4. Fire-damaged non-original cedar shake roof shingles will be removed and replaced with architectural 40-year asphalt shingles.

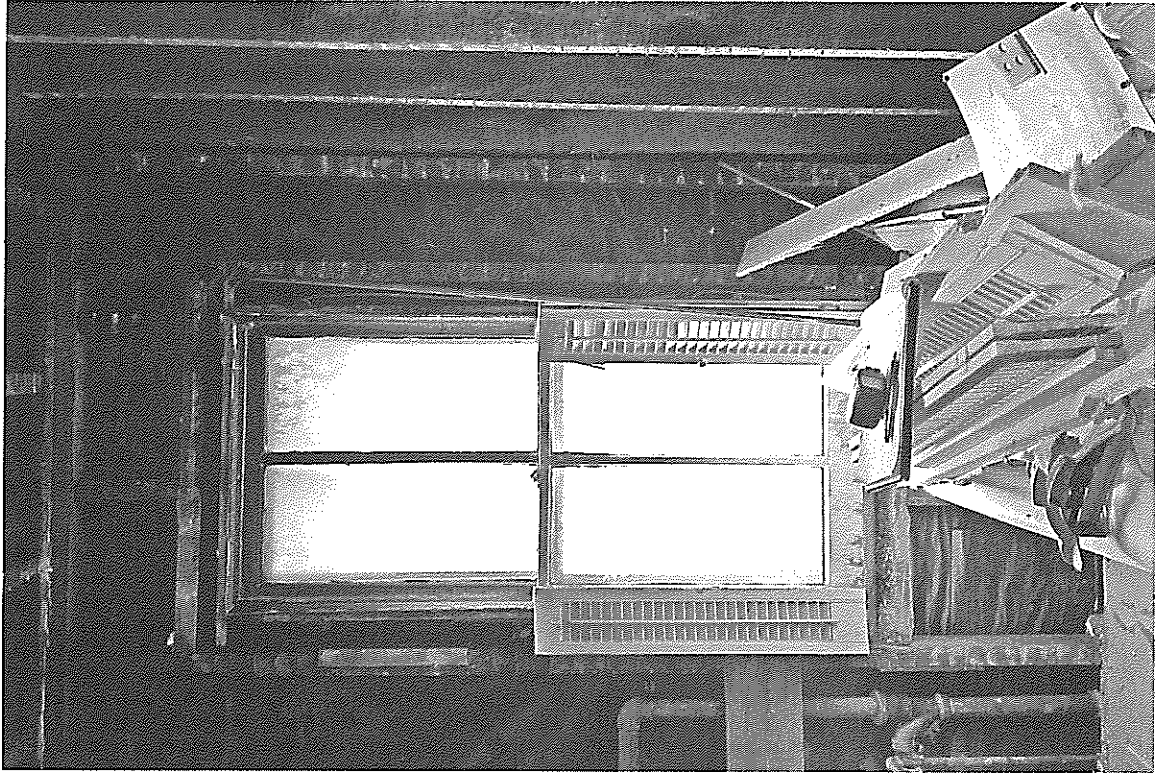
SECOND FLOOR WINDOW
(FIRE DAMAGED/TO BE
REPLACED)

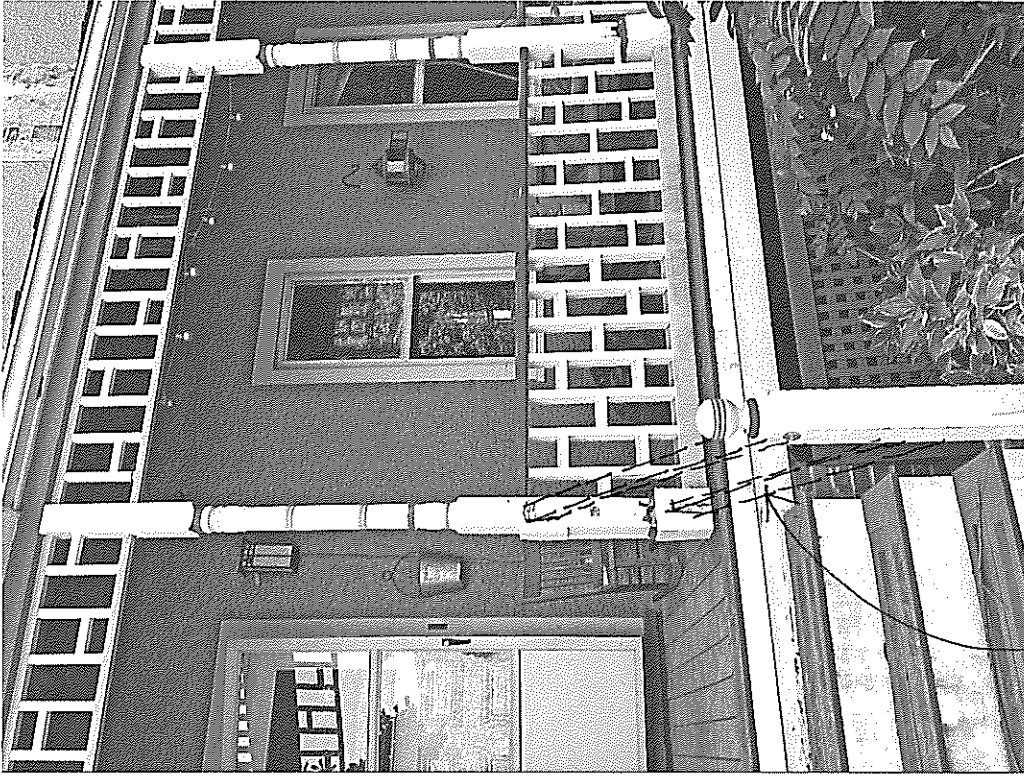
FRONT PORCH (NORTH)

MISSING RAILINGS
TO BE REPLACED
TO MATCH EXISTING

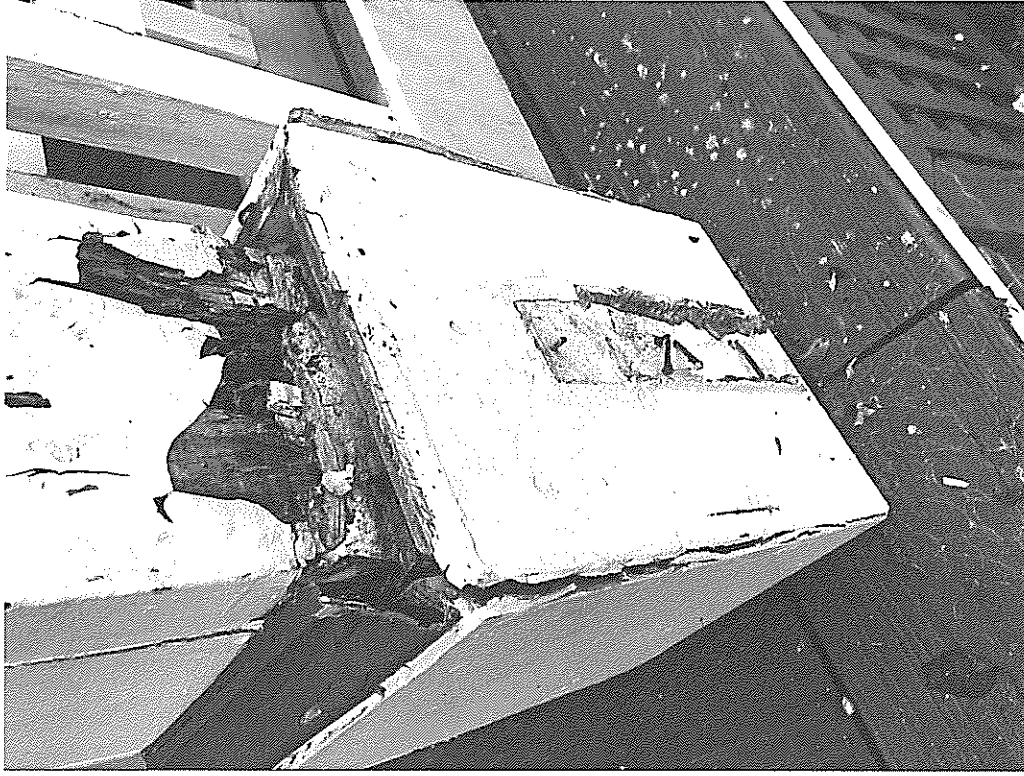
FRONT PORCH POST BASE
(TO BE REPAIRED/
REPLACED TO MATCH)

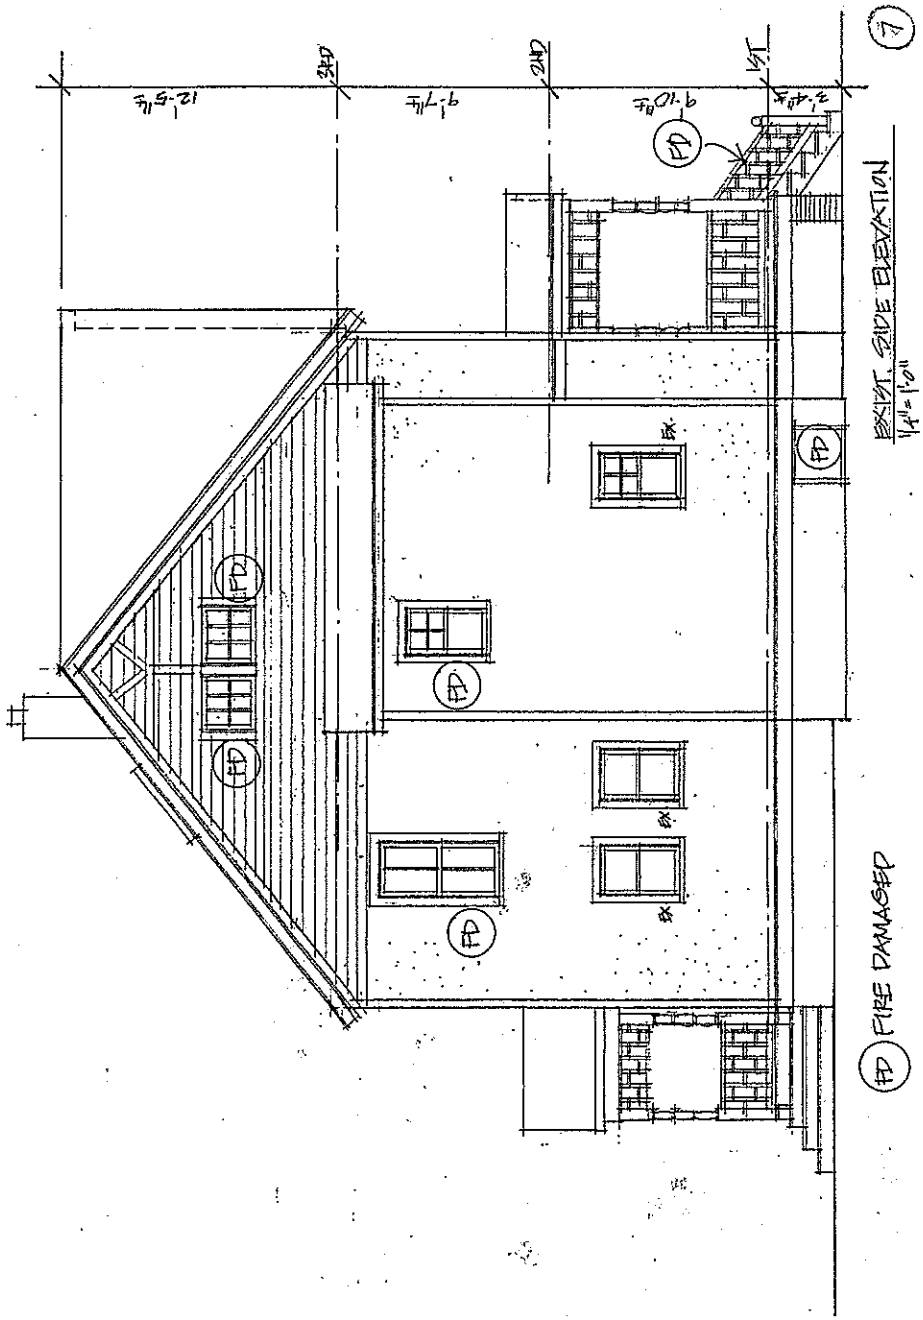
EXIST. SIDE ELEVATION
1/4" = 1'-0"

D FIRE DAMAGED

TUCCO OR
MASONRY CHIMNEY

REMOVE
SHINGLE SHAKES

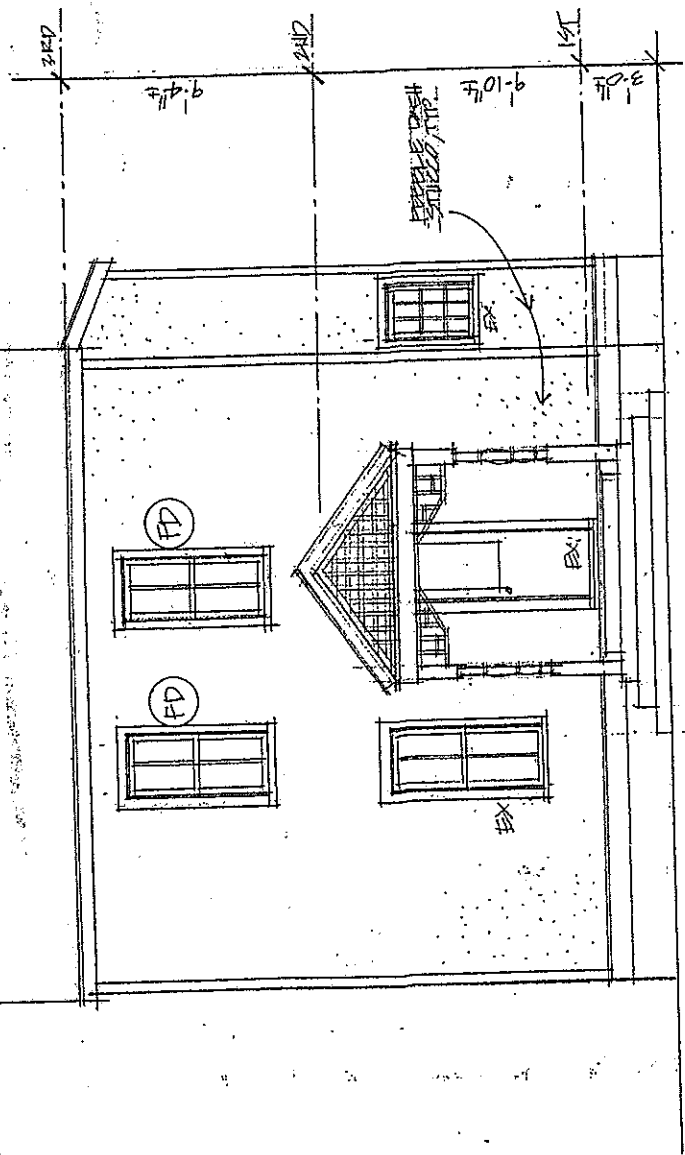
EXIST. REAR ELEVATION
1/4" = 1'-0"

FD: FIRE-DAMAGED
EX: EXISTING TO REMAIN

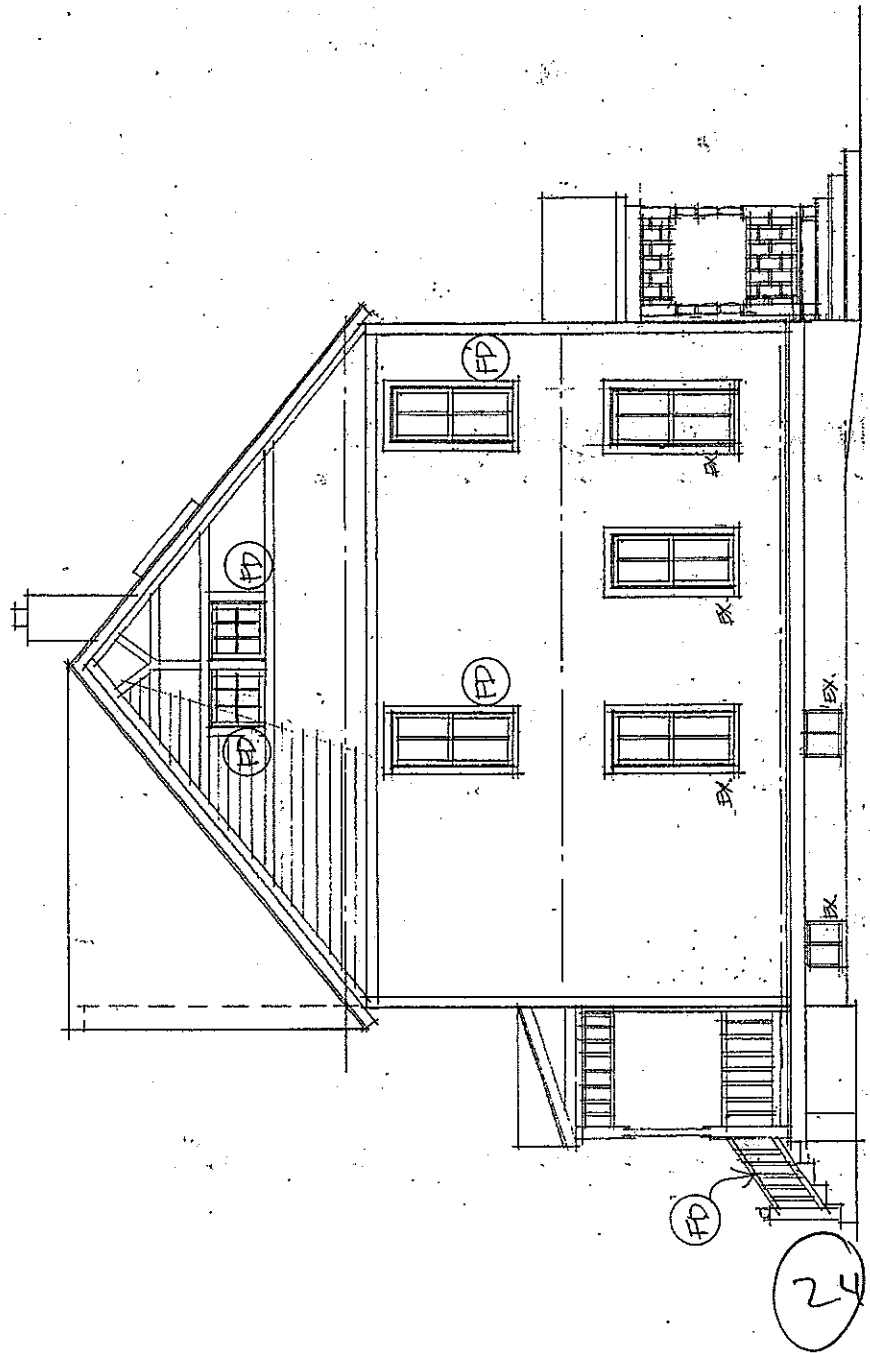
EXISTING SIDE ELEVATION
14-1-101

FD FIRE DAMAGED
EX: EXISTING

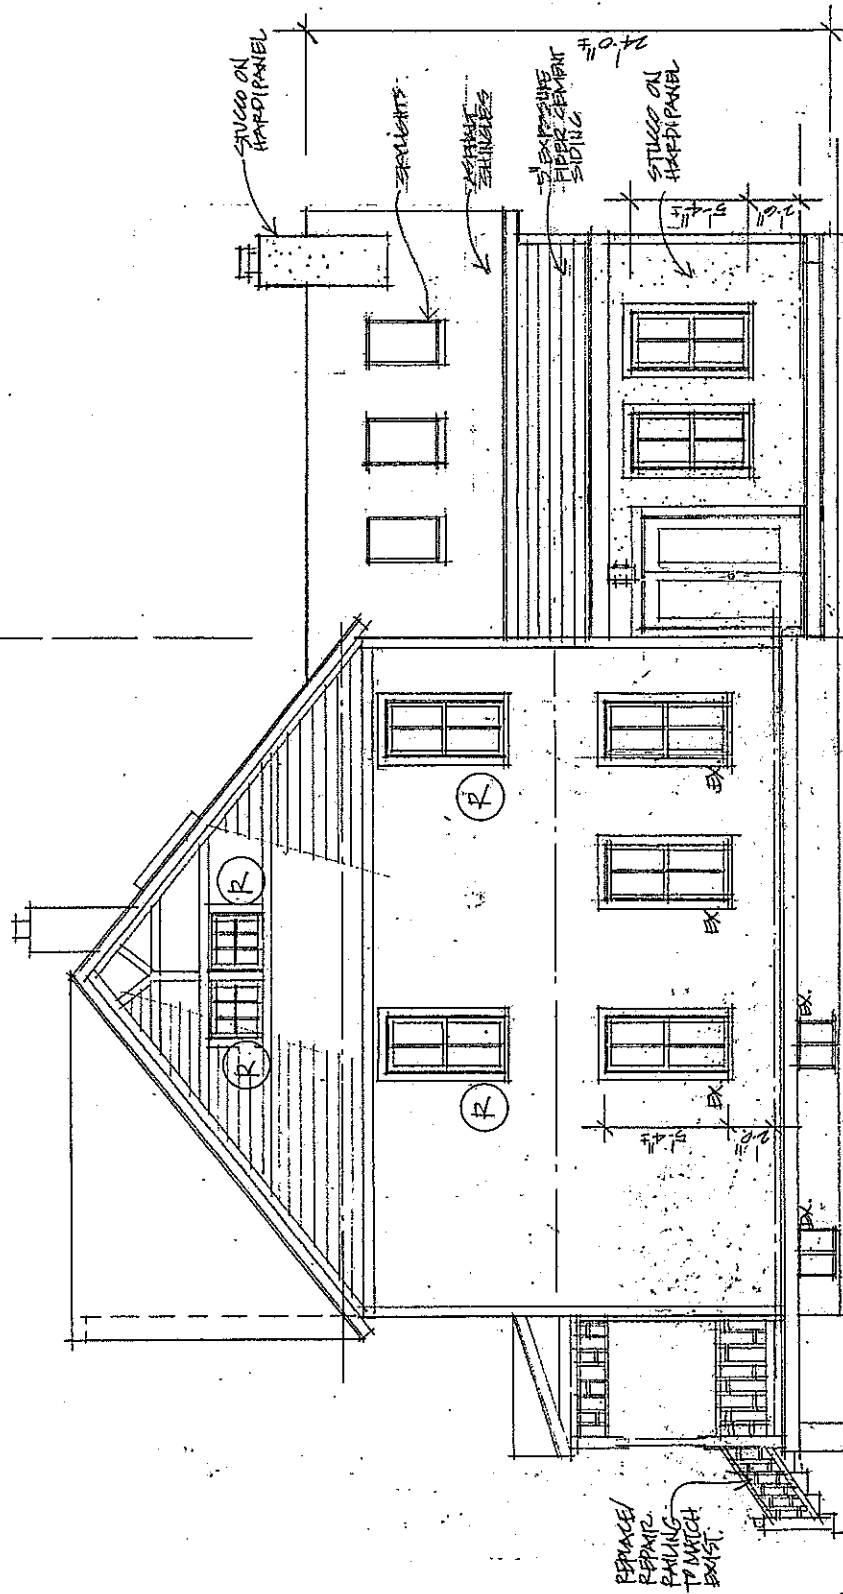
PROPOSED SIDE ELEVATION
14'0"

(R) TO BE REPLACED
EX: EXISTING TO REMAIN

- 6) **Roof:** asphalt shingles at all new roofs (9.5:12 slope), to match existing (new asphalt shingles on main house will replace the fire-damaged cedar shakes).
- 7) **Trim:** The rake boards of the gables will be built-up with ogee rake moulding. Other typical trim will be painted 1 x 4 wood or fiber cement trim at the windows and at the addition corners. The bandboard along the bottom (watertable) and the middle of the addition will be a drip cap atop a 1 x 8 fiber cement trim, painted.

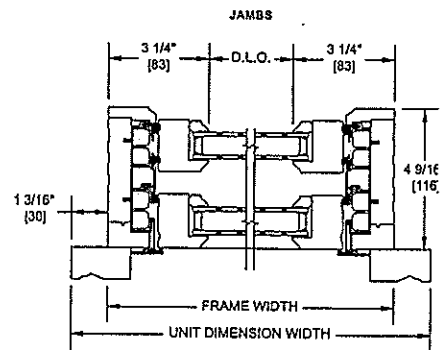
STERLING DOUBLE HUNG CROSS SECTION DRAWINGS

Vertical Section

Horizontal Section

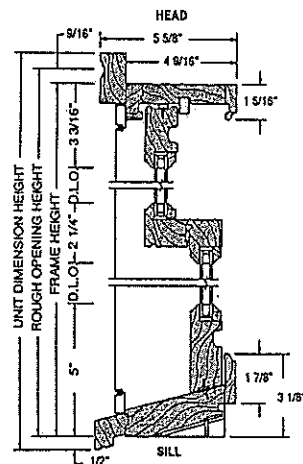
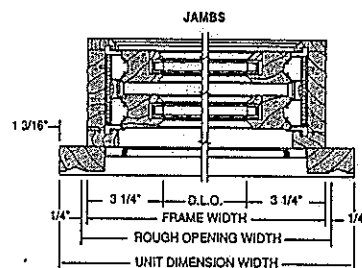
TRADITIONAL DOUBLE HUNG CROSS SECTION DRAWINGS

Vertical Section

Horizontal Section

Drawings are not to scale.

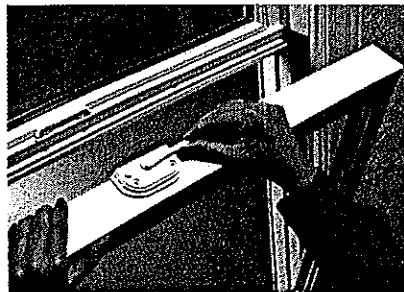
Heavy duty sash lock with dual positioning lever allows sash to be unlocked, operated, and tilted in from one location.
