Preliminary Consultation
HISTORIC PRESERVATION COMMISSION STAFF REPORT

Address: 7323 Takoma Ave., Takoma Park **Meeting Date:** 8/15/18

Proposal: Rear Addition Construction

7323 TAKOMA AVENUE
SPALDING ADDITION · PLAN.

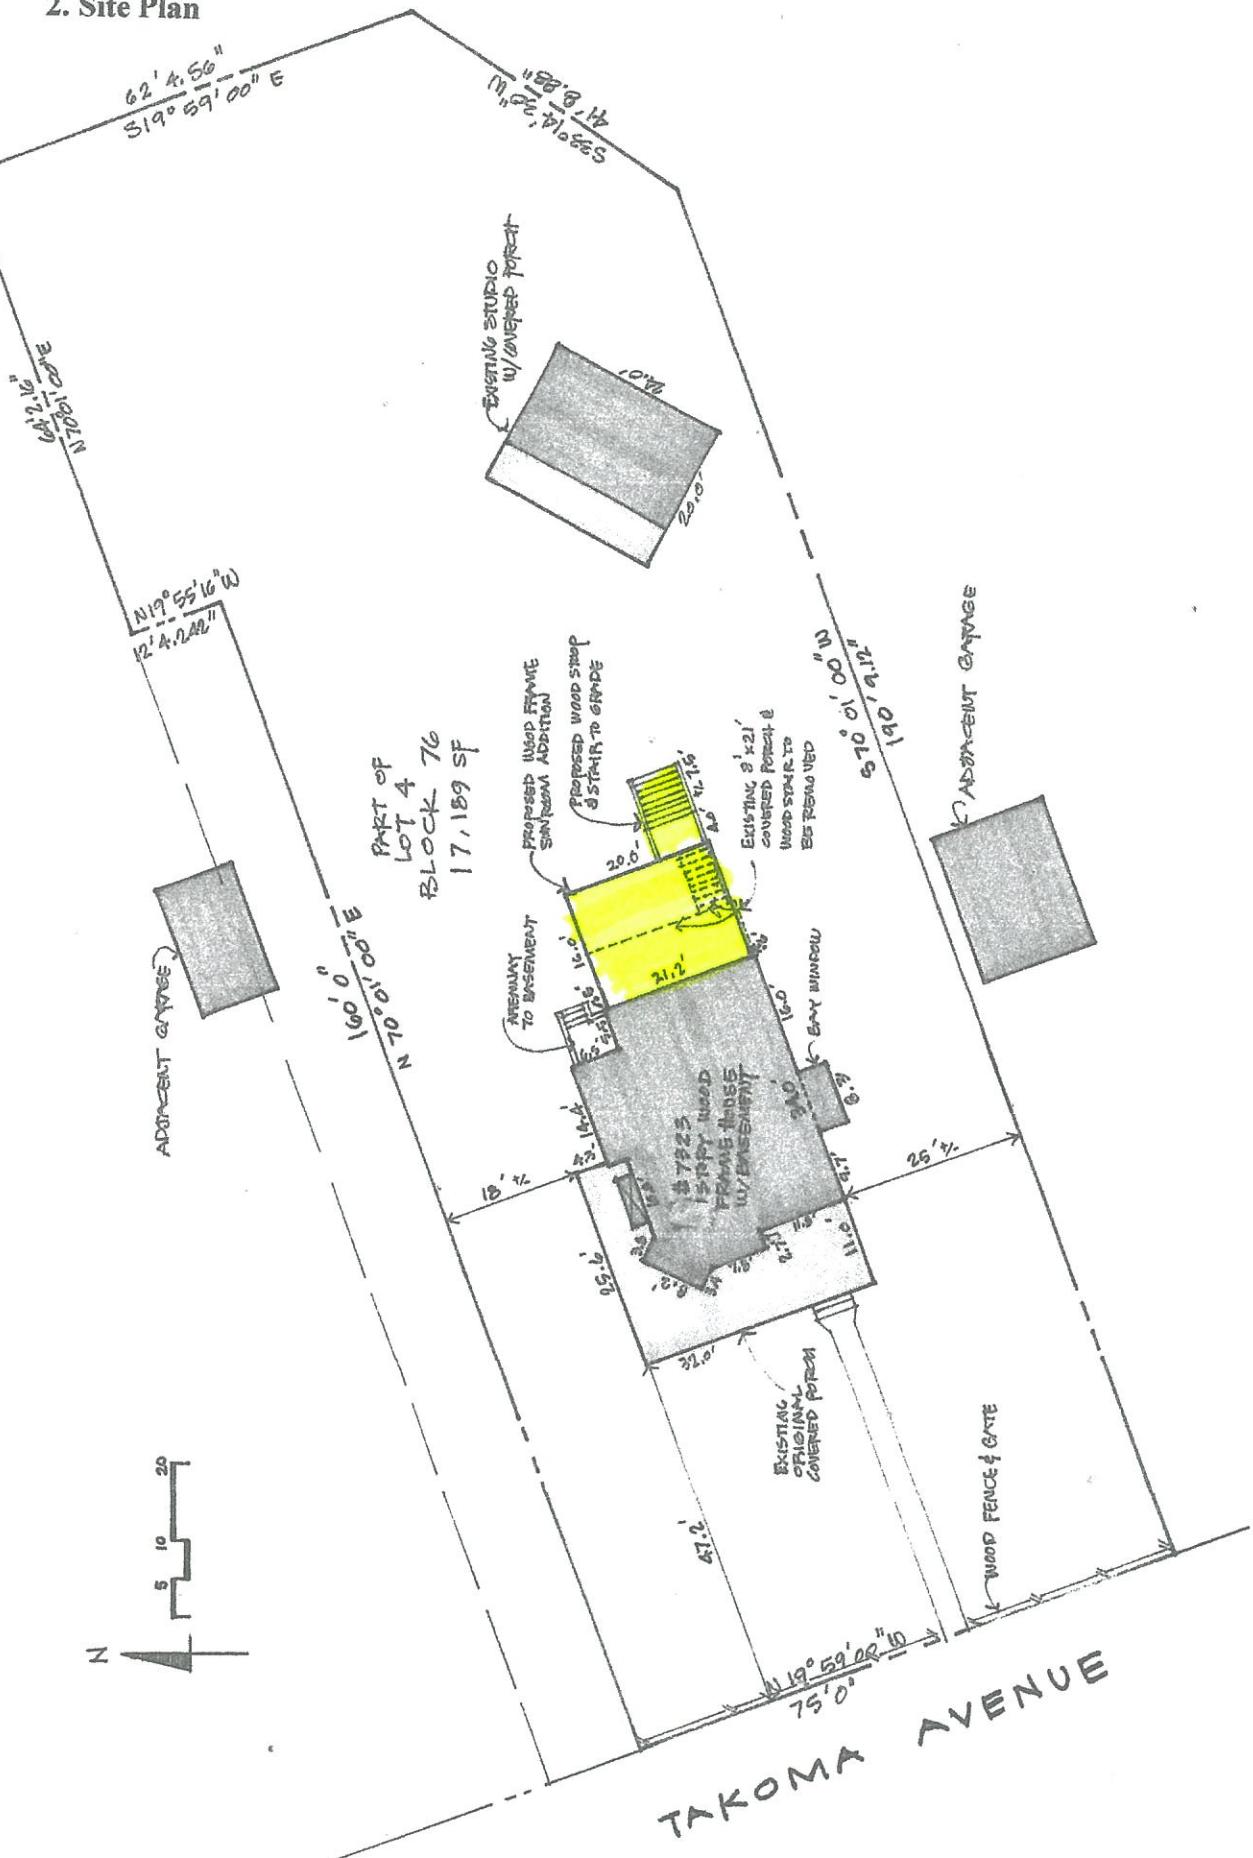
2. Site Plan

7323 Takoma Avenue
Proposed Site Plan with Sunroom Addition
1" = 20-0"

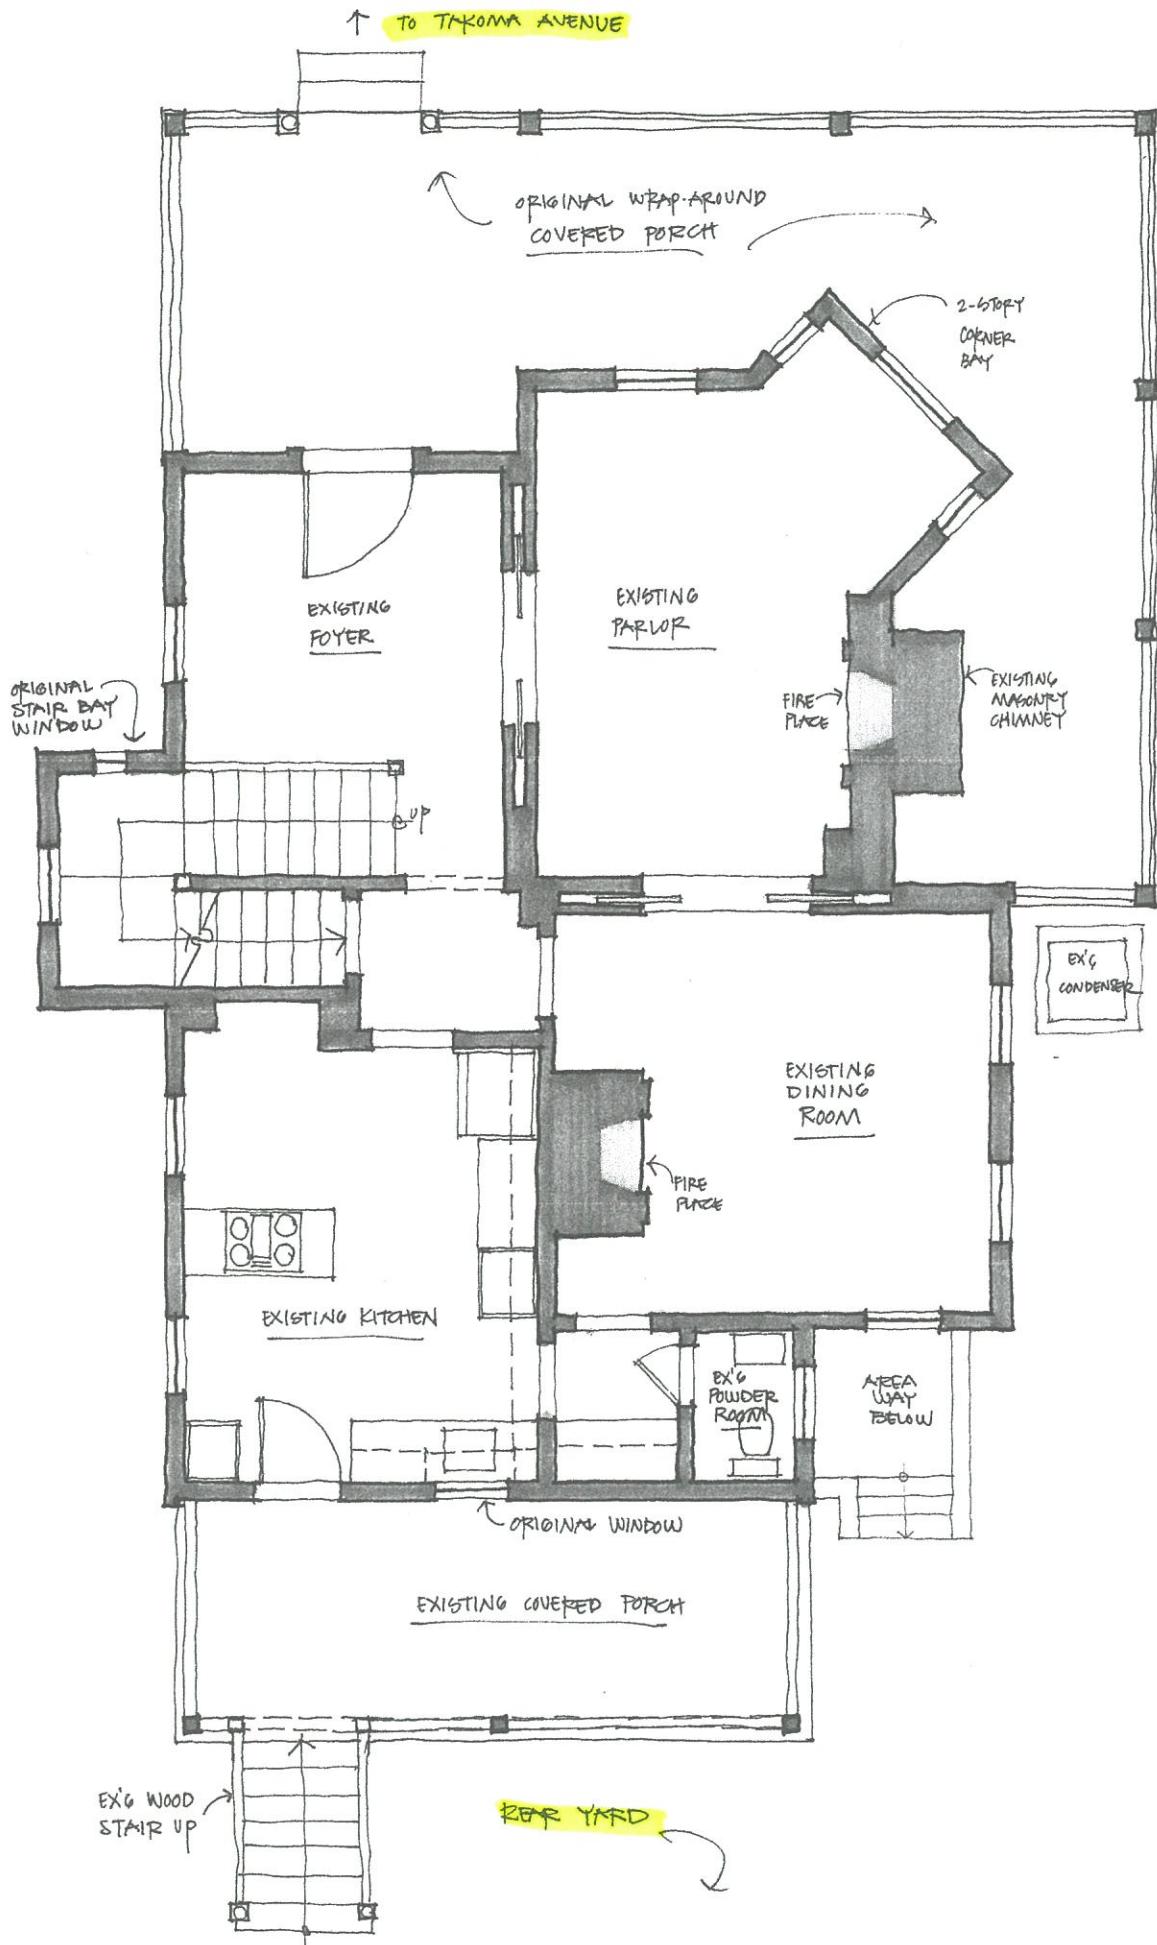
7323 TAKOMA AVENUE
SPALDING ADDITION - EXISTING Floor Plan

1/4" = 1'-0"

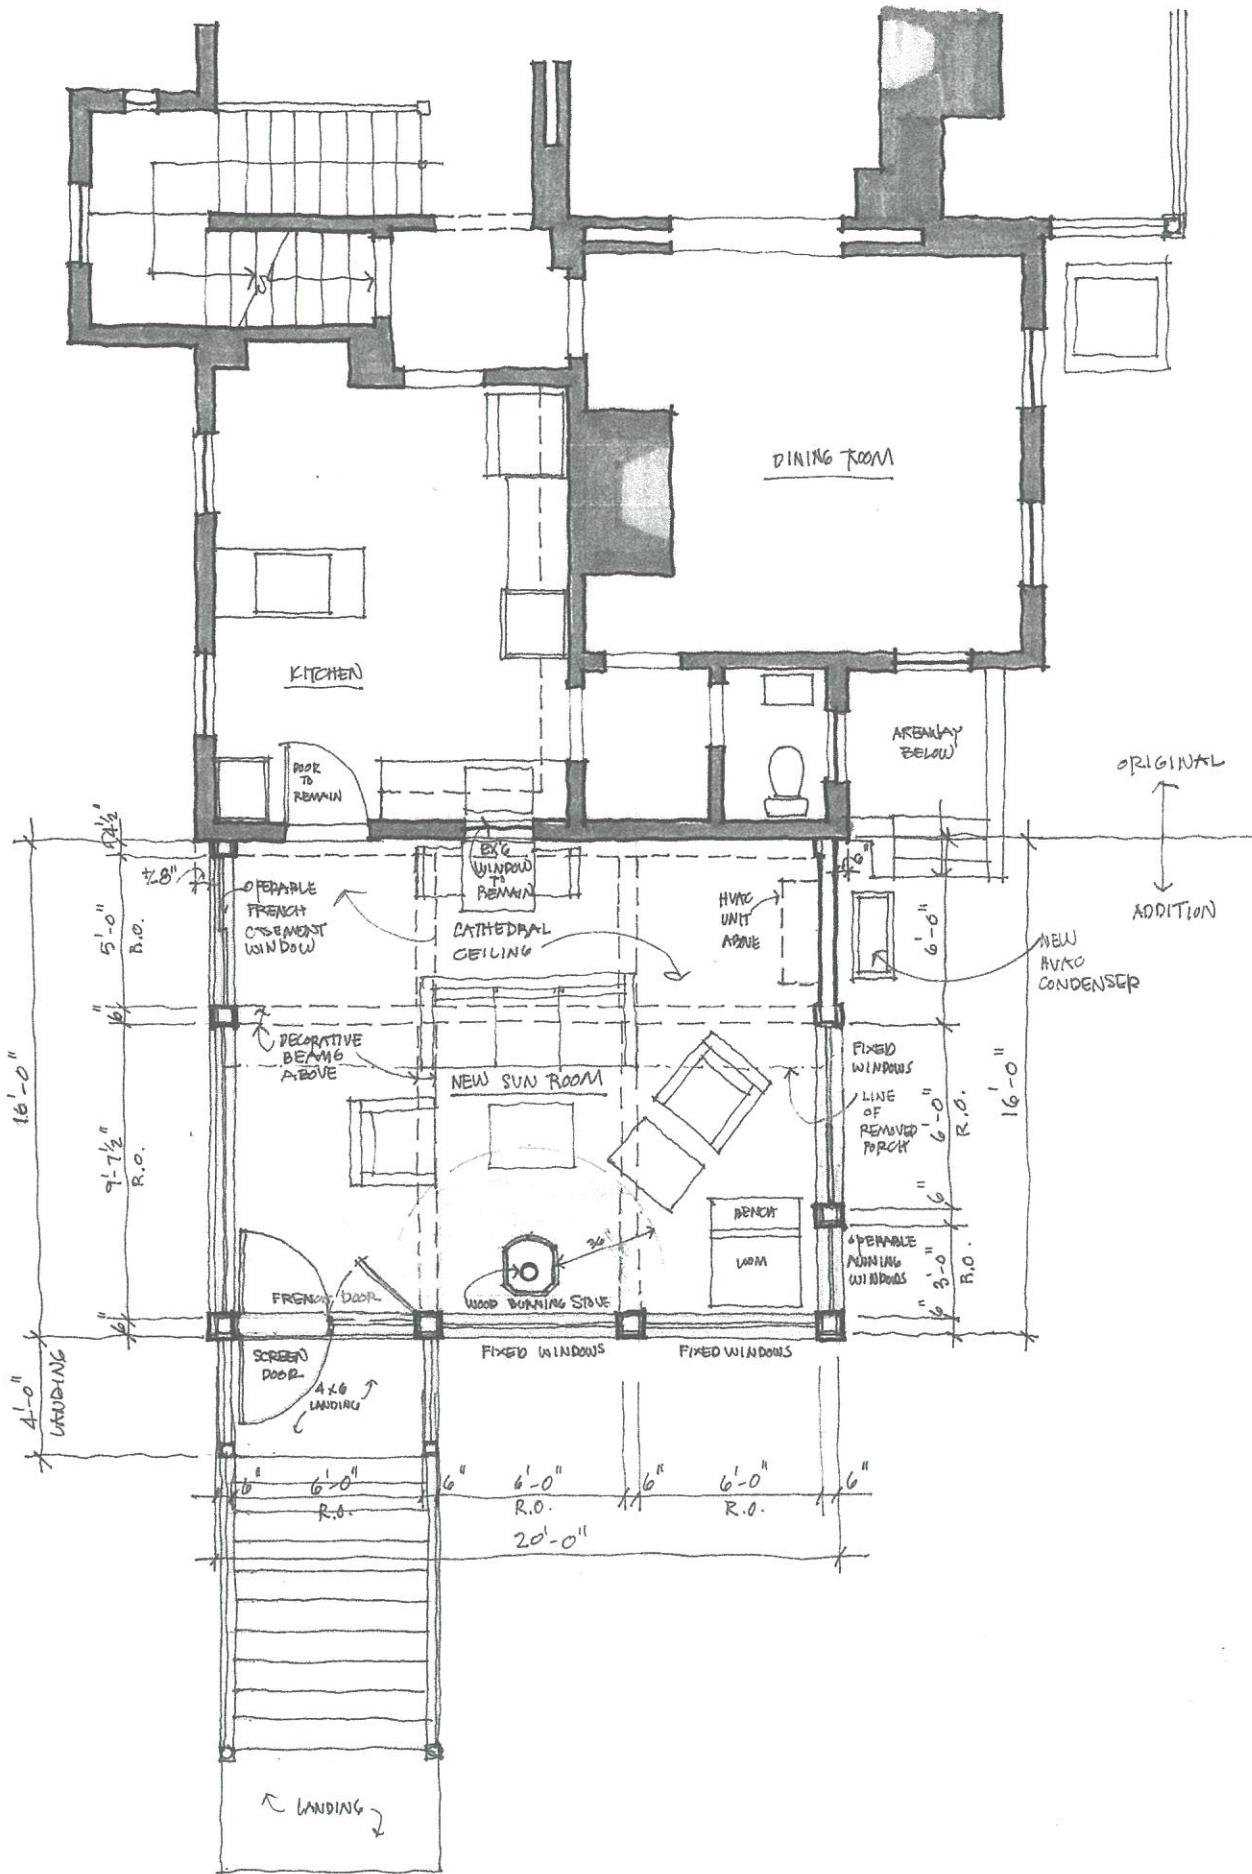
PROPOSED SCHEME C

This project proposes the removal of the existing 8' x 21' covered rear porch and existing exterior wood stair, and the subsequent construction of a new 16' x 20' four season, conditioned, sunroom in its place. Though re-use was considered, the existing porch's narrow width and insufficient structural conditions – lack of 30" deep post footings, undersized and sloped floor joist, and rafters inadequately sized to accommodate R49 ceiling insulation – make its re-use prohibitive.

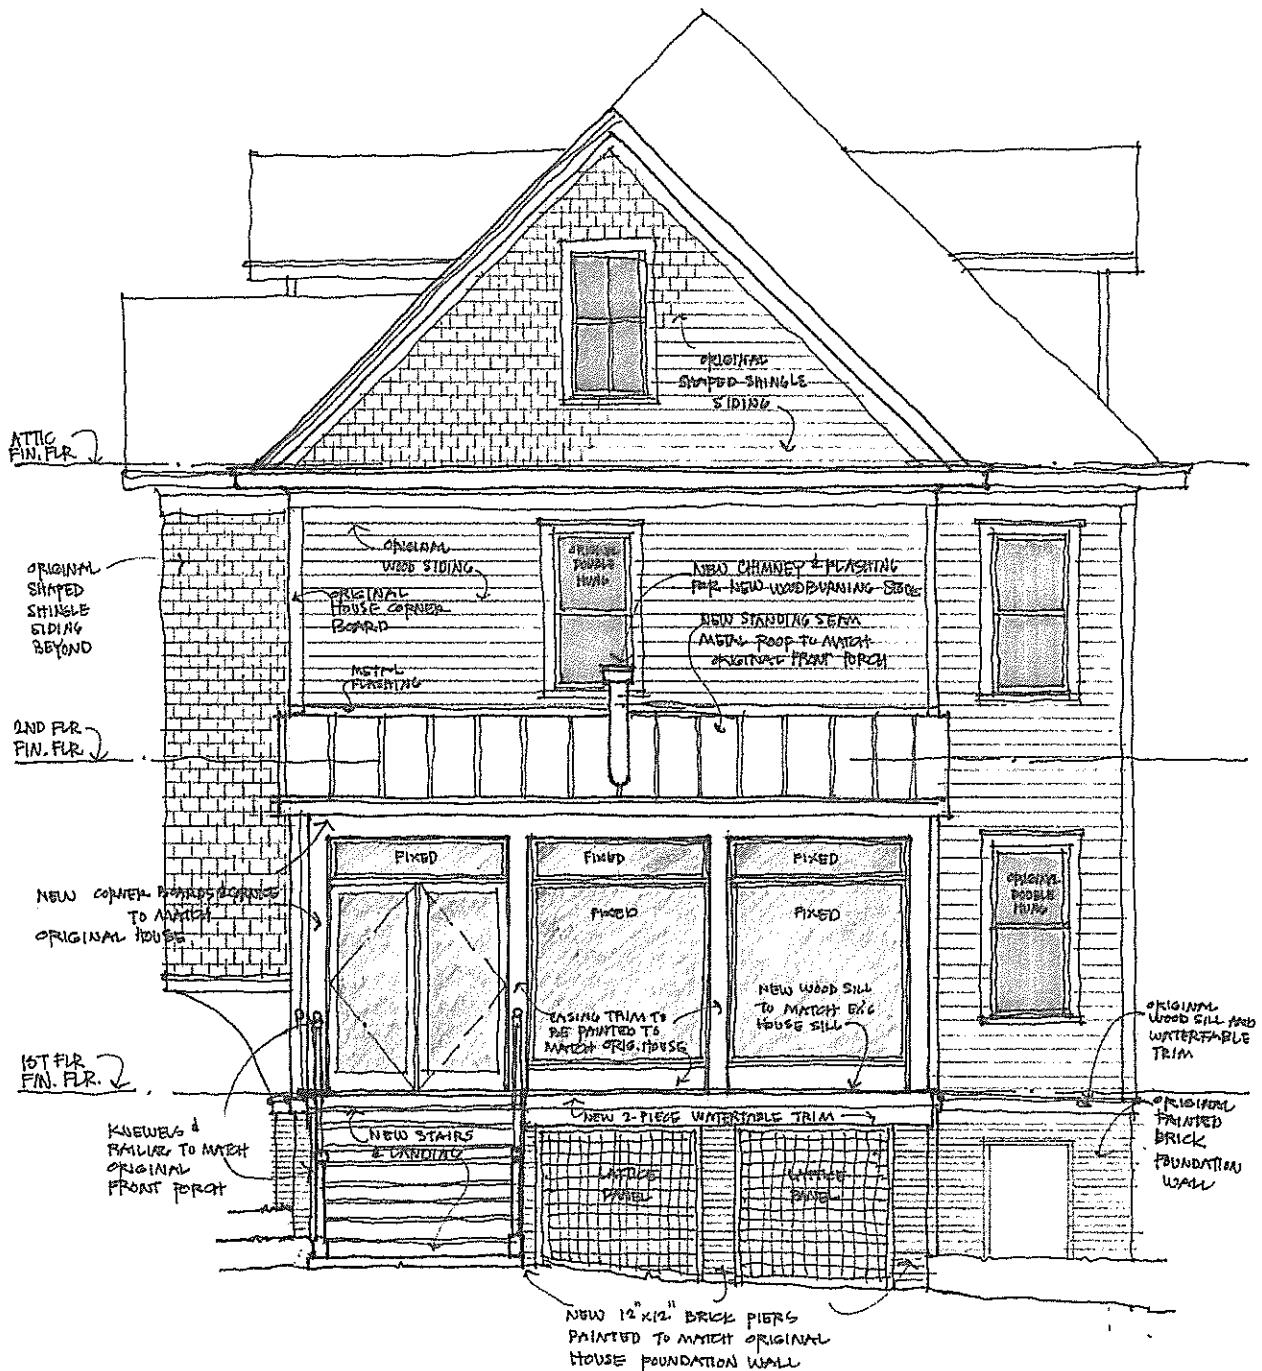
SPALDING ADDITION · EAST ELEVATION · SCHEME C

1/4" = 1'-0"

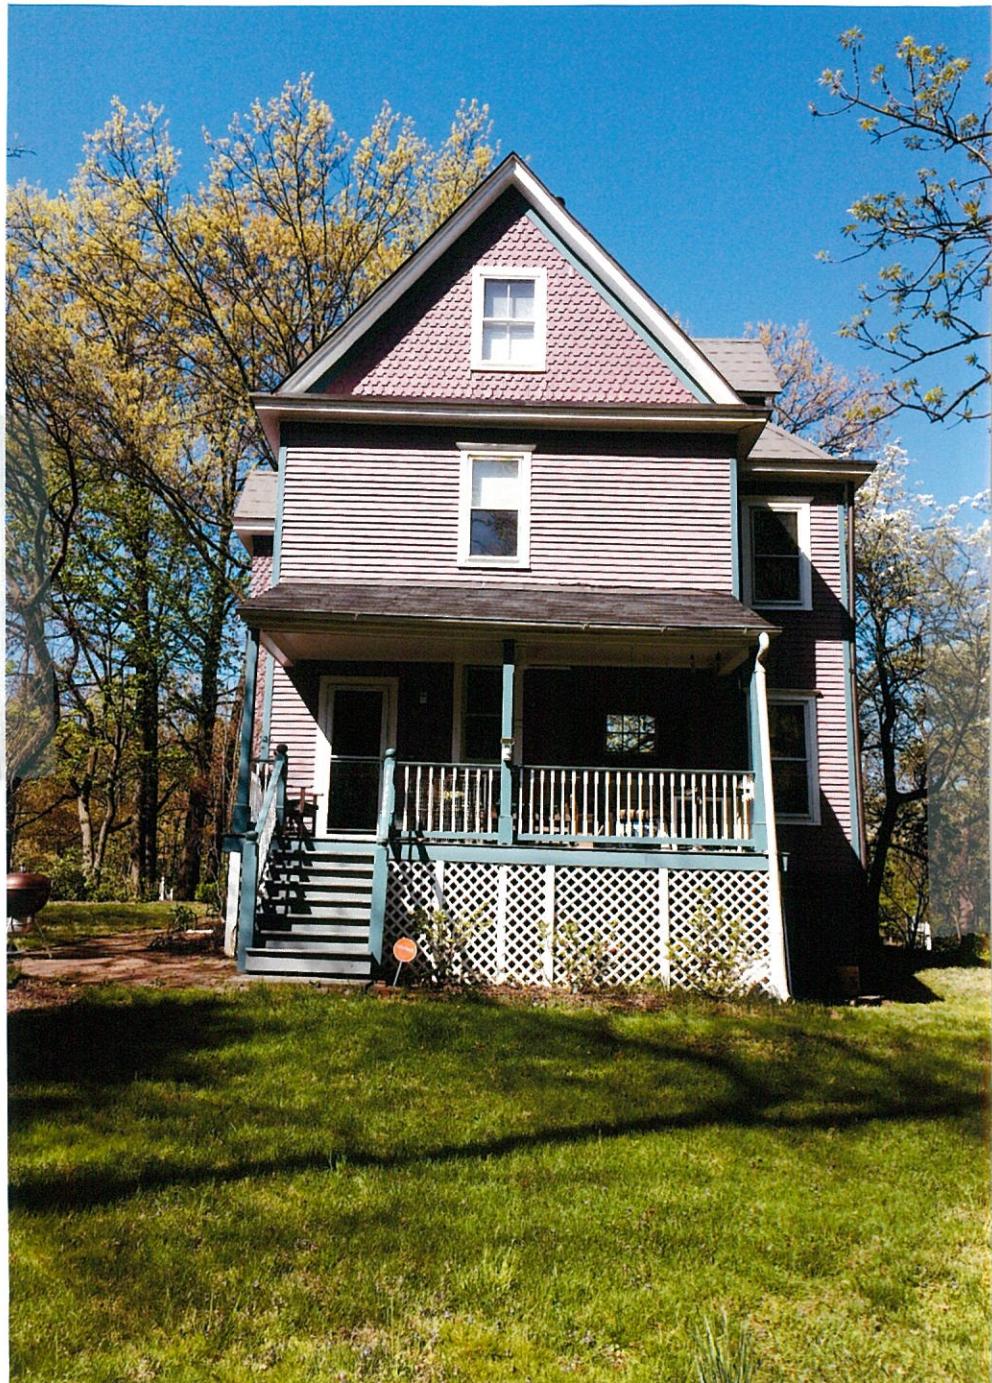
Detail: Rear Porch Elevation

The existing porch is 8' × 21' (eight feet by twenty-one feet) and is covered in a shed roof accessed by wood steps. The configuration and architectural features of the porch do not appear to be consistent with the high style found on the rest of the house. The applicant indicates that the interior structure of the porch does not align with the house, further suggesting that the porch is not an original element to the house. Additionally, a search of the historical Atlases and Sanborn maps indicate that this porch was constructed sometime after 1948. As this is not a historic feature and it is at the rear Staff would support removing the rear porch in a HAWP application.

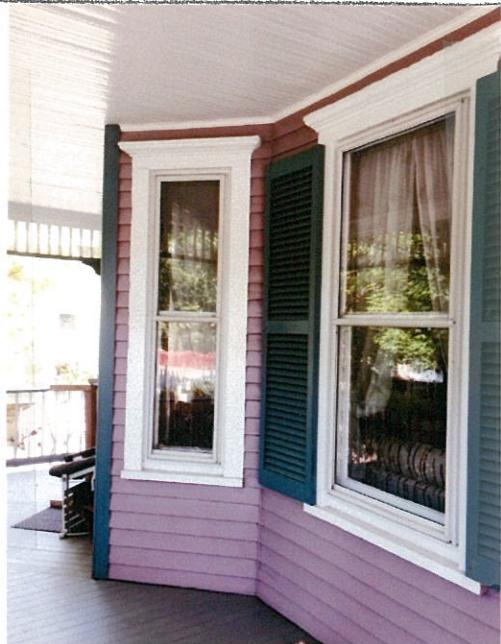
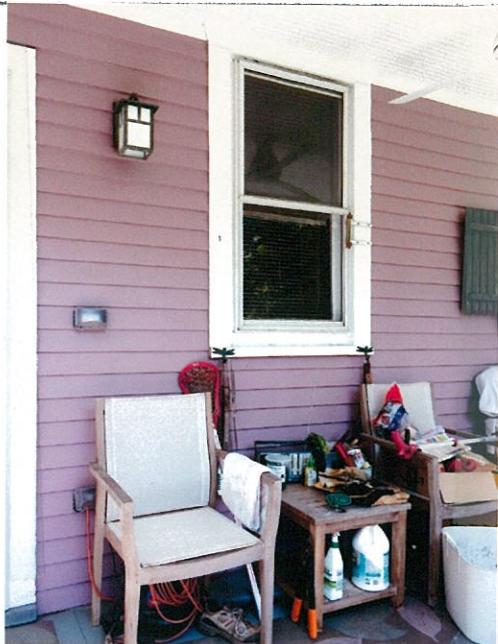
Living Room Windows onto Front Porch w/full head casing

Kitchen window onto Rear Porch w/truncated head casing

Detail: Dissimilar Casing Trim Conventions at Windows onto Porches

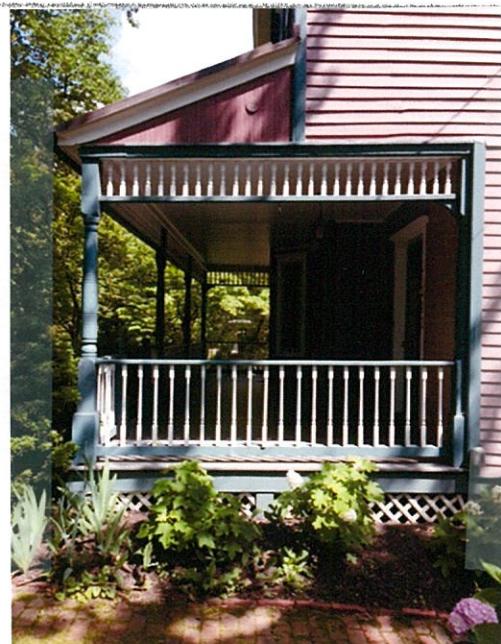
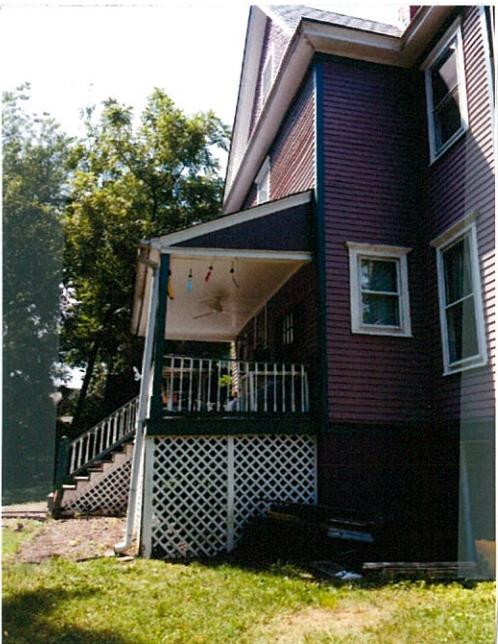
Front Porch shallow floor slope

Rear Porch steep floor slope

Detail: Dissimilar Framing Conventions at Porches

covered balcony. The extreme slope of the porch floor joists do not exhibit the same framing conventions used on the front porch. And the foundation posts connections' to the bearing beam, and stacked structural posts above, again indicate dissimilar construction techniques from the original front porch. Finally, though many of the rear porch finishes and decorative details simulate the covered front porch - such as vertical rake wall siding, similar column base and capitol detailing, and matching knewel posts - many details are lacking in the finished quality of the front porch. The asphalt shingle roof sheathing, the lack of foundation post trim, and poor watertable trim detailing, both at the connection to the original house and at the porch corners, do not exhibit the excellent attention to detail typically given to the original house. Given these observations, we determined that the removal of a rear porch that it is not original to the house, nor historically significant, will not diminish the historic value of the original house.

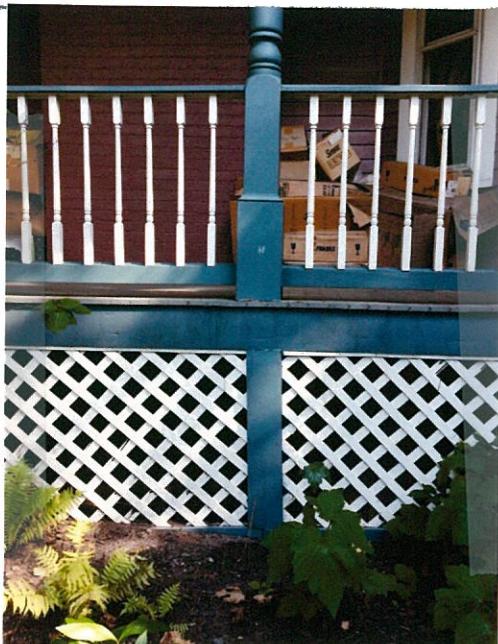
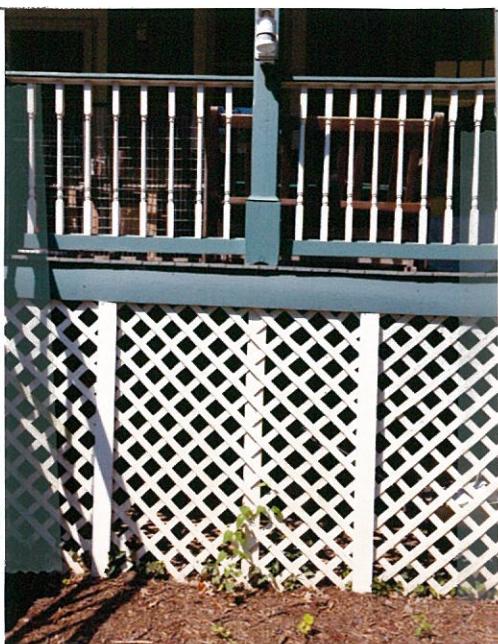
Front Porch Columns stack directly over foundation posts and are trimmed flush w/beam and posts

Rear Porch Columns are stacked over foundation posts but are not trimmed flush w/beam and posts

Detail: Dissimilar Finishing Conventions at Interior Porch Columns

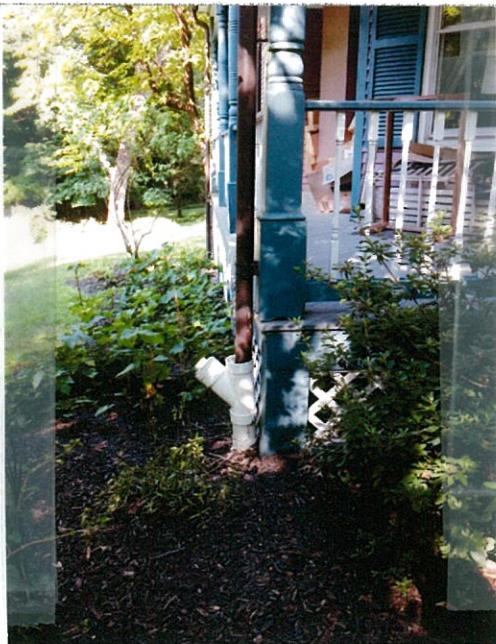
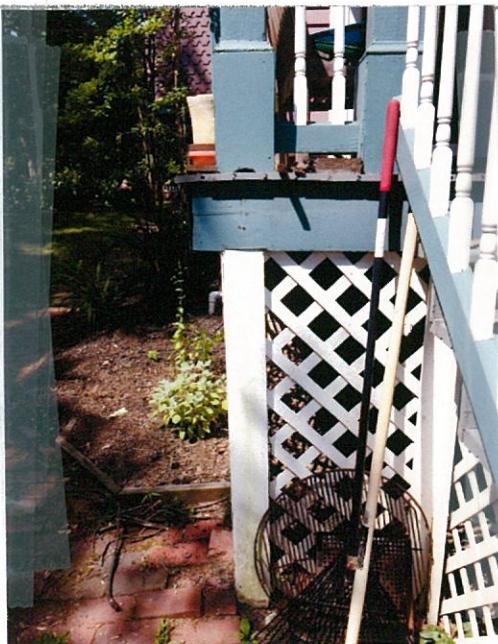
Front Porch Columns stack directly over foundation and trimed flush w/ beam

Rear Porch Columns are offset over foundation and trim is not flush w/beam and columns@corner

Detail: Dissimilar Framing Conventions at Corner Foundation Posts

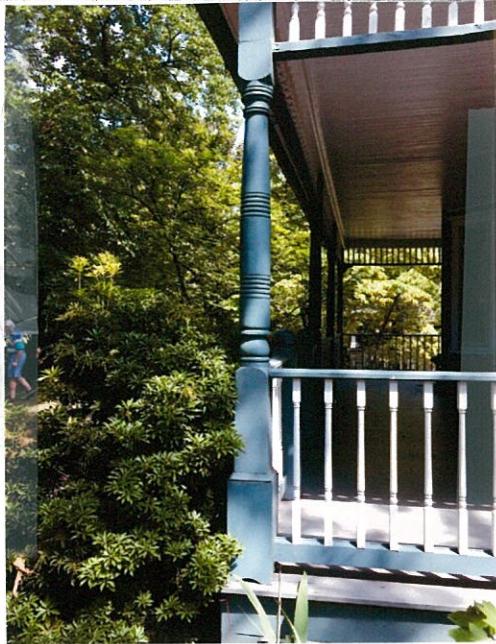
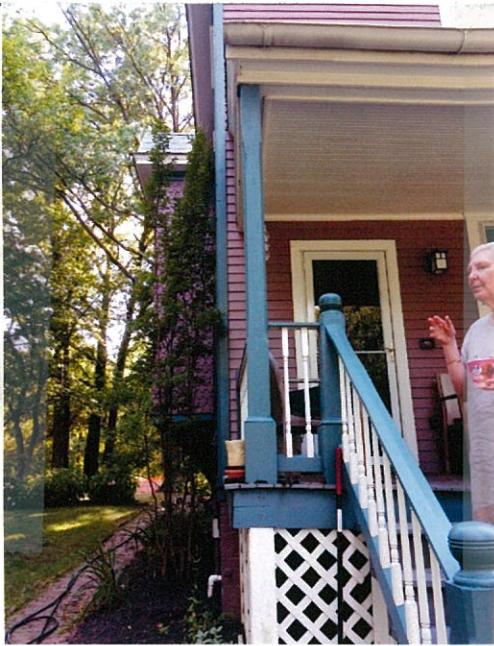
Front Porch w/ 5 $\frac{1}{2}$ " turned columns,
pedestal base, plinth block &
entablature/beveled cap

Rear Porch w/ 4 $\frac{1}{2}$ " chamfered columns
w/ plinth block

Detail: Dissimilar Columns

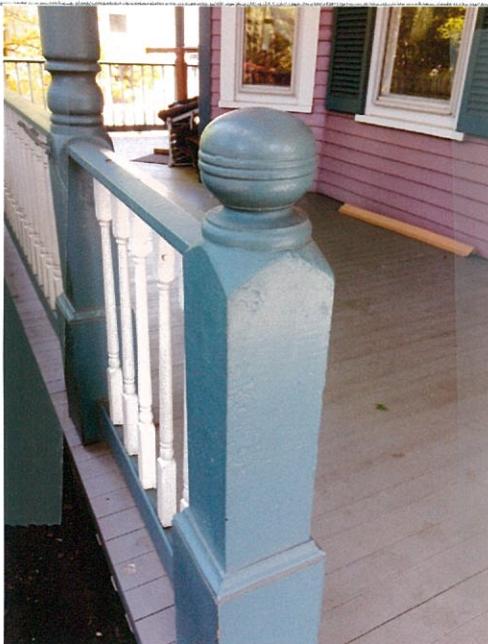
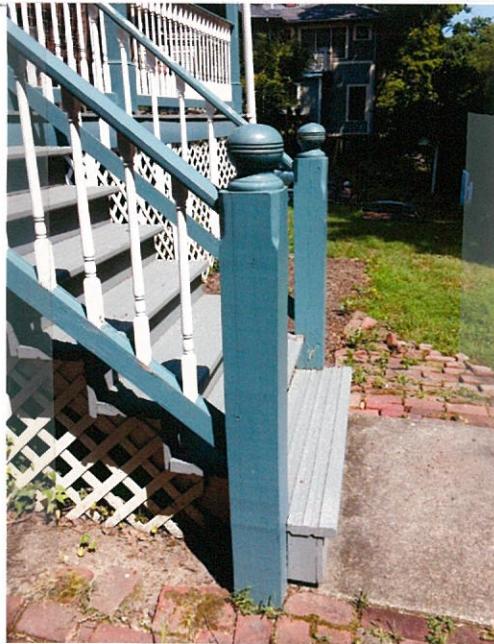
Front Porch Knewel w/shallow
bevel @ finial & plinth block

Rear Porch Knewel w/longer beveled
corners and no plinth block

Detail: Similar Knewel Posts
