*Preliminary Consultation*  
**MONTGOMERY COUNTY HISTORIC PRESERVATION COMMISSION**  
**STAFF REPORT**

<b>Address:</b>	10500 & 10520 St. Paul St., Kensington	<b>Meeting Date:</b>	10/24/18
<b>Resource:</b>	Primary Resources <b>Kensington Historic District</b>	<b>Report Date:</b>	10/17/18
<b>Applicant:</b>	McCaffery Interests	<b>Public Notice:</b>	10/10/18
<b>Review:</b>	Preliminary Consultation	<b>Staff:</b>	Rebecca Ballo
<b>Proposal:</b>	Partial demolition, rehabilitation, new construction, and site work.

**Date:** September 7, 2018  
**To:** Rei Takata; Jeff Gerner  
**From:** Emily Eig; Alyssa Stein  
**Subject:** Preservation Recommendations for 10500 St. Paul Street, Kensington

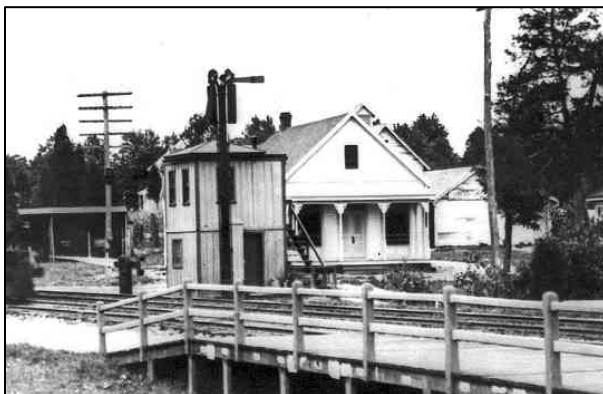
**Figure 1** Robert Humphreys, Railroad station - 1902 photo - #4 of 4 sections, 044-013C, Montgomery County Historical Society.

The Mizell building is considered a contributing resource to the Kensington Historic District. Through research, EHT Tracerics has been able to uncover a document dated from 1897 providing specifications for a store located at 10500 St. Paul Street. The one-story store was constructed by William H. Mannakee, an early land proprietor of Kensington. The building is said to be 22 feet by 40 feet, with a height of approximately 25 feet. An image circa 1902 that shows the building as a rectangular block corroborates this footprint.

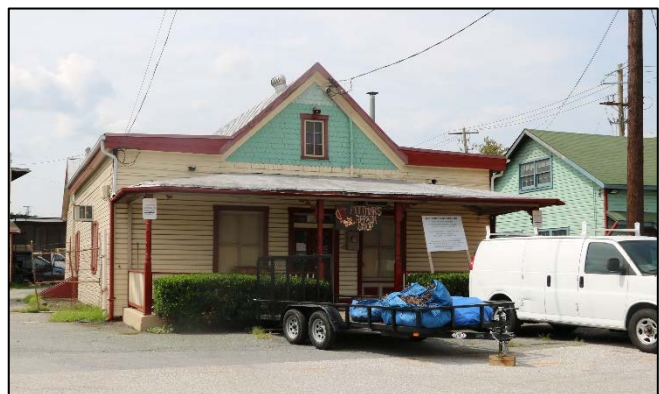
**Figure 2** 10500 St. Paul Street. EHT Traceries, 2018.
