Preliminary Consultation MONTGOMERY COUNTY HISTORIC PRESERVATION COMMISSION STAFF REPORT

Address: 21 Grafton St., Chevy Chase Meeting Date: 5/7/2019

Chevy Chase Village Historic District

PROPOSAL: Building Addition and accessory structure removal and construction, and other

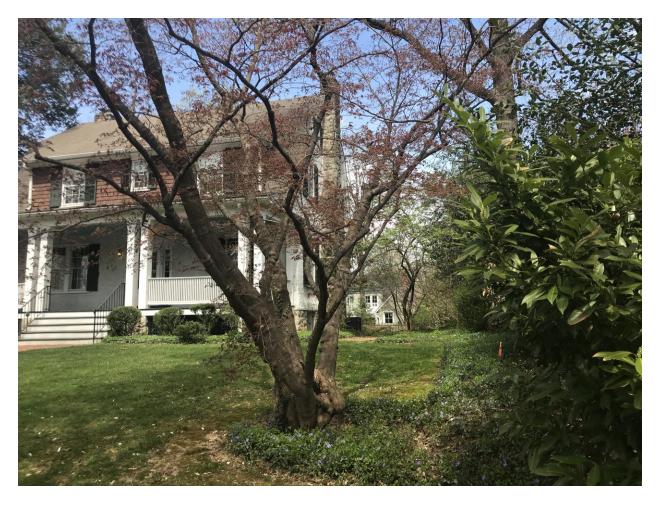
Figure 2: View of the east (right) side of the house, showing where the addition will project.

The one outstanding issue is that the addition will be offset so that it projects to the right of the east (right) historic wall plane. The first-floor plan will project by 6' (six feet), but due to the gambrel overhang, the second will project by 7' 2" (seven feet, two inches). Due to the house placement on the lot and the topography this projection will be visible from the right-of-way when evaluated in the absence of vegetation.

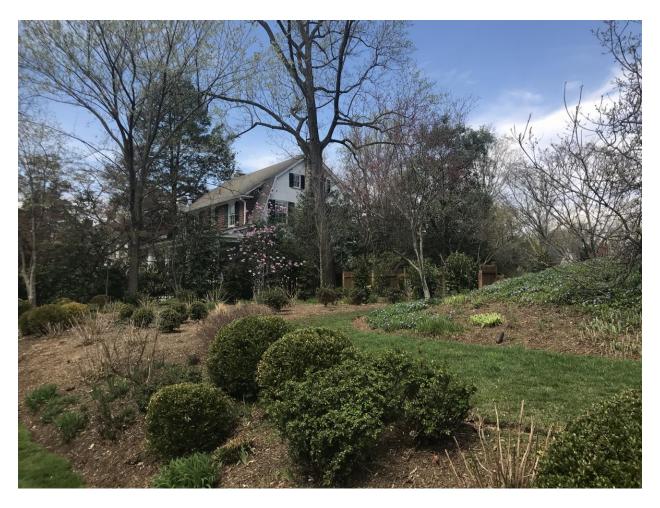
Figure 3: View from in front of 17 Grafton St. looking west.

The *Design Guidelines* state that additions should be placed to the rear, so they are less visible from the public right-of-way. This lot, however, presents a unique situation regarding the visibility of the new construction. The house to the east, 17 Grafton is on a double lot, which leaves a large open expanse between it and the subject property (see below). The 80' (eighty foot) setback between the subject property and its neighbor to the east will make any rear addition highly visible from the right-of-way.

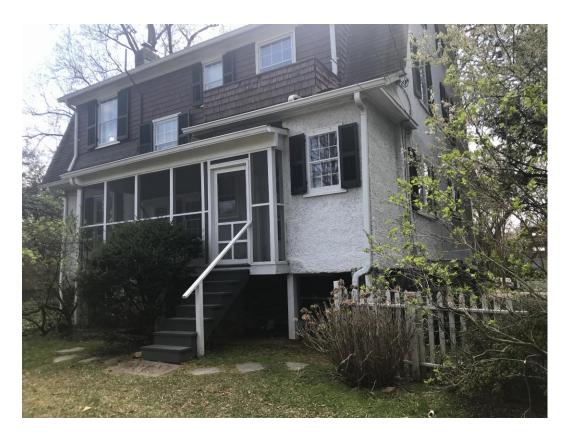
Figure 4: Rear of the house showing the rear projection.

The applicant has indicated a desire to retain the rear projection in the northwest corner of the house, which is why the design shifts the massing of the addition to the east (right). Staff could potentially support this justification; however, the Sanborn Map shows that the feature was a porch in 1927, and the house foundation changes from continuous stone to wood piers, suggesting change in construction. Staff has not fully evaluated the window in this room, but suspects that it could be identified as a non-historic wood window and was installed when the rear porch was enclosed. Staff welcomes additional information that could confirm that this feature is in its historic configuration, which would provide additional justification for retaining the space. In the absence of that information, Staff recommends that the one-story rear addition be removed, and the rear addition be shifted west so that it is fully behind the historic massing. The HPC typically requires that rear additions be inset from the historic wall planes to better differentiate the new construction from the historic and to ensure that the new construction does not overwhelm the historic.

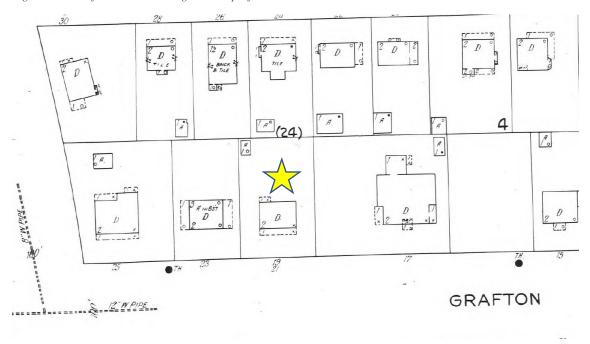
Figure 5: 1927 Sanborn map showing 21 Grafton St (co-listed as 19) with a porch projection in the northwest corner.

The existing house is a Dutch Colonial with a gambrel roof, stuccoed first floor, and shingle siding above. The full-width front porch has steep wood front steps and a sloping deck. The deck's slope appears to have been caused by settling of the porch piers. The house's six-over-six windows all appear to be historic and in working order. In the northwest corner of the house, there is a projecting one-story mud room or butler's pantry is a historic feature that, historically, was a rear porch that was probably reconfigured in 1977 when the current rear porch was added (see the 1927 Sanborn Map below).

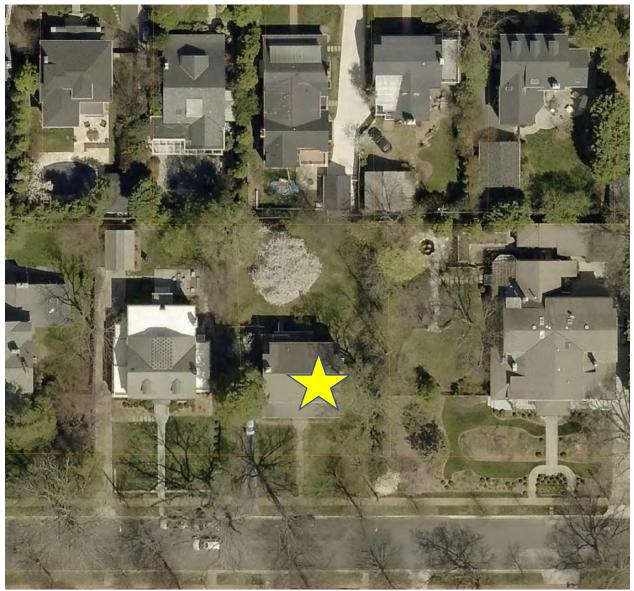
Figure 6: Detail of map showing the subject property and the surrounding buildings, their additions, and accessory structures.

In consultation with Staff the applicant notes that their desire was to construct an addition that did not project further into the rear of the yard, because they desired to retain more rear yard and already felt constrained because the houses to the rear have rear additions and accessory structures constructed virtually at the property line. Staff can confirm that it appears as though the accessory structures to the rear were installed at less than the 5' setback currently required. This is detailed in the photos submitted with the application and in the aerial photo below. Staff finds that a deeper addition could have a negative impact on the park-like character of the surrounding district, but does not find this to be a sufficiently compelling argument to have an addition project beyond the historic wall plane.

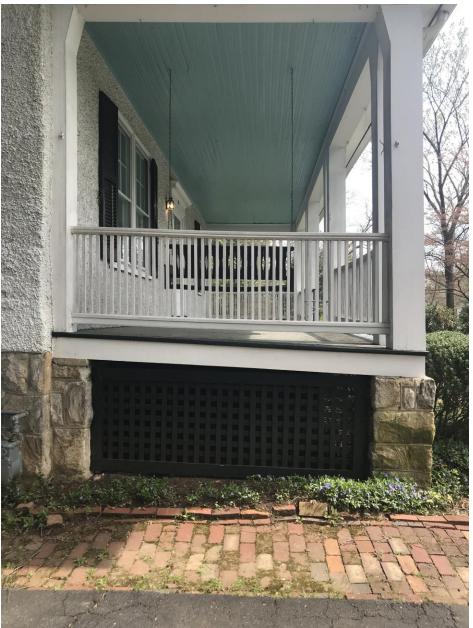
Figure 7: Slope of the front porch.

The existing front porch decking has a significant slope and needs to be replaced. Staff finds that this should be approved as a matter of course once details for the repair are submitted. Staff also notes that this repair would be eligible for the County Historic Preservation Tax Credit.

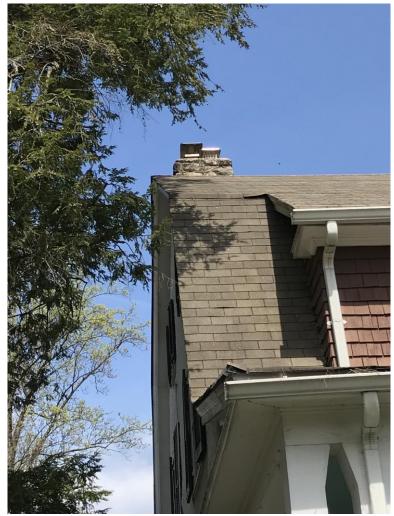
Figure 8: Coal furnace chimney proposed for removal.

Finally, the applicant proposes removing the historic furnace chimney on the west side of the house. This is an interior chimney that was installed when the house still operated a coal furnace. The chimney is visible from the right-of-way; however, its prominence is diminished as it is placed behind the gambrel ridge. The *Design Guidelines* state that for exterior alterations not addressed by the *Guidelines* the changes should be evaluated so that alterations are consistent

with the, "two paramount principles... fostering the Village's shared commitment to evolving eclecticism while maintaining its open park-like character." Staff finds that the removal of this chimney will not have a significant impact on the house or district's historic character, the district's park-like setting, or the architectural style of the house. No changes are proposed for the chimney on the east elevation will retain its prominent exterior stone detailing.

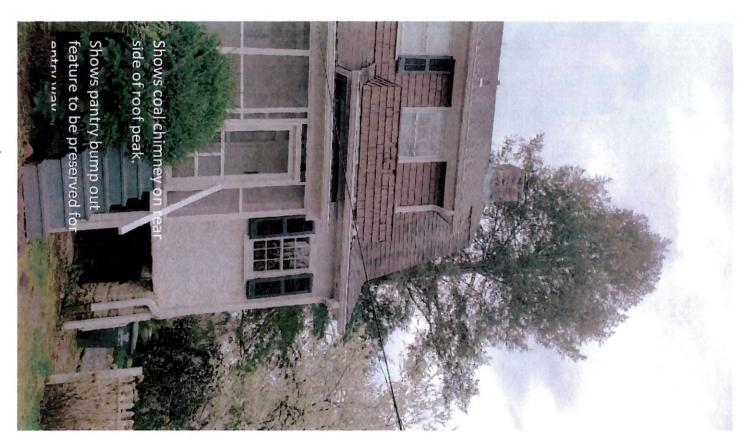
Rear Chimney shown via back/west elevation (left side)

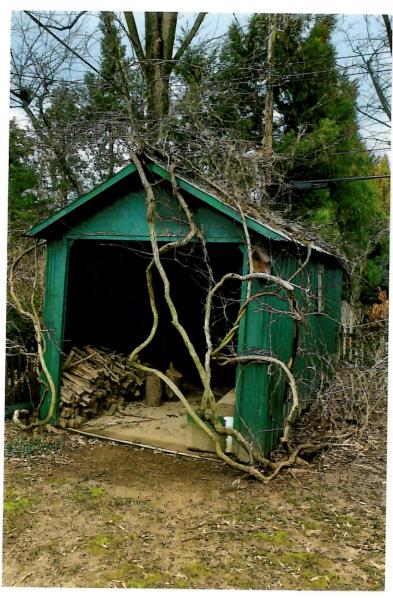
EXISTING METAL GARAGE/SHED FRONT ELEVATION

The existing accessory structure is a one-bay structure covered in corrugated metal siding and roofing. Staff is reluctant to call this structure a garage, as the driveway does not extend all the way back to this location. The Sanborn map (see above) shows a structure in this location, however, Staff is unsure if the existing structure is the one identified on the map. Staff finds that the accessory structure has significantly deteriorated and may be beyond repair. Specifically, the slab has a significant crack, the siding shows rust and corrosion. Staff would recommend demolition of this structure in a HAWP review.

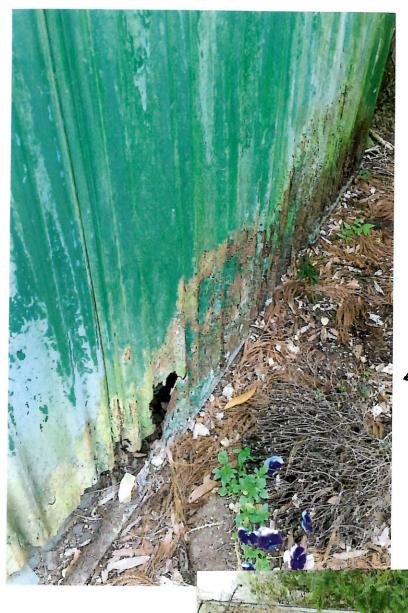
← Rotting & Deteriorating Metal Shed/garage (BACK SIDE)

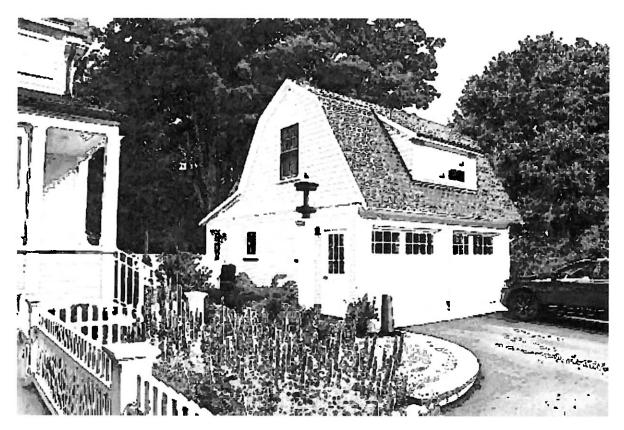
POSSIBLE SHED/GARAGE DESIGN

Staff finds that the placement and architectural details of the proposed garage are appropriate but is unsure if the height is out of character with the house and surrounding district. The height of the proposed garage was not included with the submission which would help better evaluate the proposal. However, Staff's windshield survey of the surrounding district demonstrated that the majority of garages were only one-story and a garage taller than that may be out of scale with the surrounding district. Staff recommends that the applicant make revision to the garage concept so that it is only one story tall.

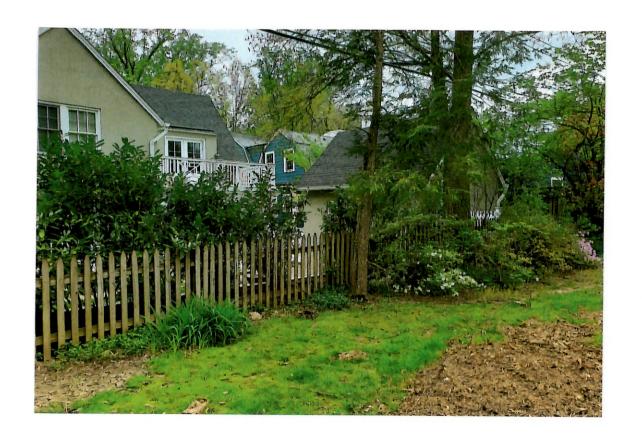
Rear yard-note close locations of additions, garages, and homes
