MONTGOMERY COUNTY HISTORIC PRESERVATION COMMISSION
STAFF REPORT

Address:	21 Grafton St., Chevy Chase	Meeting Date:	7/10/2019
Resource:	Contributing Resource Chevy Chase Village Historic District	Report Date:	7/3/2019
Applicant:	Duane and Paula Gibson (Doug Mader, Architect)	Public Notice:	6/26/2019
Review:	HAWP	Tax Credit:	No
Case Number:	35/13-19DD	Staff:	Dan Bruechert
PROPOSAL: Building Addition and other alterations

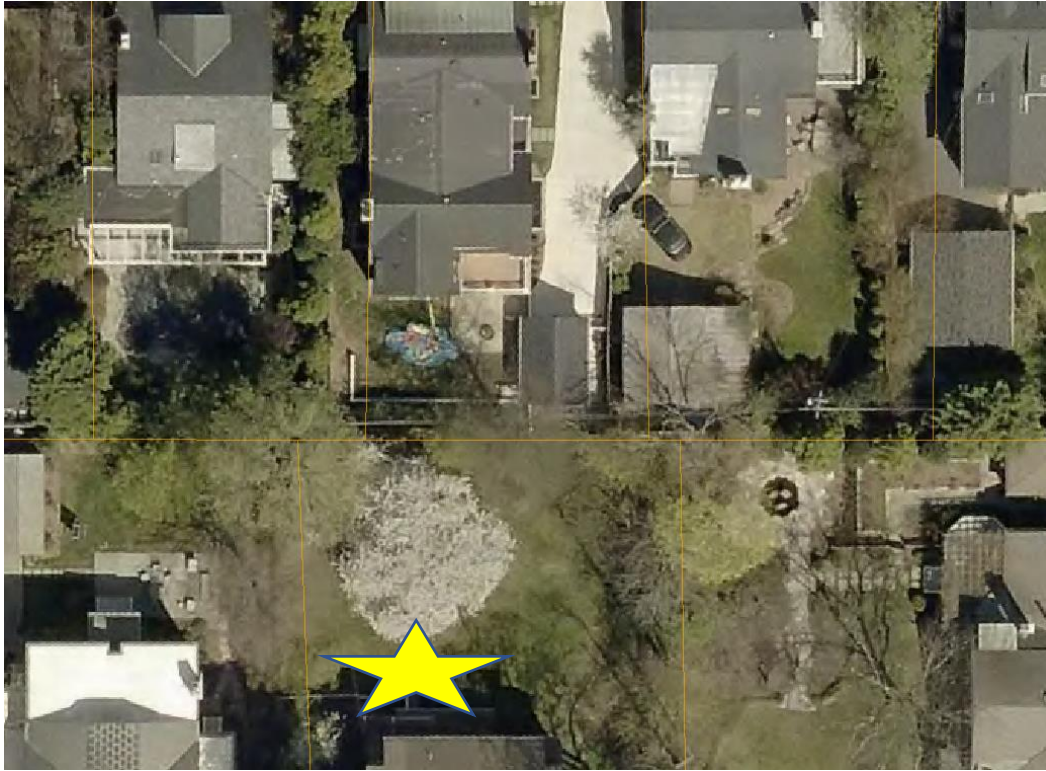
Figure 2: Rear lot of the subject property showing the encroachment of house additions and outbuildings at the rear.

Staff finds the impact of these buildings is not effectively transmitted in the map and photograph included in this Staff Report, but that it does create a sense of being closed in and an addition that projects further to the rear would only compound that sensation. Additionally, the

house to the east, 19 Grafton, is on a double lot, which leaves a large open expanse between it and the subject property (see Fig. 2, above). Regardless of whether the addition projects 6' (six feet) or is inset from the historic wall plane, it will be highly visible from the right-of-way to the east. The 80' (eighty foot) setback between the subject property and its neighbor to the east will make any rear addition highly visible from the right-of-way. This partially frustrates the purposes of the *Design Guidelines* for requiring additions to be placed to the rear of the historic buildings to make them less visible from the right-of-way, because any addition to this house will be highly visible from the right of way.

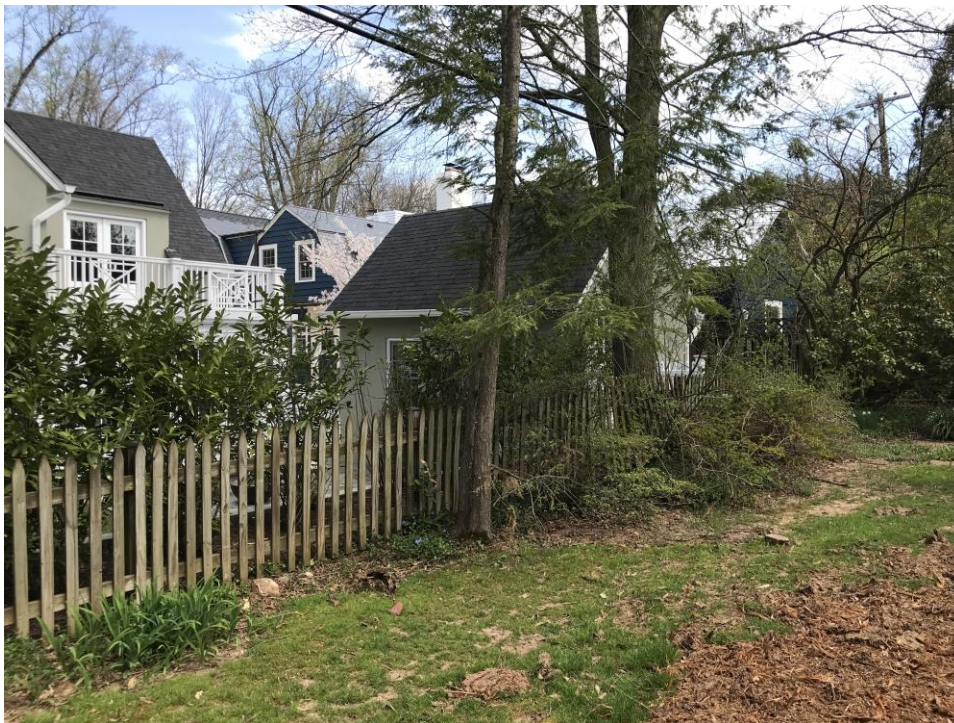
Figure 3: Rear property boundary showing two accessory structures built almost to the property line.

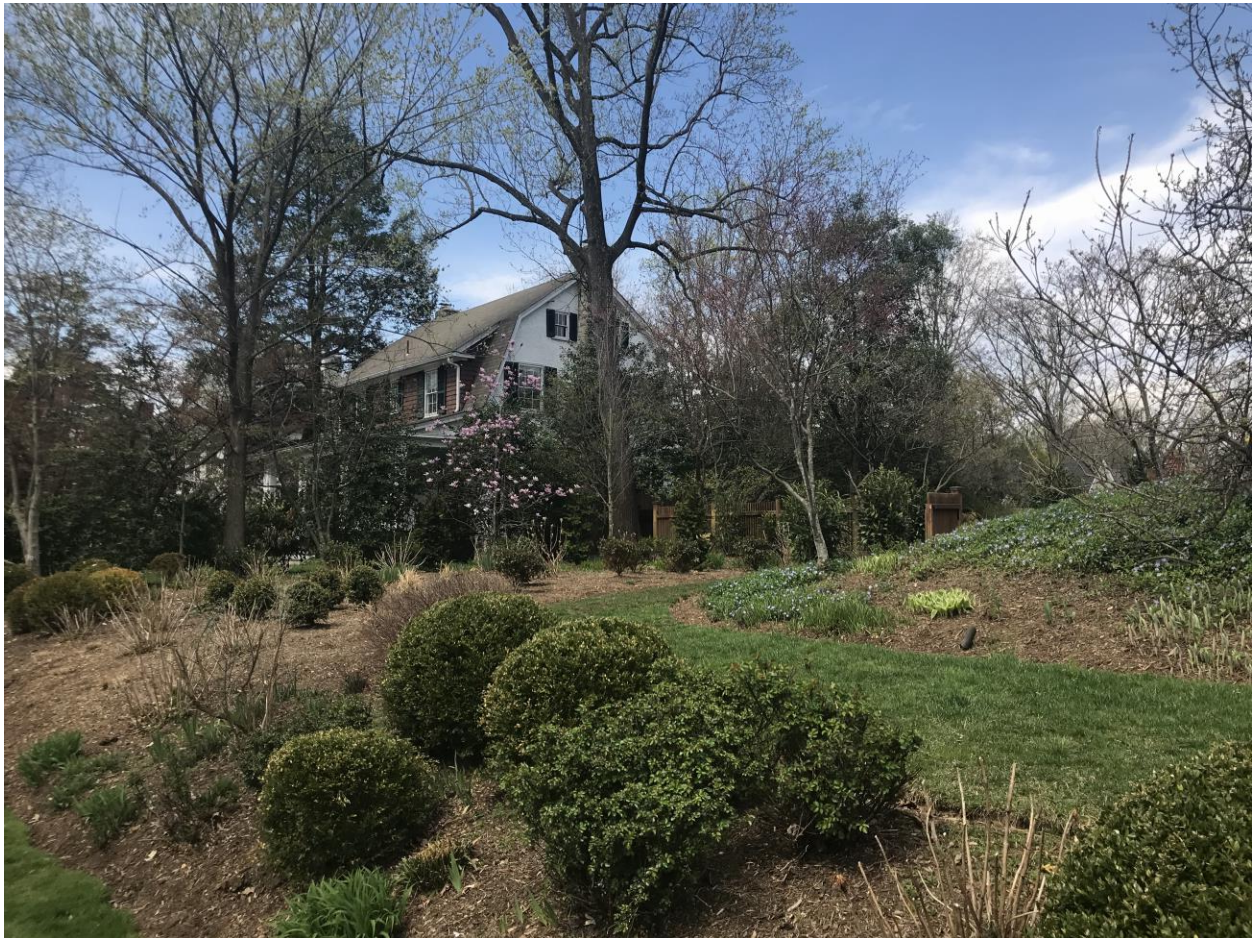
Figure 4: View from in front of 17 Grafton St. looking west. Absent the vegetation, any rear addition would be highly visible.

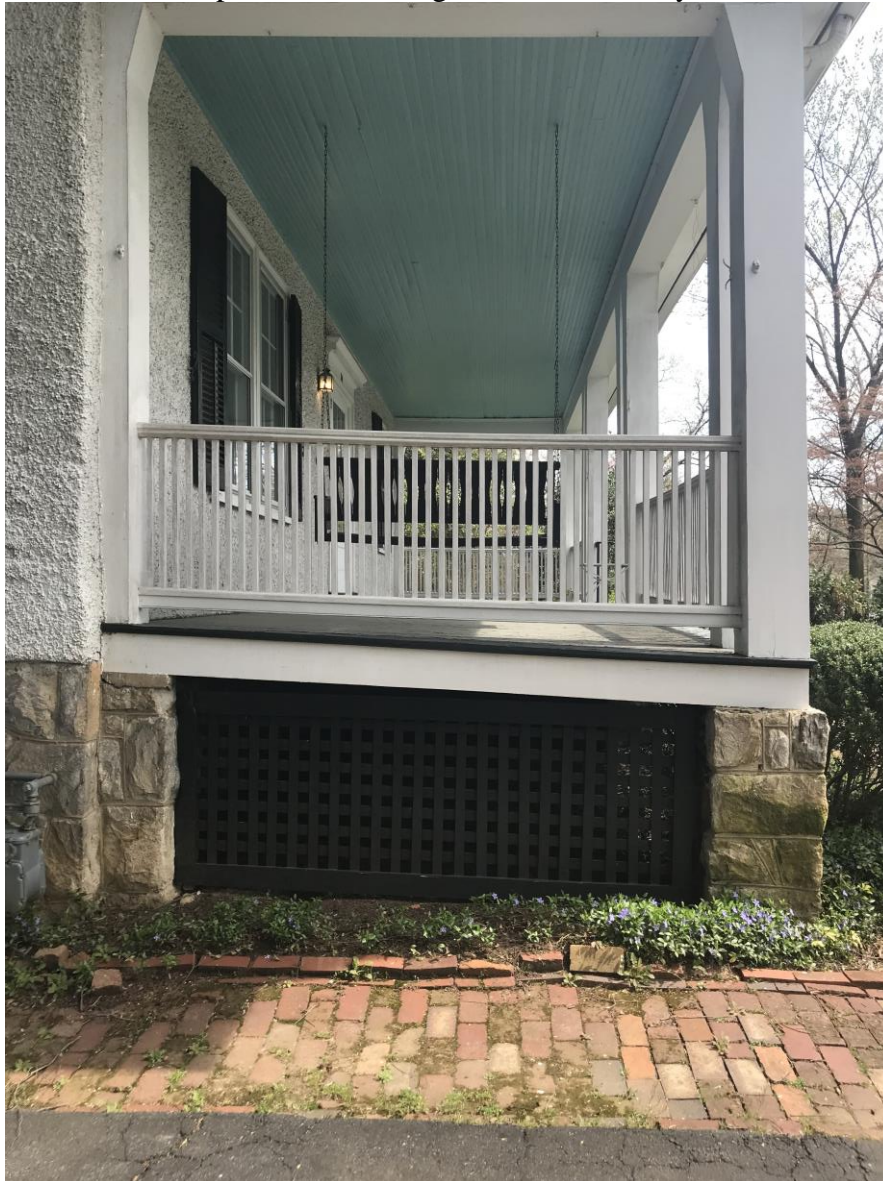
Figure 5: Slope of the front porch.

The existing house is a Dutch Colonial with a gambrel roof, stuccoed first floor, and shingle siding above. The full-width front porch has steep wood front steps and a sloping deck. The deck's slope appears to have been caused by settling of the porch piers. The house's six-over-six windows all appear to be historic and in working order. In the northwest corner of the house, there is a projecting one-story mud room or butler's pantry is a historic feature that, historically, was a rear porch that was probably reconfigured in 1977 when the current rear porch was added (see the 1927 Sanborn Map below).

The existing front porch decking has a significant slope and needs to be replaced. Staff finds that this should be approved as a matter of course once details for the repair are submitted. Staff also

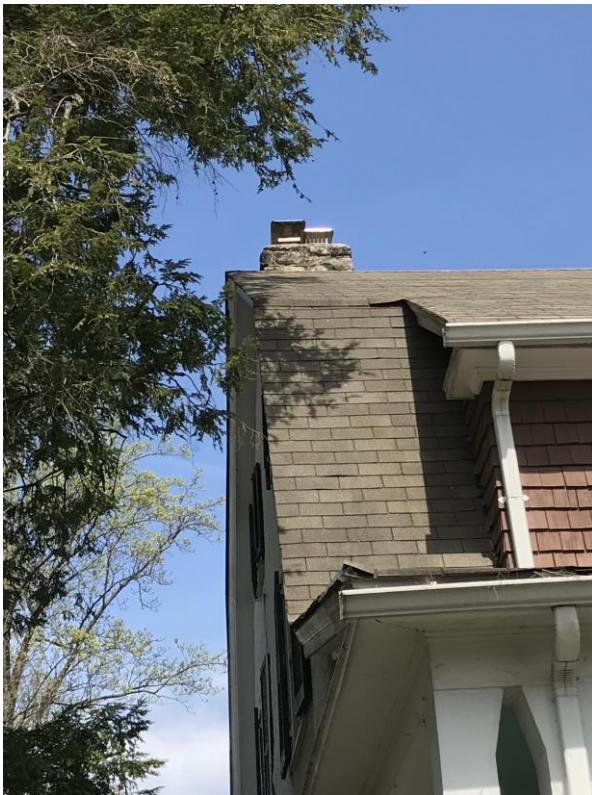
Figure 6: Coal furnace chimney proposed for removal.

Next, the applicant proposes removing the historic furnace chimney on the west side of the house. This is an interior chimney that was installed when the house still operated a coal

furnace. The chimney is visible from the right-of-way; however, its prominence is diminished as it is placed behind the gambrel ridge. The *Design Guidelines* state that for exterior alterations not addressed by the *Guidelines* the changes should be evaluated so that alterations are consistent with the, “two paramount principles... fostering the Village’s shared commitment to evolving eclecticism while maintaining its open park-like character.” The HPC was nearly unanimous in its finding that the coal chimney could be removed without a significant impact on the historic character of the house or the surrounding district. Staff agrees with the HPC’s assessment that the removal of this chimney will not have a significant impact on the house or district’s historic character, the district’s park-like setting, or the architectural style of the house and recommends approval of the chimney removal.

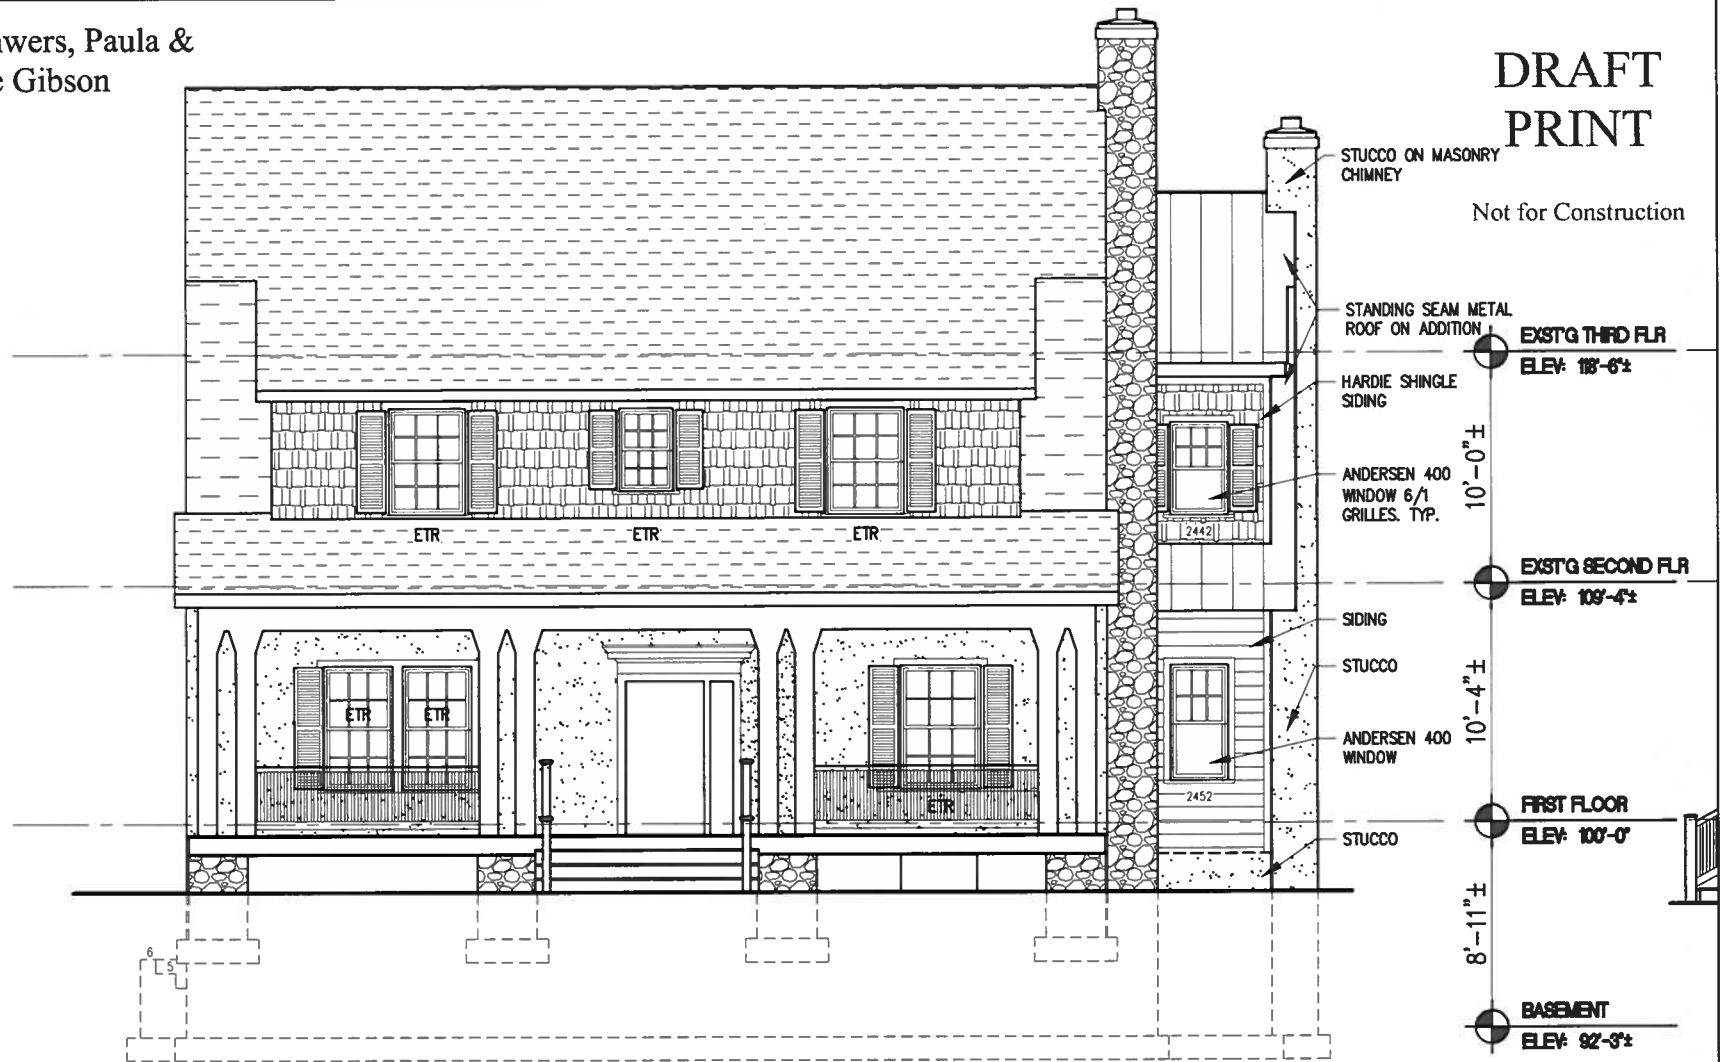
1
dd10

FRONT ELEVATION

The second proposed change is to replace the front porch steps with code-compliant steps in wood. The submitted drawings show new stairs and a railing to match the existing railing. Staff finds that with this alteration will not have a significant impact on the historic character of the house or surrounding district (per 24A-8(b)(2)).

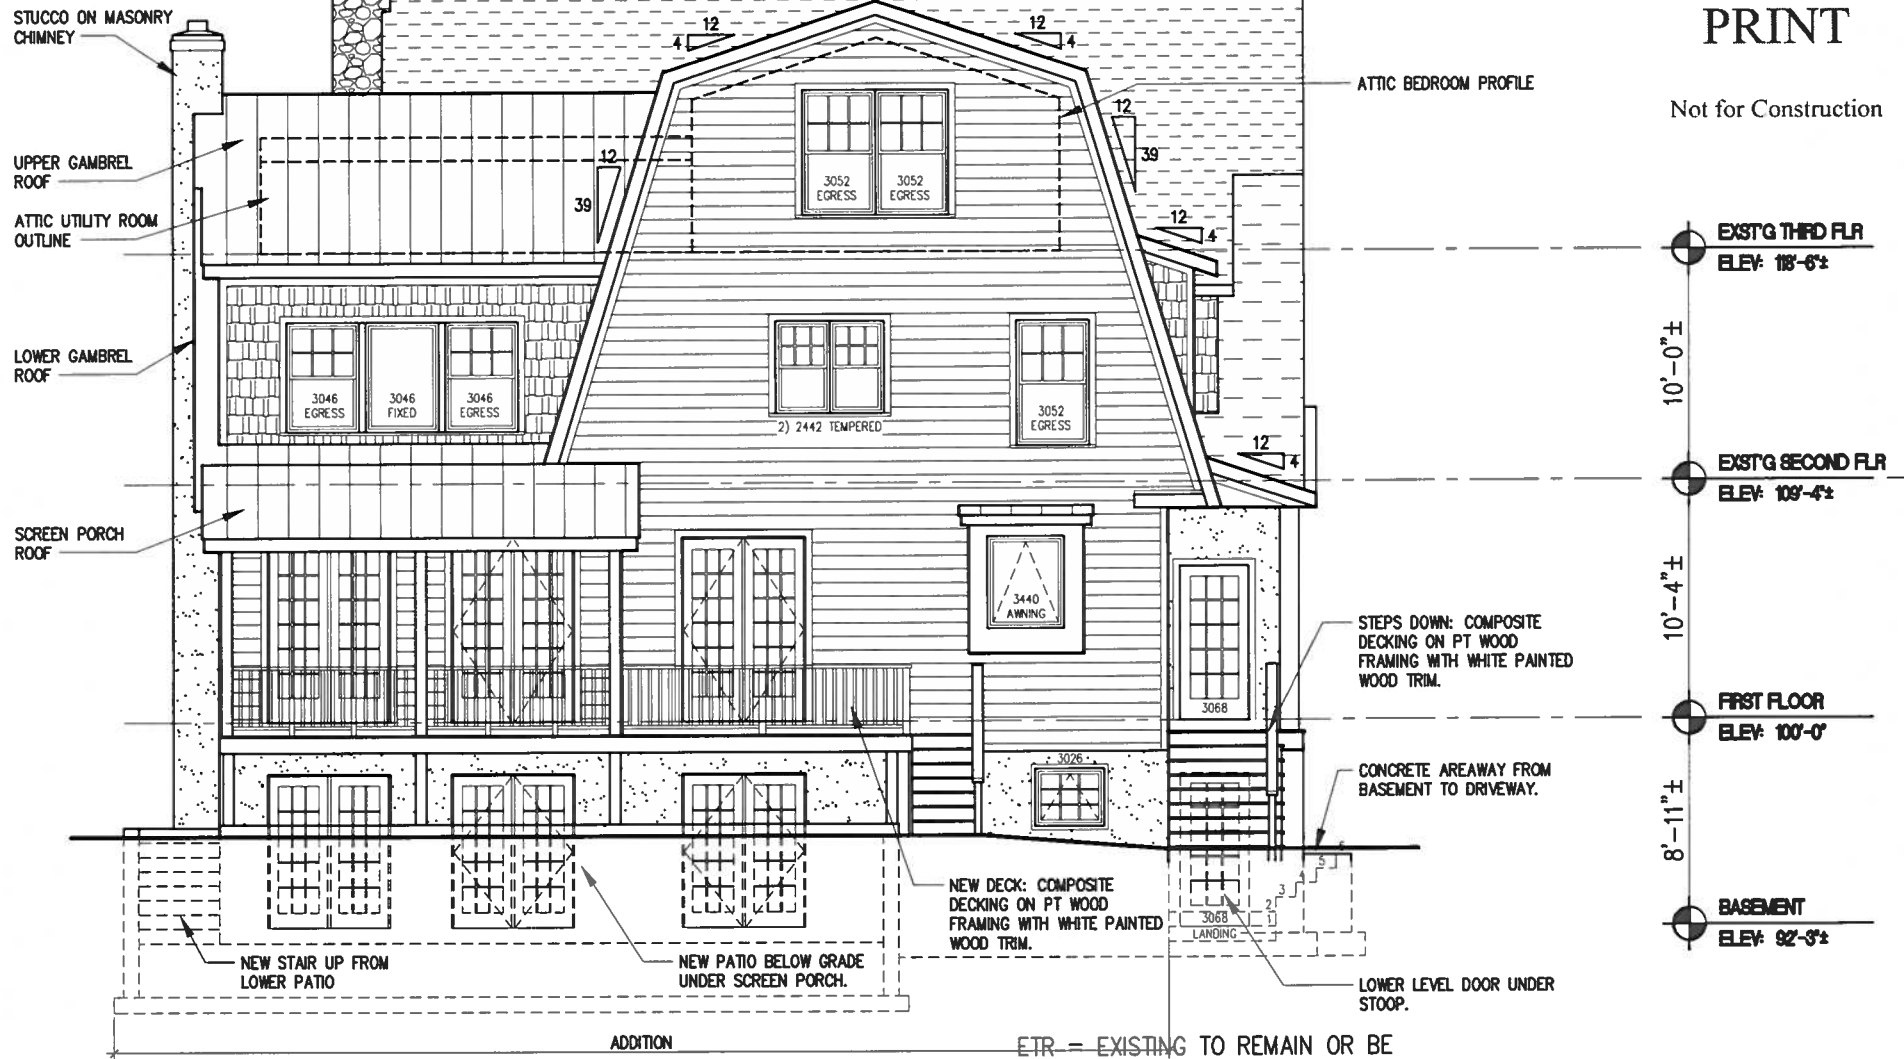
1
dd12
REAR ELEVATION
SCALE: 1/8" = 1'-0"

The applicant proposes to construct a new, two story addition at the rear of the historic house. The addition will be 42' 4" × 20' 6" (forty-two feet, four inches by twenty feet, six inches) with a side projecting gambrel and a larger rear-facing gambrel. The new gambrel roofs will be covered with standing seam metal. The applicant proposes cladding the addition in fiber cement siding with fiber cement shingles in the gambrels. The foundation and chimney will be covered in stucco matching the appearance of the historic house. The windows in the addition will be a combination of six-over-one sash, fixed, and six-lite casement aluminum clad wood windows.

- 1) **Massing and Scale.** The Prior Proposal involved two rear-facing gambrels the same height as existing structure. **The Revision drops the roof height of the rear-facing right gambrel by 6 inches (looking from rear of house), eliminates the left rear-facing gambrel, and adds a smaller, shorter side (east-facing) gambrel from the new space. Further adjustments were made to change the pitch of the roof facing east per HPC staff recommendations. This cleans up and squares the new structure with the old when viewed from the front. This removes Prior Proposal's angular facings on the new space viewed from the front elevation.** This accommodates concerns of (a) massing and scale from the east side (and front), which are greatly reduced, (b) a duplicate fireplace smokestack, which is shortened substantially due to lower roof height and includes material change to stucco from stone (in direct response to commissioners' comments), and (c) gambrel angles on the east side when viewed from the front. This also partially addresses how the new structure joins with the existing structure in a more cohesive way.

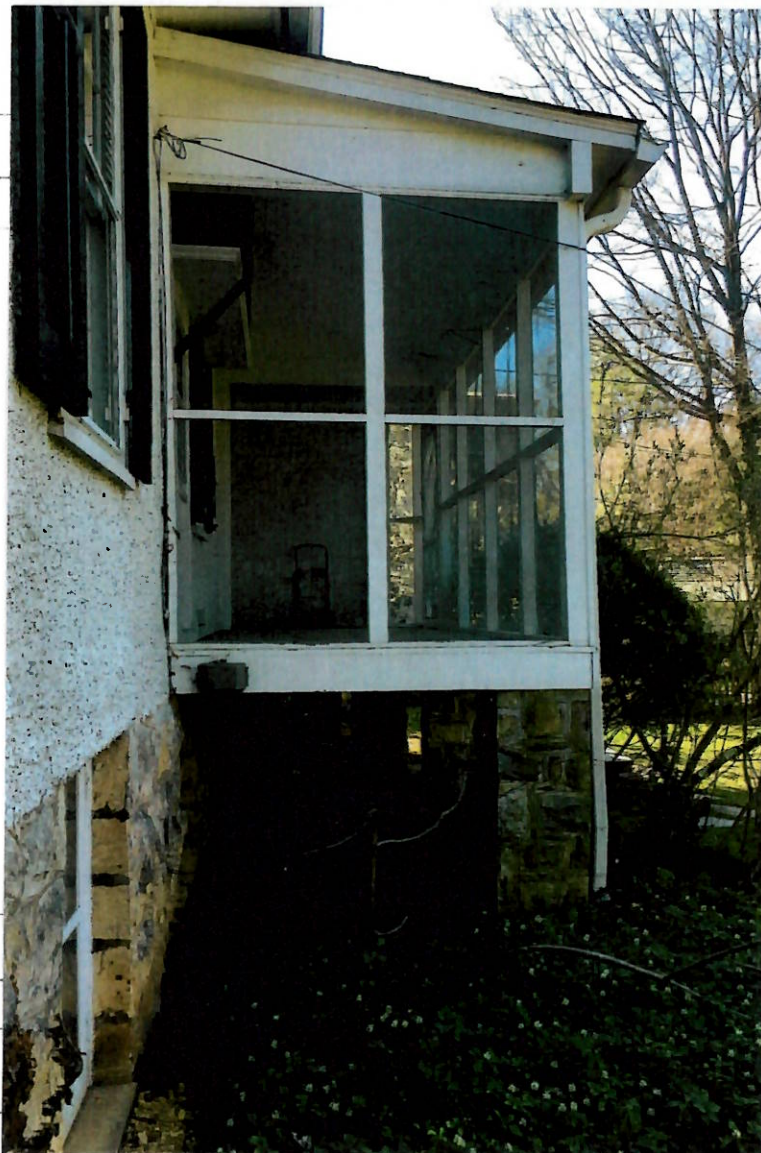
← 1977
porch
addition
(to be
removed)

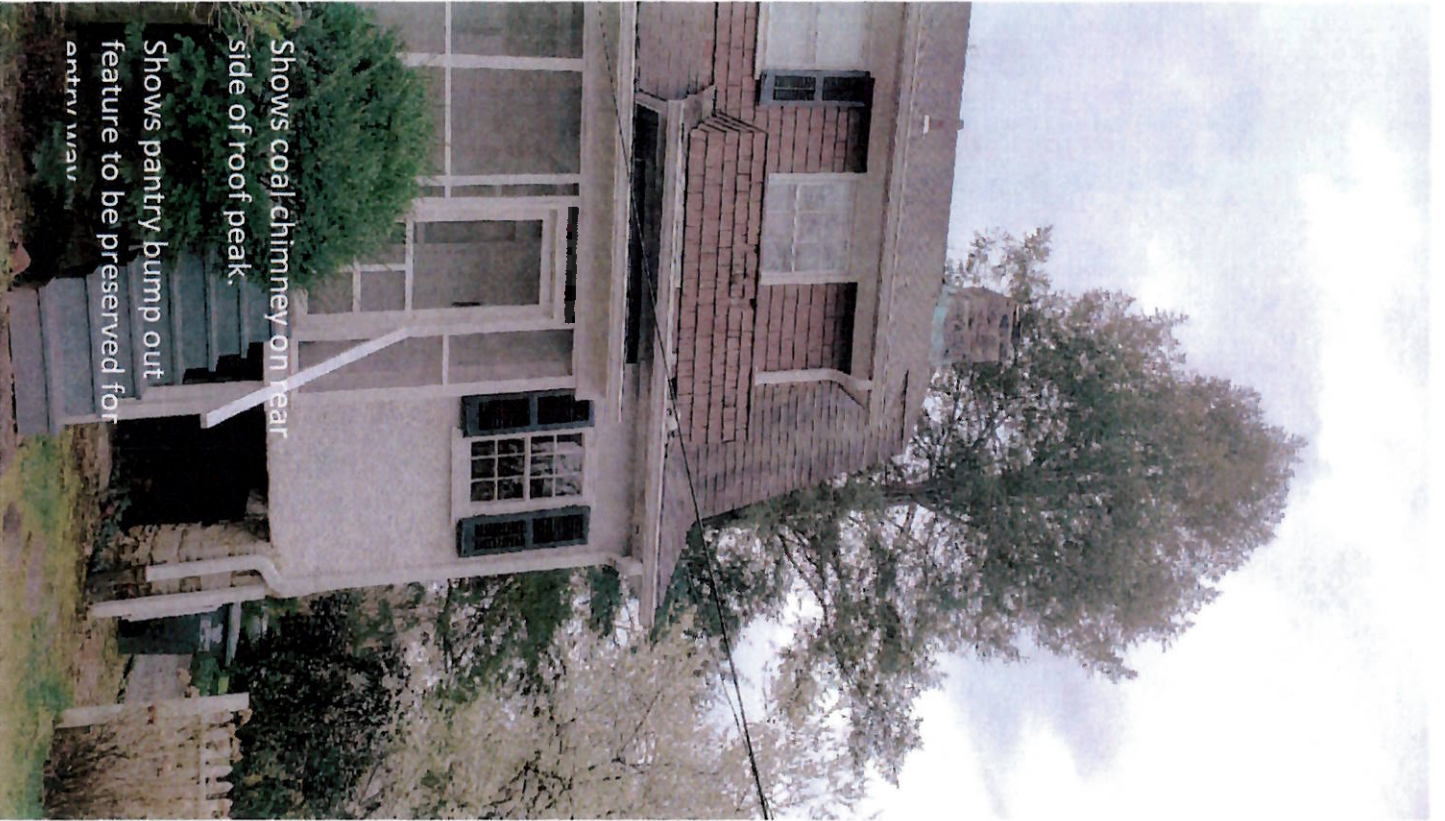
Shows coal chimney on rear side of roof peak.
Shows pantry bump out feature to be preserved for entry way

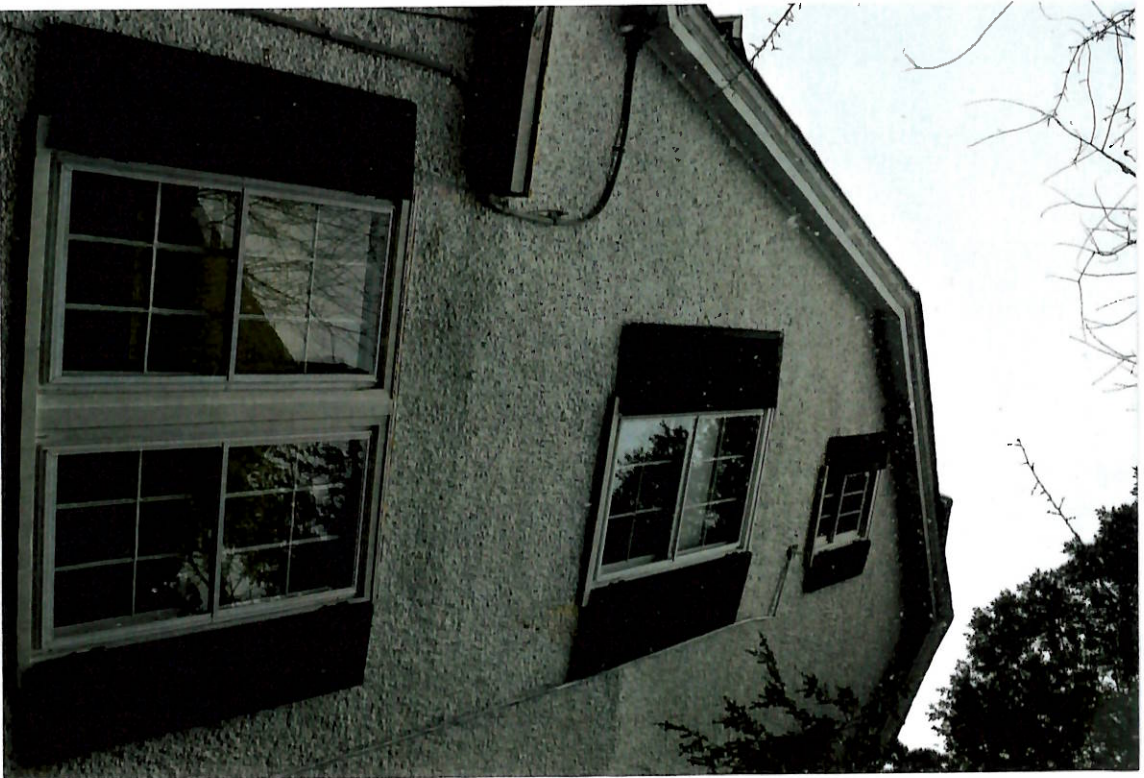
Rear Chimney shown via back/west elevation (left side)

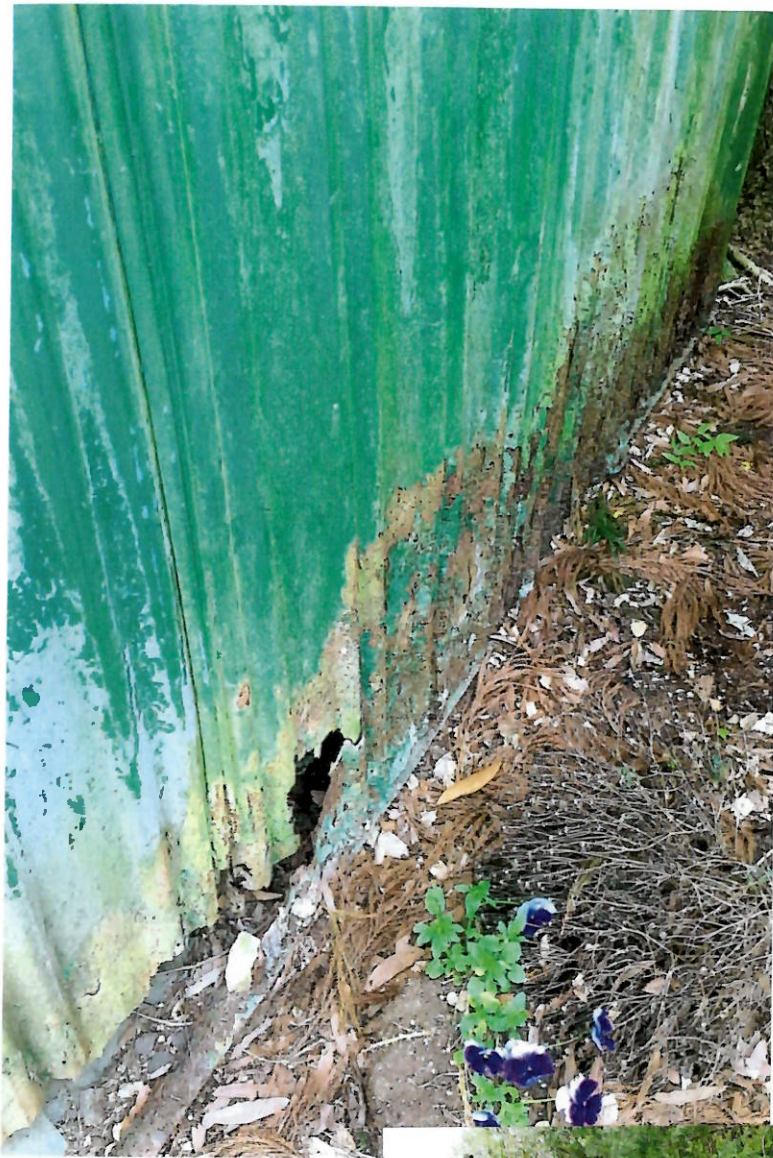
← Rotting & Deteriorating
Metal shed/garage
(BACK SIDE)

↓ Varying fence heights
of neighboring yards

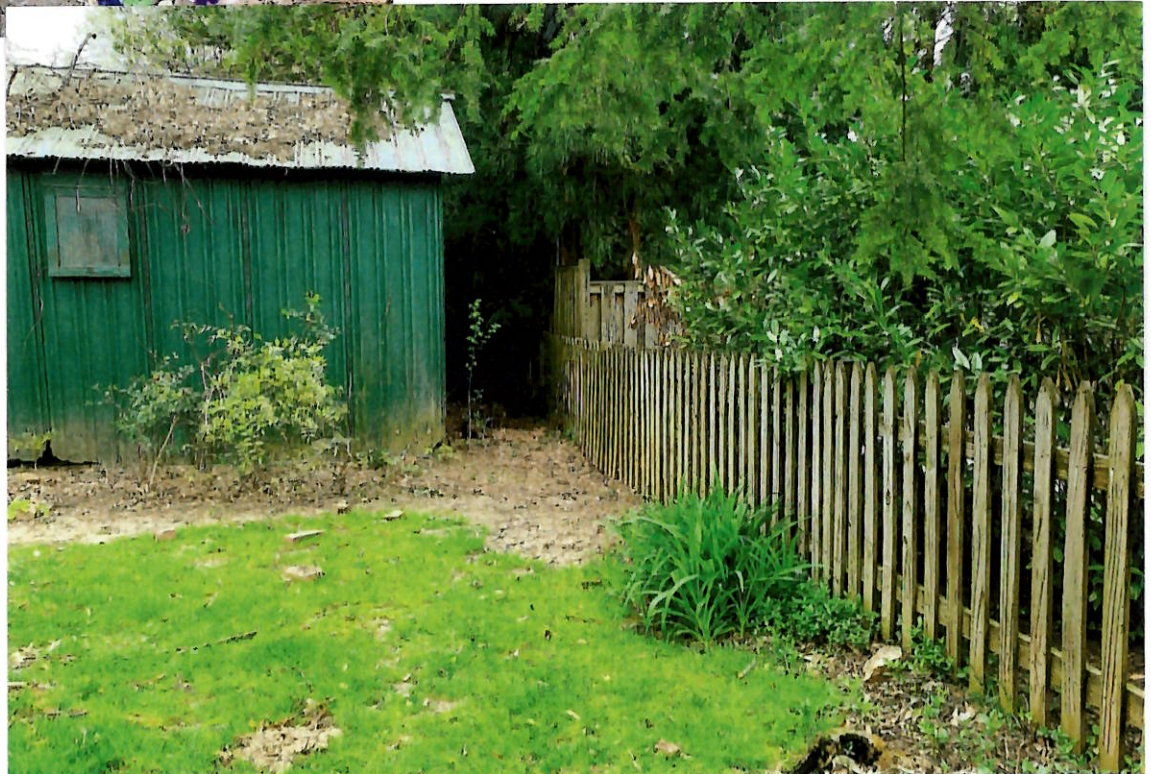
Deteriorating
Right Side of
shed/garage

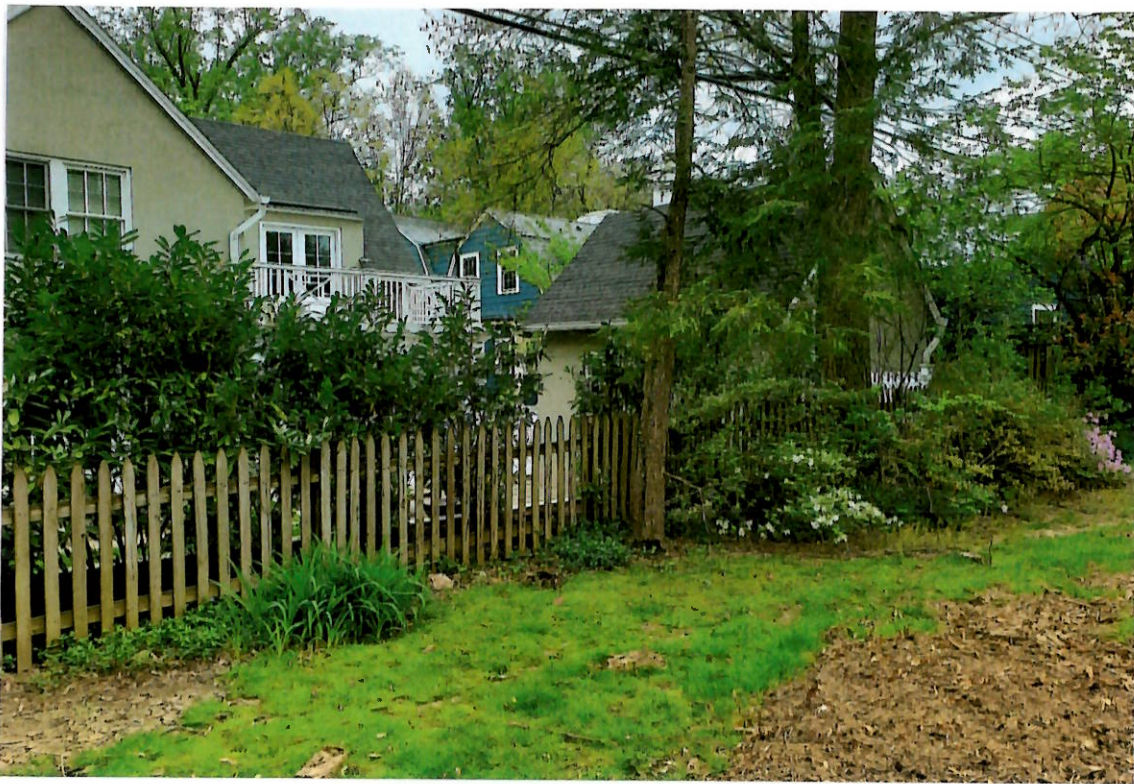
Rear yard - note close locations of additions,
garages, and homes
