***EXPEDITED***  
**MONTGOMERY COUNTY HISTORIC PRESERVATION COMMISSION**  
**STAFF REPORT**

<b>Address:</b>	11900 Darnestown Road, Gaithersburg	<b>Meeting Date:</b>	6/24/2020
<b>Resource:</b>	Master Plan Site #24/13 ( <i>Quince Orchard Colored School</i> )	<b>Report Date:</b>	6/17/2020
<b>Applicant:</b>	Pleasant View Historic Association ( <b>Thomas Taltavull, Architect</b> )	<b>Public Notice:</b>	6/10/2020
<b>Review:</b>	HAWP	<b>Tax Credit:</b>	Partial
<b>Case Number:</b>	24/13-20A	<b>Staff:</b>	Michael Kyne
<b>PROPOSAL:</b>	Building addition and renovations

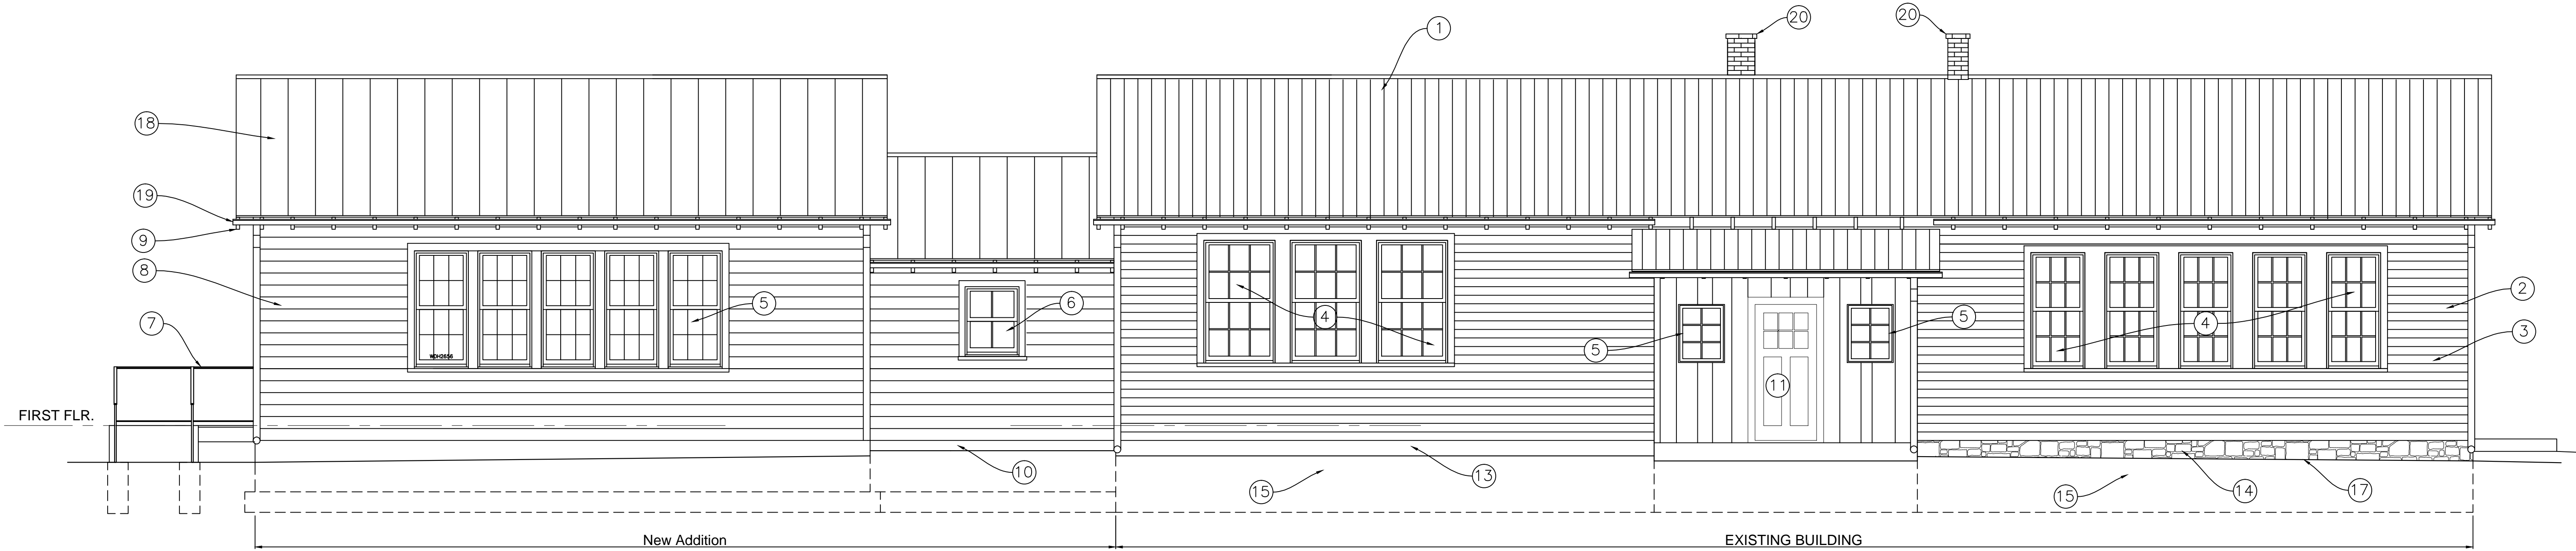
PROPOSED SOUTH ELEVATION  
1/4" = 1' - 0"

CONTRACTOR NOTE:  
1. A MOCK UP OF THE REBUILT FIELD STONE FOUNDATION WALL TO BE REVIEWED AND APPROVED BY OWNER AND THE MARYLAND HISTORICAL TRUST.

1. A mock-up of the new field stone foundation will be undertaken to ensure that the reconstructed wall matches in-kind. Once the mock-up has been completed, photographs should be submitted for review and approval.

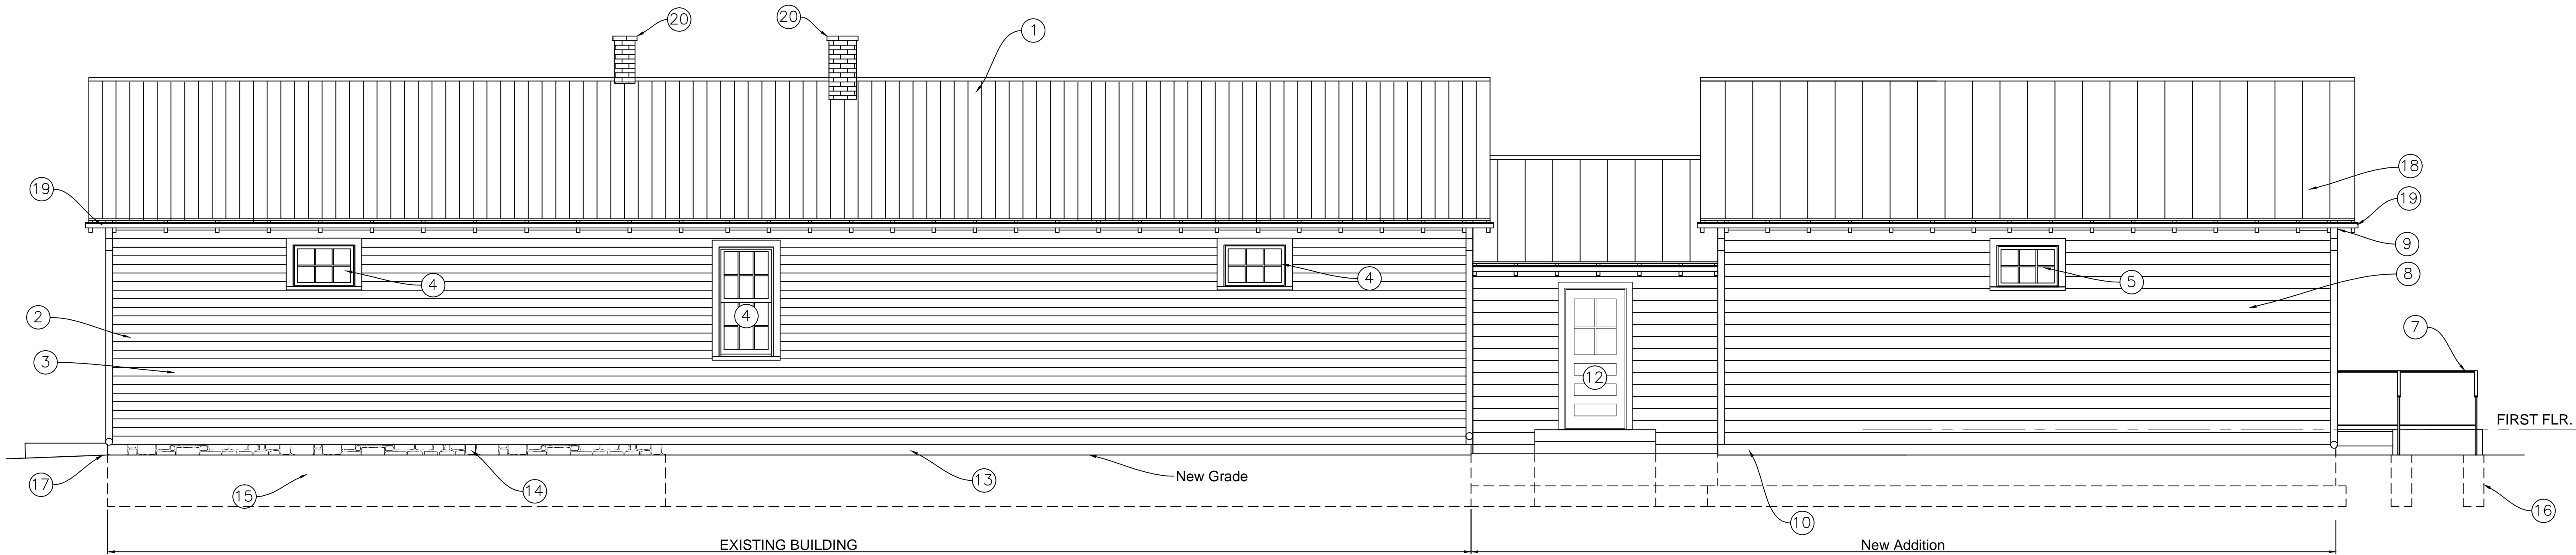
PROPOSED NORTH ELEVATION  
1/4" = 1' - 0"

CONTRACTOR NOTE:  
1. A MOCK UP OF THE REBUILT FIELD STONE  
FOUNDATION WALL TO BE REVIEWED AND APPROVED  
BY OWNER AND THE MARYLAND HISTORICAL TRUST.
