MONTGOMERY COUNTY HISTORIC PRESERVATION COMMISSION
STAFF REPORT

Address:	7100 Sycamore Ave., Takoma Park	Meeting Date:	12/15/2021
Resource:	Contributing Resource Takoma Park Historic District	Report Date:	12/8/2021
Applicant:	Marc Pfeuffer	Public Notice:	12/1/2021
Review:	HAWP	Tax Credit:	partial
Permit No.:	973888	Staff:	Dan Bruechert
Proposal:	Front Porch Alteration, Rear Demolition, and Rear Deck Construction

The applicant proposes to remove the existing parged CMU front porch guard wall and install a new railing and to demolish the rear porch and construct a new deck and sunroom at the rear.

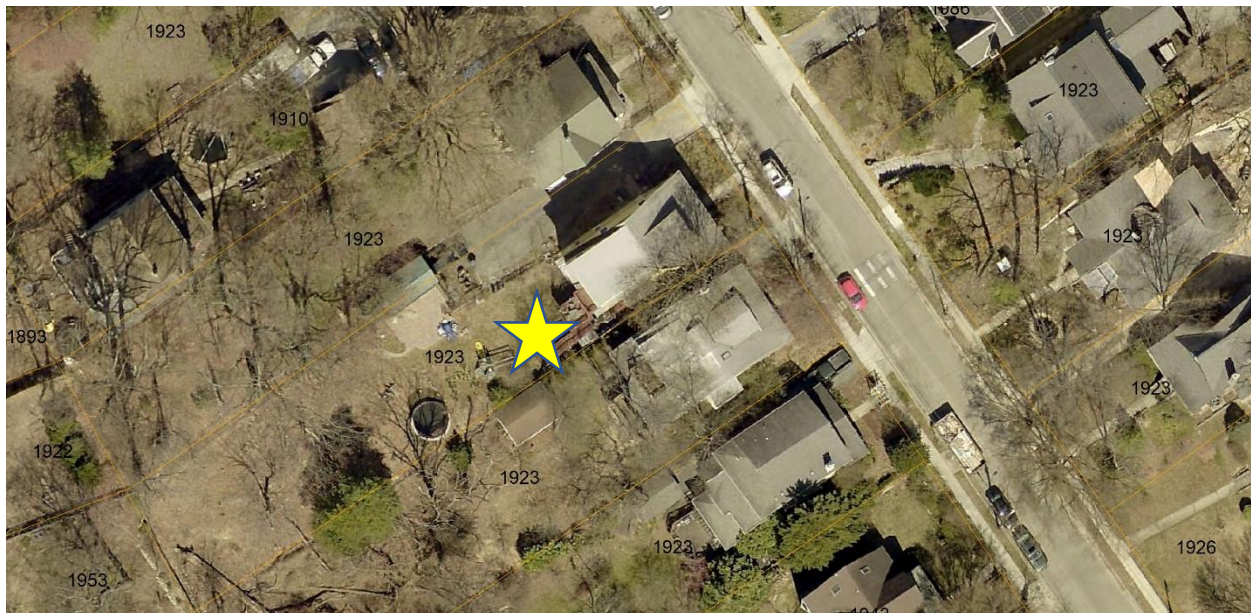
Figure 1: 7100 Sycamore Ave., Takoma Park.

SIGNIFICANCE: Contributing Resource to the Takoma Park Historic District
STYLE: Craftsman
DATE: 1923

The subject property is a one-and-a-half-story Craftsman bungalow with a concrete foundation, clapboard first floor, and shingle second floor. The full-width front porch has a solid, parged knee wall and wood decking. At the rear of the subject property, there is a rear wood porch with a balcony.

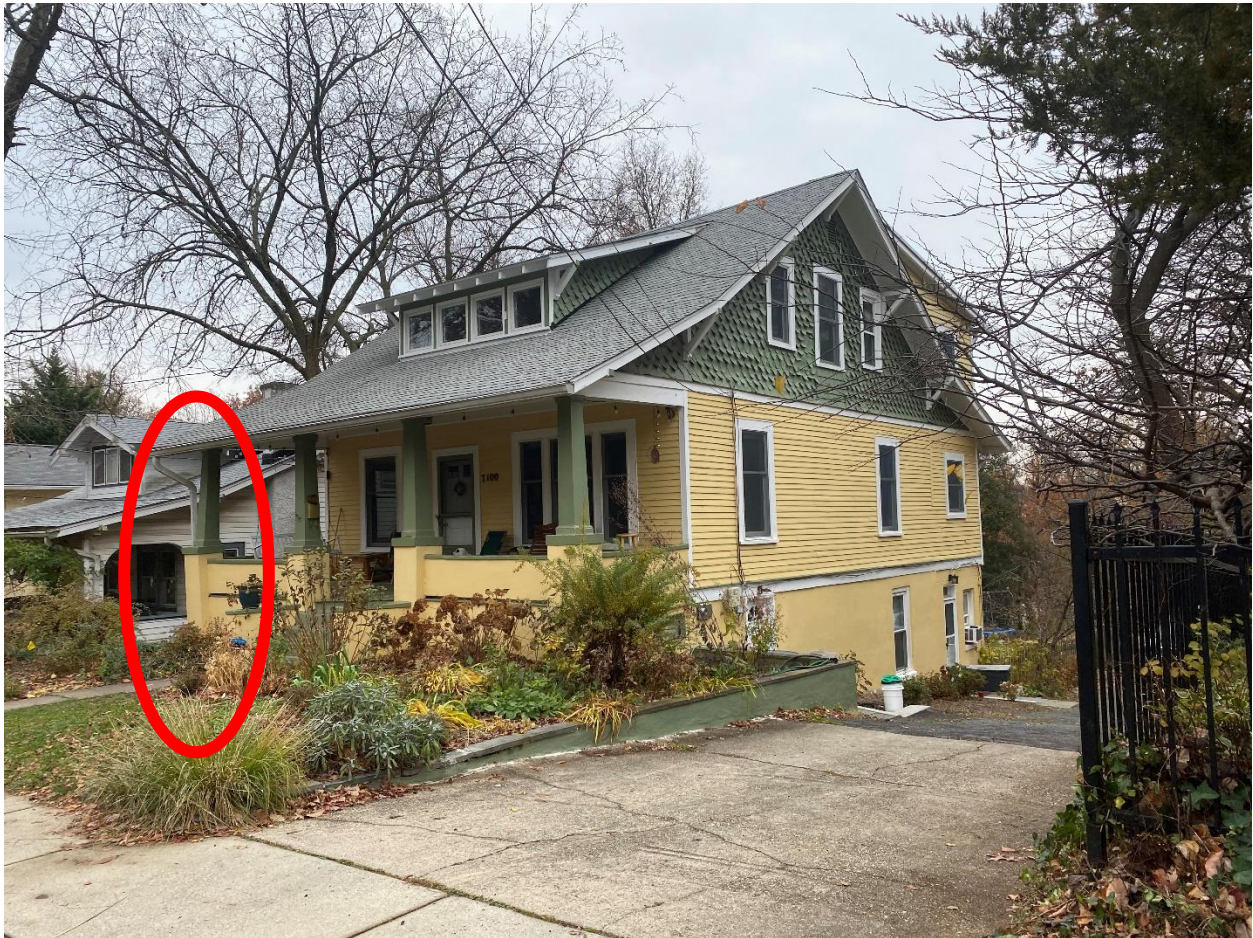
Figure 2: Note the severe lean in the left porch column.

The existing porch knee wall is CMU block with a smooth parged finish. The finish matches the building's foundation. The knee wall appears to be in fair condition, but one of the porch columns needs to be removed and rebuilt, which may require removing a portion of the knee wall. The applicants' contractor also believes the weight of the knee wall is forcing the masonry column out of place. In place of the knee wall, the applicant proposes to install a new railing system constructed out of pressure-treated lumber with square aluminum balusters. The porch decking is wood and suffers from some rot; additionally the joist appears to be in poor condition and needs to be removed. The applicant proposes to reconstruct the porch structure and install an Azek deck.

Based on the information presented in the applicant and Staff's visit to the subject property, Staff finds that these elements need to be removed and replaced (see Fig. 2, below). The question becomes what is an appropriate replacement material.

1. Repairs to the existing masonry support column – left side of house (as viewed from the street): the existing 20" x 20" masonry support column leans significantly outward due to poor soil conditions underneath the column's footing. We propose to temporarily support the existing roof on that side, then disassemble the masonry column, pour a new pad footing and rebuild the masonry column using like kind materials (masonry and stucco) to restore the column to its original condition

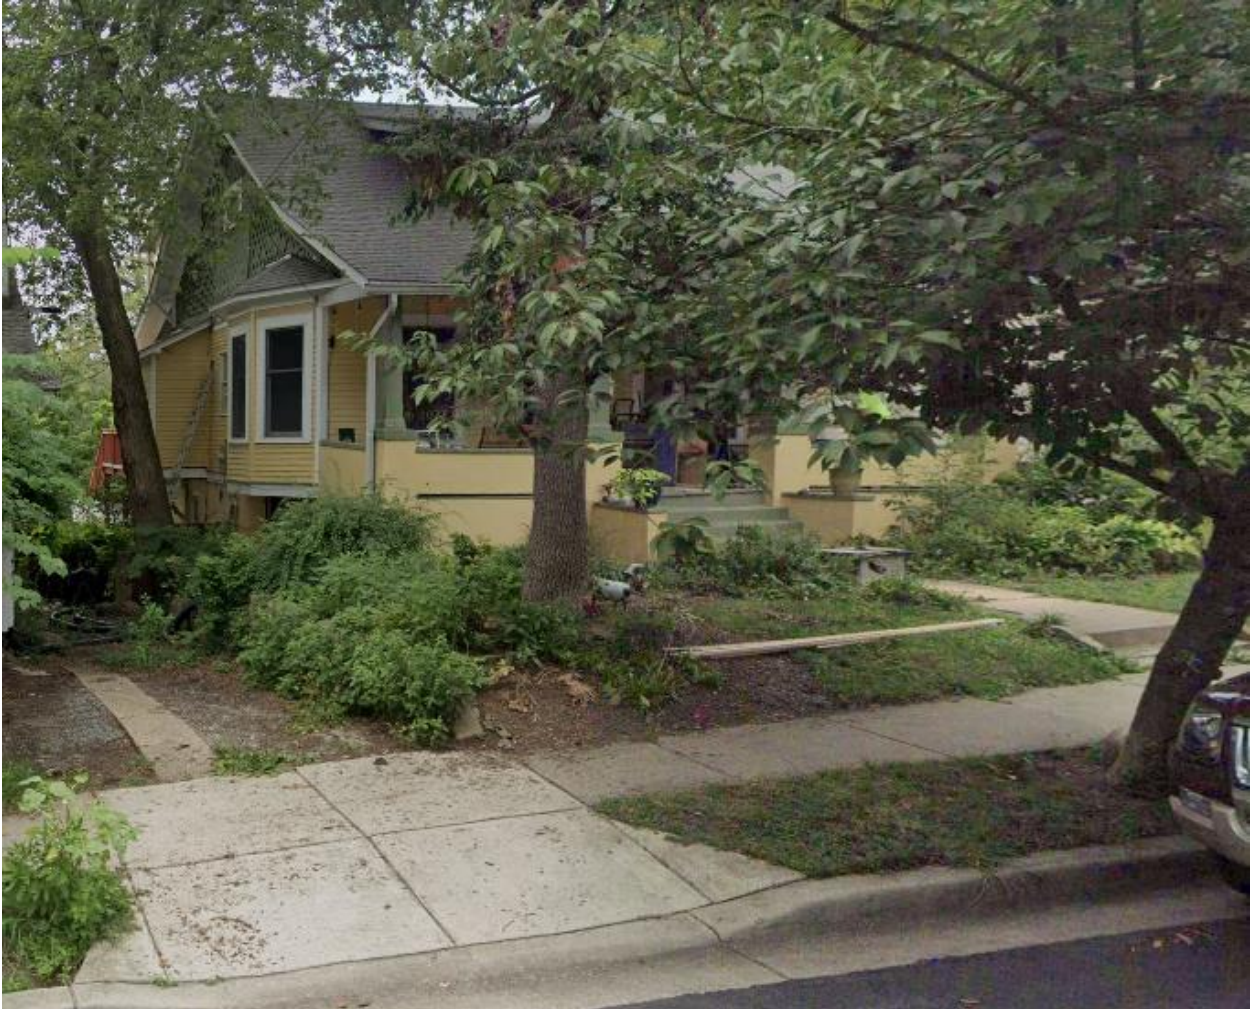
Figure 3: Image from August 2021, showing a portion of the porch and non-historic bump out.

Staff finds that of the proposed rear deck and porch, only a small section will be partially visible from the right-of-way. The last bay of the screened-in porch will project beyond the historic wall plane to align with the non-historic rear bump out (see Fig. 3, below). The visible portions will consist of the wood framing, screen enclosure, and flat roof.

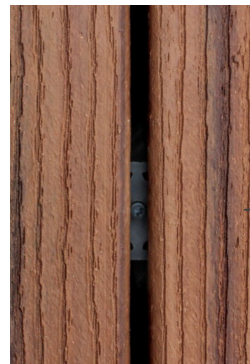
Trex Hideaway® Hidden Fastening System

Self-gapping, glass-filled nylon fastener with 304 grade stainless steel, sharp point screw for wood framing

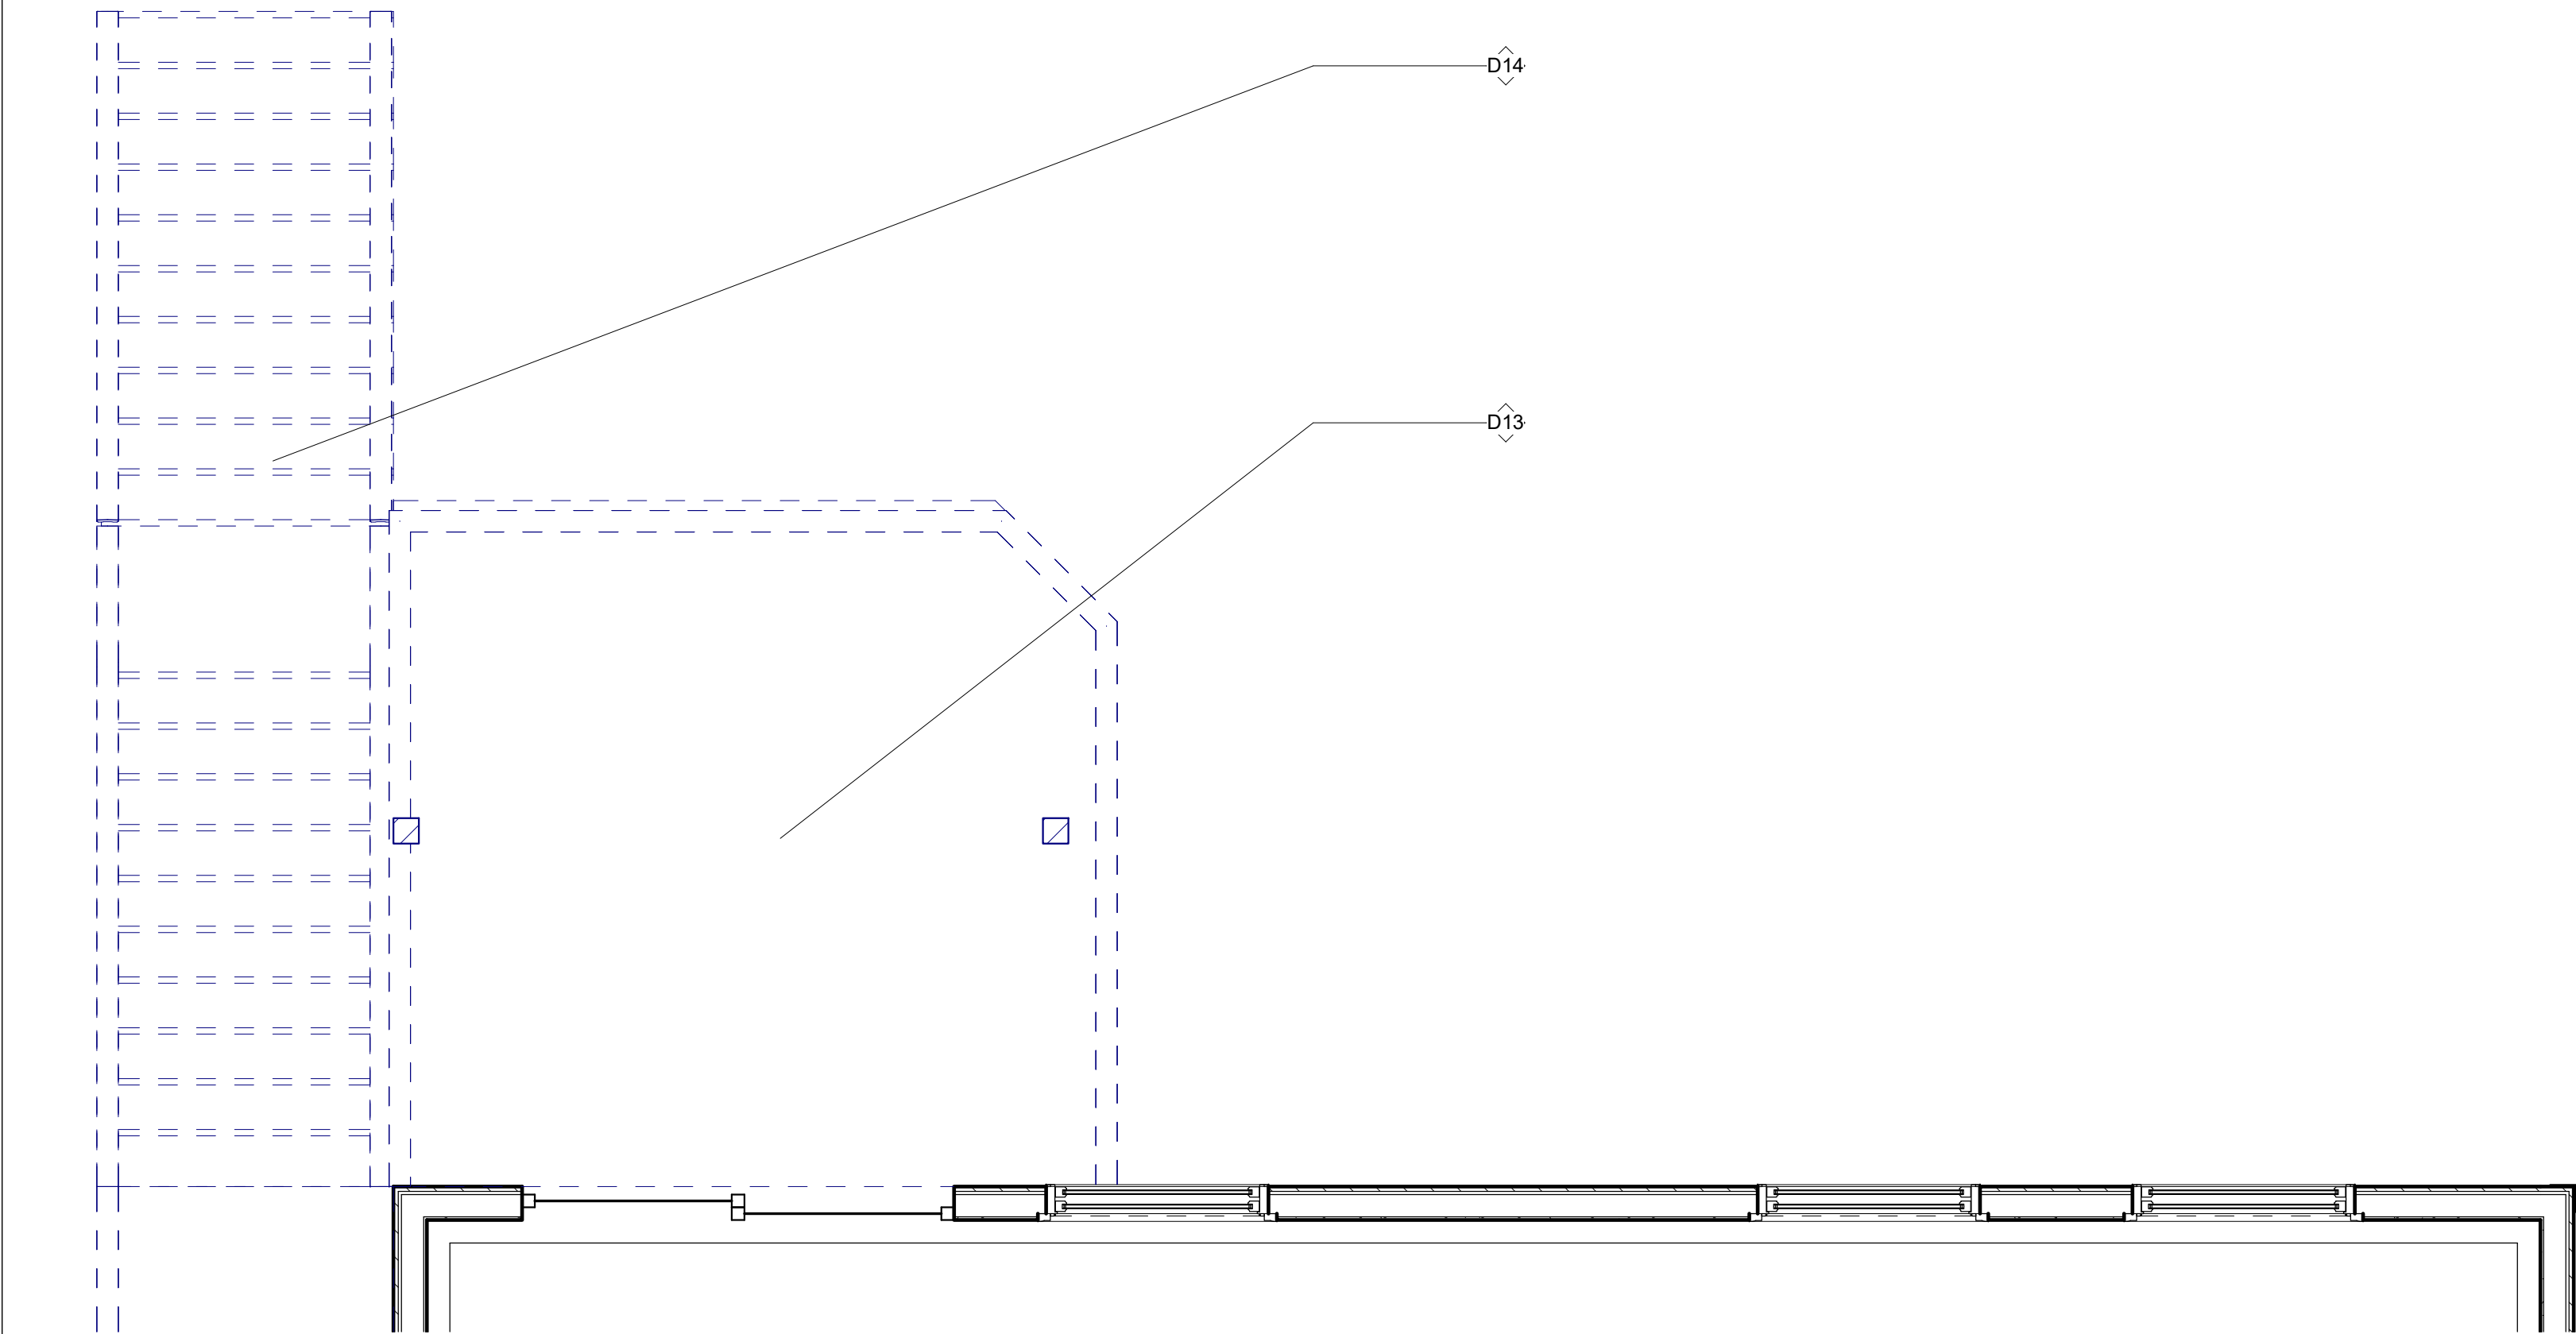
④ First Floor - Phase II - Existing/Demo
1/2" = 1'-0"

Key Value	Keynote Text
A35	New Framed Deck with composite decking - 5/4" x 6" with 1/4" spacing - hidden deckboard fasteners
A36	3 Risers @ 7.5" - 2 treads at 11.25"
A37	Custom Aluminum Screen Panels
A38	96" Tall Screen Door
A39	15 Risers @ 7.5" - 14 Treads at 11.25"
A40	New Deck/Stair Railing
D13	Demolish/Remove existing freestanding deck
D14	Demolish/Remove existing stair
