MONTGOMERY COUNTY HISTORIC PRESERVATION COMMISSION
STAFF REPORT

Address:	7100 Sycamore Ave., Takoma Park	Meeting Date:	1/5/2022
Resource:	Contributing Resource Takoma Park Historic District	Report Date:	12/29/2021
Applicant:	Marc Pfeuffer	Public Notice:	12/22/2021
Review:	HAWP	Tax Credit:	n/a
Permit No.:	973888 REVISION	Staff:	Dan Bruechert
Proposal:	Front Porch Alteration

**Thornton/Pfeuffer
Residence**

Phase II - Front Porch

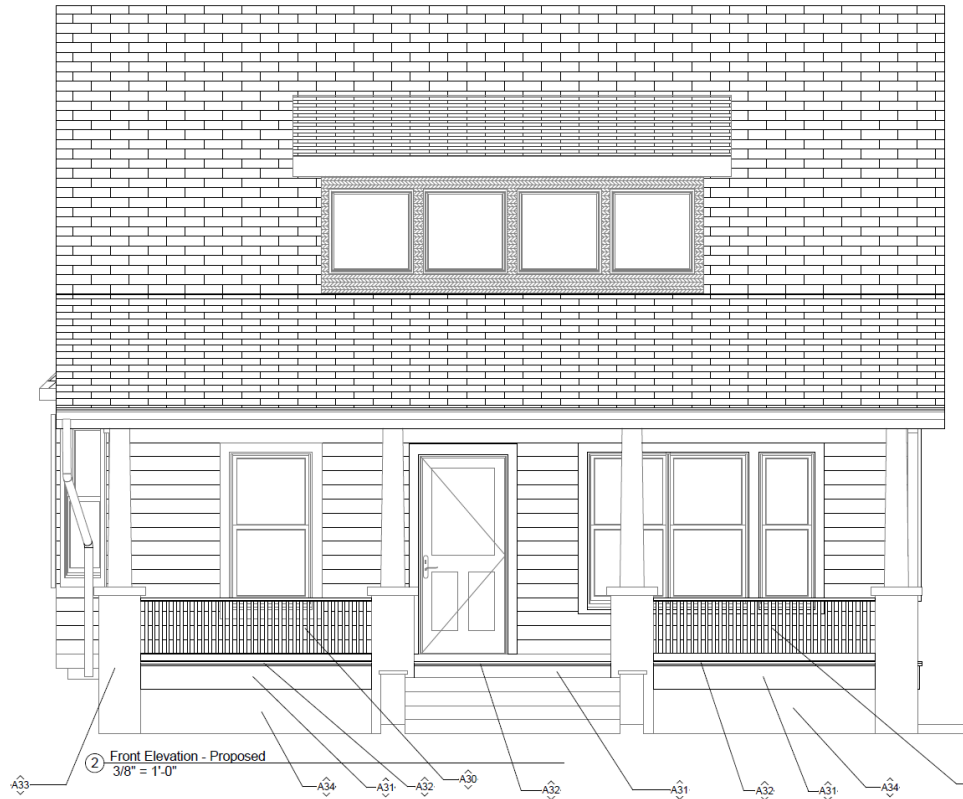
Figure 2: Proposed front elevation with new wood railing.

and recommended a condition that the knee wall/railing needed to be reconstructed to its existing appearance. That information was incorrect. The railing the applicant proposes to install is a wood, painted railing. The proposed railing includes a 1 ½" × 3 ½" (one and a half inches by three and a half inches top and bottom rail with 1 ¼" (one and one-quarter inch) balusters set between the top and bottom rails.

However, the applicant proposes replacing the existing knee wall with a new wood railing. Staff finds that the proposed railing is generally consistent with the *Design Guidelines* and 24A-(b)(2) and (d). First, the *Design Guidelines* for Contributing Resources state that the review should consider the impact to the overall streetscape rather than a close scrutiny of architectural features. Second, the *Design Guidelines* state that alterations to existing features should be consistent with the predominant style of the resource and that “exact replication of existing details and features is... not required.” Additionally, Staff finds that while the new railing is a change in design, a wood railing still respects the Craftsman style of the house as required by the *Design Guidelines*. Staff finds that wood railings are common on Craftsman houses from high-style to vernacular.

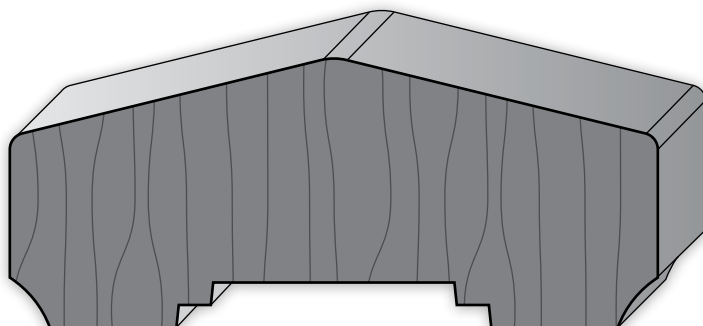
Top Porch Rail • WM-8840 • $1\frac{1}{2} \times 3\frac{1}{2}$

Primed A Grade (Clear)

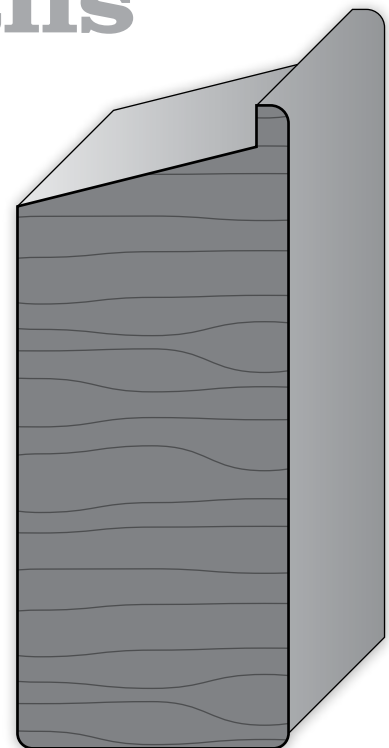
Bottom Porch Rail

WM-8841 • $1\frac{1}{2} \times 3\frac{1}{2}$
