MONTGOMERY COUNTY HISTORIC PRESERVATION COMMISSION
STAFF REPORT

| Address: | 7203 Cedar Ave., Takoma Park | Meeting Date: | 12/7/2022 |

Proposal: Roof alteration, dormer construction, fenestration alteration, window replacement, and after-the-fact front porch alteration.

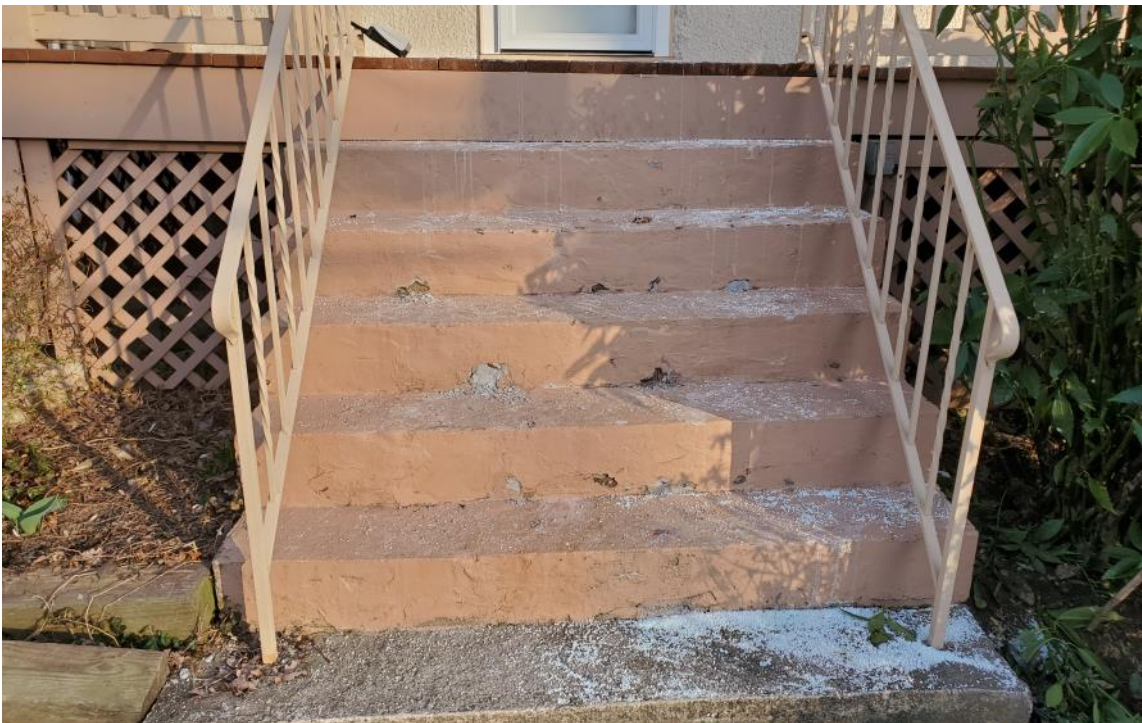
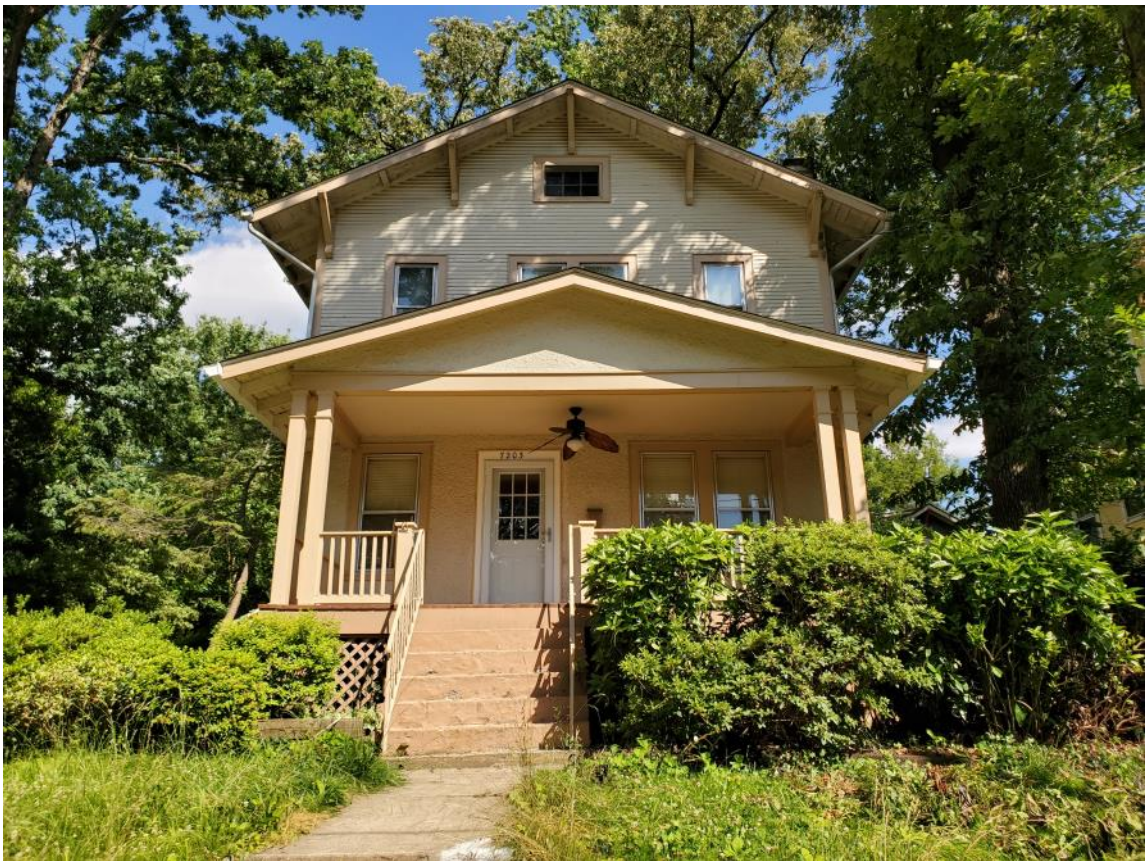
Work Item 1: Front porch steps

The following photos show the existing, non-compliant front porch steps

The application states that the existing concrete front stairs have settled to the left and do not satisfy existing code requirements. The proposal will construct new composite stairs over the existing and support the new treads with wood blocking. The specific composite was not identified, however, based on Staff's observations, it appears to be Trex. A site visit confirmed that this work has already been completed. The HPC is to review this proposed work as if it has not already been completed.

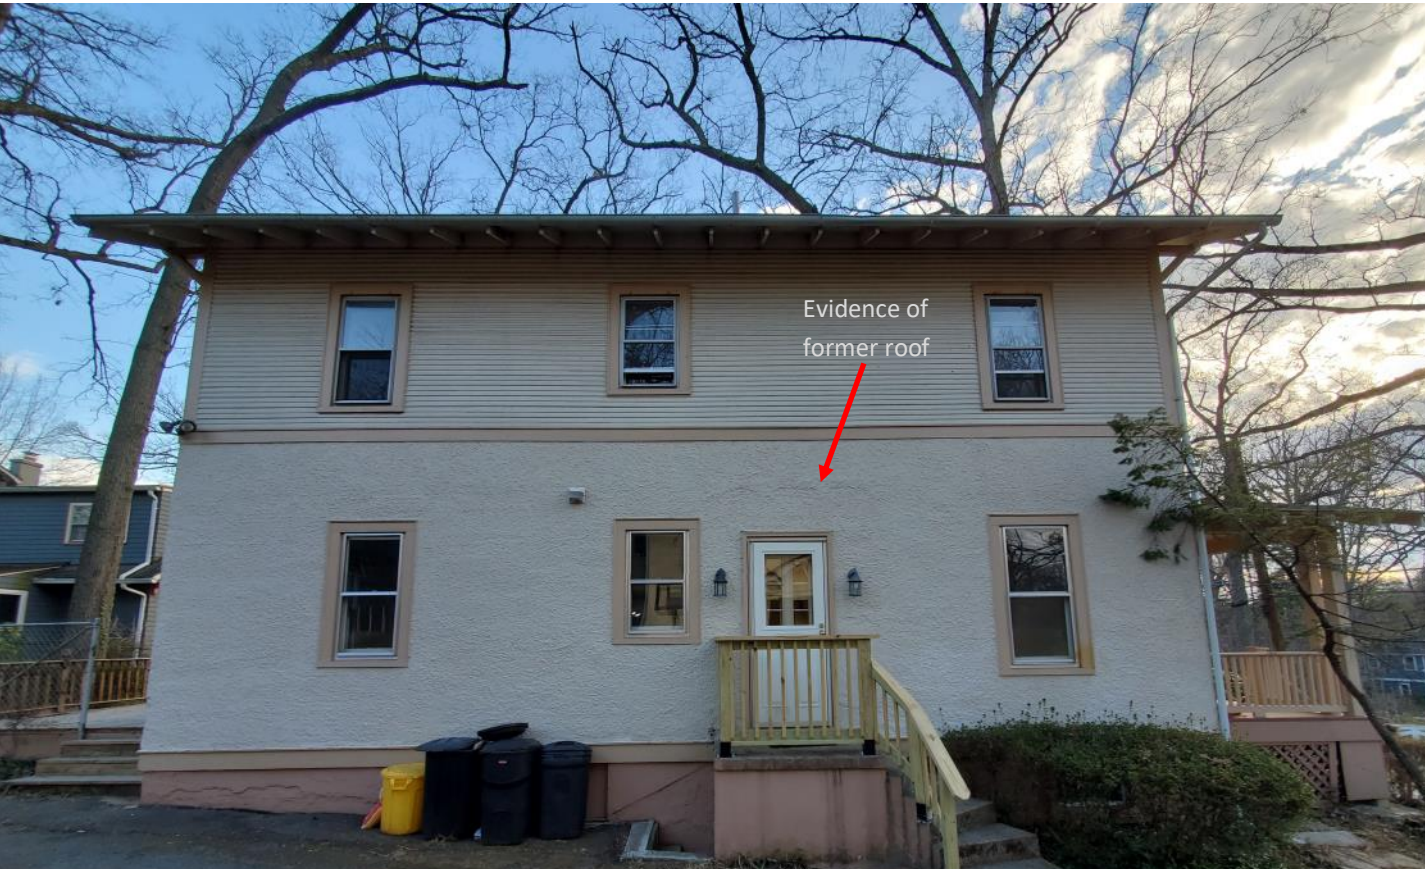
Work Item 2: Restored side stoop roof

Below are a photo of the existing left-side elevation to be compared to that in the proposed elevation drawing set.

The HPC was supportive of this proposal at the Preliminary Consultation and did not state a preference for a specific roof form. Staff finds the ghost in the stucco is evidence that there had been a shed roof over this entrance at some point in the building's history. Staff additionally finds that the proposed roof will not have a substantial impact on the house massing on the highly visible side elevation and recommends the HPC approve the shed porch roof.

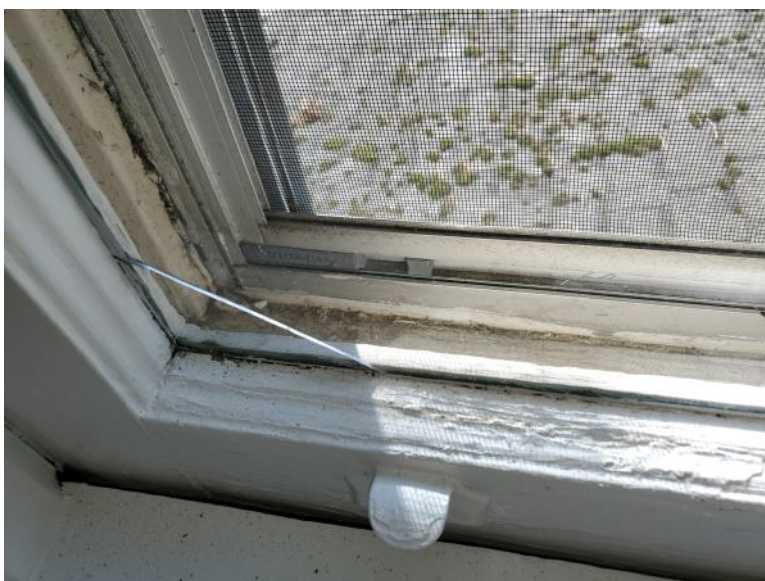
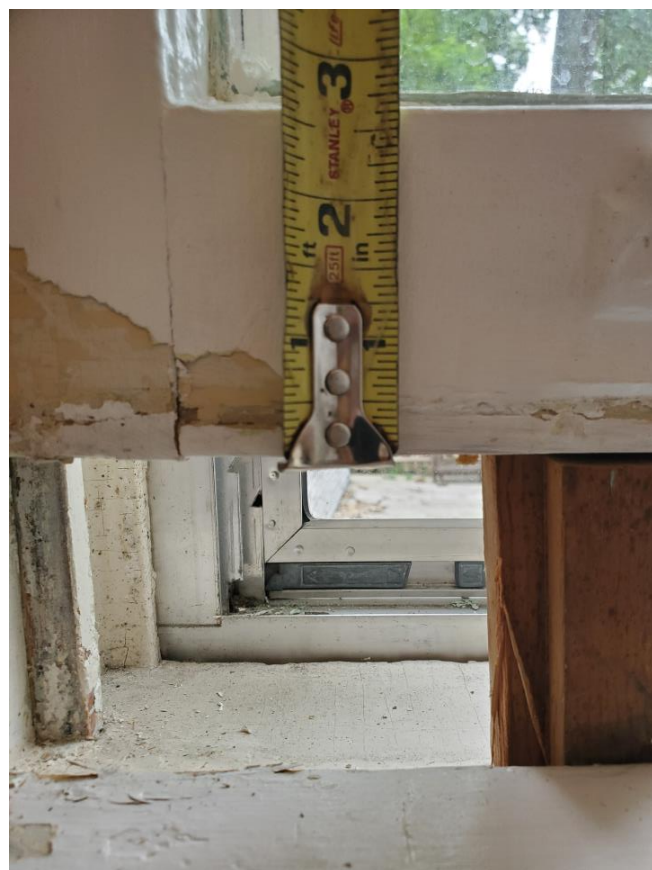
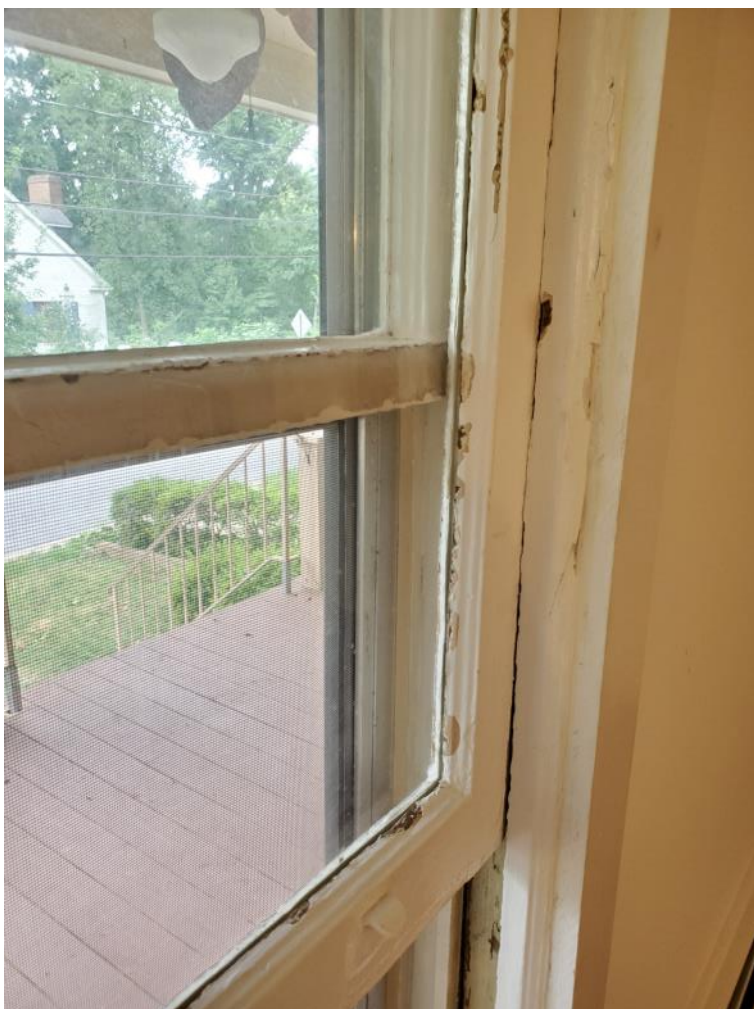
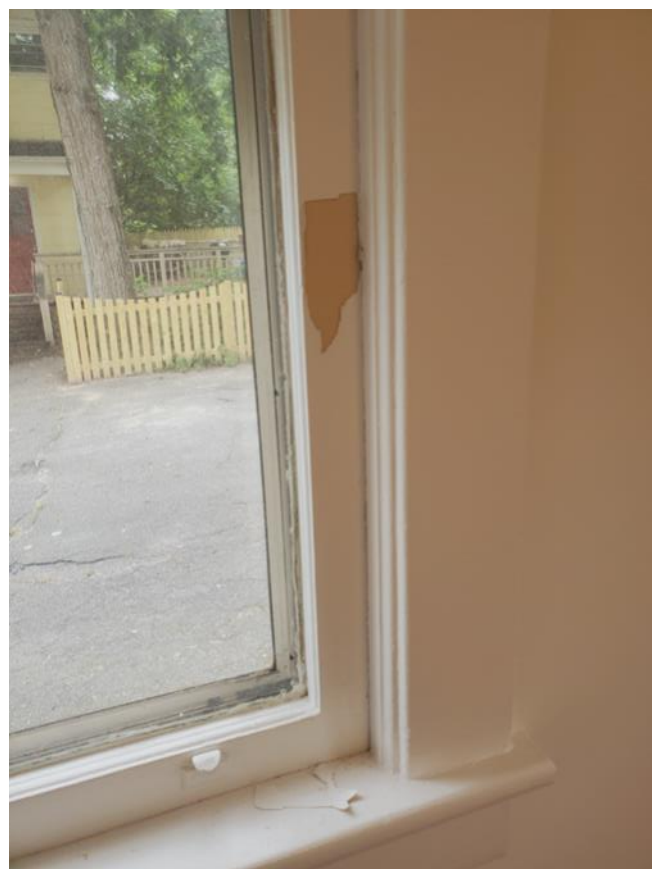
Window condition All windows last painted in Q1 2022

All the existing windows are wood one-over-one sash windows. The condition of the individual window sashes varies, but all sashes have peeling paint and have tested positive for lead (report attached). The applicant proposes removing all of the existing sashes and installing "low profile" aluminum clad sashes in their place. The proposed sash packs will have a one-over-one configuration to match the existing configuration. Additionally, the applicant proposes to remove all of the aluminum storm windows.

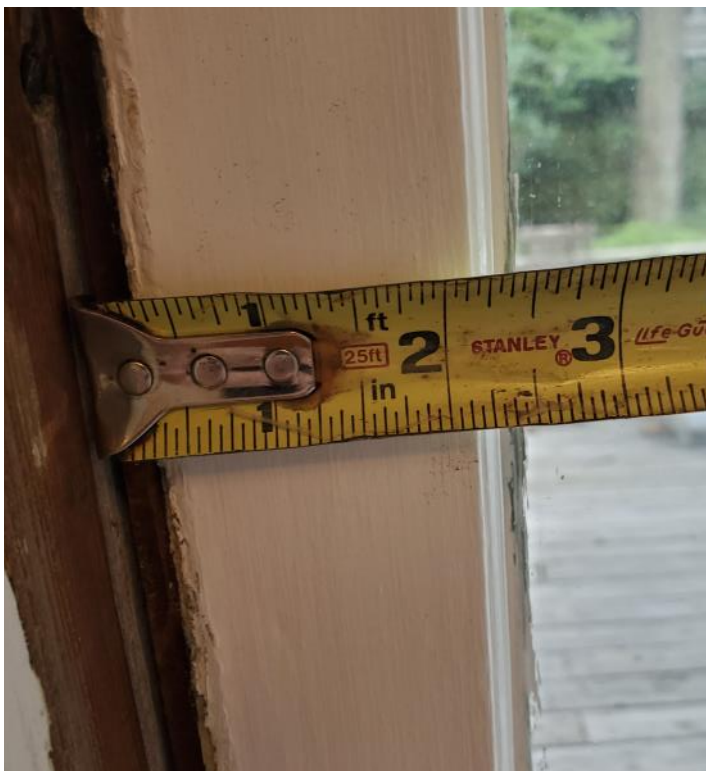
Left/right stiles: 2 3/8" + ~1/8" lateral travel space on each side

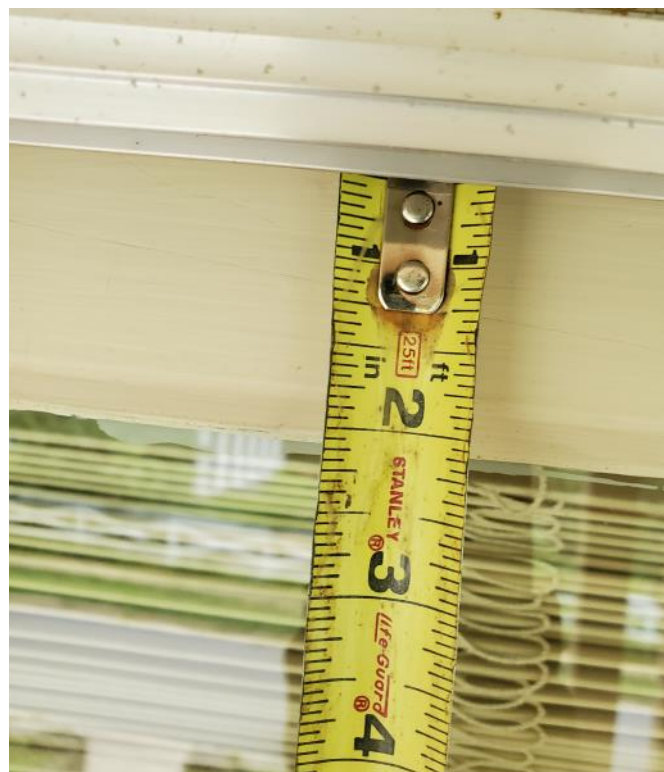
Top rail: 2 1/8"

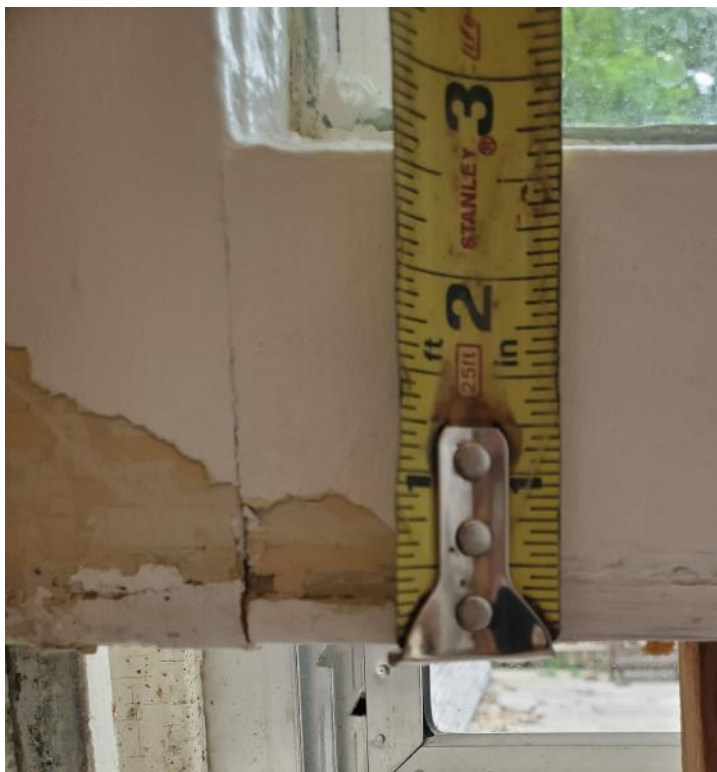
Bottom rail: 2 3/4" at interior edge of sloped sill

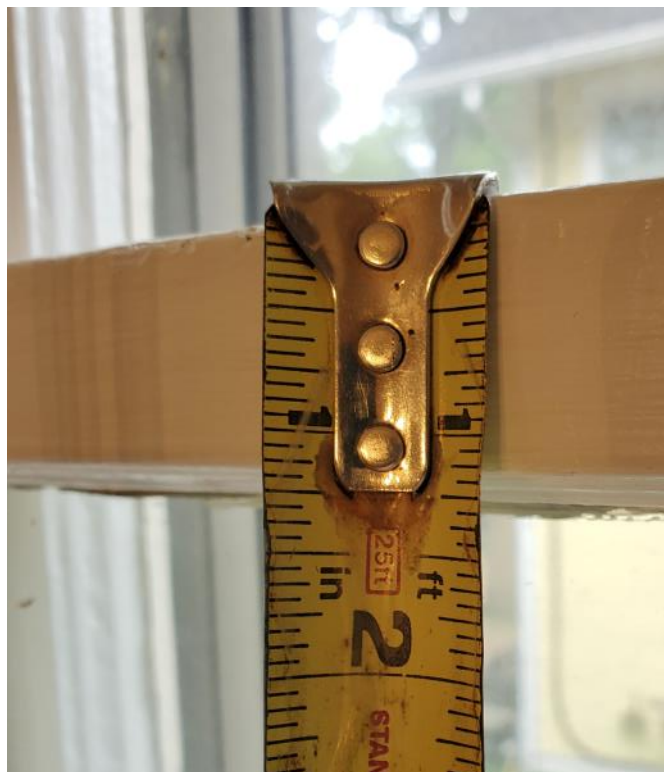
Meeting rail: 1 1/4"

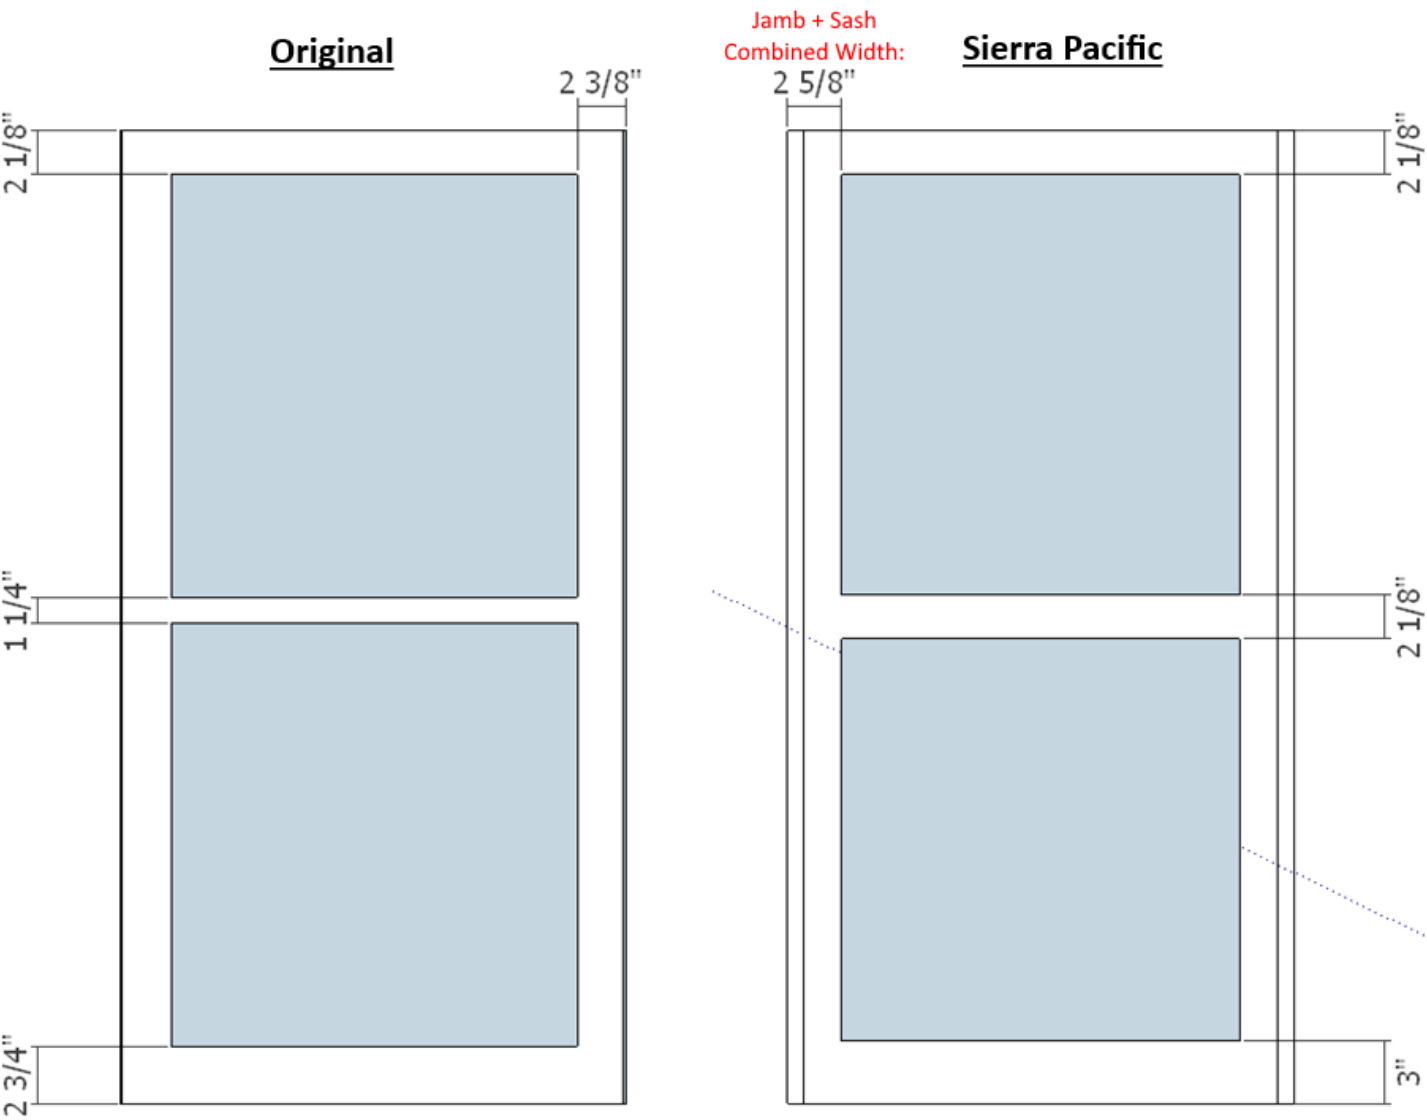
Existing vs. Proposed Sash Elevations: Meeting rail appears taller due to offset of top and bottom sash rails, as shown on the next page.

Interior rail height is shorter due to sill slope.
Existing sashes are not cut to match sill slope.

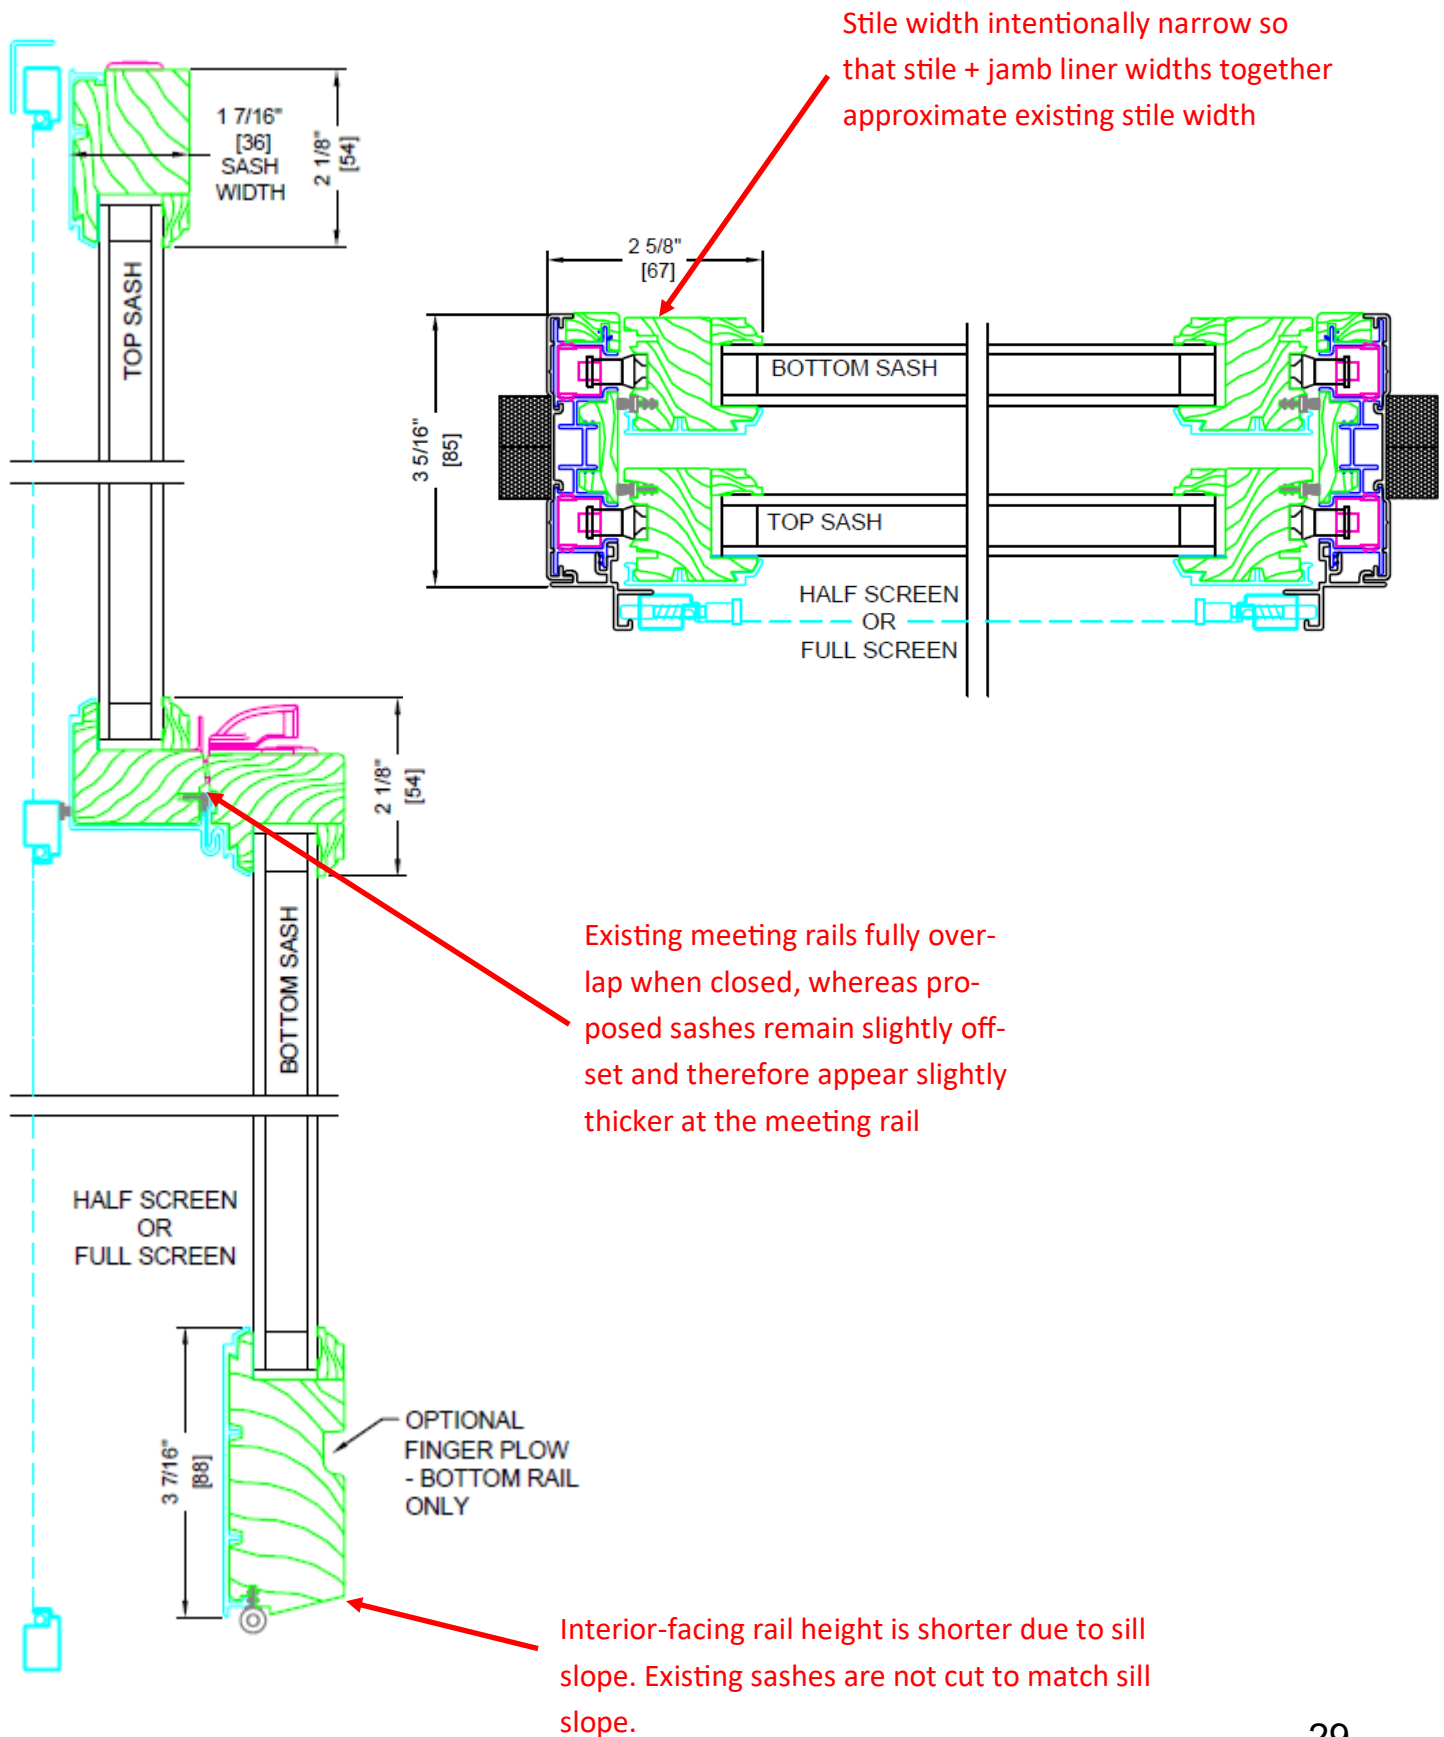
Proposed sash dimensions: vertical and horizontal sections

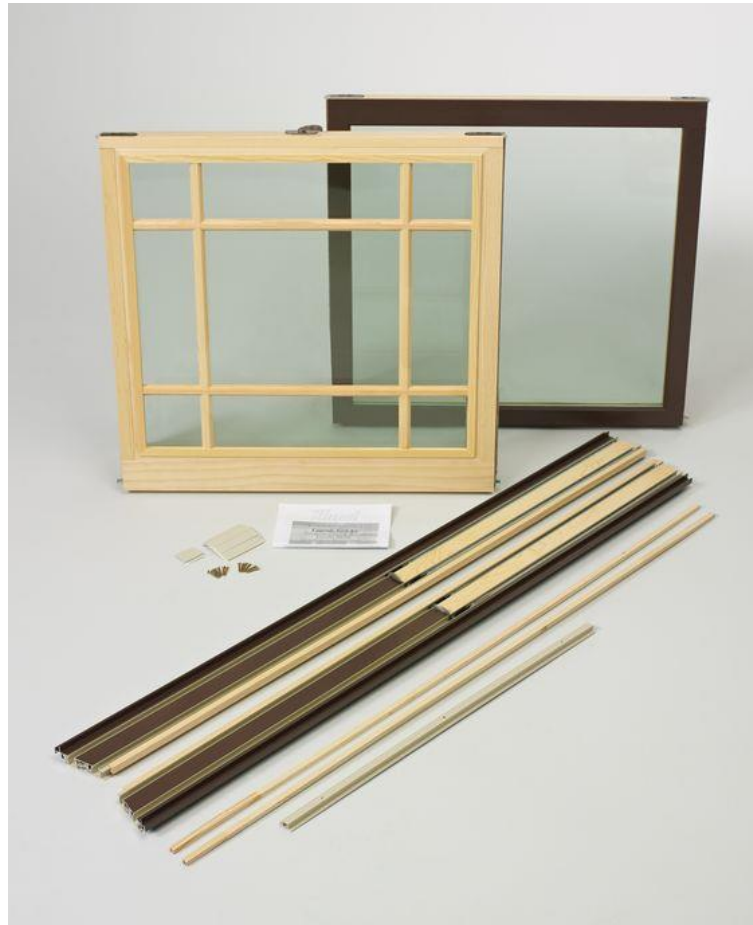
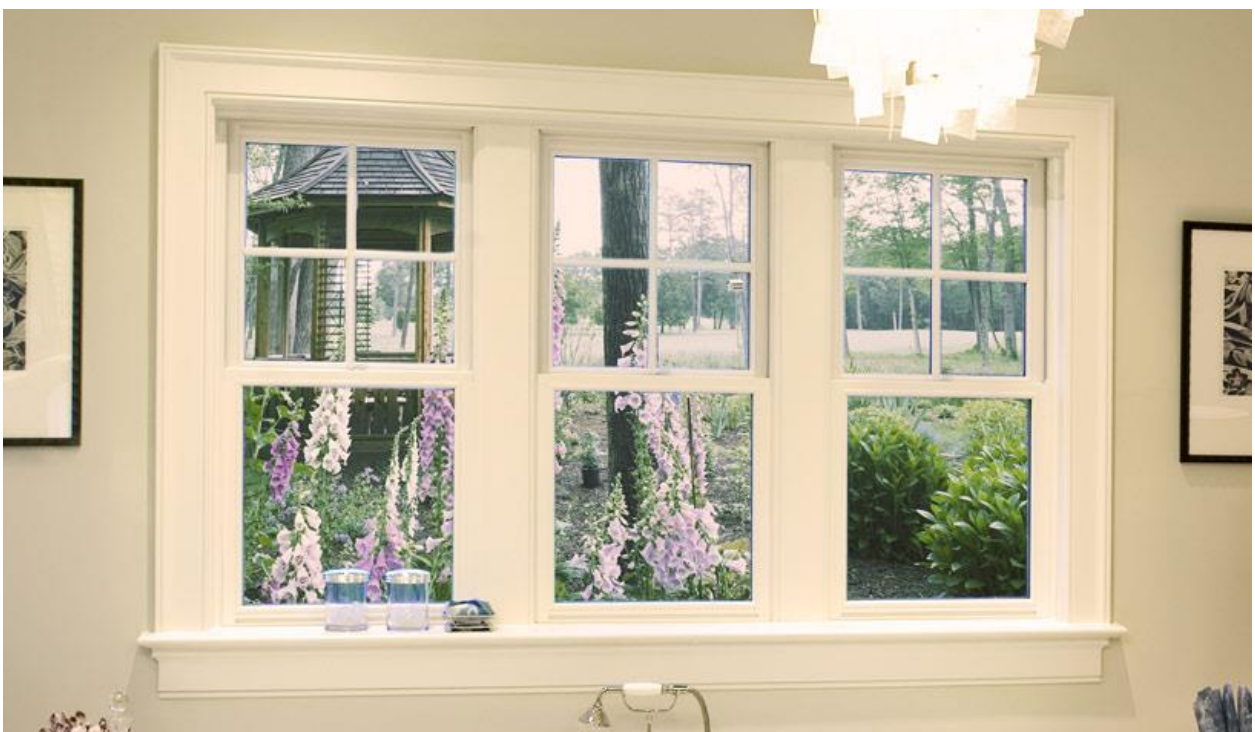
Below are photos of an example sash pack kit and similar replacement sashes in situ

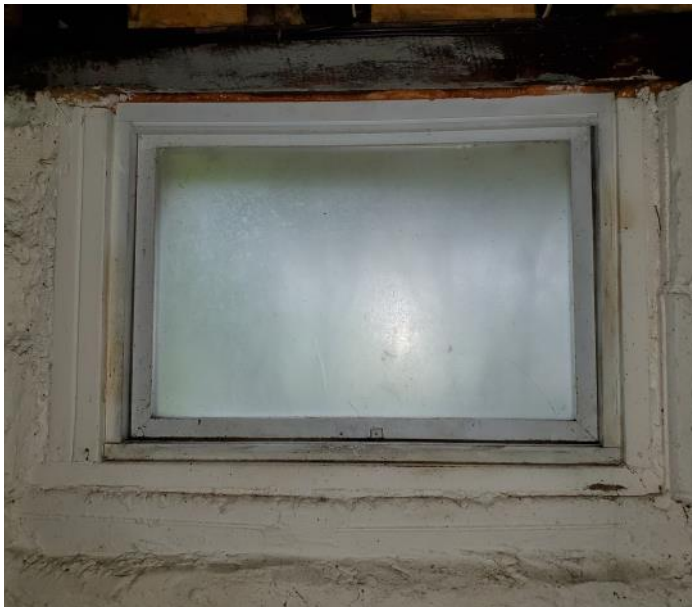
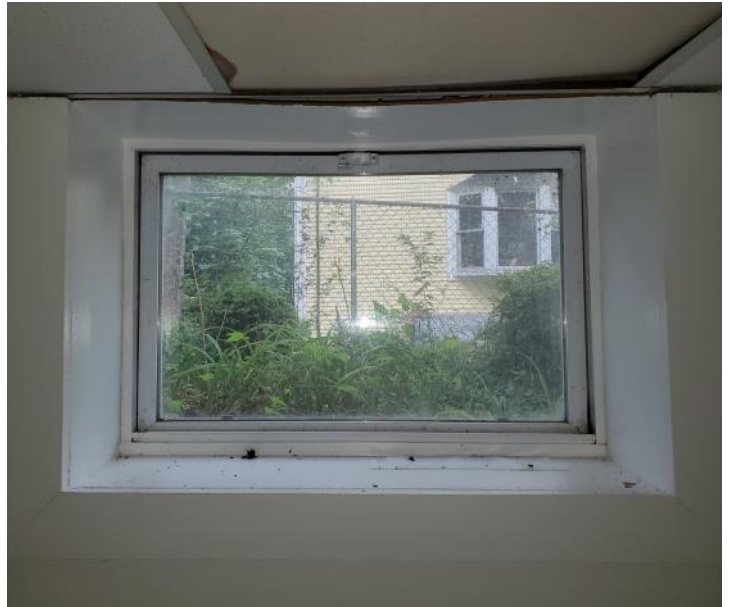
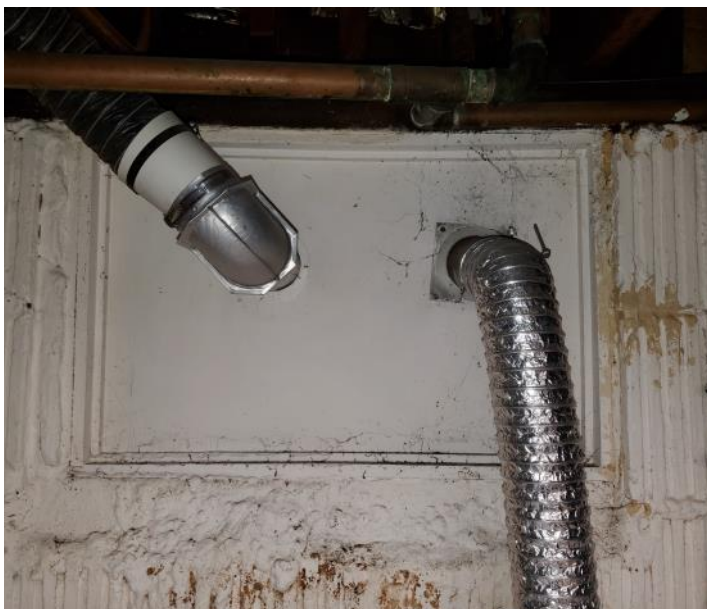
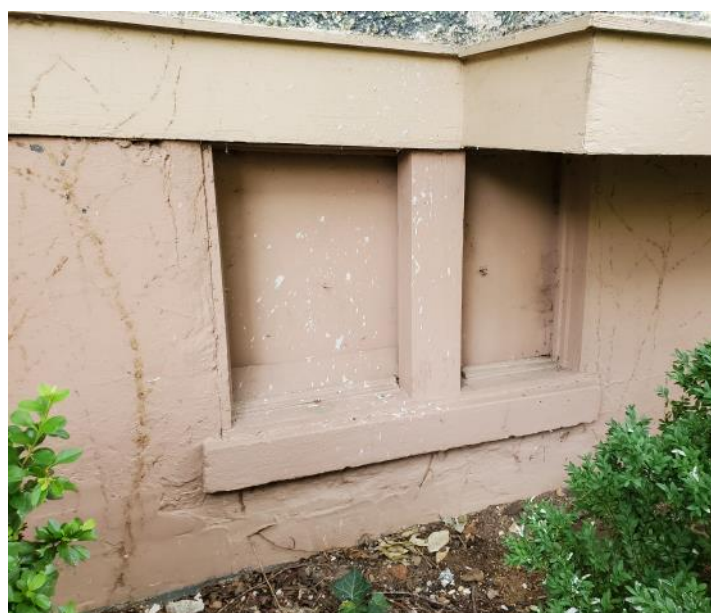
Work Item 3: Window sash replacement, con't

Existing basement windows

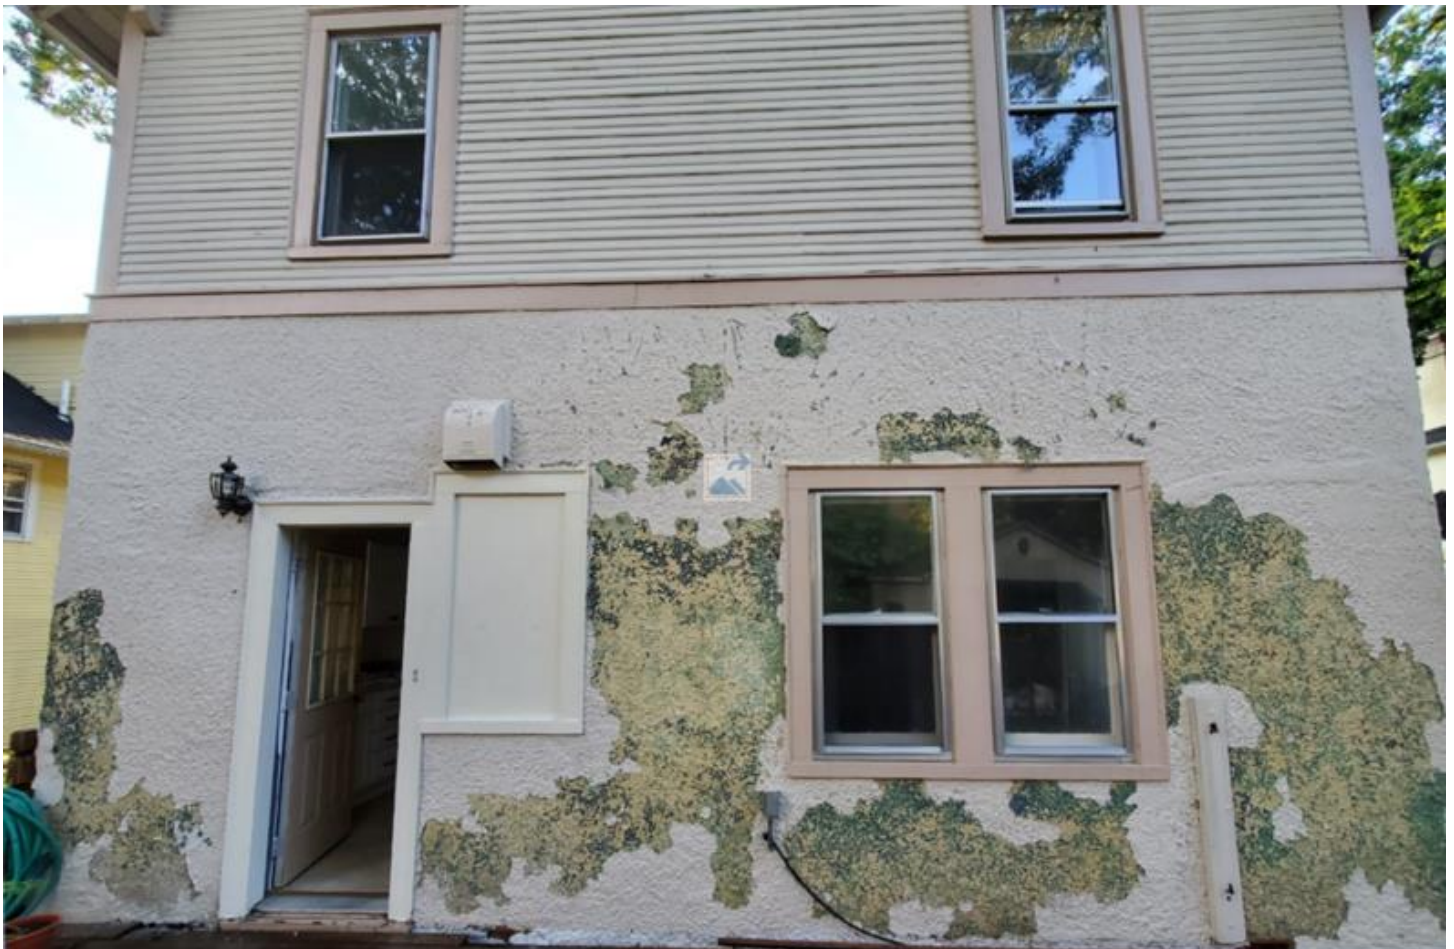
Work Item 4: Rear-facing doors/windows

Below is a photo of the existing rear fenestration to be compared to that in the proposed elevation drawing set.

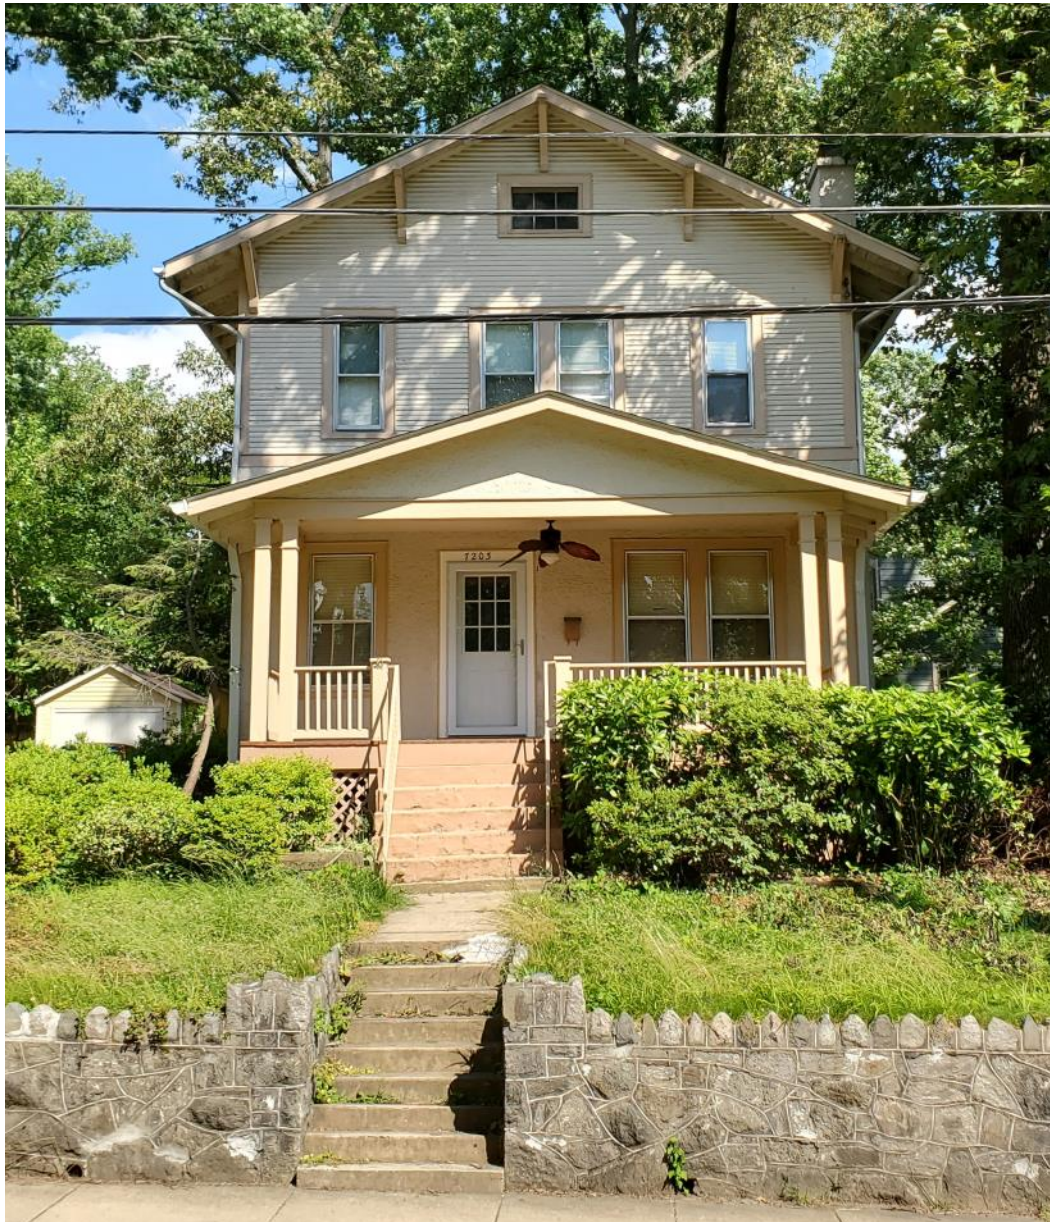
Work Item 5: Modified roof pitch

Below is a photo of the existing front elevation to be compared to that in the proposed elevation drawing set.

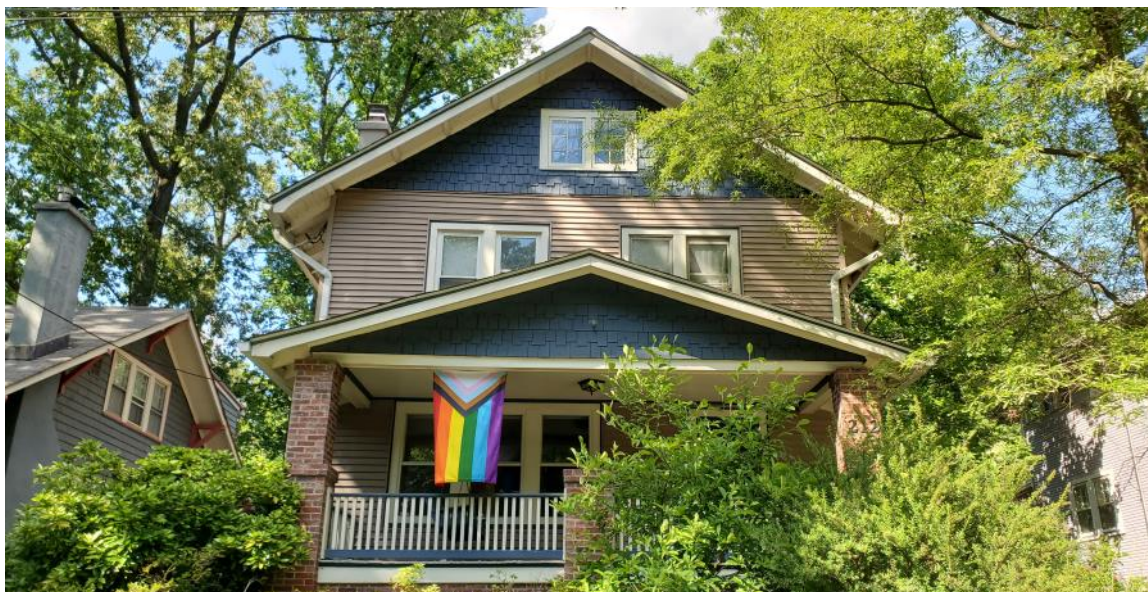
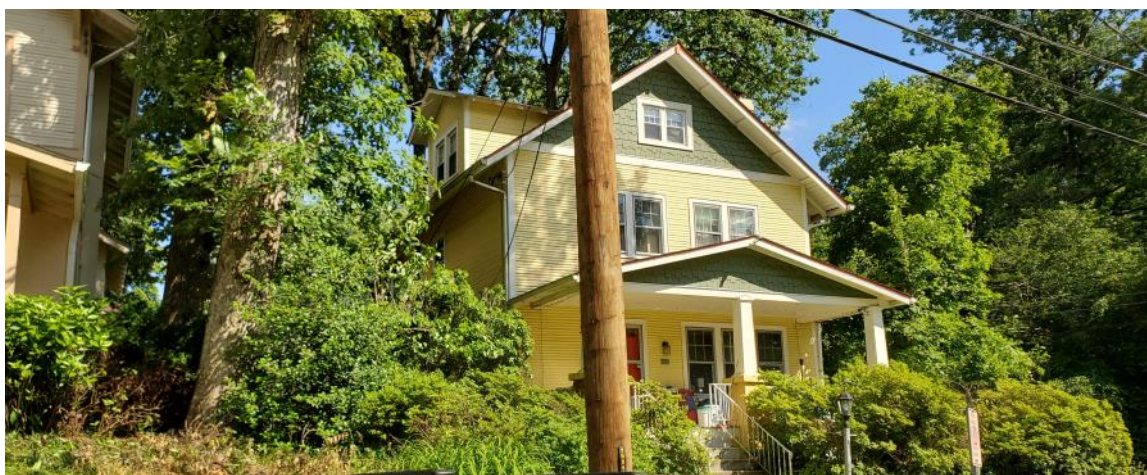
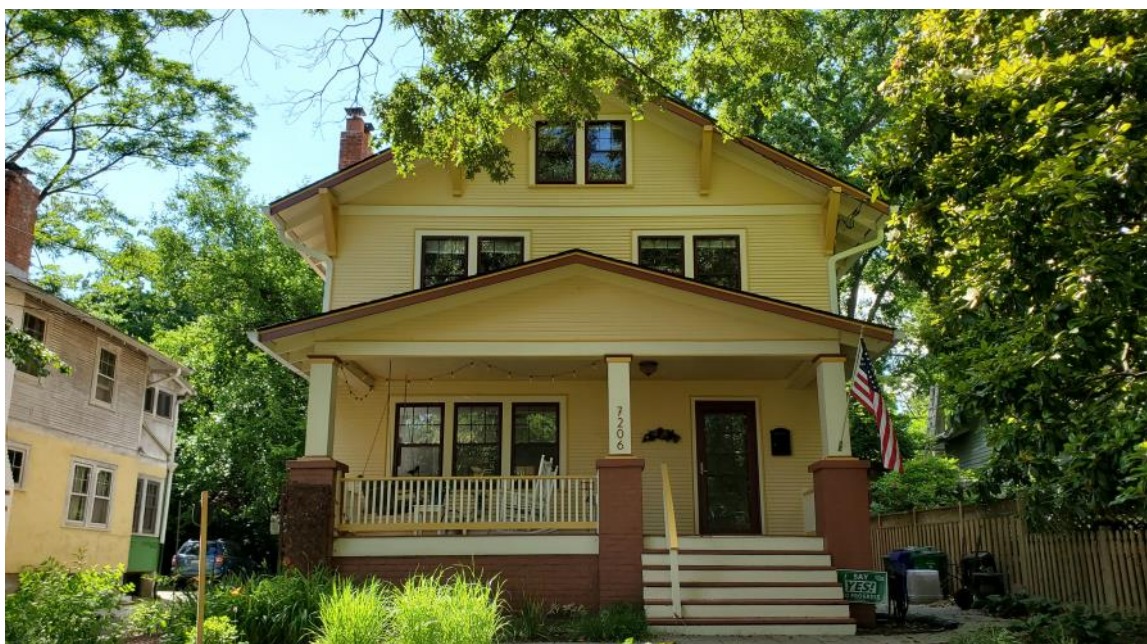
Work Item 5: Modified roof pitch, con't

The following are examples of 2-story Craftsman houses with steeper roof pitches found within a 1-block radius of the subject property, including the next-door neighbor in the middle photo.

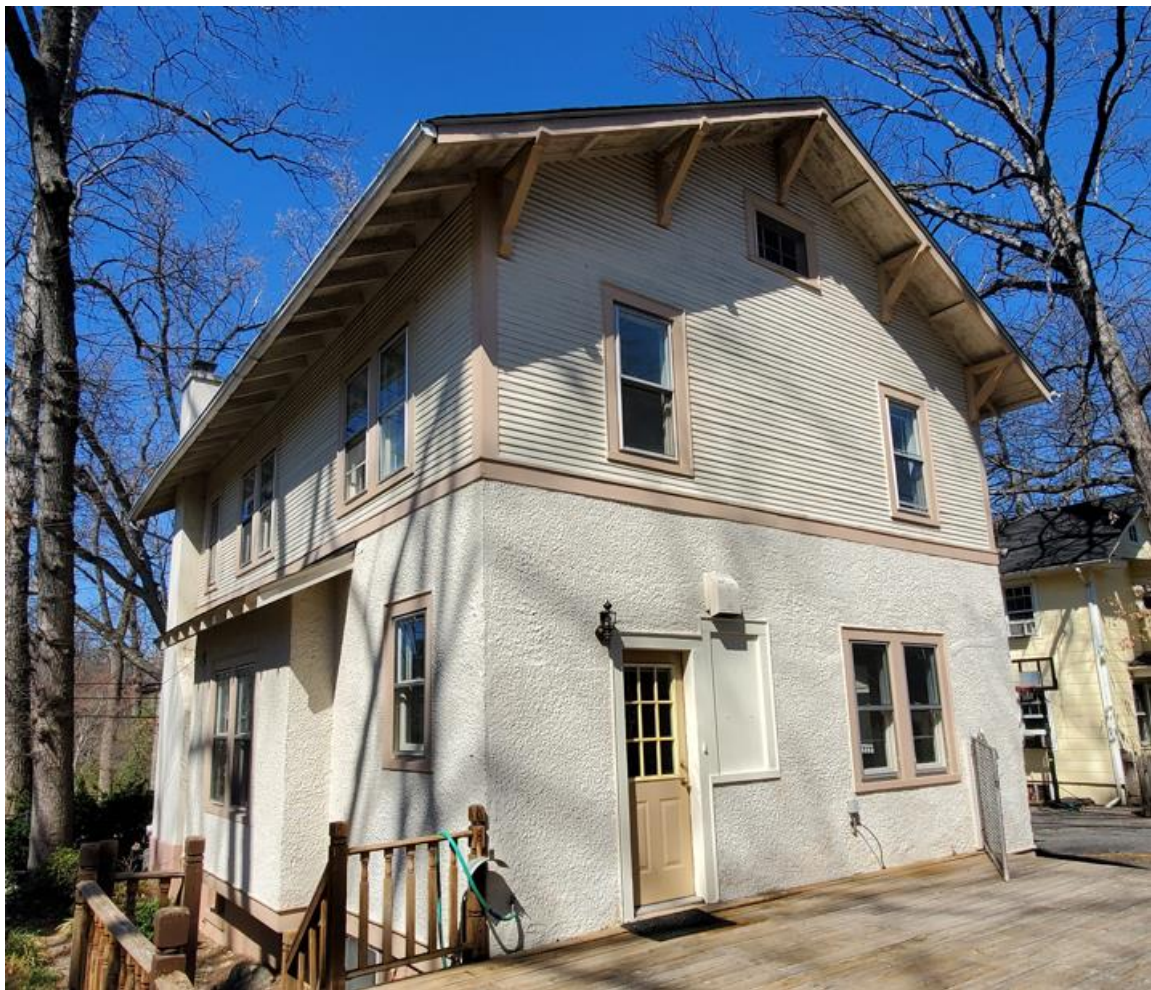
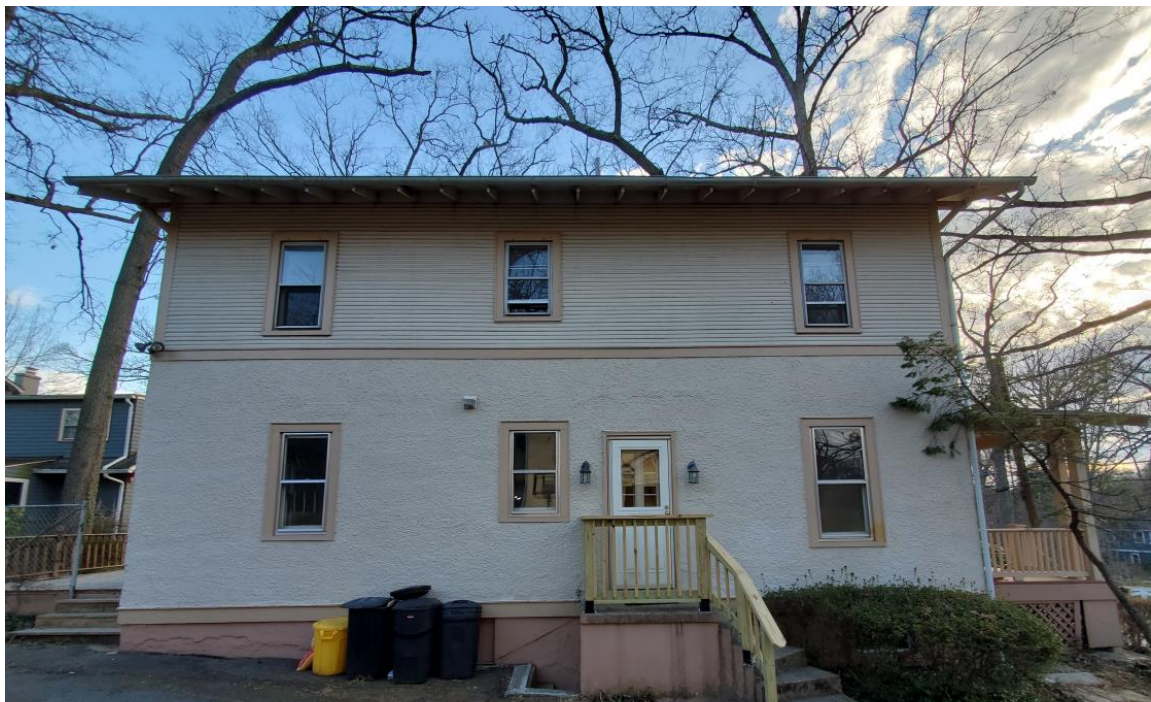
Work Item 6: Dormers and skylights

Below are photos of the existing side elevations to be compared to those in the proposed elevation drawing set. The right side elevation is impossible to photograph directly, so it is shown as completely as feasible.

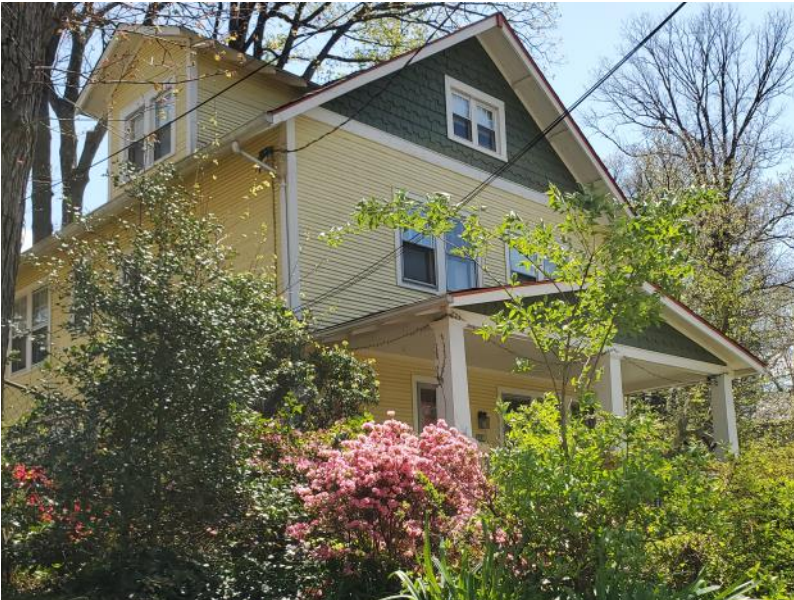
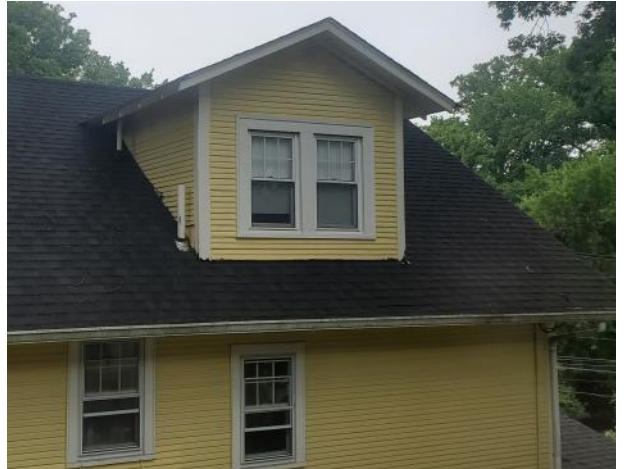
7201 Cedar Ave

The following are examples of 2-story Craftsman houses with dormers within 1-block radius of the subject property, including the next-door neighbor.

Commissioners were uniform in finding that a shed dormer could be accommodated on the right roof slope, but that the one presented was too large.
