MONTGOMERY COUNTY HISTORIC PRESERVATION COMMISSION
STAFF REPORT

| Address: | 7203 Cedar Ave., Takoma Park | Meeting Date: | 12/7/2022 |

Proposal: Roof alteration, dormer construction, fenestration alteration, window replacement, and after-the-fact front porch alteration.

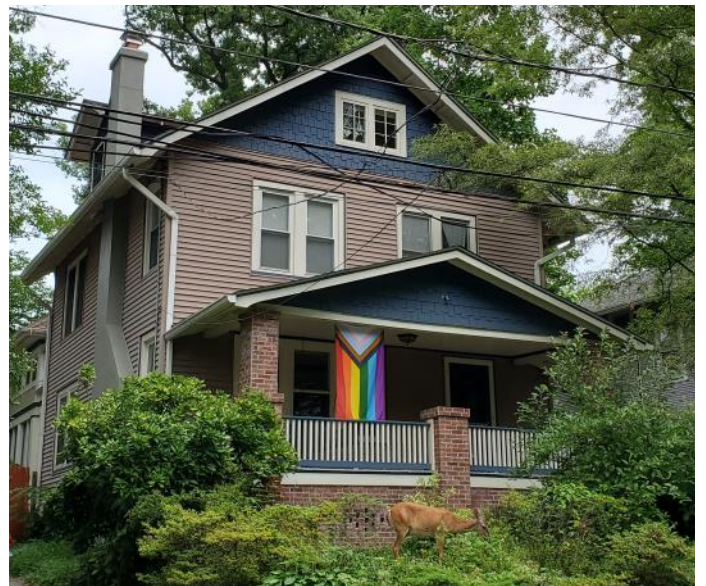
212 Tulip Ave showing one of two dormers

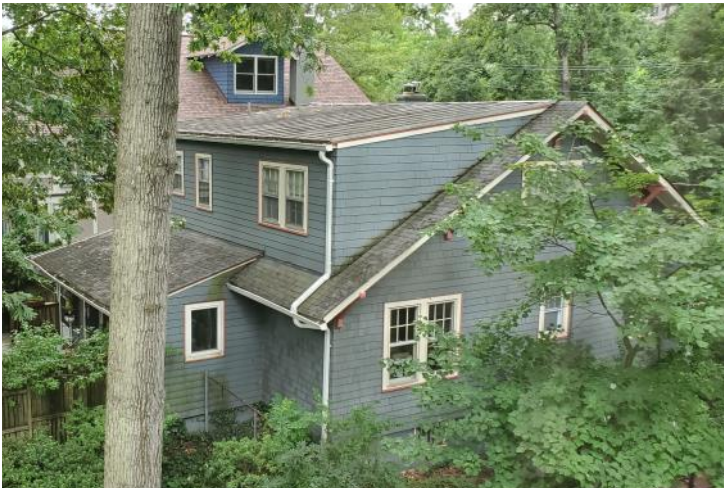
Photo taken from subject property of shed dormer at 210 Tulip Ave in foreground and gable dormer 214 Tulip Ave beyond

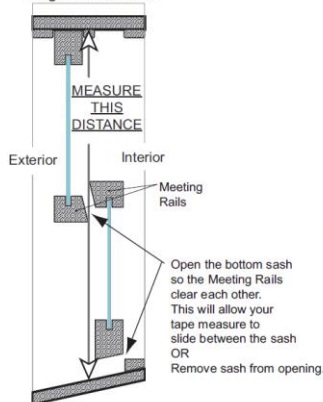
• **Note:** when measuring the height of the frame, open the bottom sash so the meeting rails clear each other **Figure 1**, this will allow your measuring tape to slide between the sash.

- Measure existing sash opening at three locations: Left, Center, Right for **Height** measurements **Figure 1** AND

Figure 1 Shows measuring the Height of the frame

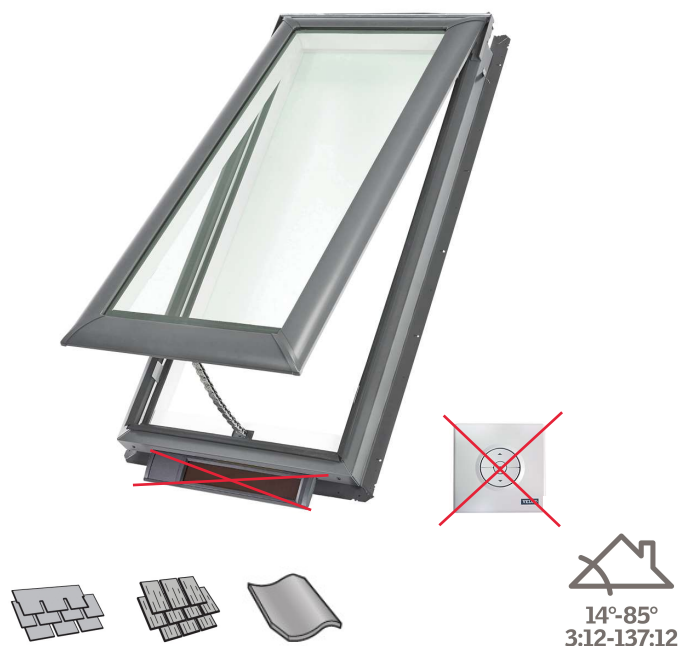
Type Sign

- Example: VSS C01 0004E 01BM05
- Located on top of interior frame cover.
