Preliminary Consultation
MONTGOMERY COUNTY HISTORIC PRESERVATION COMMISSION
STAFF REPORT

Address:	6950 Carroll Ave., Takoma Park	Meeting Date:	12/7/2022
Resource:	Outstanding Resource Takoma Park Historic District	Report Date:	11/30/2022
Applicant:	Bank of America	Public Notice:	11/23/2022
Review:	Prelim	Staff:	Dan Bruechert
Proposal:	Fenestration Alteration, HVAC Installation and Associated Screening, and Building Addition

The applicant proposes to rehabilitate the building for use as a distillery. Required changes include fenestration alterations, relocating the HVAC system to the roof, and constructing a building addition.

Date: 10/31/2022
To: Dan Bruechert (MoCo Planning)
From: Christopher Peli (CORE architecture + design)
Project: Sangfroid Distilling - 6950 Carroll Ave, Takoma Park, MD
Copies: JEFF HARNER, NATE GROENENDYK (SANGFROID DISTILLING)

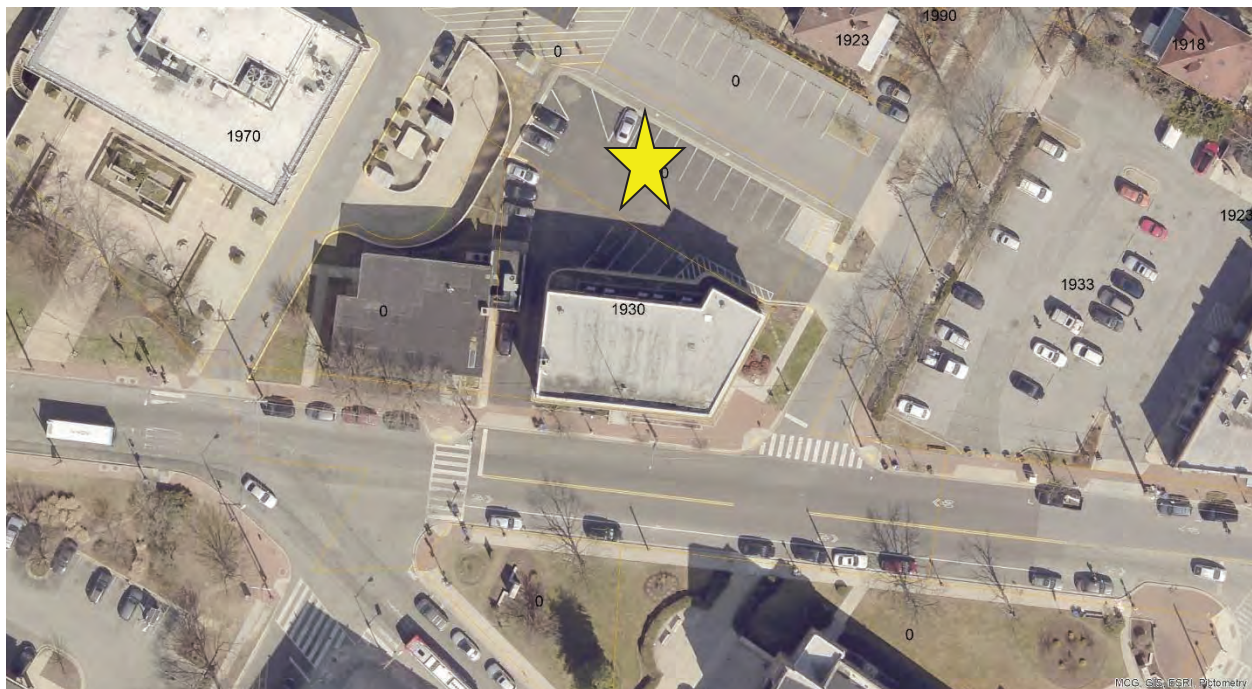
Figure 1: The subject property is located at the corner of Carroll and Willow Ave.

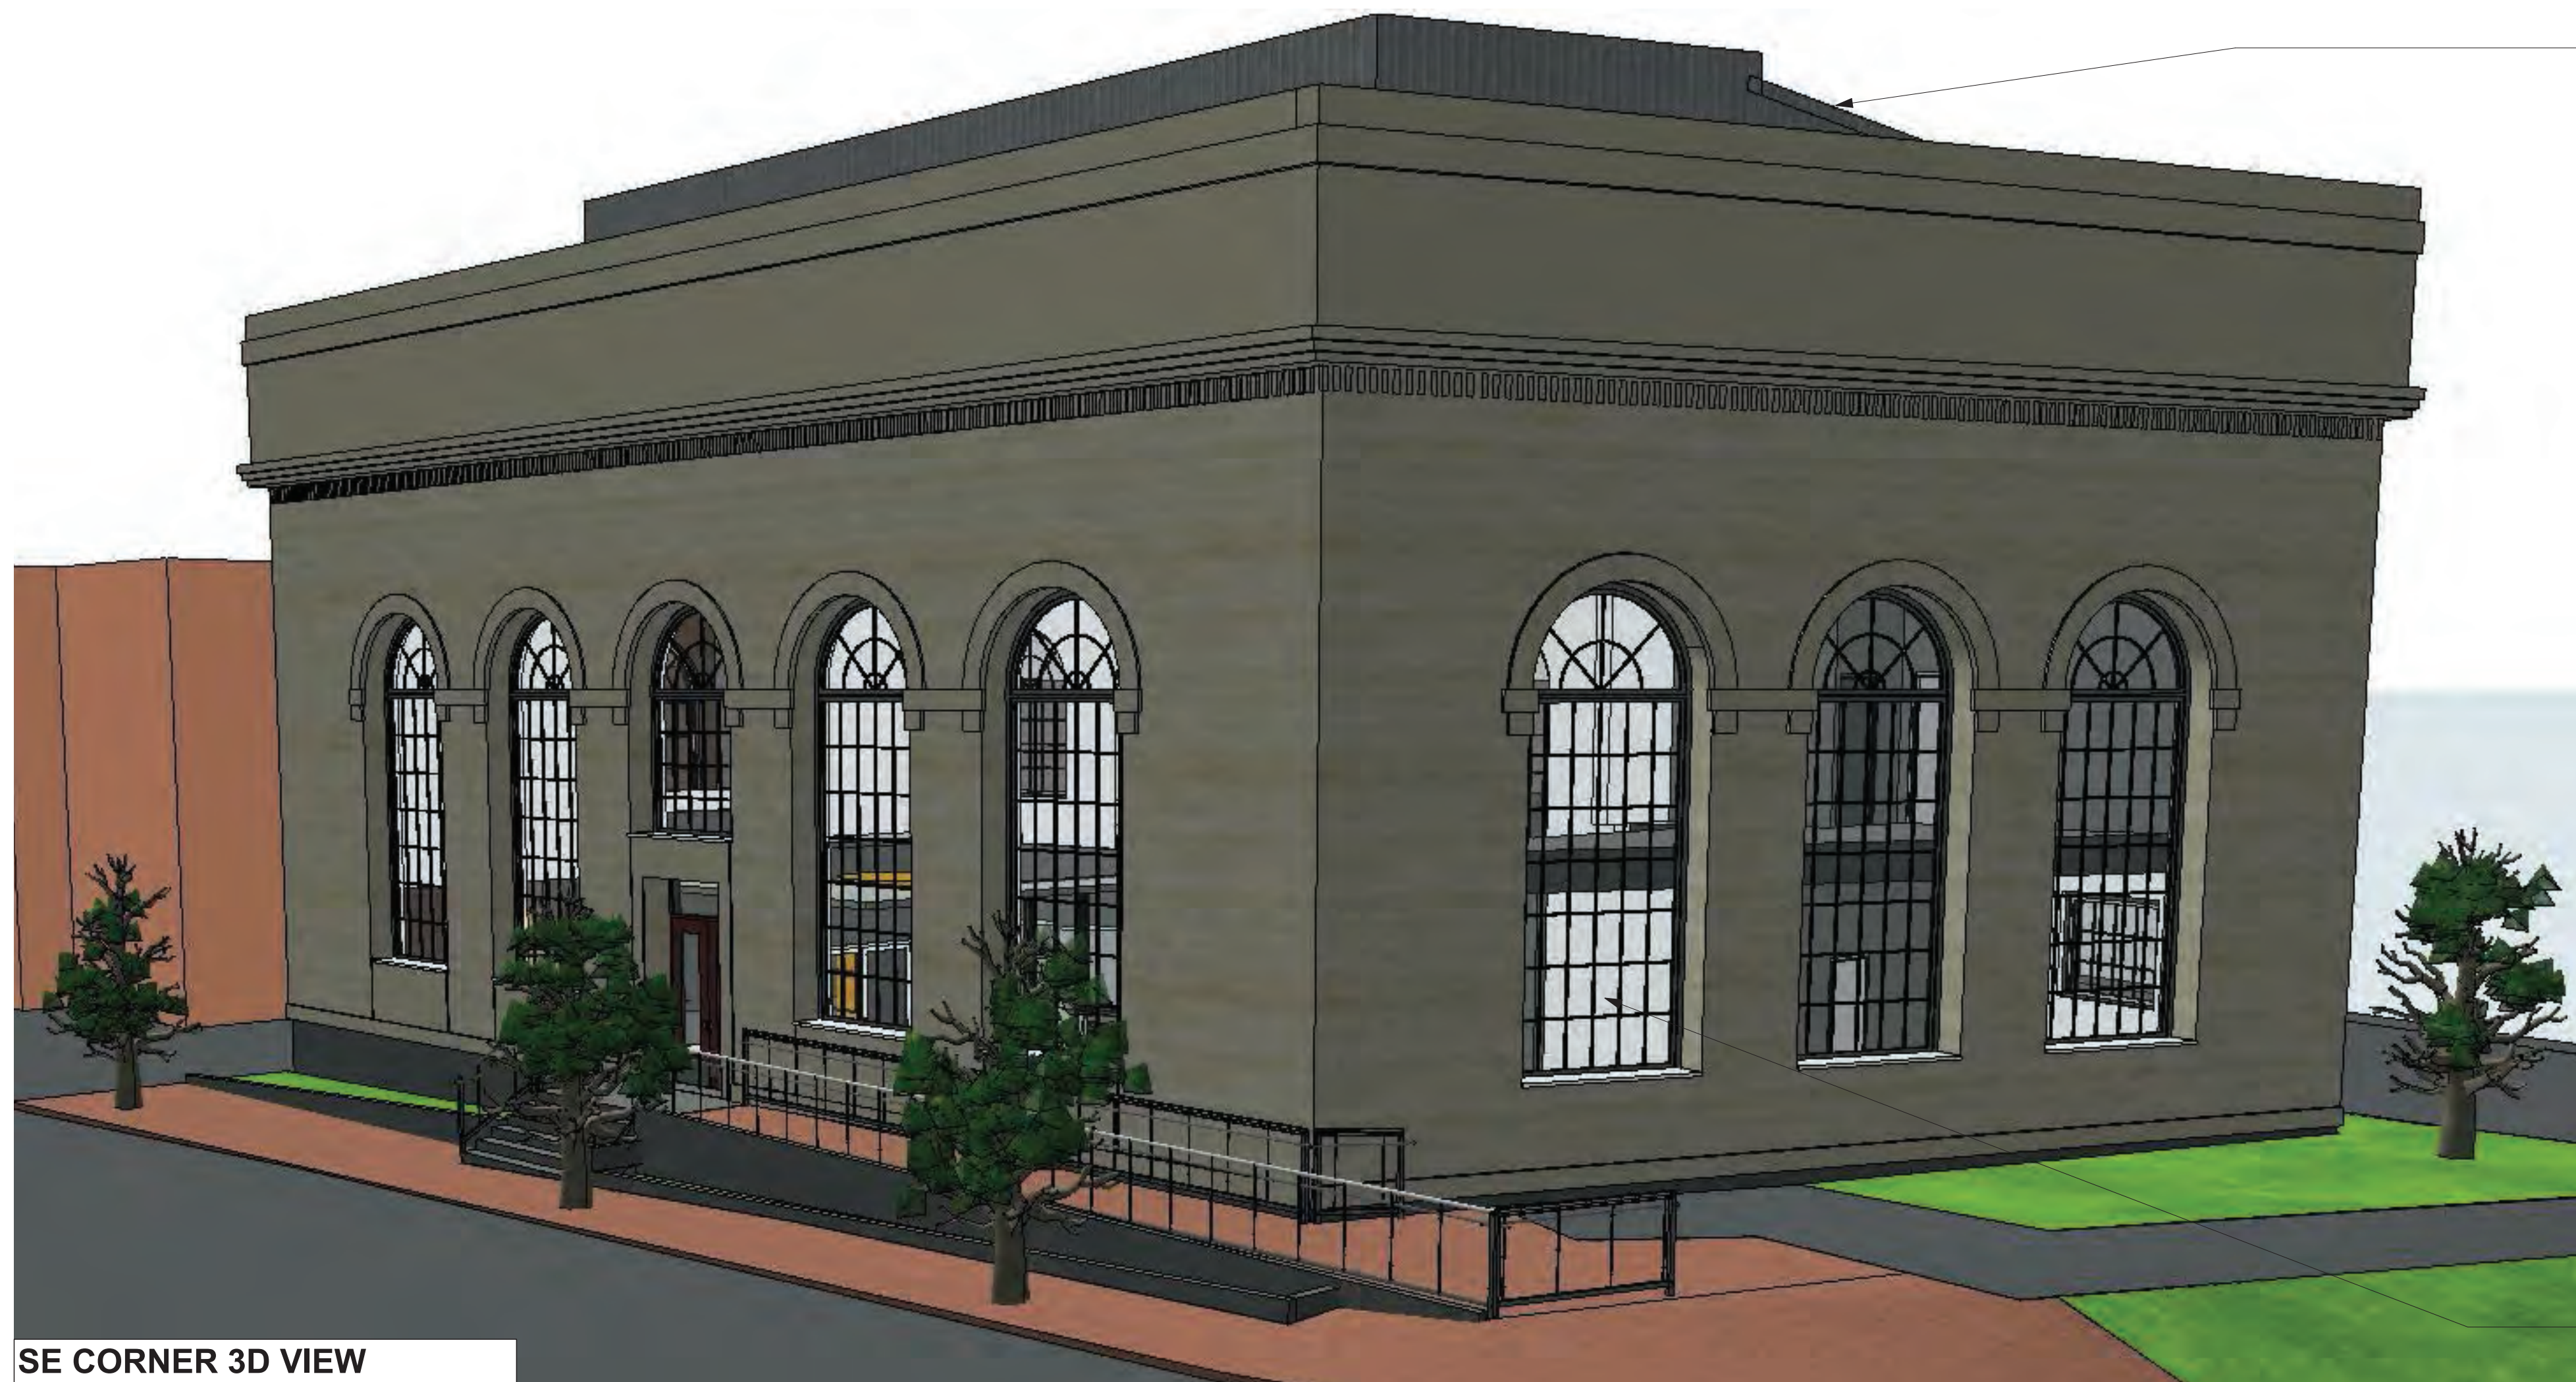
SE CORNER 3D VIEW

New egress stair to roof & mechanical equipment screening

Restore Willow Ave facade

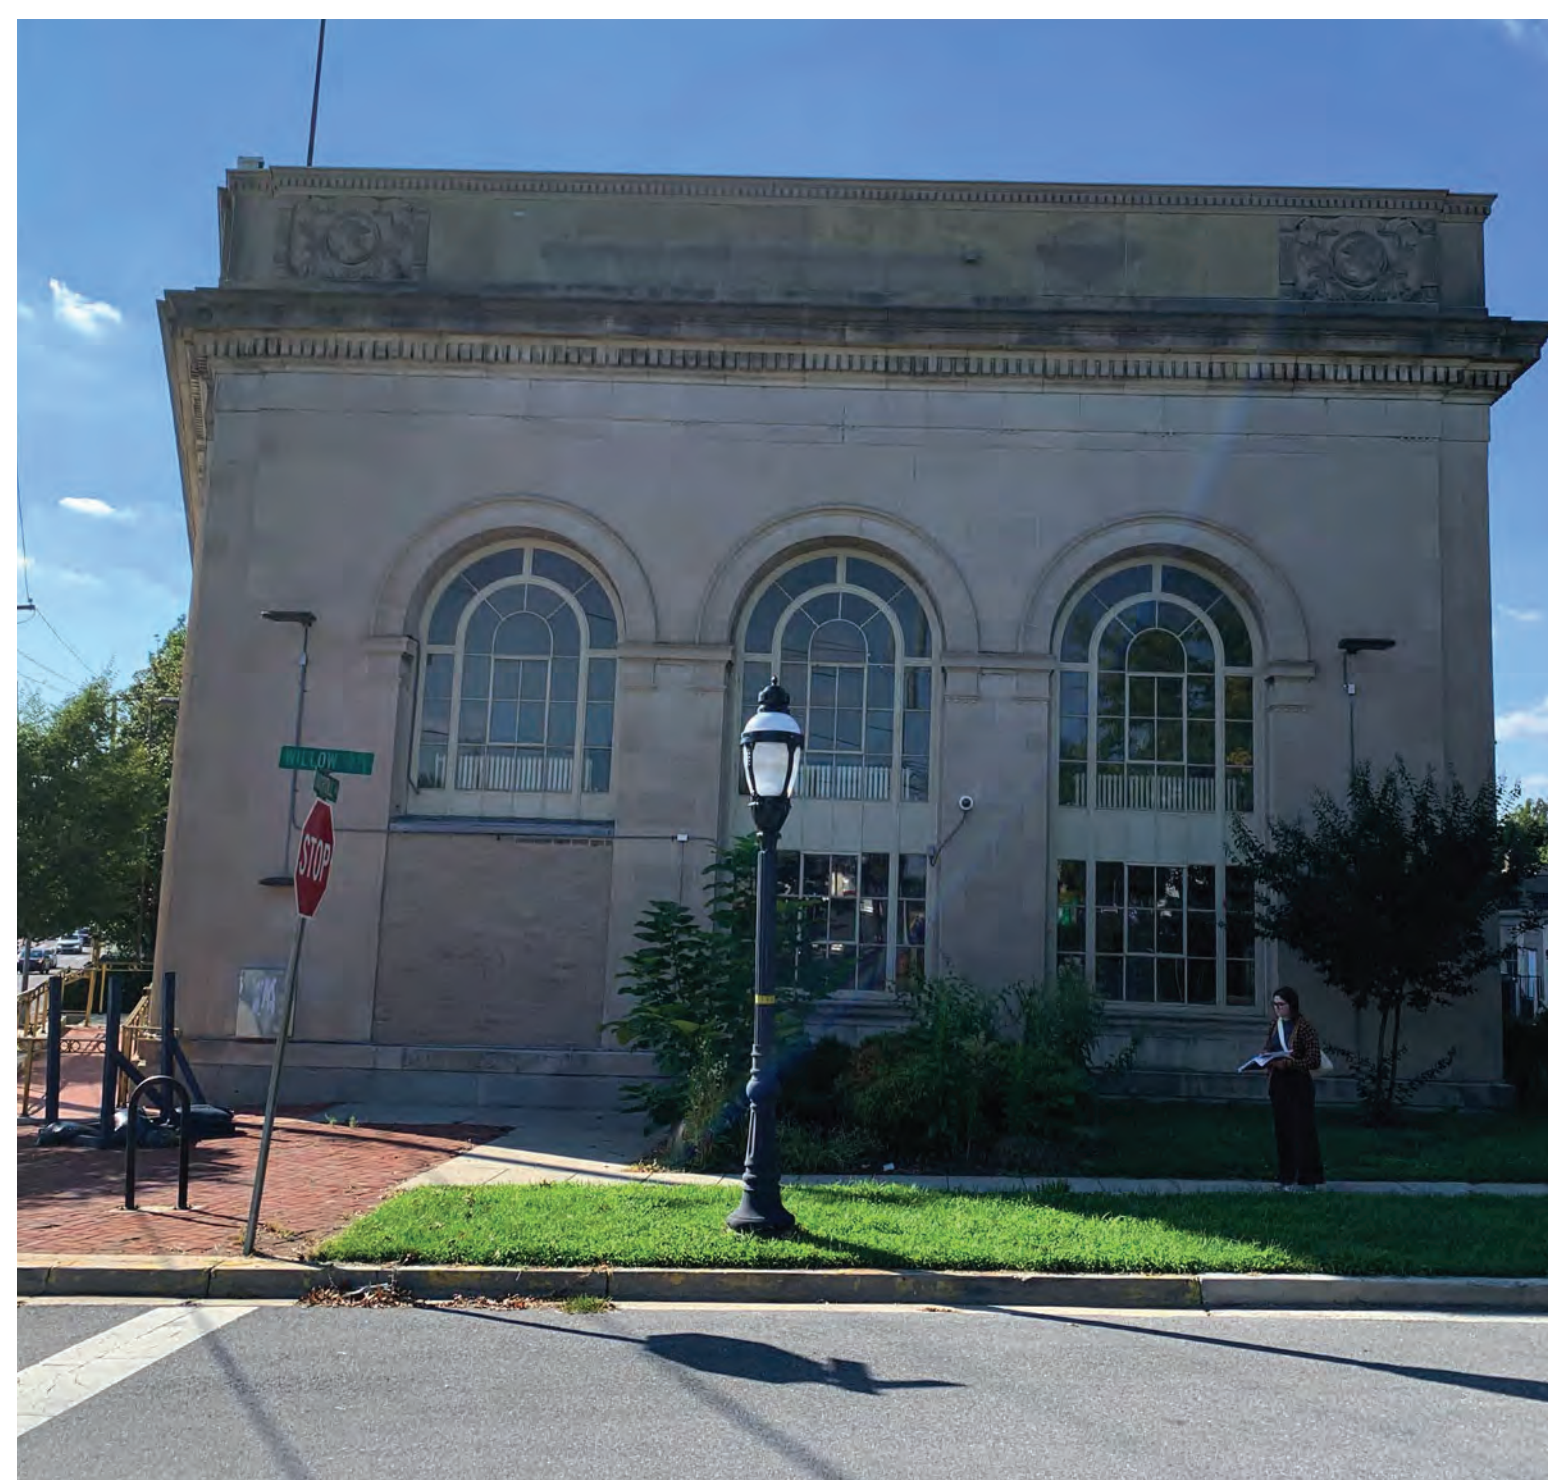
EXISTING EAST FACADE

Replace existing window with parking lot facade window. See North Elevation.

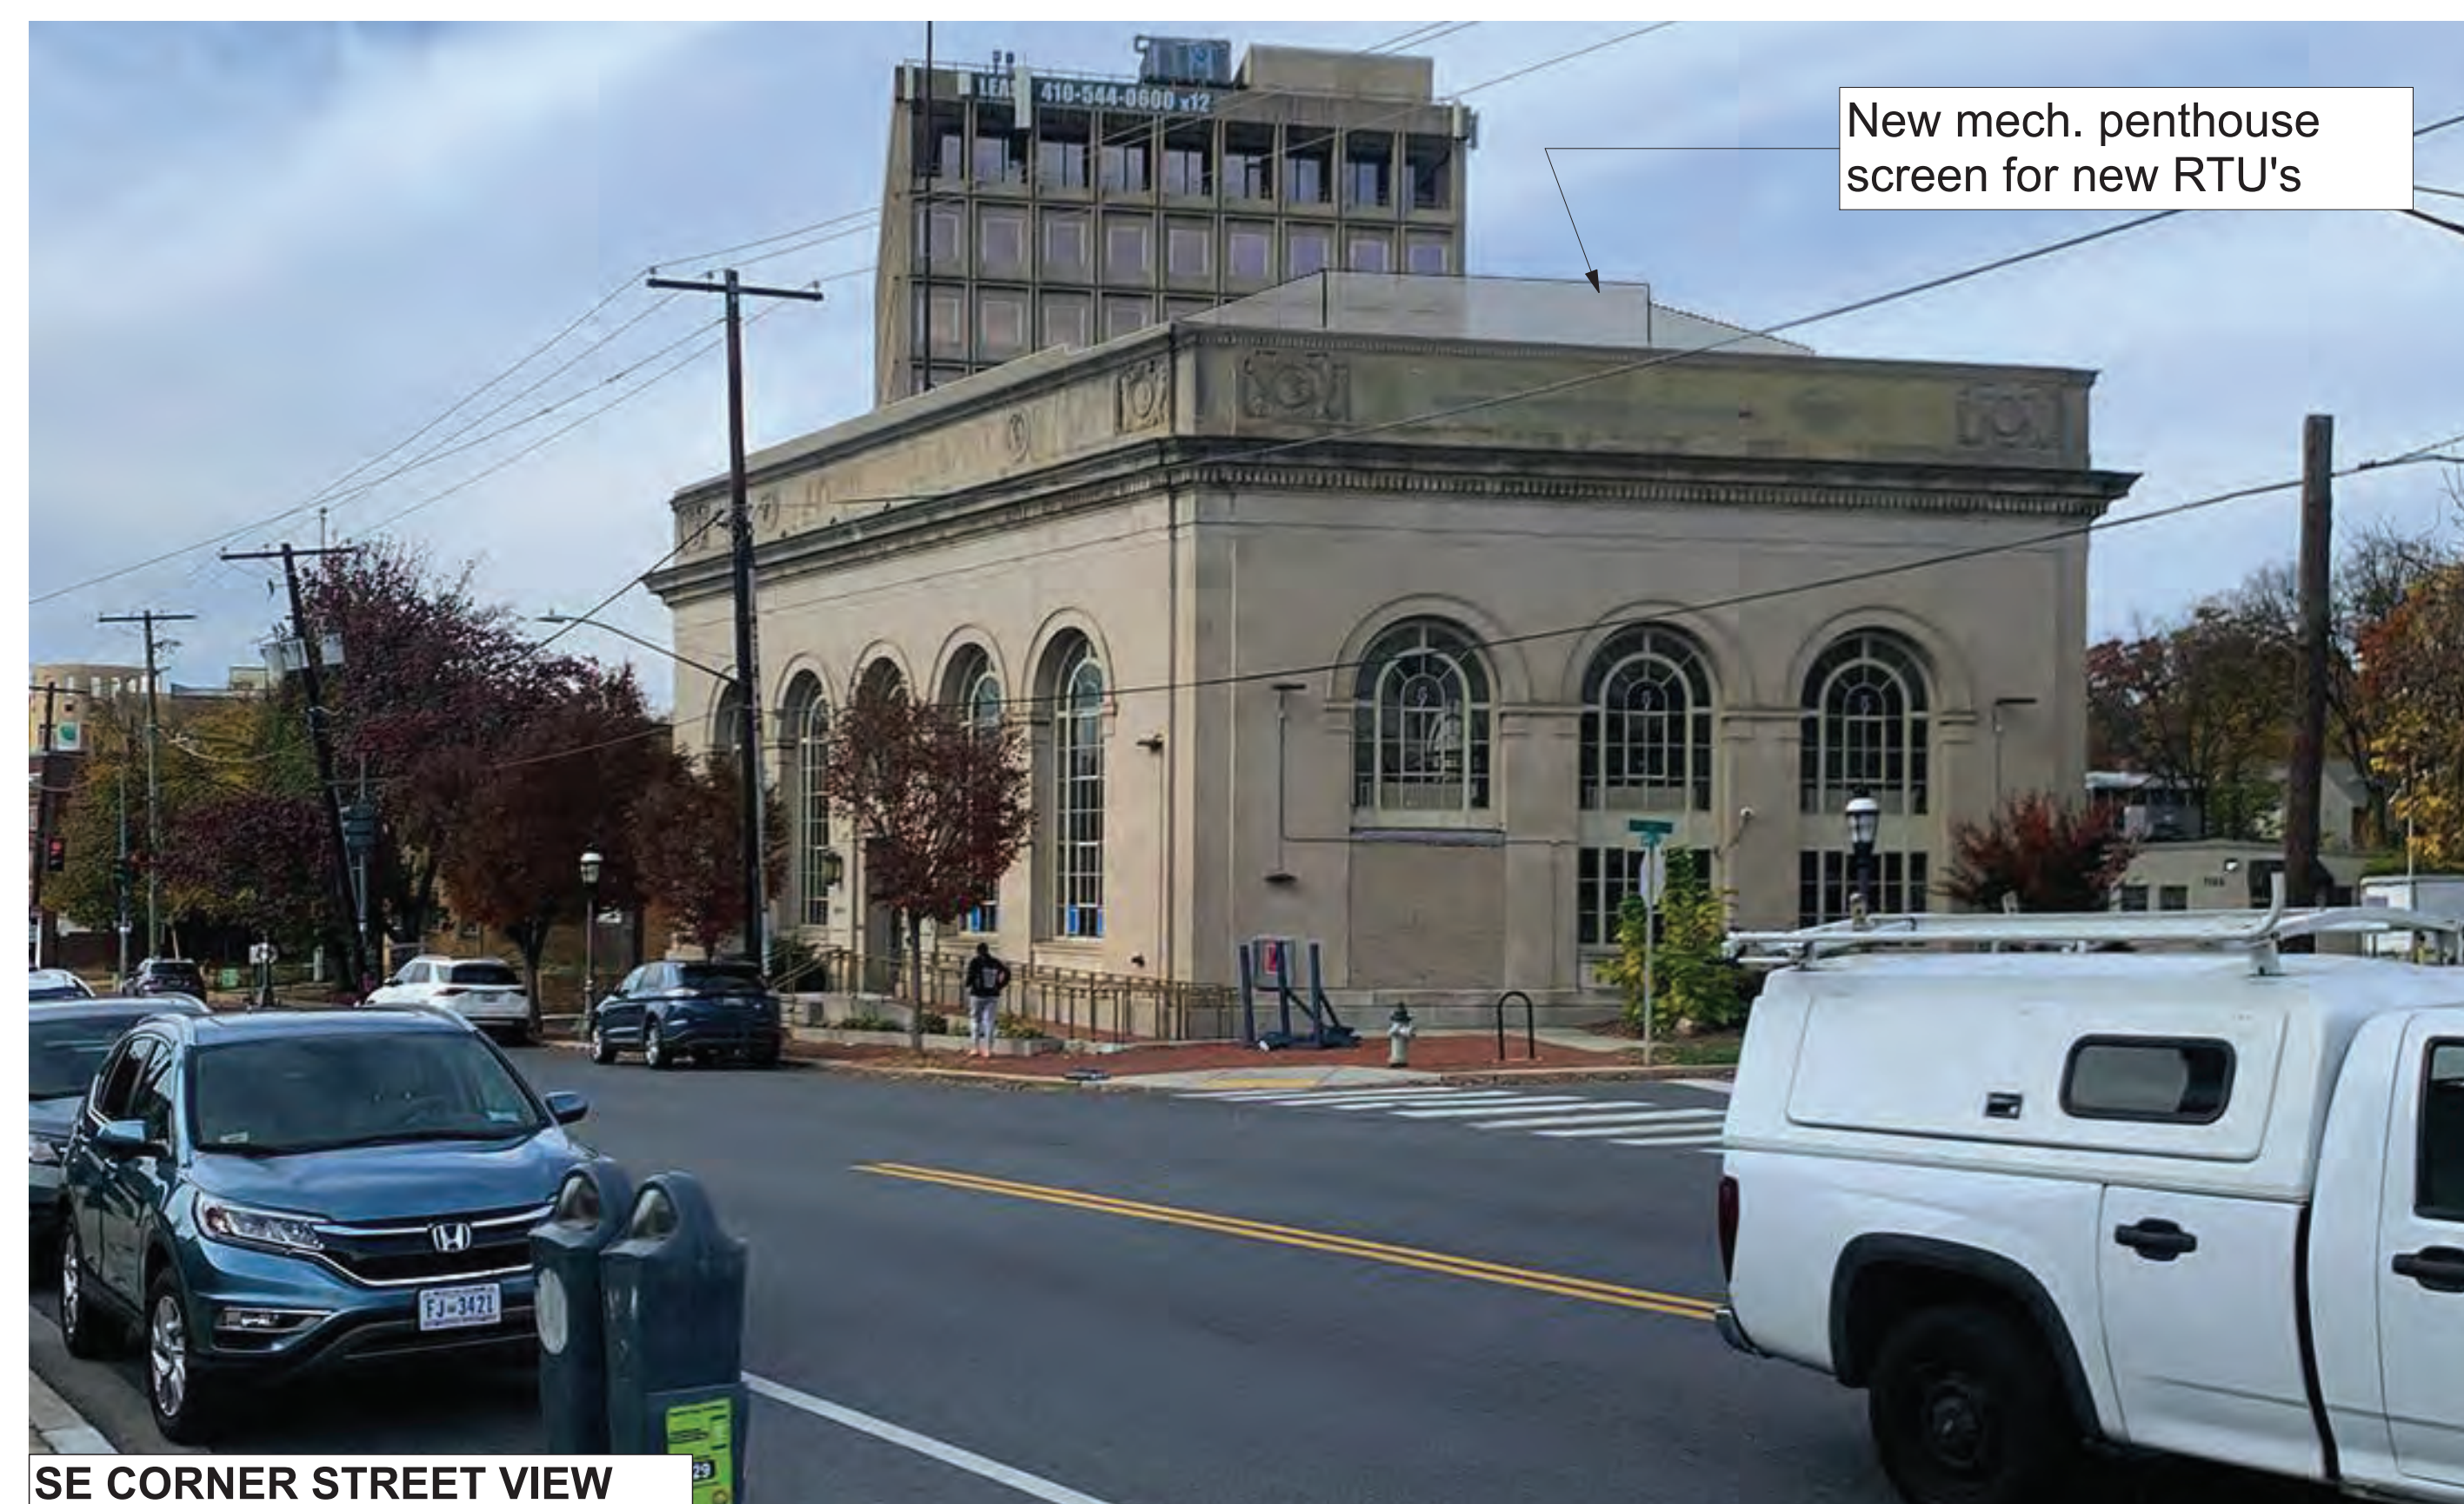
SE CORNER STREET VIEW

New mech. penthouse screen for new RTU's

The building HVAC is inadequate for modern energy code and the proposed use. We propose to replace the existing row of unsightly HVAC condenser units located at grade along the rear/parking facade of the building with an efficient Roof-Top Unit (RTU) capable of providing adequate conditioning to the building. We propose set-backs of a mechanical screen around the RTU (yet to be sized by Mechanical Engineer), of a minimum of 2:1 on the street facades, and 1:1 setback on the non-street facades. The area shown on the Roof Plan is the maximum extents based on those setback criteria, assuming a screen 8'-0" high. Our proposal includes a rooftop area for outdoor distilling equipment on the Addition roof, and ONLY equipment serving the building on the primary roof. This is to not burden the historic structure with equipment specific to the distilling use, only for the purpose of conditioning the structure itself. This will also keep the amount of higher roof mechanical to a minimum.

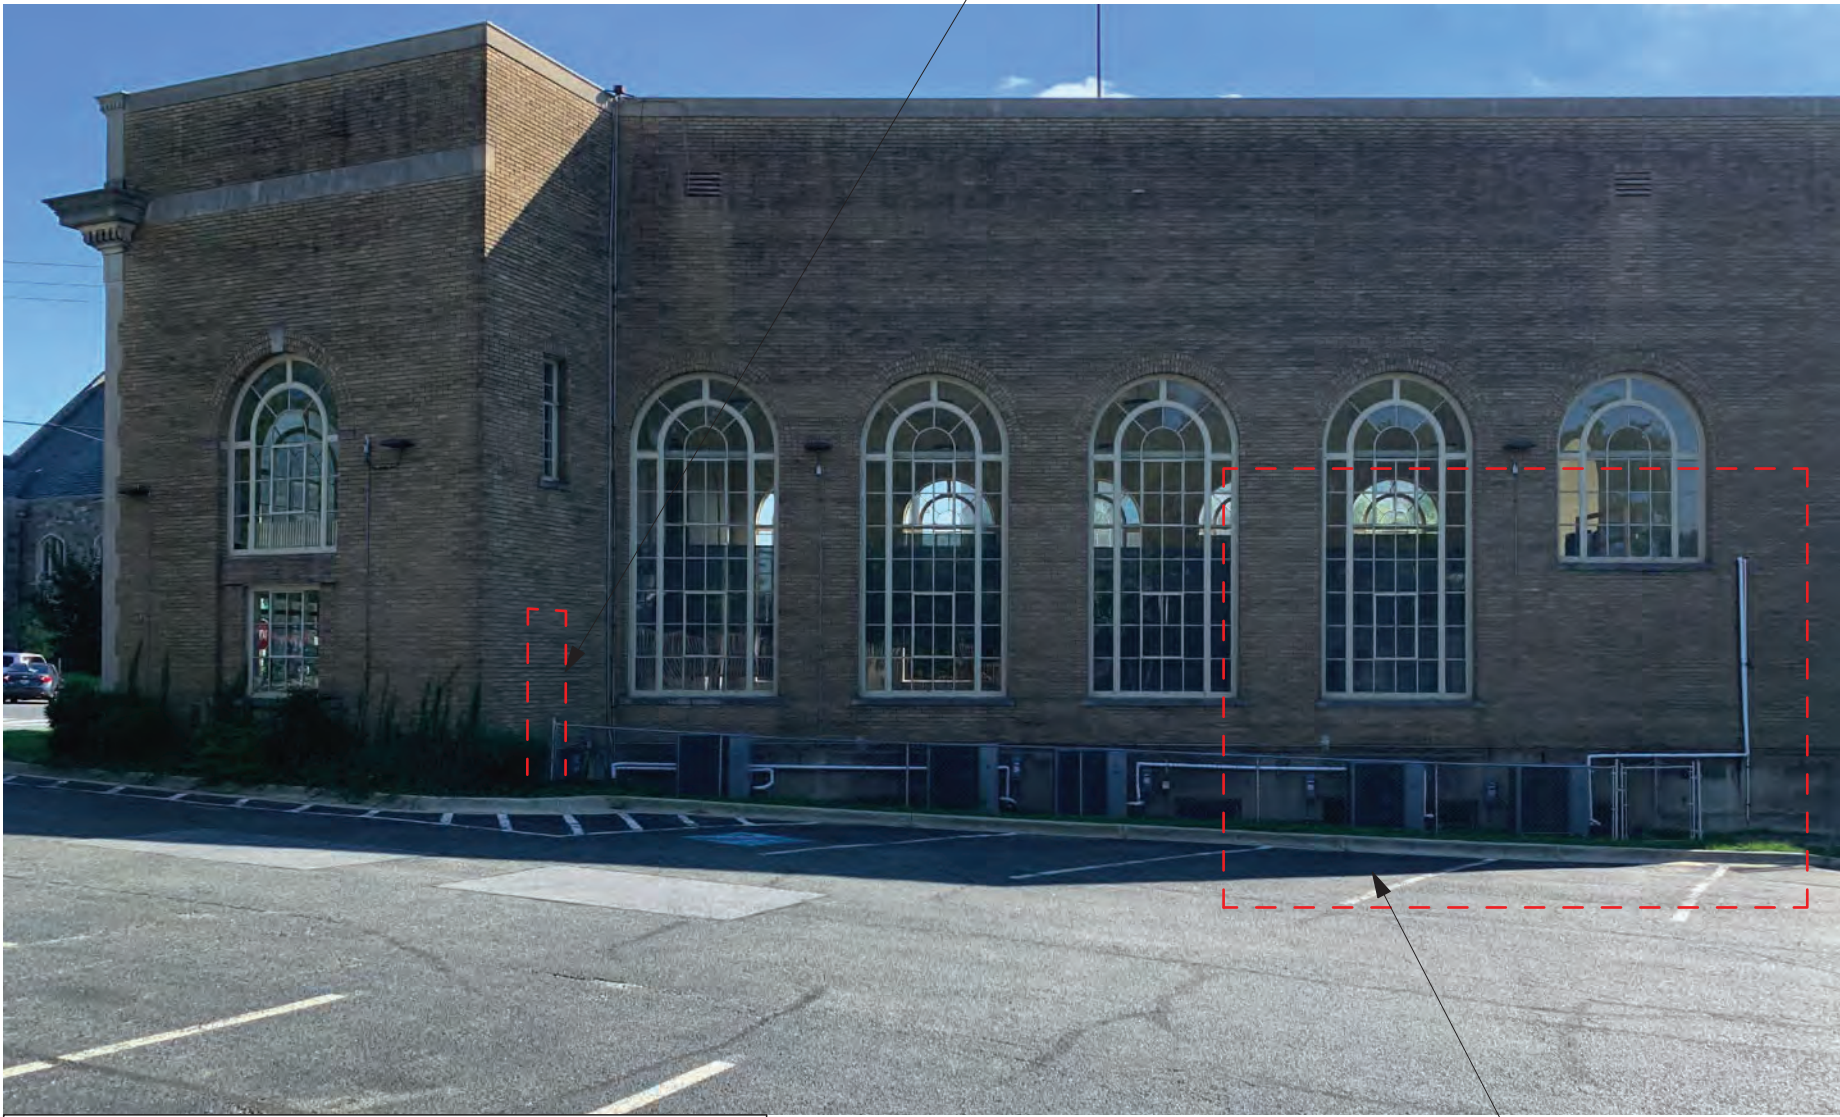
NORTH FACADE

New Egress door

New mech. penthouse
screen for new RTU's

New entry point for equipment loading.

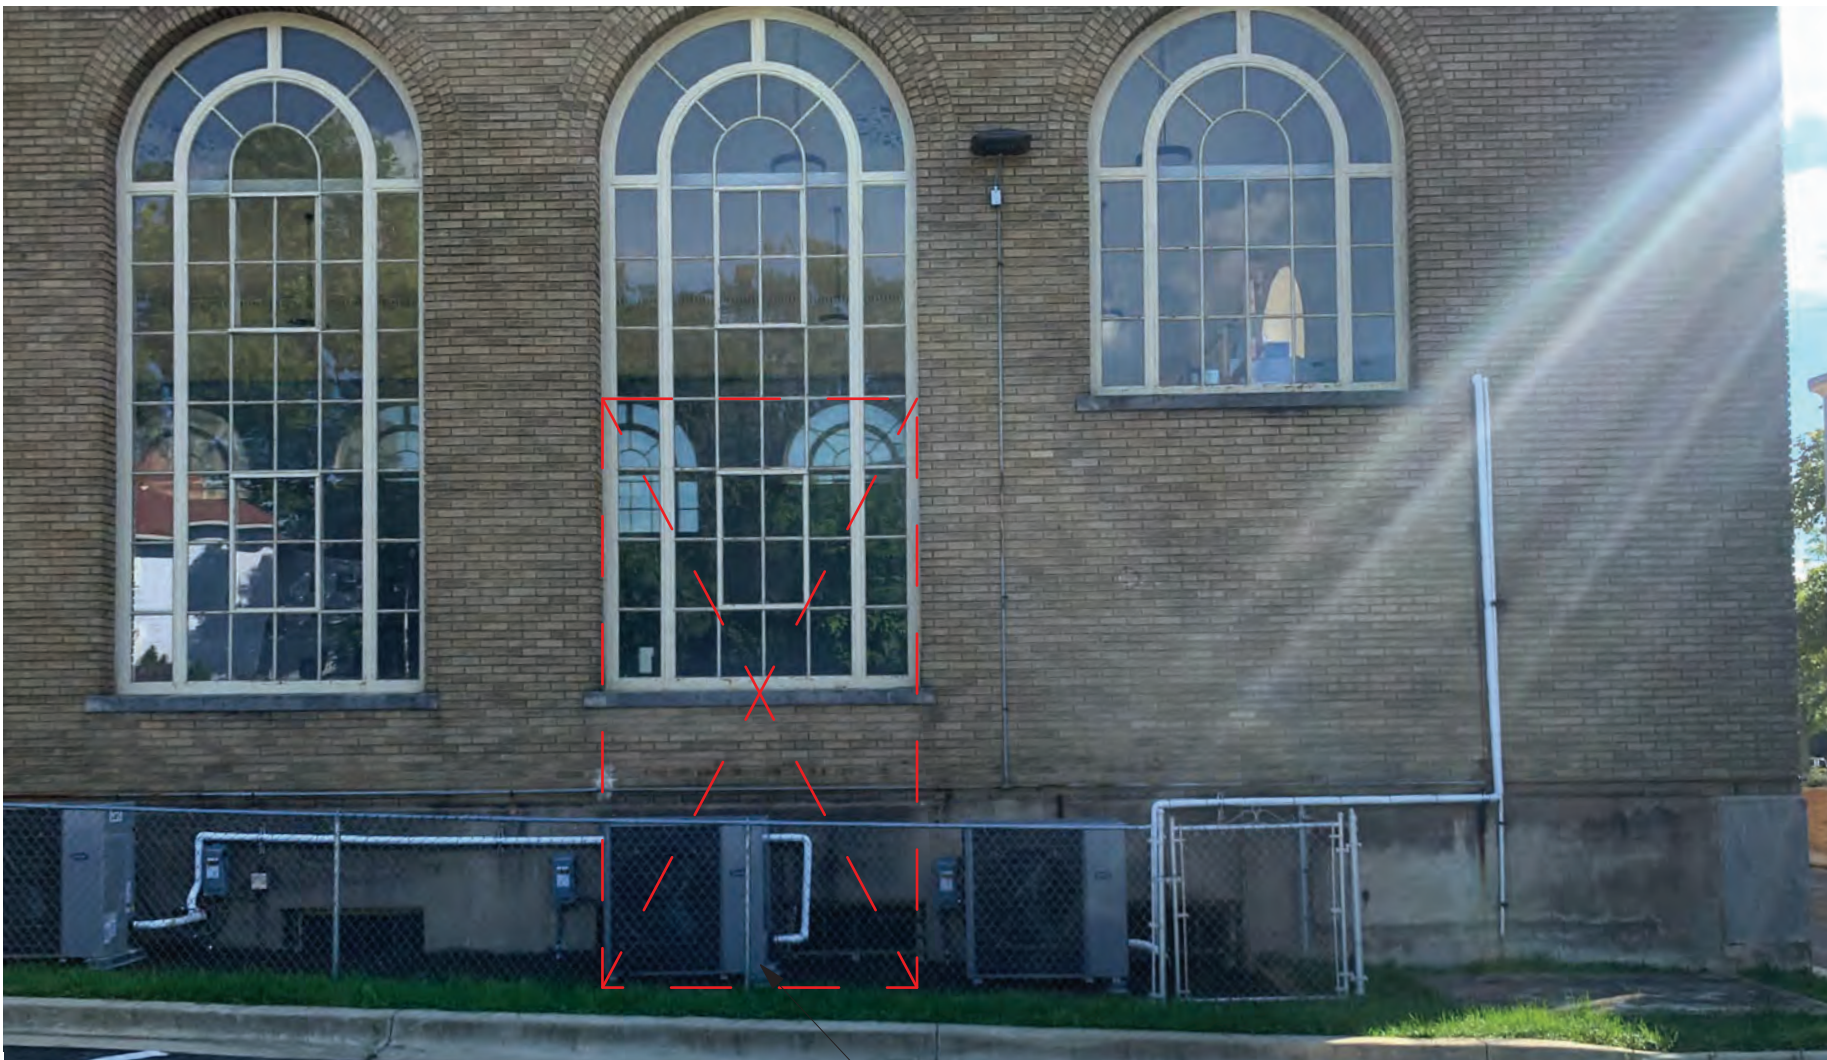
WINDOW DETAIL

Replace with window
from Willow Avenue
facade and remove sill
for addition connector

New egress stair to roof

New 976 SF addition with
mechanical roof above

A previous proposal seen by the Historic Review board (from a different owner) to replace the bottom of the disturbed window (previously used as an ATM) with a new door and sidelight design is useless for the distilling purpose. Sangfroid requires a loading capacity that can accommodate a driven fork-lift and hand carts. Loading from the side-door on Willow is both a logistical and aesthetic non-starter. Our proposal to move the current half-height window to the rear solves several issues. The owners wish to return the Willow Ave façade to its original grand design and eliminate the bricked-in scar on the most prominent corner of the lot. By installing the half-height window on the rear façade, we are proposing to use the masonry opening below that window for a connection 'link' into the building from a small addition.
