**MONTGOMERY COUNTY HISTORIC PRESERVATION COMMISSION**  
**STAFF REPORT**

<b>Address:</b>	10212 Montgomery Ave., Kensington	<b>Meeting Date:</b>	6/14/2023
<b>Resource:</b>	Primary One Resource <b>Kensington Historic District</b>	<b>Report Date:</b>	6/7/2023
<b>Applicant:</b>	Warner Circle Mansion Condominiums, LLC (Karl Voglmayr, Agent)	<b>Public Notice:</b>	5/31/2023
<b>Review:</b>	HAWP	<b>Tax Credit:</b>	partial
<b>Permit No.:</b>	1032588	<b>Staff:</b>	Dan Bruechert
<b>PROPOSAL:</b>	Comprehensive Rehabilitation, Partial Demolition, Sitework, and New Construction

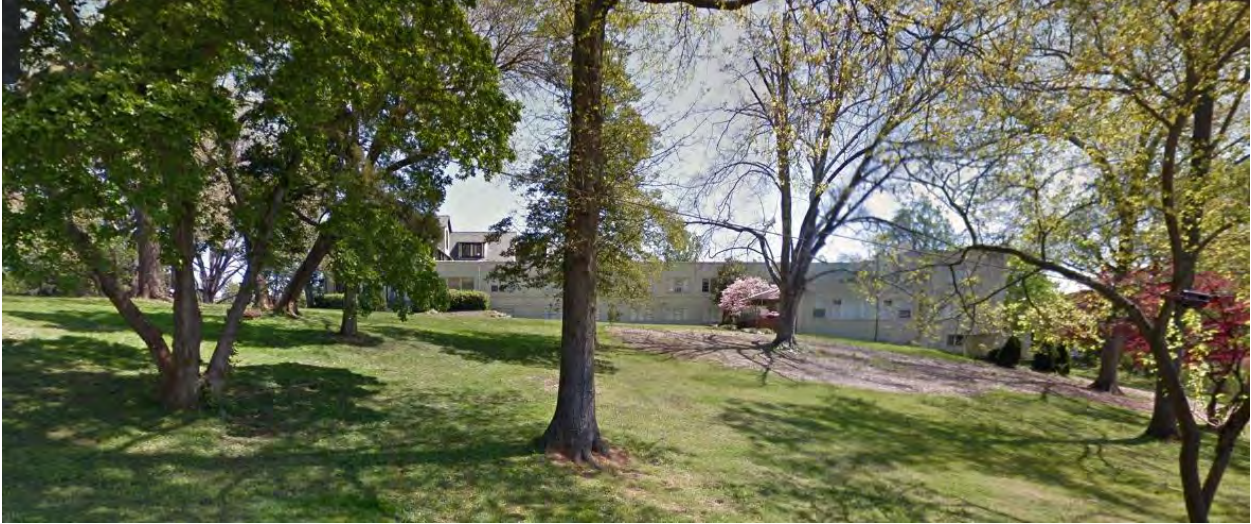
*Figure 2: 2012 Google StreetView image of the now-demolished addition.*

In 2006, Montgomery Parks acquired the subject property to preserve the historic landscape and mansion house and redevelop the property at a later date. Before Park's ownership, the manor house operated as an assisted living facility with a large non-historic addition (*Figure 2*). The addition, which was constructed before the Kensington Historic District was established, was demolished more than 15 years ago. The interior of the subject property was divided into multiple small rooms to meet the needs of the residents of the facility.

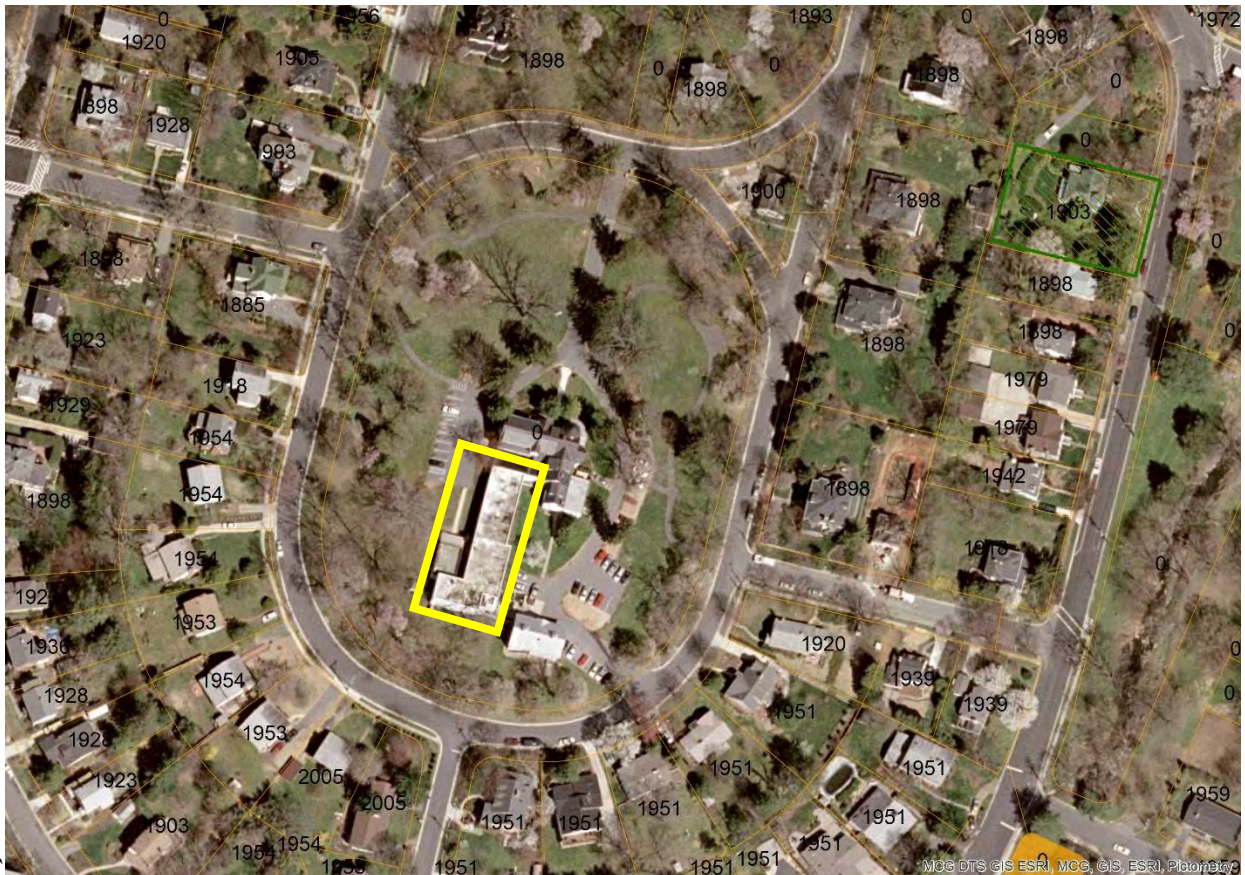
*Figure 3: Warner Manor showing the large non-historic addition (2012) in the yellow rectangle.*

The site has two egress points and a circular driveway. The primary access is from the north and provides direct access to the front door, the other is in the southeast corner of the lot and provides access to both the carriage house and the main house. The driveways vary in width from 14' – 20' (fourteen to twenty feet). Much of the parking shown in the 2012 aerial photograph (*Figure 3*) has been removed.

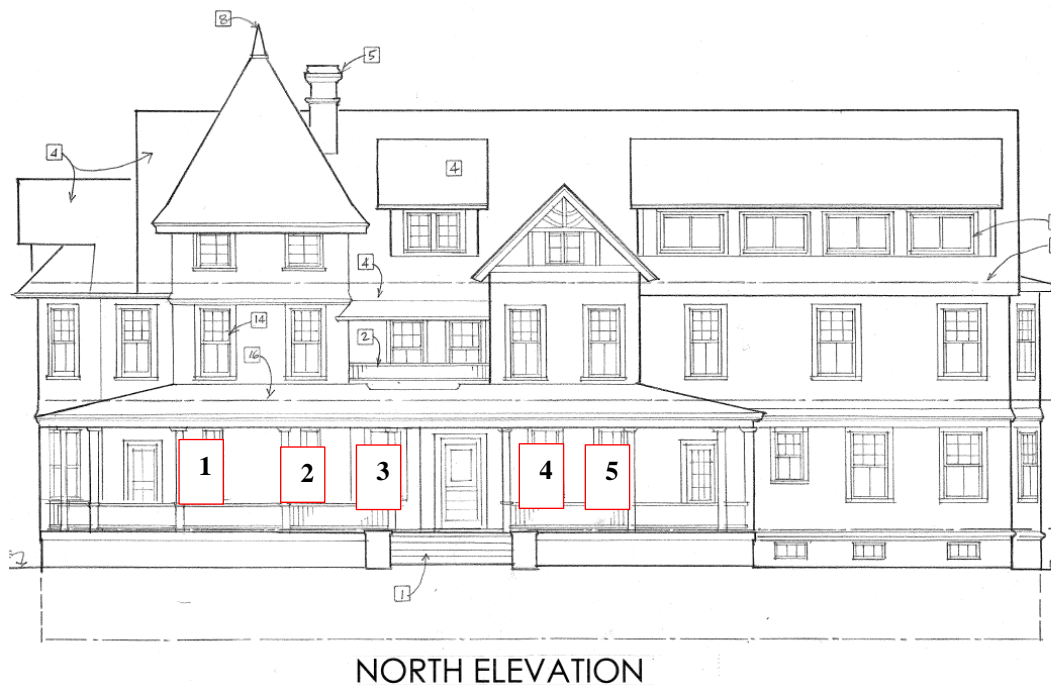
*Figure 4: The north elevation with the retained historic windows labeled.*

The existing windows are a mix of historic and replacement multi-lite sash and casement windows in a variety of conditions. The applicant provided a window survey documenting the condition of the windows at the Preliminary Consultation, but the discussion did not cover the topic. The applicant proposes to rehabilitate the eight (8) historic two-over-one sash windows on the first floor, identified below, and remove and replace the remaining 100 (one hundred) windows with aluminum clad wood windows in matching configurations. Of the 100 (one hundred) windows proposed for removal, approximately less than one-third of the windows potentially date from the original construction. The remaining two-thirds of the extant windows are replacements, boarded-up openings, or have had louvers installed in the existing casing. The window survey shows that all of the historic windows have dry rot, deteriorated exterior trim, have been painted shut, and/or are missing pieces.

Staff finds the eight historic windows that are being repaired with interior storms is work eligible for the County historic preservation tax credit and does not require the HPC's approval. Based on the window survey and Staff's observations at an extensive site visit, Staff finds that the building's deferred maintenance and period of vacancy have left the windows in poor condition. The window survey did not quantify the amount of deterioration on each window and a more in-depth window-by-window evaluation may be desirable, however, Staff finds approving the window removal can be justified under 24A-8(b)(3) and (6). Staff does not find aluminum-clad wood windows to be an appropriate material to replace the historic and existing wood windows. Standard 6 requires, "Deteriorated historic features will be repaired rather than replaced. Where the severity of deterioration requires replacement of a distinctive feature, the new feature will match the old in design, color, texture and, where possible, materials. Replacement of missing features will be substantiated by documentary and physical evidence." In this application, for the most architecturally significant building in the Kensington Historic District, Staff finds a contemporary wood window can be manufactured to accurately recreate the profiles of the historic wood windows. Staff finds a simulated divided light window with permanently affixed exterior and interior grilles and a spacer bar between the glass is sufficient to recreate the appearance of the historic windows and recommends the HPC adds a condition to the approval of this HAWP that the replacement windows in the historic mansion need to be wood windows with final approval authority is delegated to Staff to ensure conformance with the characteristics described above.

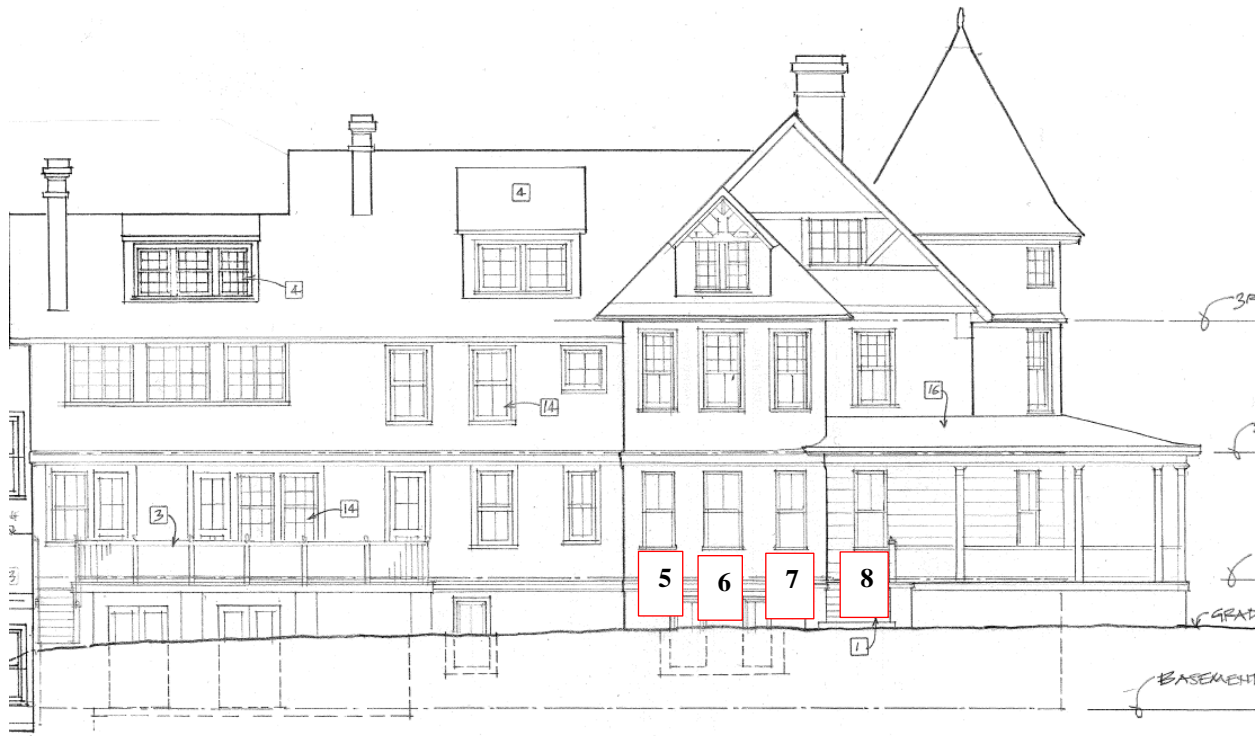
*Figure 5: The east elevation with the historic windows to be retained labeled.*

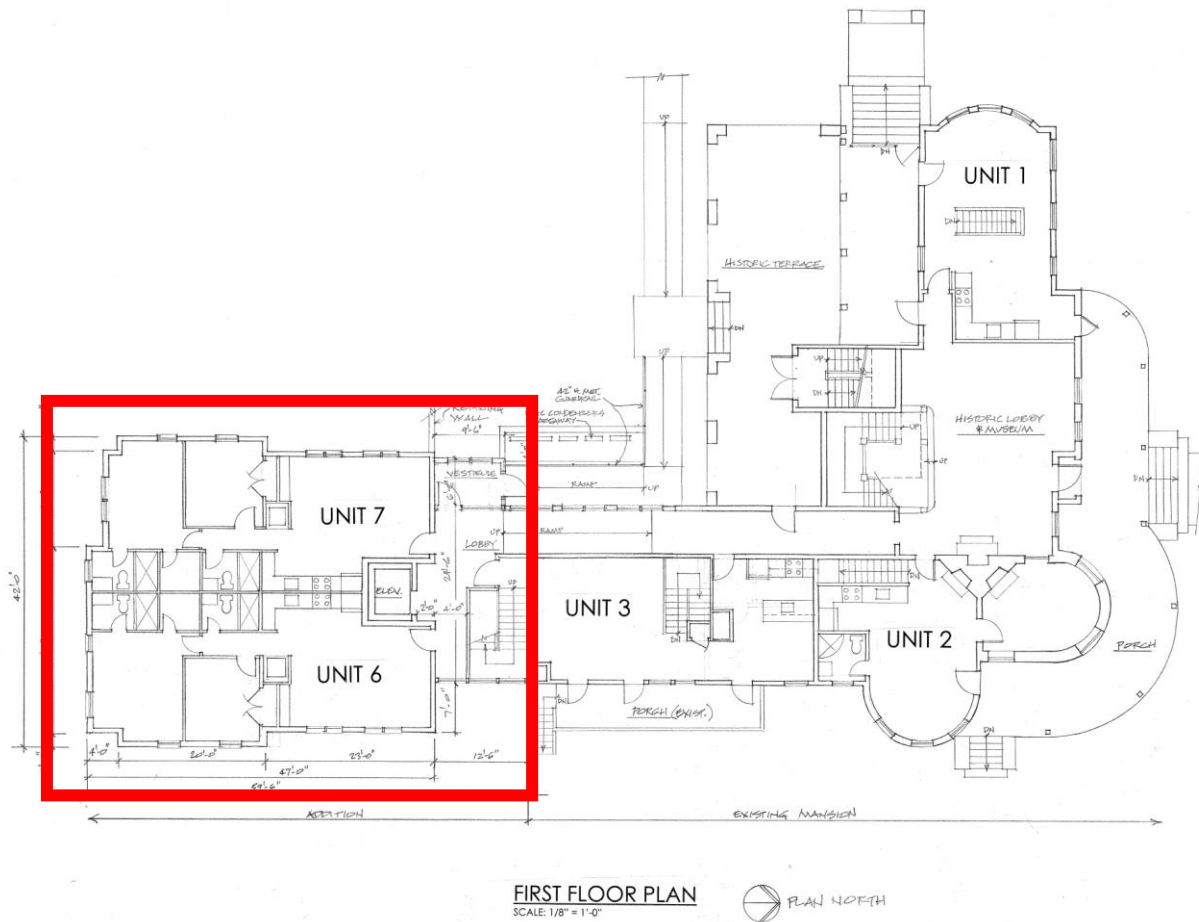
*Figure 6: Proposed house floor plan with the proposed addition outlined in red.*

The applicant proposes to construct a building addition that is separated from the historic building by a flat-roofed hyphen. The addition will be constructed off of the southern end of the south L. Six residential units, a stairway, and an elevator will be constructed in the addition and hyphen. The addition measures 59' 6" × 42' (fifty-nine feet, six inches by forty-two feet) and will be 40' 6" (forty feet, six inches) tall, several feet lower than the historic house's rear-facing gable. Because the grade slopes away from the house, more of the addition's foundation is exposed than is typical in the historic house.

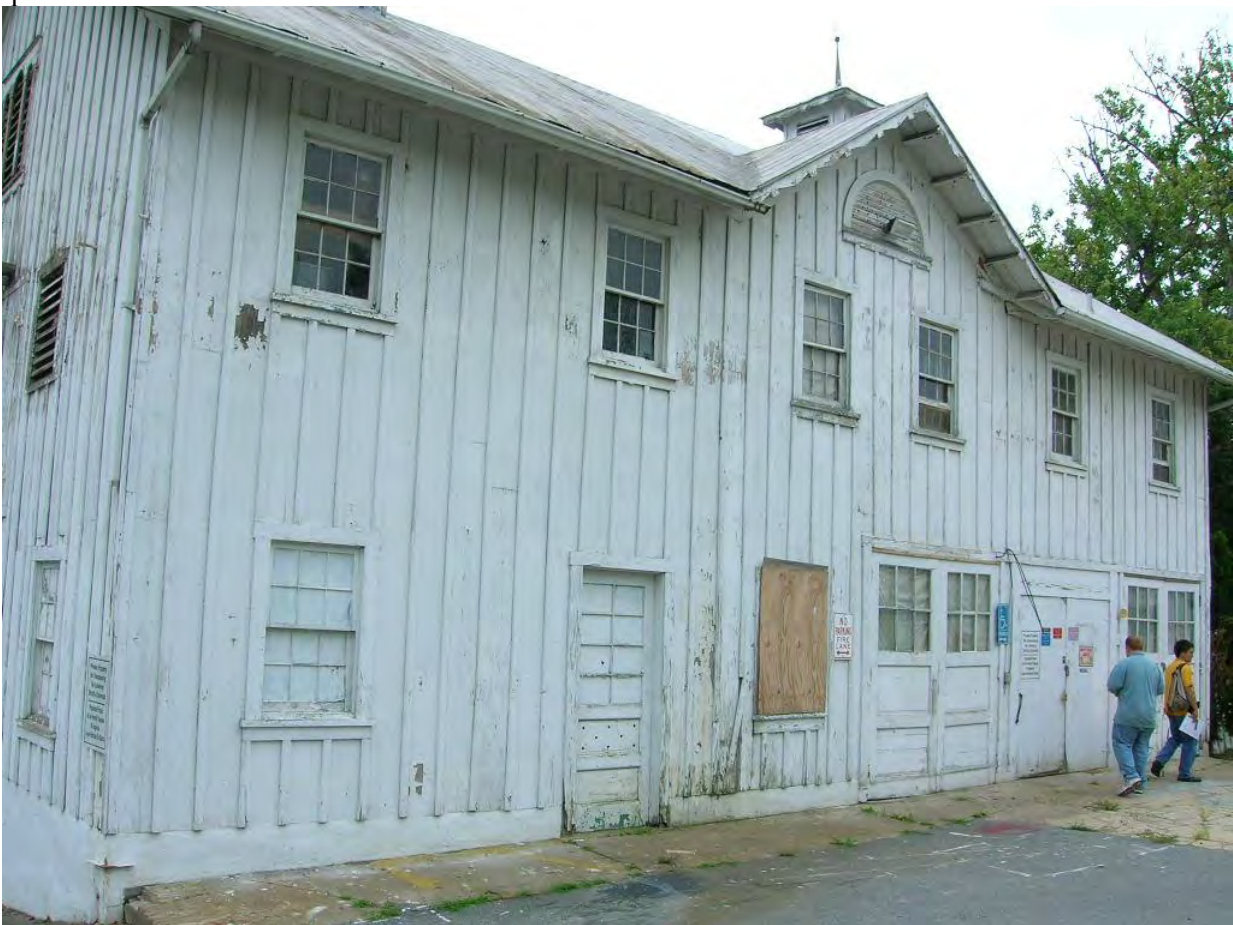
*Figure 8: Photo of the carriage house from 2006.*

The carriage house has suffered from significant deferred maintenance. The windows and doors show evidence of rotting and water infiltration. Much of this damage is evident in a 2006 photo in Staff files (*Figure 6*). Several window and door openings have been removed and boarded up in the intervening years, though there still appear to be several original windows. Because half of the carriage house was unconditioned from the time of its construction, many of the windows have suffered more degradation than the windows in the historic mansion house. The applicant proposes to remove all of the window and door openings on the carriage house and replace them. The proposed windows will be multi-lite

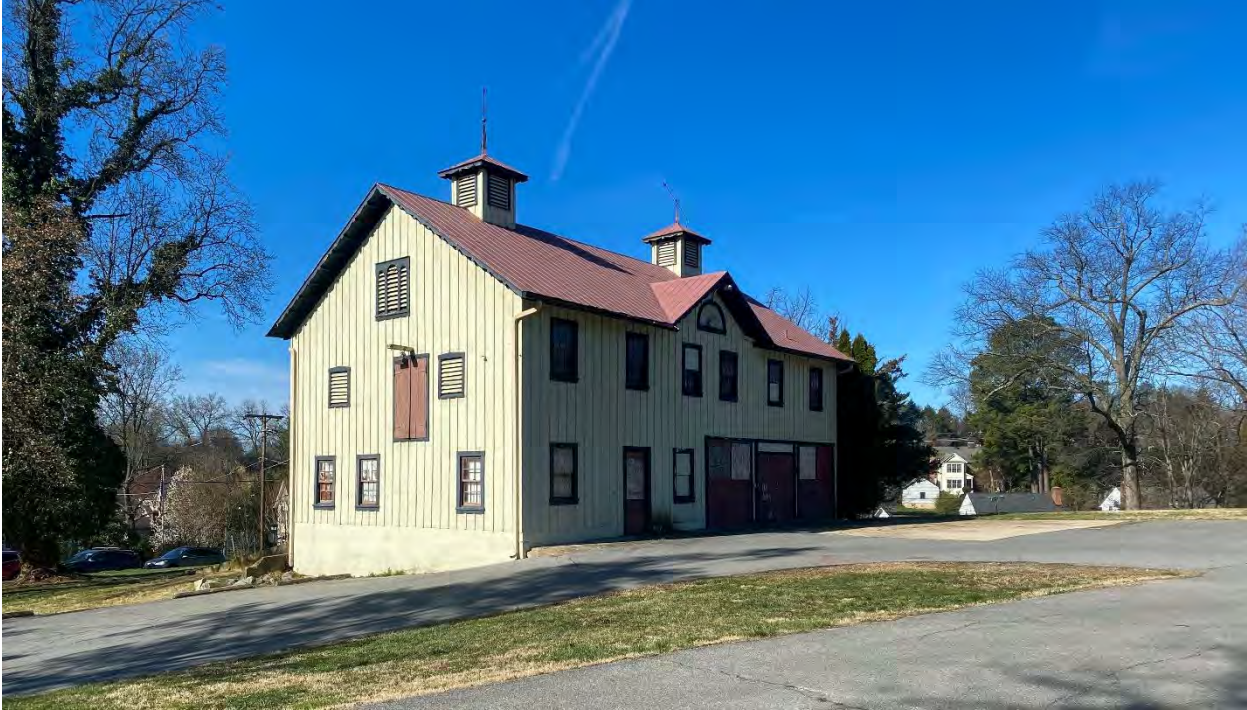
*Figure 9: 2023 image of the carriage house.*

Above the poured concrete foundation, the carriage house is covered in board and batten siding. The siding, like much of the rest of the carriage house, has suffered from deferred maintenance and shows signs of rot and warping in locations. The applicant proposes to remove all of the existing siding, insulate the building, and install fiber cement board and batten siding.

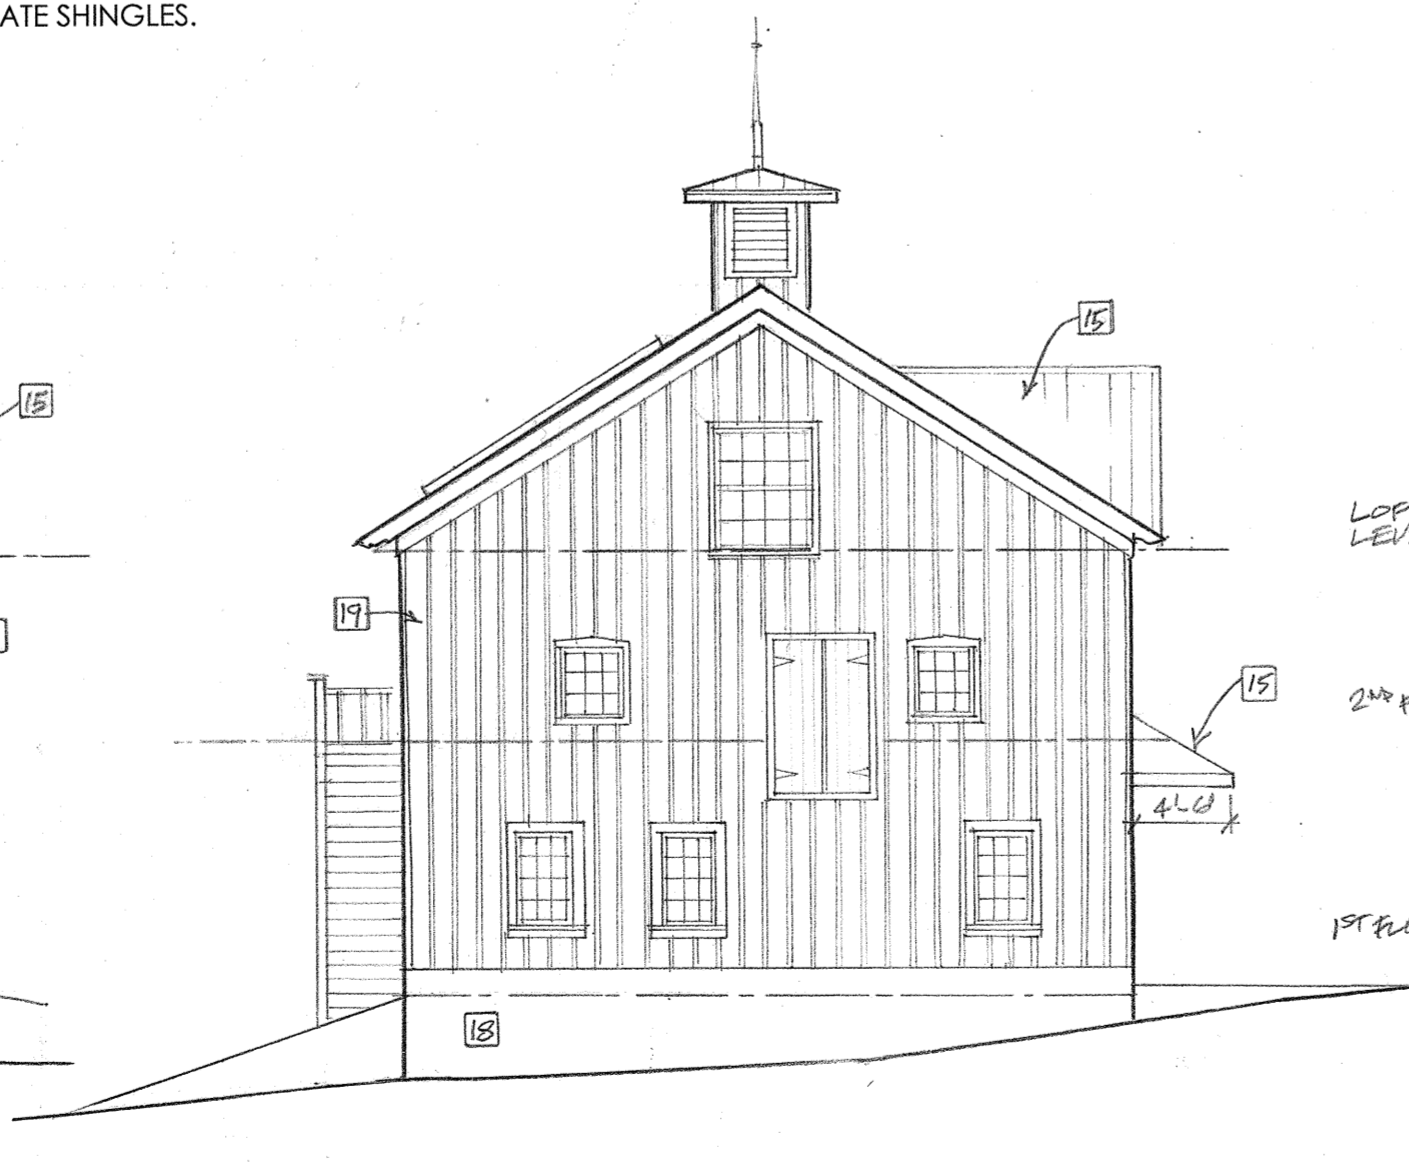
**CARRIAGE HOUSE EAST ELEVATION**  
SCALE: 1/8" = 1'-0"

aluminum clad wood windows in a mix of sash and casement configurations. In most instances, the new windows will match the configuration of the existing ones. The applicant proposes to convert two louvered openings (the rectangular attic openings on the east elevation and the half-round attic louver on the north elevation) into windows. The doors will be replaced with new wood doors matching the configuration of the existing ones.

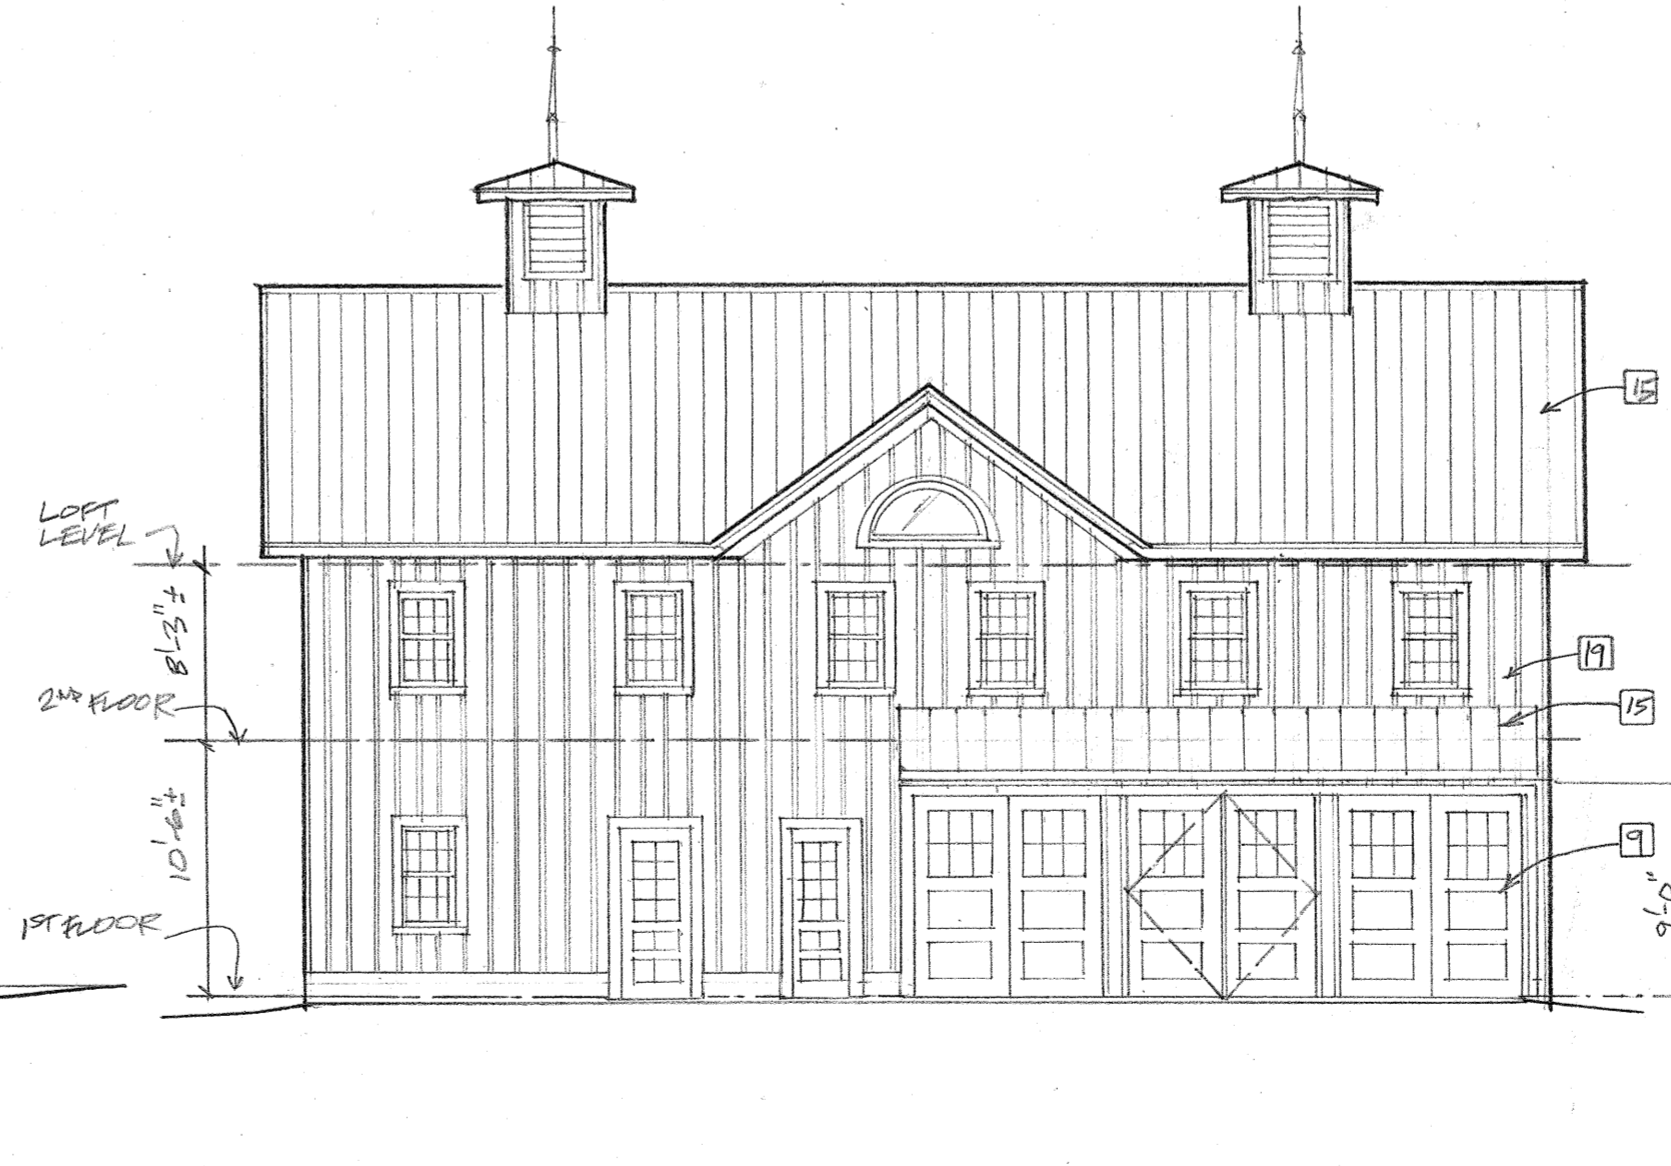
**CARRIAGE HOUSE NORTH ELEVATION**  
SCALE: 1/8" = 1'-0"

3. The half-round louver in the north-facing gable on the carriage house shall not be replaced with a single-lite window. Revised drawings showing the retention of this louver shall be submitted with the final permit drawings;

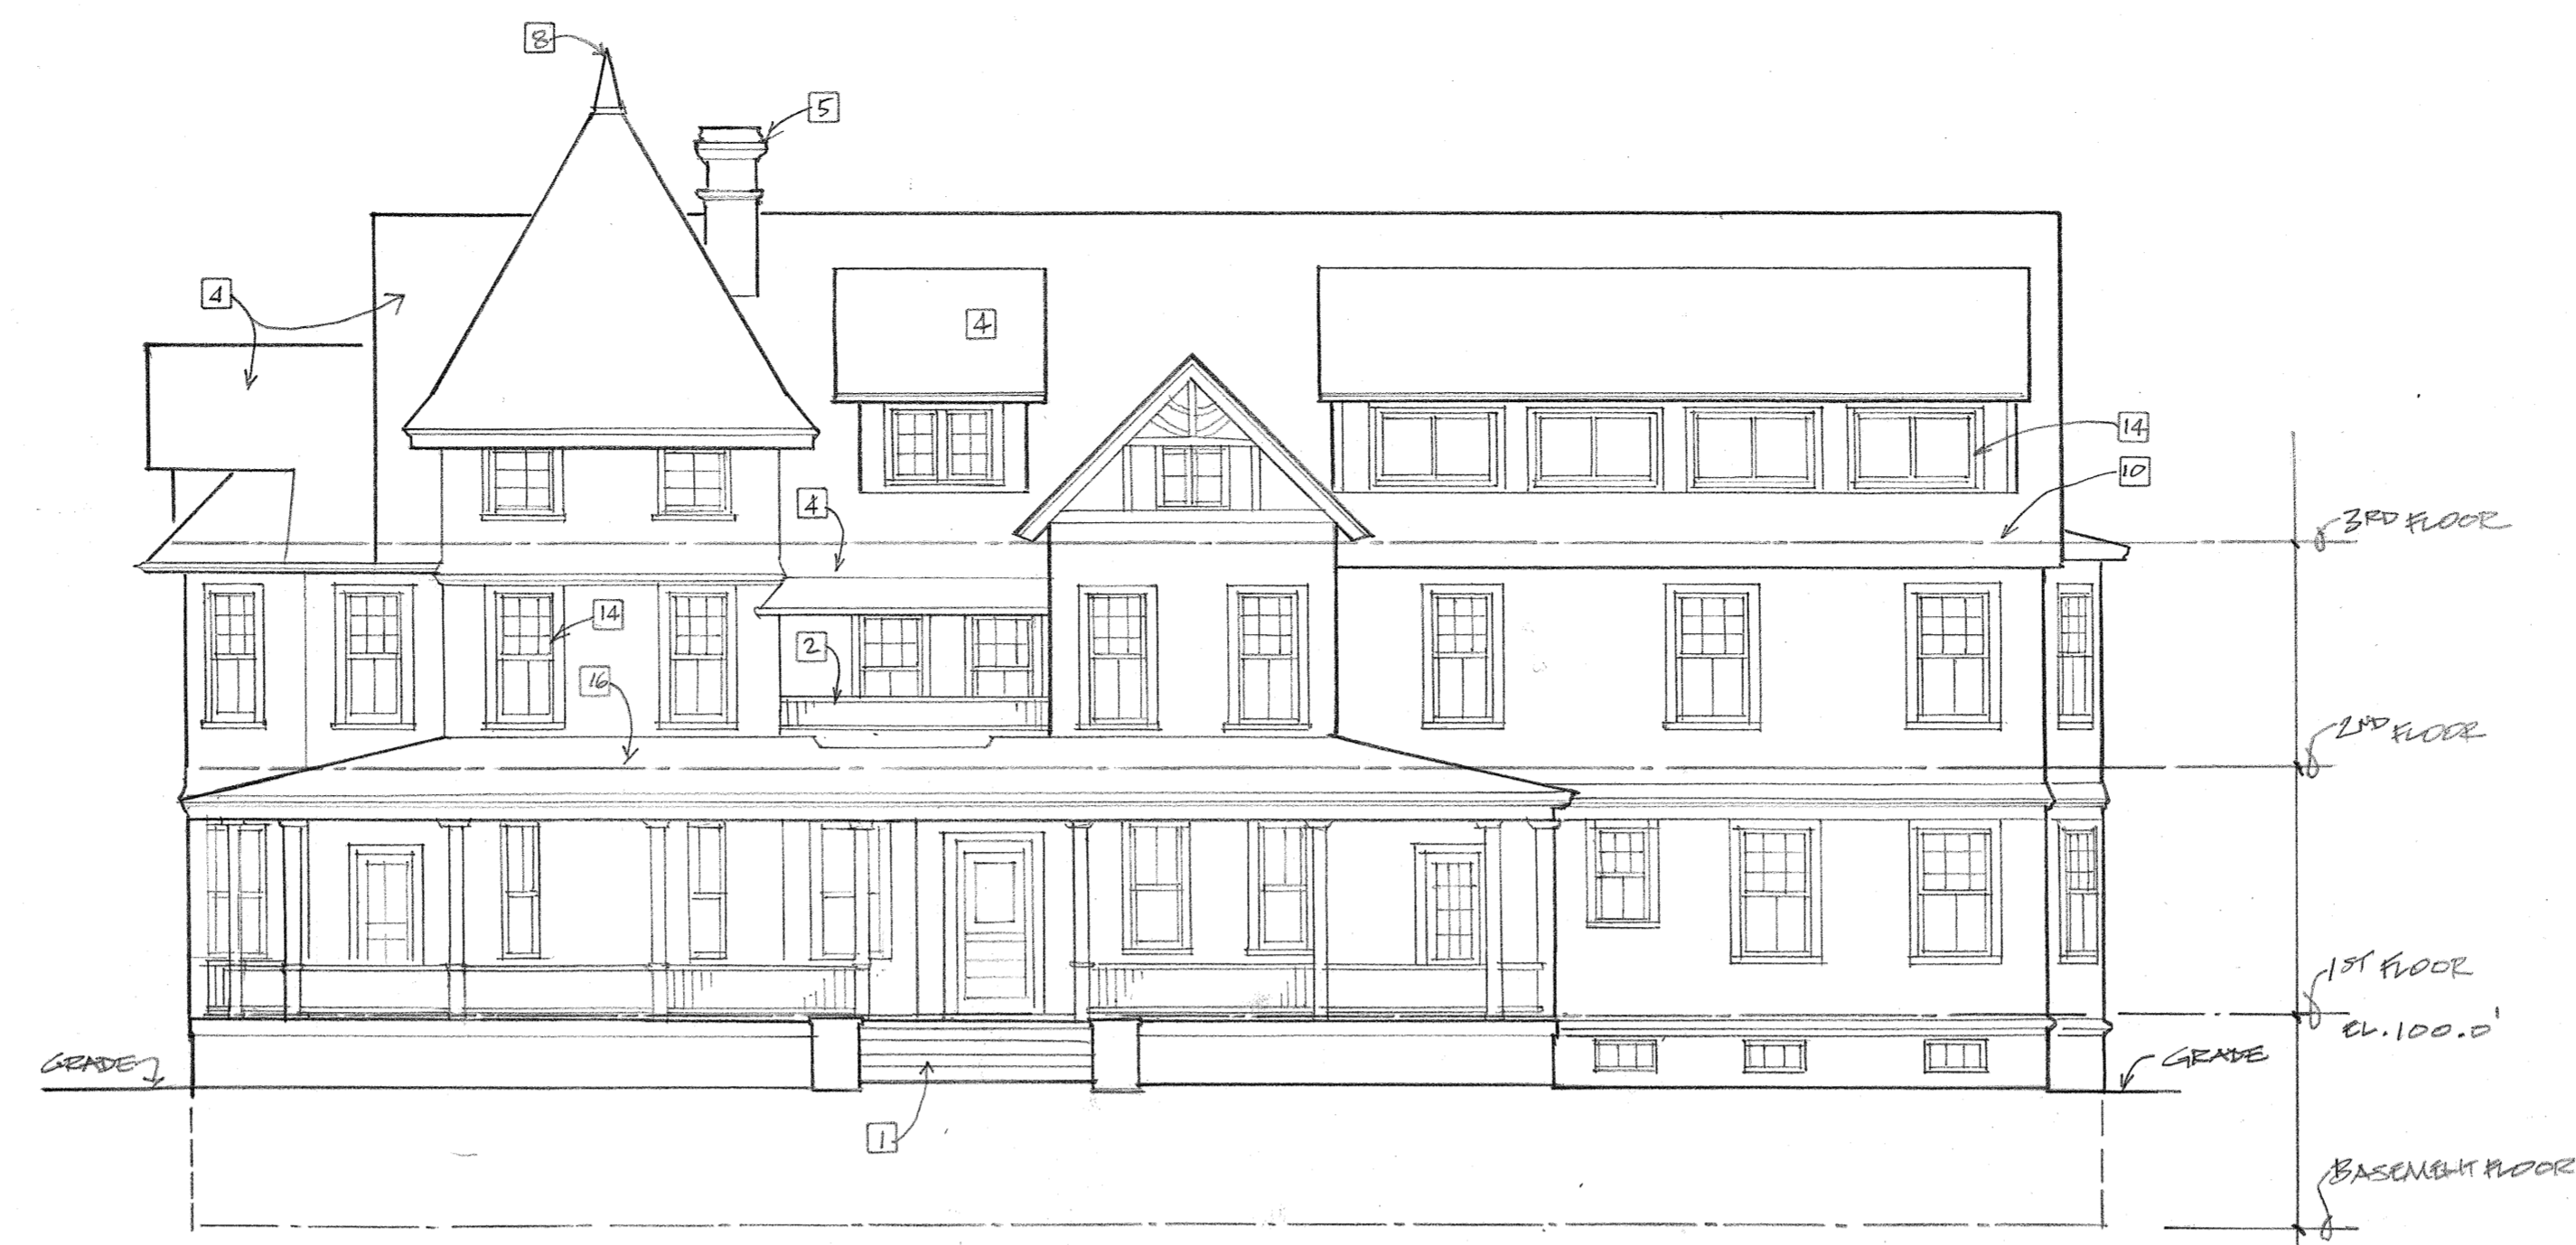
**NORTH ELEVATION**  
SCALE: 1/8" = 1'-0"

- KEYED NOTES**
1. RESTORE STONE STEPS
  2. RECONSTRUCT 2<sup>ND</sup> FLOOR BALCONY, INCLUDING WATERPROOFING, BALUSTRADE, RECONSTRUCT AND EXTEND ROOF ABOVE.

3. RECONSTRUCT SIDE PORCH, STAIR, RAILINGS, SCREENING, AND LATTICE.
  4. RESTORE EXISTING SLATE ROOFING, INCLUDING ALL SURFACE AREA AS REPLACEMENT OF BROKEN OR MISSING TILES.

12. HARDIE CEMENT BOARD SHAKES, 5" EXPOSURE TO MATCH EXISTING.
  13. COMPOSITE TRIM BOARD.
  14. RE-FRAME WINDOW OPENING TO HISTORICAL CONFIGURATION.
  15. STANDING SEAM METAL ROOFING.

2. The proposed Hardie shakes in the building addition are too thin to be an appropriate substitute material. A thicker fiber cement shake or wood shake shall be installed with at least a ½” reveal;

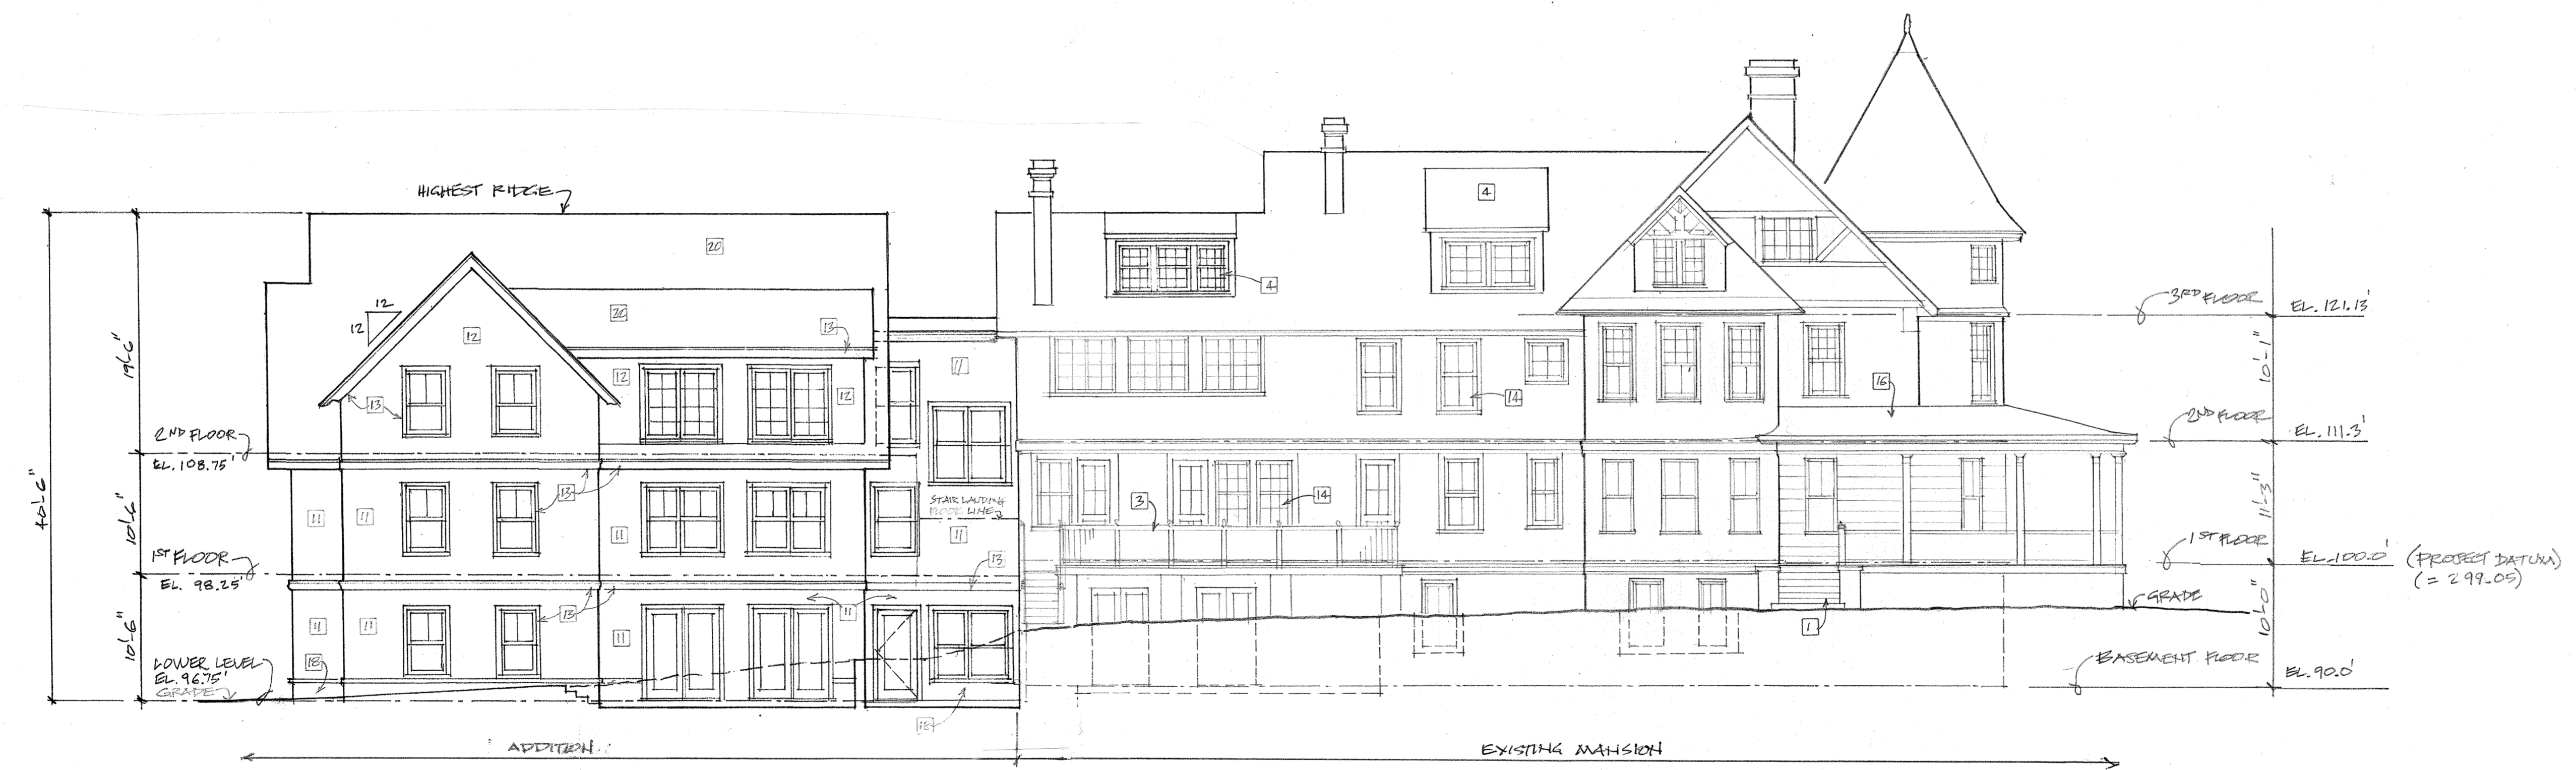
**EAST ELEVATION**  
SCALE: 1/8" = 1'-0"

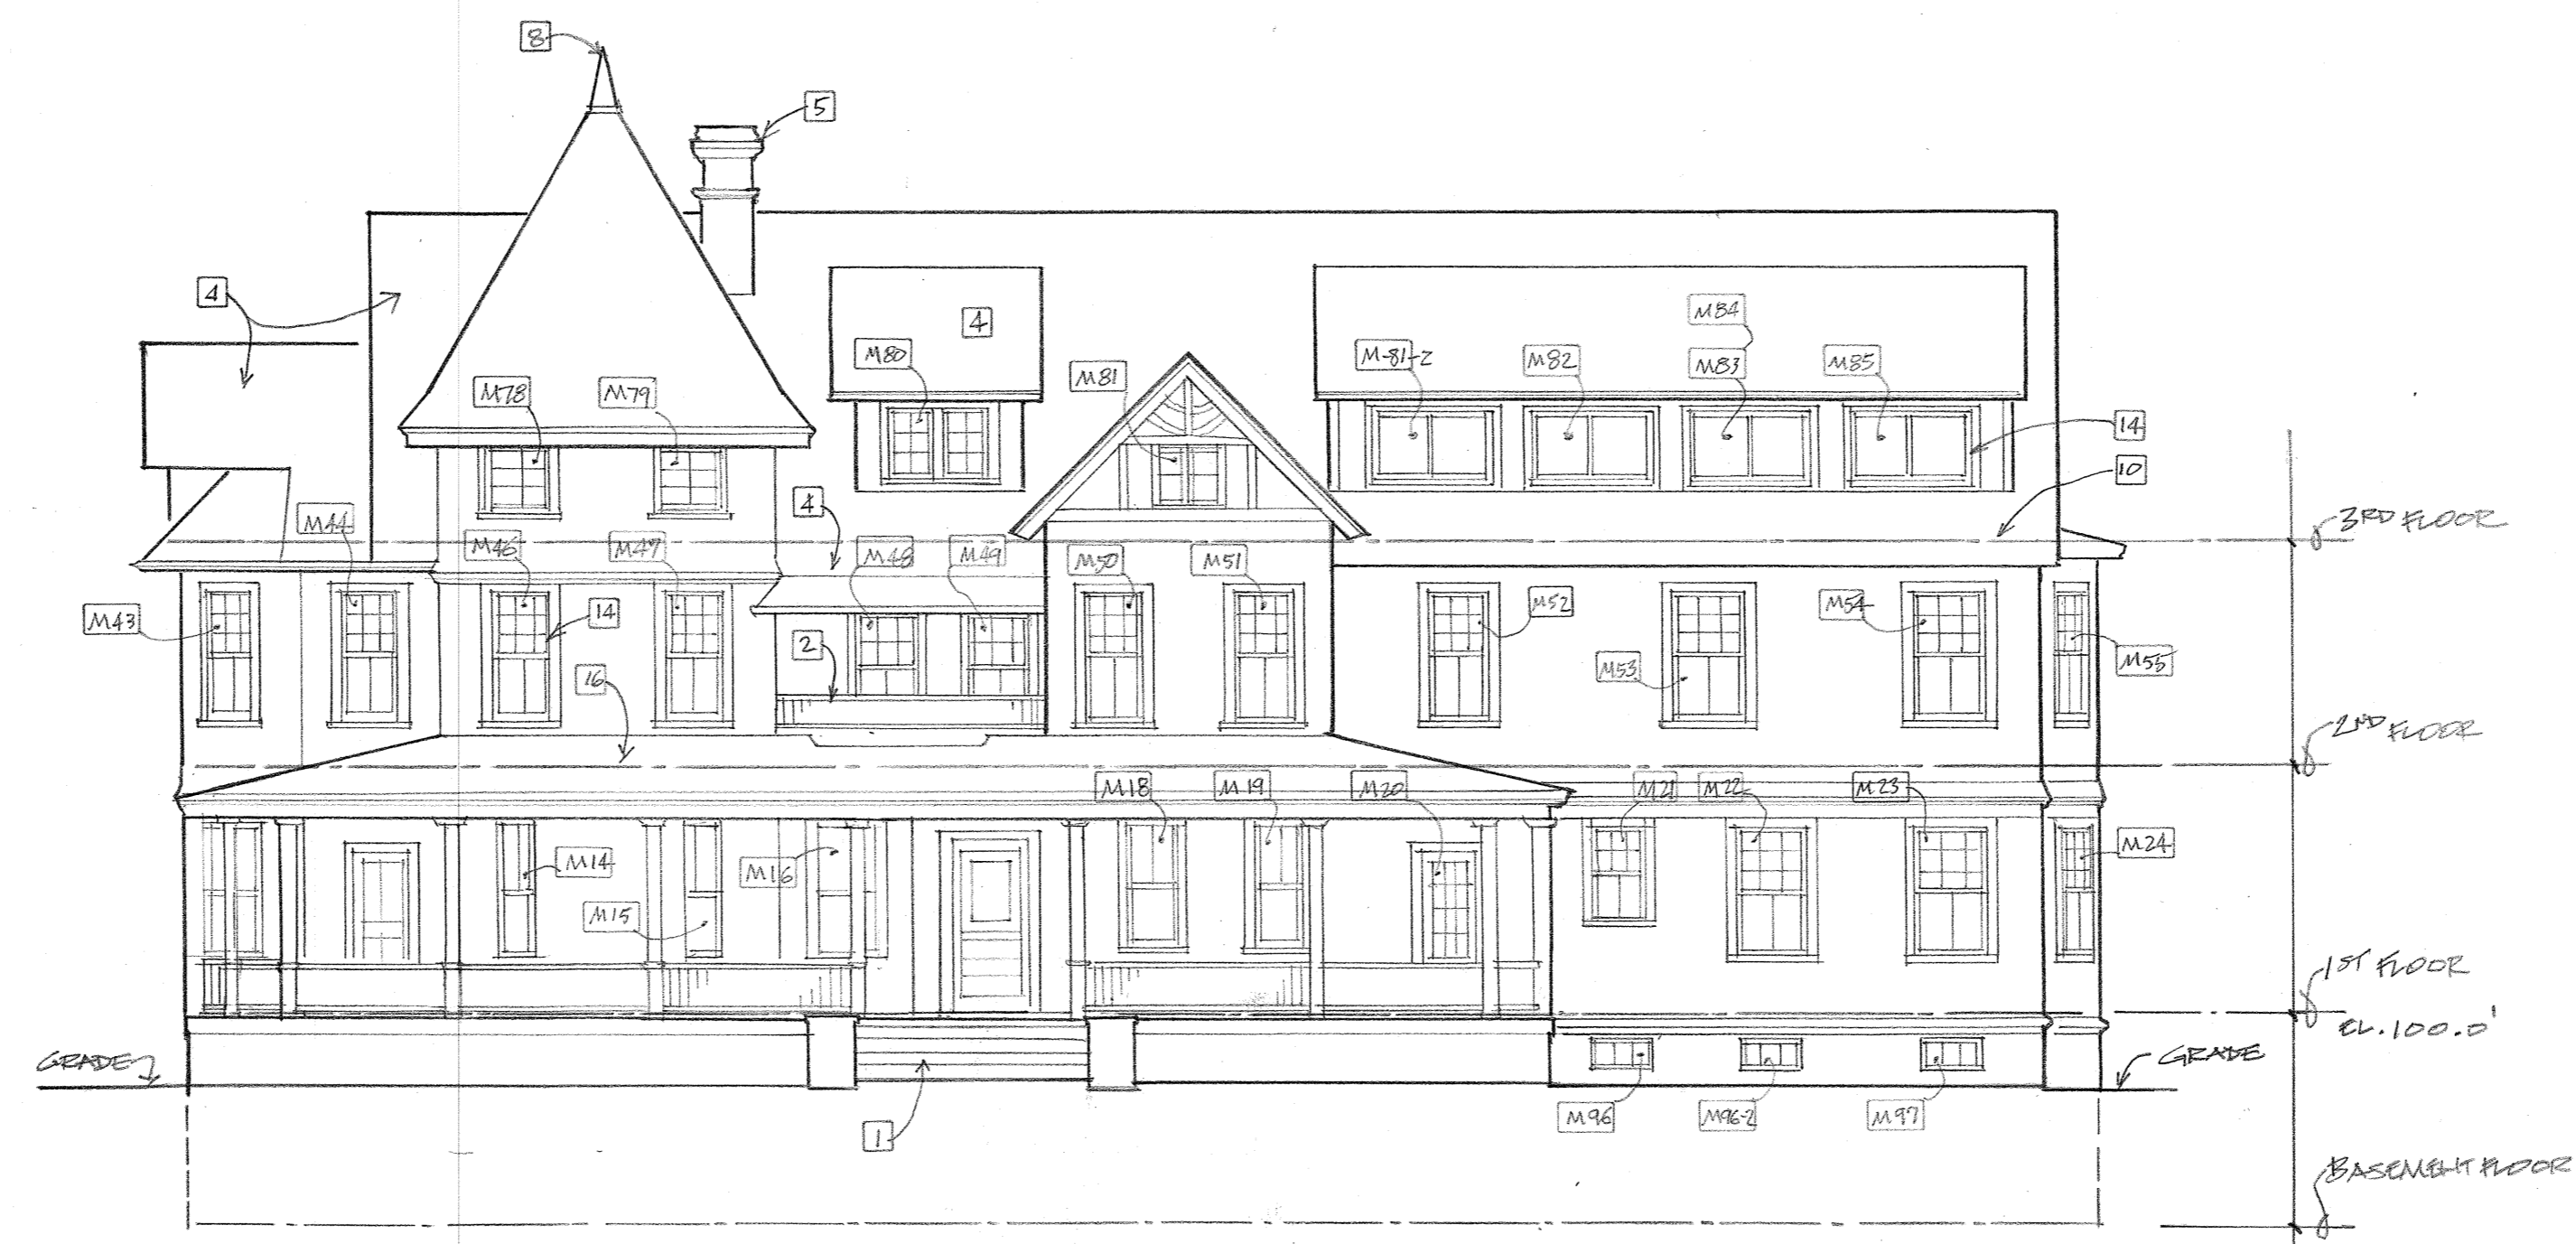
**NORTH ELEVATION**  
SCALE: 1/8" = 1'-0"

- KEYED NOTES**
1. RESTORE STONE STEPS
  2. RECONSTRUCT 2<sup>ND</sup> FLOOR BALCONY, INCLUDING WATERPROOFING, BALUSTRADE, RECONSTRUCT AND EXTEND ROOF ABOVE.

3. RECONSTRUCT SIDE PORCH, STAIR, RAILINGS, SCREENING, AND LATTICE.
  4. RESTORE EXISTING SLATE ROOFING, INCLUDING ALL SURFACE AREA AS RELACEMENT OF BROKEN OR MISSING TILES.

16. FLAT SEAM METAL ROOFING.
  17. FIXED WINDOW SYSTEM WITH METAL WINDOW FRAMES.
  18. PARGING TO MATCH EXISTING.
  19. BOARD & BATTEN SIDING.
  20. NEW SLATE SHINGLES.

21. REPLACE CEDAR SHINGLES TO MATCH EXIST. (TYPE)

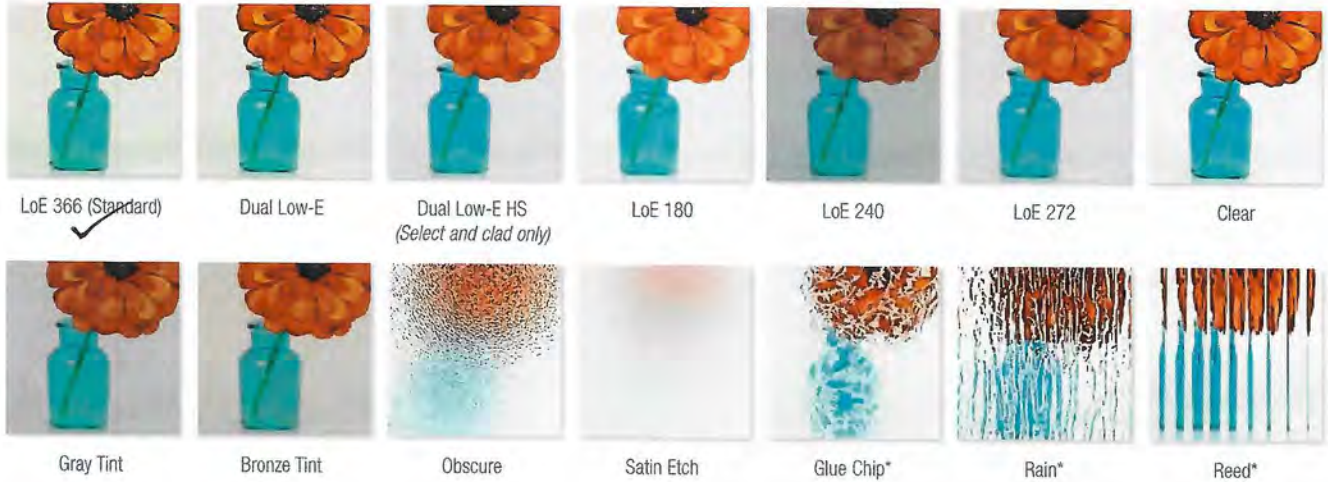
**GLASS** Pinnacle Windows | Pinnacle Select Windows | Pinnacle Patio Doors

\*Special order item. Units with 1-1/4" OA triple IG are only available in LoE 366/180, obscure, satin etch, glue chip, rain and reed glass.

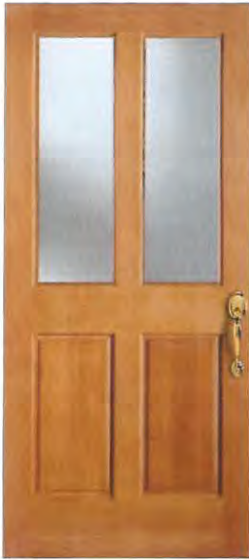
## 7042 TRADITIONAL

### DOOR SPECIFICATIONS (AS SHOWN):

**Panel Type:** 1-7/16" Innerbond DHRP

Rough opening needs to be 2" wider and 2 1/2" taller than your door.

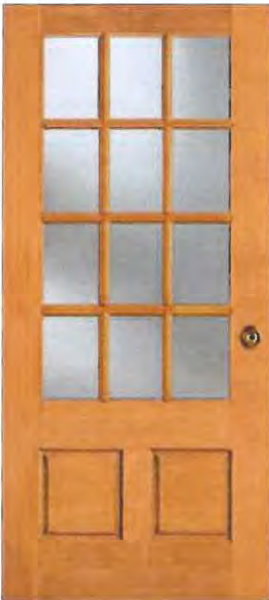
## 7522 THERMAL SASH

### DOOR SPECIFICATIONS (AS SHOWN):

M17	3 - 8	8 - 2	3 Raised Panel Door	Half Lite with a central pane with 24 small 4x4 square muntins, around the edge of the window.	This is an original door from the building and is need of repair. The hinges are loose and broken with the bottom of the door with rotten edges.	The door will be restored to its original condtion with new ADA door hardware.
M20	3 - 1	7 - 1	Full Lite Door	15 Lite door	This is not an original door, and was installed by Motgomery Parks during the building life cycle.	Install two doors each with 12 Lite 2 raised panel door. Simpson Door 7522 Thermal Sash. Painted to match color scheme of Carriage
M27	3 - 1	7 - 1	Single Door	NA	The door opening has been boarded up. No door exists currently.	Replace with 12 Lite 2 raised panel door. Simpson Door 7522 Thermal Sash. Painted to match color scheme of Carriage House.

M28	6 - 1	7 - 1	Double Door	NA	The door opening has been boarded up. No door exists currently.	Install two doors each with 12 Lite 2 raised panel door. Simpson Door 7522 Thermal Sash. Painted to match color scheme of Carriage
M105	3 - 0	7 - 4	Half Lite Door	NA	This door is severely damaged and cannot be salvaged.	Remove door and create opening for access to addition.
C106	7 - 10	8 - 2	Half Lite 2 panel raised doors	6 Lite	This door is severely damaged and cannot be salvaged.	Replace with Tilt-up style 6 Lite 2 raised panel garage doors.
C107	7 - 10	8 - 2	Solid Double Door	NA	This is not an original door, and was installed by Motgomery Parks during the building life cycle.	Replace with Tilt-up style 6 Lite 2 raised panel garage doors.
C108	7 - 10	8 - 2	Carriage House Fitness Door	6 Lite	This door is severely damaged and cannot be salvaged.	Replace with Tilt-up style 6 Lite 2 raised panel garage doors.

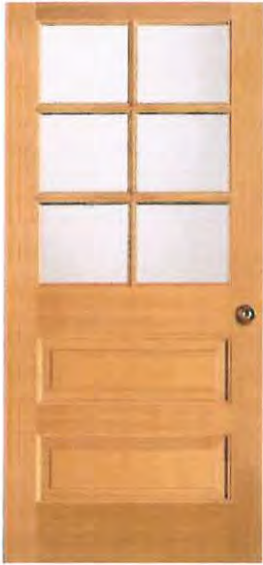
## 7624 THERMAL SASH

### DOOR SPECIFICATIONS (AS SHOWN):

**Panel Type:** 1-7/16" Innerbond DHRP

Rough opening needs to be 2" wider and 2 1/2" taller than your door.

C110	3 - 0	7 - 2	Half Lite 2 Raised Panel Door	NA	The door is damaged and is missing parts. The door has signs of dry rot.	Replace with 6 Lite 2 raised panel door. Simpson Door 7624 Thermal Sash. Painted to match color scheme of Carriage House
C114	3 - 11	7 - 1	Half Lite Door with 3 Raised Vertical Panels	6 Lite	The door is damaged with cracks and missing pieces. The door is not salvageable.	Replace with 9 Lite 2 Raised Vertical Panel Door. Simpson Door 37914 Thermal Sash. Painted to match color scheme of Carriage
C117	2 - 5	7 - 1	Half Lite with 2 Raised Panels	8 Lite	The door on is the inside is boarded up. The exterior of the door is in poor condition with severe rot. The door is not salvageable	Replace with 6 Lite 2 raised panel door. Simpson Door 7624 Thermal Sash. Painted to match color scheme of Carriage House
