**MONTGOMERY COUNTY HISTORIC PRESERVATION COMMISSION**  
**STAFF REPORT**

<b>Address:</b>	10212 Montgomery Ave., Kensington	<b>Meeting Date:</b>	6/14/2023
<b>Resource:</b>	Primary One Resource <b>Kensington Historic District</b>	<b>Report Date:</b>	6/7/2023
<b>Applicant:</b>	Warner Circle Mansion Condominiums, LLC (Karl Voglmayr, Agent)	<b>Public Notice:</b>	5/31/2023
<b>Review:</b>	HAWP	<b>Tax Credit:</b>	partial
<b>Permit No.:</b>	1032588	<b>Staff:</b>	Dan Bruechert
<b>PROPOSAL:</b>	Comprehensive Rehabilitation, Partial Demolition, Sitework, and New Construction

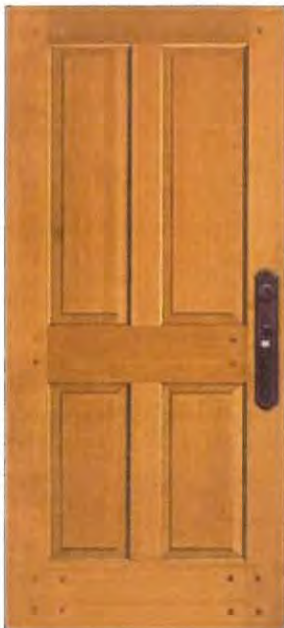
## 77144 NANTUCKET

### DOOR SPECIFICATIONS (AS SHOWN):

C129	3 - 11	7 - 4	Barn Door	NA	The door is splintering and has rot that has been closed with metal. The door is not salvageable.	Create a false door replicating the barn door with cedar boards.
C134	2 - 8	6 - 8	Half Lite with 3 Raised Panels	6 Lite	The door is damaged and is not salvageable	Replace with 6 Lite 2 raised panel door. Simpson Door 7624 Thermal Sash. Painted to match color scheme of Carriage House.
M145			3 Raised Panel Door		This is an original door from the building and is need of repair. The door has severe paint damage and needs to be replaed.	Replace door with 2 Lite 3 raised panel door.
M146			NA	NA	The door has been boarded up. The door leads to the basement of the mansion.	Replace with solid 4 pannel door. Simpson Door 77144.

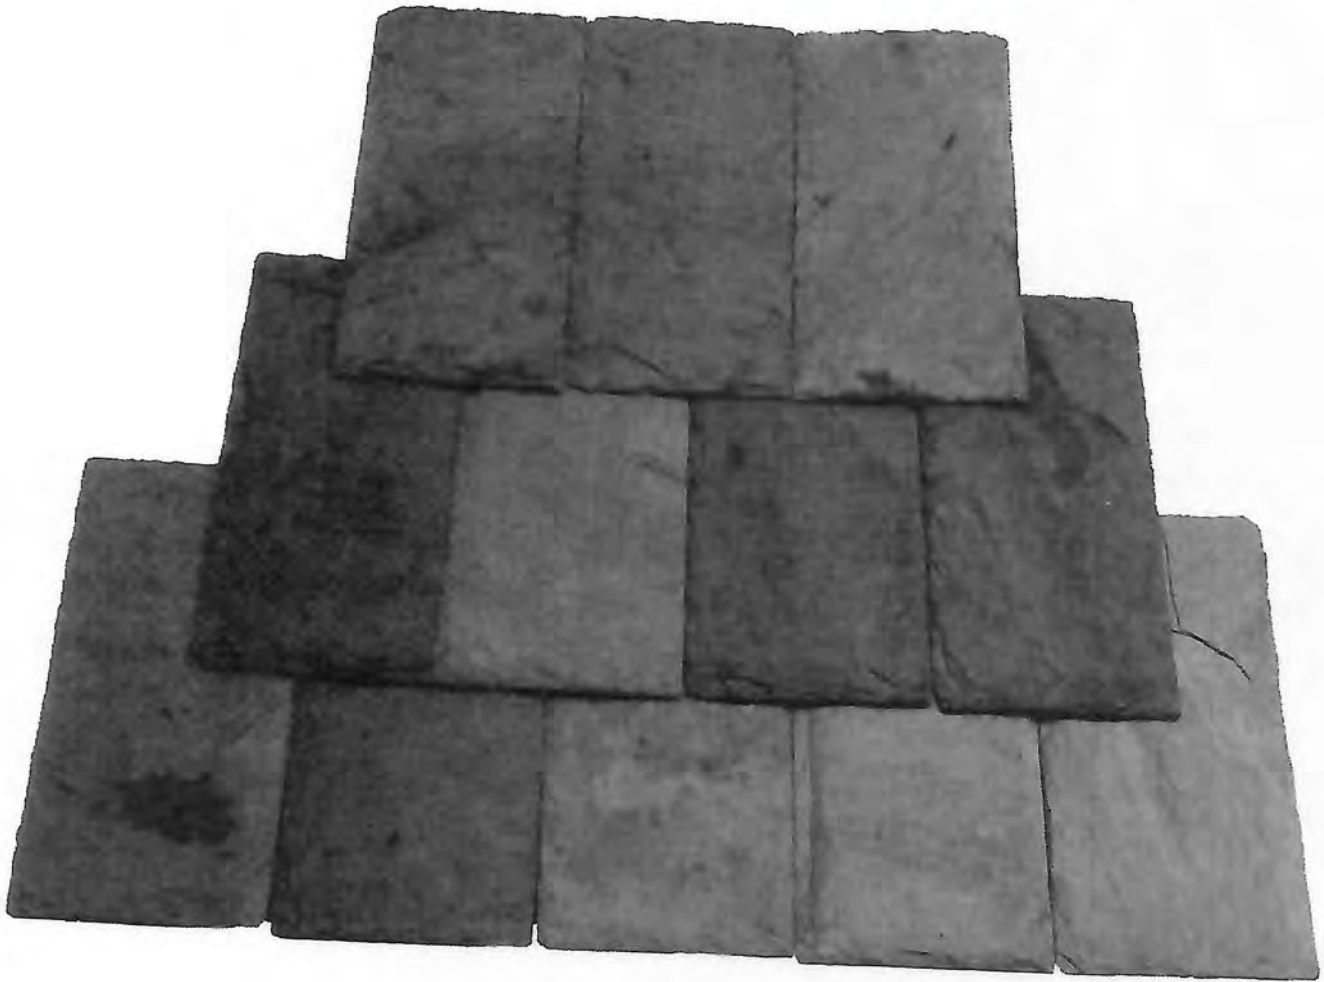
**(Slate specifications included in work item)**

Average Breaking Load (lbs)	Water Absorbtion (%)	Depth of Softening (Inches)
ASTM - C406 - 10 Specification	575 min.	0.25 max	0.002 max
Vermont Unfading Gray	1270	0.04	0

**Breaking Load:** The Slate is put under a defined amount of increasing pressure until the slate ruptures.

Describe, in detail, the proposed work and impact on existing feature: Except the front turret dome, all roof slate will be removed, and new underlayment installed as needed. New (real) slate will be installed on the roof. All slate roofing will be carefully removed, and any needed roof substrate work (water damage) will be repaired as noted above. New ice and water shielding will be installed, and the reclaimed slate shingles will be installed, or new materials of similar color and shape will be used to replicate the existing slate roof appearance as closely as possible. Additionally, copper flashing, which has a life expectancy of than 100+ years if allowed to expand and contract freely, will be used at the roof penetrations (bath and plumbing vents). All other flashings will be copper at the valleys and around the two chimneys.
