MONTGOMERY COUNTY HISTORIC PRESERVATION COMMISSION
STAFF REPORT

Address:	54 Walnut Avenue, Takoma Park	Meeting Date:	9/20/2023
Resource:	Contributing Resource Takoma Park Historic District	Report Date:	9/13/2023
Applicant:	Steve Shira	Public Notice:	9/6/2023
Review:	HAWP	Tax Credit:	Pending
Permit Number:	1038899	Staff:	John Liebertz

PROPOSAL: Fence installation, hardscape alteration, and front porch alteration; additional after the fact approvals for shed installation, grading, and other yard alterations.

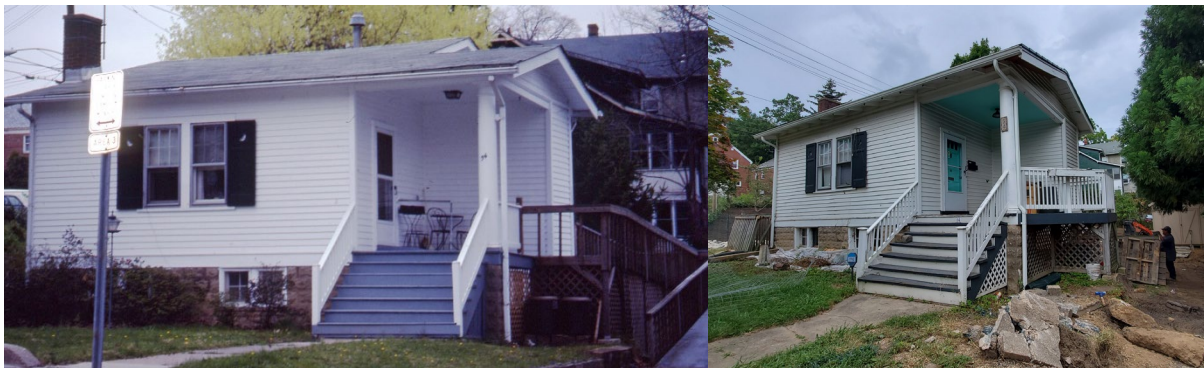
Figure 2: Sanborn Fire Insurance map showing the subject property (outlined in red). View of the façade of the house, undated (left) and 2023 (right). Note the presence of an accessibility ramp prior to the construction of the non-historic porch addition (bump-out).

Staff finds that the demolition of the non-historic porch addition (bump-out) meets the applicable guidelines and recommends approval. As shown on the Sanborn Fire Insurance Maps and earlier photographs of the house, this is not original to the building and likely dates to the 1980s. Photographs depict its use as the landing for a no longer extant accessibility ramp (*Figure 2*). The removal of this element would restore the porch to its original design.

Staff finds the installed shed (8'x14') to be consistent with the applicable guidelines and recommends approval (*Figure 10*). The property formerly included a no longer extant garage in the northwest corner of the property (*Figure 2*). The new wood-frame, front-gable, shed rests on a wood platform, has orientated strand board walls, and an asphalt shingle roof. The front elevation has a pair of double-leaf doors with a louvered vent in the upper gable end. The side elevation features paired, one-over-one with four-over-four simulated divided light, double-hung, vinyl-sash windows and a single-leaf door. The scale, form, design, and placement of the shed is compatible with the individual resource and the surrounding historic district.

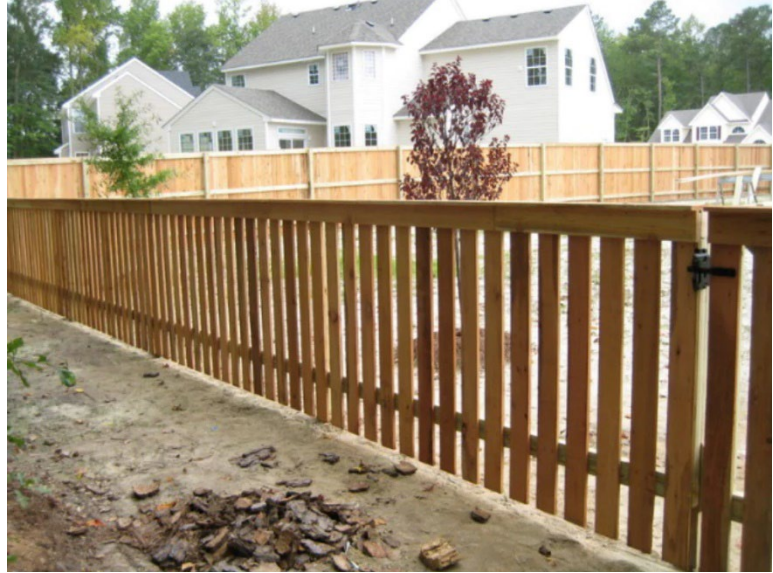
**Figure 3: Example of the proposed fence.
Source: Applicant.**

Staff finds that the installation of the cedar picket fence with cap board to be consistent with the applicable guidelines and recommends approval with conditions. The HPC regularly approves cedar picket fences of the proposed height (*Figure 3*). The fence is compatible with the streetscape and patterns of open space associated with Takoma Park. Staff requests that the applicant submit elevations and specifications for the proposed gates and note the location of the gate on Eastern Avenue on the landscape plan.

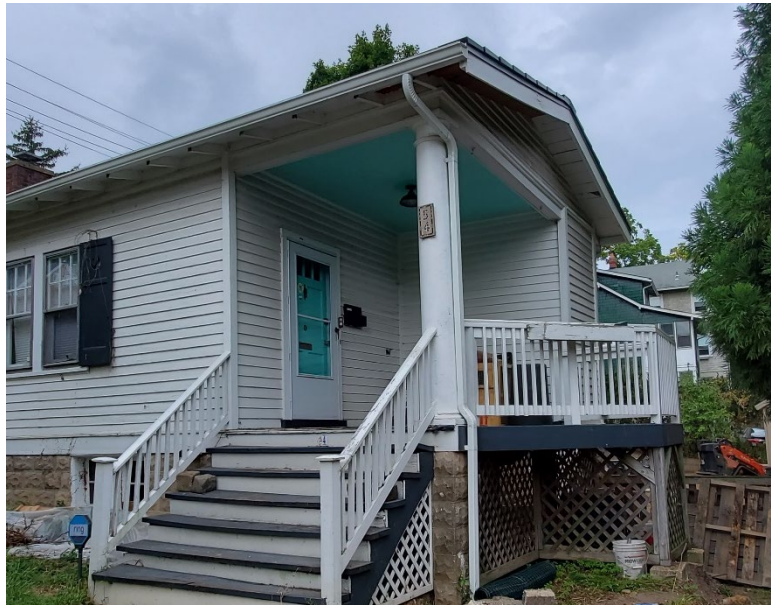
**Figure 4: View of the porch addition to be demolished.
Source: Montgomery Planning.**

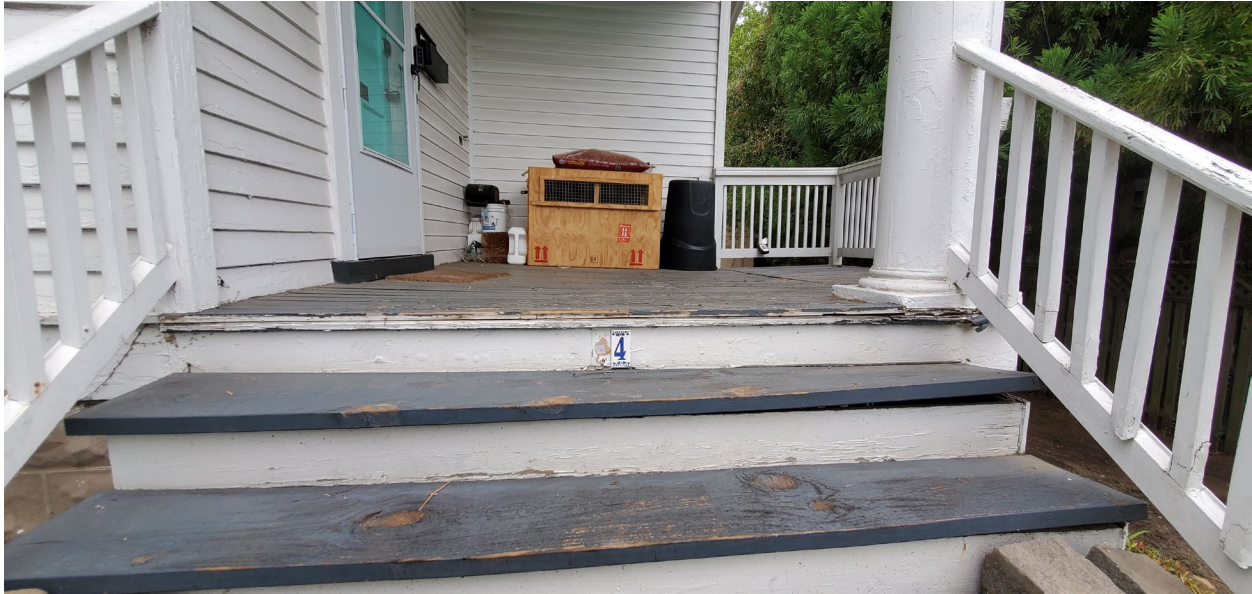
Figure 5: View of the front porch flooring.
Source: Montgomery Planning.

Staff agrees that the condition of the existing porch flooring warrants its replacement (*Figure 5*). The City of Takoma Park has cited the property owner for code violations. The next question is what material or materials are appropriate for this application. The typical requirement for front porch replacements for Contributing Resources in the Takoma Park Historic District is that they be replaced in-kind. This requirement comes from the finding that front porches are character defining features for the resources and Standard 6 states, "...Where the severity of deterioration requires replacement of a distinctive feature, the new feature will match the old in design, color, texture and, where possible, materials." In this instance, wood is the appropriate material. The HPC tends to avoid prescriptive solutions by specifying a species of wood, only that the material be wood and installed with a finish that is as close to the historic finish as possible. This work would also qualify for the County and State historic rehabilitation tax credits of 25% and 20% respectively.

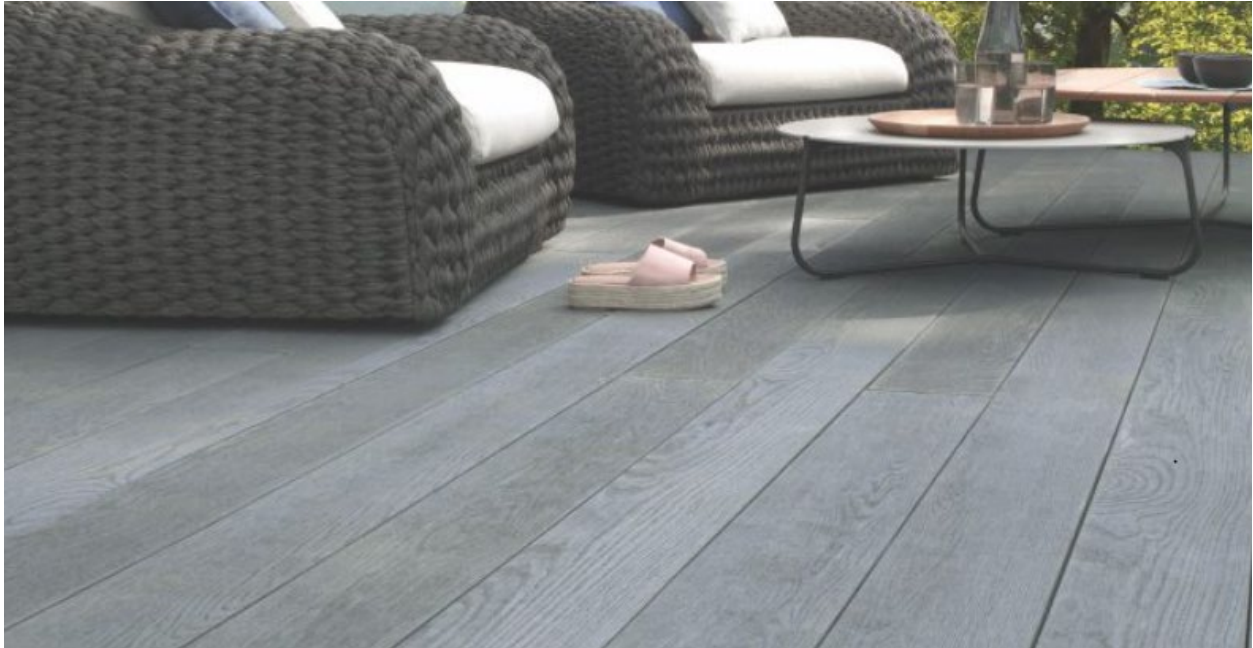
Figure 6: Example of Brushed Basalt Millboard flooring.
Source: Millboard.

Regarding the proposed replacement material, staff finds that Millboard is not a compatible substitute for wood. According to Millboard, the product is: 1) made from wood-free polyurethane resin combined with mineral stone to create a resin mineral board; 2) has a solid-core; 3) hand-molded from wood rather than formed via extrusion; and 4) can be sawn and cut with standard woodworking tools. The boards are 1.25" deep and available with a 5" or 7"-width. The product is finished with Lastane, a proprietary rubberized coating that provides traction. There are presently eight different boards available (Burn Cedar, Coppered Oak, Antique Oak, etc.), but the most relevant sample provided is the Brushed Basalt. Millboard suggests

that this board best emulates the appearance of painted wood flooring (*Figure 6*). Of note, paints and stains will not adhere to the product.

Staff finds that the dimensions and appearance of Millboard are close to but do not replicate historic wood porch flooring. In the early twentieth century, most tongue-and-groove porch flooring consisted of 1" (depth) by 3¼" (width across face), but the width could vary. In comparison, Millboard decking is wider and is not tongue-and-groove. The company recommends a 1/8" space between the side of the boards (*Figure 7*). This yields a different design and appearance than traditional porch flooring. In addition, staff finds the appearance and physical characteristics of the product does not match wood porch flooring. The product's attempt to replicate the appearance of wood creates a finish and texture incompatible with smooth, painted, porch flooring.

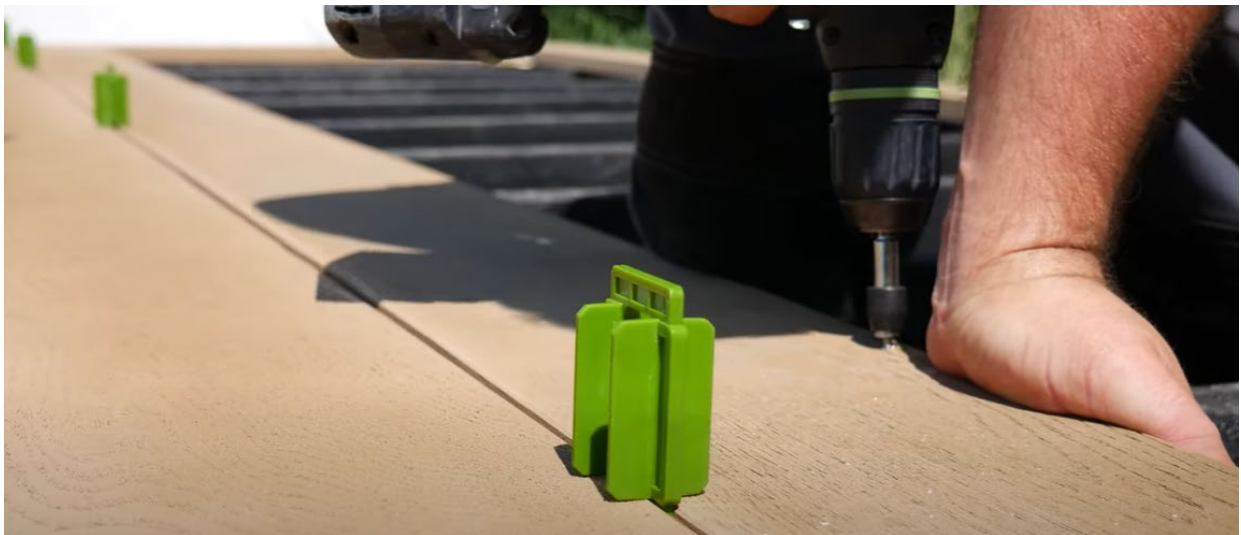
Figure 7: Example of Millboard installation.
Source: Millboard (via Youtube).

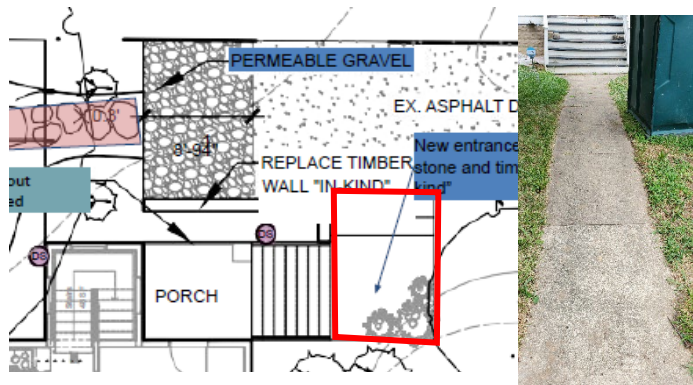
Figure 8: Site plan showing the proposed stone landing and stair (outlined in red), left. View of the concrete walkway to be demolished, right.

Staff finds the removal of the concrete walkway to be consistent with the applicable guidelines and recommends approval (Figure 8). The removal of this feature would not adversely affect the character defining features of the individual resource or the surrounding district.

Staff finds the proposed 8’x8’ stone landing and stair connecting the front porch to the driveway to be consistent with the applicable guidelines and recommends approval with conditions (Figure 8). The HPC regularly approves the use of stone walkways, landings, and walkways in the historic district, but staff requests additional design and material specifications for the stair and material specifications for the landing.

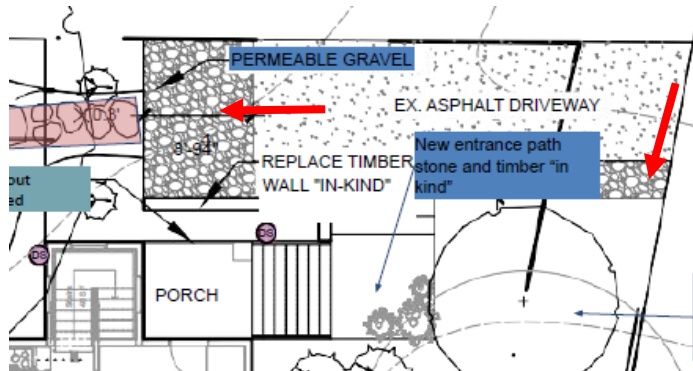
Figure 9: View of the proposed permeable gravel border (red arrows).

Staff finds the proposed permeable gravel driveway installed to the south and west of the existing asphalt driveway to be consistent with the applicable guidelines and recommends approval with conditions (Figure 9). The permeable surface would aid with stormwater management issues and would not adversely affect the character defining open space or landscape of the individual site or the surrounding historic district. Staff requests that the applicant submit specifications for the type/size of the gravel.

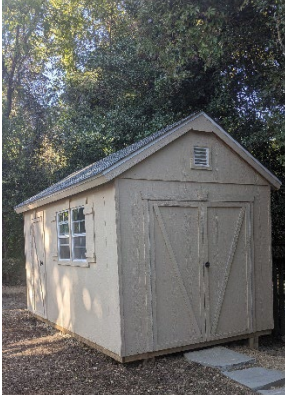
Figure 10: View of the installed shed.

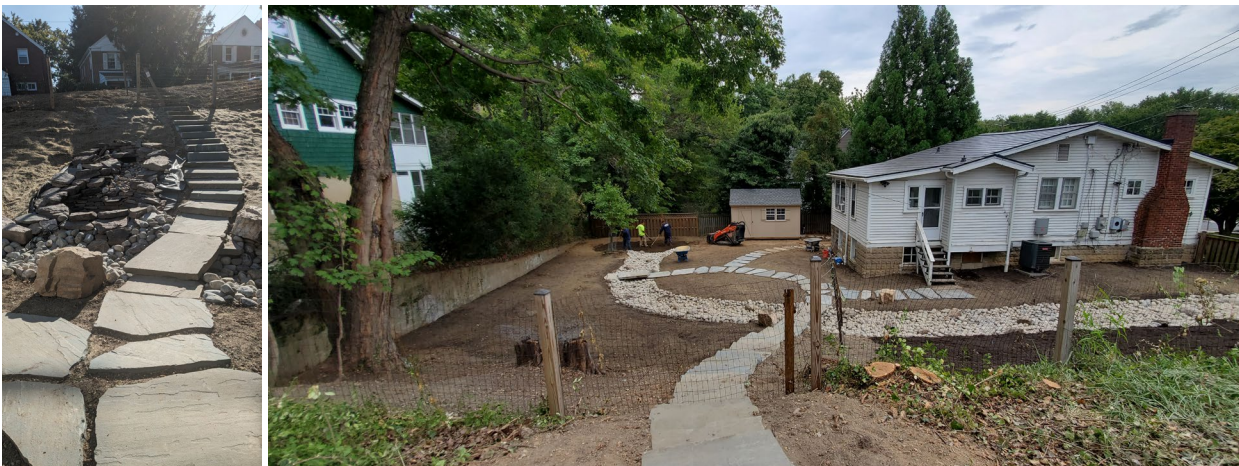
Figure 11: View of the stone water feature (left) and landscape alterations in the rear yard (right). Source: Montgomery Planning and Applicant.

Staff finds the installed 350 sq. ft. rain garden, dry creek bed, stone water feature, flagstone stair and walkway, and regrading the yard away from the house to be consistent with the applicable guidelines and recommends approval (*Figure 11*). The changes in grade, rain garden, and dry creek bed will alleviate stormwater management issues for the property and aid in the long-term preservation of the resource. While the amount of work completed is extensive, all these elements are in the rear of the property where visibility will be partially obscured by the proposed fence. The natural stone water feature is built into the hillside and is not readily visible from the public rights-of-way. In addition, the HPC regularly approves the use of flagstone for walkways and pathways in the historic district. There are no trees proposed for removal that require review by the HPC. Overall, these elements would not adversely affect the character defining open space associated with Takoma Park. It is incumbent on the applicant to ensure that the flagstone stair accessing Eastern Avenue complies with all property and building codes and that no railings are required.

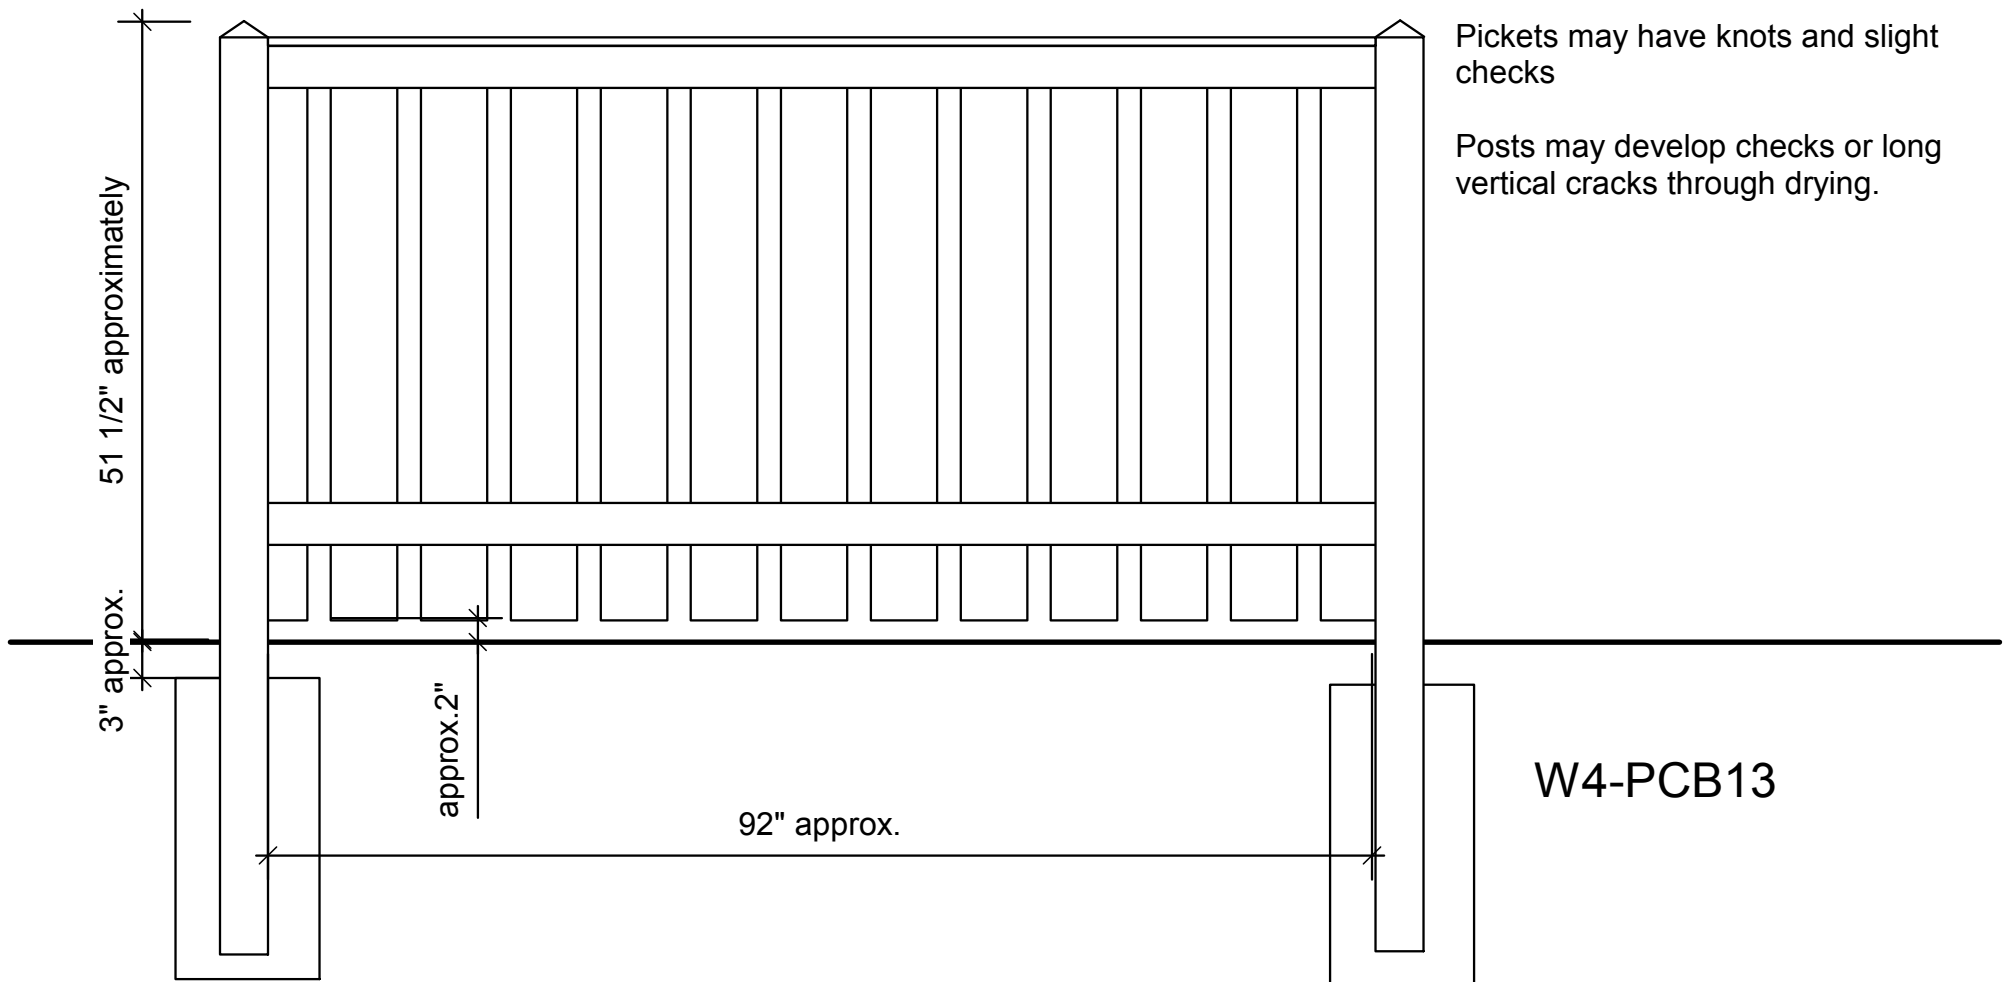
2" (+ 4") approx. @ bottom of fence

May be gaps at pickets when dried.

Pickets may have knots and slight checks

Posts may develop checks or long vertical cracks through drying.

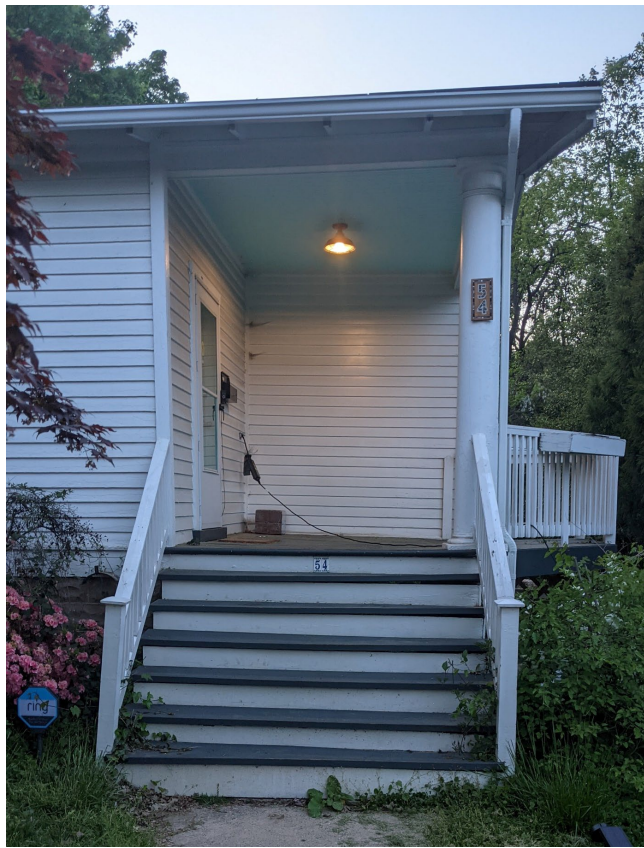
**Existing porch
with bump out.
Bump out to be
removed.**

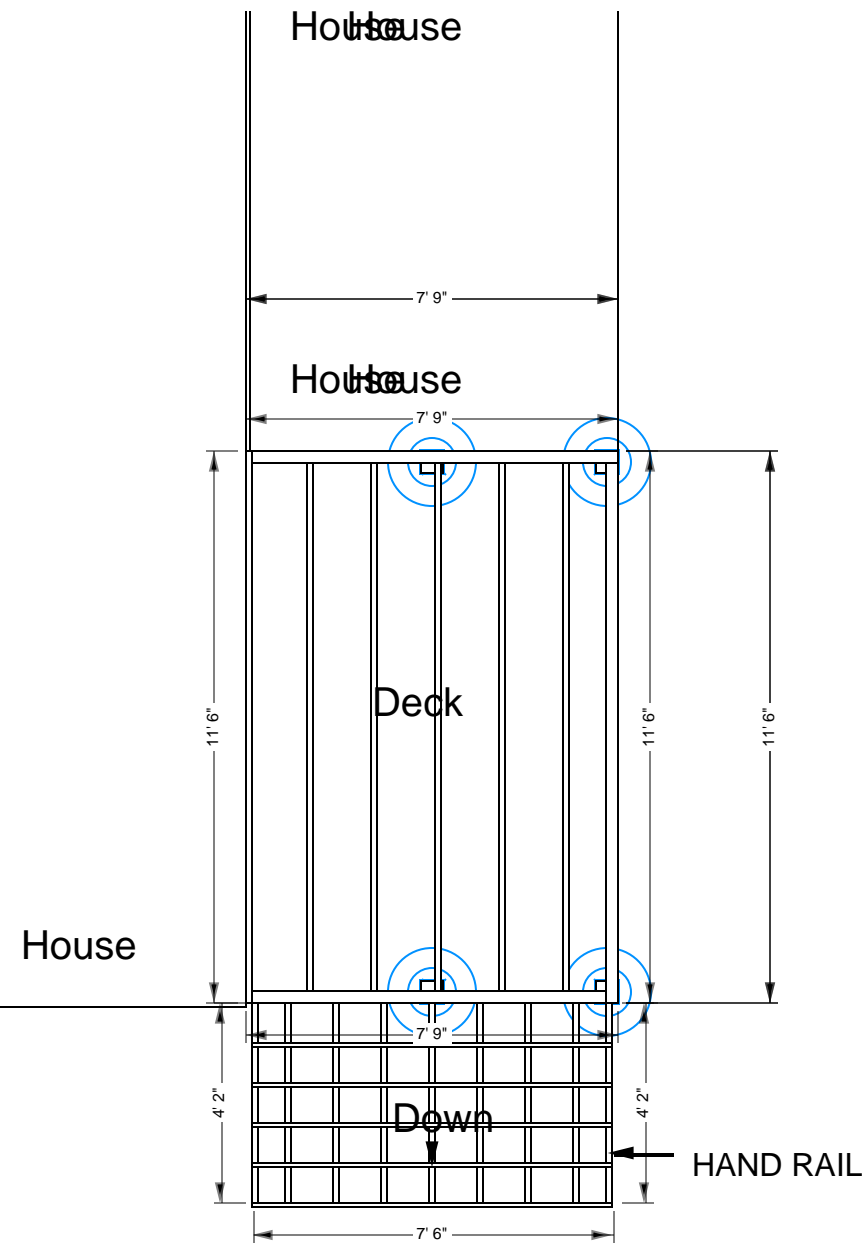
2x10 Ledger Board to be flashed and bolted (2) 1/2" bolts with washers or equivalent every 16" on center. (See ledger detail in deck construction guide)

Joists to be 2x10 pressure treated southern yellow pine installed 16" on center.

All hardware to be corrosion resistant and installed per manufacturers' instructions.

Footings to be installed to 48" depth as is required by your local building ordinance.
Frost footing sizes based on 55 lbs per square foot tributary loads applied to 1500 psi soil compression capacity (assumed clay soil).
See footing detail in deck construction guide.

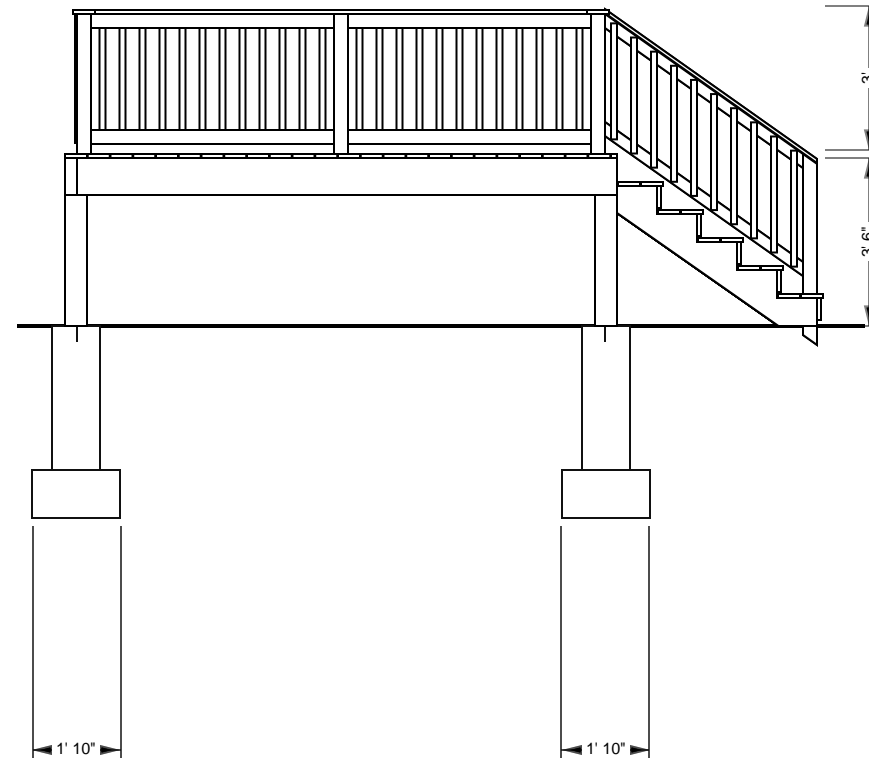
2x10 Ledger Board to be flashed and bolted (2) 1/2" bolts with washers or equivalent every 16" on center. (See ledger detail in deck construction guide)
Joists to be 2x10 pressure treated southern yellow pine installed 16" on center.
Beams to be 2-2x10 pressure treated southern yellow pine nailed.
Guard Rails to be 36" high with less than 4" openings per IRC code. (See rail detail in deck construction guide)
Stairs to be built max rise 7-3/4" min rise 4" in run 10" per IRC code. (See stair detail in deck construction guide)
Decking to be 5/4x6 Pressure Treated Pine. (Follow manufacturers' installation instructions)
All hardware to be corrosion resistant and installed per manufacturers' instructions.

DISCLAIMER: ONLY USE #2 OR BETTER PRESSURE TREATED SOUTHERN PINE 2X10 FOR FRAMING MATERIALS. NEVER SUBSTITUTE SOFTWOODS OR COMPOSITE FOR FRAMING MATERIALS.

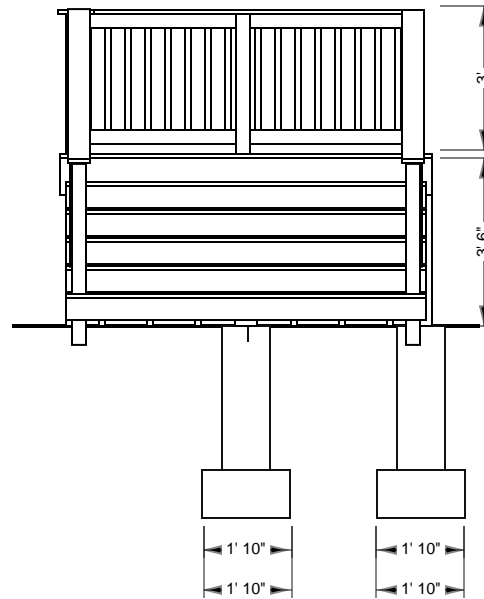
2x10 Ledger Board to be flashed and bolted (2) 1/2" bolts with washers or equivalent every 16" on center. (See ledger detail in deck construction guide)
Joists to be 2x10 pressure treated southern yellow pine installed 16" on center.
Beams to be 2-2x10 pressure treated southern yellow pine nailed.
Guard Rails to be 36" high with less than 4" openings per IRC code. (See rail detail in deck construction guide)
Stairs to be built max rise 7-3/4" min rise 4" in run 10" per IRC code. (See stair detail in deck construction guide)
Decking to be 5/4x6 Pressure Treated Pine. (Follow manufacturers' installation instructions)
All hardware to be corrosion resistant and installed per manufacturers' instructions.

DISCLAIMER: ONLY USE #2 OR BETTER PRESSURE TREATED SOUTHERN PINE 2X10 FOR FRAMING MATERIALS. NEVER SUBSTITUTE SOFTWOODS OR COMPOSITE FOR FRAMING MATERIALS.

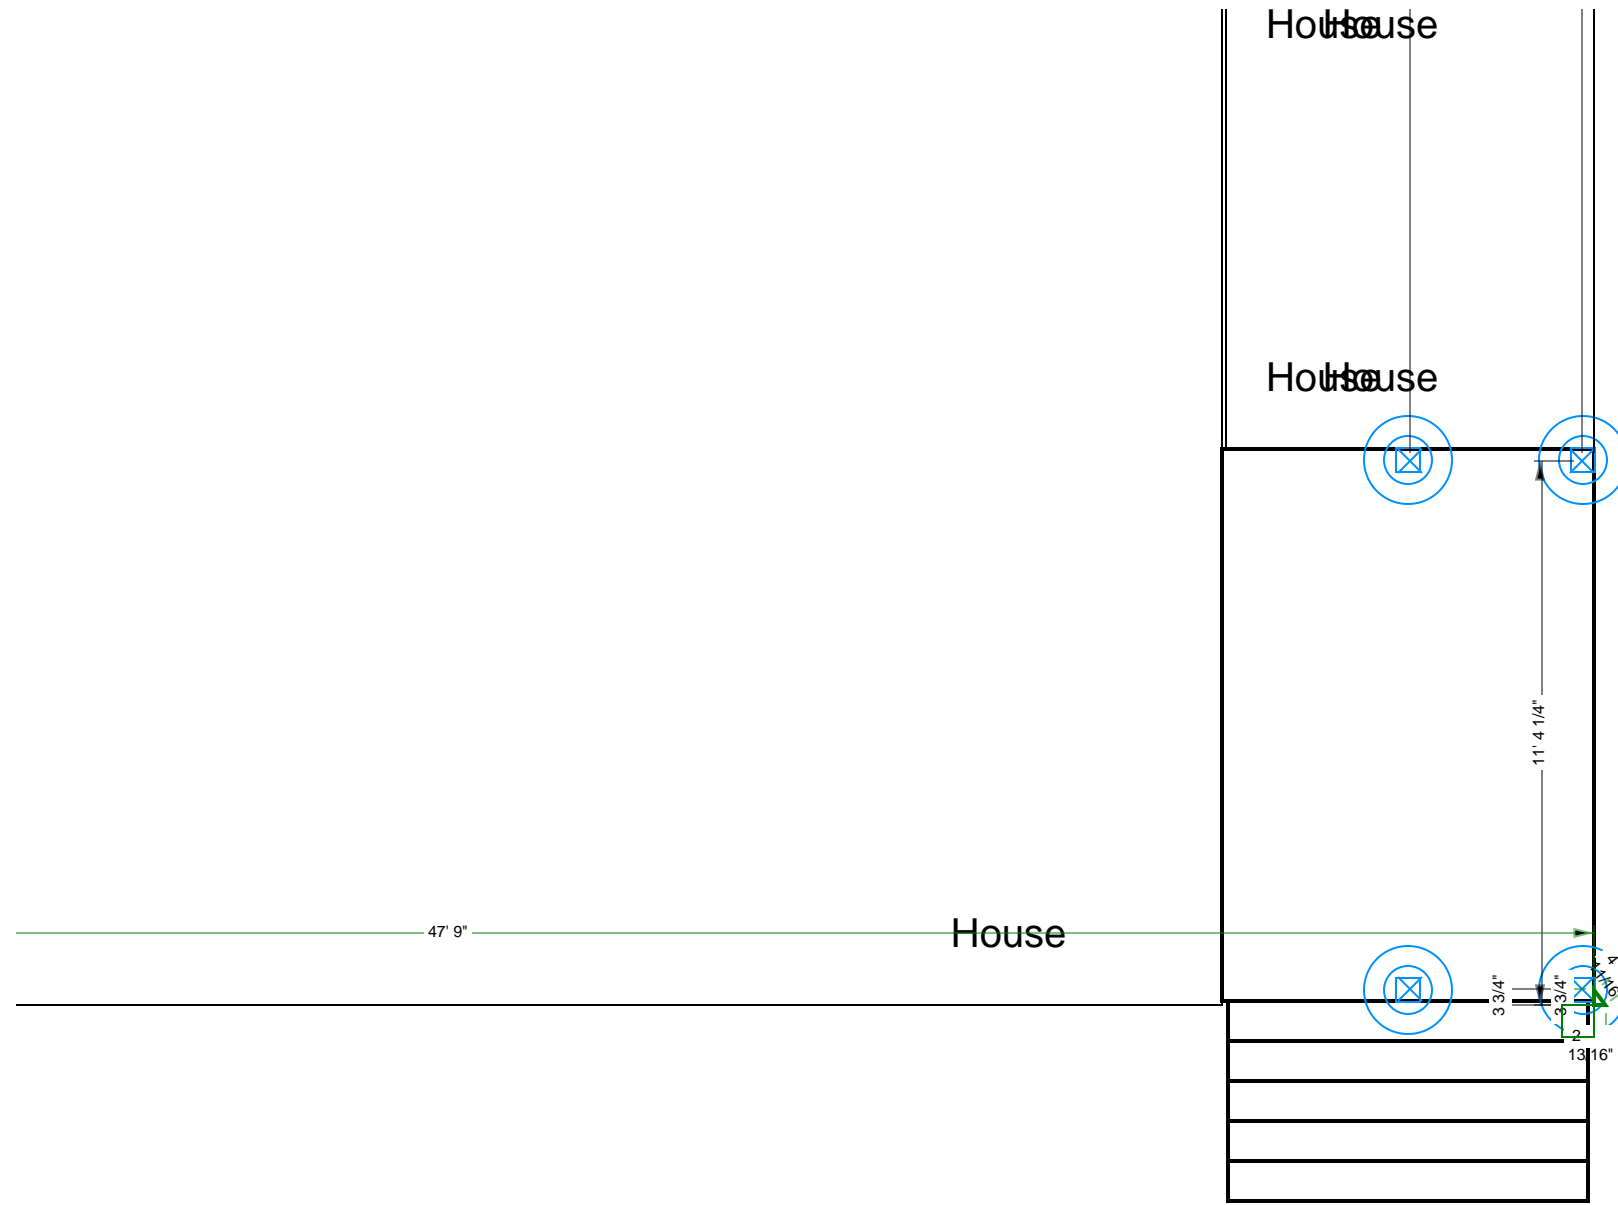
STAIR FOOTING REQUIREMENTS
WHERE THE STAIRWAY MEETS GRADE, ATTACH THE STAIR
STRINGERS TO THE STAIR GUARD RAIL POSTS. POSTS SHALL
BEAR ON FOOTINGS

Total Depth: 48
Base Diameter: 22
Pier Diameter: 12

Footings to be installed to 48" depth as is required by your local building ordinance. Frost footing sizes based on 55 lbs per square foot tributary loads applied to 1500 psi soil compression capacity (assumed clay soil). See footing detail in deck construction guide.

DISCLAIMER: USE ONLY 2,500 PSI CONCRETE FOR FROST FOOTING FOUNDATIONS.

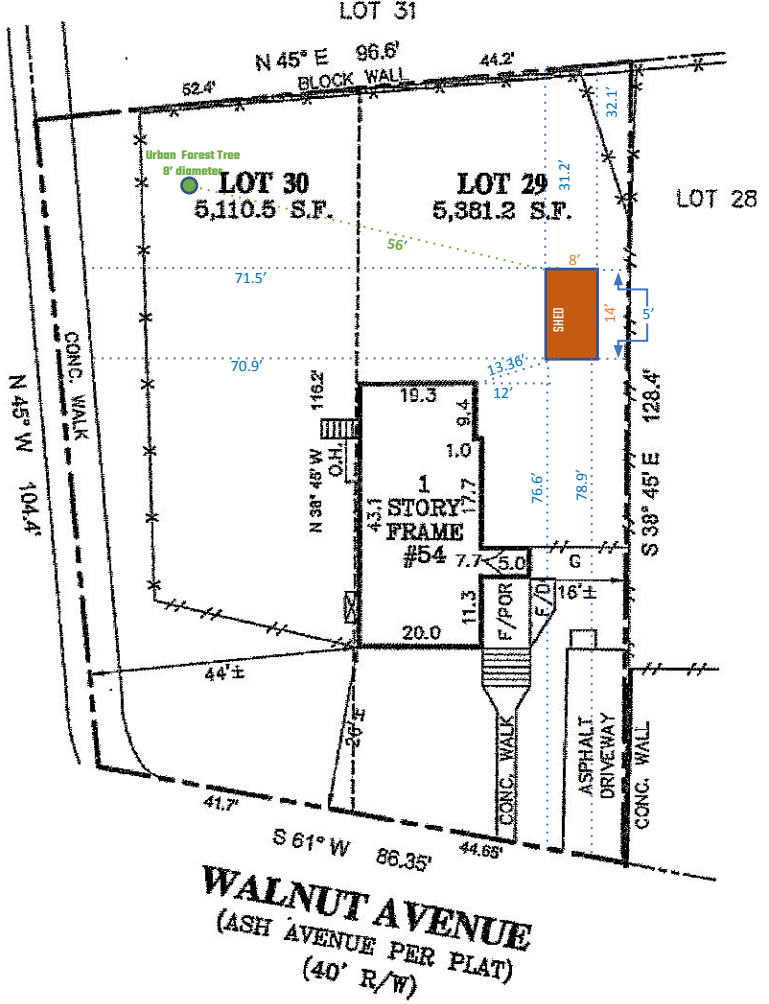
LOCATION DRAWING
LOTS 29 & 30, BLOCK A
THE FIFIELD SUBDIVISION
TAKOMA PARK
MONTGOMERY COUNTY, MARYLAND

EASTERN AVENUE
(40' R/W)
