MONTGOMERY COUNTY HISTORIC PRESERVATION COMMISSION
STAFF REPORT

Address:	7324 Baltimore Avenue, Takoma Park	Meeting Date:	10/25/2023
Resource:	Contributing Resource Takoma Park Historic District	Report Date:	10/18/2023
Applicant:	Conor McCarthy (Richard J. Vitullo, Architect)	Public Notice:	10/11/2023
Review:	HAWP	Tax Credit:	Partial
		Staff:	John Liebertz

PROPOSAL: For demolition of rear addition, construction of new addition, and fenestration alterations.

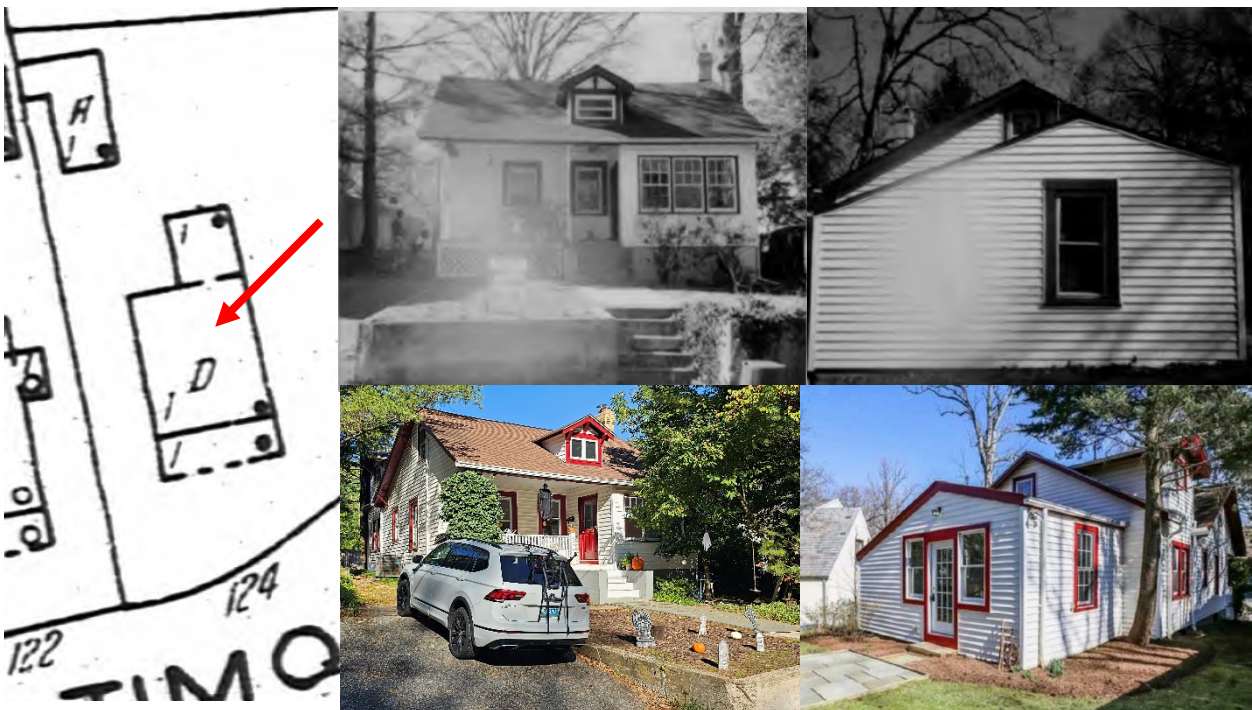
Figure 2: View of the 1927 Sanborn Fire Insurance Map (left). View of the façade, 1988 (upper middle) and 2023 (lower middle). View of the rear elevation, 1988 (upper right) and ca. 2022 (lower right). Source: Sanborn Fire Insurance Company, Applicant, Montgomery Planning.

The subject property located near the intersection of Baltimore Avenue and Albany Avenue is a Contributing Resource to the Takoma Park Historic District. The site features a Craftsman-styled, wood-frame house constructed ca. 1921. The one-and-a-half-story, three-bay, side-gable house with a gable dormer (*Figure 2*) rests on a concrete foundation. The original wood lap siding is covered with vinyl siding that was installed in the last quarter of the twentieth century. The façade features a recessed, partially infilled porch accessed by a centrally located stair. In the last quarter of the twentieth century, the property owners constructed a one-story, wood-frame, gable roof, rear addition. The addition rests on a concrete block foundation and is clad with vinyl siding.

new fenestration to the non-historic rear addition.¹ Fenestration on the addition consists of six-over-six, six-over-one, and one-over-one windows and multi-light, single-leaf doors. Recently, the rear addition was damaged beyond repair during a storm when a tree fell.

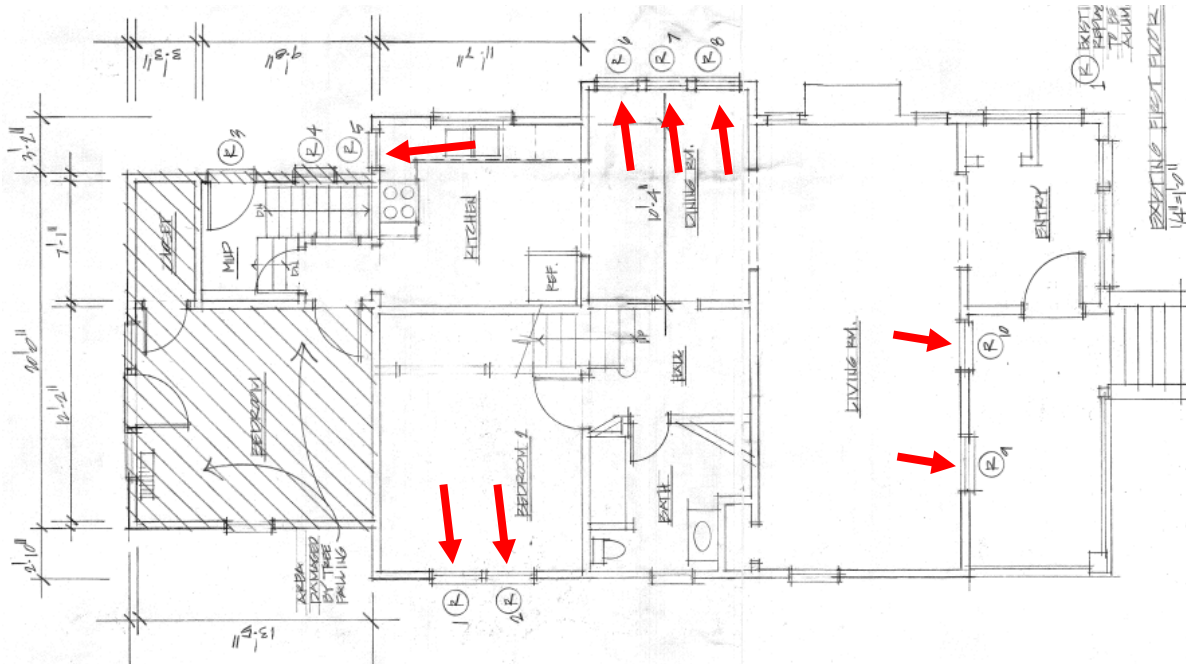
Figure 3: View of the first-floor plan showing the location (red arrows) of the eight vinyl-sash windows to be replaced.

Staff finds the proposed replacement of the eight (8) vinyl windows on the first story with simulated divided light, aluminum-clad, wood windows to be consistent with the applicable guidelines and recommends approval (*Figure 3*). The proposed design is compatible with the Craftsman-style of the house. There are no historic photographs available that depict the original design of the windows. The replacement of vinyl-sash with aluminum-clad, wood windows is an appropriate substitution in this case.

The windows that will replace the 8 vinyl windows on the 1st floor will also be aluminum-clad wood windows and 7 of them will be 6-over-1 double hungs; the 8th window (facing the rear in the kitchen) will be a 4-over-1 double hung. **These vinyl windows are numbered and noted on the Existing 1st Floor Plan; photos of each of them, also numbered, are included in this submission.**

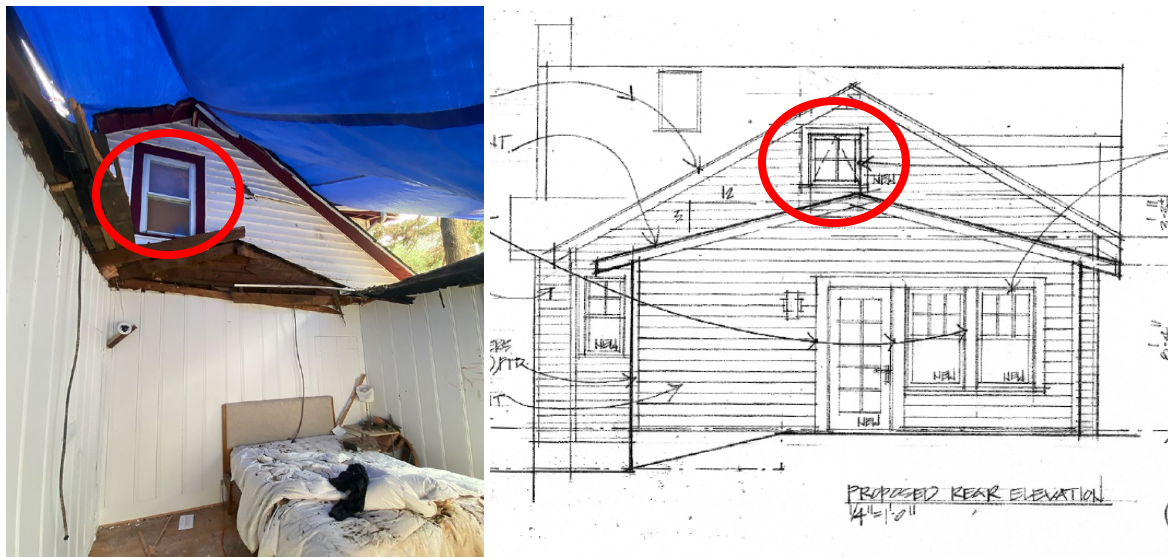
Figure 4: View of the rear upper gable end window (red circle) to be replaced.

Staff finds the alteration to the size of the window opening and replacement of the one-over-one, double-hung, vinyl-sash window with a smaller four-light, aluminum-clad, wood, awning window to be consistent with the applicable guidelines and recommends approval (*Figure 4*). The proposed window located in the upper gable end of the rear elevation would permit for the construction of the addition. Salvaged vinyl siding would be utilized to infill any missing sections. This alteration would not be visible from the public rights-of-way and should be approved as a matter of course.
