*Preliminary Consultation*  
**MONTGOMERY COUNTY HISTORIC PRESERVATION COMMISSION**  
**STAFF REPORT**

<b>Address:</b>	102 East Kirke Street, Chevy Chase	<b>Meeting Date:</b>	4/17/2024
<b>Resource:</b>	Outstanding Resource Chevy Chase Village Historic District	<b>Report Date:</b>	4/10/2024
<b>Applicant:</b>	Britt & Will Williams Luke Olson, Architect	<b>Public Notice:</b>	4/3/2024
<b>Review:</b>	Preliminary Consultation	<b>Staff:</b>	Dan Bruechert
<b>Proposal:</b>	Demolition of garage and construction of new garage, partial demolition, fenestration alteration, new two-story rear addition, hardscape alterations, tree removal, pool installation.

## 102 EAST KIRKE STREET, CHEVY CHASE VILLAGE HISTORIC DISTRICT

SCOPE OF WORK: 2 STORY REAR ADDITION W/ BACK PORCHES, PATIO, 2 CAR  
DETACHED GARAGE, & DRIVEWAY RECONFIGURATION

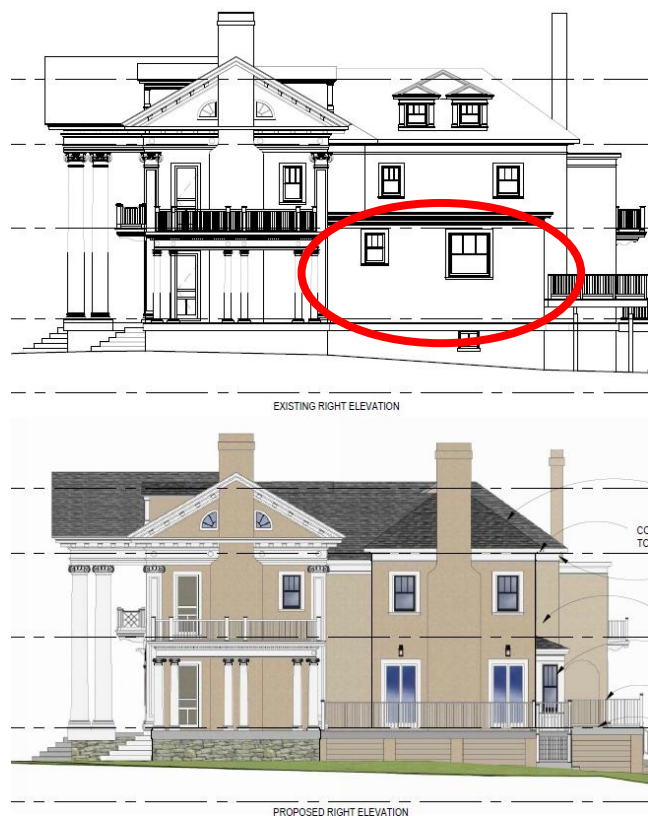
*Figure 3: Existing west elevation showing the one-story addition (circled) and proposed addition and deck, below.*

The proposed addition measures 30' × 27' (thirty feet wide, by twenty-seven feet deep), and will have stucco siding, painted composite trim, aluminum clad SDL windows, with roofing that matches the existing house. The proposed addition has a lower eave line than the historic eave with a lower roof height. The addition will eliminate three historic windows that are currently exposed. Because the property is on a corner lot, the proposed addition will be highly visible from the right-of-way.

To the west of the proposed addition, the applicant proposes to construct a deck using a composite material measuring approximately 31' × 12' (thirty-one feet wide by twelve feet deep).

Finally, Staff finds the proposed deck to the west of the addition adds mass to the proposed addition and appears to visually compete with the historic two-story porch. Staff recommends the deck either be eliminated or enlarged so its massing is more compatible with the historic. This porch could be a simplified version of the two-story porch.

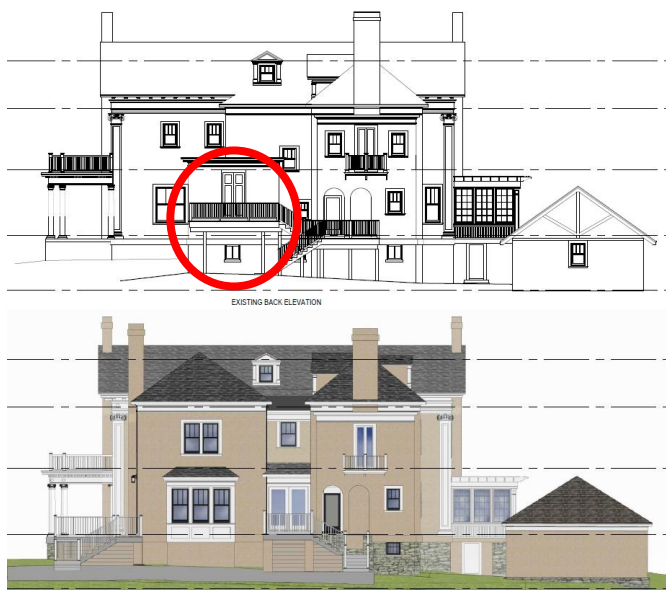
**Figure 4: existing rear addition (circled) with the larger two-story addition shown below.**

Staff finds the existing rear addition is not original to the date of construction and does not significantly contribute to the architectural significance of the property. Staff finds its demolition will not negatively impact on the character of the property or the surrounding district.

Staff finds the footprint of the proposed addition is wider than the existing two-story ell, but is not as deep and has the same approximate square footage as the existing two-story ell. Because of the large scale of the historic house, Staff does not find the addition will overwhelm the historic house. Staff has some
