Preliminary Consultation
MONTGOMERY COUNTY HISTORIC PRESERVATION COMMISSION
STAFF REPORT

Address:	10012 Menlo Ave., Silver Spring	Meeting Date:	10/9/2024
Resource:	Nominal (post-1935) Capitol View Park Historic District	Report Date:	10/2/2024
Applicant:	Alpha Houses LLC (Salem Badawy, Agent)	Public Notice:	9/25/2024
Review:	Preliminary Consultation	Staff:	Dan Bruechert
Proposal:	Partial Demolition, Two Story Addition, and Tree Removal

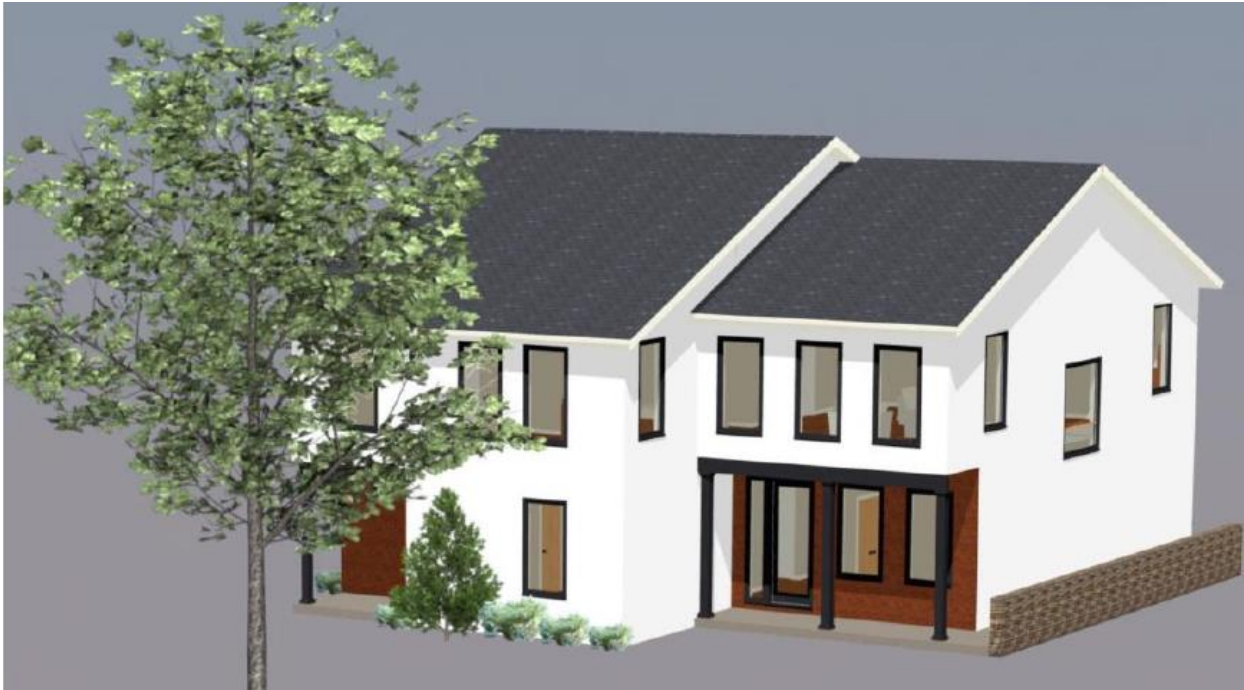
Figure 2: 3D rendering of the subject property with the proposed second story.

Staff finds the massing of the proposed house with its relatively simple form and two side gables is appropriate for the variety of architectural styles found throughout the Capitol View Historic District.

Staff finds the materials presented which include fiber cement panels, architectural shingles, and aluminum-clad wood windows and doors, are all appropriate for building additions and new construction in the Capitol View Park Historic District.

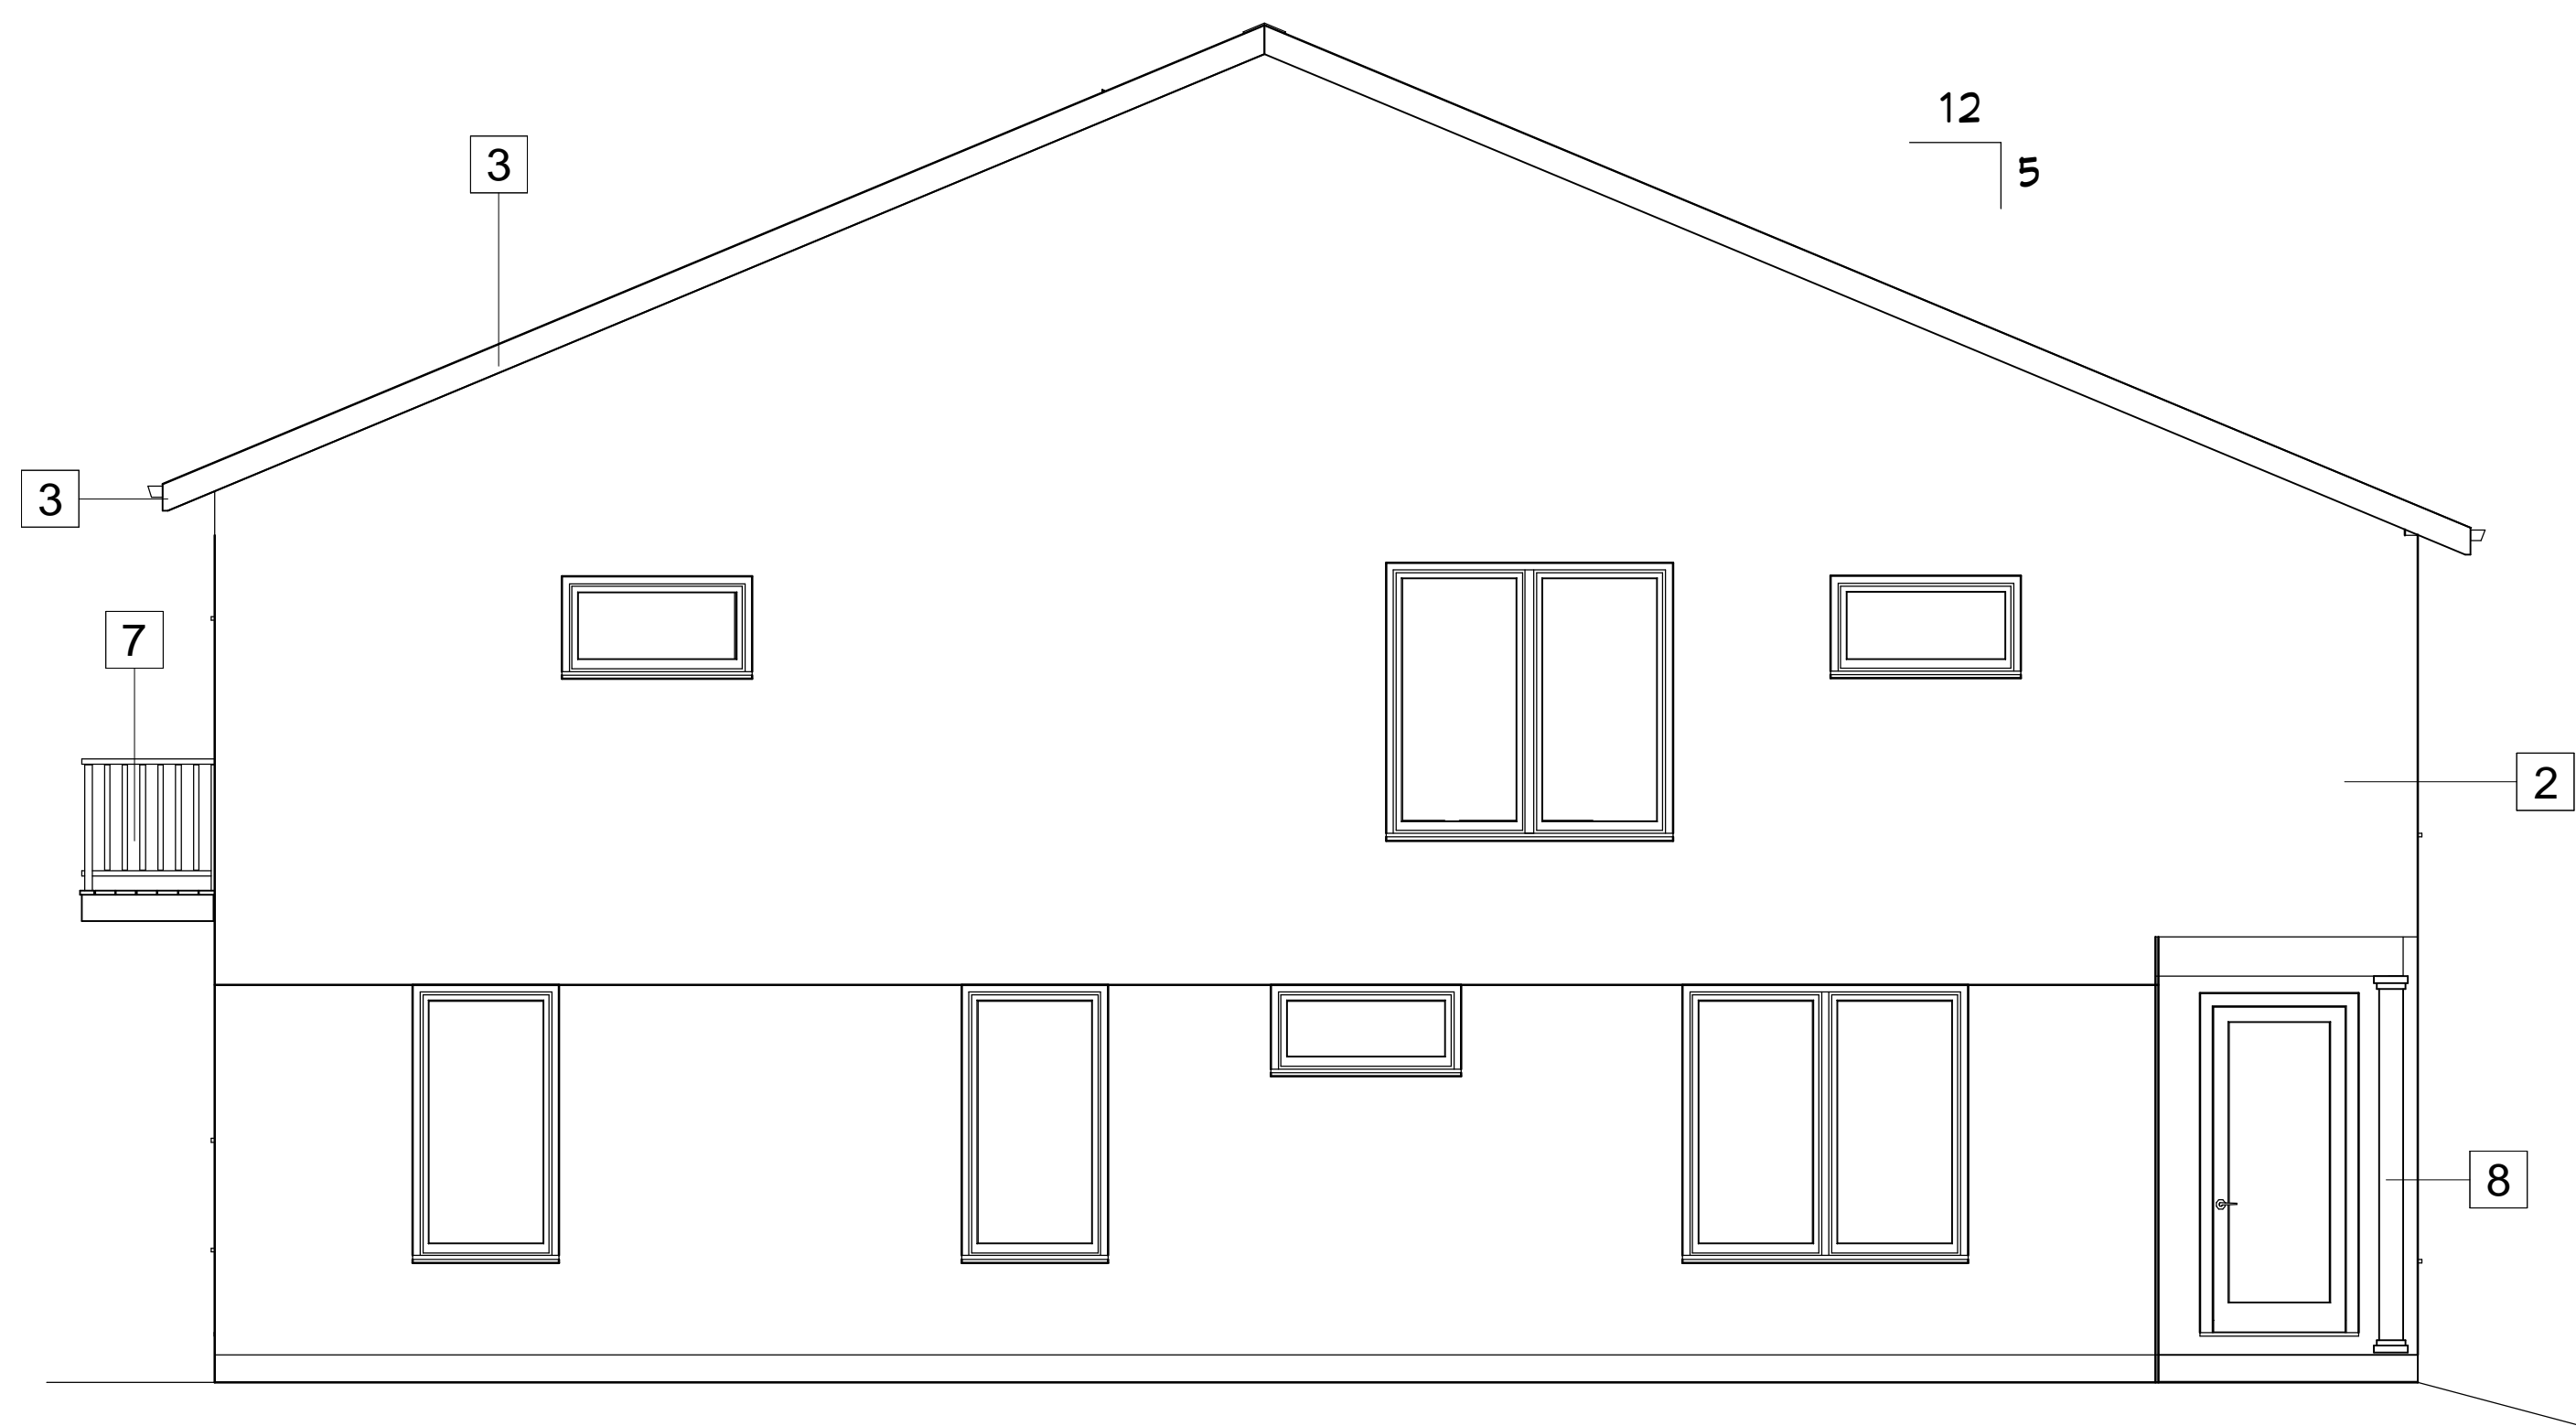
LEFT SIDE ELEVATION

- 1 - FIBERGLASS SHINGLES
- 2 - HARDI PANEL SIDING
- 3 - ALUM GUTTER ON 1x6 FASCIA
- 5 - EXIST STUCCO VENEER TO BE PAINTED WHITE
- 6 - 1x6 RAKE
- 7 - PVC RAILING
- 8- 8x8 POST
- 10- CONC SLAB
- 11- STONE RETAINING WALL
- 12- 5/4"x 4 TRIM

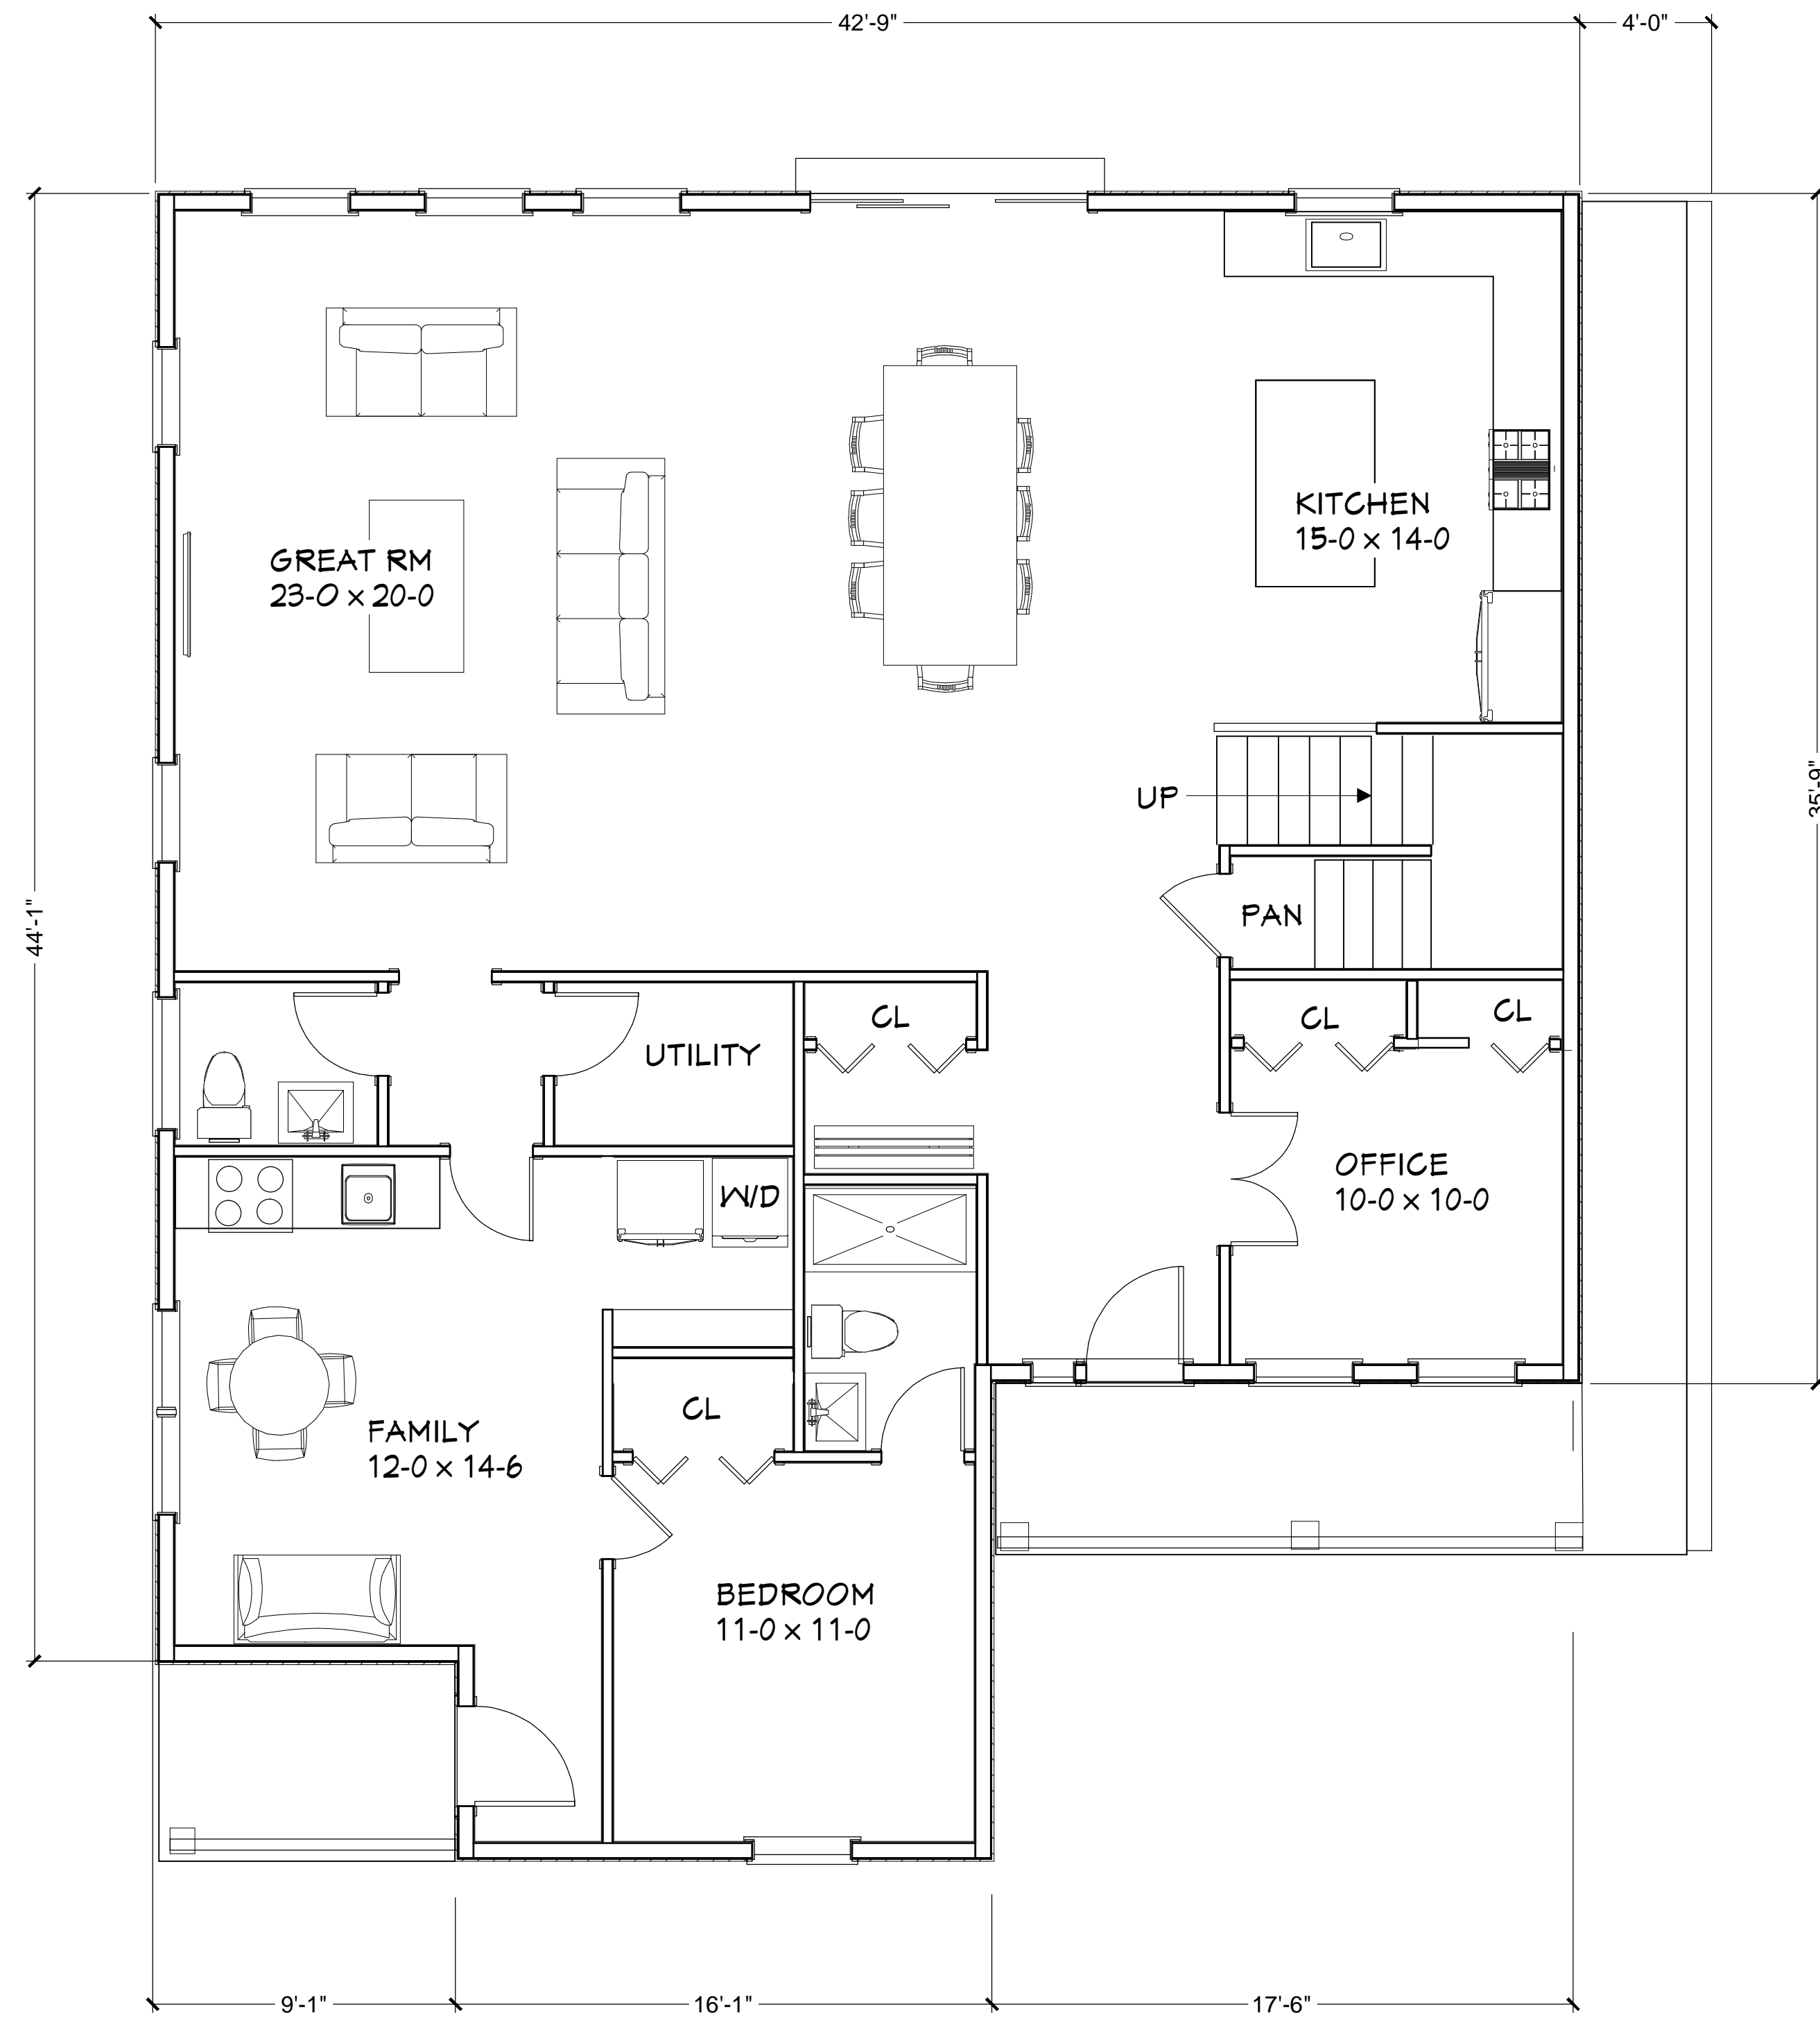
FIRST FLOOR PLAN

1826 SF

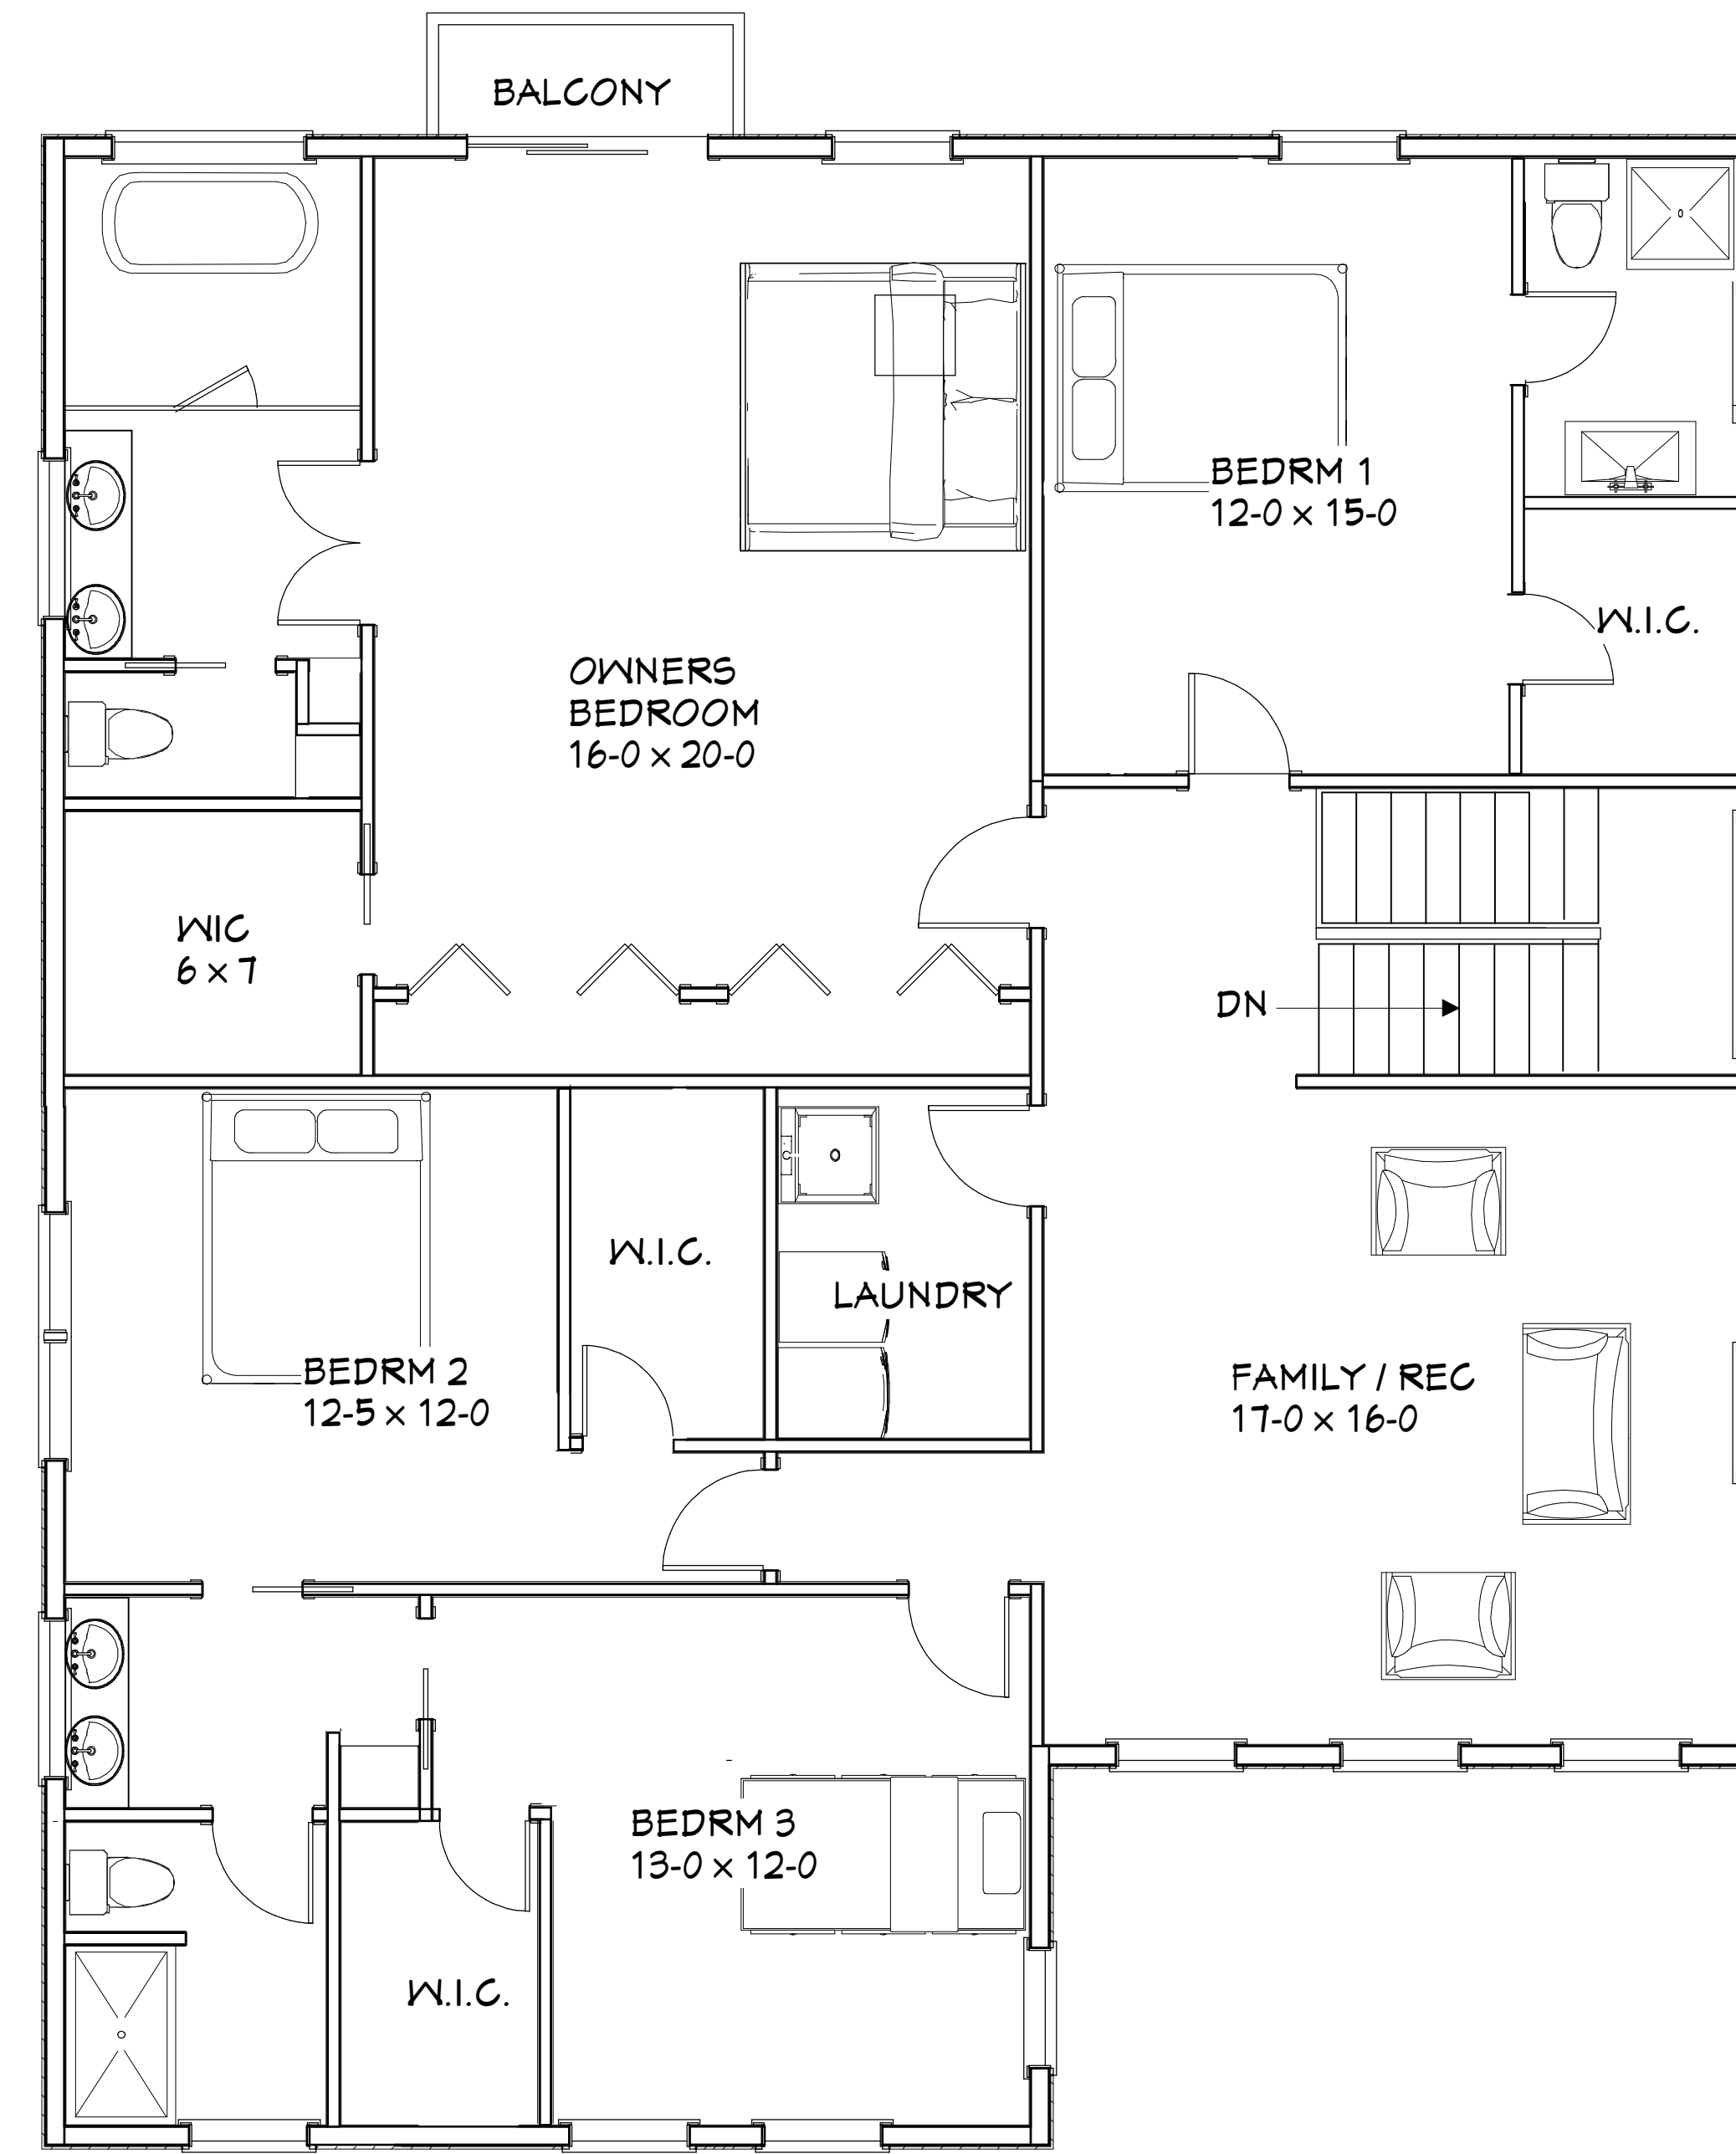
SECOND FLOOR PLAN

1975 SF

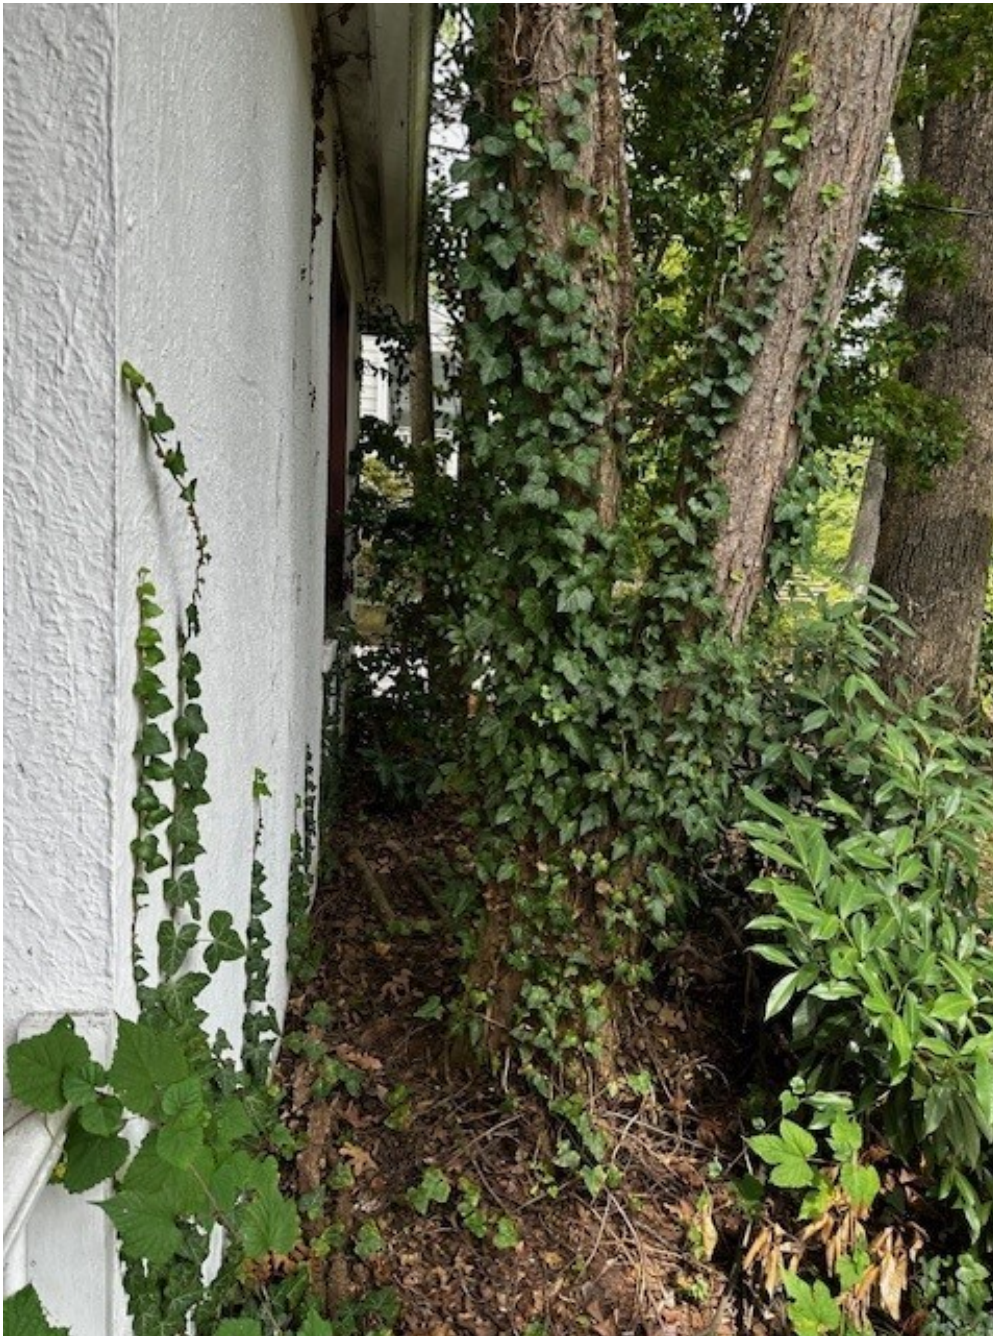
Two mature Hemlocks 18" from the foundation. Too close to the foundation.

- Four trees encroach on the foundation the largest only 12 inches away. These trees were planted as accents to the house but now, disproportionately tower over the house and can threaten the foundation exploiting any existing flaws.

The health of the hemlocks has been affected by the weather, spider mites and the Hemlock Woolly Adelgid. The crown are thin and the overall vigor fair to poor. The Cedar, is in fair health with sparse foliage, spider mite damage and cedar hawthorn/apple rust.

Removal is recommended for these trees to protect the foundation.

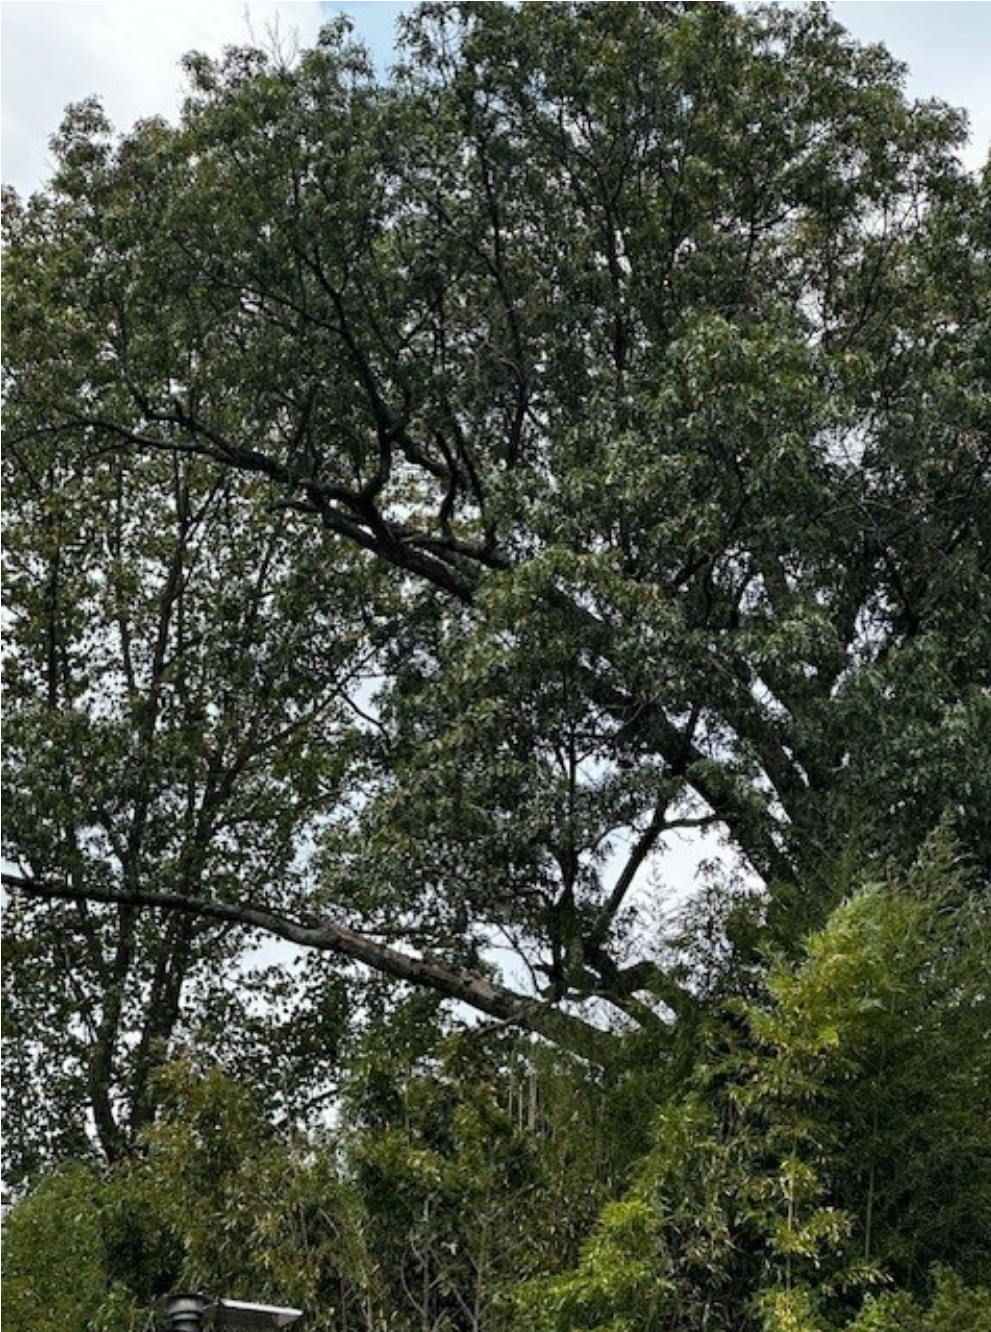
Red Oak rear leaning away from the house all weight is unbalanced over the rear of the property.

The other two trees proposed for removal are much larger. One is a 41” (forty-one inch) Red Oak and is 3’ (three feet) from the house. The arborist also identified that the tree has a pronounced lean and the retaining wall partially supporting its roots is decaying. The sixth tree is a 29” (twenty-nine inch) White Oak in a planter in front of the house. The evaluation identifies the weight of the existing driveway in the critical root zone and the grade of the planter as threats to the long-term health of the tree and indicates

- The 41" diameter Red Oak in the rear has a pronounce lean toward the rear neighboring house. No counterbalancing limbs are present to offset the gravitational pull on this tree. The stem is 17 inches from the decaying timber wall and 39 inches from the house. Replacement of the timber wall has a high risk of causing failure of the root system with severe results. Removal is recommended.
-

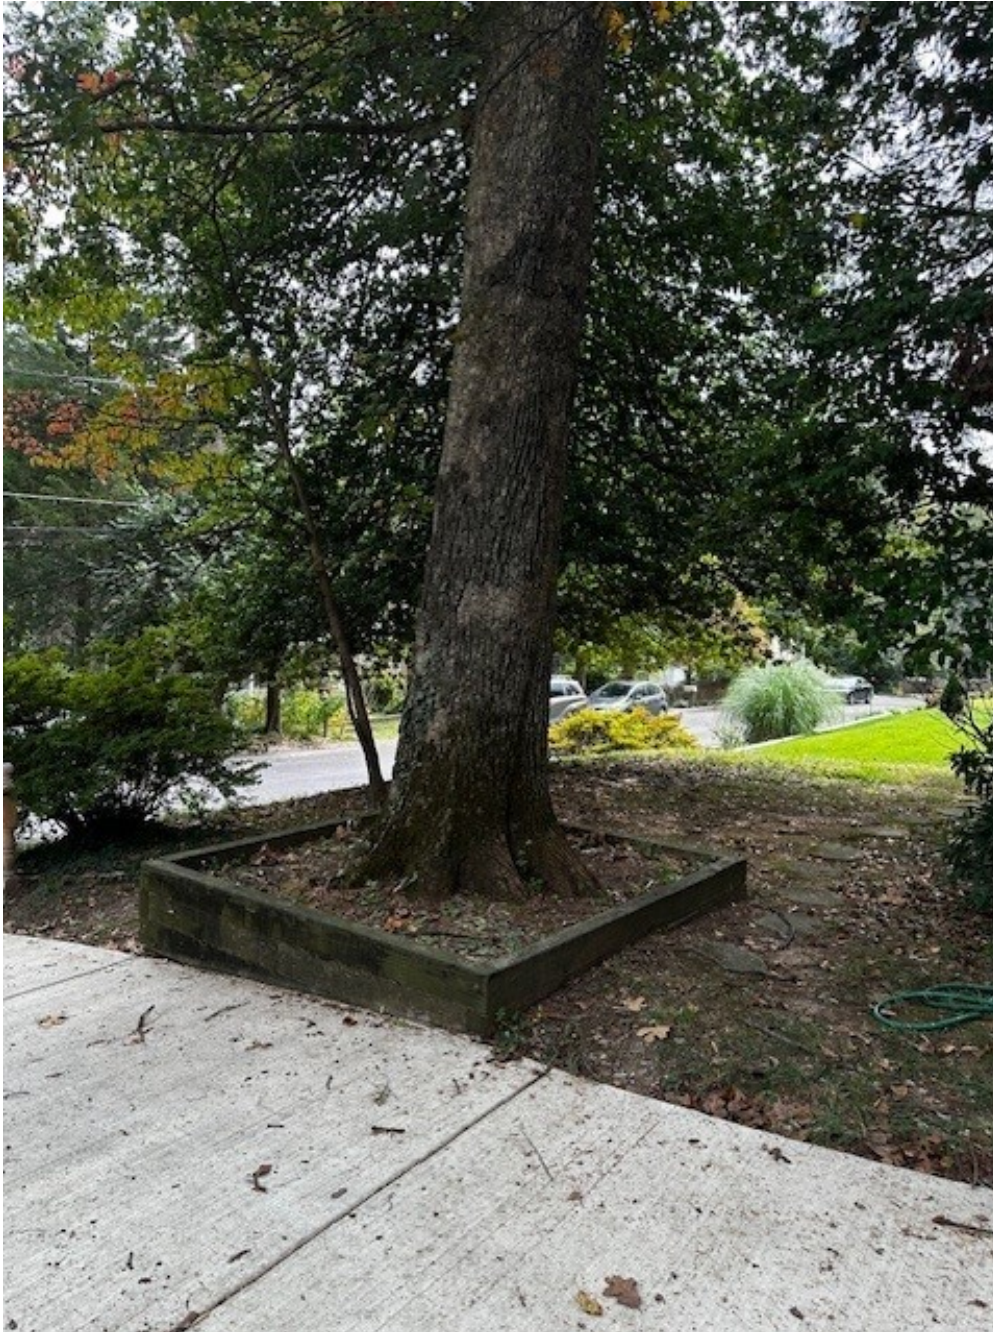
Removal

White Oak if front 24 inches from the driveway

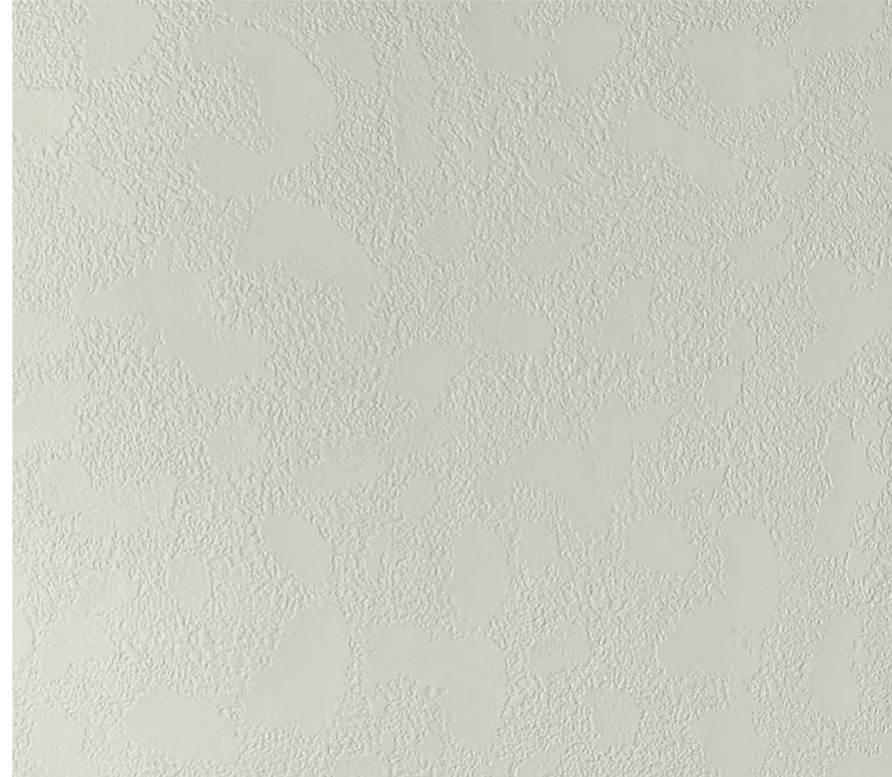
James Hardie Primed HZ5 Fiber Cement Stucco
Panel Siding 48-in x 96-in

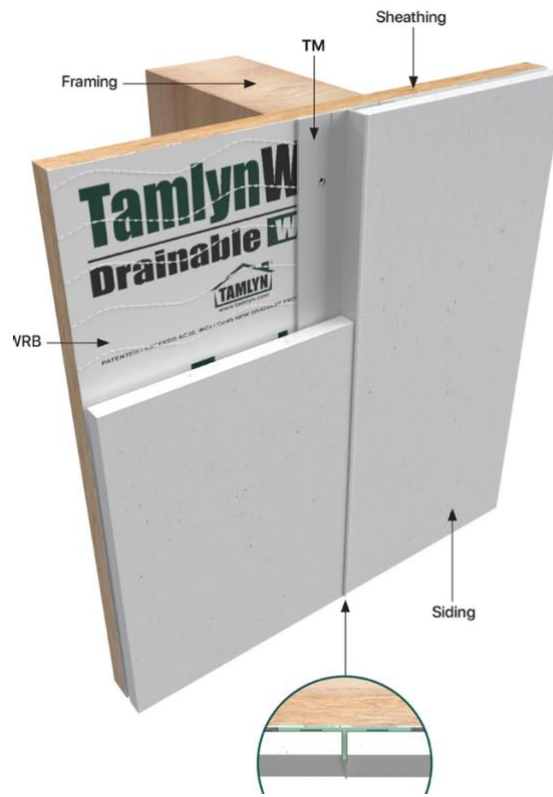
Vertical & Horizontal Profiles:
Tamlyn XtremeTrim® Panelseam® T-Mold

MATERIALS: Extruded aluminum alloy with proprietary coating that protects against harsh weather conditions and allows for paint adhesion.

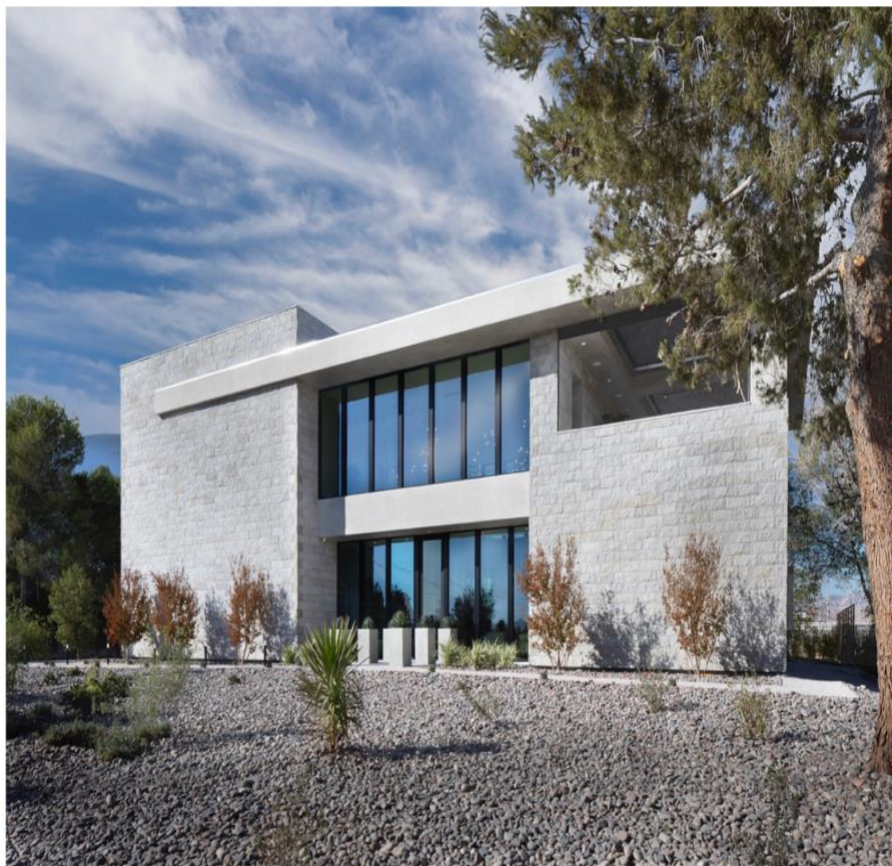
Brand: PLY GEM MIRA Series Windows - Aluminum-Clad Wood

Ply Gem aluminum-clad wood windows offer the timeless beauty of wood windows with durable aluminum clad exterior.

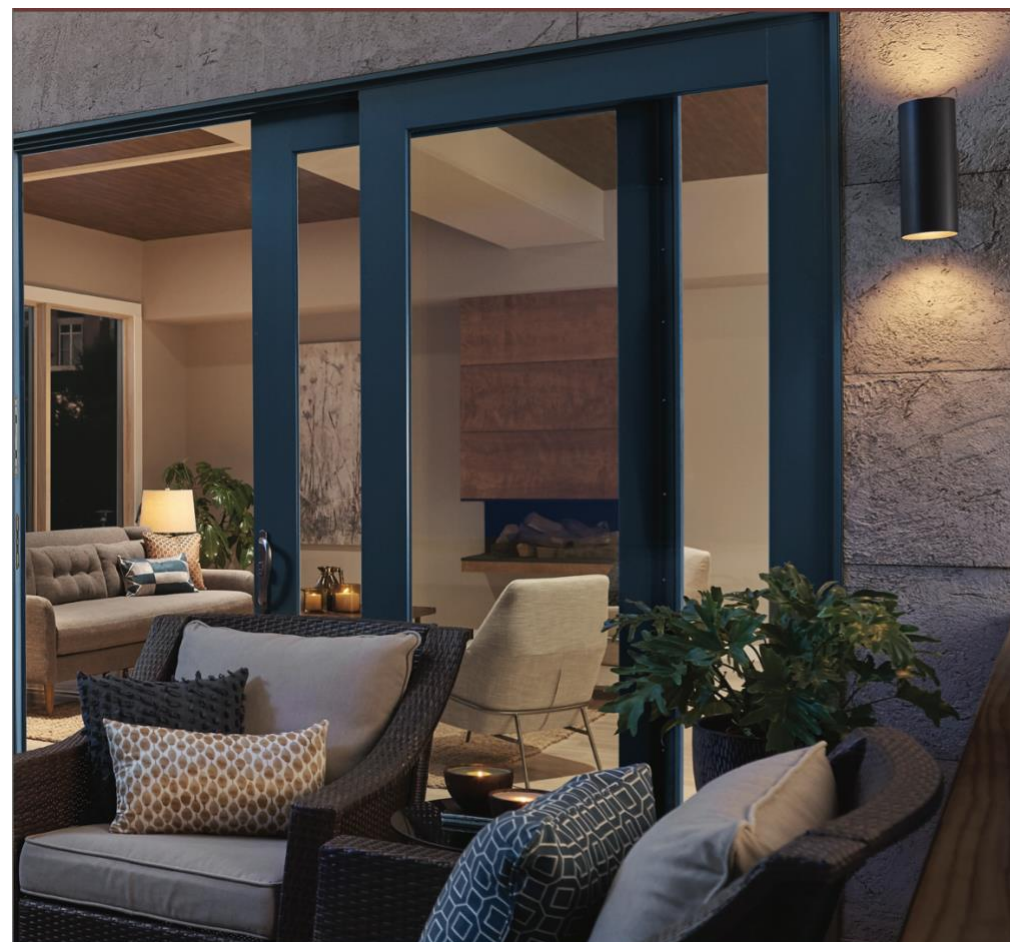
MIRA Aluminum-Clad Wood Bi-Parting Patio Doors

Material: Aluminum Clad - Wood protected by aluminum exterior

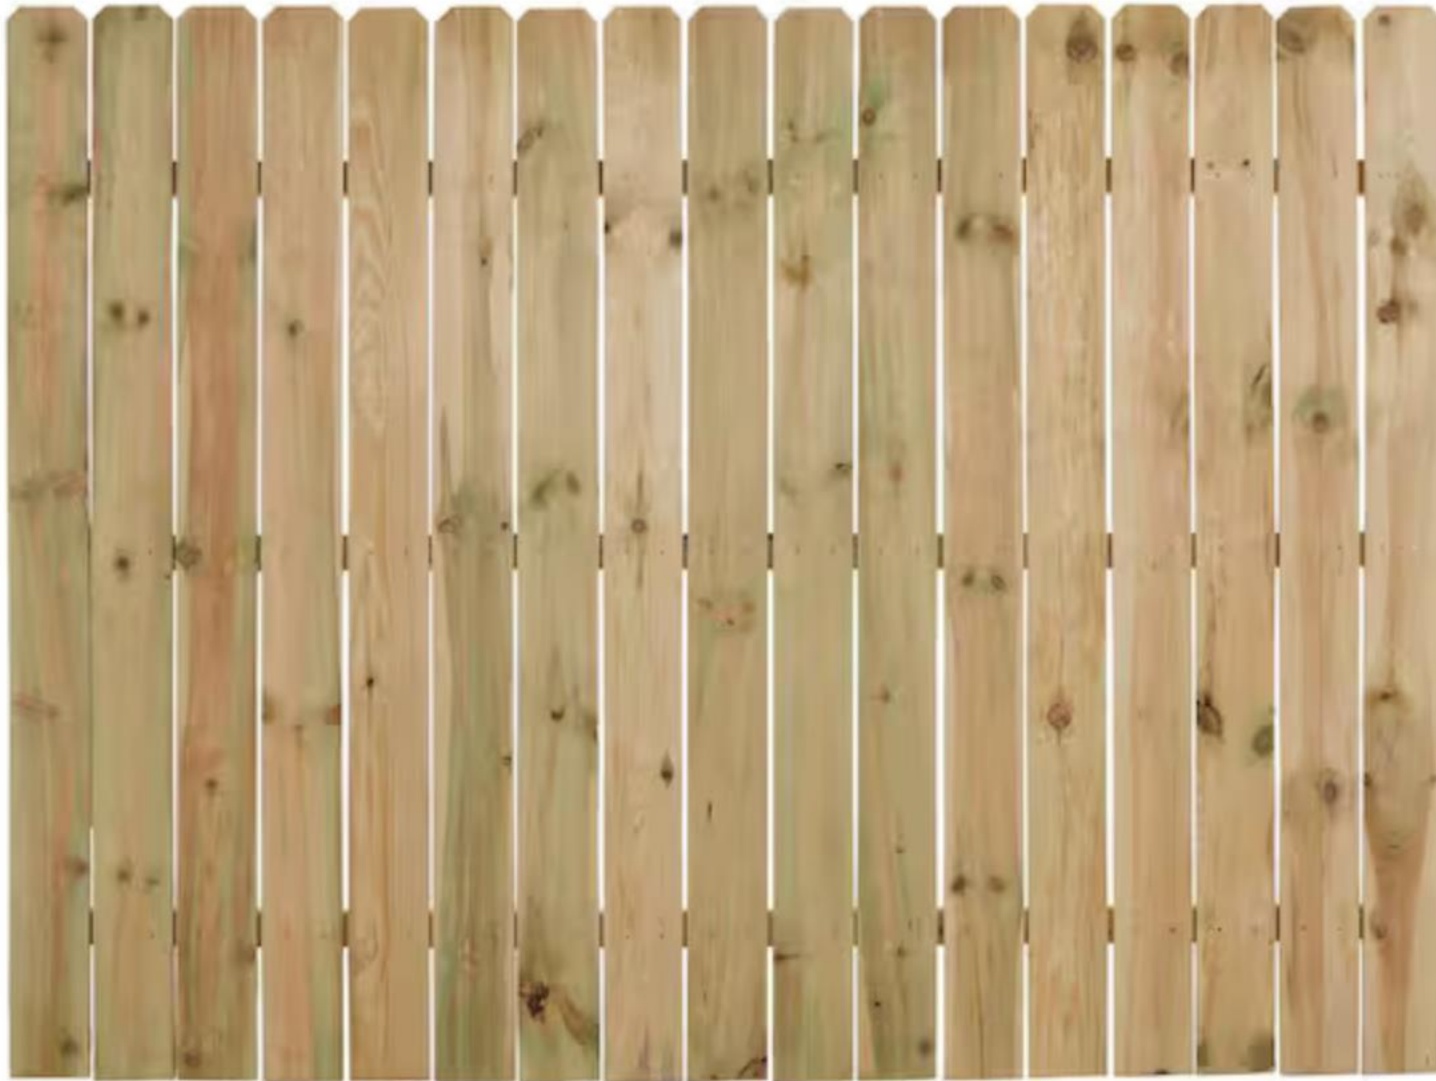
Proposed fencing

Fence to be installed along the side and rear edges of the property 6 foot tall vertical board fence.
Materials: 6 ft. H x 8 ft. W Pressure-Treated Pine Dog-Ear Fence Panel.

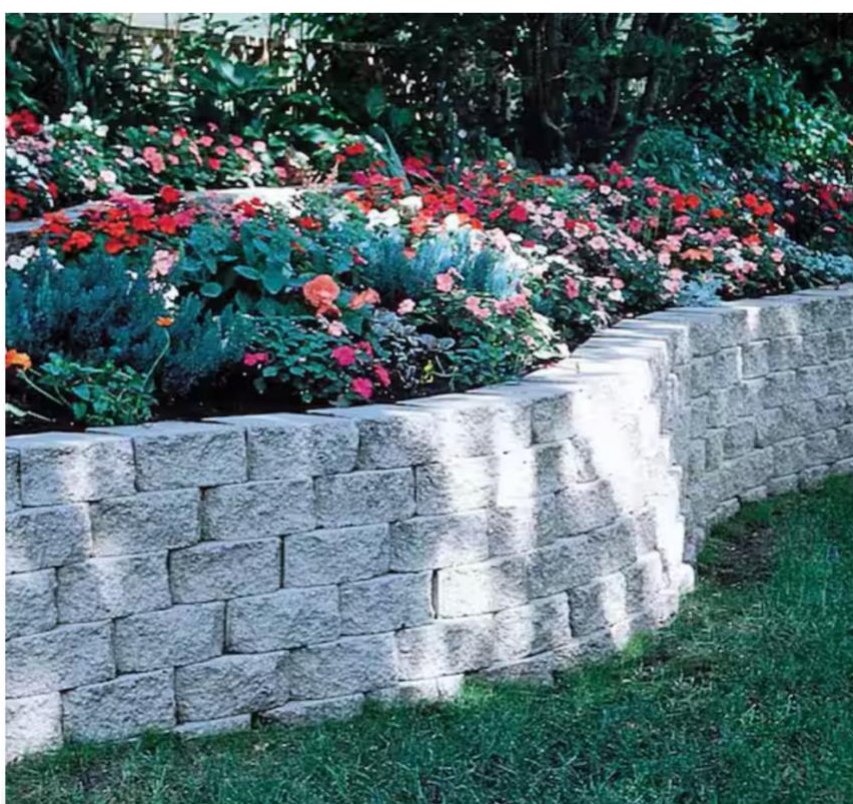
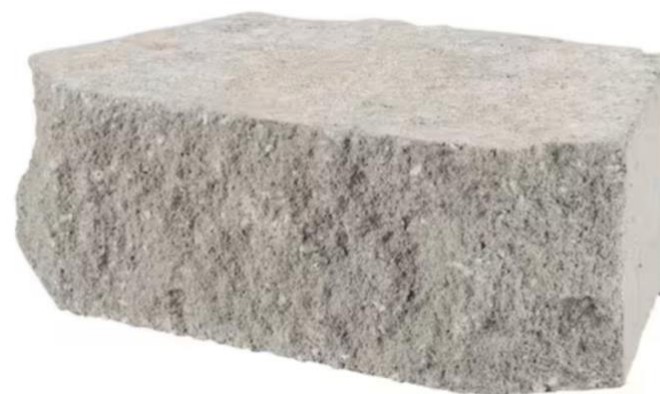
Retaining walls

Existing walls will be replaced using Pewter Concrete Retaining Wall Block (4 in. x 11.75 in. x 6.75 in.).

Locations: front, rear, and along the right (northeastern) side of the property.
