Preliminary Consultation
MONTGOMERY COUNTY HISTORIC PRESERVATION COMMISSION
STAFF REPORT

Address:	10012 Menlo Ave., Silver Spring	Meeting Date:	10/9/2024
Resource:	Nominal (post-1935) Capitol View Park Historic District	Report Date:	10/2/2024
Applicant:	Alpha Houses LLC (Salem Badawy, Agent)	Public Notice:	9/25/2024
Review:	Preliminary Consultation	Staff:	Dan Bruechert
Proposal:	Partial Demolition, Two Story Addition, and Tree Removal

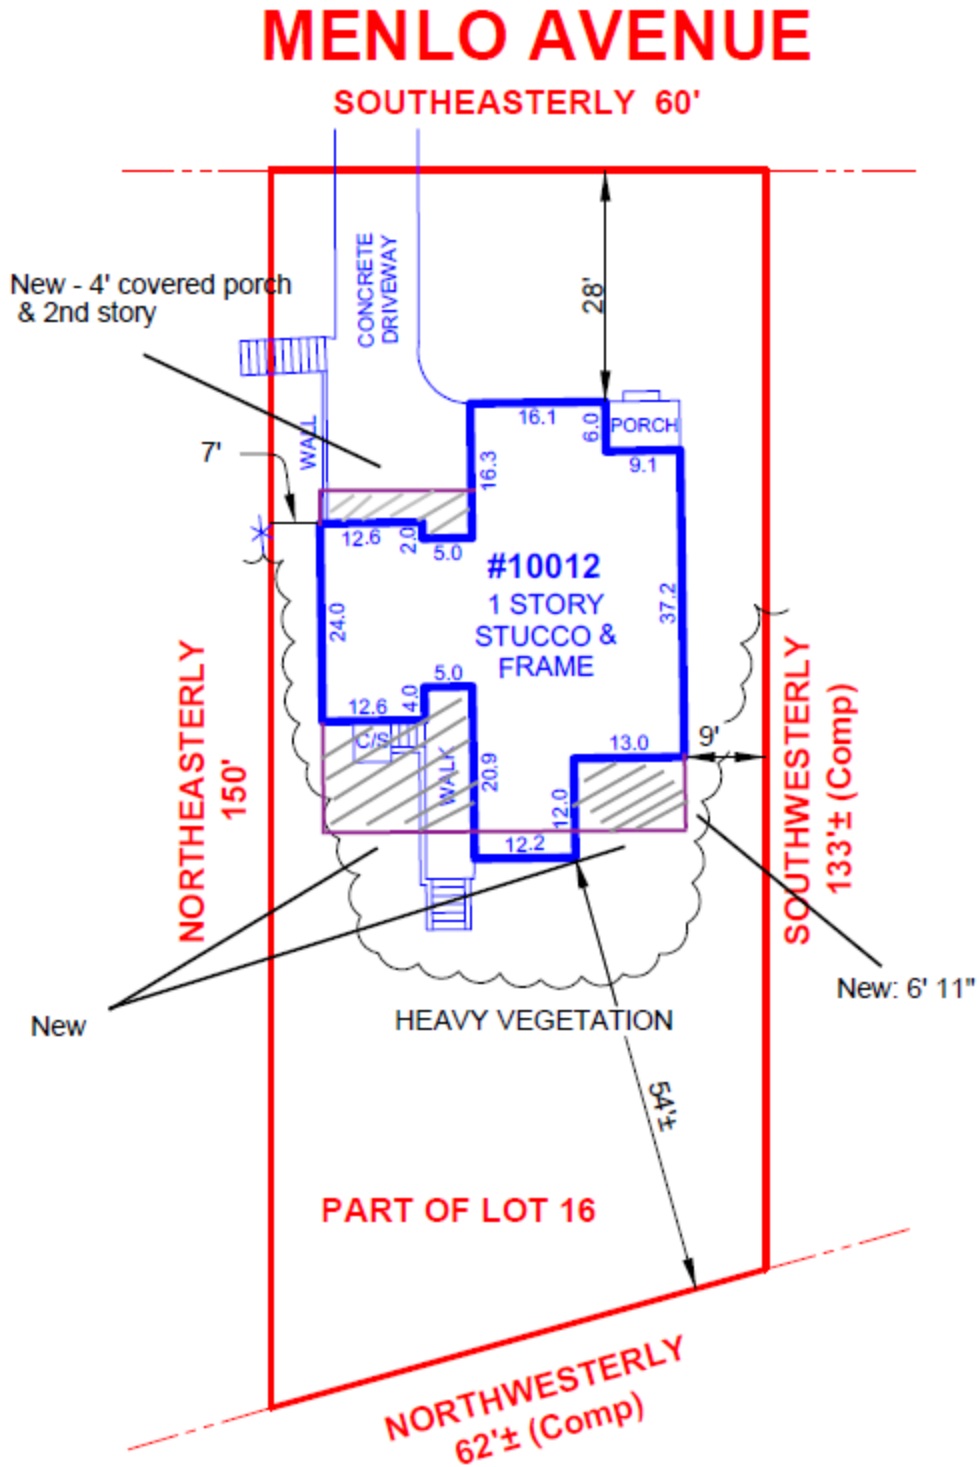
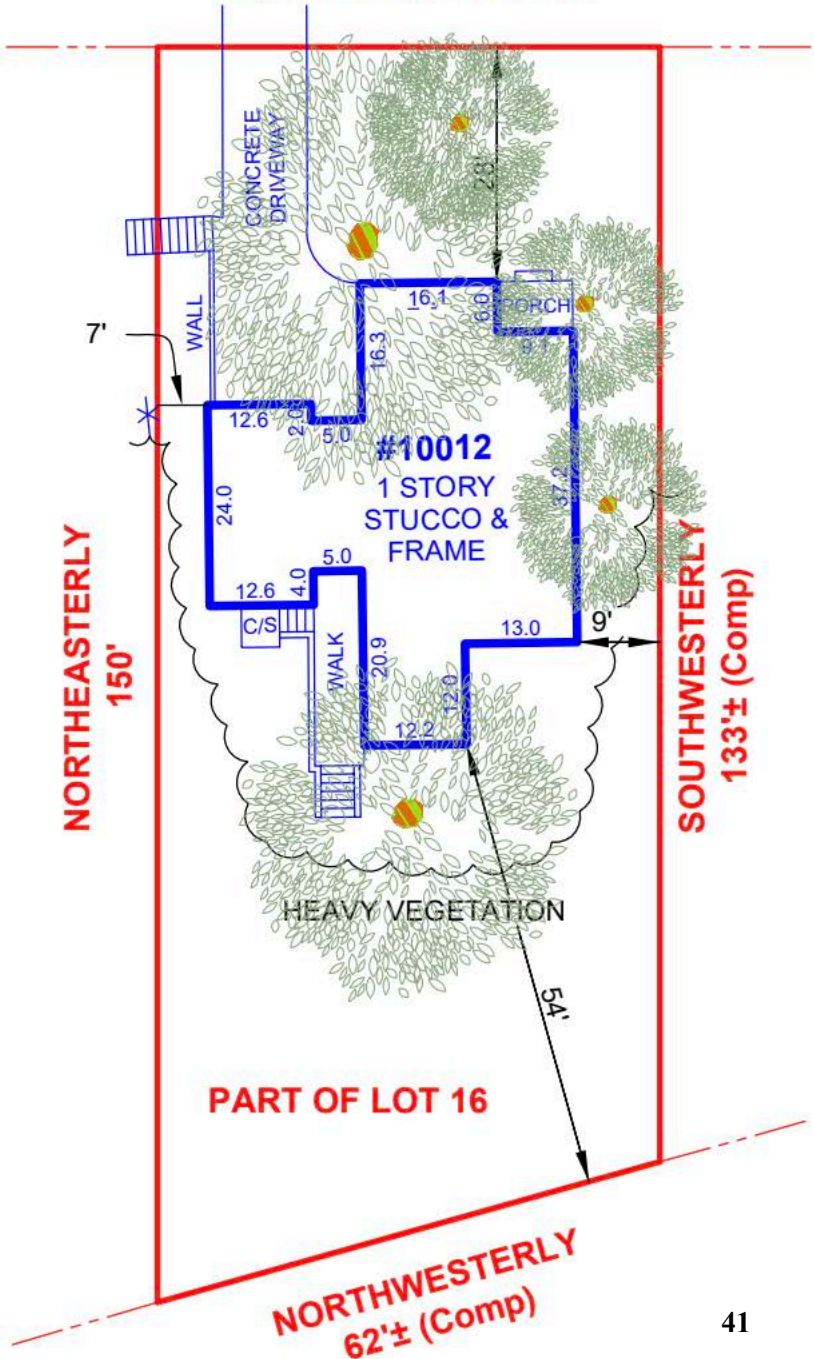
Proposed site plan for 10012 Menlo Ave

MENLO AVENUE

SOUTHEASTERLY 60'

NORTHEASTERLY
150'

SOUTHWESTERLY
133'± (Comp)

NORTHWESTERLY
62'± (Comp)
