**MONTGOMERY COUNTY HISTORIC PRESERVATION COMMISSION**  
**STAFF REPORT**

| <b>Address:</b> | 10012 Menlo Ave., Silver Spring | <b>Meeting Date:</b> | 12/4/2024 |
| <b>Proposal:</b> | Partial Demolition, Two Story Addition, Hardscape Alteration, and Tree Removal | | |

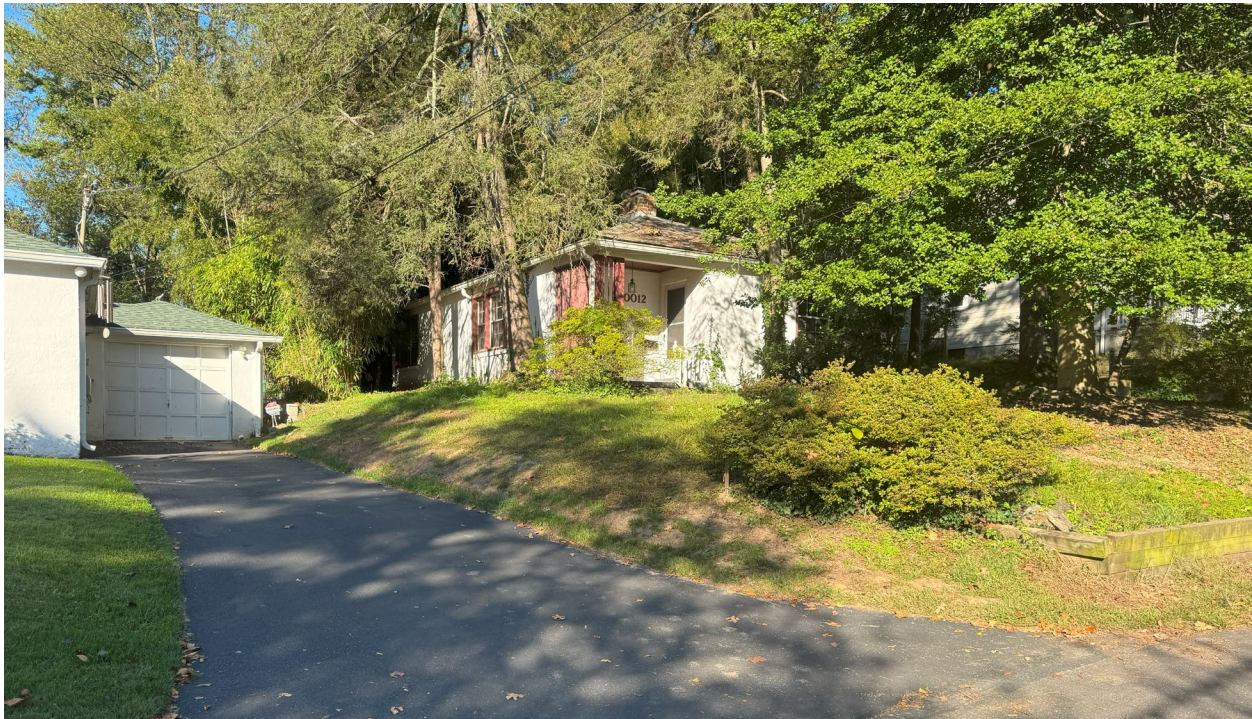
**Figure 2: View showing the subject property from the south. The rearward expansion of the first floor will be visible from this perspective.**

The revised interior floorplan is designed to function as a single-family home with an ADU or “granny flat” located in the front left corner of the house. This unit will retain an independent entrance, utilizing the existing door visible in *Fig. 2*, above.

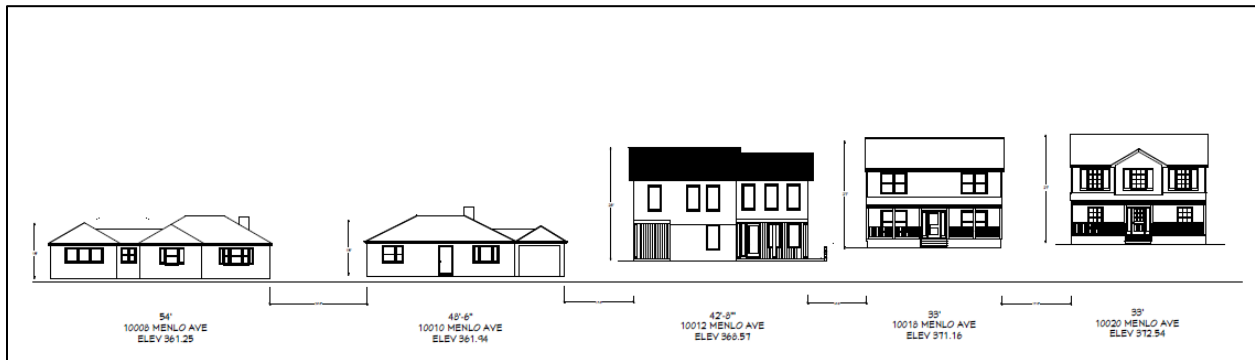
*Figure 3: Updated streetscape study.*

Staff concurs with the finding of the majority of the Commissioners at the October 9<sup>th</sup> Preliminary Consultation, finding the massing of the proposed house with its relatively simple form and two side gables is appropriate for the variety of architectural styles found throughout the Capitol View Historic District. At the Preliminary Consultation, the applicant presented a streetscape study with an inconsistent scale that did not accurately represent the distance between the houses along Menlo Ave. *Fig. 3*, below, shows the revised streetscape study showing the change in elevation and the distance between the houses. Staff finds that while the proposed taller house will have a visual impact on the one-story ranch house to the south, it will not overwhelm the size and scale of the houses on the block or the surrounding district and Staff recommends the HPC approve the revised house massing and design under 24A-8(b)(2) and (d) and *Standards 2, 9, and 10*.

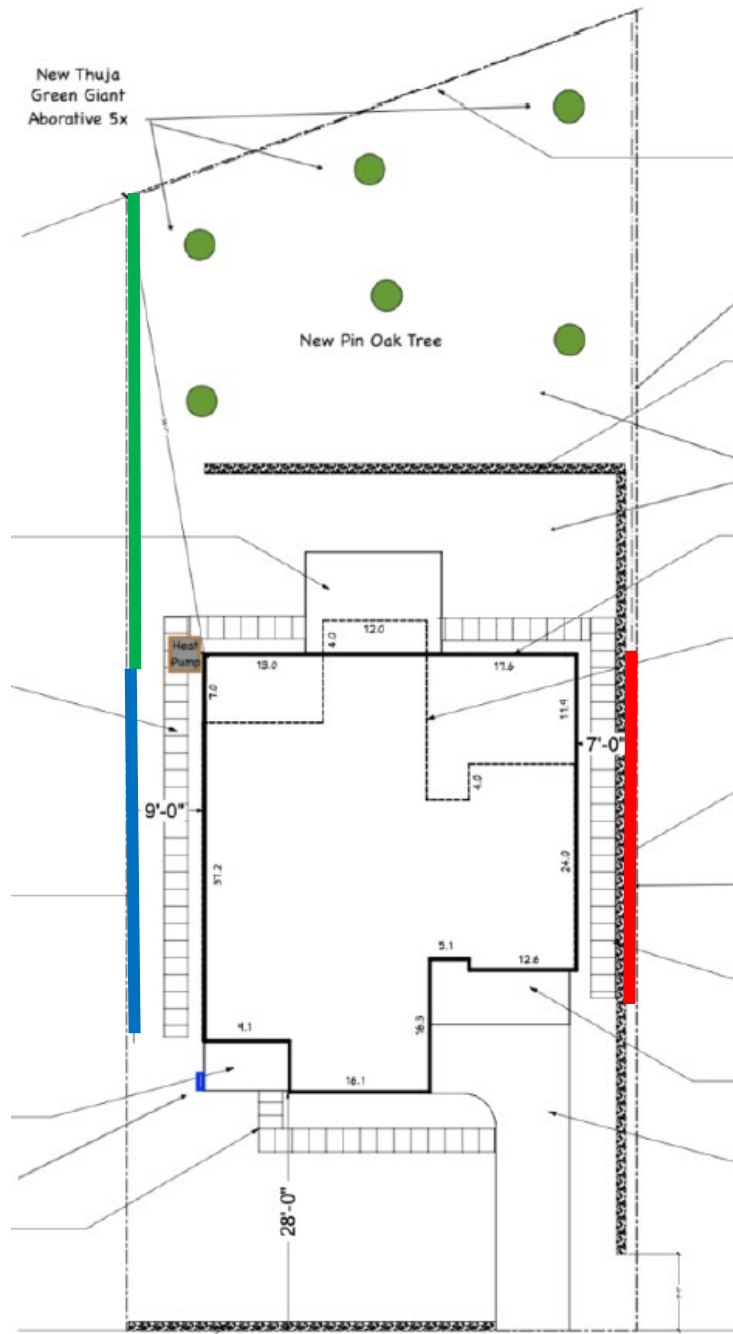
*Figure 4: Staff's recommended fence condition recommends no fence be installed in the area shown in red; restricts the fence to no taller than 48" with an open picket design shown in blue and allows for a 6' privacy fence in the area shown in green.*

Staff finds that revisions are warranted to the proposed fencing. On the right side of the house, the applicant proposes to install a 3' (three-foot tall) retaining wall, as discussed above. Immediately adjacent to that retaining wall, the applicant proposes to install a 4' (four-foot tall) wood picket fence. The combination of the retaining wall and the fence, even though it has an open picket design creates a 7' (seven-foot tall) wall up to the front wall plane of the house. Staff finds this will negatively impact the open character of the district and Staff recommends the HPC add a condition to the approval of this HAWP that eliminates the proposed picket fence forward of the house's rear wall plane. This would still allow for a 3' (three-foot tall) barrier between the subject property and its neighbor to the north. Further, the applicant proposed to install a 6' (six-foot-tall) privacy fence along the south property line. The HPC's typical condition for fences in the Capitol View Park Historic District is that they are limited to no taller than 48" (forty-eight inches tall) and have an open picket design. This height and design restriction

helps to reinforce the sense of openness that is characteristic of the district. Staff recommends the HPC add a condition to the approval of this HAWP that any fence forward of the rear wall plane on the south property line be limited to 48" (forty-eight inches tall) and has an open picket design. The fence to the rear of the rear wall plane may be 6' (six feet tall) with a solid appearance. With the identified conditions, Staff recommends the HPC approve the proposed fences under 24A-8(b)(2) and (d) and *Standard 2*.

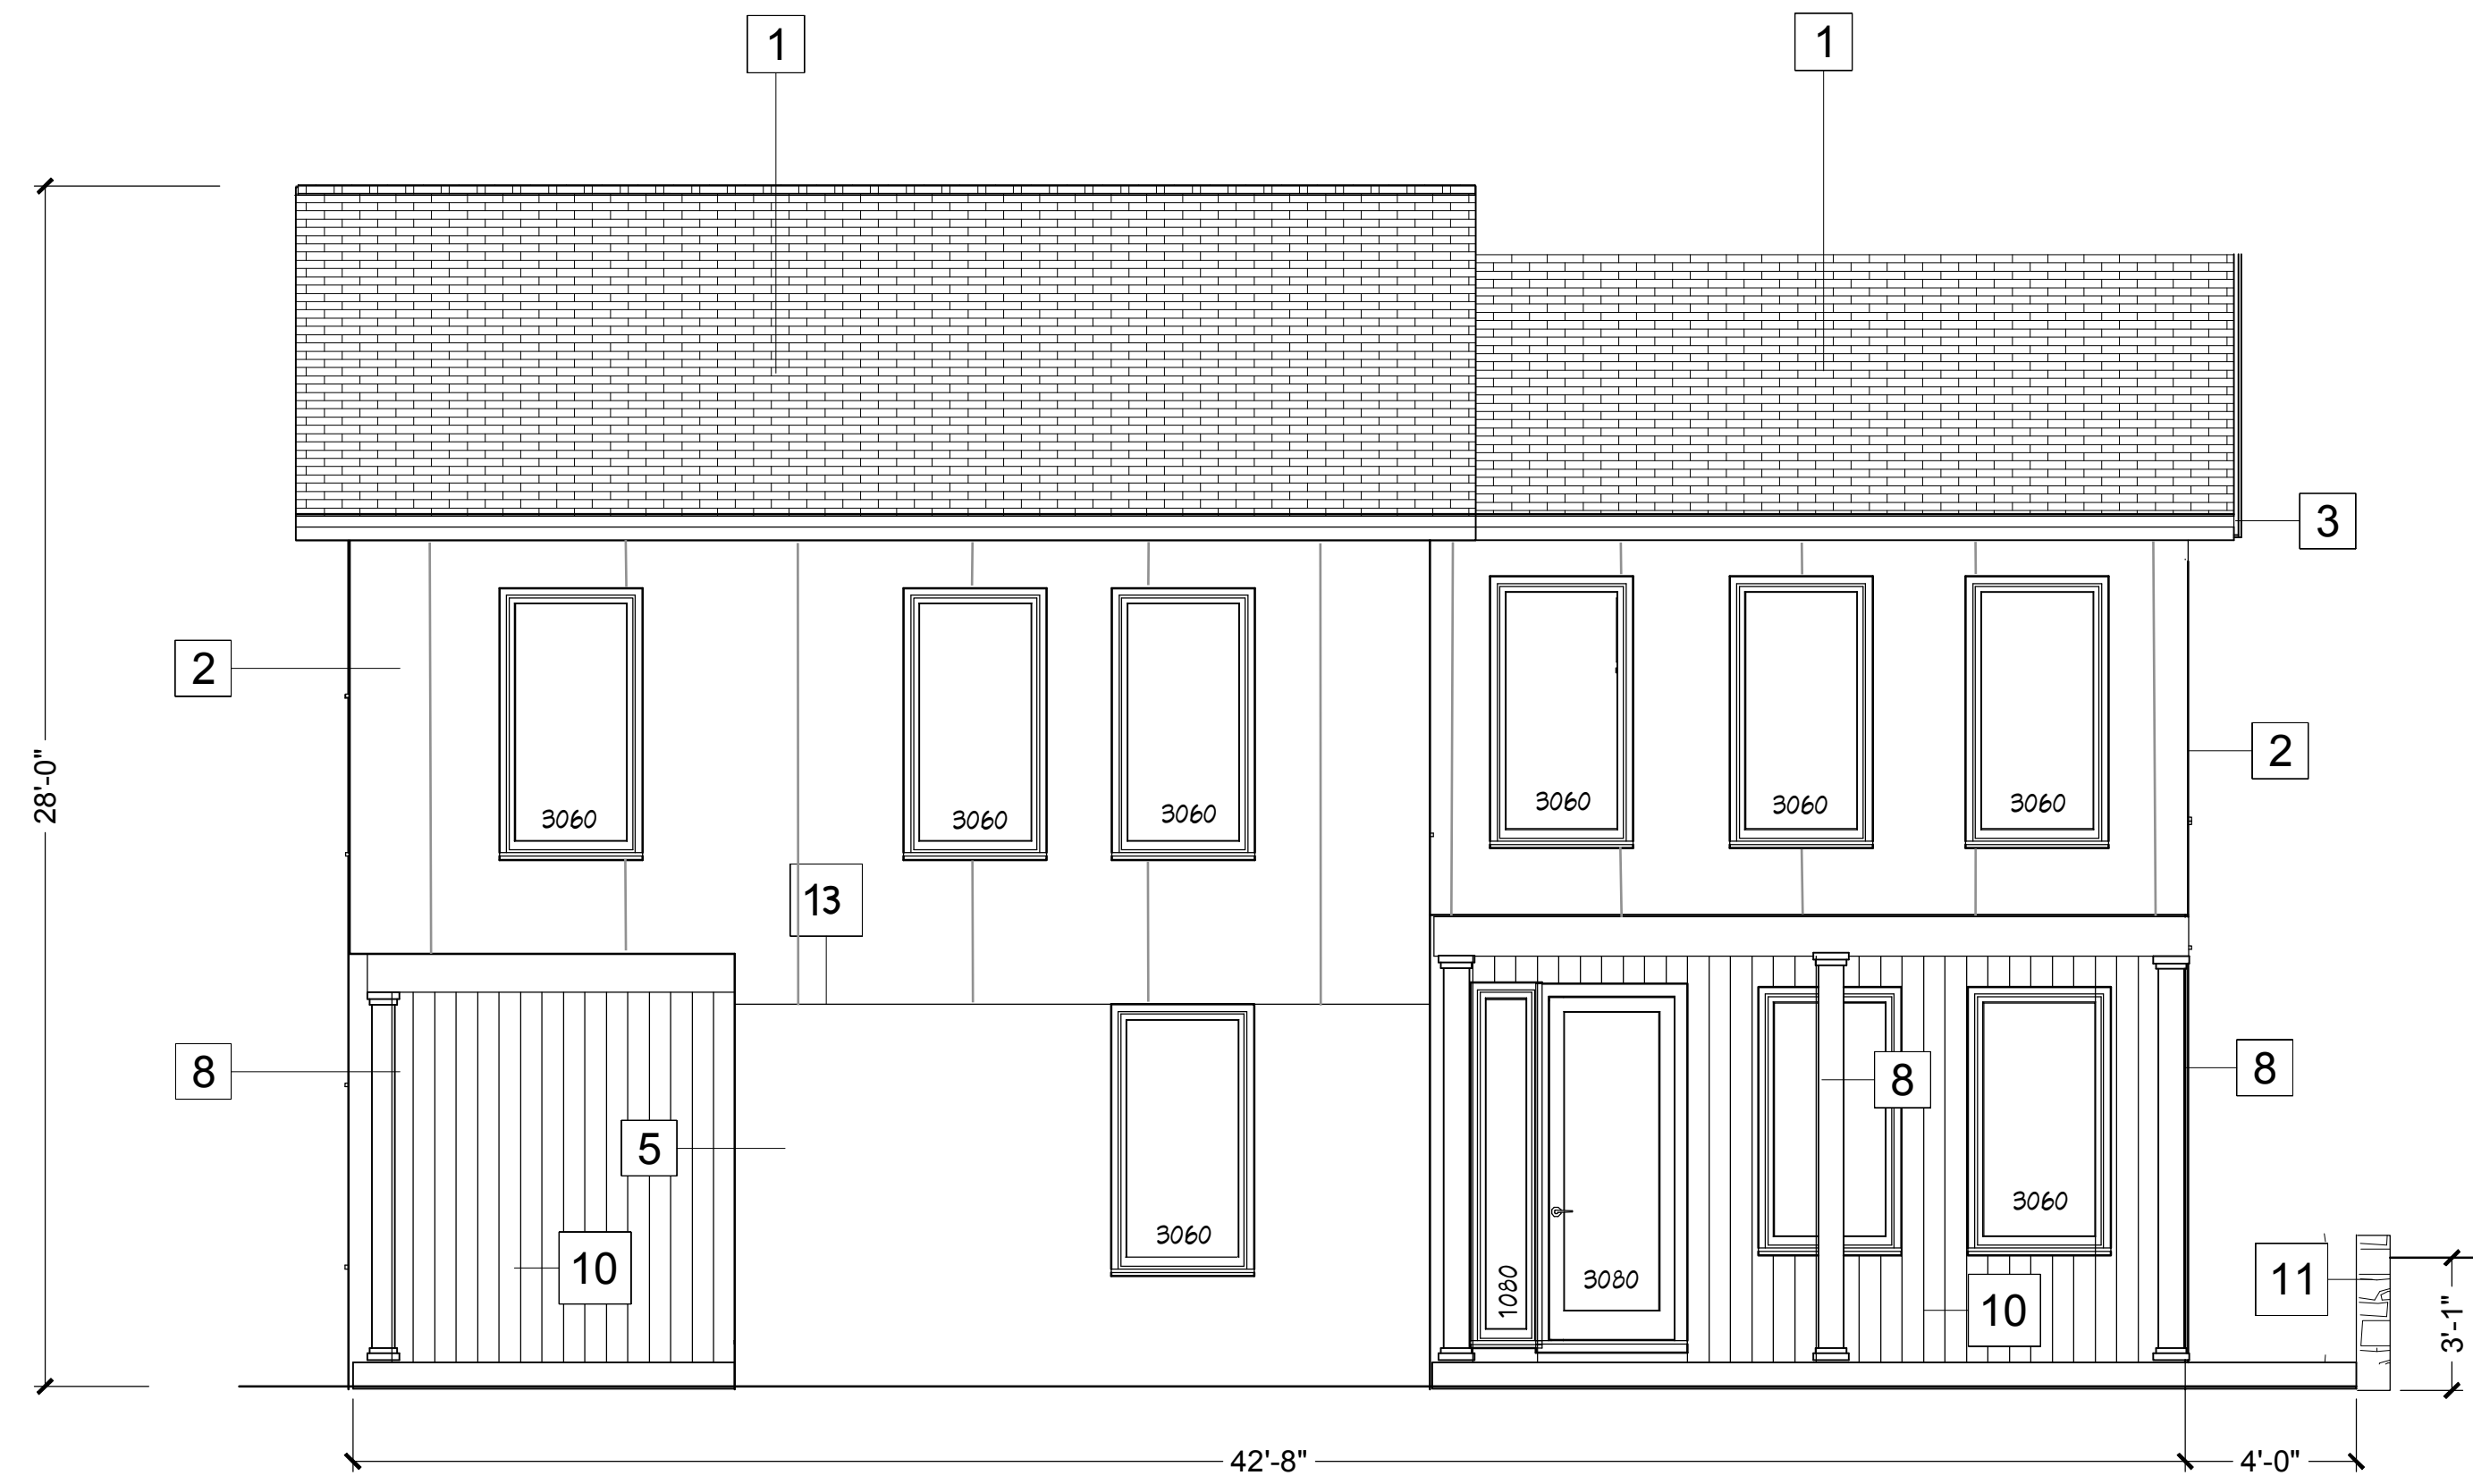
**FRONT ELEVATION**

- 1 - FIBERGLASS SHINGLES ARCHITECTURAL
  - 2 - HARDI PANEL SIDING - WHITE
  - 3 - ALUM GUTTER ON 1x6 FASCIA
  - 5 - EXIST STUCCO VENEER TO BE PAINTED WHITE
  - 6 - 1x6 RAKE
  - 7 - PVC RAILING - BLACK METAL PICKETS
  - 8 - 8x8 WD POST - BLACK
  - 10 - CEDAR 1x6 KILN-DRIED V-JOINT
  - 11 - STONE RETAINING WALL
  - 12 - CONC FOUNDATION
  - 13 - TAMLYN HORIZ Z TRIM - Profile 1/2"
  - 14 - TAMLYN HORIZ BEAD REVEAL - Profile 1/8"
- WINDOWS TO BE ANDERSEN 400 OR EQUAL

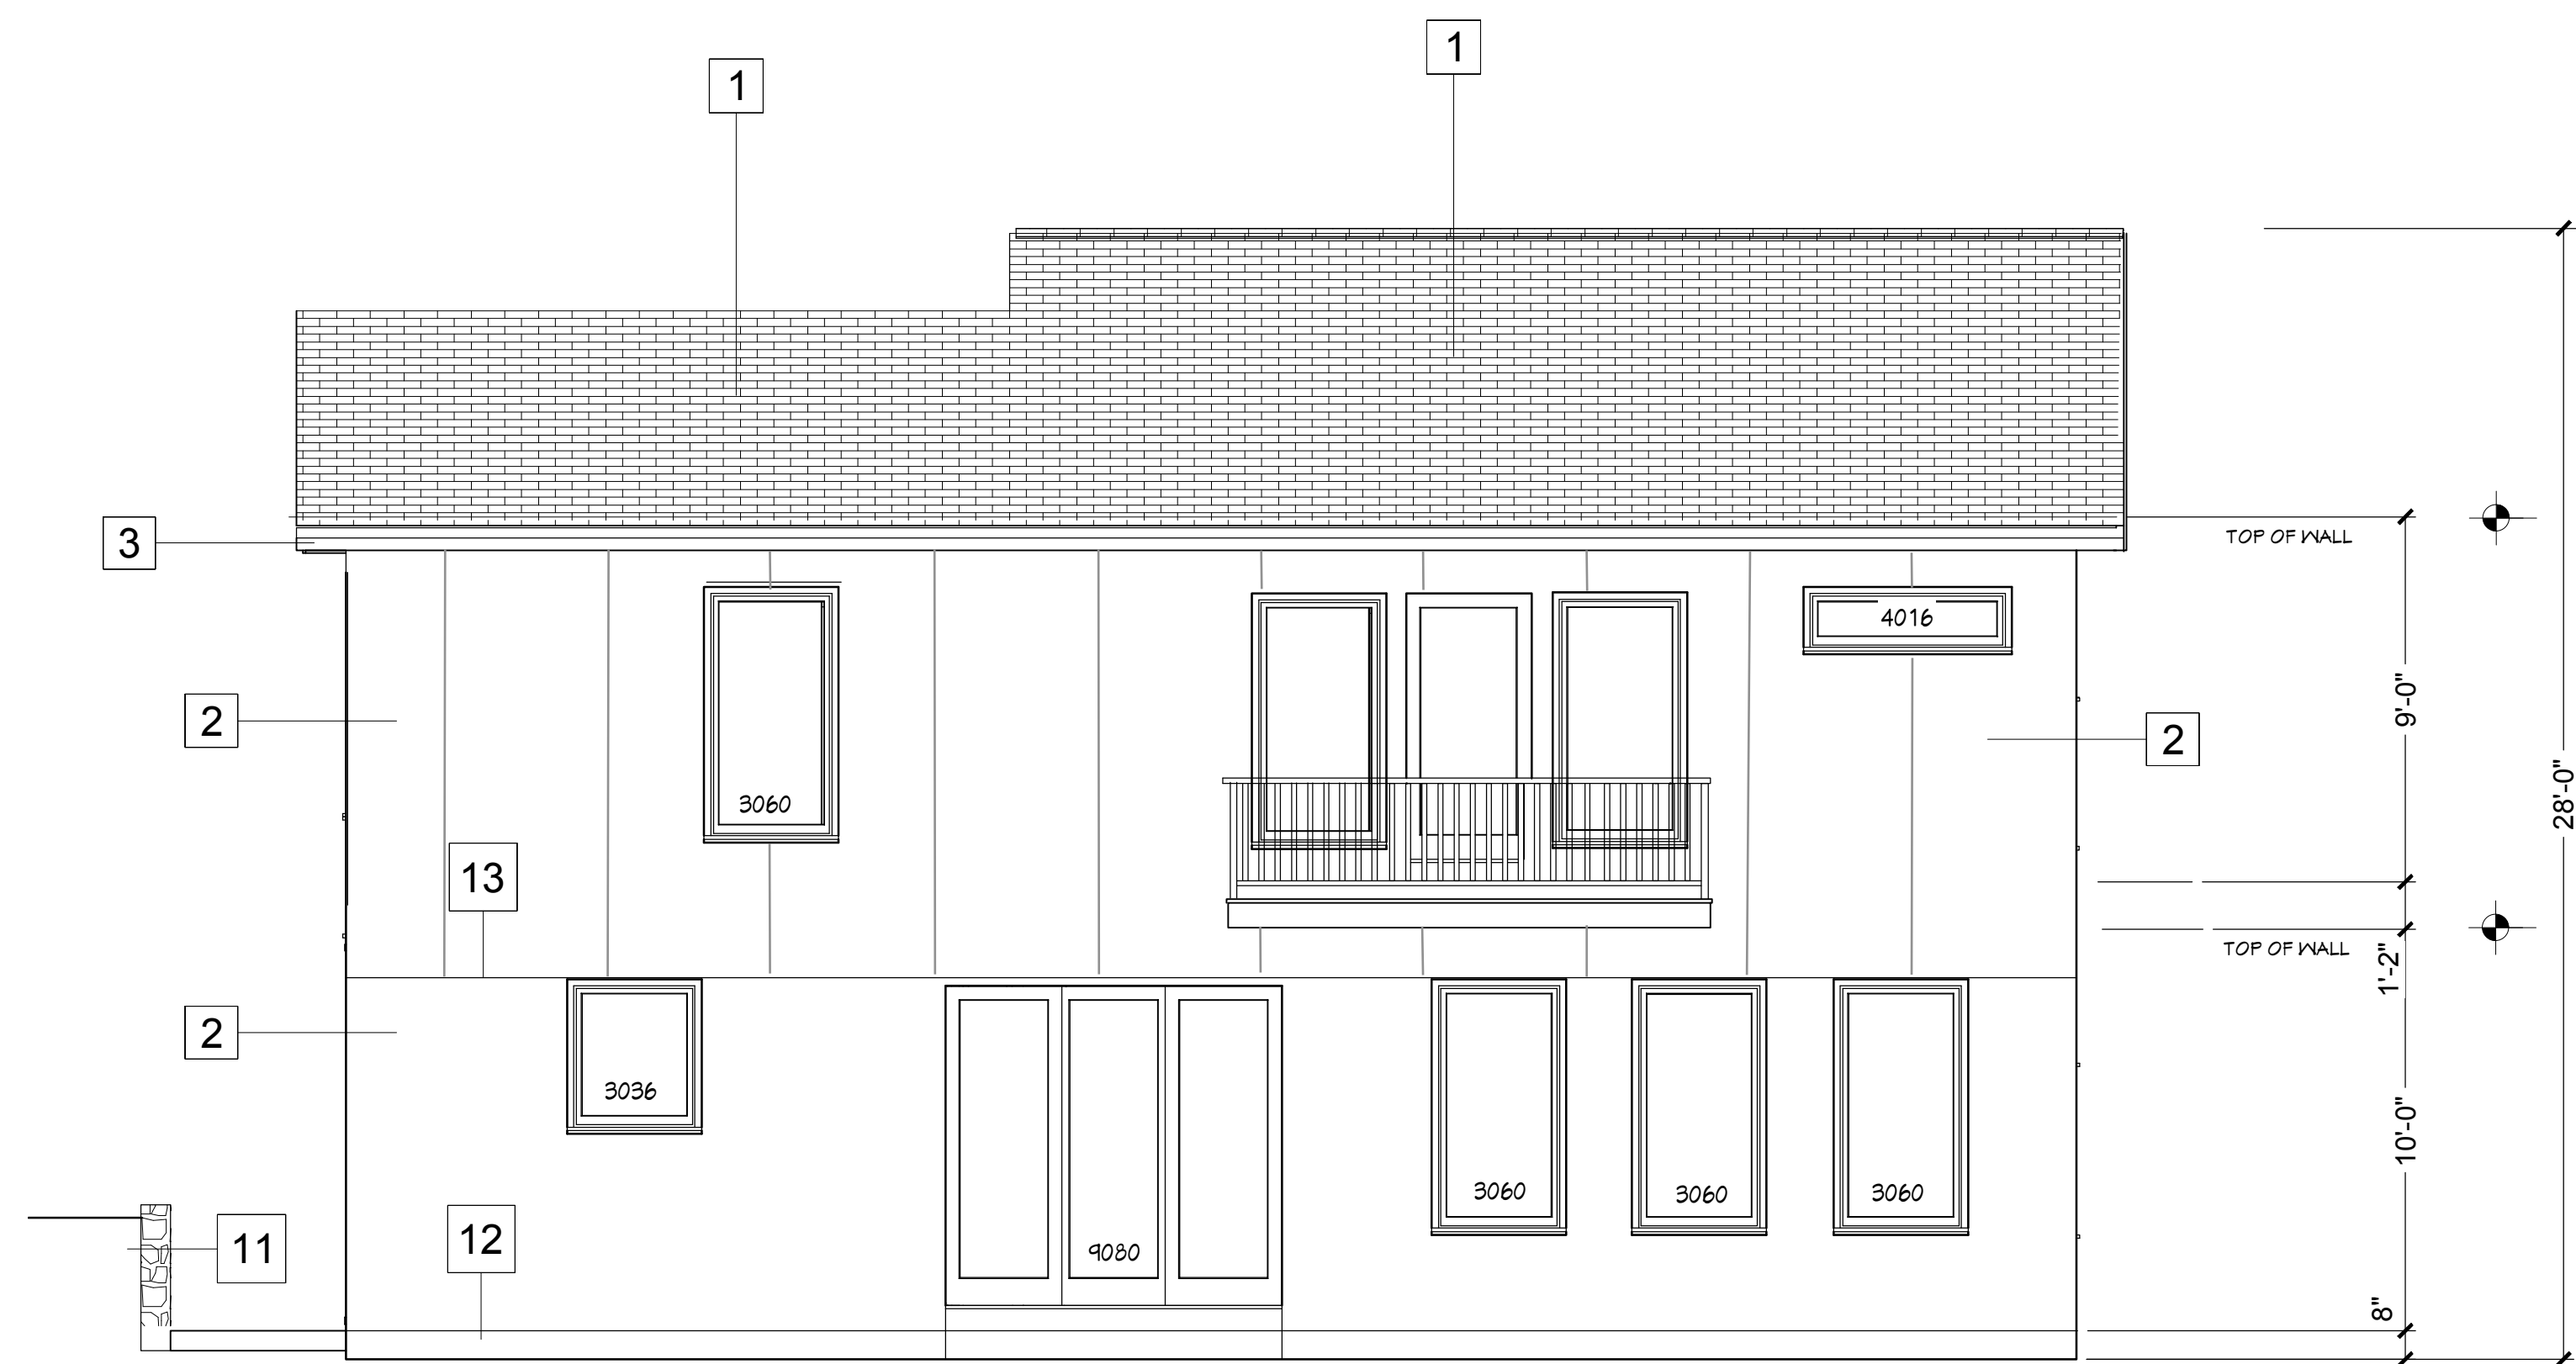
**REAR ELEVATION**

- 1 - FIBERGLASS SHINGLES ARCHITECTURAL
  - 2 - HARDI PANEL SIDING - WHITE
  - 3 - ALUM GUTTER ON 1x6 FASCIA
  - 5 - EXIST STUCCO VENEER TO BE PAINTED WHITE
  - 6 - 1x6 RAKE
  - 7 - PVC RAILING - BLACK METAL PICKETS
  - 8 - 8x8 WD POST - BLACK
  - 10 - CEDAR 1x6 KILN-DRIED V- JOINT
  - 11 - STONE RETAINING WALL
  - 12 - CONC FOUNDATION
  - 13 - TAMLYN HORIZ Z TRIM
  - 14 - TAMLYN HORIZ BEAD REVEAL
- WINDOWS TO BE ANDERSEN 400 OR EQUAL

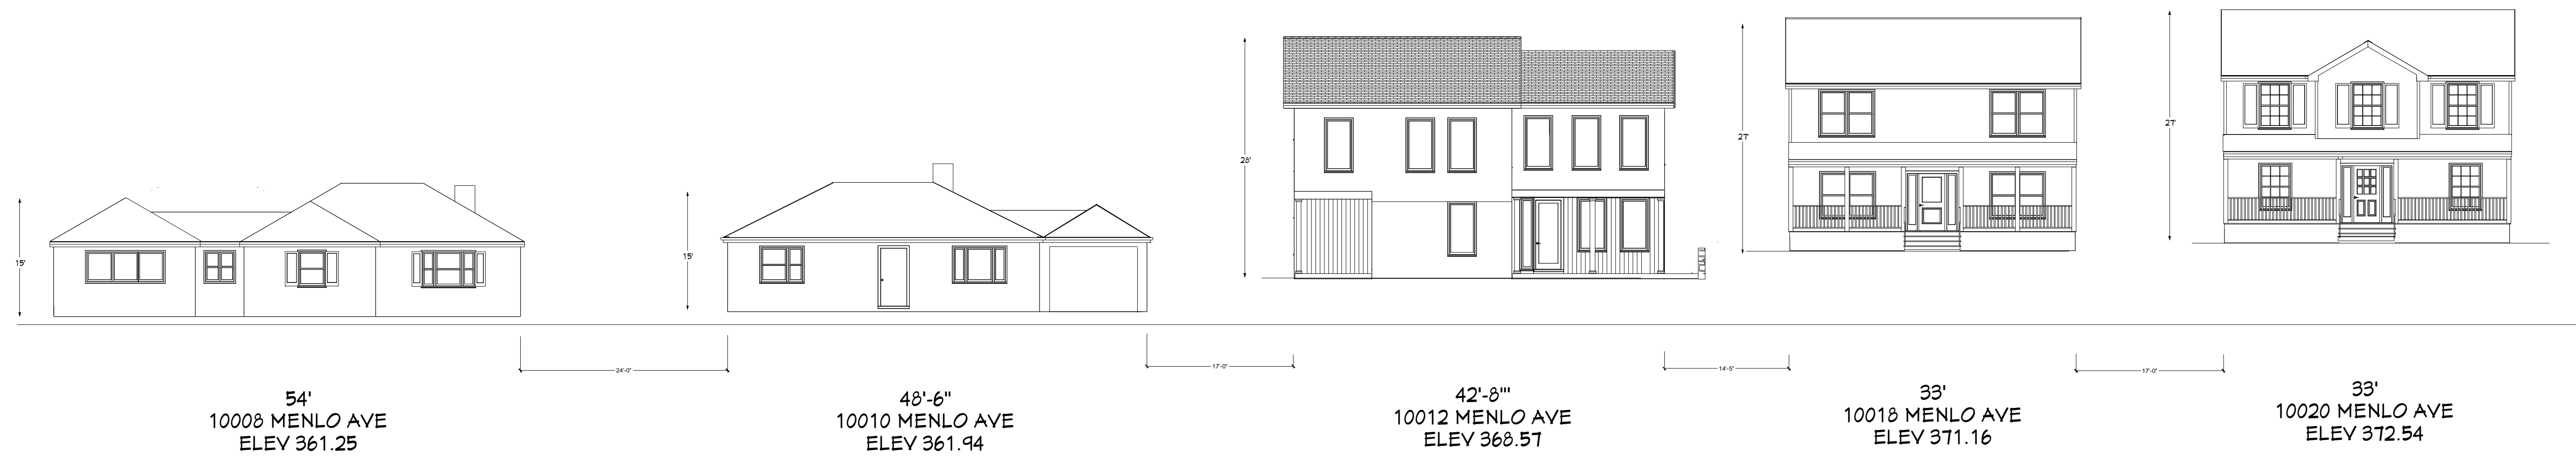
**STREETSCAPE STUDY ALONG MENLO AVE**

**SCALE 1" = 10 ft**

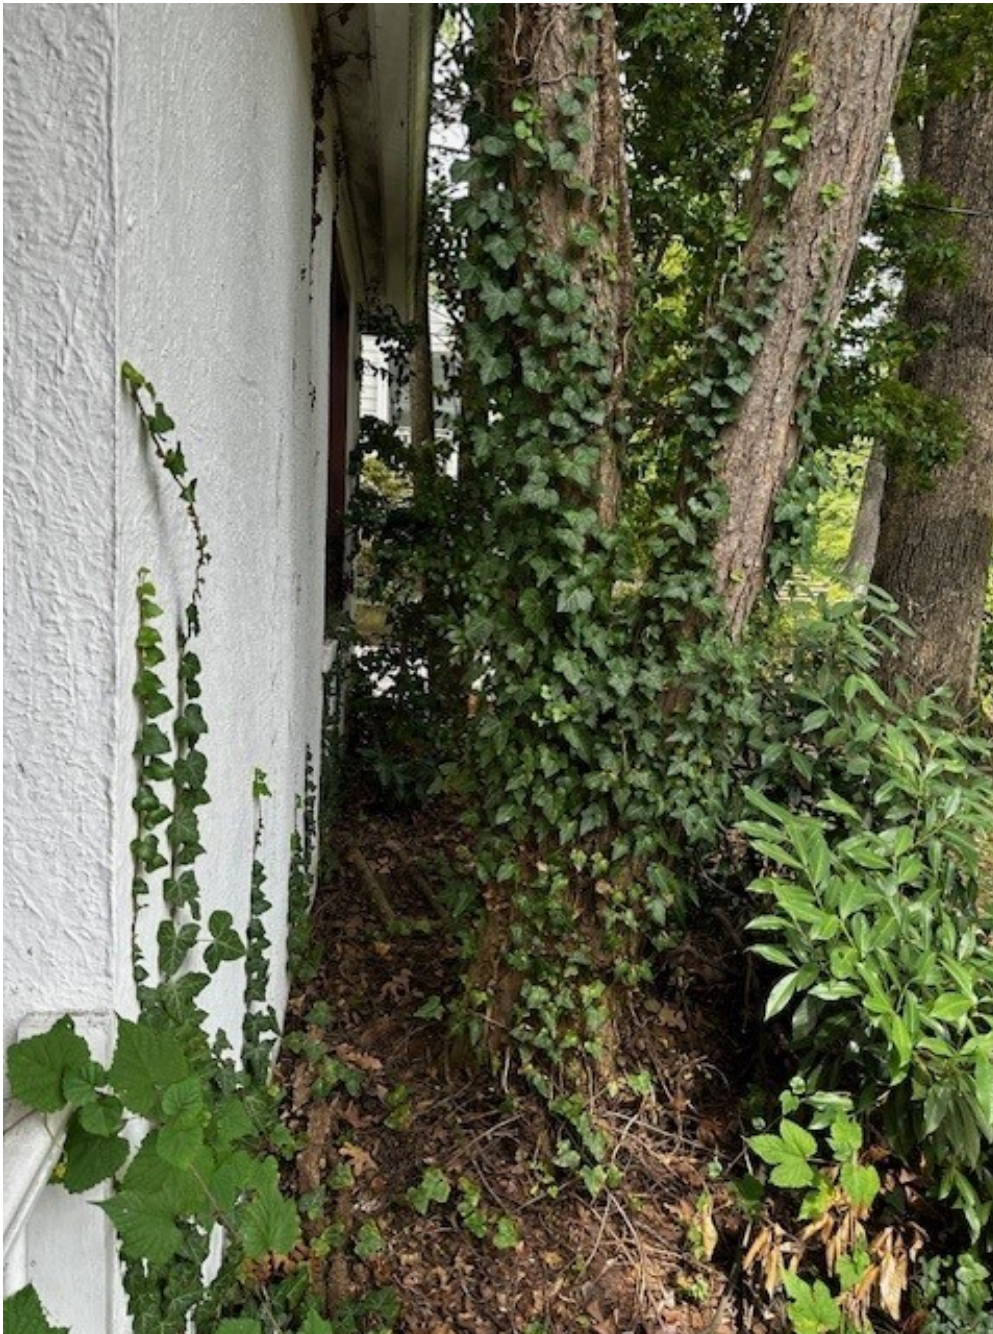
Two mature Hemlocks 18" from the foundation. Too close to the foundation.

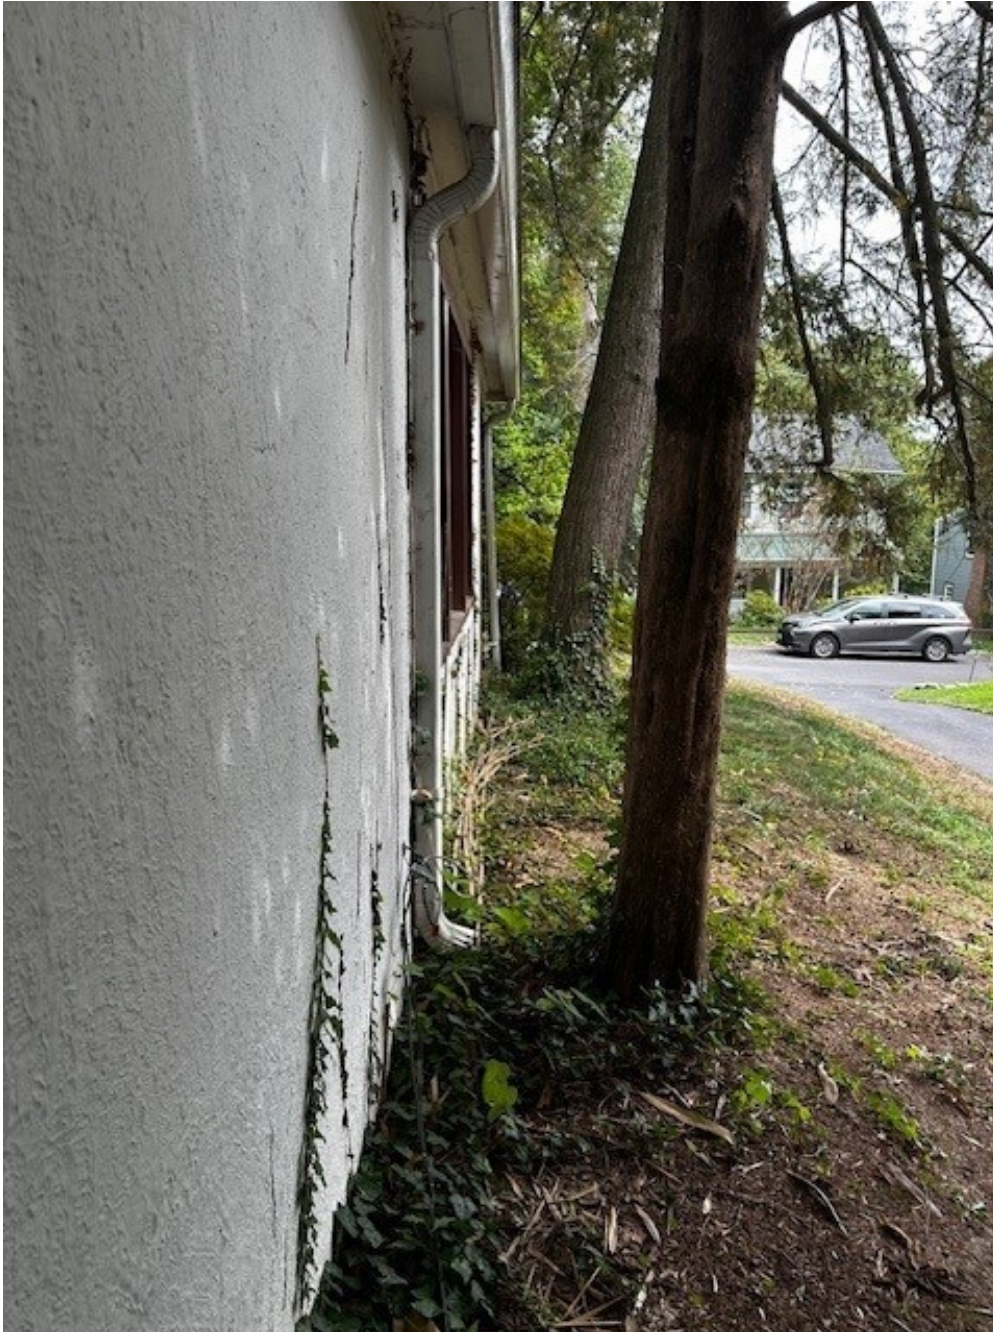
Massive Hemlock 12 inches from the foundation and Cedar 24 inches from foundation.

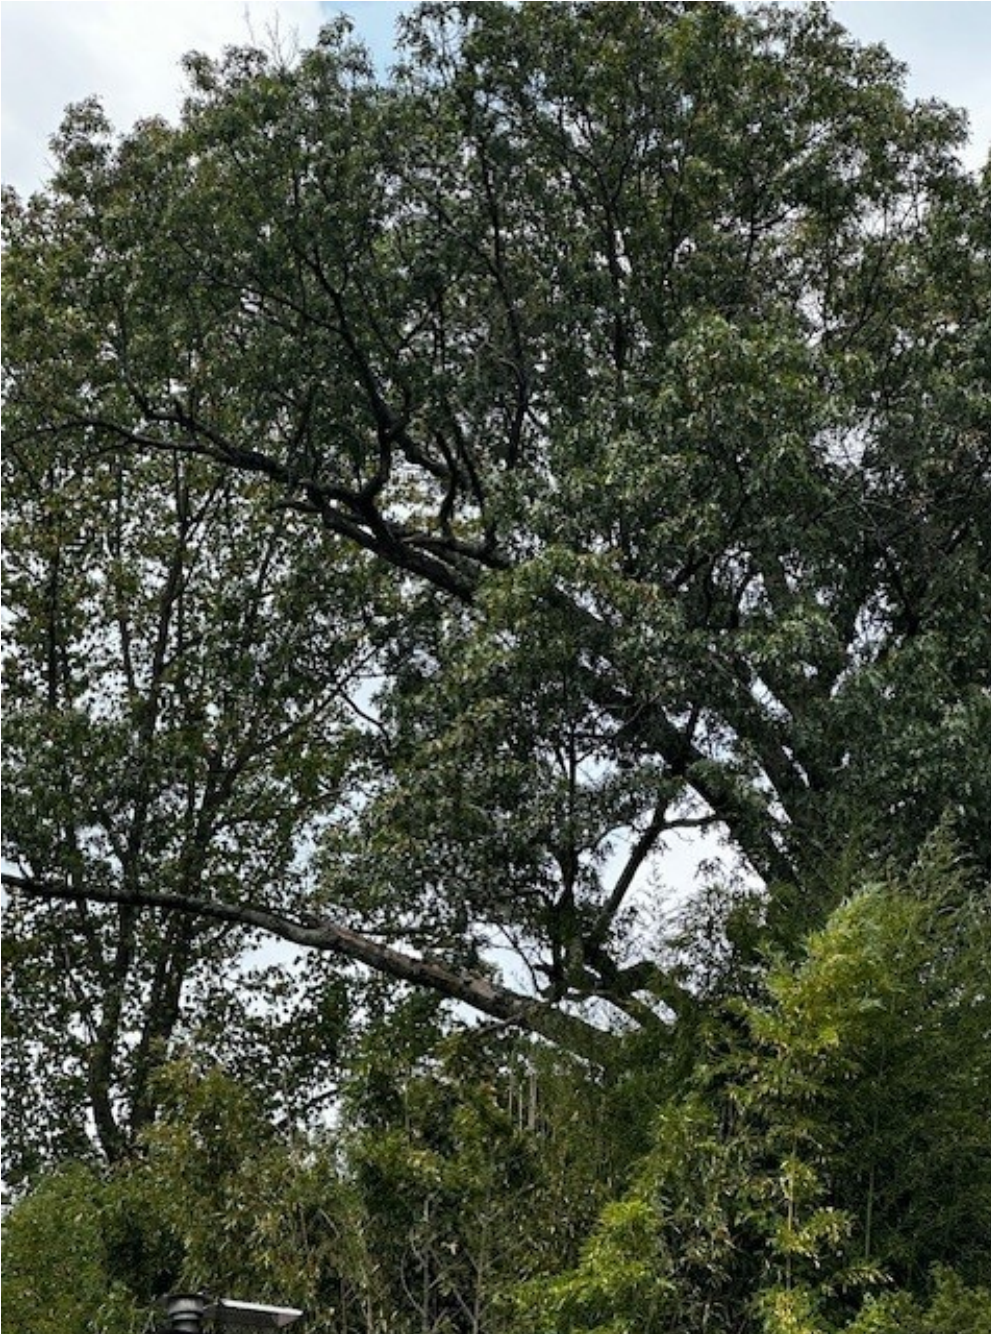
Red Oak rear leaning away from the house all weight is unbalanced over the rear of the property.

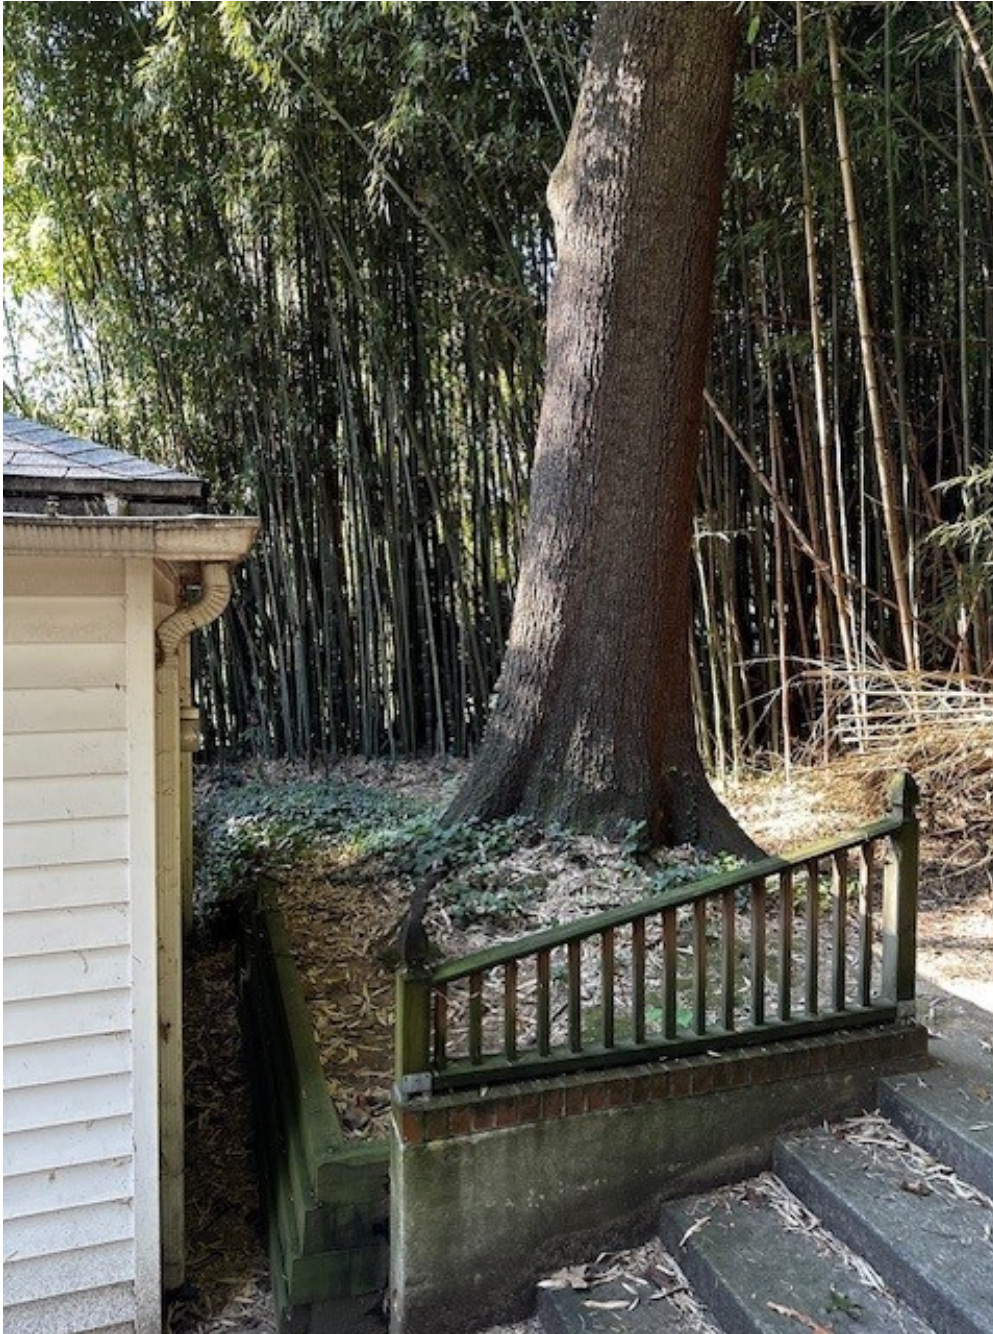
Red Oak rear 17" from the timber wall 39" from the house.

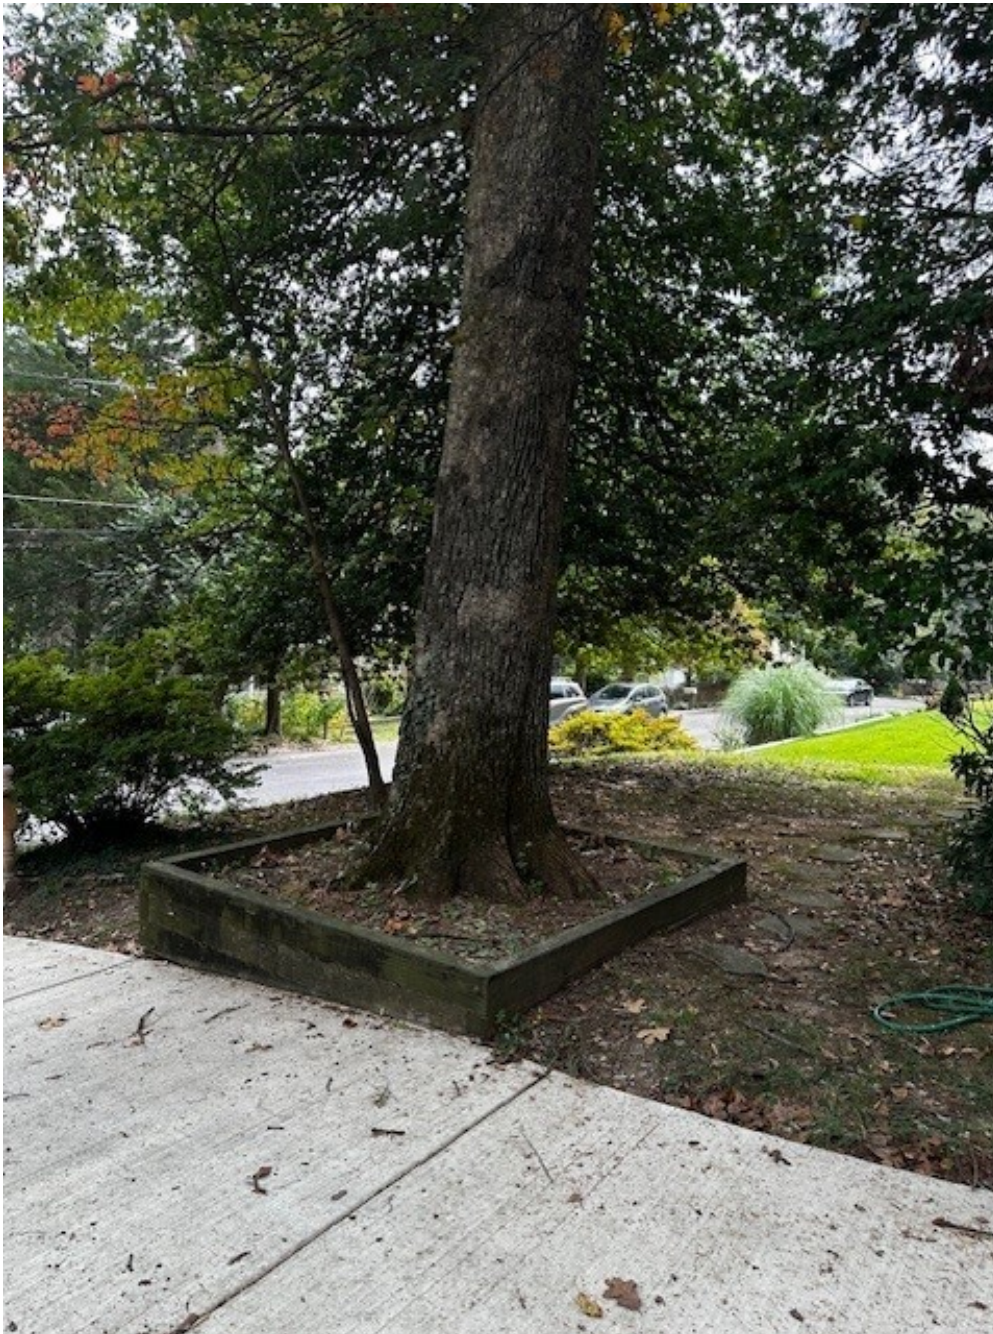
White Oak if front 24 inches from the driveway

the retaining wall partially supporting its roots is decaying. The sixth tree is a 29" (twenty-nine inch) White Oak in a planter in front of the house. The evaluation identifies the weight of the existing driveway in the critical root zone and the grade of the planter as threats to the long-term health of the tree and indicates there is a 'moderate to high risk of failure.' The applicant proposes to plant one Pin Oak and five Thuja Greet Giant Arborvitae in the rear yard to mitigate the loss of the trees and to satisfy the requirements of the Montgomery County Tree Canopy Law. The Tree Canopy Law requires replanting a shade tree (defined as a tree capable of growing to heights greater than 50 feet) for each tree removed when a sediment control permit is required.

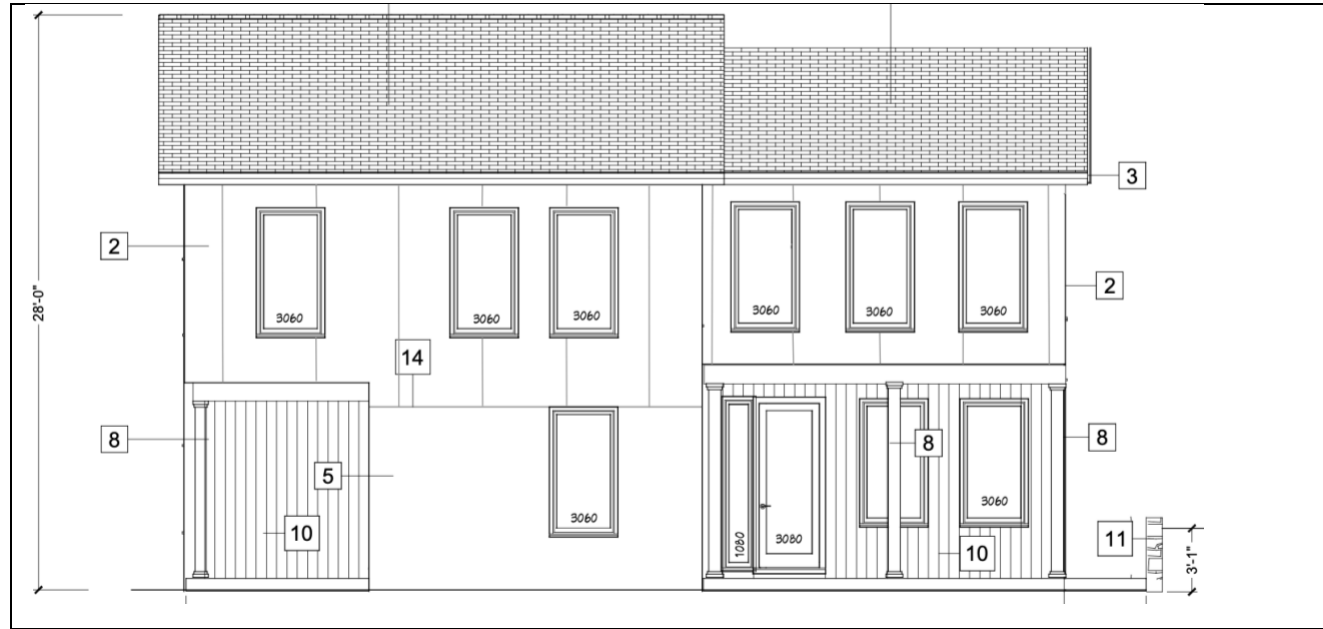
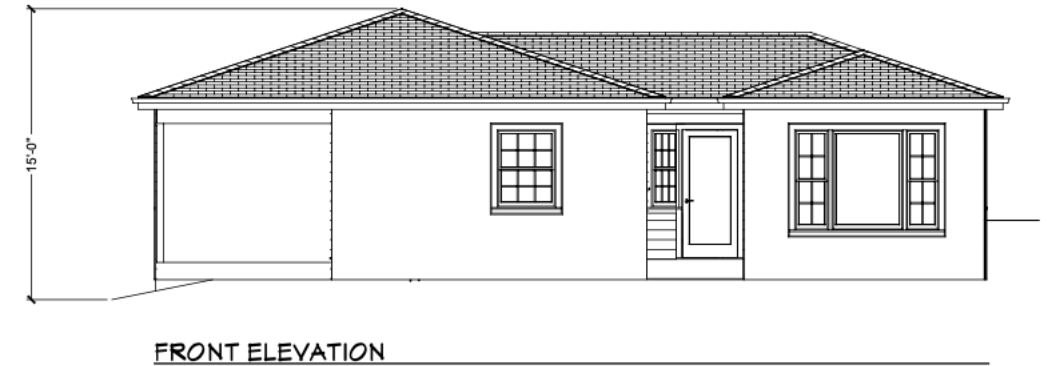
Window openings will be modified to accommodate the new windows. Cedar siding and trim will be installed around the windows on the right-side porch. Window opening on the left side will be expanded, and stucco repair will be completed. No trim to be installed around window. New Windowsill is a 5/8' thick engineered stone (see material specification sheet)

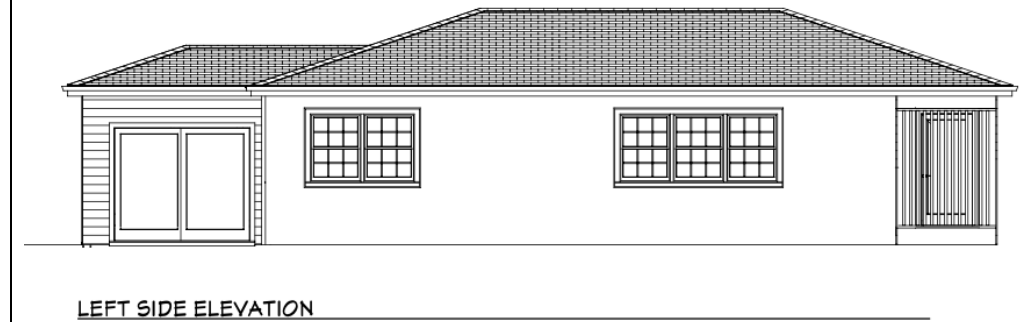
Window openings will be modified to accommodate the new windows. Closed openings to be filled with in kind materials (blocks and stucco). New Windowsills are engineered stone (see material specification sheet).

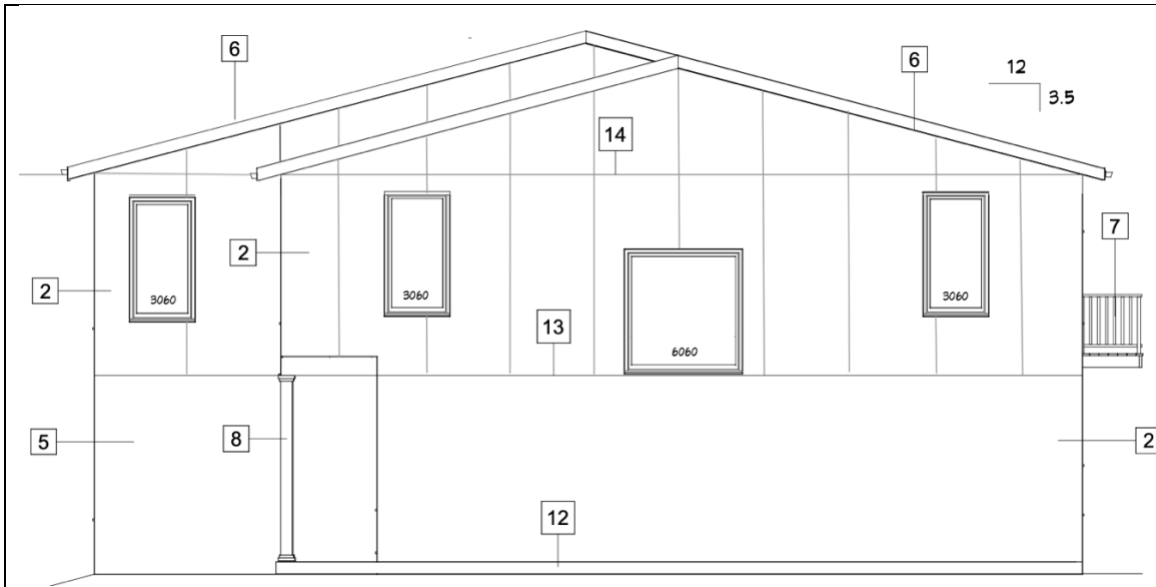
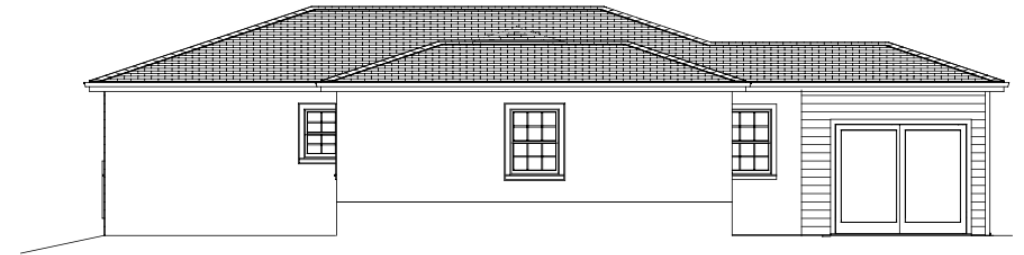
RIGHT SIDE ELEVATION

The two windows on the left side will be removed, and openings will be closed with in kind materials (cinder Blocks and stucco). Back wall with window and sliding patio door will be demolished.

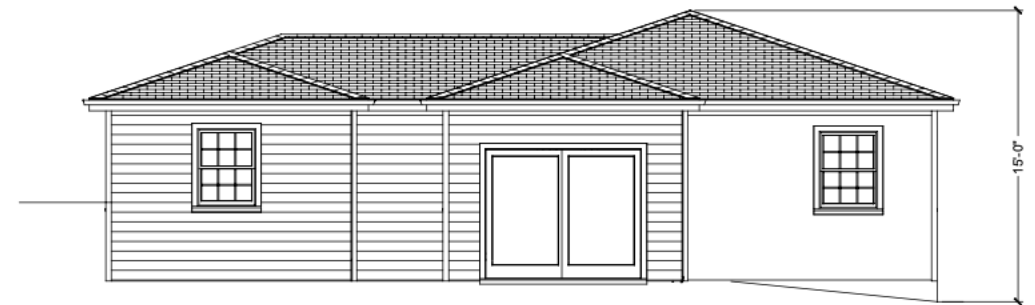
REAR ELEVATION

Rear addition and wall will be demolished to allow for the rear addition.
