**MONTGOMERY COUNTY HISTORIC PRESERVATION COMMISSION**  
**STAFF REPORT**

| <b>Address:</b> | 10012 Menlo Ave., Silver Spring | <b>Meeting Date:</b> | 12/4/2024 |
| <b>Proposal:</b> | Partial Demolition, Two Story Addition, Hardscape Alteration, and Tree Removal | | |

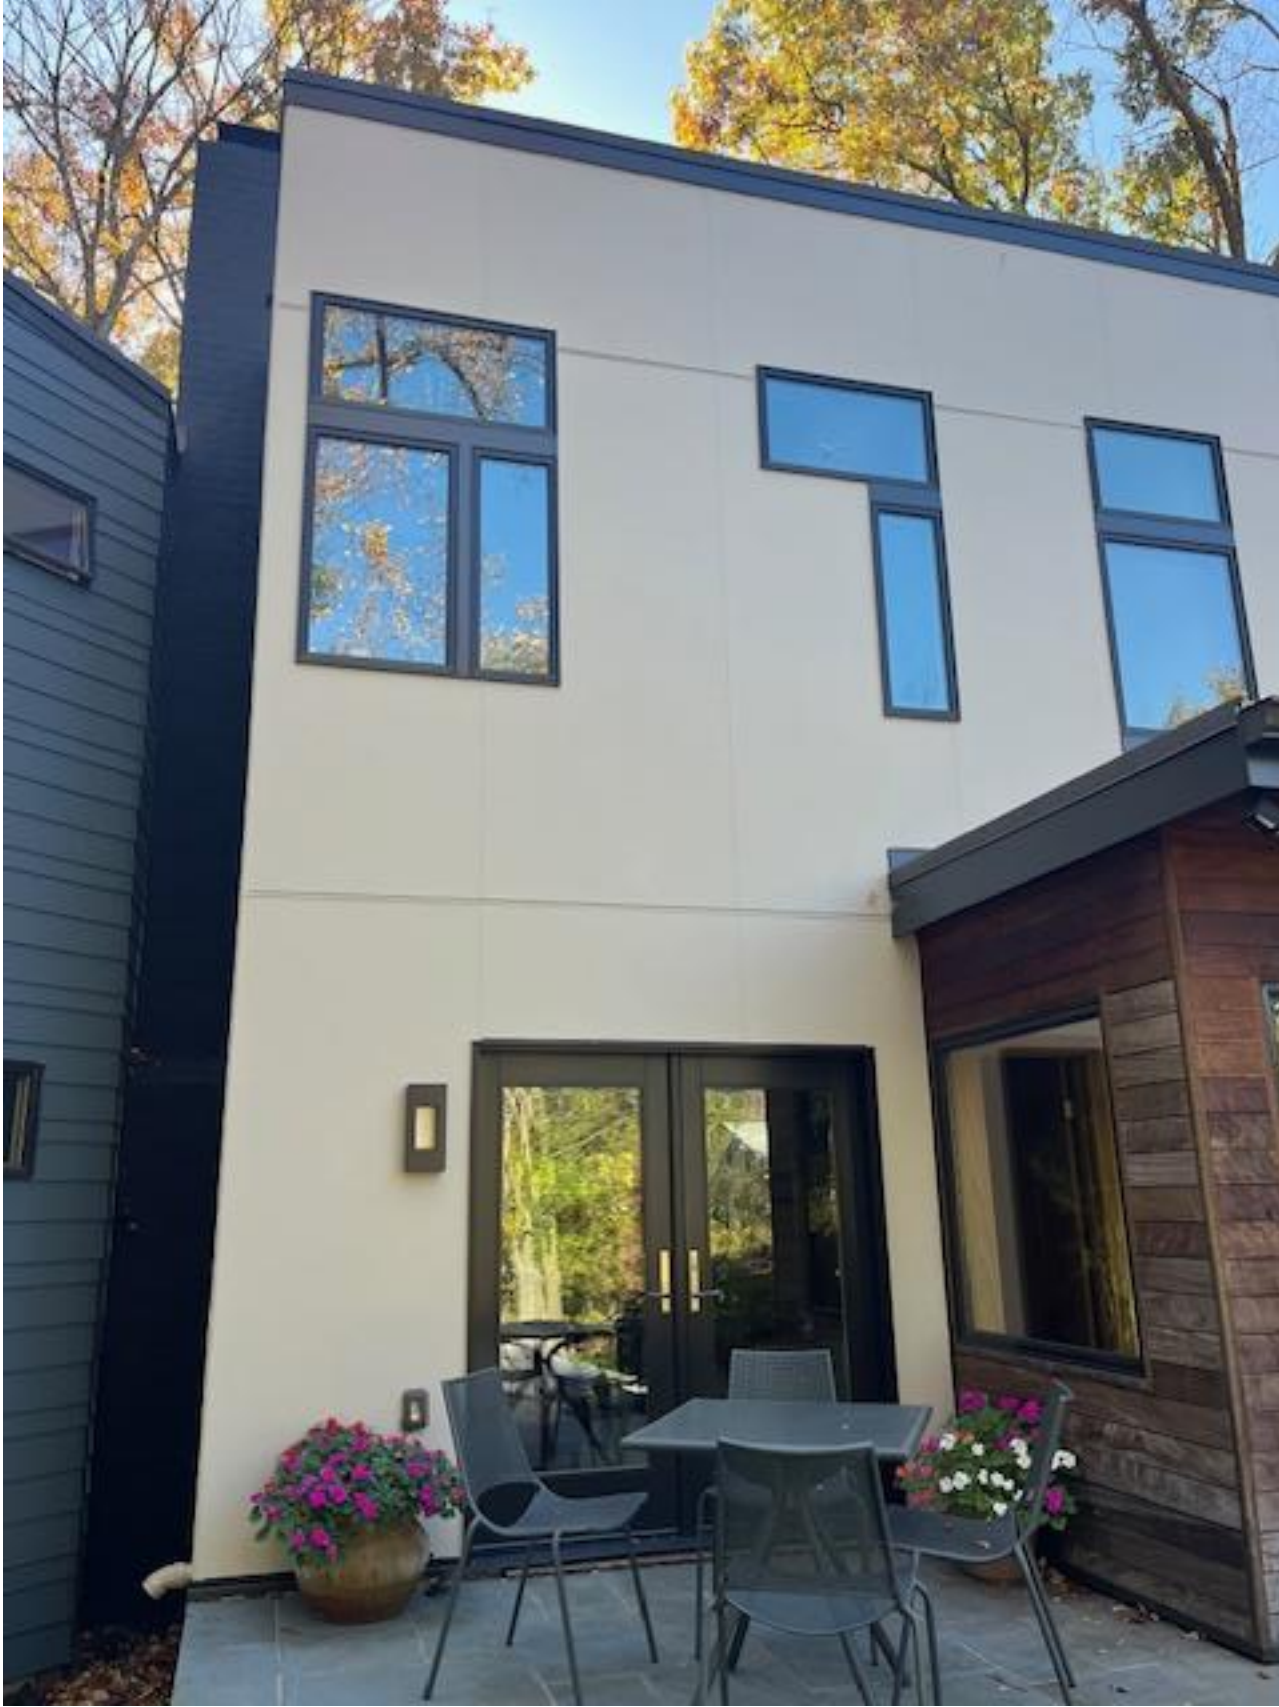
Caulked vertical joints between panels show a nearly seamless surface. Example from Garrett Park house.

The proposed second floor has an architectural side gable roof with Hardie panel siding, single-light aluminum-clad windows and doors, and wood columns. The vertical joints of the fiber cement panels will be caulked to create a nearly seamless installation, while the horizontal joints will be visible due to the flashing trim piece that will prevent water infiltration.

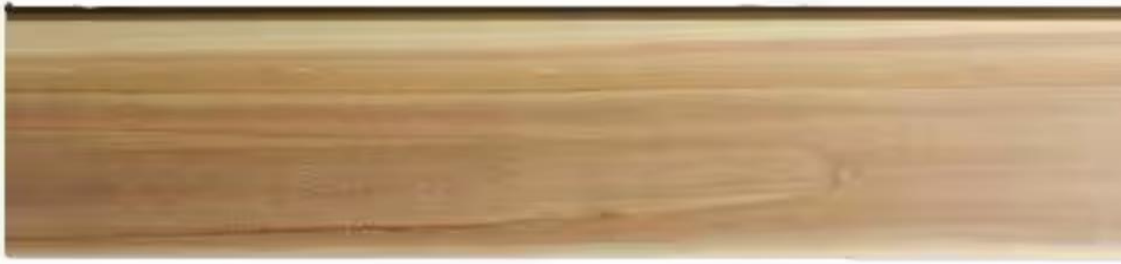
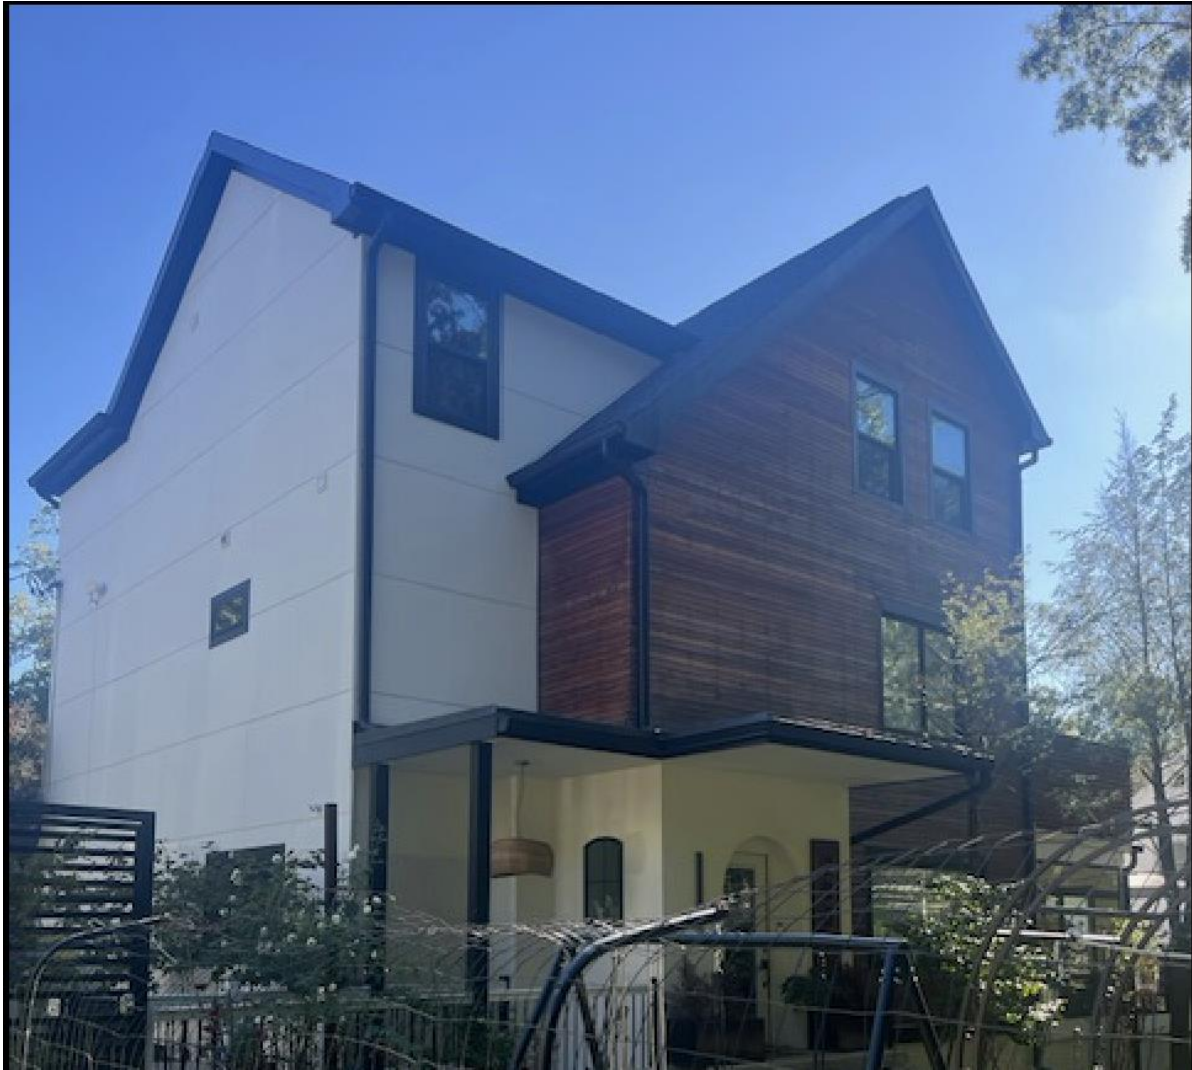
1 in. x 6 in. x 8 ft. Kiln-Dried Cedar V-Joint Board

On the back wall and ceilings of the front porches.

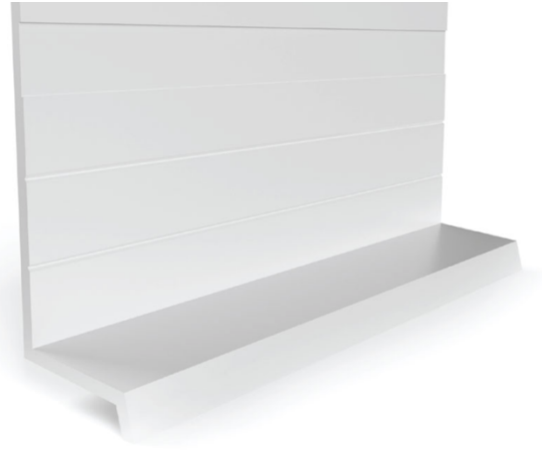
Tamlyn  
Horizontal Bead  
Reveal

Installed horizontally between panels. No. 14 on the elevations

**Notes: MA E AL** Extruded aluminum alloy with proprietary coating that protects against harsh weather conditions and allows for paint adhesion.

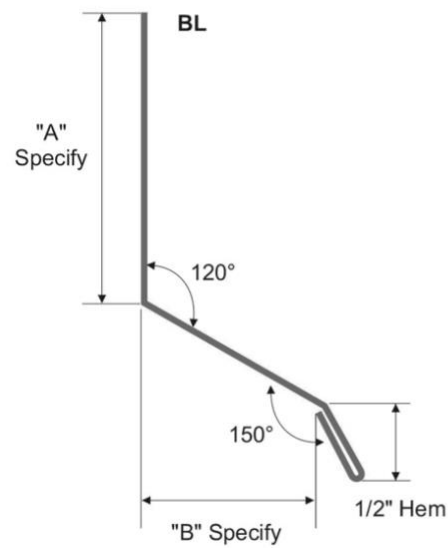
## LEDGER FLASHING

PRODUCT: Stone Ledger Flashing

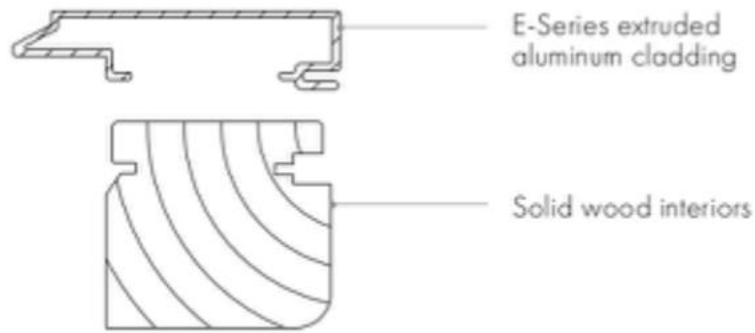
## Fascia

1x6 Pine Trim fascia Board covered with aluminum fascia

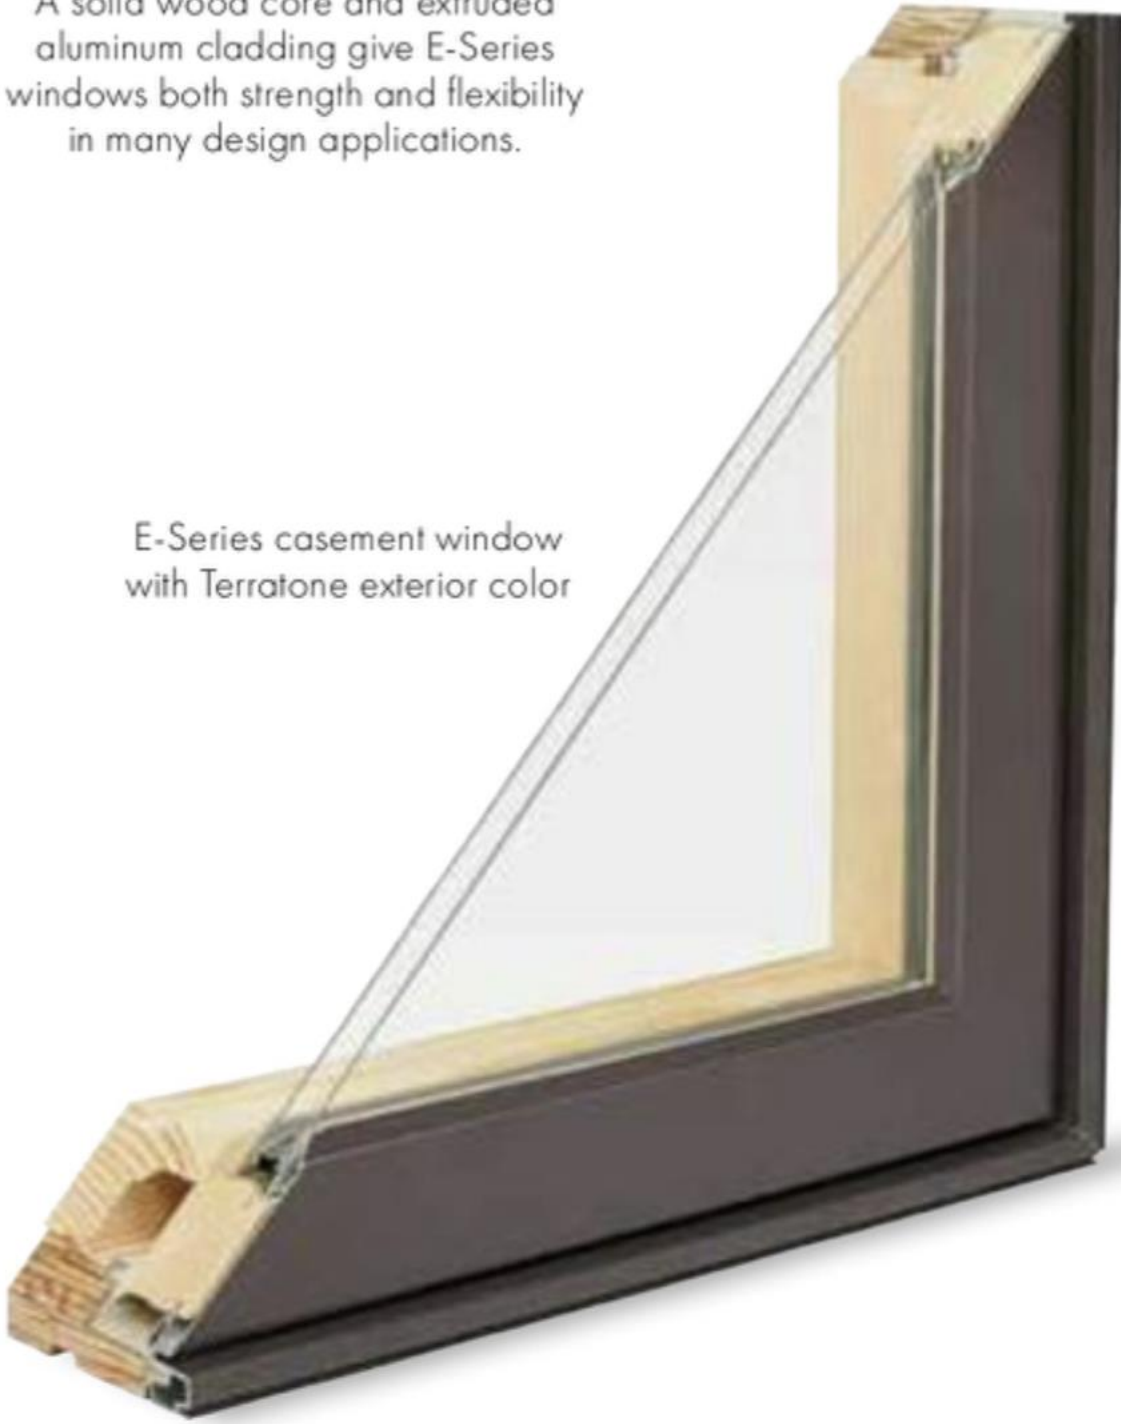
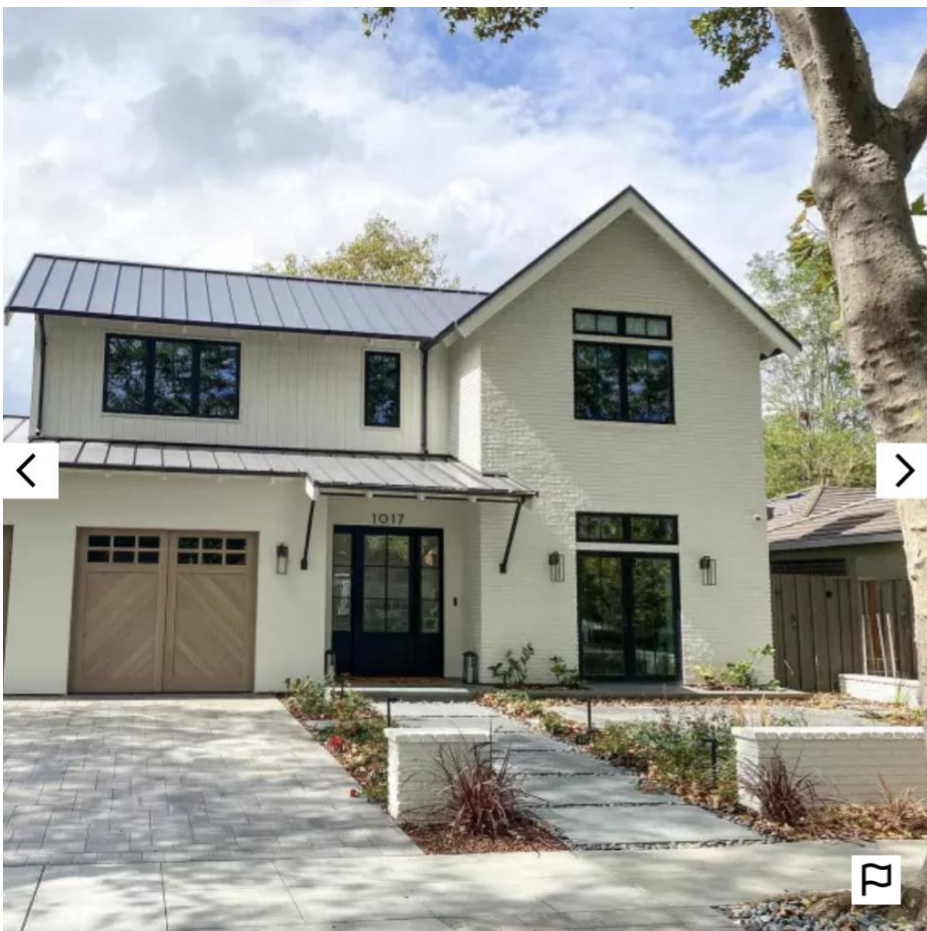
E-Series casement window with Terratone exterior color

A solid wood core and extruded aluminum cladding give E-Series windows both strength and flexibility in many design applications.

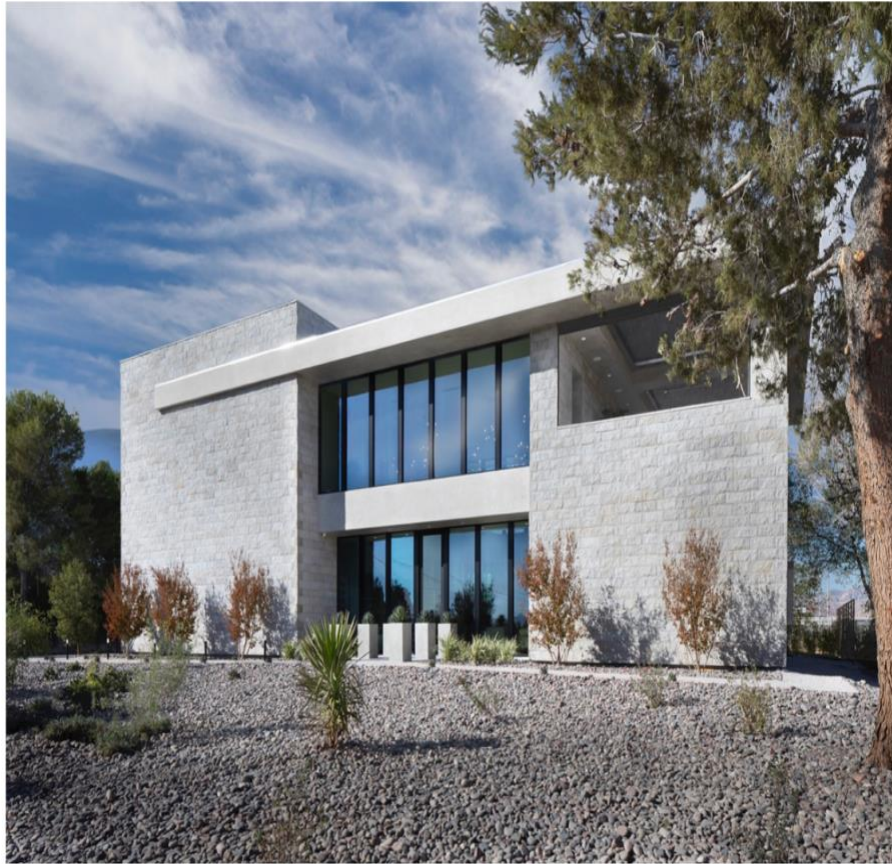
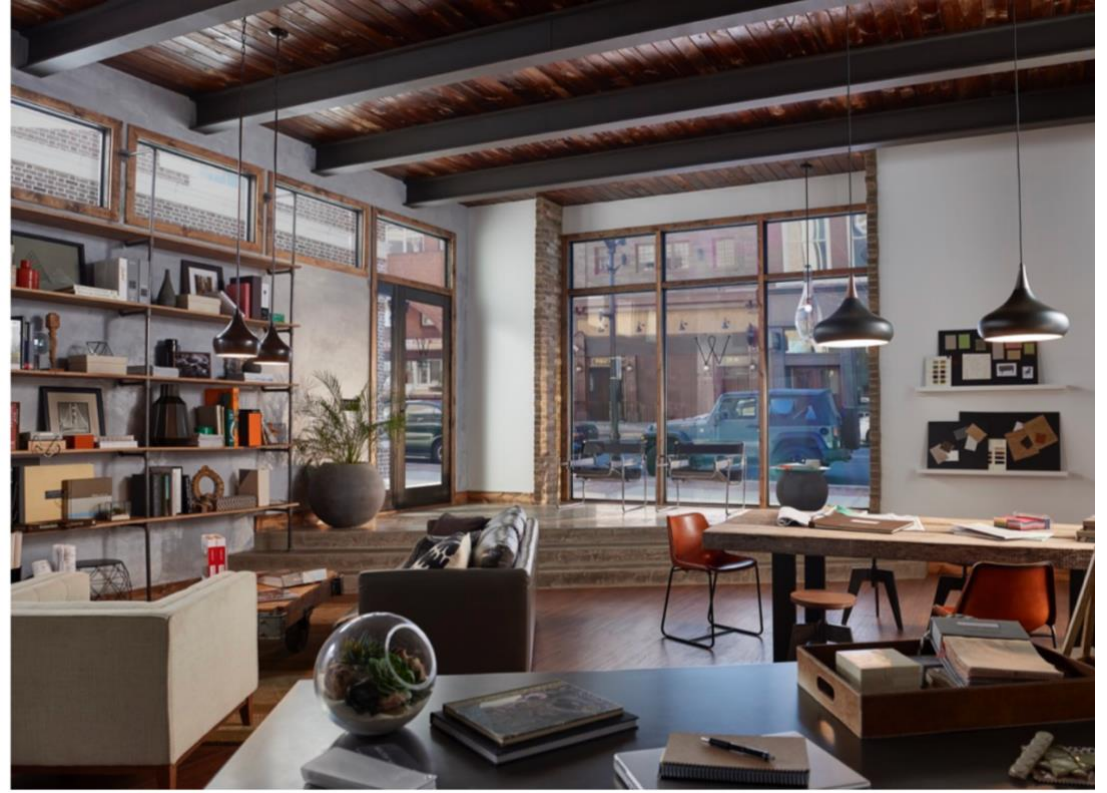
MIRA Fixed Windows in Black

Aluminum-clad wood windows that offer the timeless beauty of wood windows with durable aluminum clad exterior.

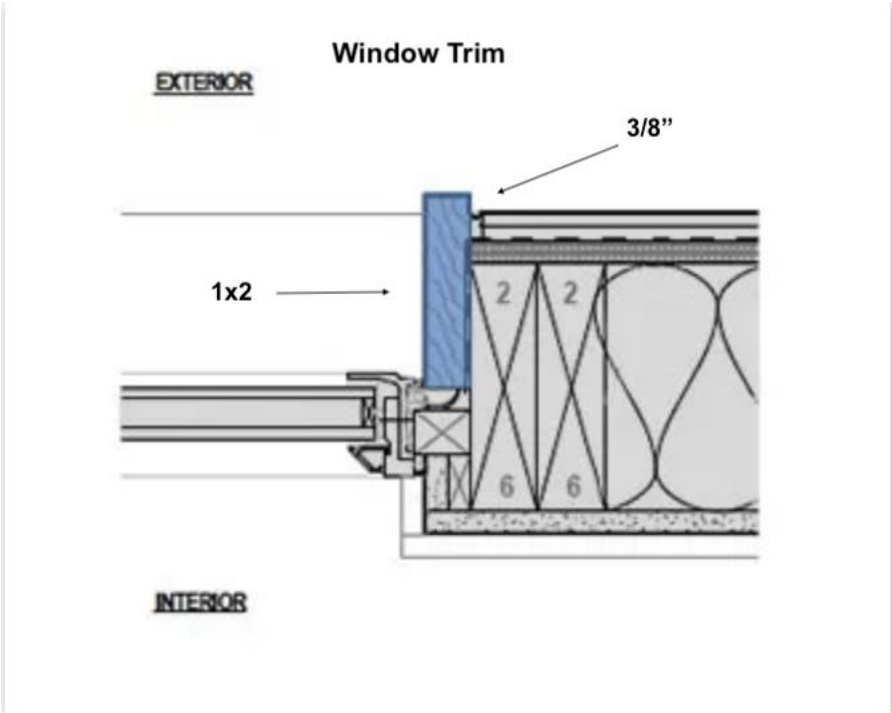
### Window Trim

1 x 2 Pine wood trim board  
(Actual: 3/4 in. x 1-1/2 in.)

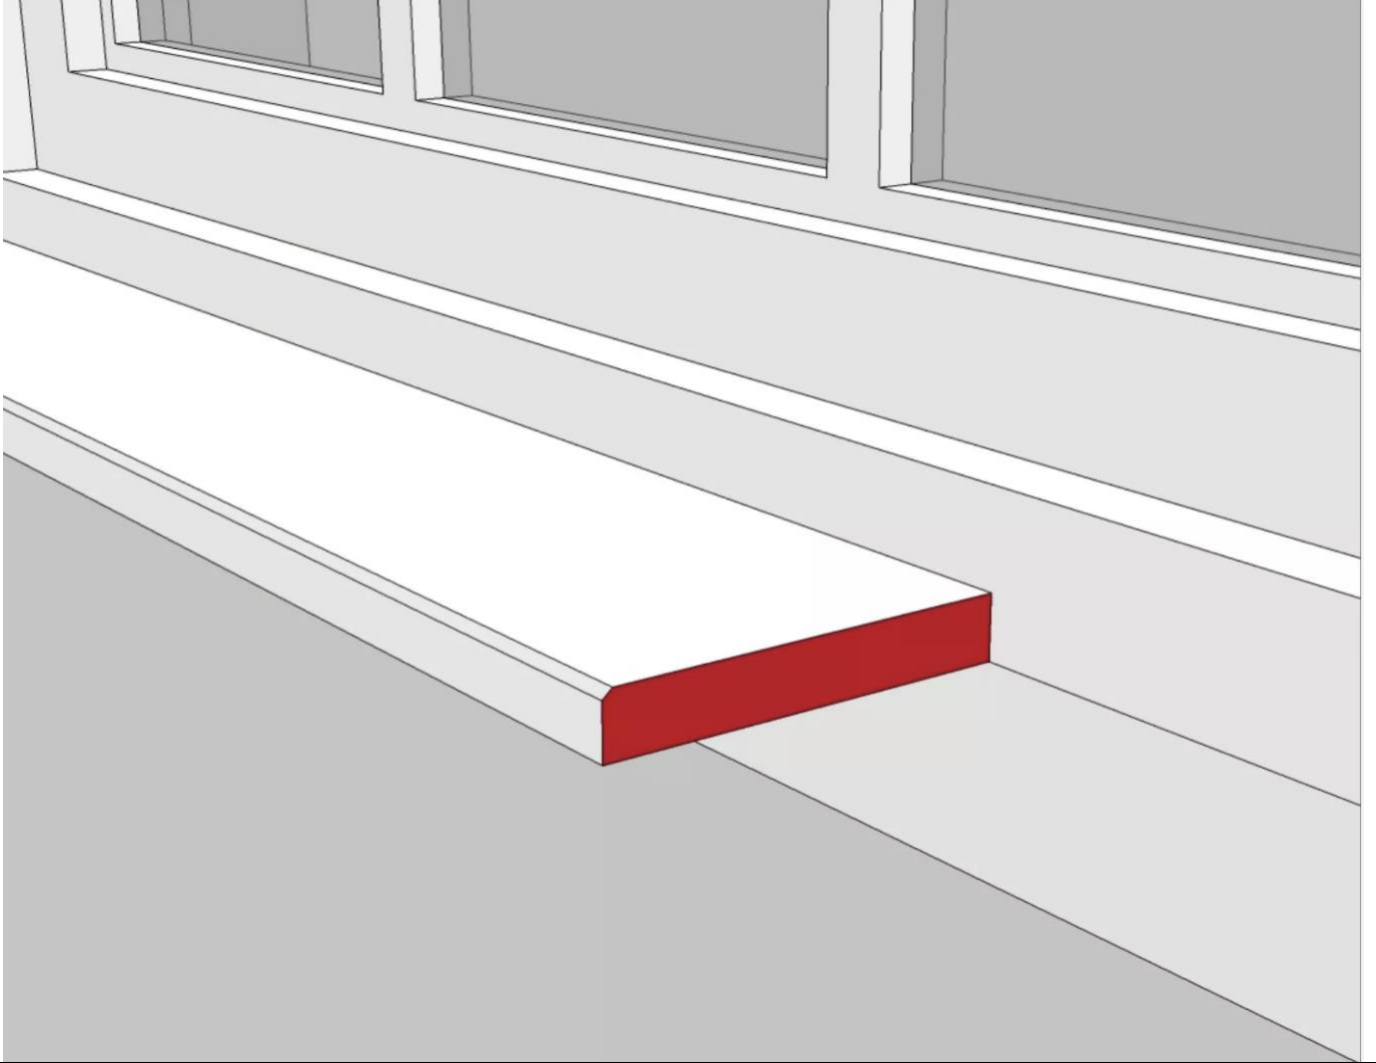
### Window Sill on Block/Stucco Walls

ENGINEERED STONE SILL  
5/8 x 6

Window openings will be modified to accommodate the new windows. Cedar siding and trim will be installed around the windows on the right-side porch. Window opening on the left side will be expanded, and stucco repair will be completed. No trim to be installed around window. New Windowsill is a 5/8' thick engineered stone (see material specification sheet)

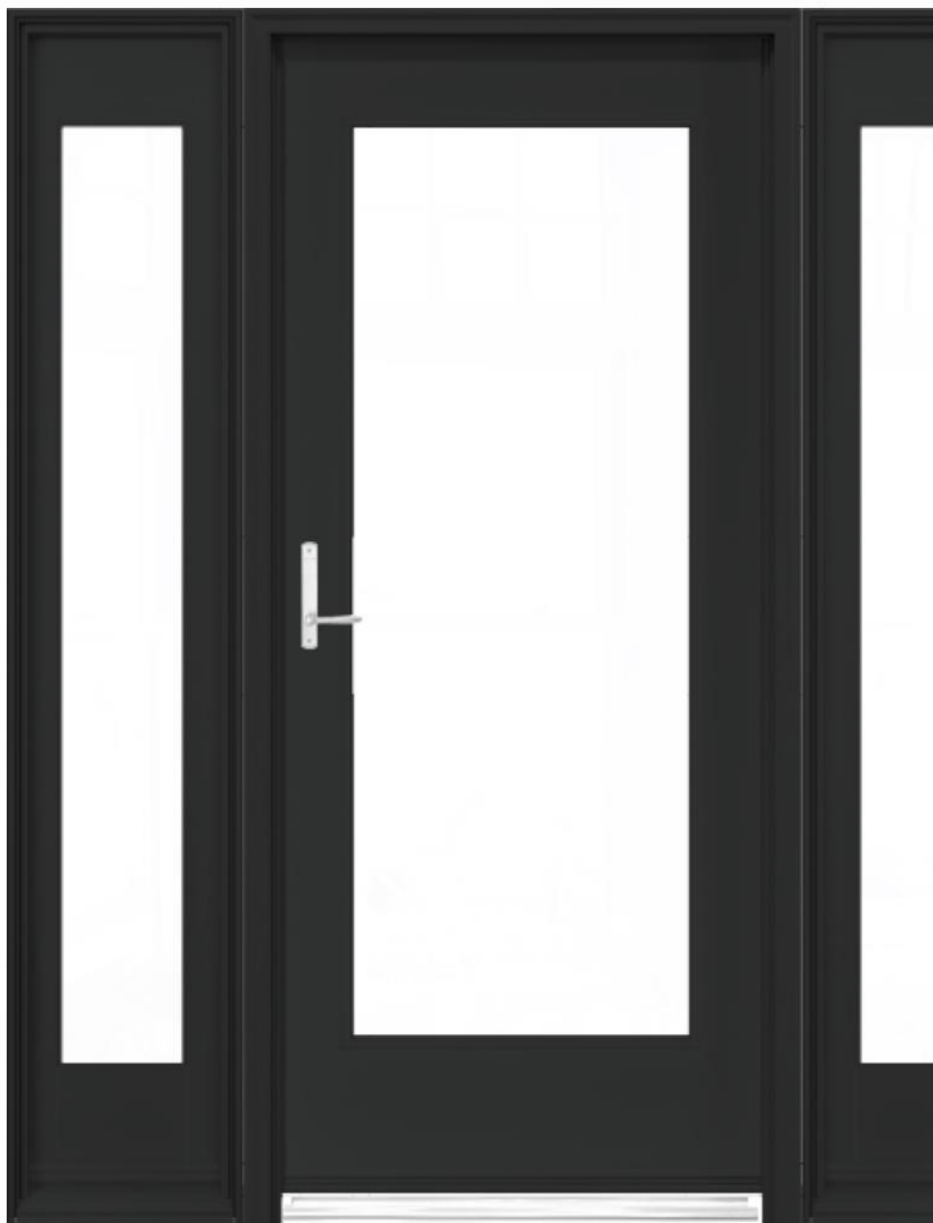
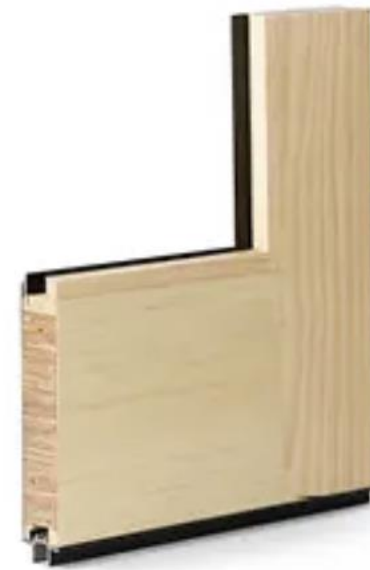
Panel Style 102 Straightline Glass Panel

Main entry door: right porch,  
Glazed full light door  
Andersen 102 Straightline Glass Panel

Panel style:  
Traditional aluminum-clad wood Traditional panels feature 4 11/16”  
stiles with a choice of 4 11/16”, 8” or 12” bottom rail heights.

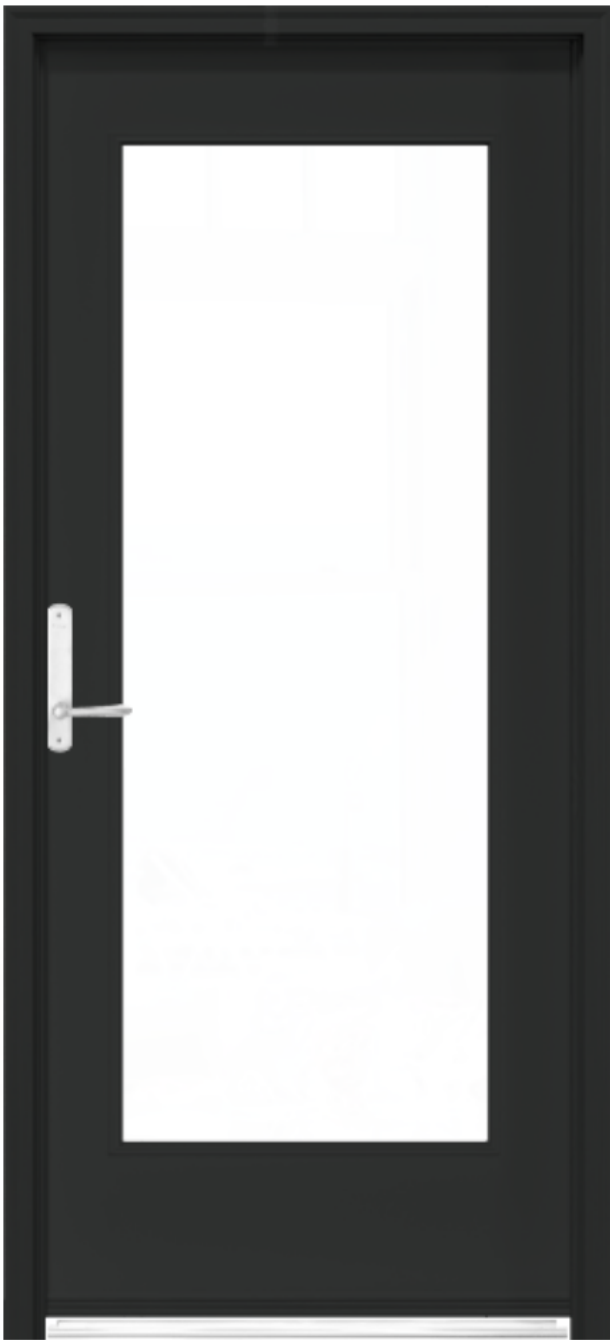
Panel Style 102 Straightline Glass Panel

Notes:  
Actual wood is sapele, a non-endangered species of mahogany, grown in Africa, with color and characteristics similar to American mahoganies.

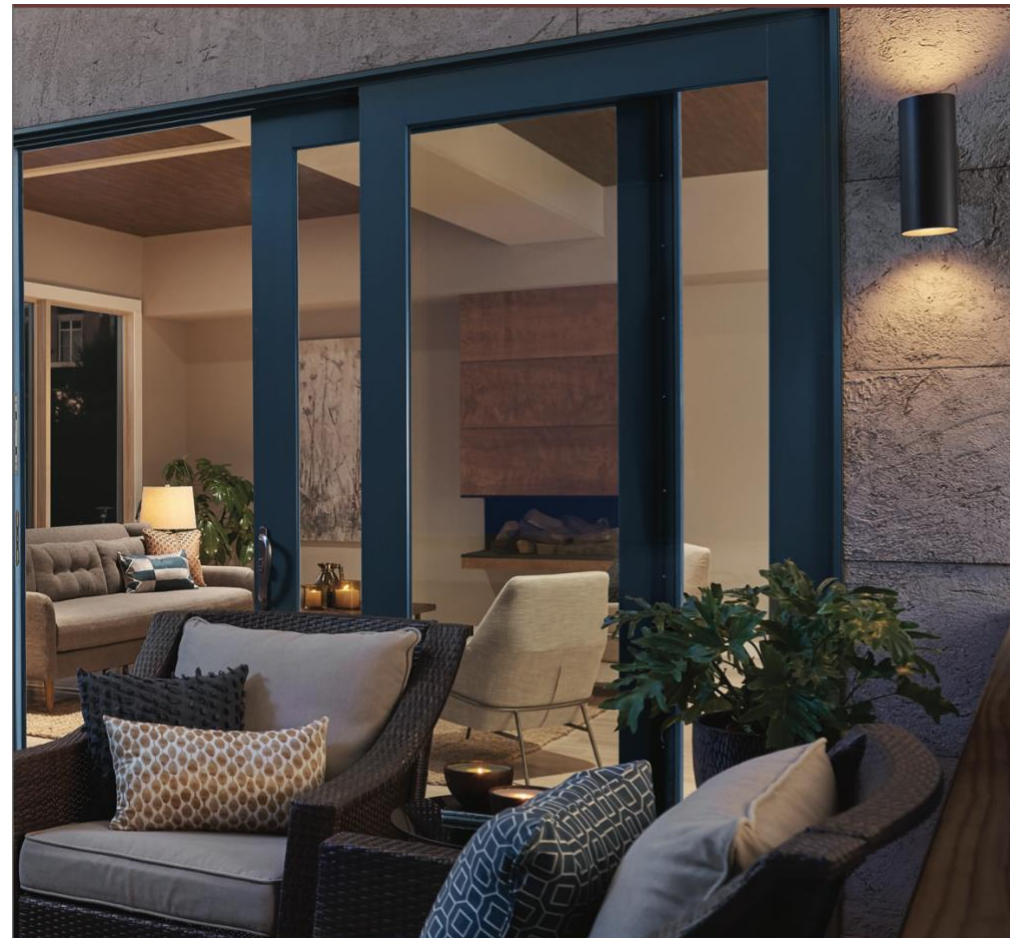
## Back patio door

MIRA Aluminum-Clad Wood Bi-Parting Patio Doors

Material: Aluminum Clad - Wood protected by aluminum exterior

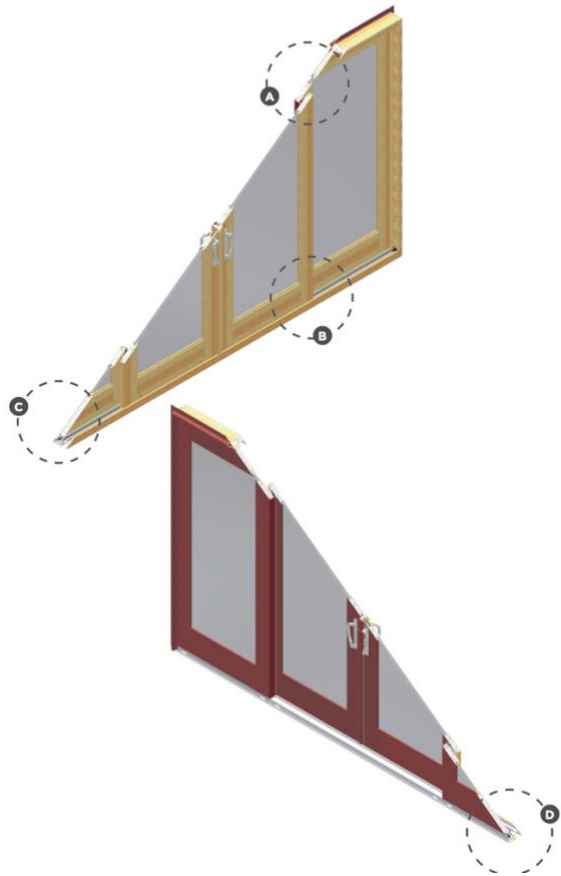
## BI-PARTING SLIDING PATIO DOOR

- Stainless steel rollers for smooth operation and long lasting performance
- Aluminum sill deck in medium bronze with durable stainless steel track on interior of sill for smooth sliding operation

- Dual finseal weatherstripping over the full height of the door and 1/2" tall finseal weatherstripping for increased protection against leaks for reduced air infiltration

- Multi-point lock system
- 1 3/4" panels with wide stiles and rails for an authentic French look
- Select clear wood interior ready for paint or stain to match any interior décor (also available primed or prefinished in white, black or off-white)

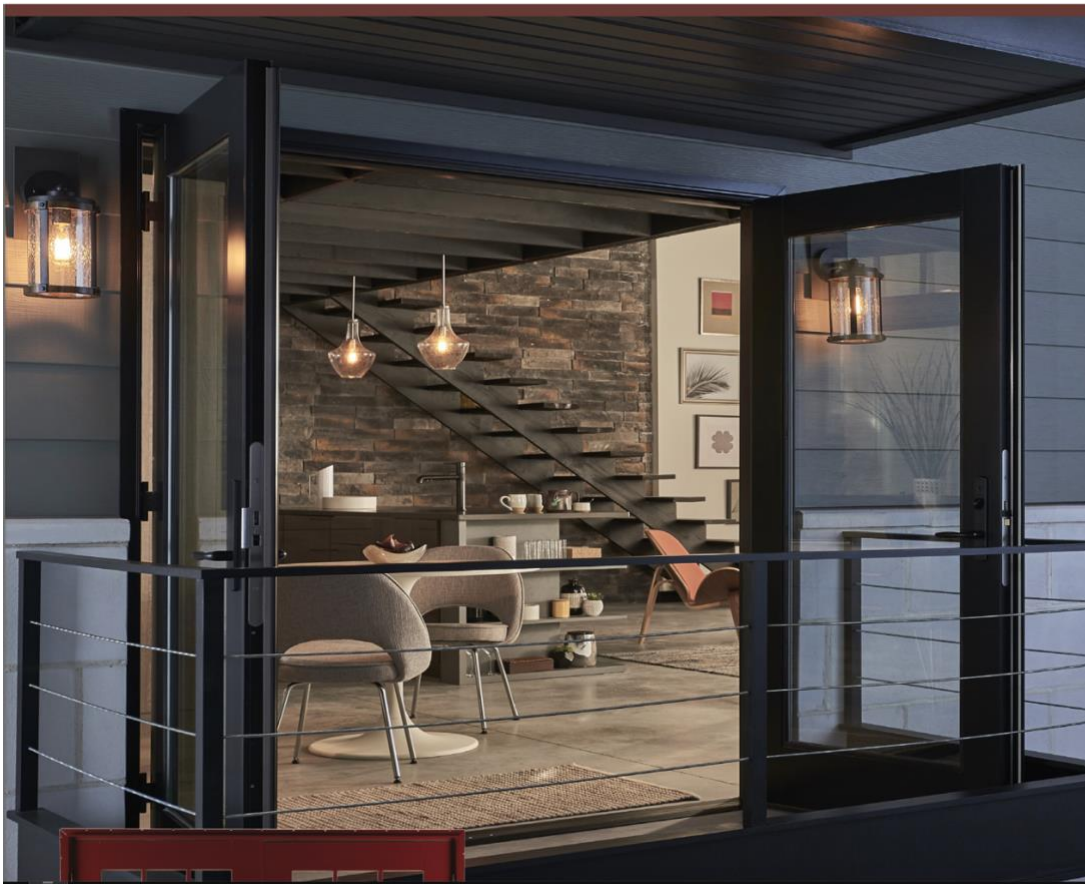
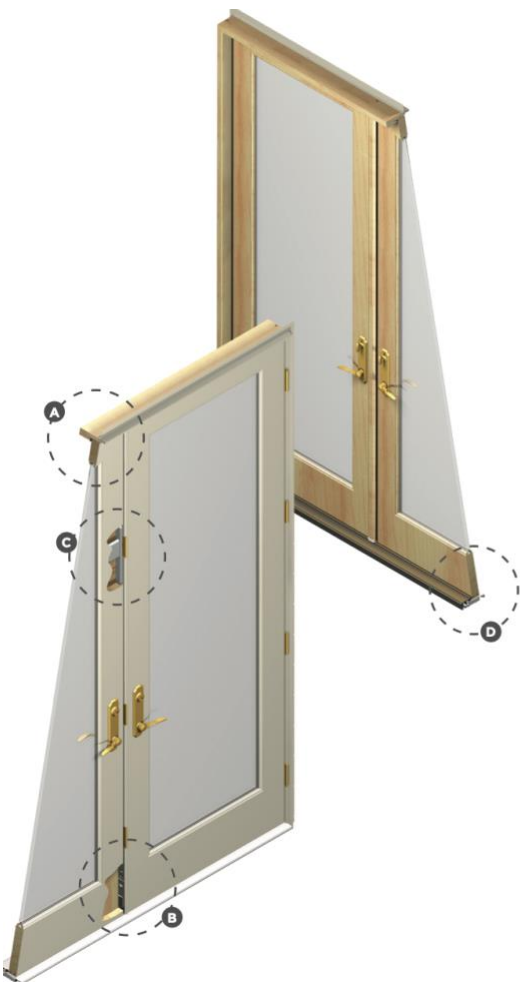
### Rear Terrace Door

Ply Gem Mira Aluminium-Clad Wood French Outswing Door.

- Adjustable hinges are standard for smooth operation. Ball Bearing flat hinges optional
- Handle activated shoot bolts at the head and sill for added security

- Aluminum sill deck to prevent sag and resist dents
- Aluminum astragal with stainable wood interior
- Full-perimeter weatherstripping for air-tight performance and smooth operation

- Vacuum-treated, solid wood components resist damage from water and fungus
- Durable .050 extruded aluminum cladding on exterior surfaces of frame and .080" on panels resists dings and dents while providing structural integrity. Available with ADA compliant sill

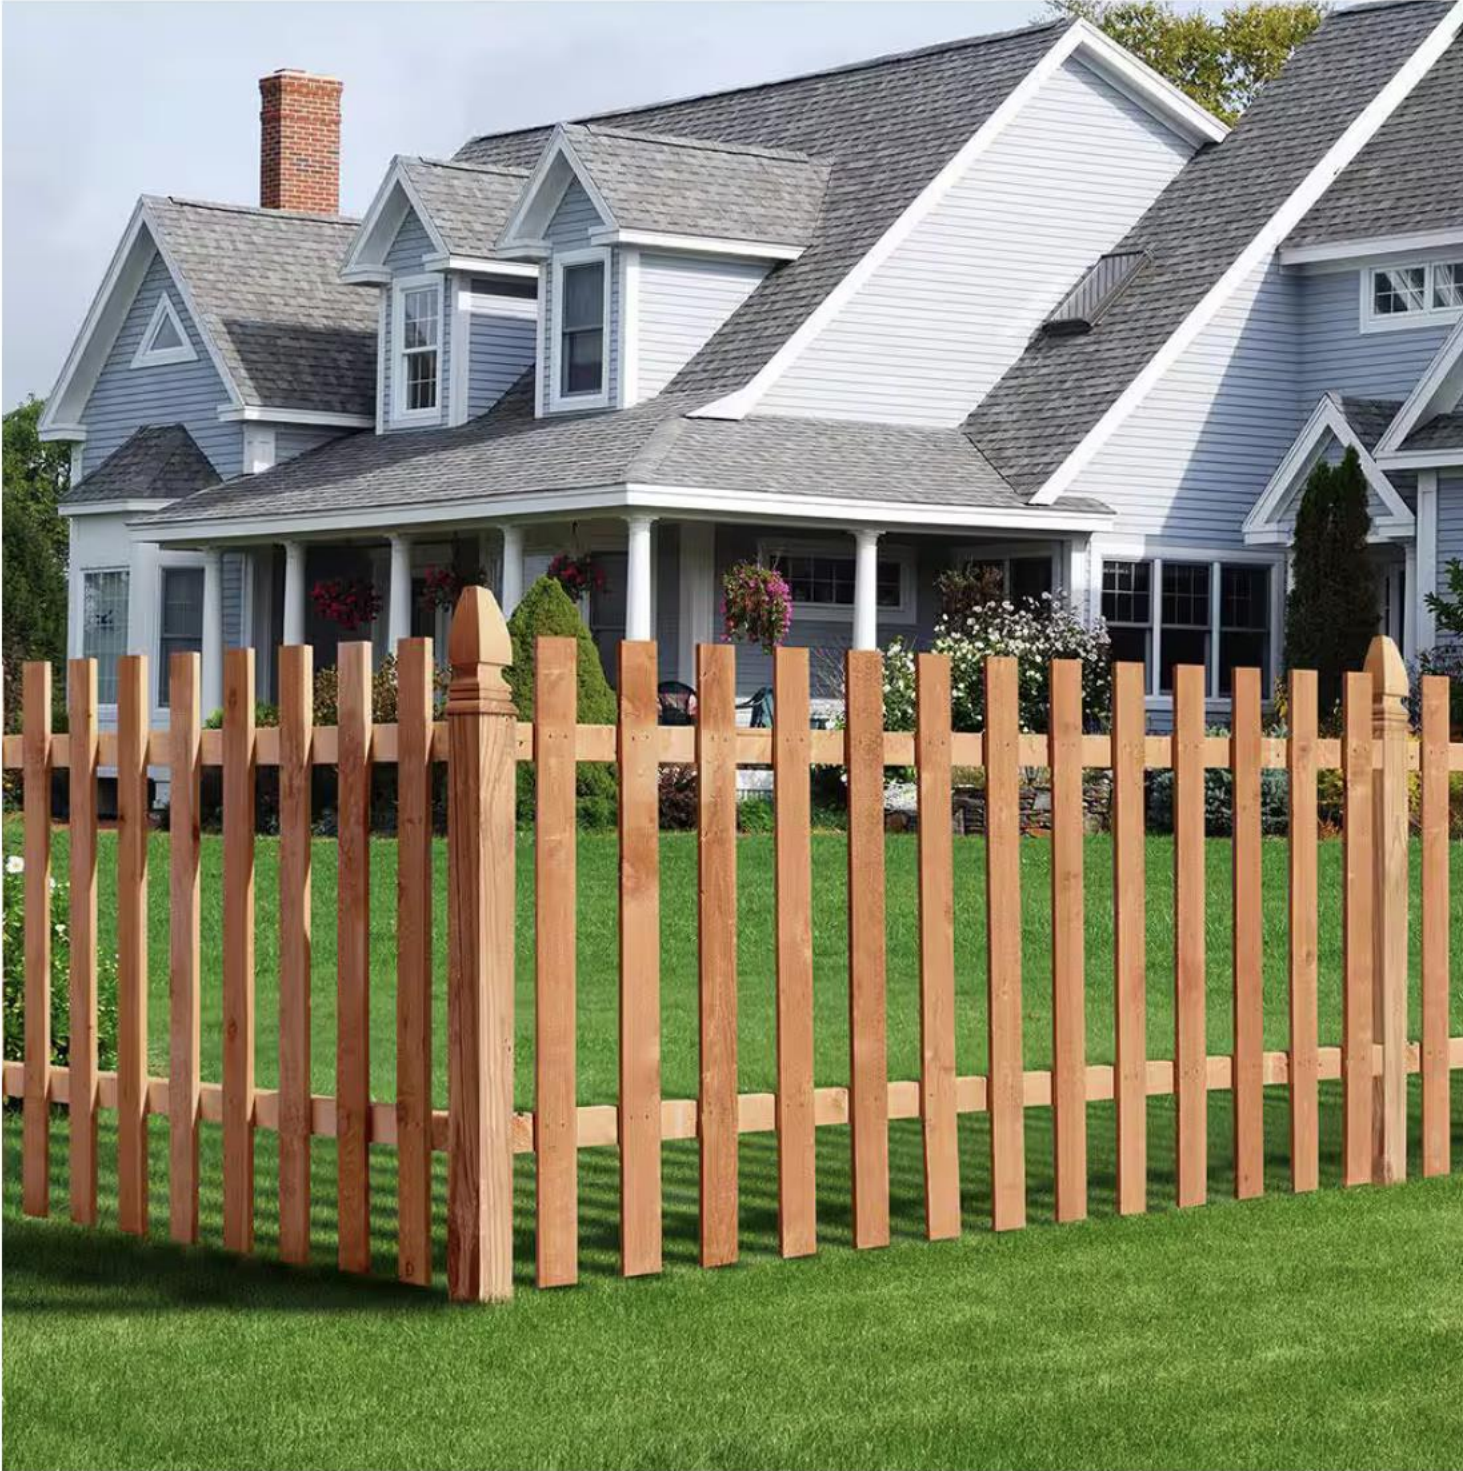
Fence to be installed along the sides of the house

3-1/2 ft. high Western Red Cedar Spaced Picket Flat Top Fence

1. The 4' (four-foot tall) fence along the north property line cannot extend forward of the rear wall plane. The fence on the south property line, forward of the rear wall plane, cannot be taller than 48" (forty-eight inches tall) and must have an open picket design. Final approval authority to verify that this condition has been satisfied is delegated to Staff.

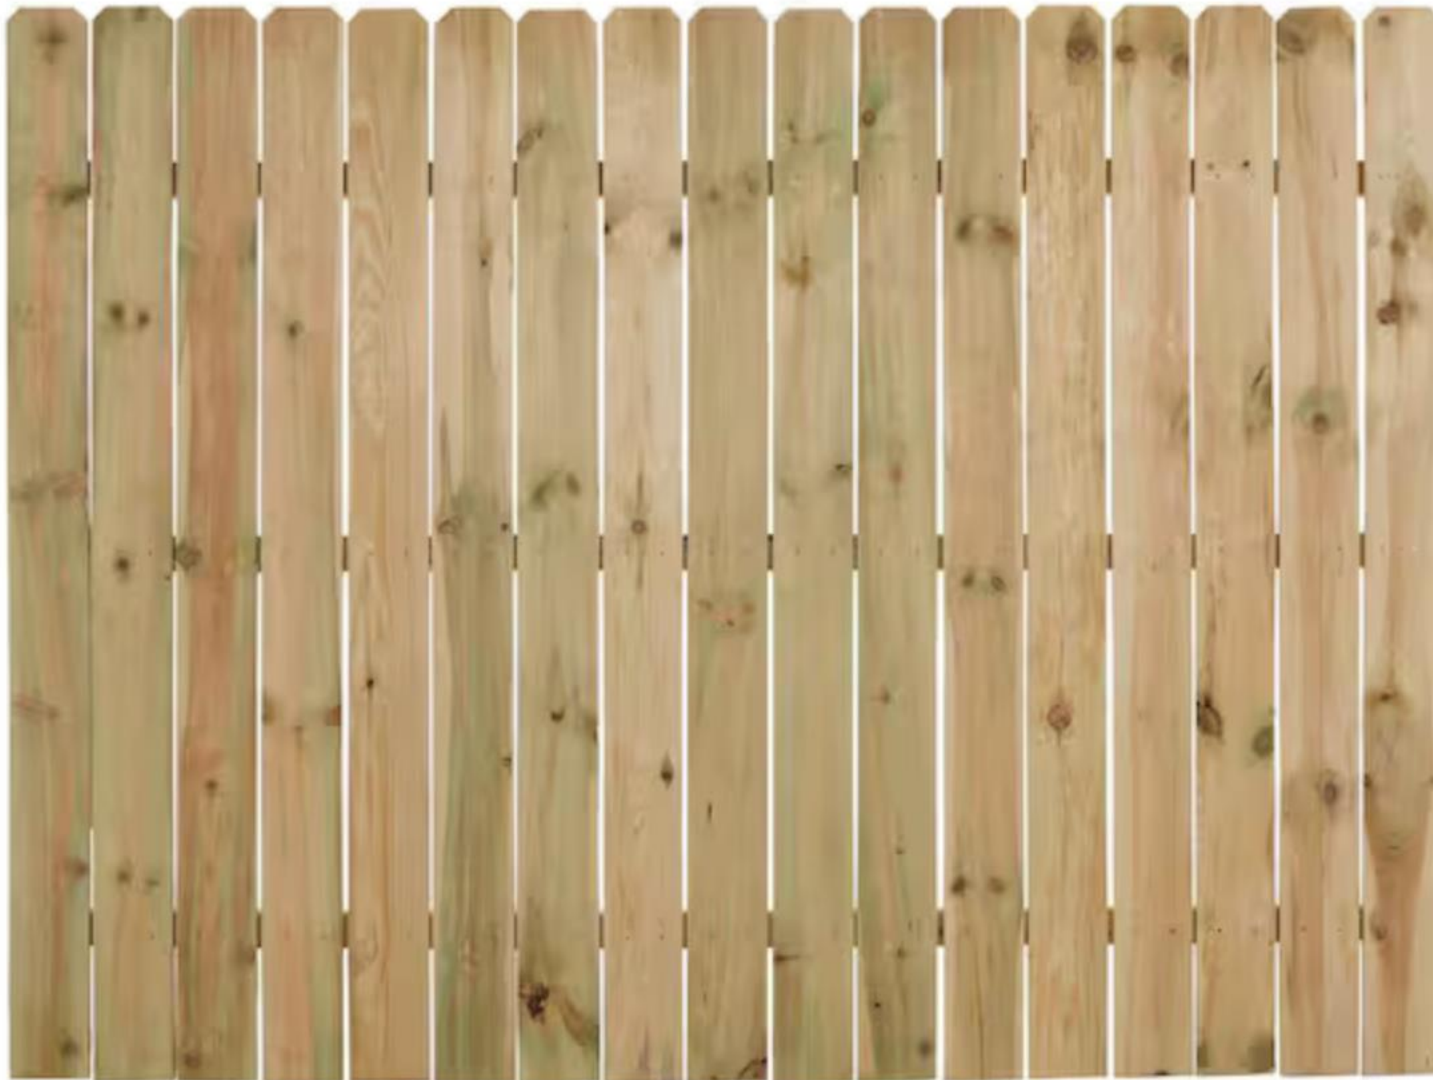
Fence to be installed in the backyard. Materials: 6 ft. H Pressure-Treated Pine Dog-Ear Fence Panel.

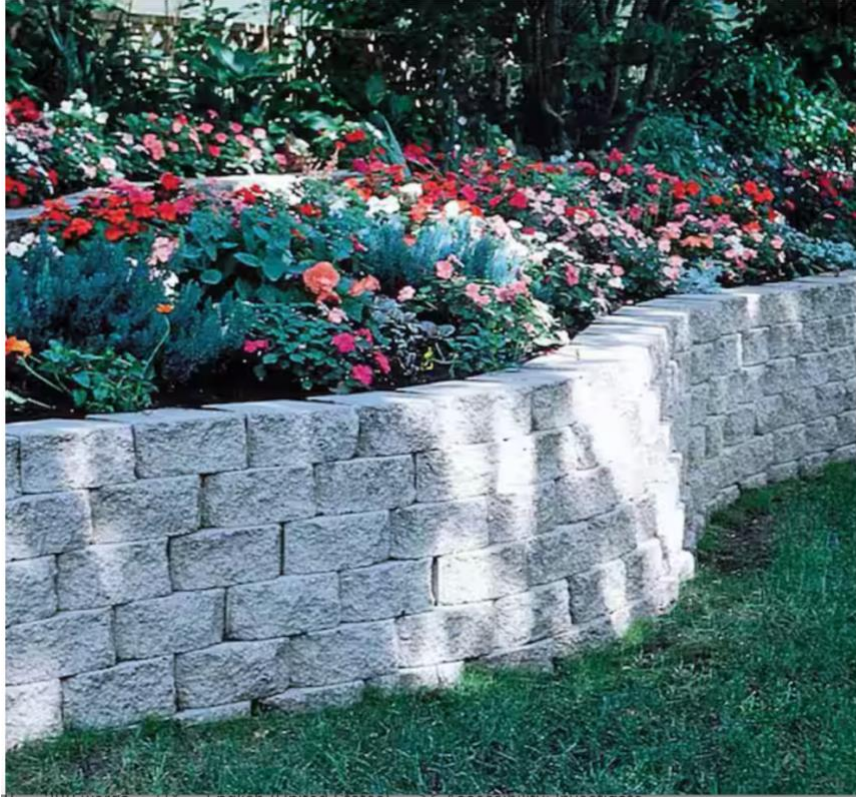
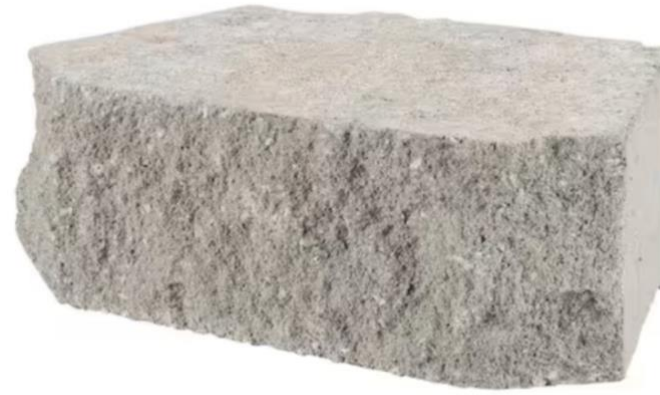
## Retaining walls

Existing walls will be replaced using Pewter Concrete Retaining Wall Block (4 in. x 11.75 in. x 6.75 in.).

Locations: front, rear, and along the right (northeastern) side of the property.

Removal of 6 trees, clearing of bambo in the backyard and along the right side of the house. Install a stone patio in the backyard. Replace the wood reatining walls with Pewter Concrete Retaining Wall Block

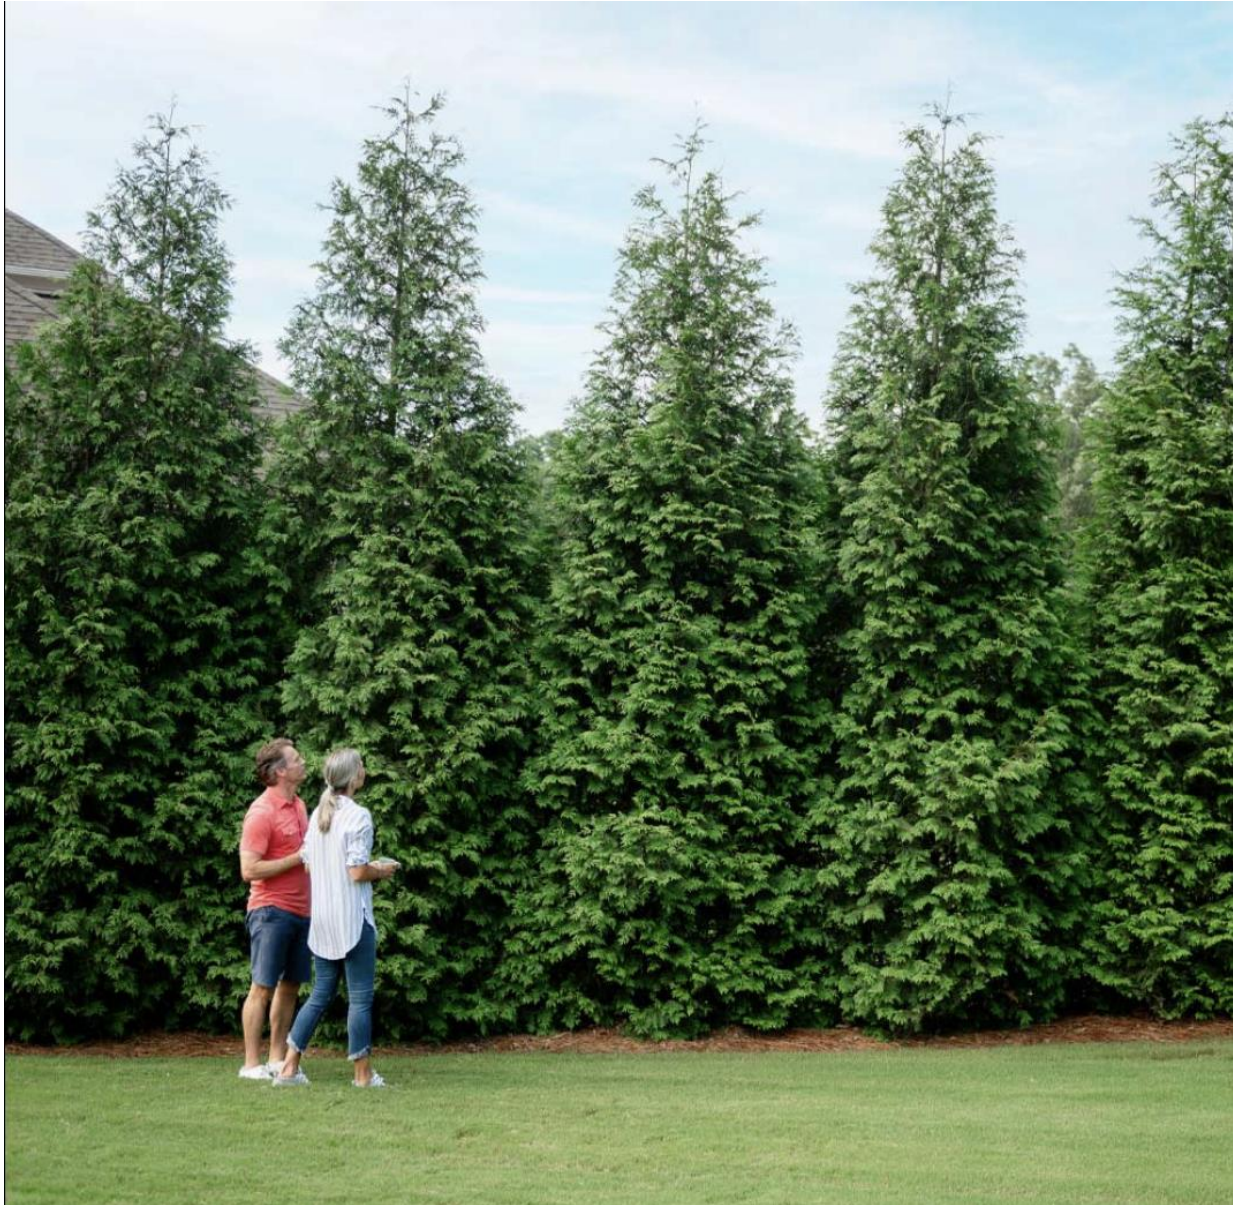
**Thuja Green Giant Arborvitae (5x)**

Tree species to be planted:
