Address:	7500 Maple Ave., Takoma Park	Meeting Date:	6/25/2025
Resource:	Multiple Resources Takoma Park Historic District	Report Date:	6/18/2025
Project Contact	: City of Takoma Park	Public Notice:	6/11/2025
Review:	HAWP	Tax Credit:	No
Case Number:	1119049	Staff:	Dan Bruechert
Proposal:	Right-of-way alterations associated with the Map	le Ave. Connectivity	Project

MONTGOMERY COUNTY HISTORIC PRESERVATION COMMISSION STAFF REPORT

The applicant proposes to install traffic calming measures along Maple Ave. within the Takoma Park Historic District.

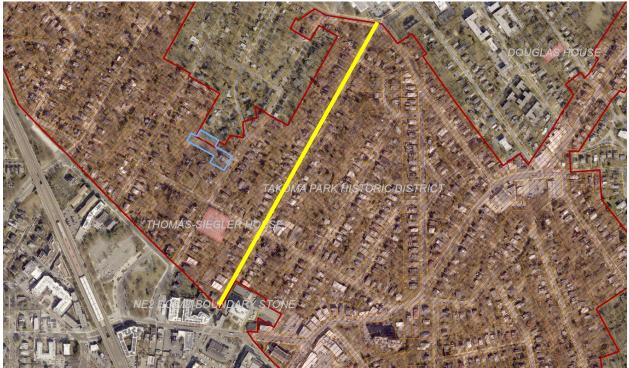
Figure 1: The project is on Maple Ave. from Philadelphia Ave. to the Takoma Park/DC line.

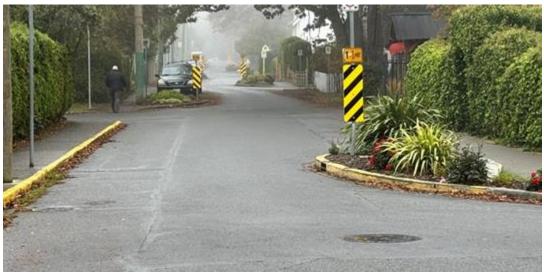
Figure 3: A typical chicane on a residential street.

Second, the applicant proposes to install 13 (thirteen) curb extensions/chicanes along Maple Ave. These are concrete traffic calming features that project approximately 8' (eight feet) into the roadway (see *Figure 3*, below). The chicanes will be detached from the existing curb to maintain existing gutter flow and are located so as not to interrupt access to any of the existing driveways. The drawings submitted with the mandatory referral review note the chicane curbs will be 6'' (six inches tall) and notated the chicanes as 'planted/grass area(s).' One chicane, located at a Ride-On bus stop, will be concrete. The intended effect of the chicanes is to narrow the roadway so that cars need to slow down so that only one car may pass through an area at a time.

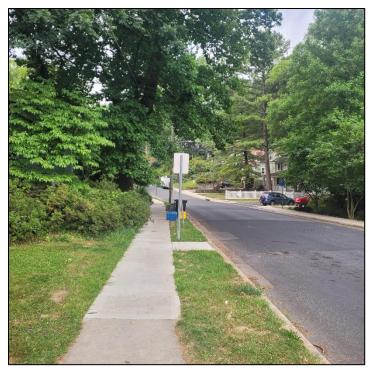
Photograph 1: View of Maple Avenue from 7421 Maple Avenue, near Philadelphia Avenue, looking southwest (RK&K June 2023). Project plans indicate a curb extension at this location.

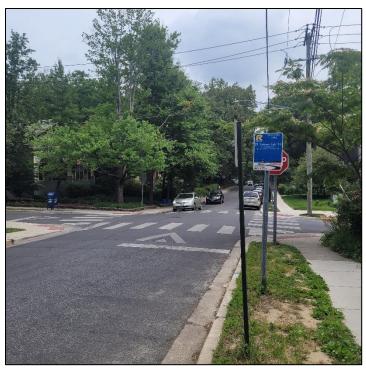
Photograph 3: View of the intersection of Tulip and Maple Avenues, looking northwest (RK&K June 2023). According to project plans a curb extension will be added near the stop sign, just prior to the intersection.

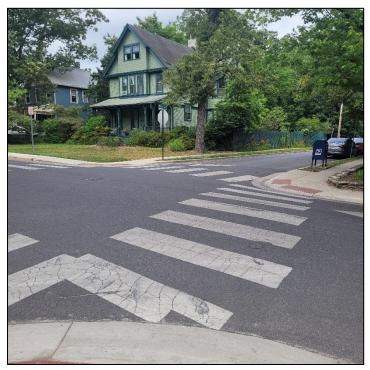
Photograph 4: View of the intersection of Tulip and Maple Avenues, looking southwest (RK&K June 2023). According to project plans a curb extension will be added in front of the mailbox, just after the intersection.
