MONTGOMERY COUNTY HISTORIC PRESERVATION COMMISSION
STAFF REPORT

Address:	23345 Frederick Road, Clarksburg	Meeting Date:	5/28/2025
Resource:	Contributing Resource (Clarksburg Historic District)	Report Date:	5/21/2025
		Public Notice:	5/15/2025
Applicant:	Javier Nogales (Michal P. Rouse, Architect)	Tax Credit:	No
Review:	HAWP	Staff:	Laura DiPasquale
Case Number:	1115052		
PROPOSAL:	Porch modifications, fenestration alterations, siding replacement, and other alterations

SIGNIFICANCE: Old Parsonage/Contributing Resource
(Clarksburg Historic District)
DATE: 1856
STYLE: I-House with Greek Revival detailing

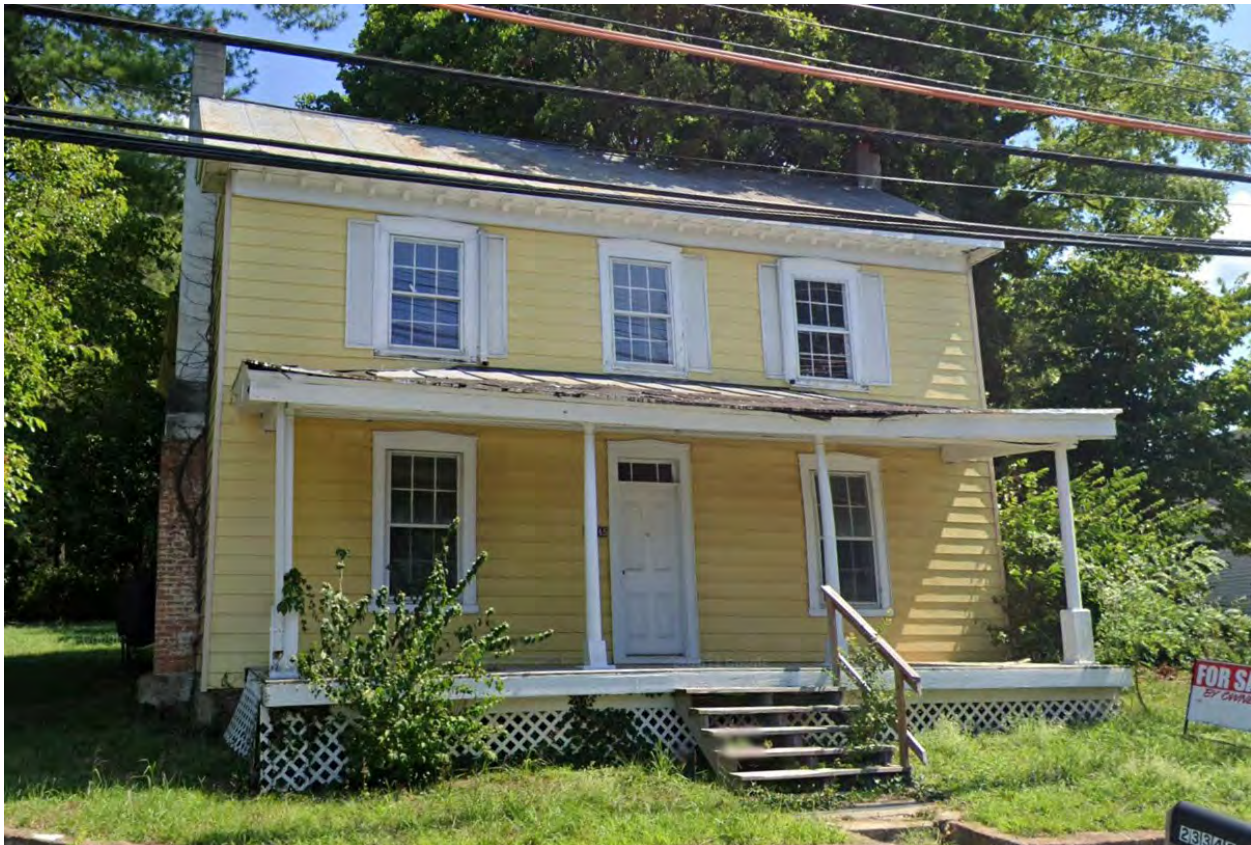
Figure 2: Front elevation of 23345 Frederick Road, Clarksburg.

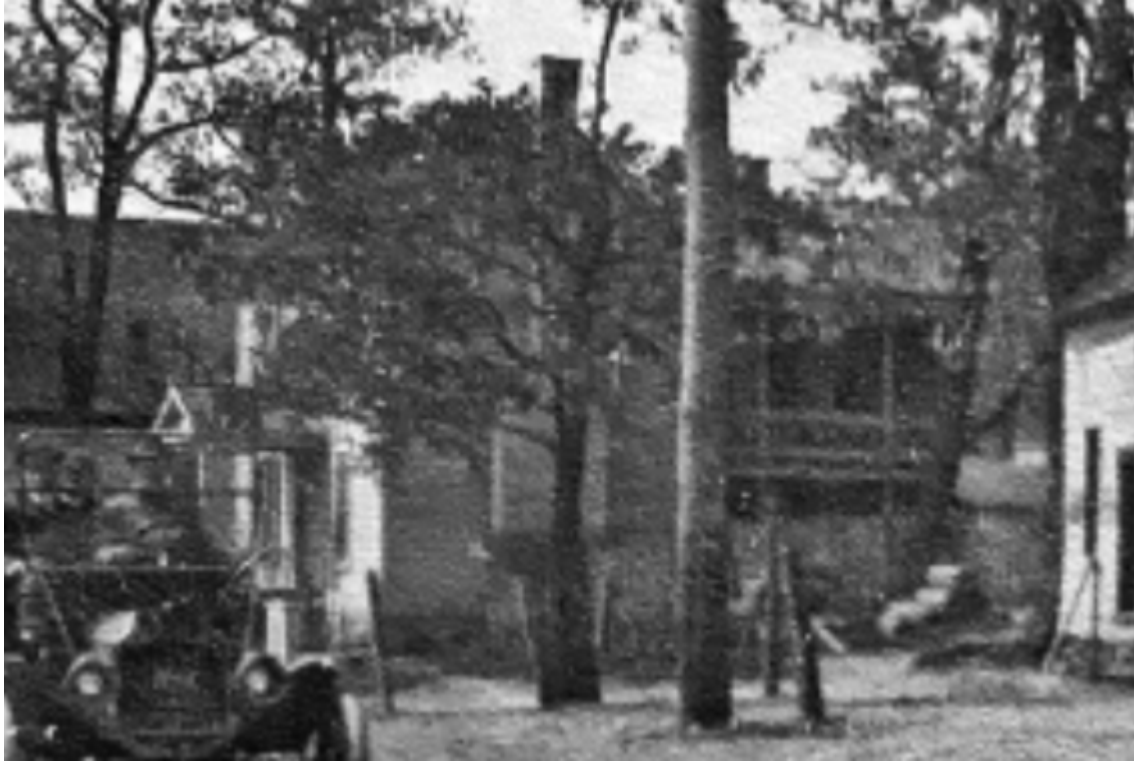
Figure 3: Circa 1913 photograph of Frederick Road, Clarksburg showing the subject property from an oblique angle.

Staff finds that the existing porches (front and side rear) are not original and that their modifications should be treated with leniency, provided the changes are compatible with the resource and district, per Chapter 24A-8(d) and *Standard 9*. A circa 1913 photograph of Frederick Road in Clarksburg shows a gable-roofed single-bay front porch covering the entry that does not extend the full width of the façade. A two-story porch or piazza with posts and railings extends along the side of the rear ell.¹ Per the *Vision of Clarksburg*, one-story front porches with simple wood columns are a common feature on vernacular I-houses such as 23345 Frederick Road. Staff finds that the front existing porch is in poor condition and must be largely rebuilt. Staff finds that the general details of the proposed porch with four squared posts, squared balusters, and a standing-seam metal roof is compatible with the property, per Chapter 24A-8(b)(2) and *Standard 9*, but that the details should be further simplified to be in keeping with the vernacular I-house style of the building. Staff recommends that the cornice brackets on the front porch be eliminated and the newel posts eliminated or replaced with plain 4x4 posts with minimal caps, so as not to add conjectural features that create a false sense of historical development, which runs contrary to the *Standards*.² Staff finds that the proposed Azek trim and posts and TimberTech railings should be replaced with wood (which, if pressure-treated, should be painted after a curing period), per Chapter 24A-8(b)(2), but that the proposed Aeratis porch flooring and stair treads are consistent with *Policy No. 24-01*, provided the flooring is run perpendicular to the façade. Staff notes that the dimensions/proportions of the front posts varies visually throughout the application, but that the proposed first floor plan identifies a dimension of 4 1/8-inches in width, which staff finds to be an appropriate square dimension for the porch posts, or up to 5 inches square

As with the front porch, staff finds that the existing side/rear porch, stair and landing are not original, having replaced a two-story side porch visible in the 1913 photograph, so staff finds that an exact replication of the earlier feature is not necessary, but that the proposal should be compatible with the character of the property, per Chapter 24A-8(b)(2) and *Standard 9*. As with the front porch, staff recommends that the details of the rear porch, stair, and landing railing be simplified to be more in keeping with the vernacular character of the I-house style building and to avoid creating a false sense of history, per the *Standards*. Staff recommends that all posts be approximately 4-inches square, and that the landing posts replicate the simple style of the proposed rear stair railing newel posts. Staff notes that the first-floor rear posts supporting the landing above are not dimensioned, but should likewise be 4-inches square, if structurally sufficient, or a maximum 6-inches square, with no ornamentation. Staff finds that the proposed Azek trim and posts and TimberTech railings should be replaced with wood, per Chapter 24A-8(b)(2), but that the proposed Aeratis porch flooring and stair treads are consistent with *Policy No. 24-01*.

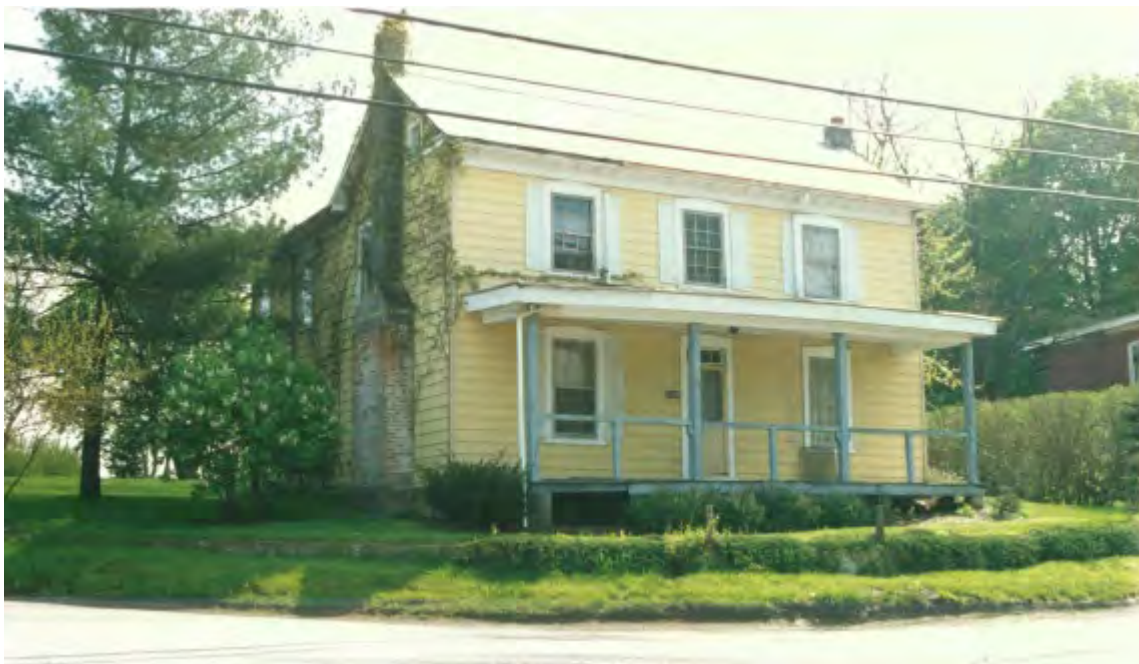
Figure 4: Circa 1990s photograph of 23345 Frederick Road, from A Vision of Clarksburg.

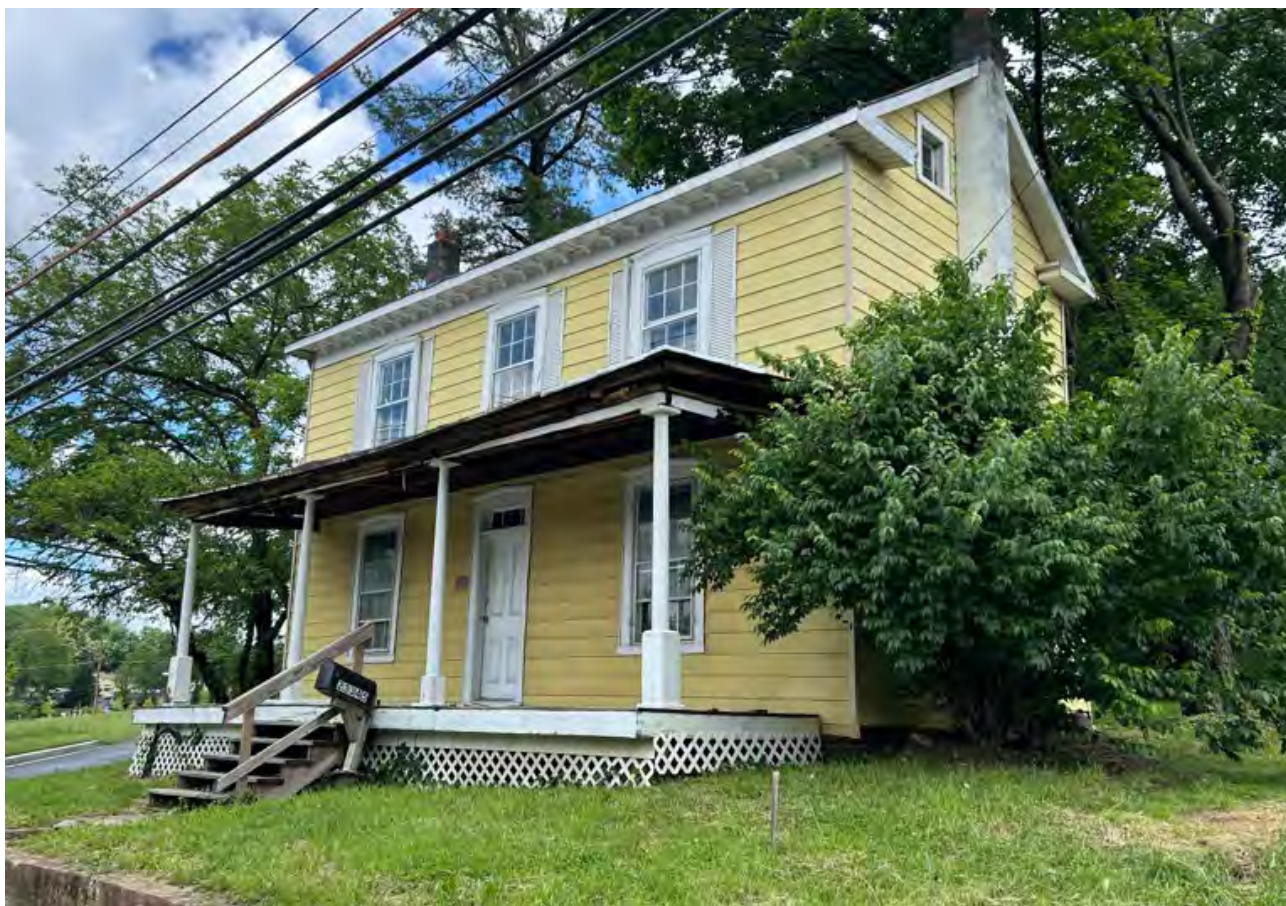
Figure 5: Front elevation of 23345 Frederick Road.

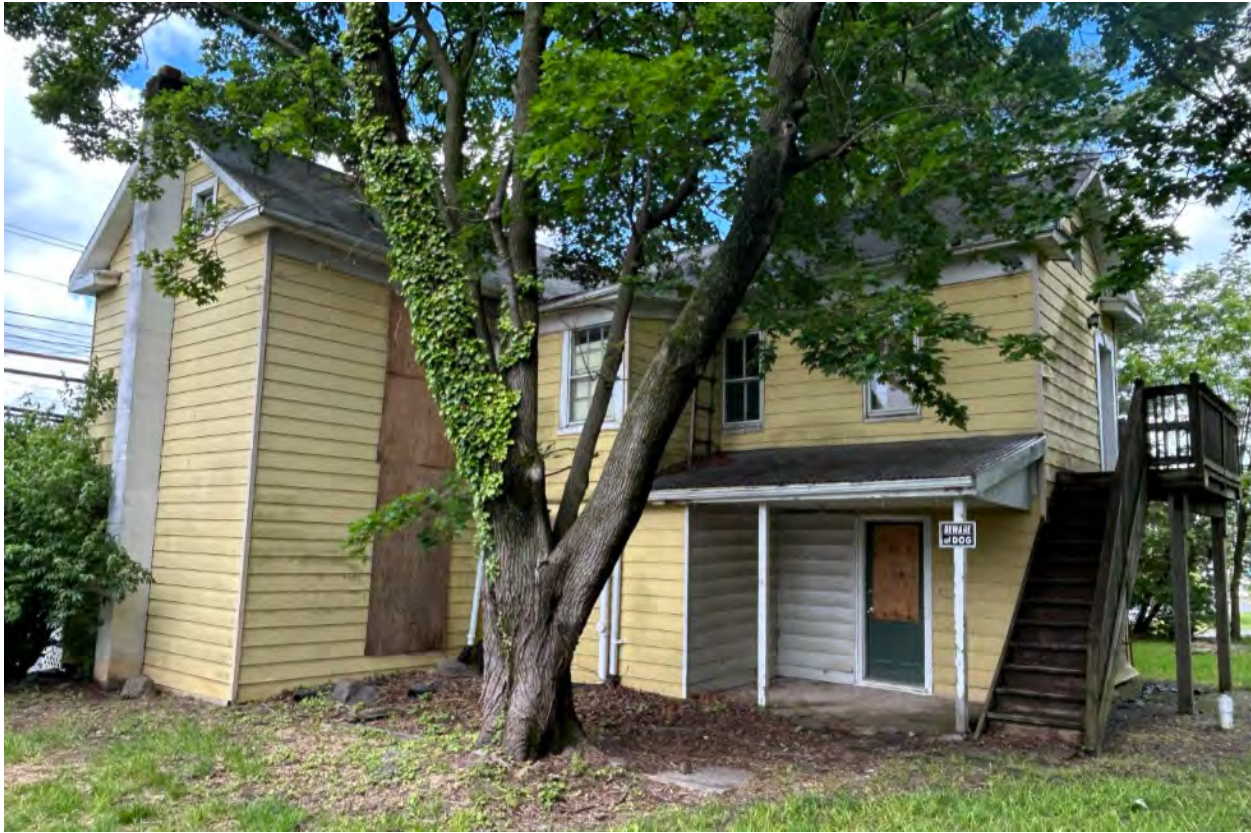
Figure 8: Existing southeast side elevation and rear stair.

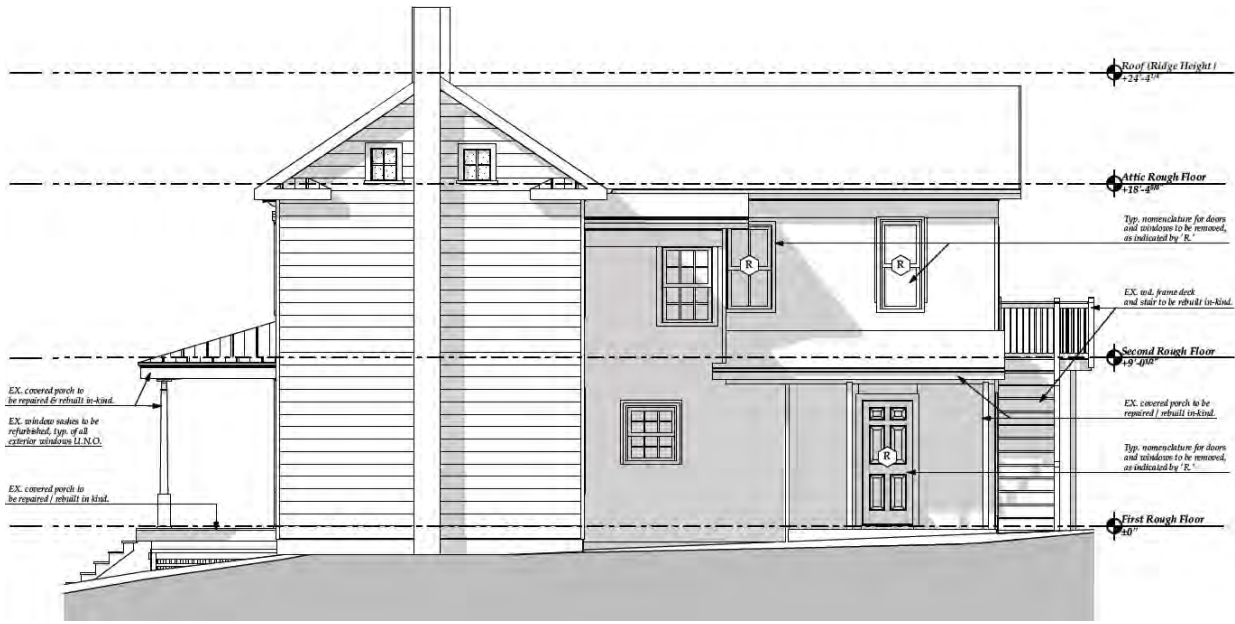
Figure 9: Existing southeast side elevation.

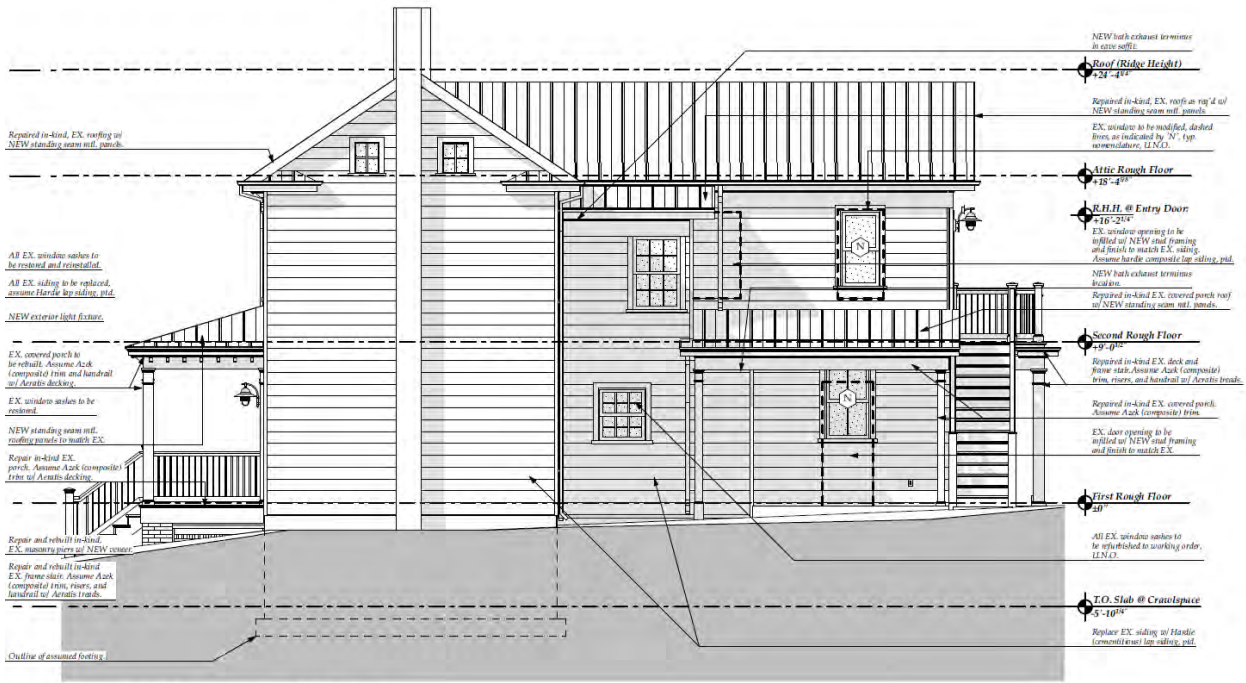
PROPOSED Southeast (Side) Elevation

Figure 10: Proposed southeast side elevation.

On the southeast side elevation of the rear ell, the applicants propose to remove the existing first-floor door and two existing second-floor windows, and on the northeast rear elevation of the ell, the applicants propose to remove a set of first-floor windows and a second-floor door. On the rear elevation of the ell, the applicants propose to modify a non-historic first-floor window opening and to replace an existing wood door with two new wood doors. The *Secretary of the Interior's Rehabilitation Guidelines* recommend “adding new window openings on rear or other secondary, less visible elevations, if required by a new use. The new openings and the windows in them should be compatible with the overall design of the building but, in most cases, not duplicate the historic fenestration.” Staff finds that the proposed locations are minimally visible from the public right-of-way and would meet these guidelines, as well as Chapter 24A-8(b)(1). Staff finds that the proposed Marvin Elevate fiberglass windows and ¾-lite wood doors have traditional profiles that would be generally compatible with the historic resource, per *Standard* 9, but that wood windows would be the appropriate compatible material for use on the historic ell, per Chapter 24A-8(b)(2). As currently presented, the application proposes a two-over-two window at the first floor and one-over-one window at the second floor. Staff recommends that both new windows have the same configuration, either one-over-one or two-over-two.

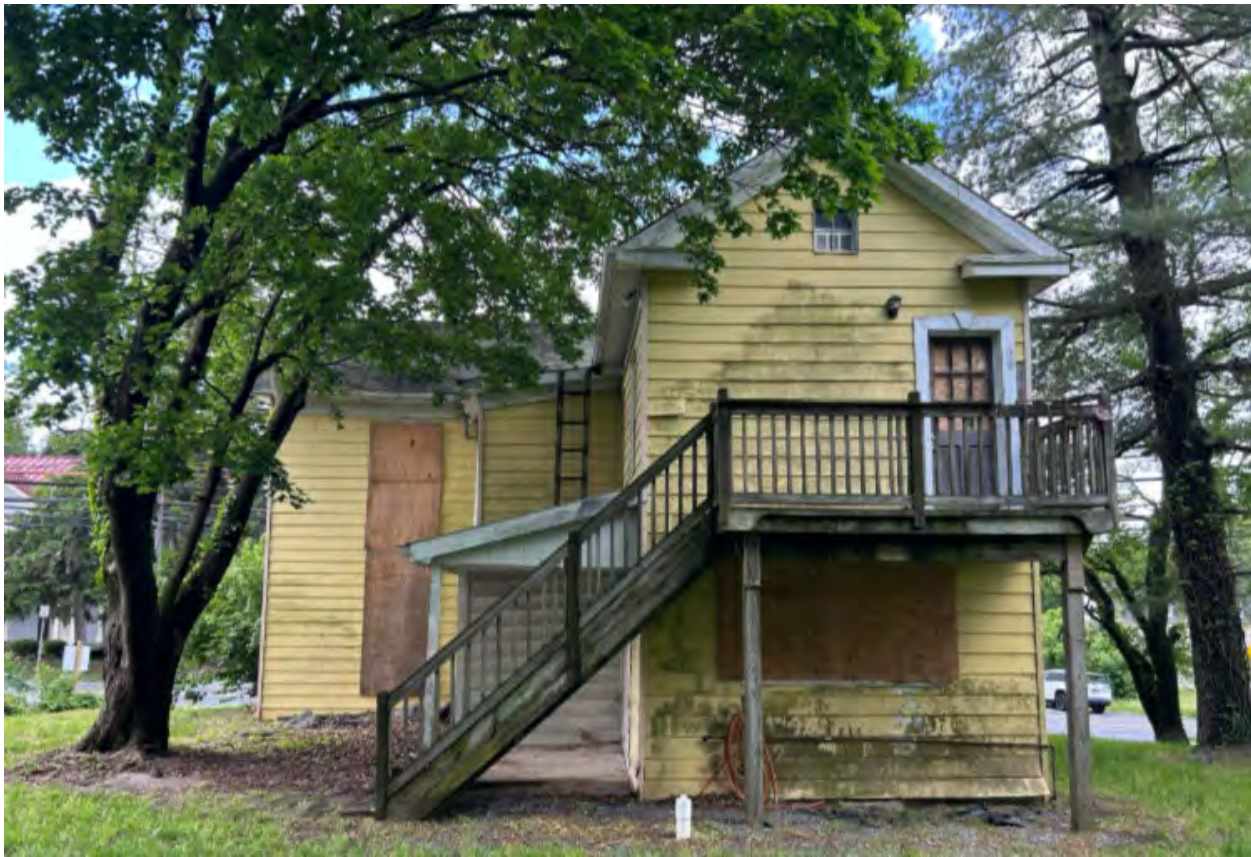
Figure 11: Photograph of the existing rear elevation, May 2025 (Historic Preservation Office).

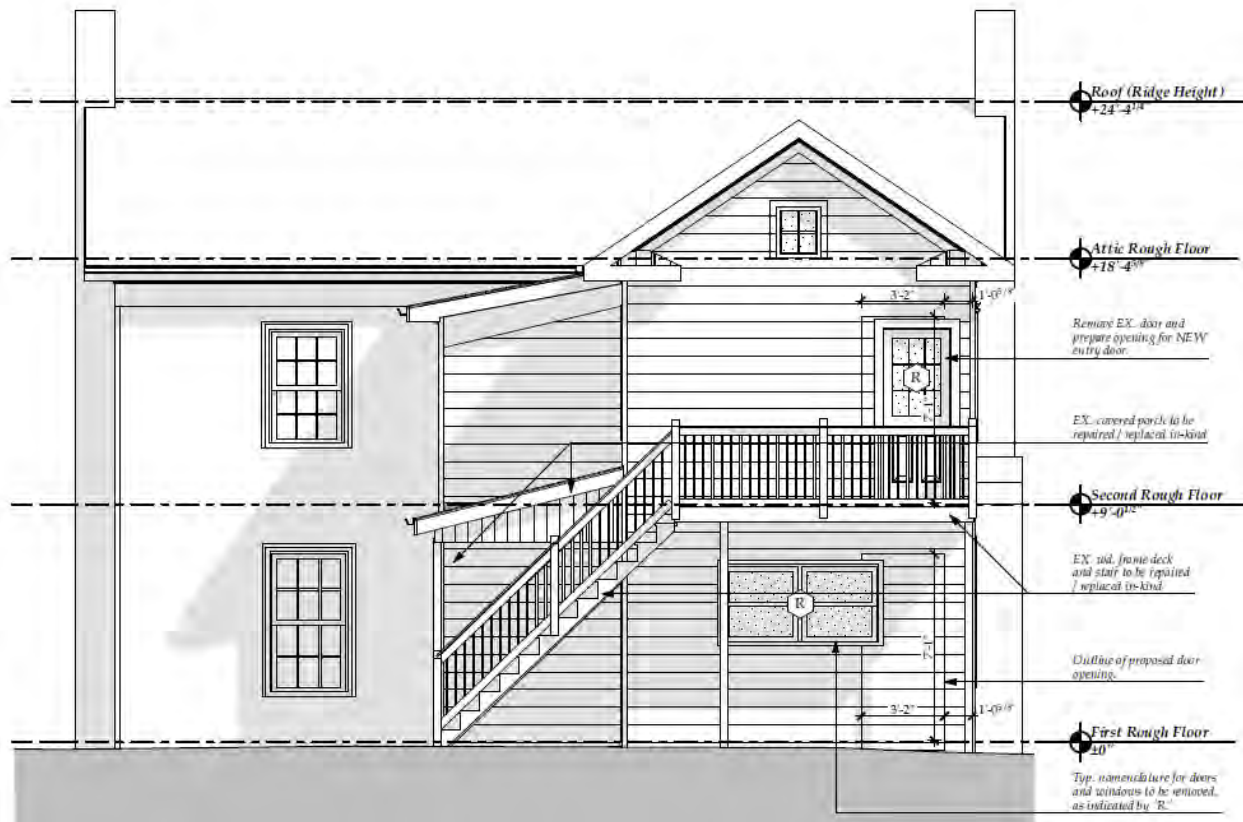
Figure 12: Existing rear elevation drawing.

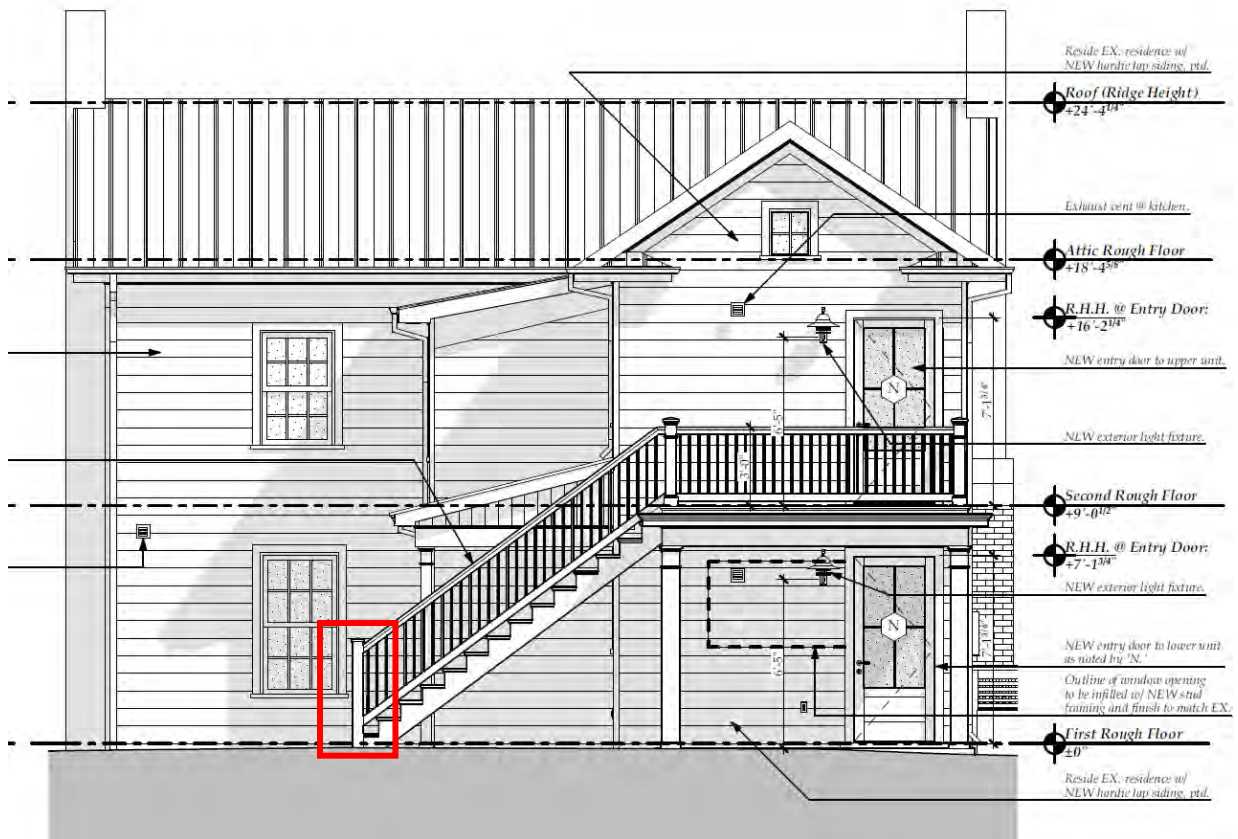
Figure 13: Proposed rear elevation. The posts on the 2nd-floor landing should replicate the simple square appearance of the newel posts at the base of the stair (outlined in red), and the ornamentation removed from the landing support columns.

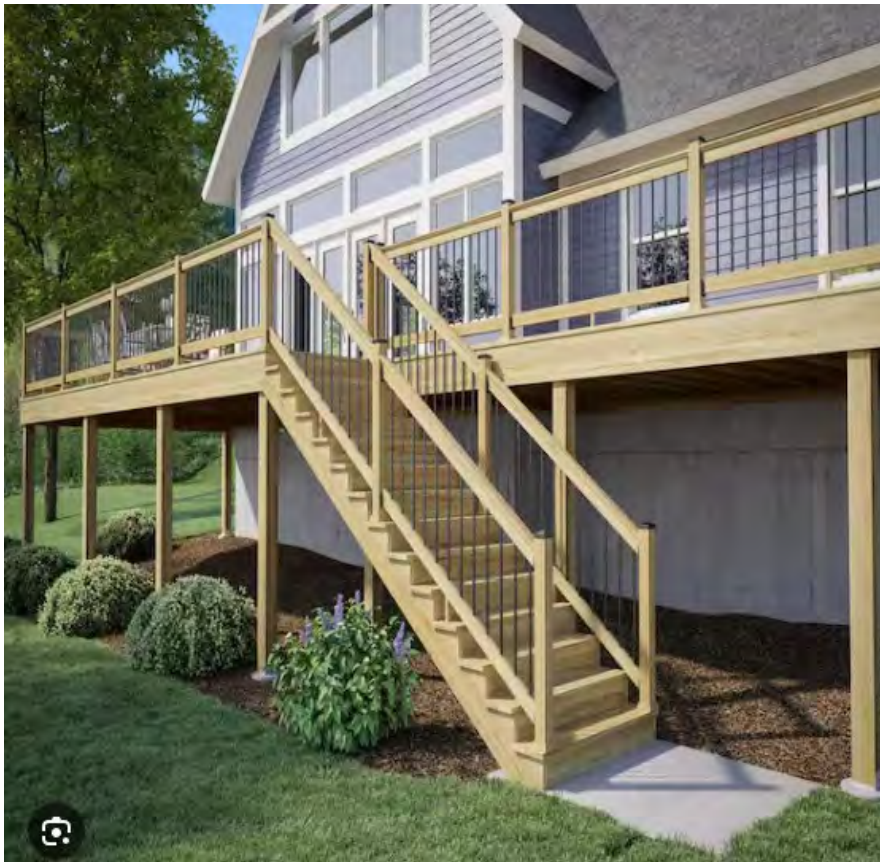
Figure 14: Example of the simplified rear stair and landing posts recommended by staff.

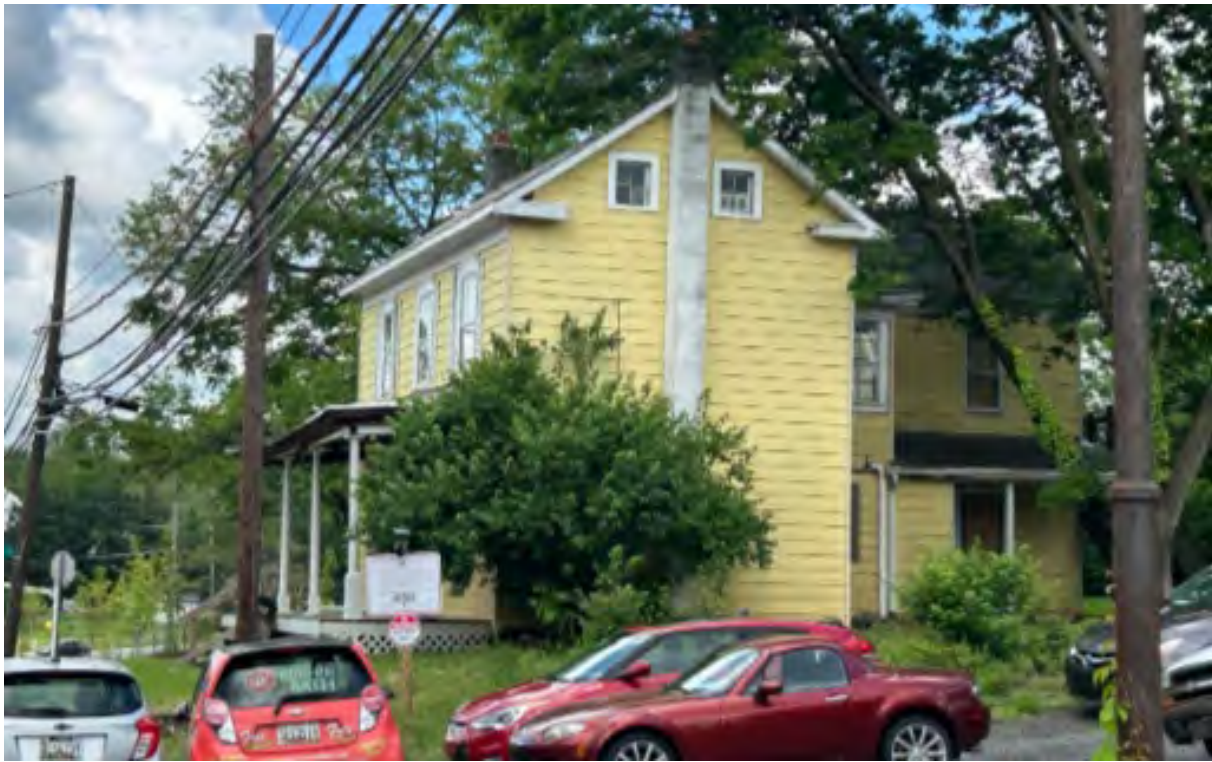
Figure 16: Front and southeast side elevations showing limited visibility of rear ell windows from Frederick Road.

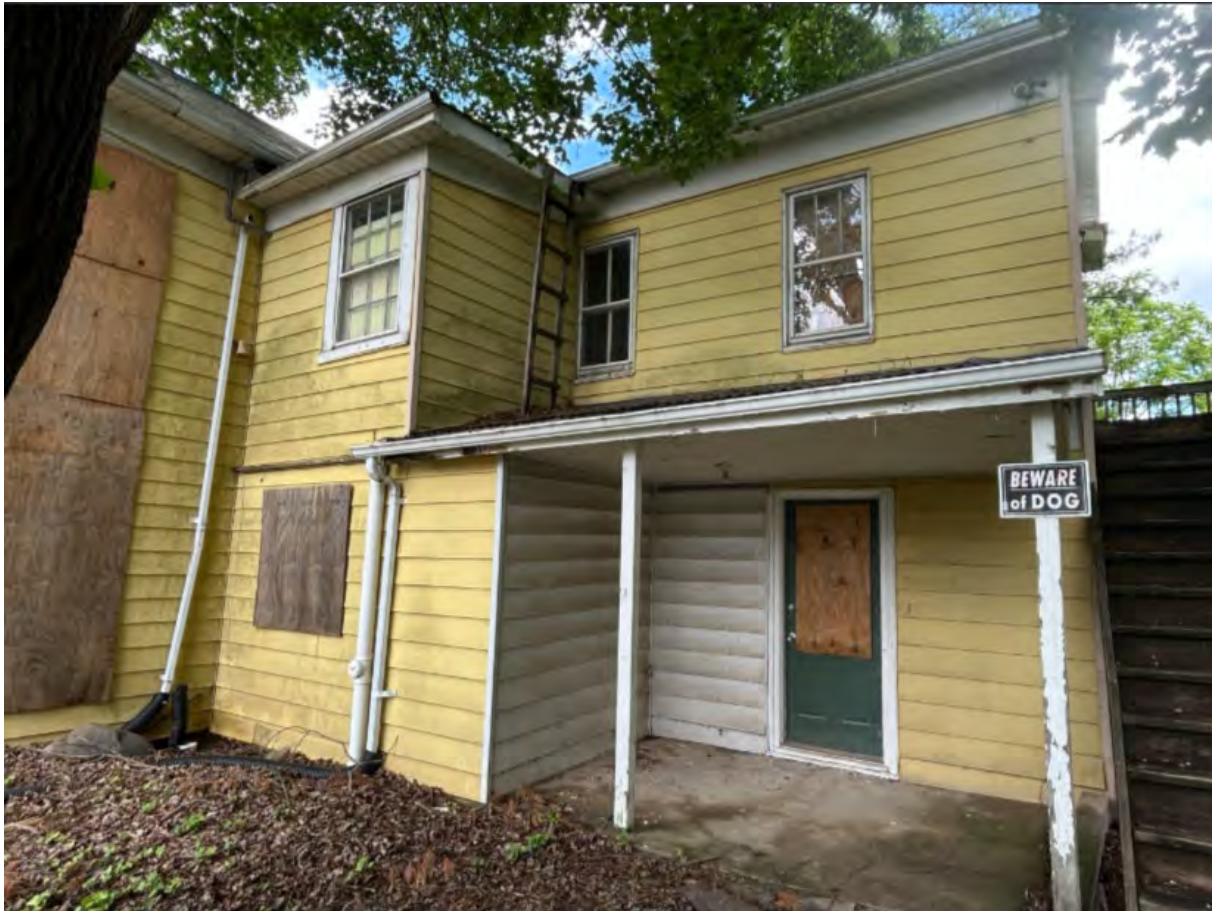
Figure 17: Southeast side elevation of 23345 Frederick Road. The first-floor door would be replaced with a window. The central two-over-two window would be infilled, and the size and configuration of the far-right window would be modified.

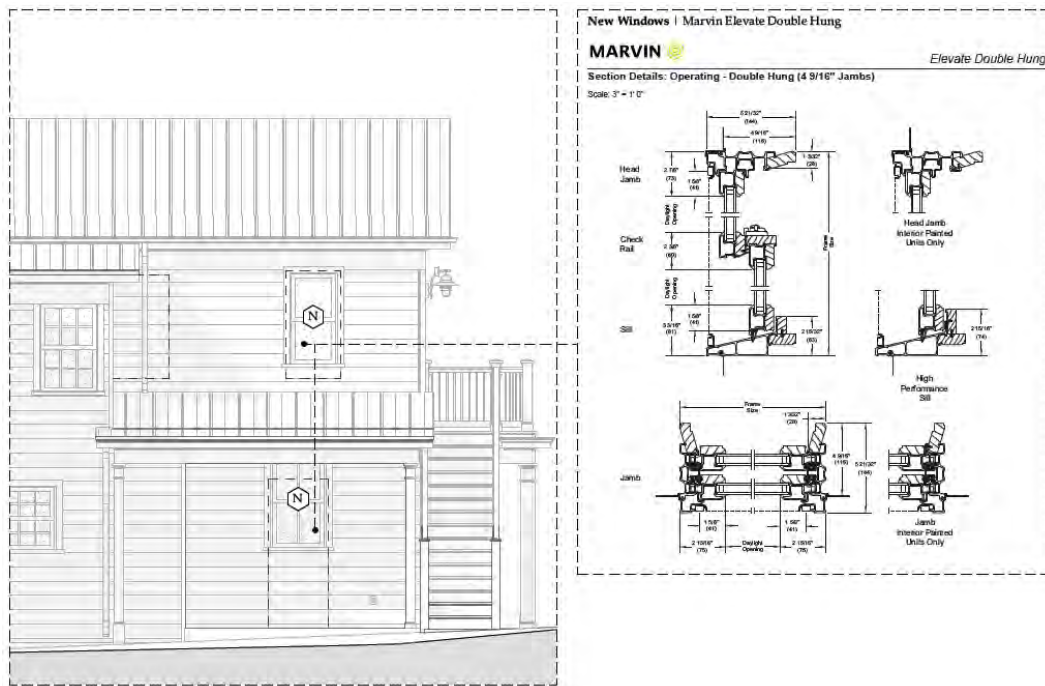
Figure 18: Detail of the proposed side elevation of the rear ell and proposed window details.

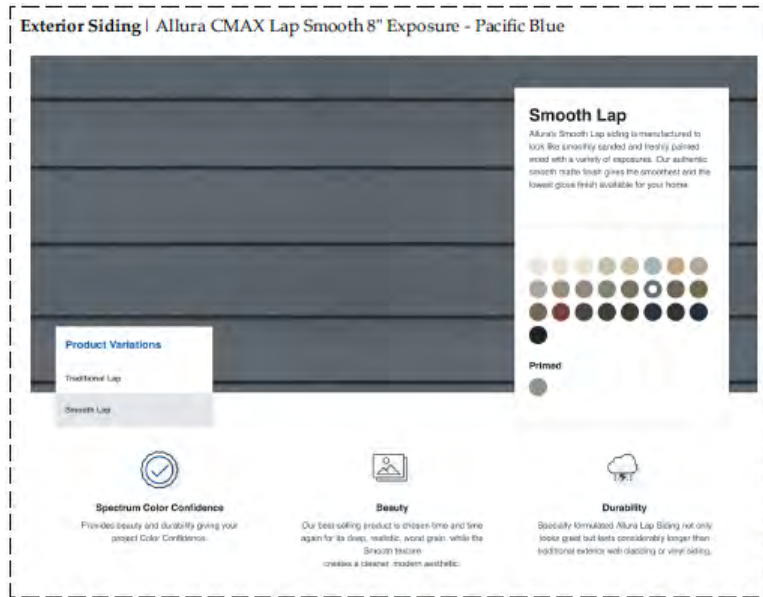
Figure 20: Proposed siding material.

The applicants propose to replace the existing wood-textured aluminum siding with smooth 8-inch exposure fiber cement siding. Staff finds that the aluminum siding predates designation, but that it appears to cover the original wood Dutch lap siding with a narrower, approximately 5-inch exposure, which is visible on the front façade where the porch fascia was recently removed. Staff finds that the removal of the aluminum siding and restoration or in-kind replacement of the wood Dutch lap siding to match the dimensions, texture, profile and appearance of the historic wood siding would be the appropriate treatment, per *Standard 6* and Chapter 24A-8(b)(2). The restoration of the historic siding would be eligible for the County historic preservation tax credit.

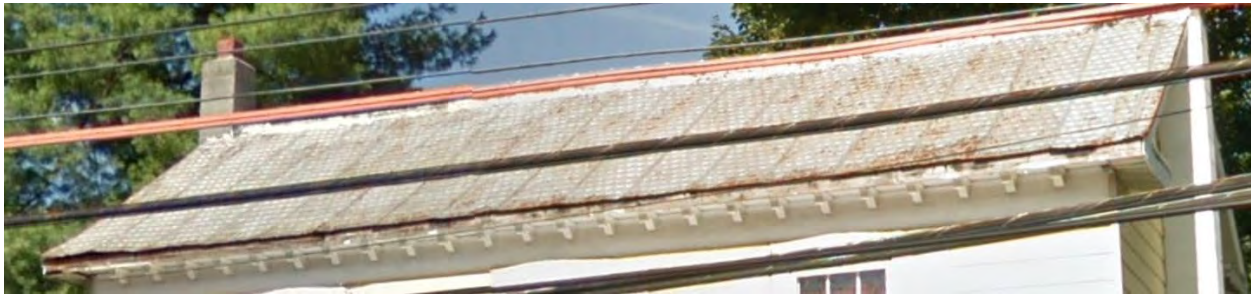
Figure 22: Google Streetview image of the roofing showing the 17 existing panels, shingle texture, and deterioration.

The applicants propose to replace the existing roofing with new McElroy Metals 138T Galvalume Standing Seam roofing with 1.375-inch seams and 16-inch exposure. Staff finds that the existing roofing is unusual and appears to be low-profile standing-seam metal panels embossed with a shingle pattern, seemingly a hybrid of the standing-seam metal roofing and pressed metal shingles popular throughout the country by the late nineteenth century. The roof has 17 panels across the approximately 34-foot wide main roof. Staff is unfamiliar with any other properties with this particular roofing type and it does not appear to be commercially available. Staff finds that the roofing shows evidence of rust and extreme wear, and that, if original to the building, or dating to between the late-nineteenth and early-twentieth centuries, the material is over 100 years old and has likely long exceeded its predicted service life. As such, staff finds that the severity of deterioration warrants replacement, per *Standard 6*, but that an in-kind replacement would be extremely difficult and recommends approval of a compatible roofing material. The *Vision of Clarksburg* notes that the district includes many asphalt shingle replacement roofs, but that numerous properties retain their original standing-seam metal roofs. Staff recommends that a low-profile standing-seam metal roof with maximum 1-inch seams and 18 to 20-inch exposure to more closely replicate the dimensions of the existing roofing would be most appropriate for the replacement roofing. Staff recommends the HPC condition the replacement on the applicants providing detailed photographic documentation of the roofing and encourage the applicants to donate a small section of the roof to the Historic Preservation Office for future reference.

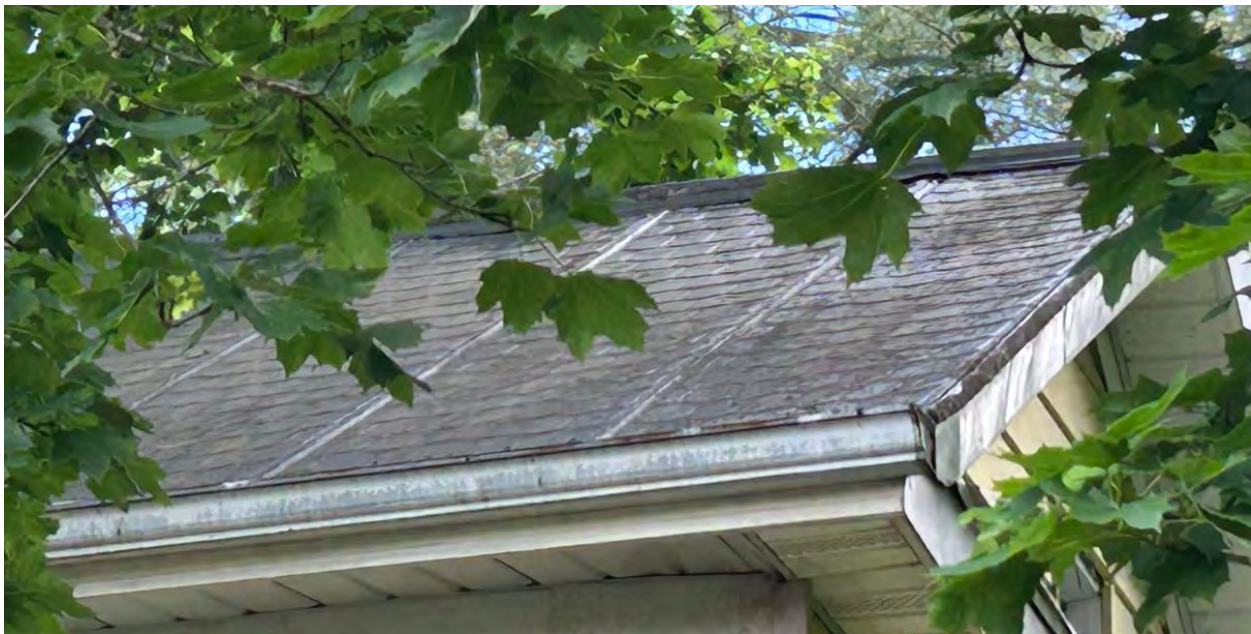
Figure 23: Detail of the roofing on the rear ell.

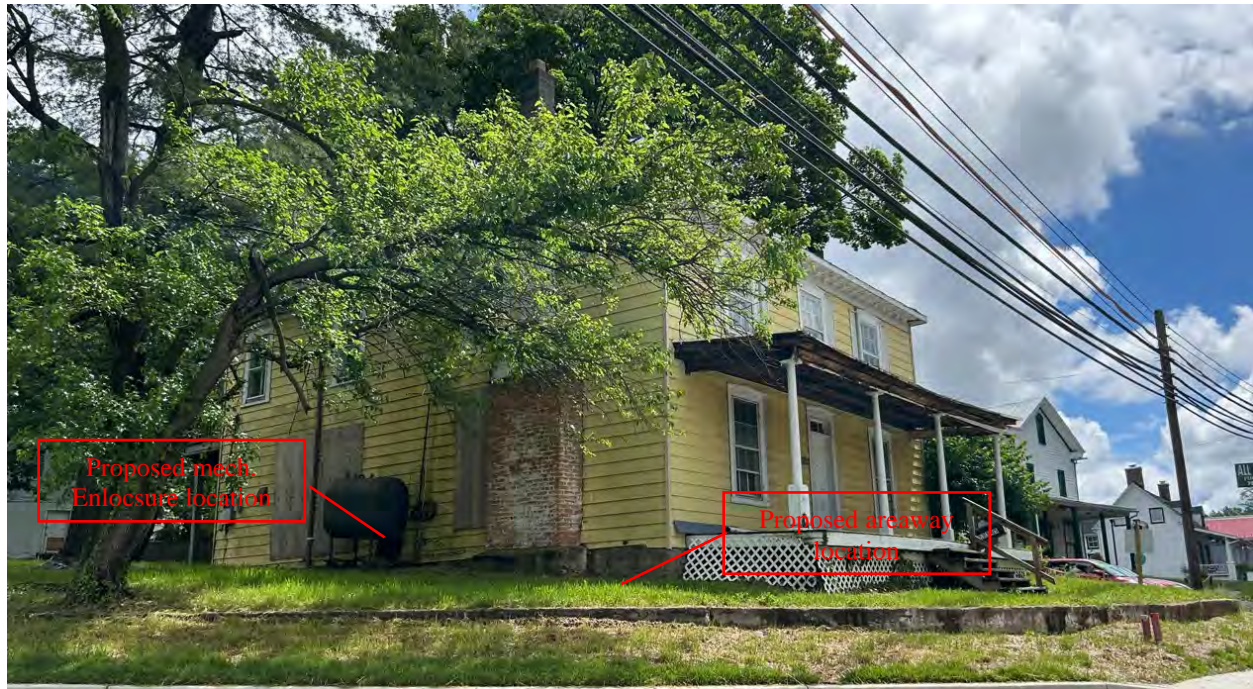
Figure 24: Northwest side elevation and front elevation. The proposed condensing unit enclosure would replace the existing fuel tank.

Along the northwest side elevation, visible from Frederick Road and Spire Street, the applicants propose to cut a new set of doors in the foundation wall, accessed by a new areaway enclosed by a timber retaining wall, and to install a new concrete pad and condensing unit enclosure. Staff finds that, although the equipment enclosure will be visible from the public right-of-way, the proposed location is along a secondary elevation and would not obscure or damage any historic materials or character-defining features of the property, per *Standard 2*. The applicants also propose to install two new vents on the rear elevation, which staff finds will not substantially alter the exterior features of the resource, per Chapter 24A-8(b)(1).

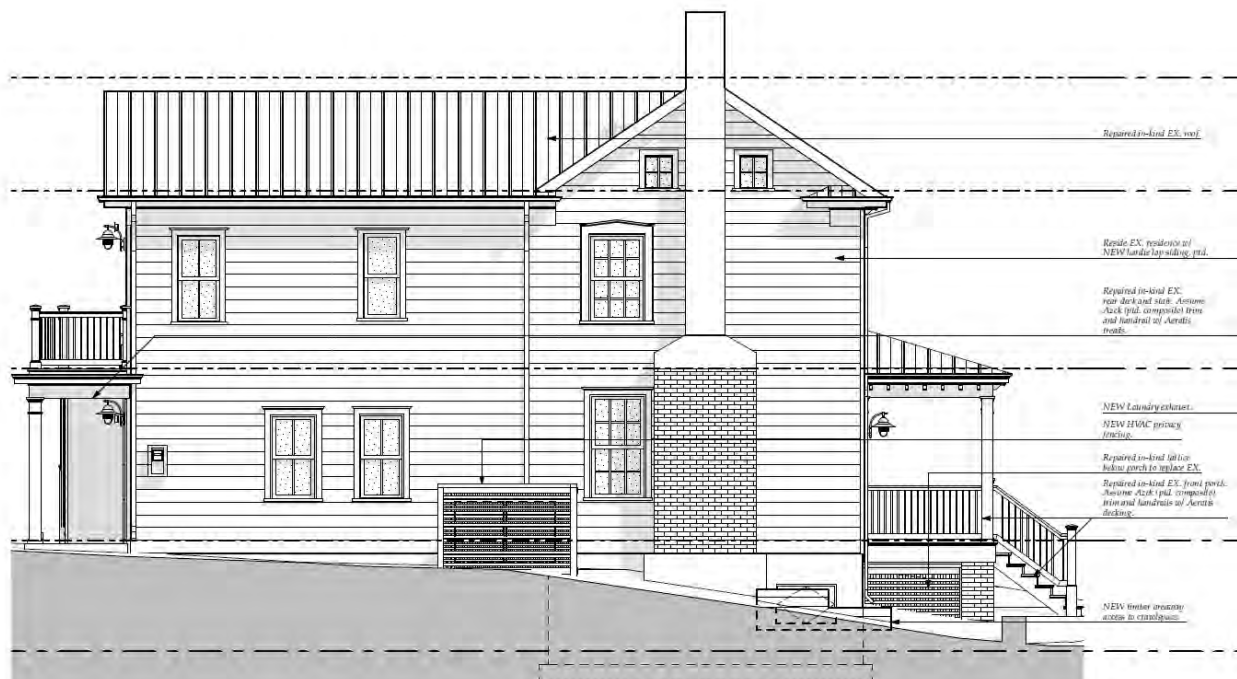
Figure 25: Proposed northwest side elevation showing the areaway and mechanical unit enclosure.

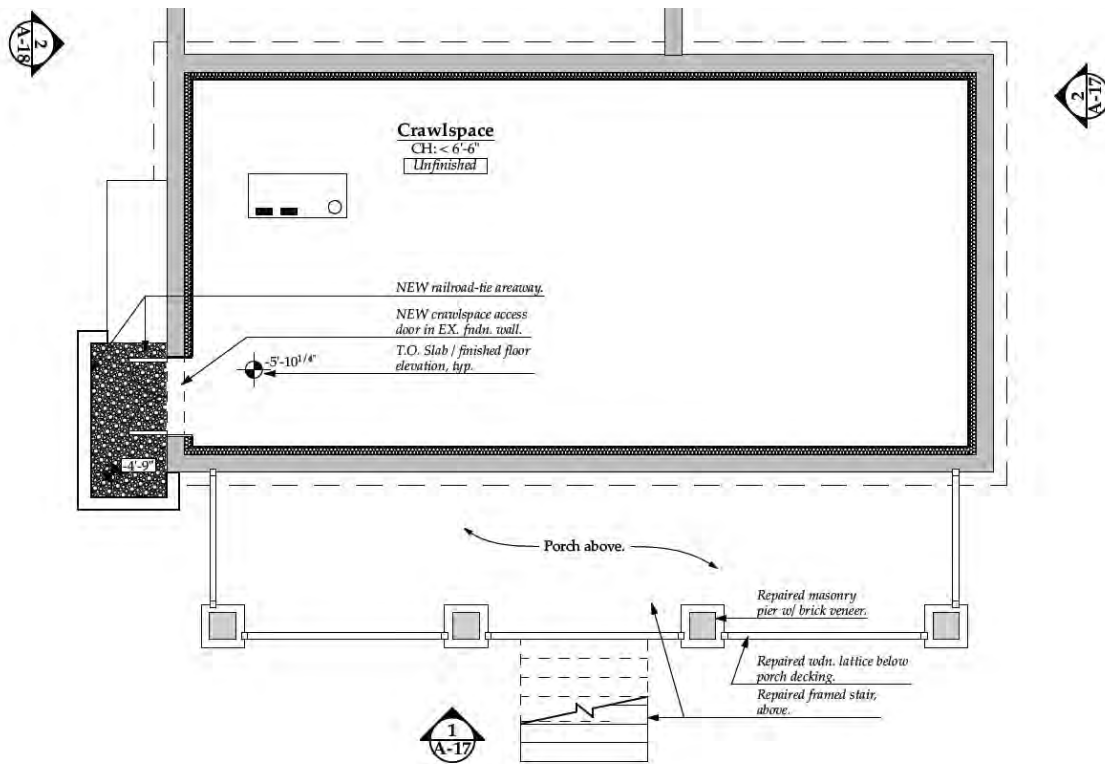
Figure 26: Proposed basement plan.

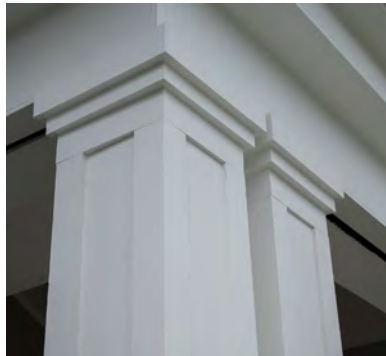
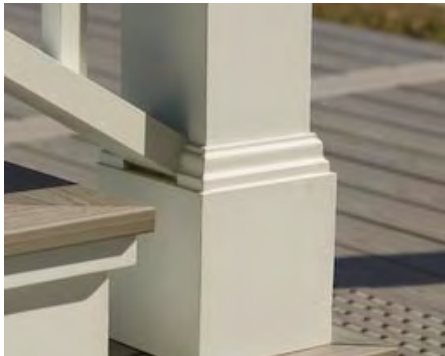
Porch & Deck Flooring | Aeratis Traditions

Aeratis Traditions tongue and groove porch flooring/ porch decking is a paint ready wood replacement product. Competitively priced compared to wood at the time of install, Aeratis Traditions T&G porch flooring offers an unsurpassed warranty, endless design capabilities, significantly lower maintenance than wood and an appearance that not even the most discerning historic official could tell it is not a wood porch when your project is complete.

Aeratis Traditions is an uncolored, paint-ready board that is designed specifically to replace wood tongue and groove products. Traditions can be painted or stained in any color. Unlike the Legacy or Heritage line which can also be painted, Traditions flooring requires paint or

Lengths: 12', 16', or 20'
Width: 3-1/8" (3.092)
Thickness: 7/8"

2. The rear landing support columns must be simplified square wood posts and the minimum size required by Code.
3. The front porch flooring must be run perpendicular to the façade.
