**MONTGOMERY COUNTY HISTORIC PRESERVATION COMMISSION**  
**STAFF REPORT**

<b>Address:</b>	102 East Kirke Street, Chevy Chase	<b>Meeting Date:</b>	9/17/2025
<b>Resource:</b>	Outstanding Resource <b>Chevy Chase Village Historic District</b>	<b>Report Date:</b>	9/10/2025
<b>Applicant:</b>	Britt & Will Williams (Luke Olson, Architect)	<b>Public Notice:</b>	9/3/2025
<b>Review:</b>	HAWP	<b>Tax Credit:</b>	n/a
<b>Permit No.:</b>	1067931 REVISION#3	<b>Staff:</b>	Dan Bruechert
<b>Proposal:</b>	Revisions to previously approved patio and swimming pool.

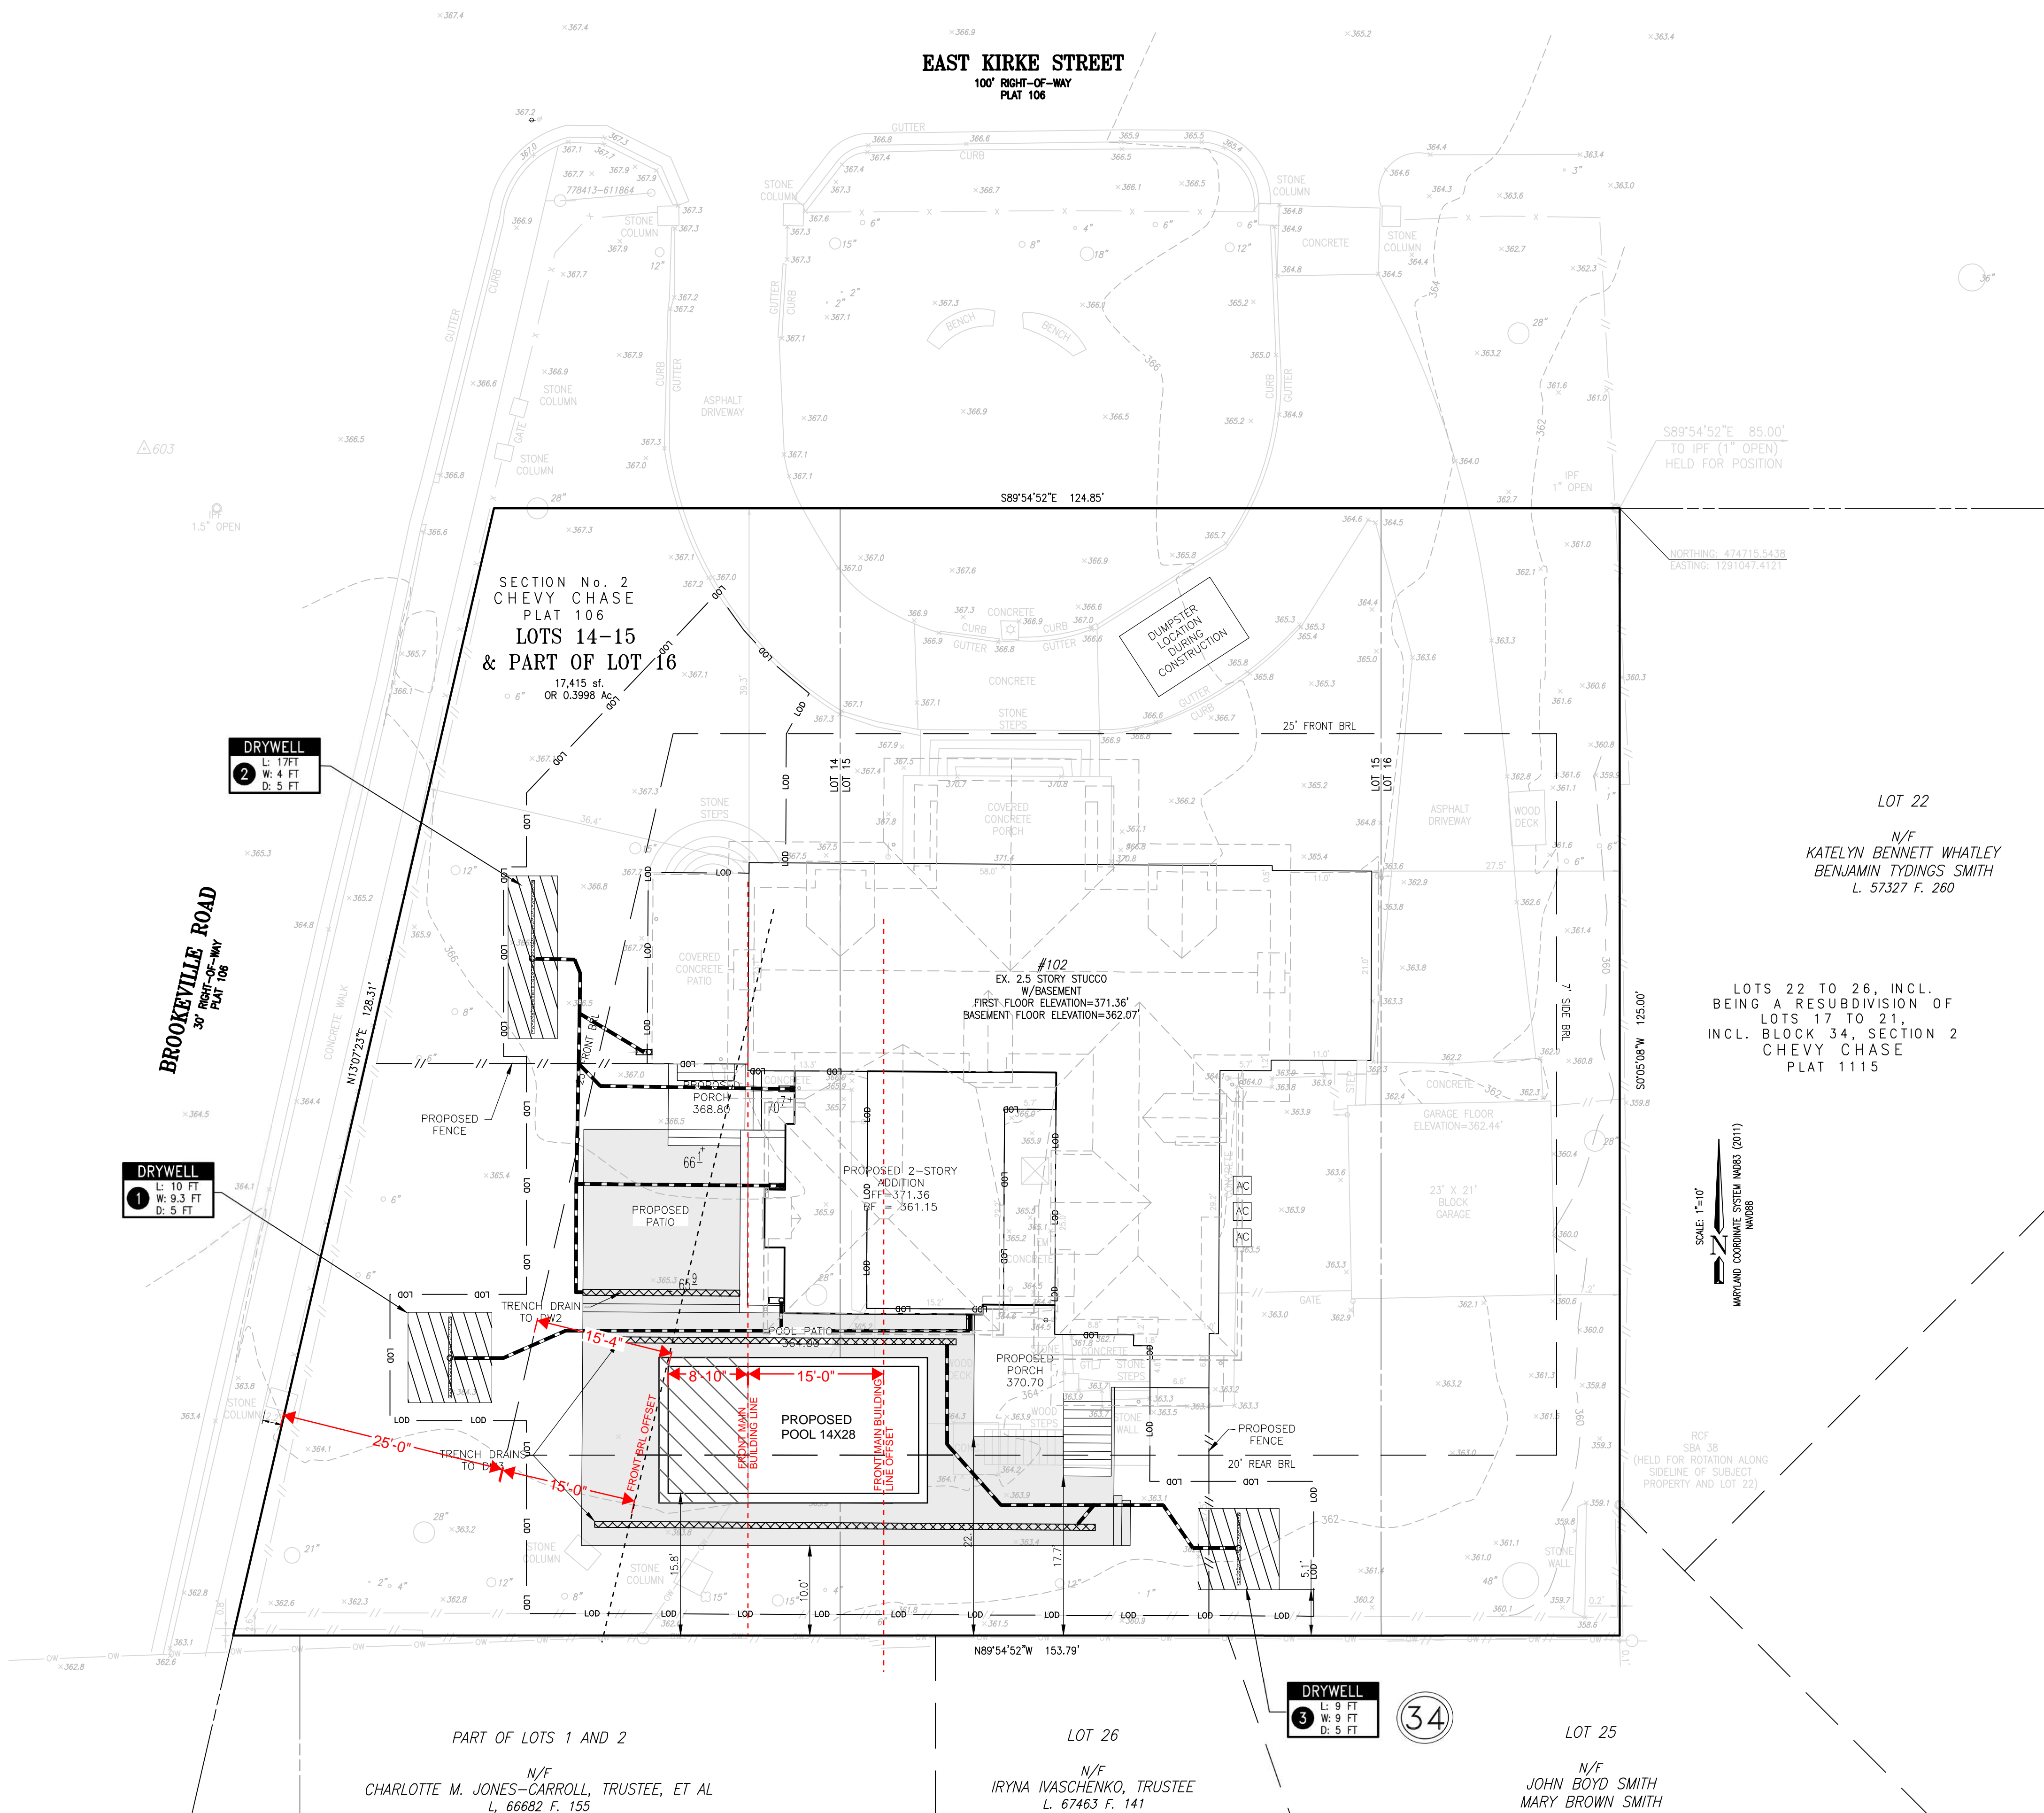
PLAN VIEW

LIMITS OF DISTURBANCE: 4,902 SQ. FT.

DRAINAGE PLAN  
102 E. KIRKE STREET  
LOTS 14-15 & PART OF LOT 16, BLOCK 34  
SECTION No. 2 CHEVY CHASE  
BETHESDA (7th) ELECTION DISTRICT  
MONTGOMERY COUNTY, MARYLAND

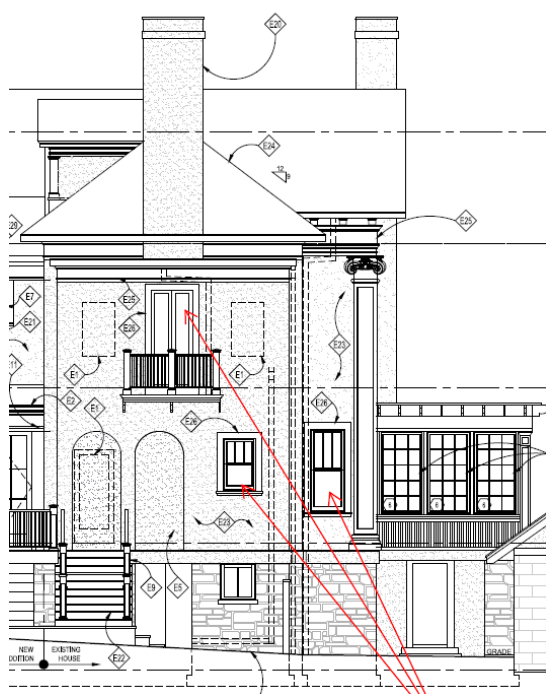
**Figure 2: South elevation showing the location of the proposed window and door replacements.**

The second floor French Doors (Door #3), shown in *Figure 2*, above, are wood with each door divided up into three lights. The doors show signs of warping and have allowed a significant amount of water infiltration to the point that the interior floors adjacent to the French Doors show substantial damage.

On the south and east elevations, the applicant proposes to remove and replace five existing wood windows (identified as windows 1, 2, 3, 7, and 8 in the application). Three windows are on the east elevation of the existing rear-L (see *Figure 3*, below). One of the windows is on the south elevation of the main house mass and the last window is on the south elevation of the rear ell (see *Figure 2*, above). These windows are not visible from the public right-of-way.
